**LUPIN MINES INCORPORATED**  
**(a wholly-owned indirect subsidiary of Mandalay Resources Corp.)**

**RE: 2020 Annual Geotechnical Inspection – Lupin Mine Tailings Containment Area, Nunavut  
Lupin Mine, Nunavut, License Number 2AM-LUP2032**

LMI	Lupin Mine Incorporated		
	2020 Dam Safety Inspection		
Site Inspection Photograph Log for Dam 1A and 1B

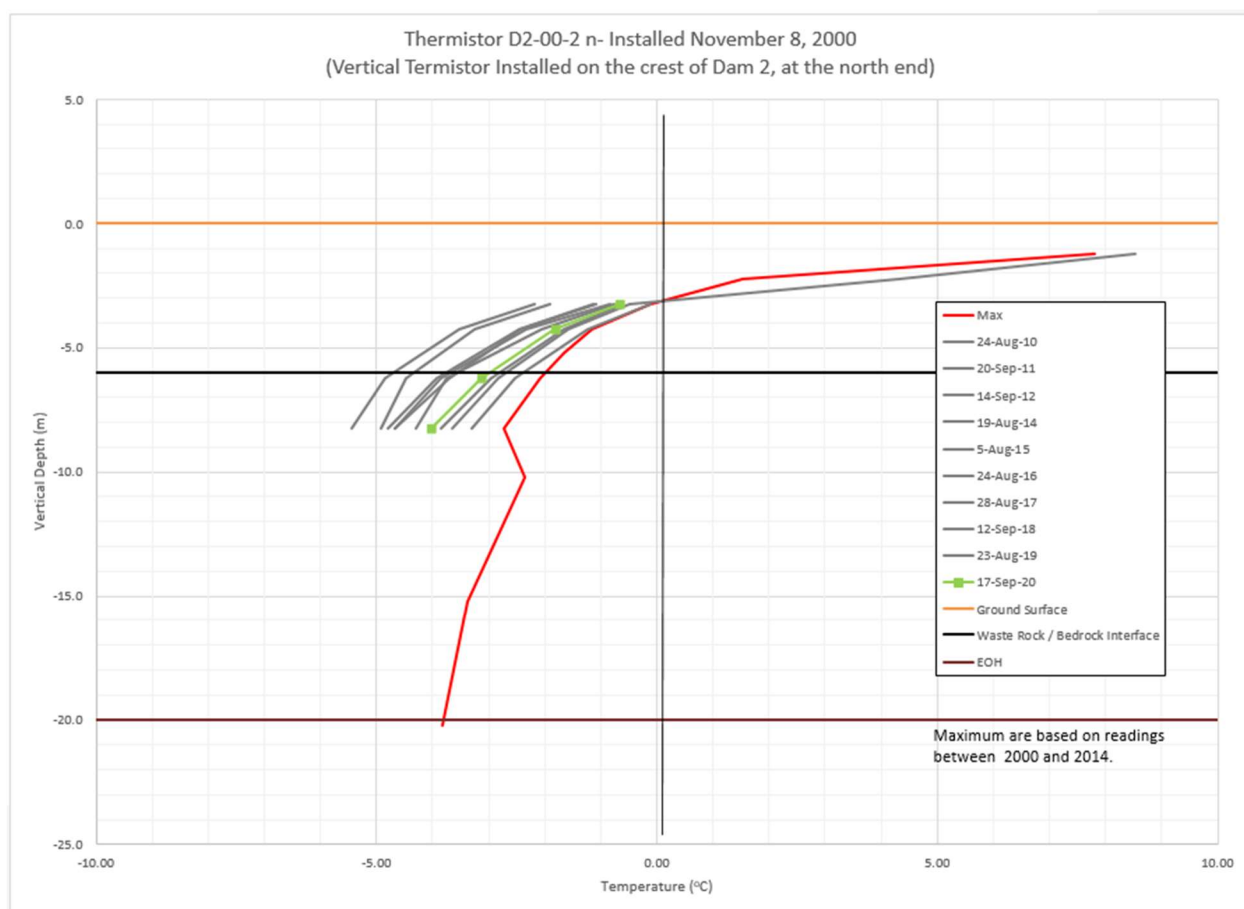
**Figure 3-1: Thermistor Reading for Dam 2**

For the perimeter dams, the four functioning thermistors are less than 20m deep. The four thermistor readings are shown in the figures below. The data suggests the 2020 readings are within the historical variations, taking into account annual climatic variations and time of reading. Generally, the active layer (thaw zone) ranges from 2m to 3m depth, as interpolated by the 0°C gradient line. The largest historical variation in the 2020 data set is approximately 3.3°C (between -1.2°C and -4.5°C) in Dam 1 (D1A-00-01s) at the depth of 7m.

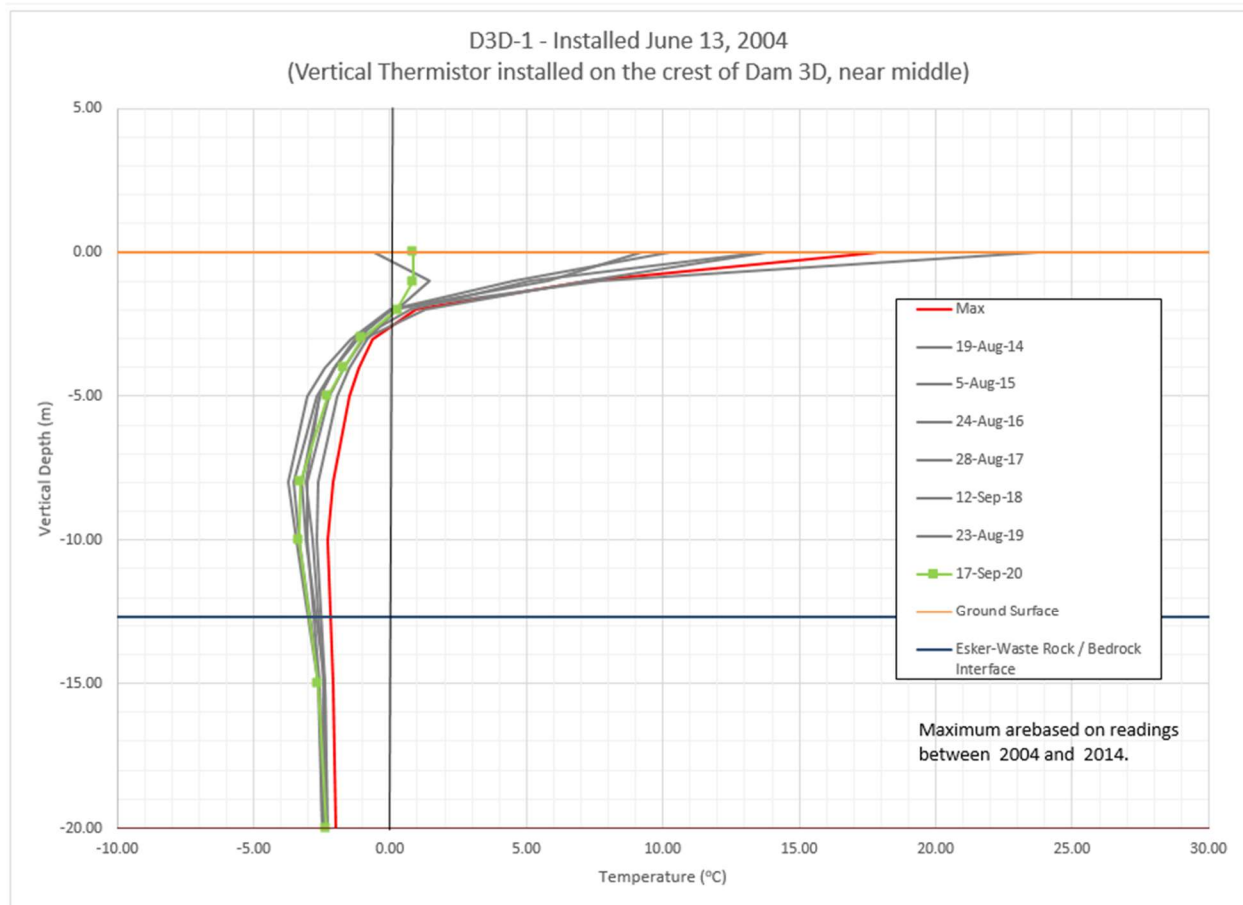
**Figure 3-4: Thermistor Reading for Dam 3D**

For the internal dams, the two functional thermistors are also less than 20m deep in Dam K and Dam 3D. These were not historically monitored as rigorously as the ones installed in the perimeter dams, and only have recent data from 2014. The two thermistor readings are shown in the figures below. The active layer is observed to be between 2m to 3m, as interpolated by the 0°C gradient line. The variations between the data set are less than 2°C and generally occur below the historical maximum.

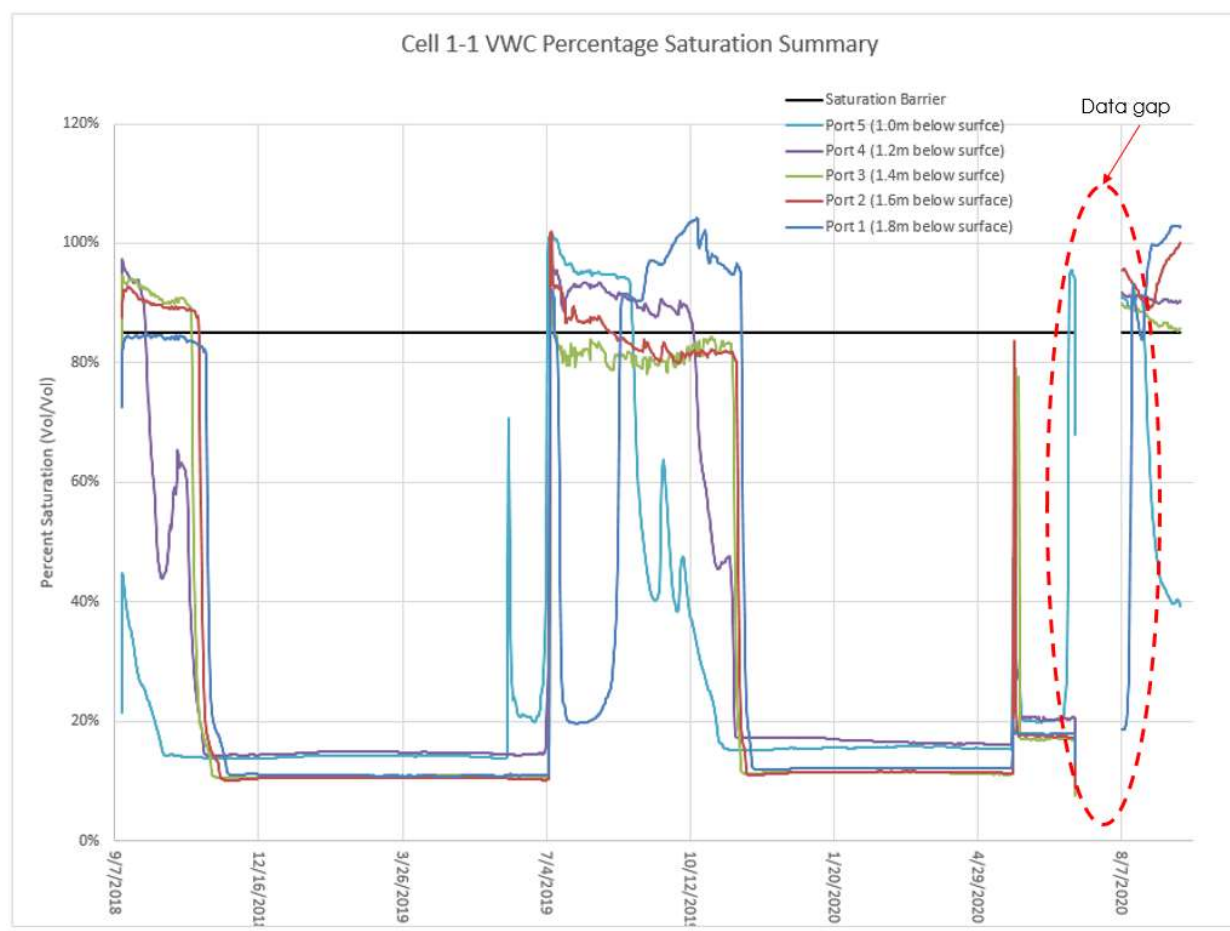
**Figure 3-6: Cell 1-1 VWC Percentage Saturation Summary**

The figure below shows the percentage saturation for VWC in Cell 1. All sensors show frozen conditions between November and July. In addition, all sensors indicate some variability in the initial data recorded between September and October 2018, potentially related to the method of installation. This variability can be confirmed with longer monitoring periods once a long-term trend is established. There is a spike in the percentage of saturation in all sensors in early July related to overall thawing. The 2020 data indicated Ports 1, 2 and 4 are above 85% saturation once thawed. Port 3 showed a variable trend but remains above 80% saturation. It should be note that there is a gap in data collection between July 6<sup>th</sup> to August 7<sup>th</sup>. The cause of the data gap is unknown and will be noted for future reference.

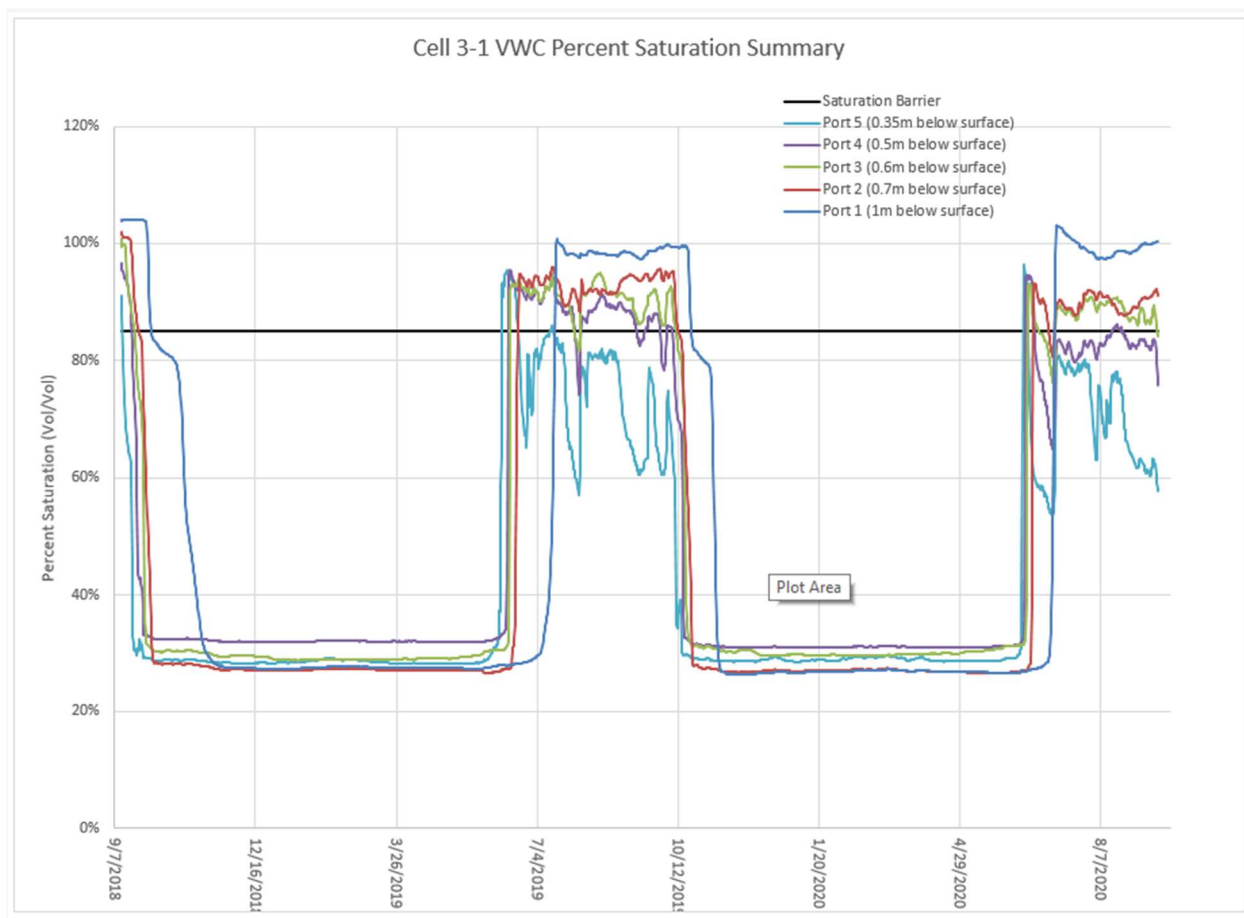
**Figure 3-7: Cell 3-1 Port 1 VWC Result**

The figure below shows the percentage saturation for VWC in Cell 3. The majority of the sensors show frozen conditions between October and June. Similar to Cell 1-1 VWC, all sensors indicate there might be variability at the initial data collection period between September and October 2018 potentially related to the method of installation. This variability can be confirmed with longer monitoring periods once a long-term trend is established. There is a spike in percentage of saturation in the top sensors in June signaling overall thawing. The 2020 data indicated Ports 3 to 1 are above 85% saturation once thawed. Port 5 showed a variable trend between 57% to 86% saturation, mostly related to surface evaporation and rehydration from rain.

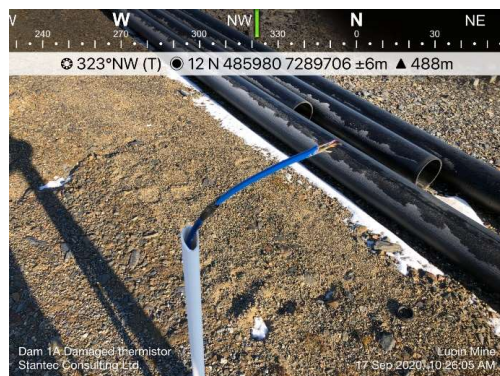
Photo 3b: View of the damaged thermistor.

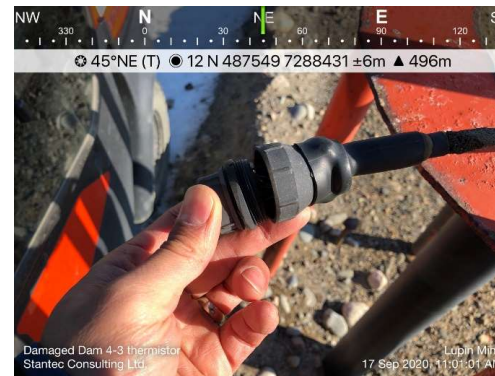
Photo 18: View of the damaged thermistor

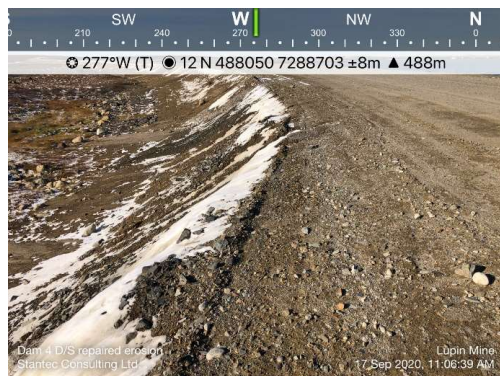
Photo 19: Looking west at a repaired erosion gully at the downstream crest near the east abutment of Dam 4.

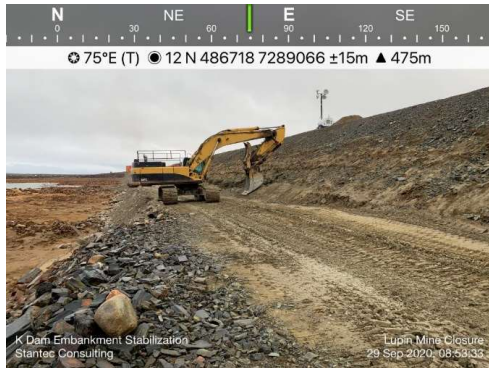
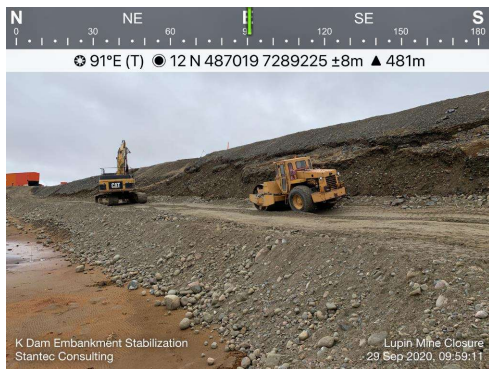
Dam K has experienced considerable undercutting at the toe from Pond 2 wave action that was reported previously, and it was repaired this year. Construction was conducted as the Pond 2 water level was lowered to allow stable access to the toe of the dam. A buttress was constructed with compacted sand and gravel to reinforce the toe and support the face of the dam. The buttress was constructed to approximately half the height of the dam with a 5m crest. The construction work was overseen by a designated EOR representative to ensure the buttress was constructed using appropriate material and compacted accordingly.

Photo 32: Looking east at the reinforcement buttress being constructed eroded toe at Dam K.

Photo 35: Looking east at the reinforcement buttress being constructed eroded toe at Dam K.

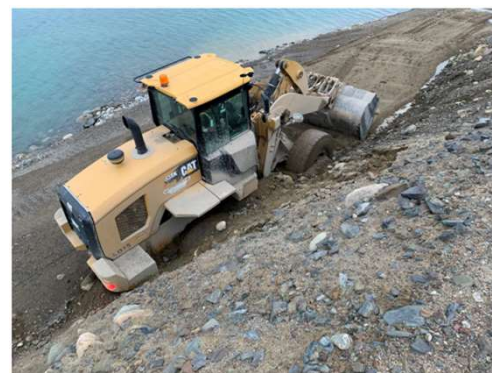
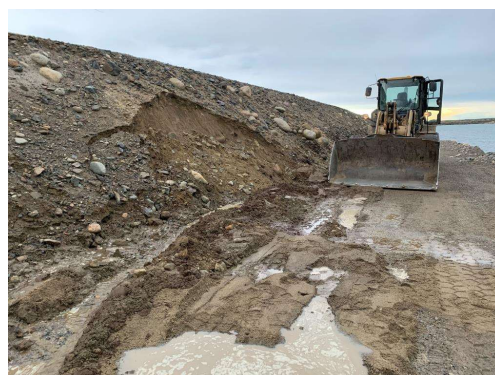
Dam M was repaired with a reinforcement buttress and crest surface backfill in 2016 (Norwest 2016). The toe of the buttress has experienced some wave erosion at the HWM. The water level rose in 2019 freshet and by this year the buttress toe along with the riprap were submerged and localized minor sloughing was observed. During 2020 closure activities, seepages were observed along the toe at the old buttress crest. Engineering instruction was provided to the contractor to place additional fill to limit the seepage. During the construction, the loader got stuck and caused a minor localized failure at the downstream face when it tried to free itself. This was observed by the EOR representative and documented in an incident report. Further repair was suspended until the contractor could provide a different construct method.

Dam M	2.2	Sloughing in localized sections of the buttress due to raised water level during 2020 freshet. A construction incident has caused a localized minor failure to the downstream face of the dam.	Repair the sloughed section of the buttress and the localized failed section once the water level is lowered. Re-slope the buttress to 2H:1V design for final closure.	Minor erosion at the downstream toe above the riprap protection	Repair the eroded toe areas.
Dam N	0.8 <sup>(2)</sup>	A shallow channel was constructed to manage 2020 freshet. It was backfilled under engineering oversight. Material was stockpiled on the dam in preparation for cover placement.	Monitor the water level behind Dam N and lower the water when practicable to yield minimum 1m freeboard. Monitor the dam around the stockpile for deformation.	Minor wave action erosion at HWM.	Monitor the water level behind Dam N and lower the water when practicable to yield minimum 1m freeboard.

Photo 46: Looking down at the incident on the Dam M buttress where localized failure caused by the equipment, near the junction of Dam N.

Photo 47: Looking at localized failure caused by the equipment near the junction of Dam N

1. Upon recommencement of closure activities in 2021, the localized failed section of Dam M should be repaired.
2. Monitor the seepage at the downstream toe of the divider dyke for erosion and potential instability. Repair as needed in 2021 when access is available.
3. Monitor the proximity of the breached location in Dam L for any seepage and potential instability. Repair as needed in 2021 when access is available.
4. Monitor the water level behind Dam N and lower the water level to maintain a minimum 1m freeboard.

1. Upon recommencement of closure activities in 2021, the localized failed section of Dam M should be repaired. LMI will also be carrying out the closure work as per the construction drawings filed with the NWB in July 2020 under Part G, Item 1.
2. Monitor the seepage at the downstream toe of the divider dyke for erosion and potential instability. Repair as needed in 2021 when access is available.
3. Monitor the proximity of the breached location in Dam L for any seepage and potential instability. Repair as needed in 2021 when access is available.
4. Monitor the water level behind Dam N and lower the water level to maintain a minimum 1m freeboard.

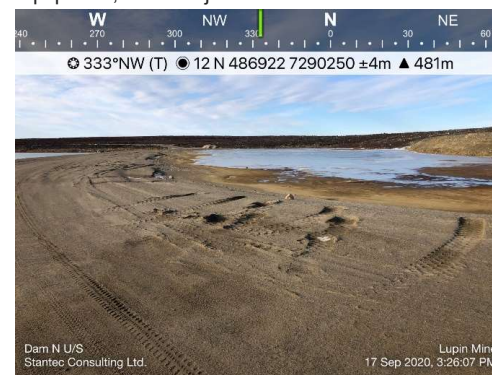
During freshet, a shallow ditch was constructed at the north abutment of Dam N to passively manage the freshet water. This was backfilled after the freshet. Both the construction and backfill were overseen by EOR representative. During the inspection Dam N was observed to be in stable condition, but it had only 0.5m of freeboard between it and Pond 2. This was communicated to LMI site personnel, and the need to increase the freeboard to 1m to meet water license requirement was highlighted. Stantec was later informed that the pond level was lowered after water treatment operations and Cell N freeboard increased to 0.8m prior to winterization.

Photo 49: Looking north at the crest of Dam N and ponding water with approximately 0.8m freeboard.

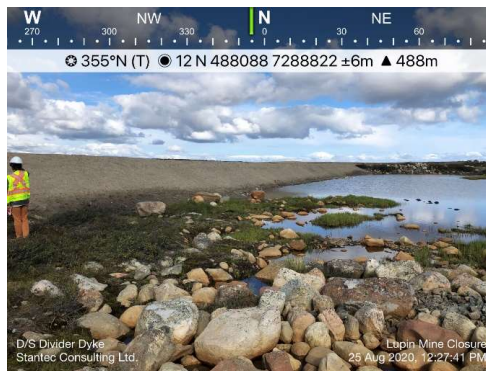
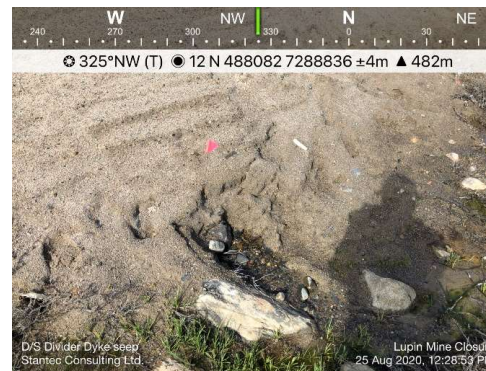
The cracks and erosion observed in the divider dyke were repaired by the newly placed compacted fill. However, new zones of seepage were observed at the newly constructed downstream toe of the divider dyke. These seepages were not observed previously and were monitored during closure activities. The seepages will continue to be monitored until the proposed spillway is constructed in 2021. The seepages are expected to stop once the spillway is constructed to passively manage the water at the closure elevation, which is below the observed seepage zones.

Photo 51: Looking north at the downstream slope and the seepage zones at the toe of the divider dyke.

Photo 52: Looking northwest at one of the seepage zone at the toe.

Divider Dykes	1.7	The dam was raised by 0.8m temporary to manage freshet. The old erosion and crest were repaired. New seepages are	Continue to monitor the seepages until the closure spillway is constructed. Repair any erosion	Erosion, sloughing and cracks along upstream and downstream of the northern portion of the dyke. Uneven	Second priority to complete the repair to the northern section

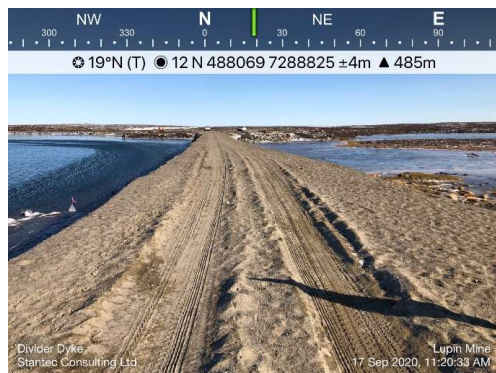
Photo 53: Looking north at the eroded crest slopes and sloughed crest of northern divider dyke.
