WATER LICENCE INSPECTION FORM

| Lupin Mines Inc | | Karyn Lewis | |
| 2AM-LUP2032 | | Project Manager | |
| 2020 July 2 | | Baba Pedersen | |

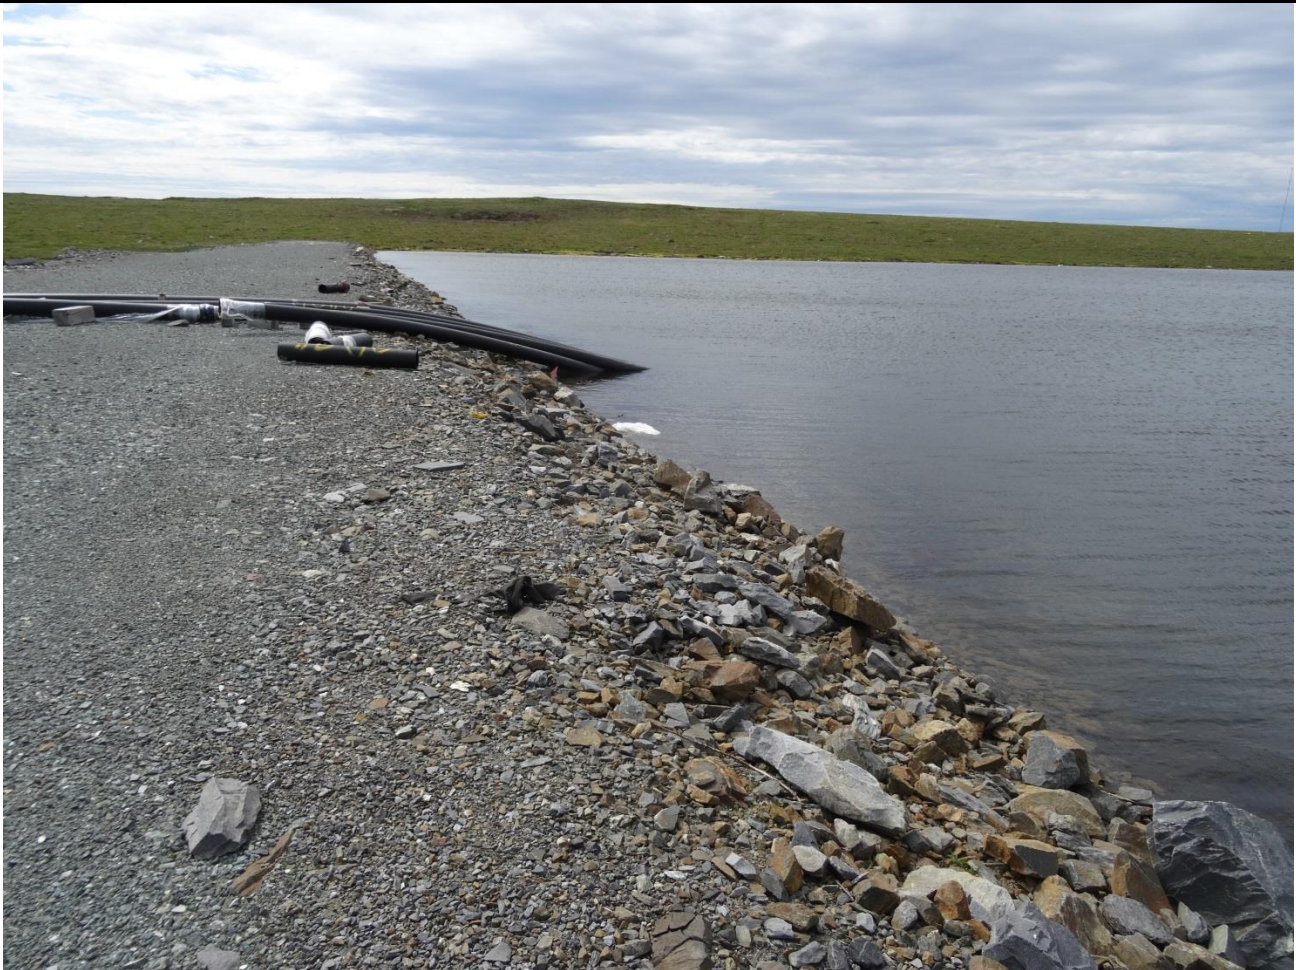
Photo 3

| <p>The Mine Site Reclamation Project is now in full operation. There are approximately up to 84 people on site at any time. The following was observed by the writer:</p> <p>1. The Sewage Lagoon (Photo 3) is within volume limits as it still has more than 1 meter of Freeboard. The writer was informed that the content of the Lagoon has been Sampled recently and LMI is awaiting the Lab Results.</p> <p>2. The Temporary Land Fill Storage Area (Photos 4 through 8) is comprised of only Non-Hazardous Materials and there was no visible Run-off into any bodies of water or streams.</p> <p>3. LMI Mitigation Measures for Dust Control is by the use of a Truck (as seen in Photo 9) watering all Roads. During very strong winds (Photos 10 and 11) windblown dust has the potential of traveling long distances, hence the use of a water truck is needed to minimize the risk of windblown dust.</p> | | | |

Description: Sewage Lagoon

| SECTION 3 | <input type="checkbox"/> Comments | <input type="checkbox"/> Non-Compliance with Act or Licence | <input checked="" type="checkbox"/> Action Required |
|---|---|---|---|
| <div><div>1. Sewage Lagoon Sample Results from the Lab <b>MUST</b> be provided to the writer for approval prior to Decanting.</div><div>2. The Temporary Landfill Storage Area is in an acceptable state. The writer walked the entire area and the perimeter and found no major concerns.</div><div>3. LMI <b>MUST</b> pay constant attention to Dust Control Mitigation Measures in order to minimize the effects of windblown dust getting into any Bodies of Water.</div><div>4. The writer has no concerns with the Incineration of Camp Food Waste.</div><div>5. The writer has no concerns with Potable Water retrieval or Consumption Levels.</div><div>6. LMI <b>MUST</b> inform the Nunavut Water Board <b>IN WRITING</b> if there are to be any changes in the Approved Project Schedule.</div><div>7. Where required, Sample Station Signage is to be Repaired or Replaced prior to the next scheduled Inspection.</div></div> | | | |

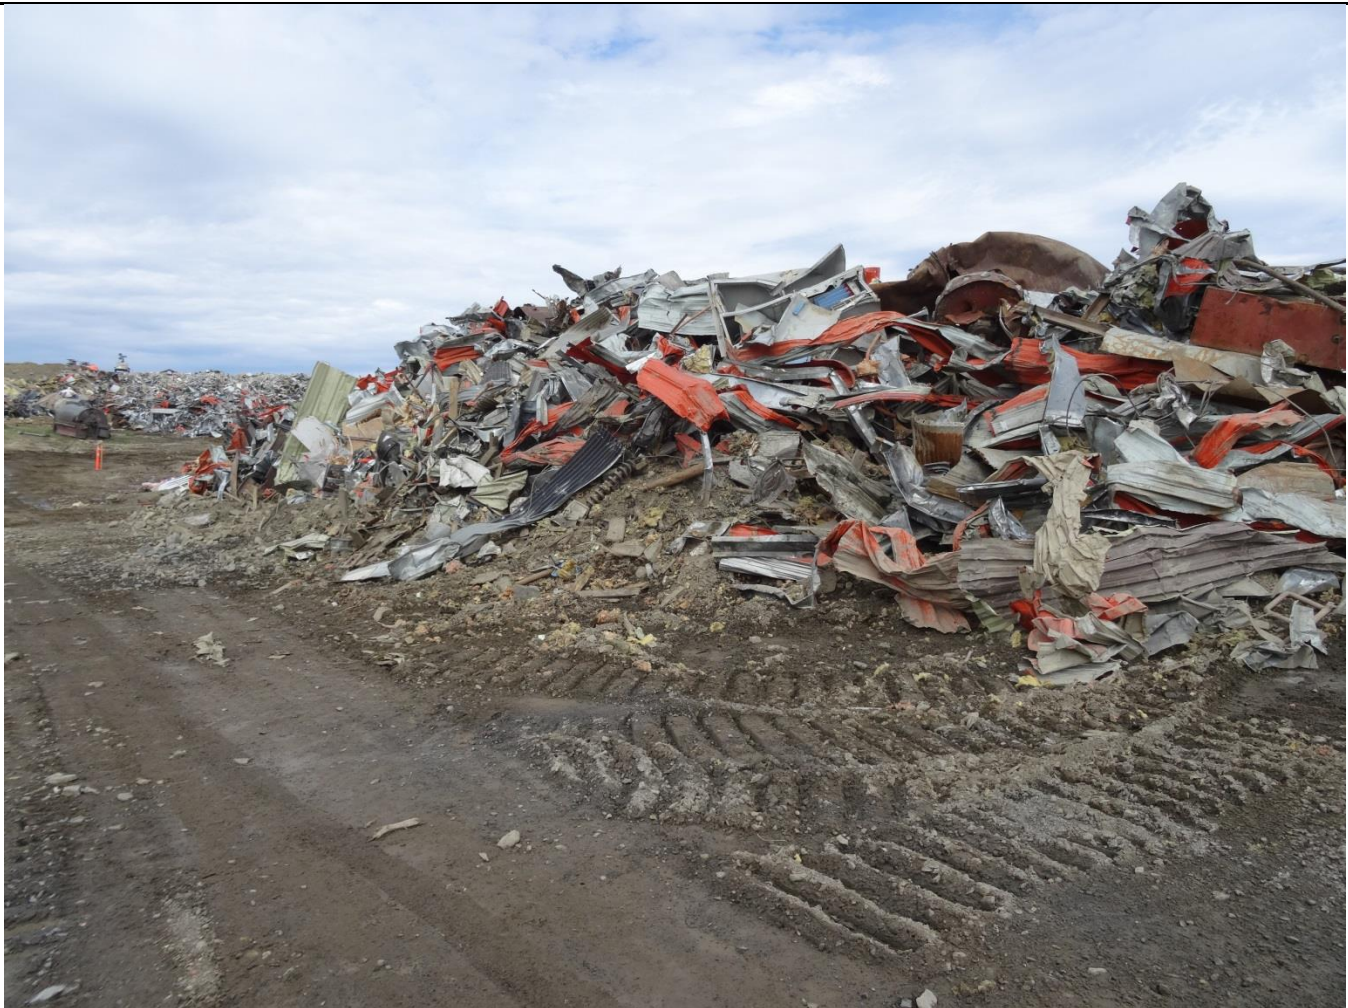
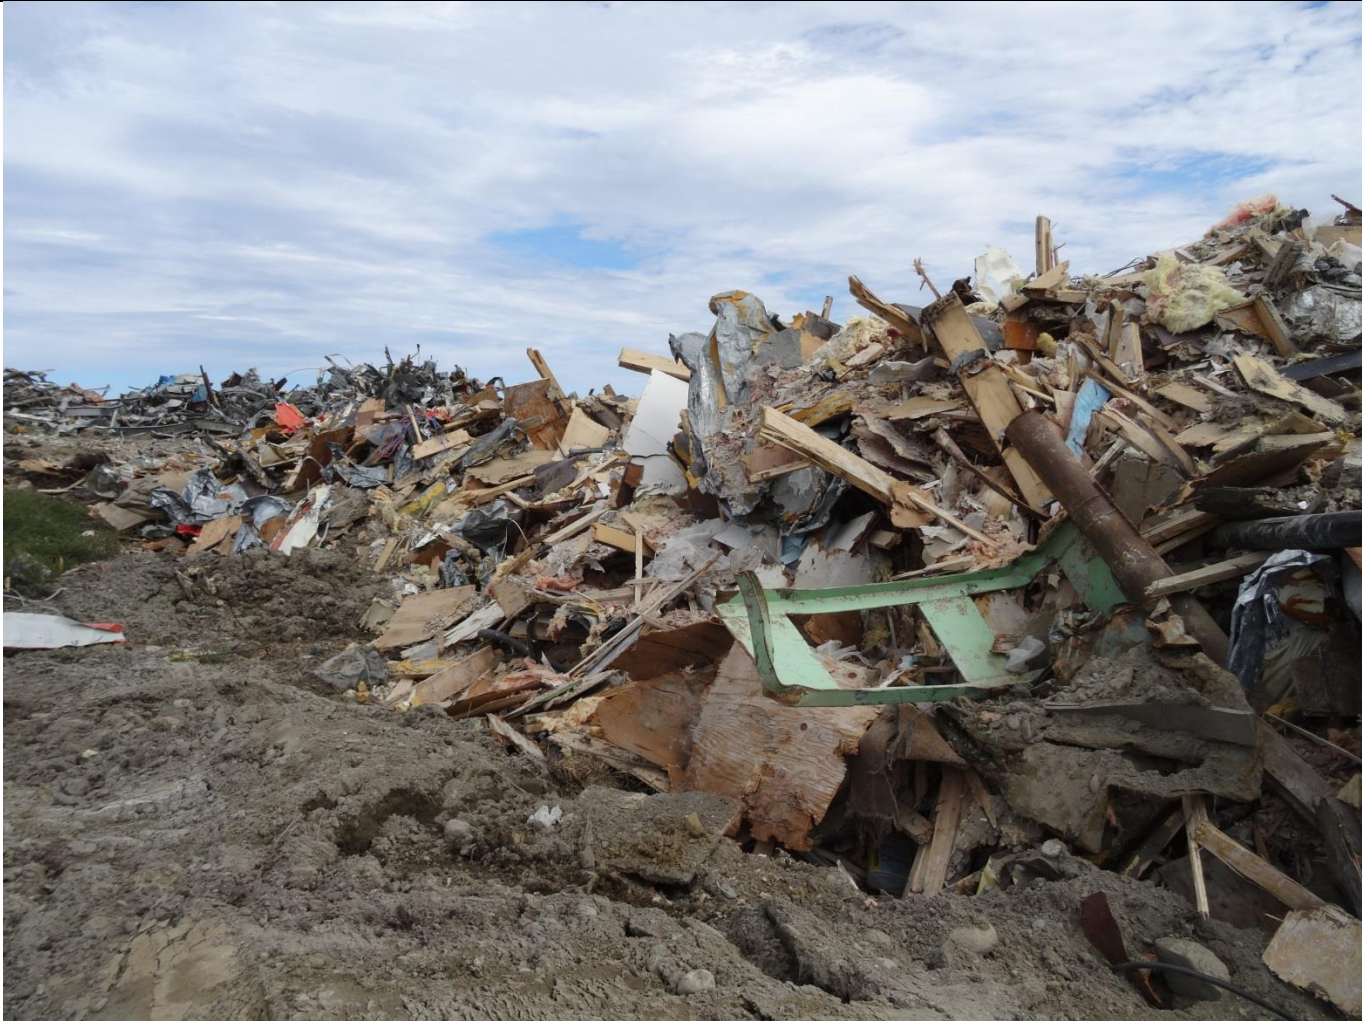
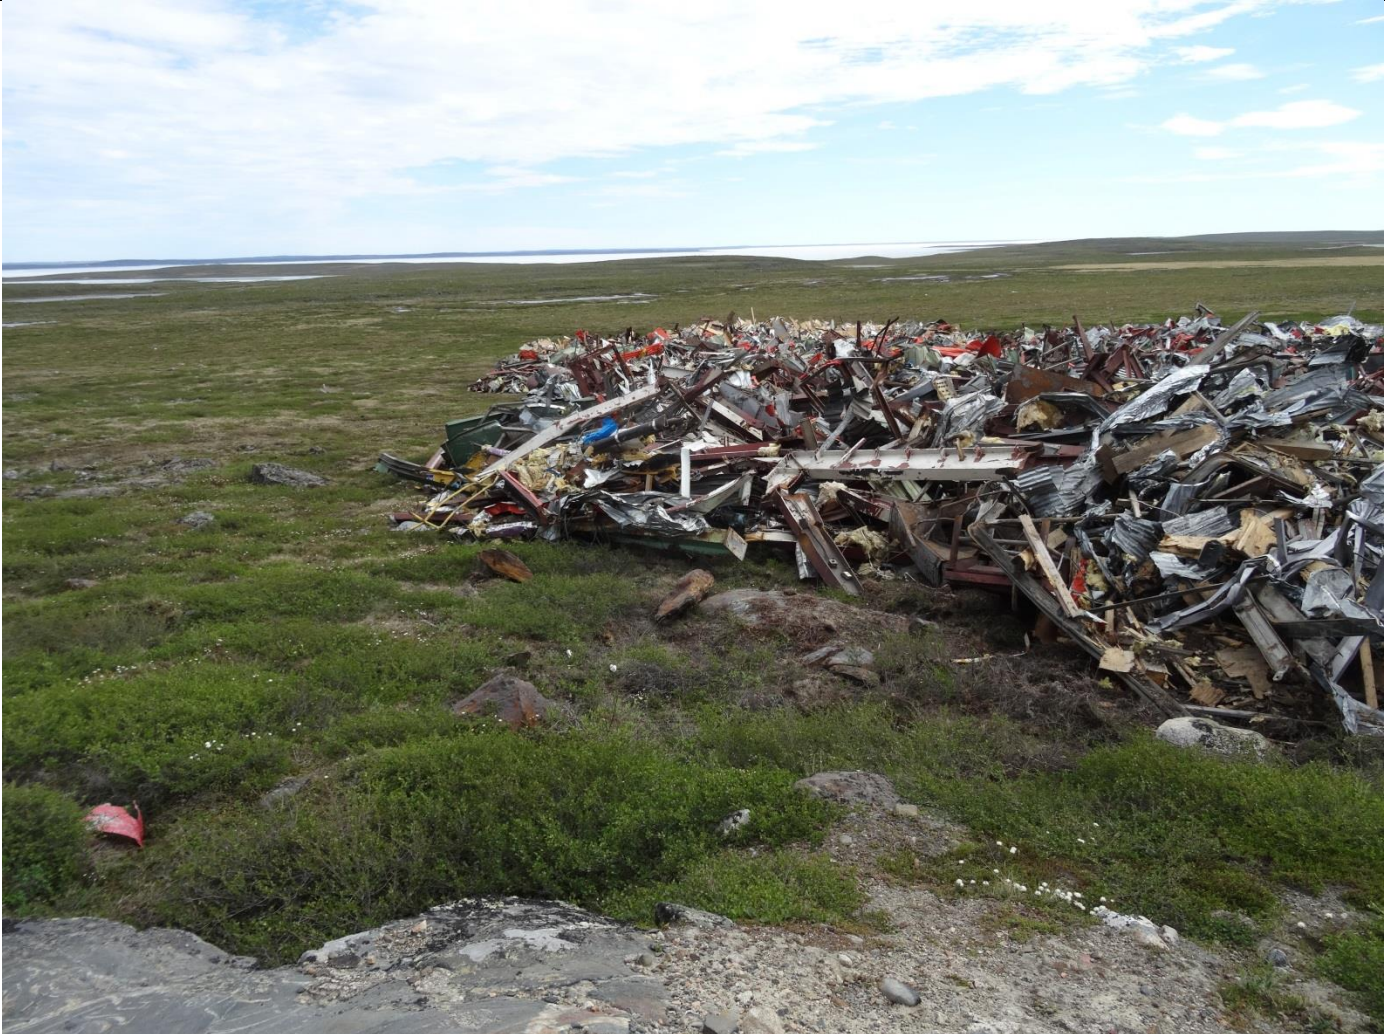
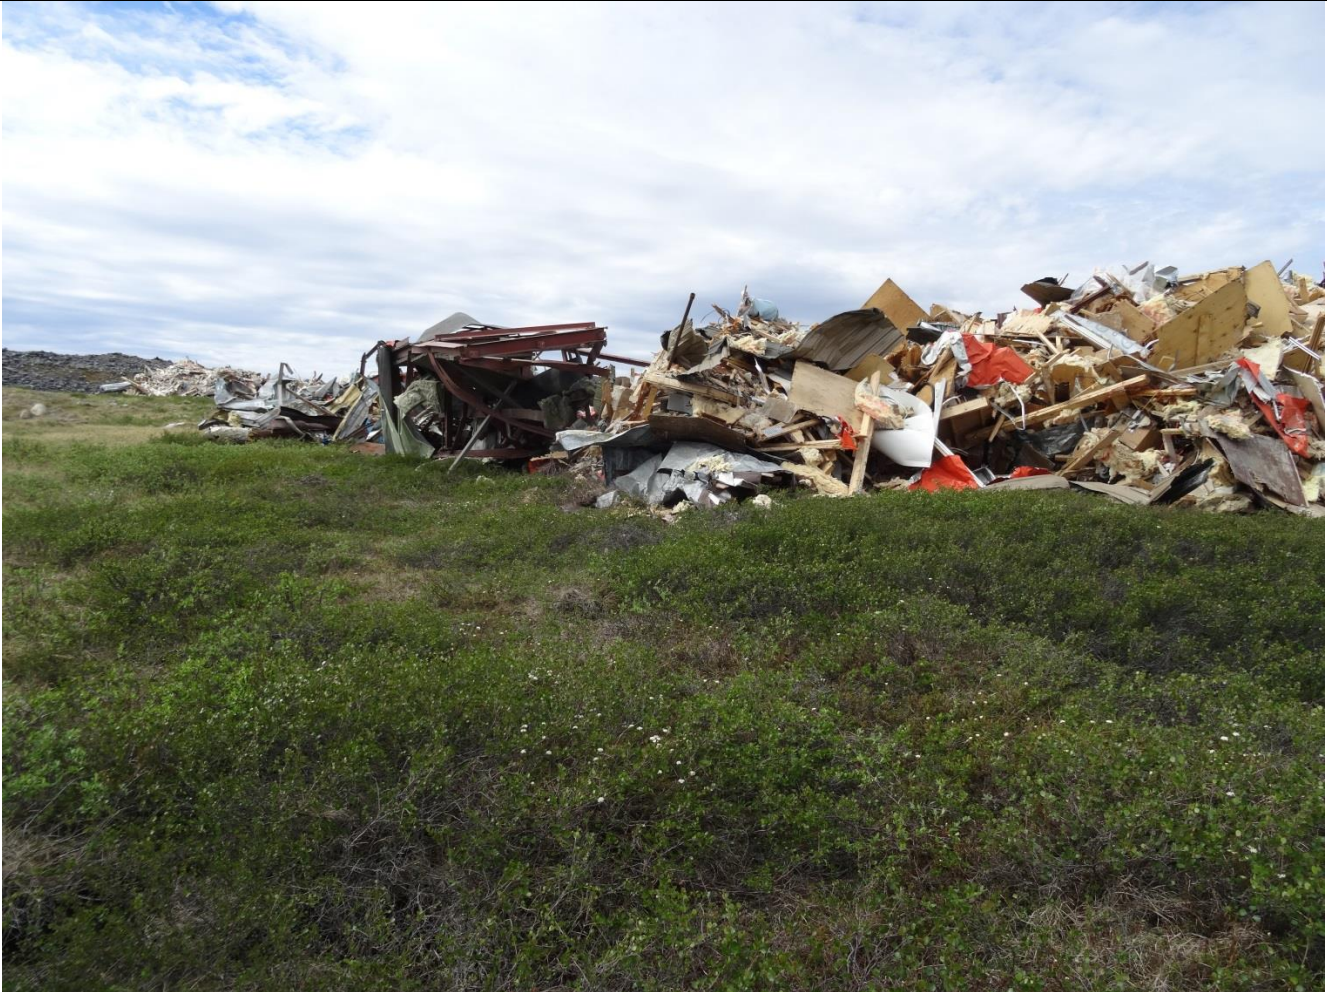
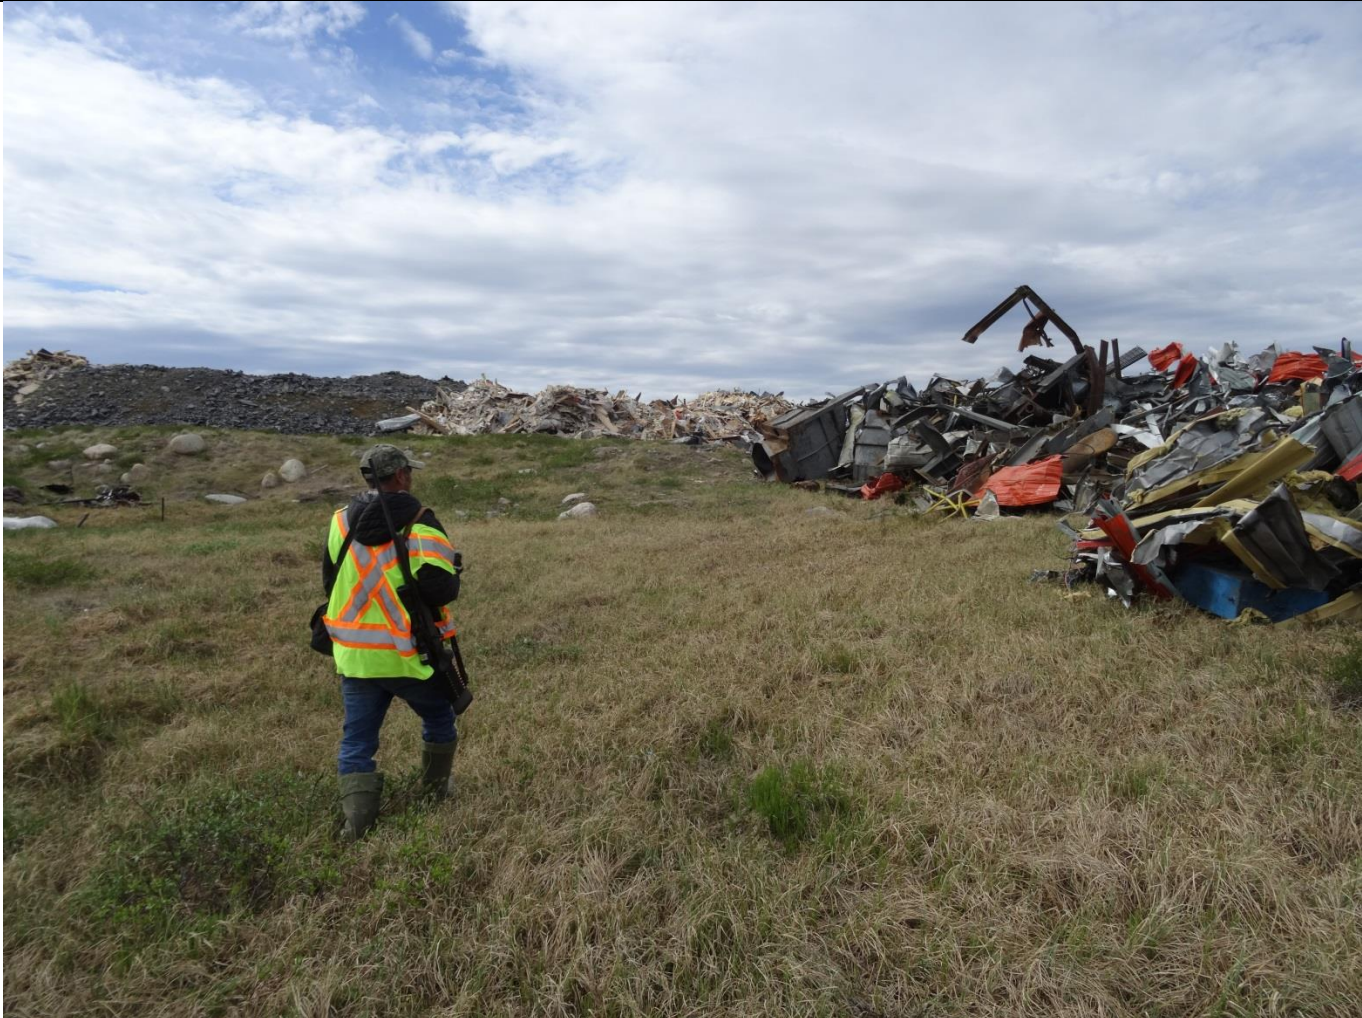
Description: Temporary Storage of Demolished Debris – View 1

Description: Temporary Storage of Demolished Debris – View 2

Description: Temporary Storage of Demolished Debris – View 3

Description: Temporary Storage of Demolished Debris – View 4

Description: Temporary Storage of Demolished Debris – View 5

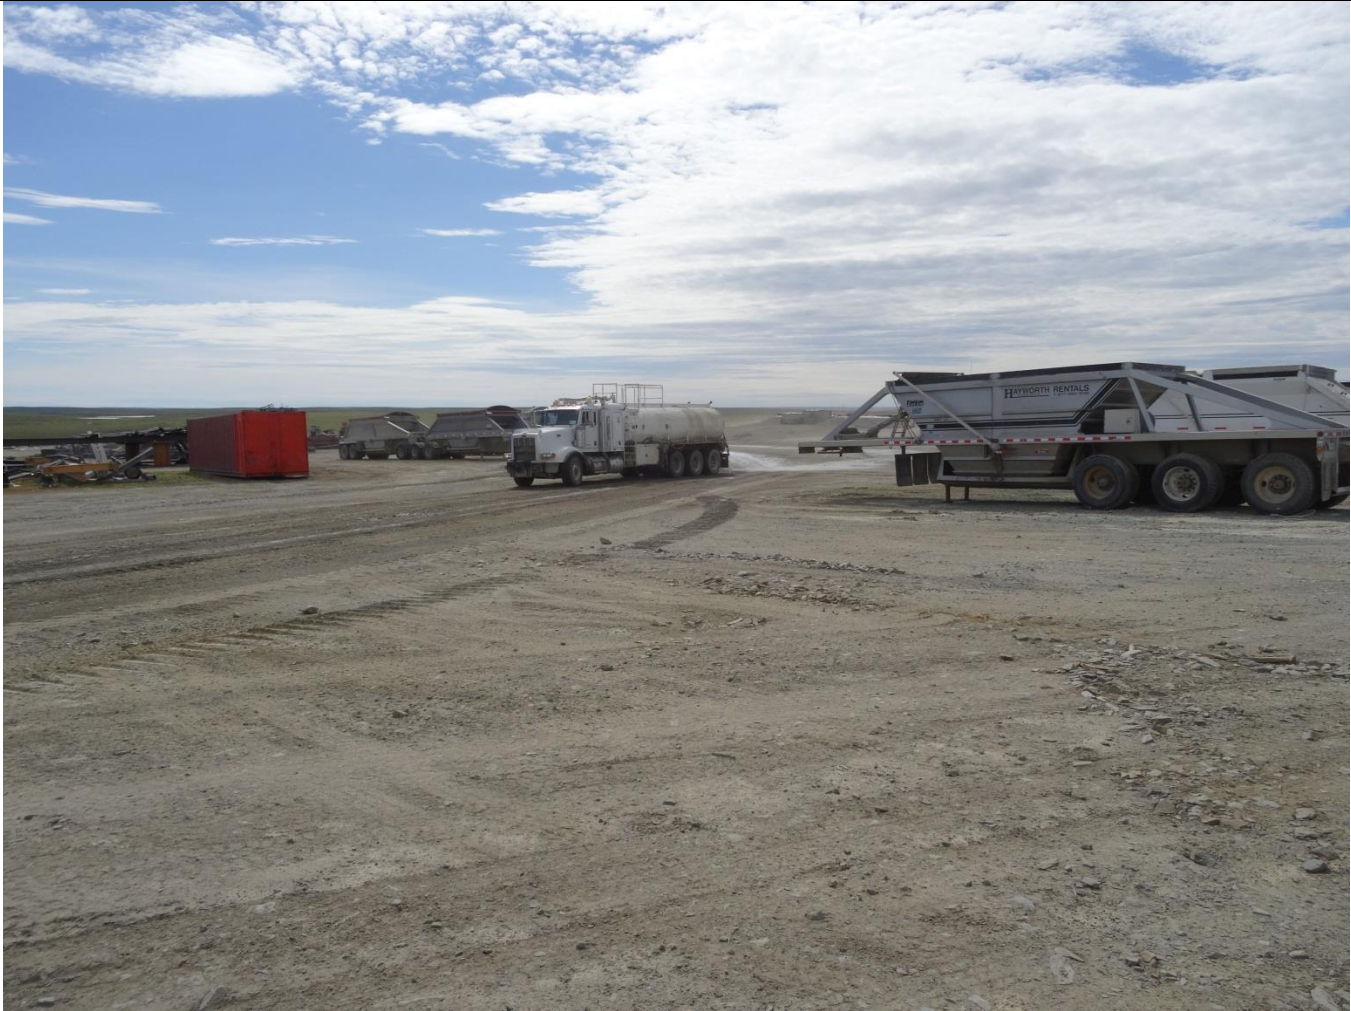
Photo 9

Description: Truck Watering Road

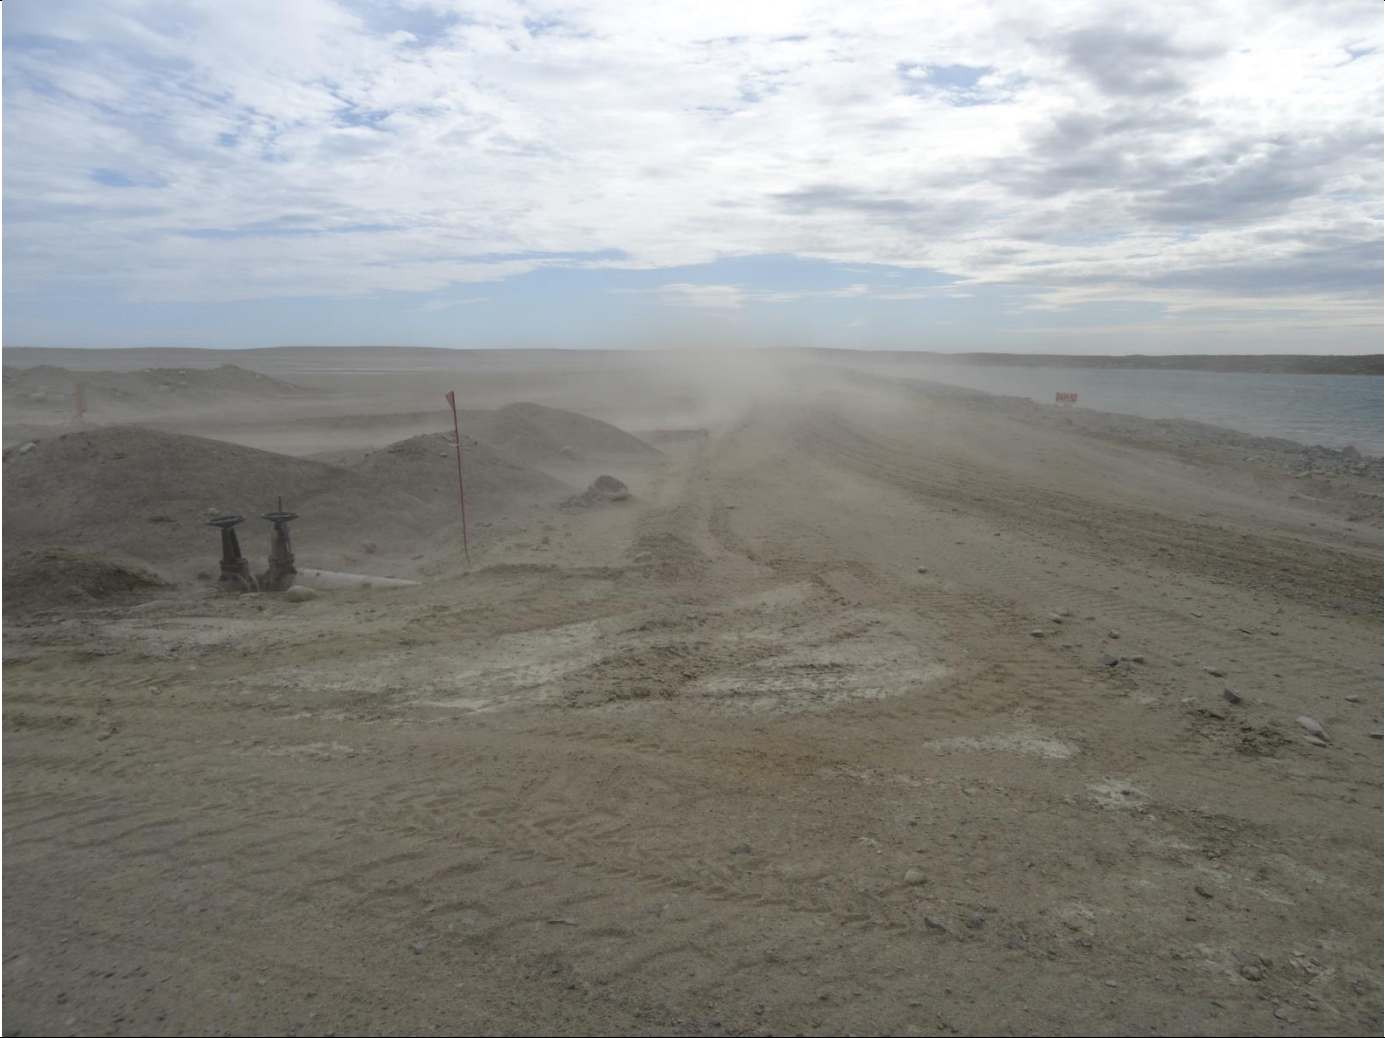
Photo 10

Description: Wind Blown Sand Dust – View 1

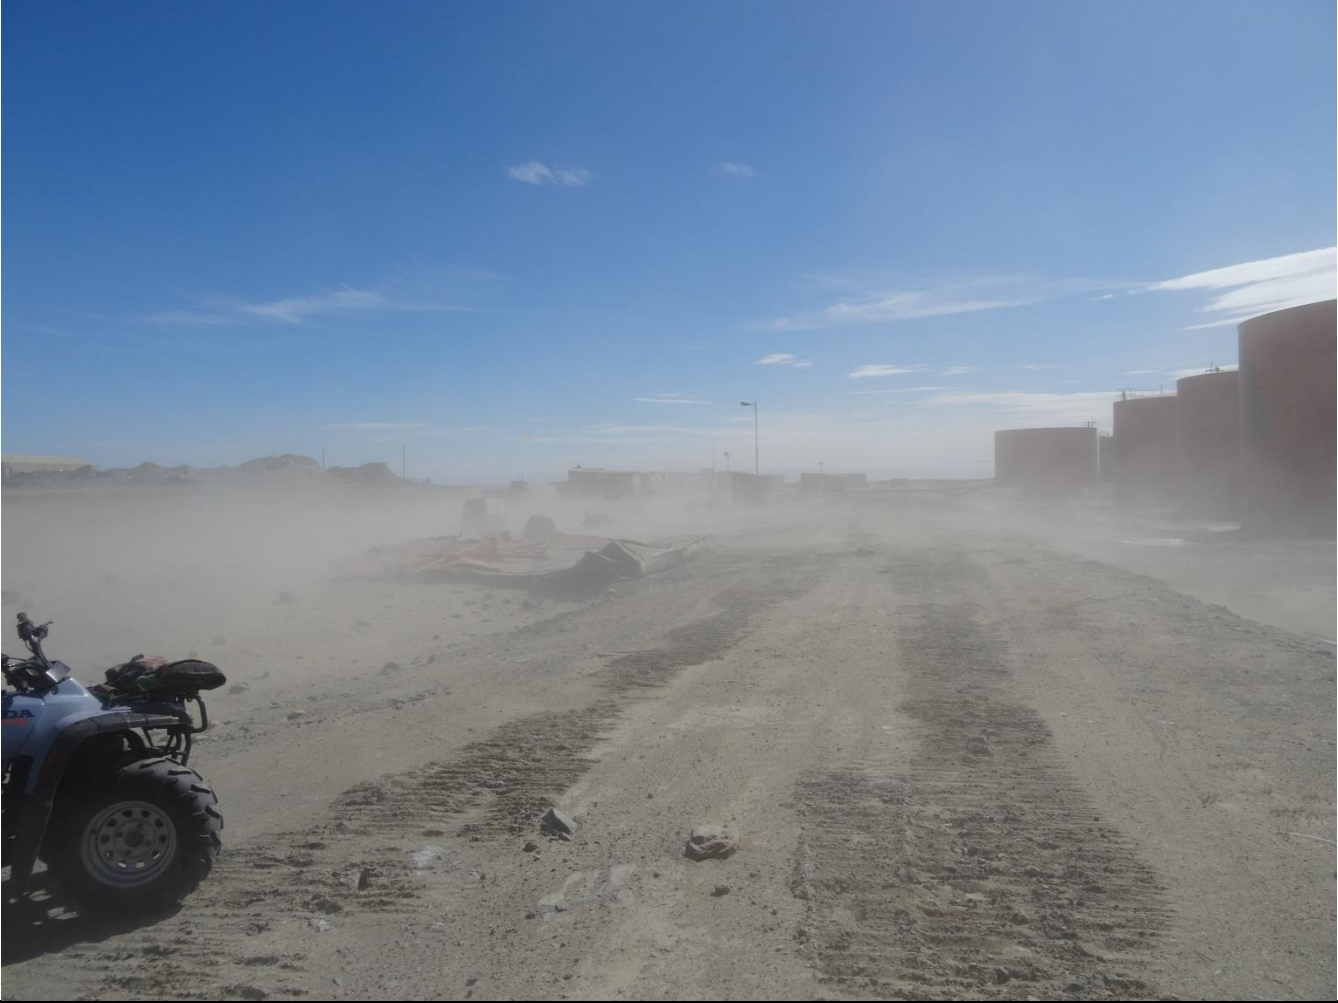
| Photo Log # DSC05825 | Location |
|---|---|
| Photo 11 | |

| Photo Log # DSC05825 | Location |
|---|---|
| Description: Wind Blown Sand Dust – View 2 | |

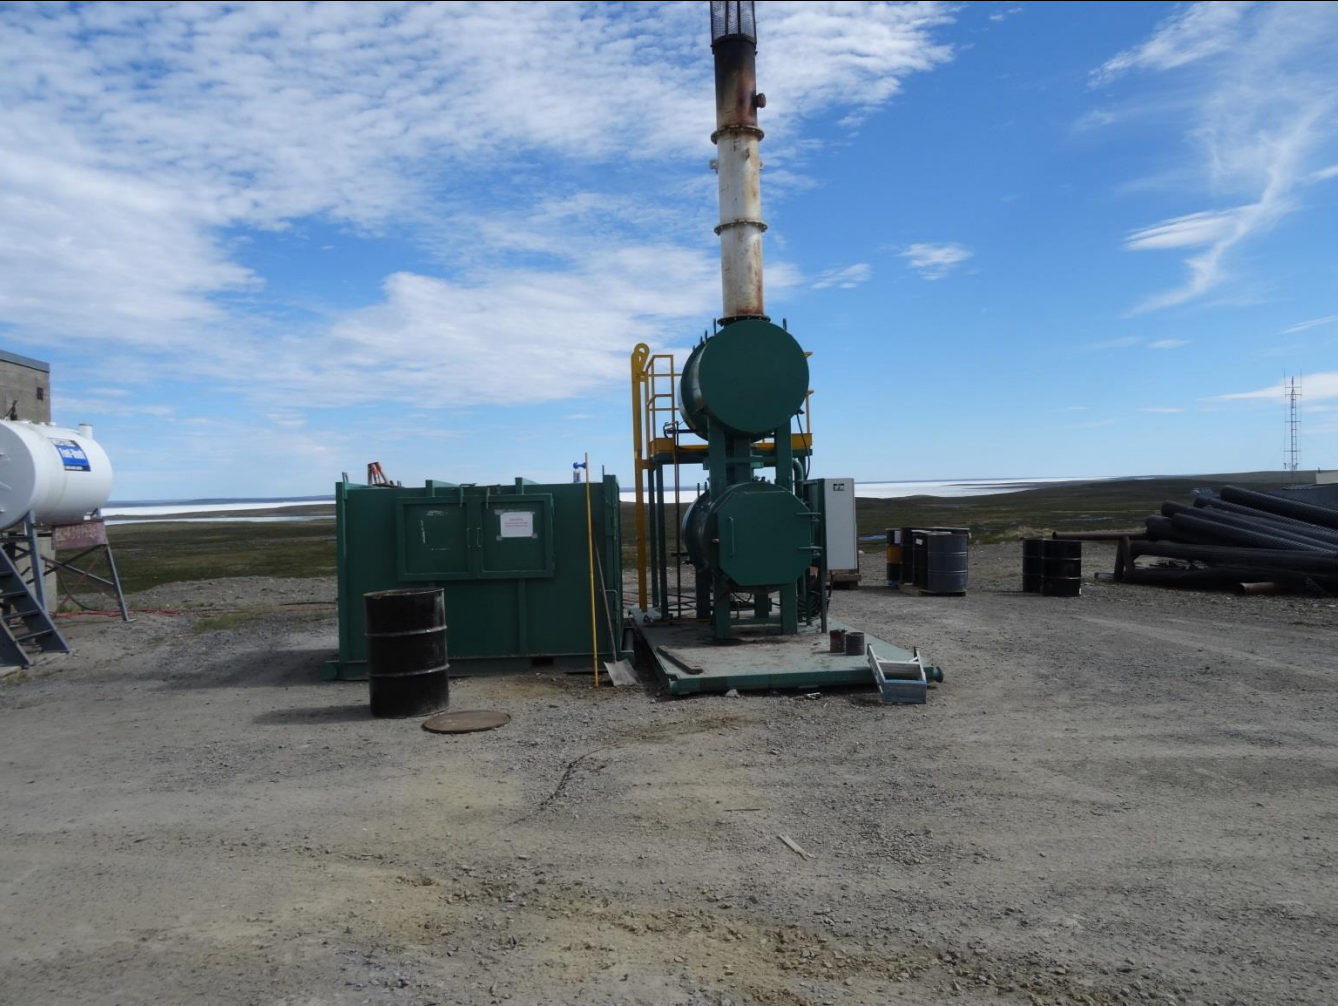
| Photo Log # DSC05735 | Location |
|---|---|
| Photo 12 | |

4. Incineration of Camp Food Waste (Photo 12) is done daily with a large Incinerator.
5. Potable Water is taken from the Contwoyto Lake Intake (Photos 13 and 14). LMI has recently emailed the writer a copy of Water Consumption Records showing they are well within allowable limits.
6. LMI has verbally told the writer that they and their Contractor, Nahanni, may try and complete the planned 2 year project in 1 year only.
7. The writer gave Nahanni verbal instructions to ensure all Signage for Sample Stations were In-Place before the writer’s next scheduled Inspection.

| Photo Log # DSC05735 | Location |
|---|---|
| Description: Incinerator for Camp Food Waste | |

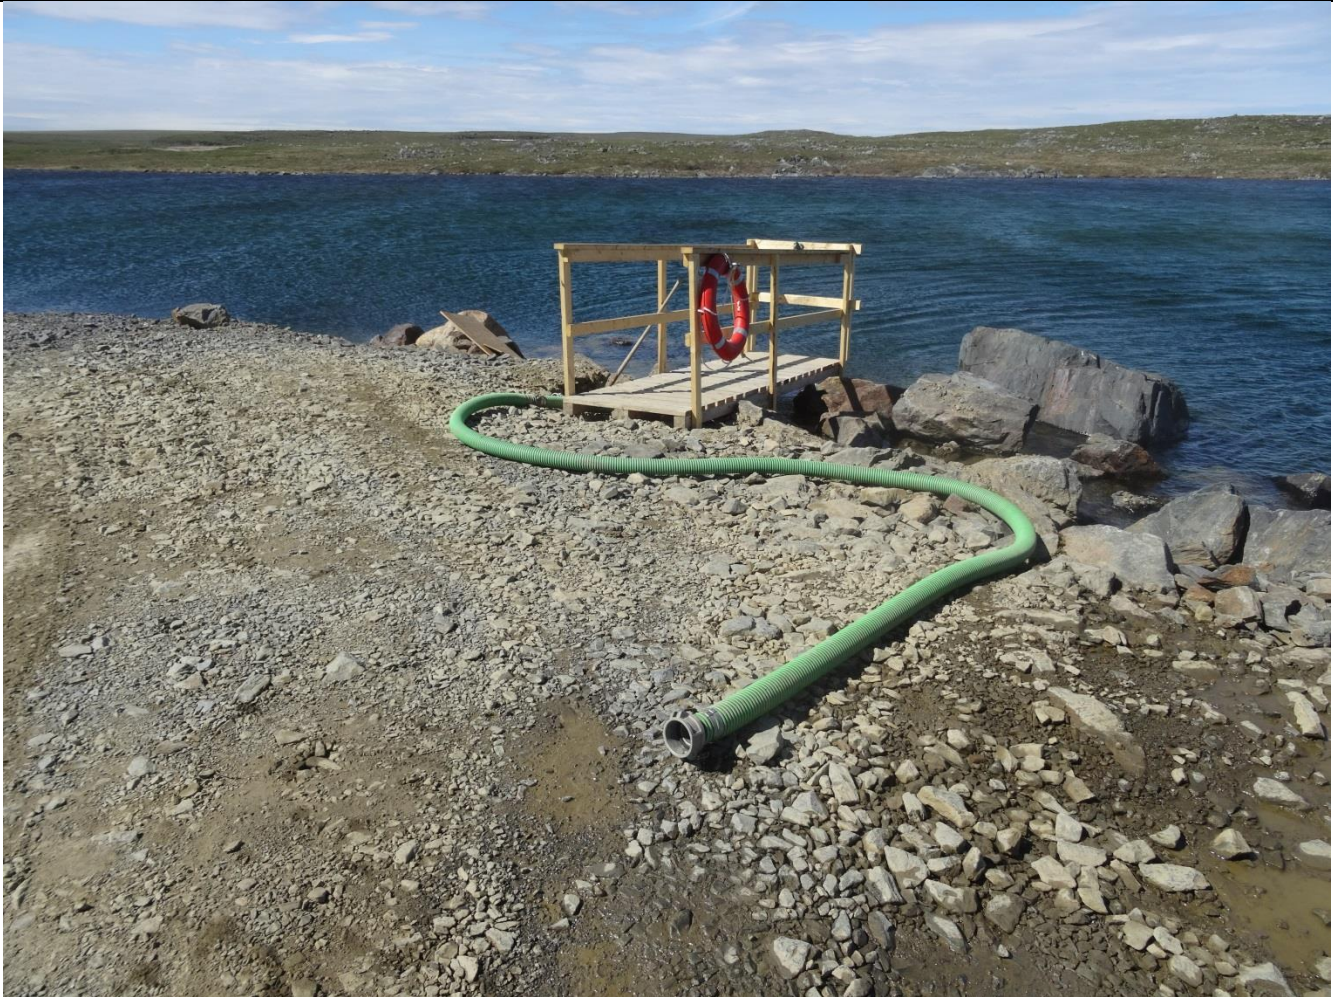
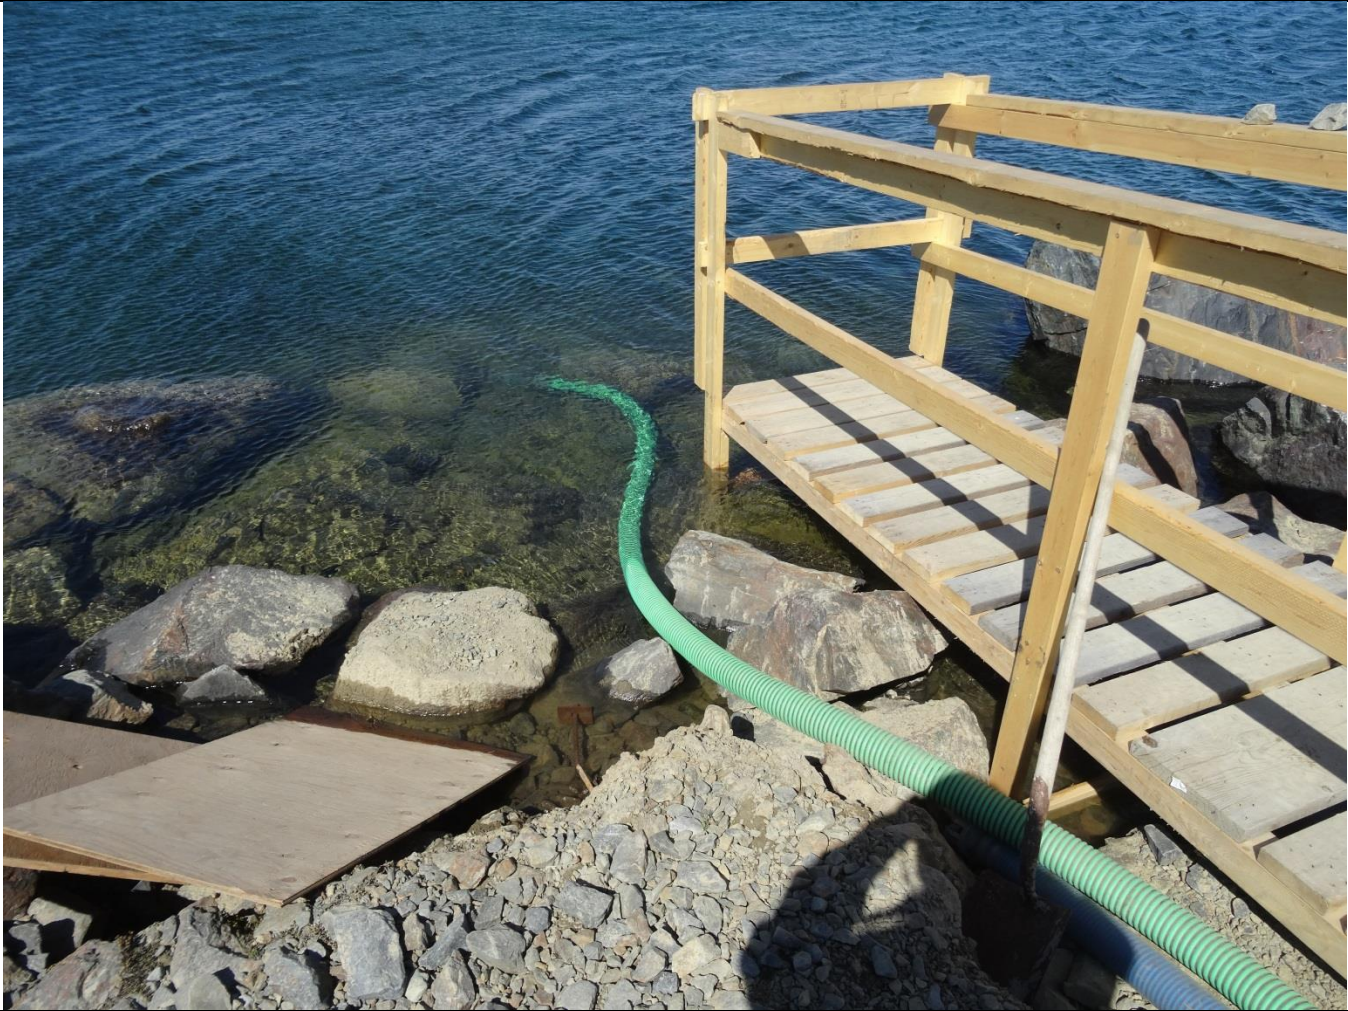
Description: Water Intake – View 1

Description: Water Intake – View 2

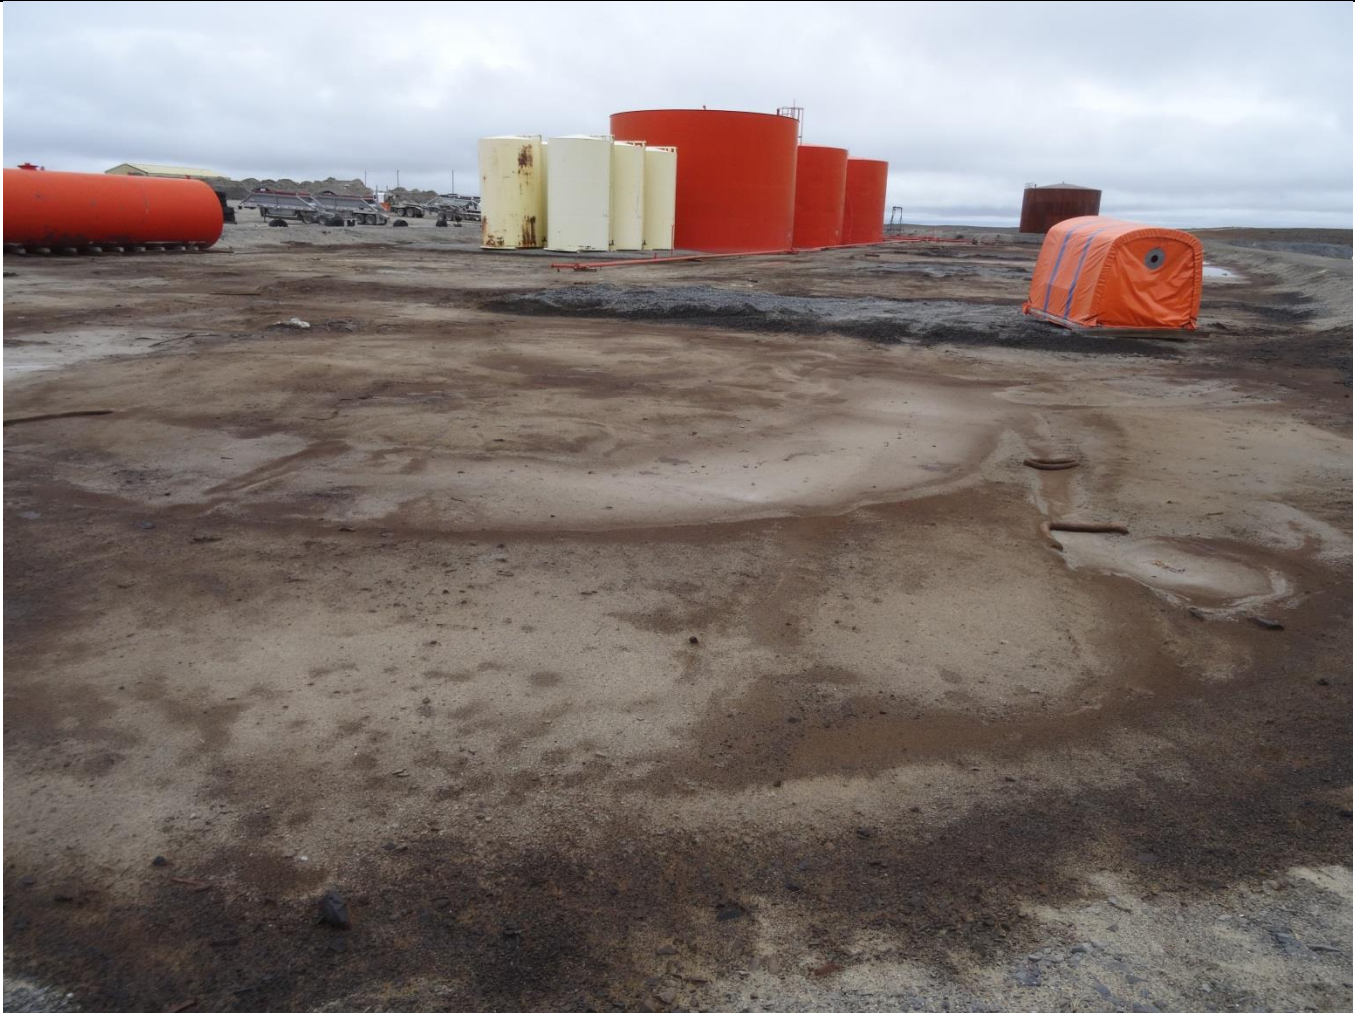
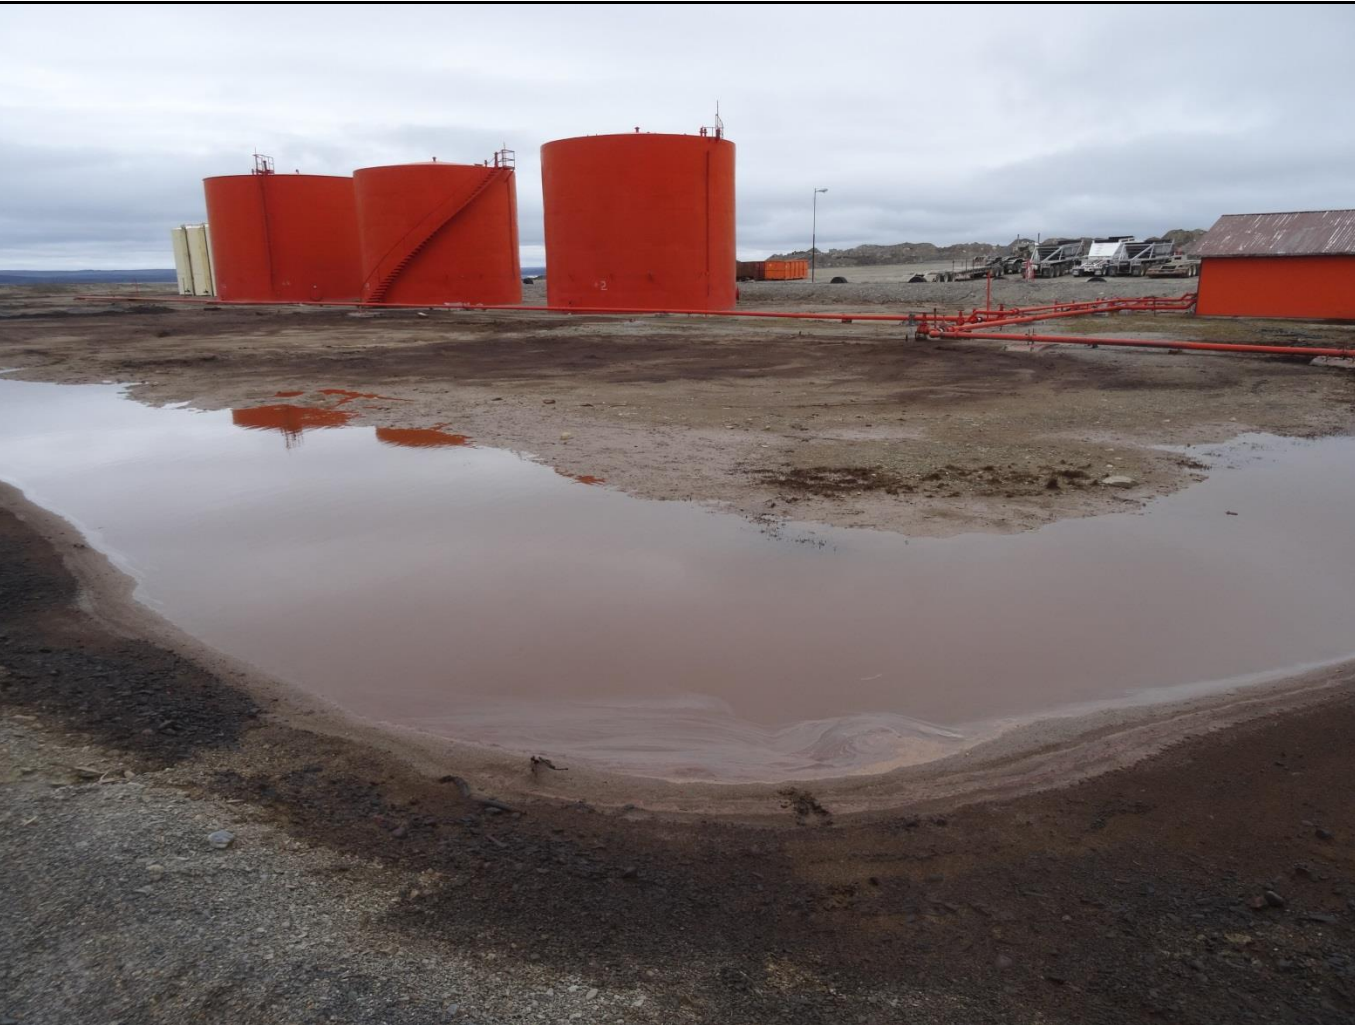
Tanks M-16, M-17, M-18, M-19, M-20, M-21 and M-22 have been Cleaned and Decommissioned, but remain Standing

The Main Pump Shack Remains in Place within the Tank Farm

Pump Station #1, Pump Station #2 and all associated Pipeline located just Outside the East Side of the Tank Farm have all been Cleaned, Dismantled and Placed in the Land Fill

Description: Main Tank Farm – View 1

Description: Main Tank Farm – View 2

Description: Main Tank Farm – View 3 – Showing Pump Shack

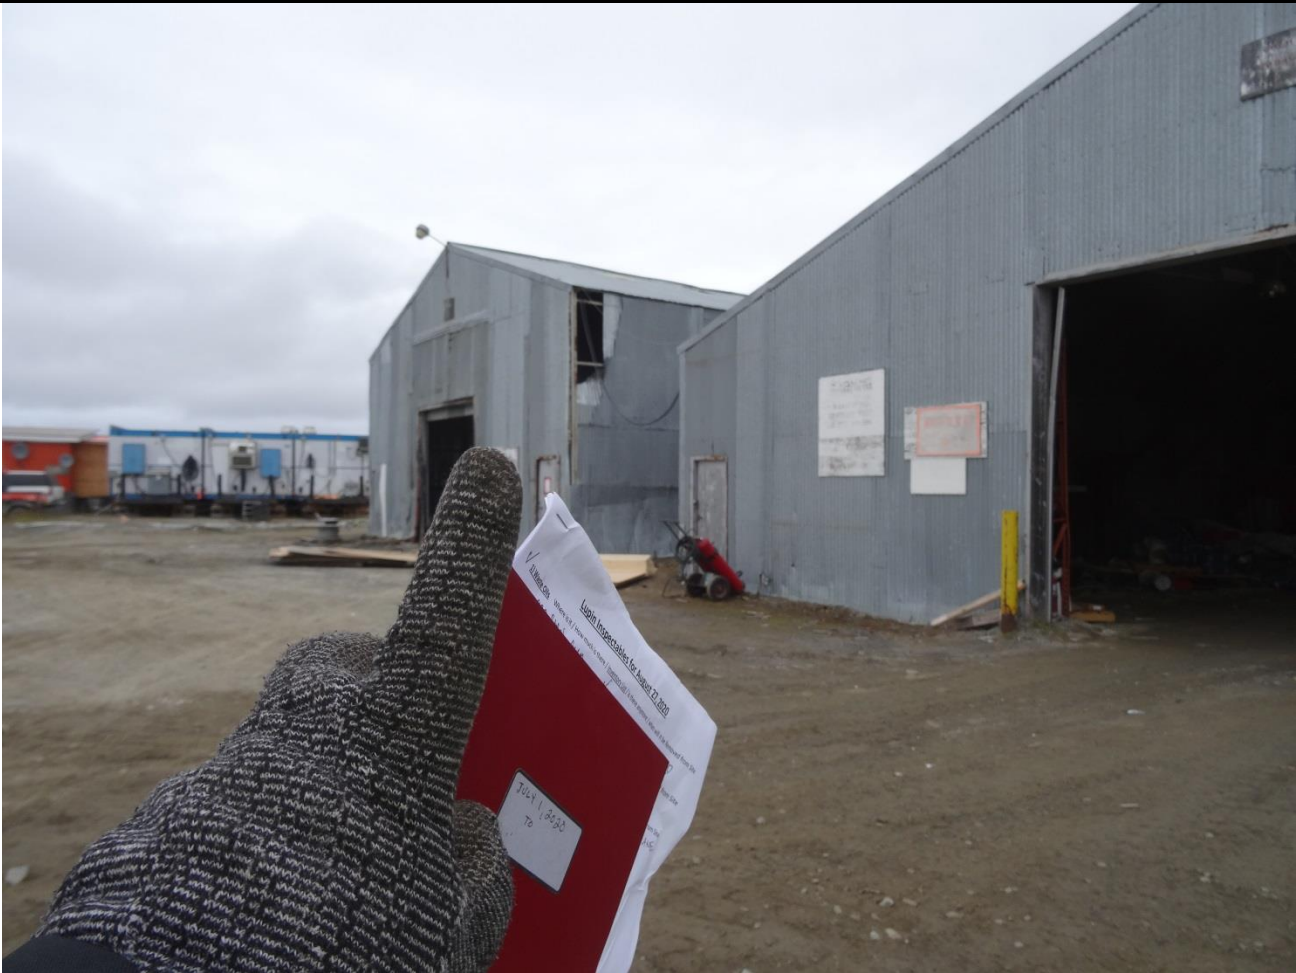
Photo 7

This Building is still Standing and scheduled to be Demolished in 2021

Description: Cold Storage Building #1 – On Left Side

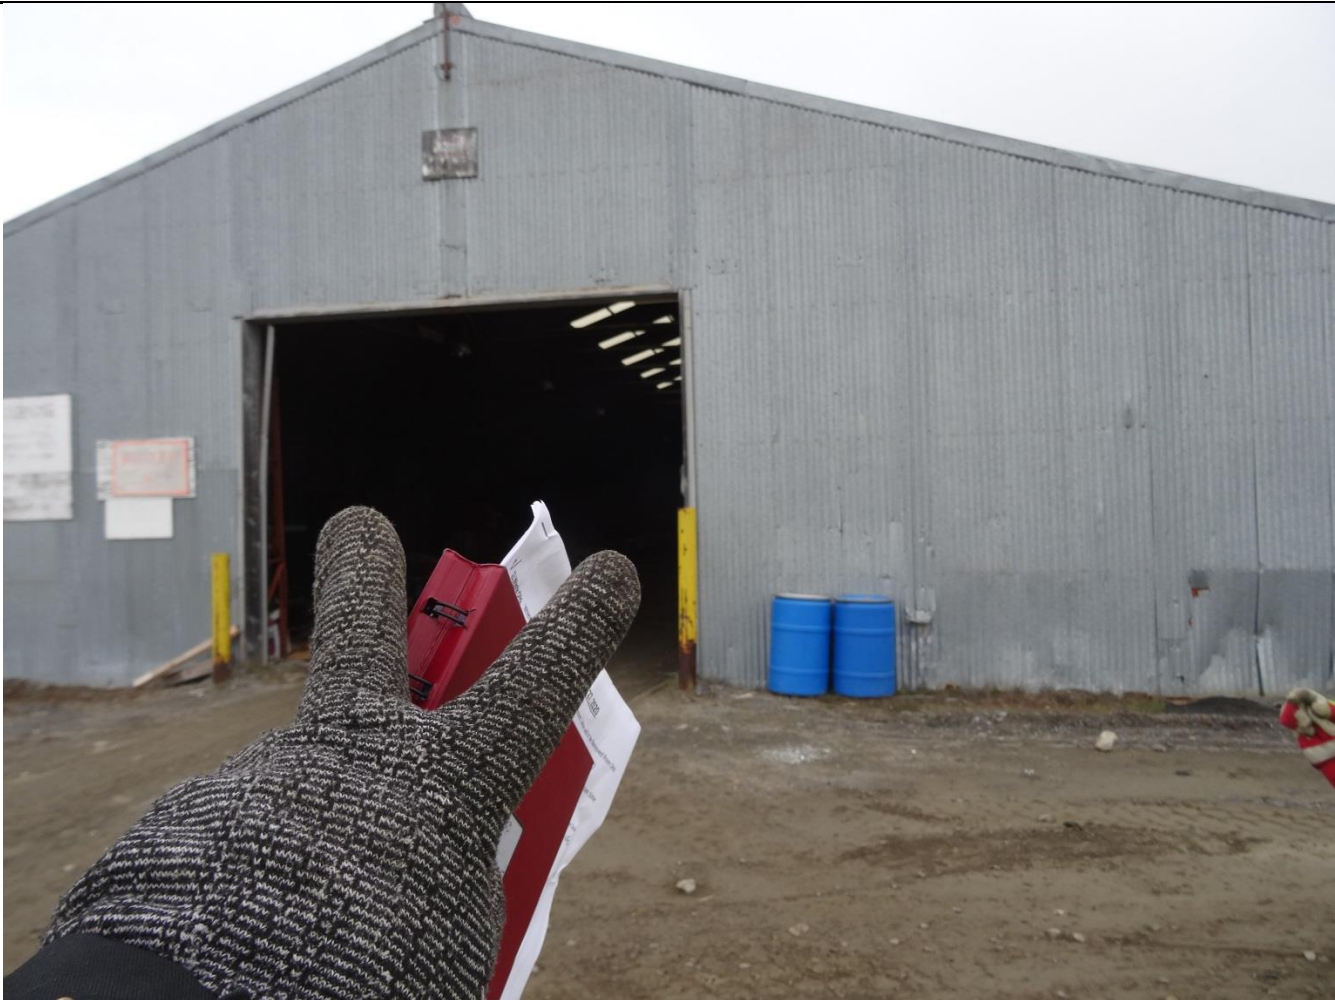
Photo 8

This Building is still Standing and scheduled to be Demolished in 2021

Description: Cold Storage Building #2, aka #20 ATV Building
