WATER LICENCE INSPECTION FORM

| Lupin Mines Inc | | Karyn Lewis | |
| 2AM-LUP2032 | | Project Manager | |
| 2020 July 2 | | Baba Pedersen | |

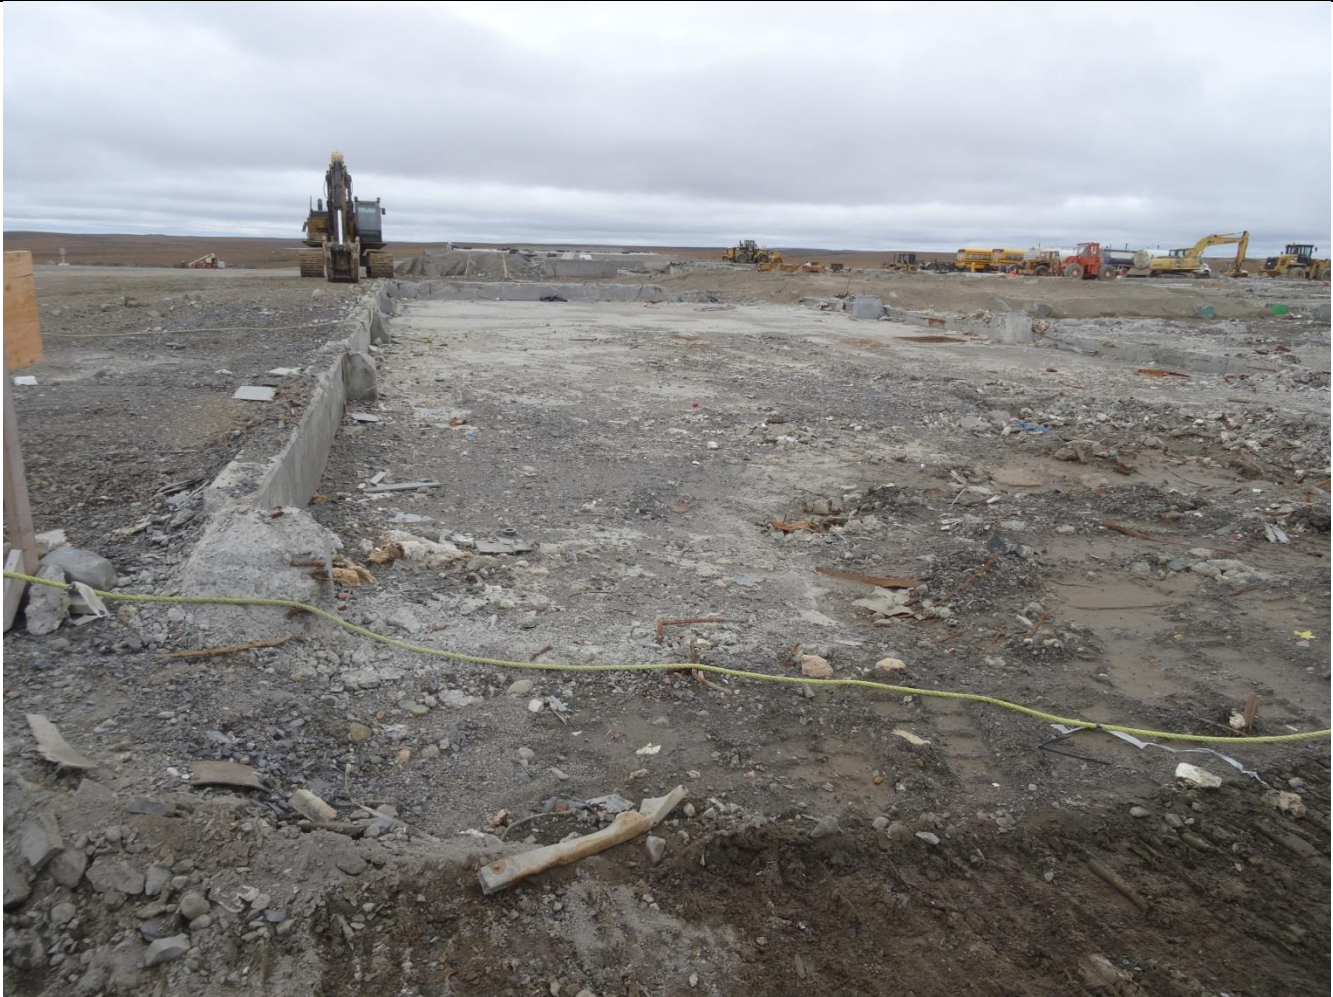
Photo 9

All Debris has been removed and placed in the Land Fill

The Concrete Foundation Remains in place

Description: #19 Batch Plant, aka Paste Plant – Concrete Foundation Remains – All Debris Removed and Placed into the Land Fill

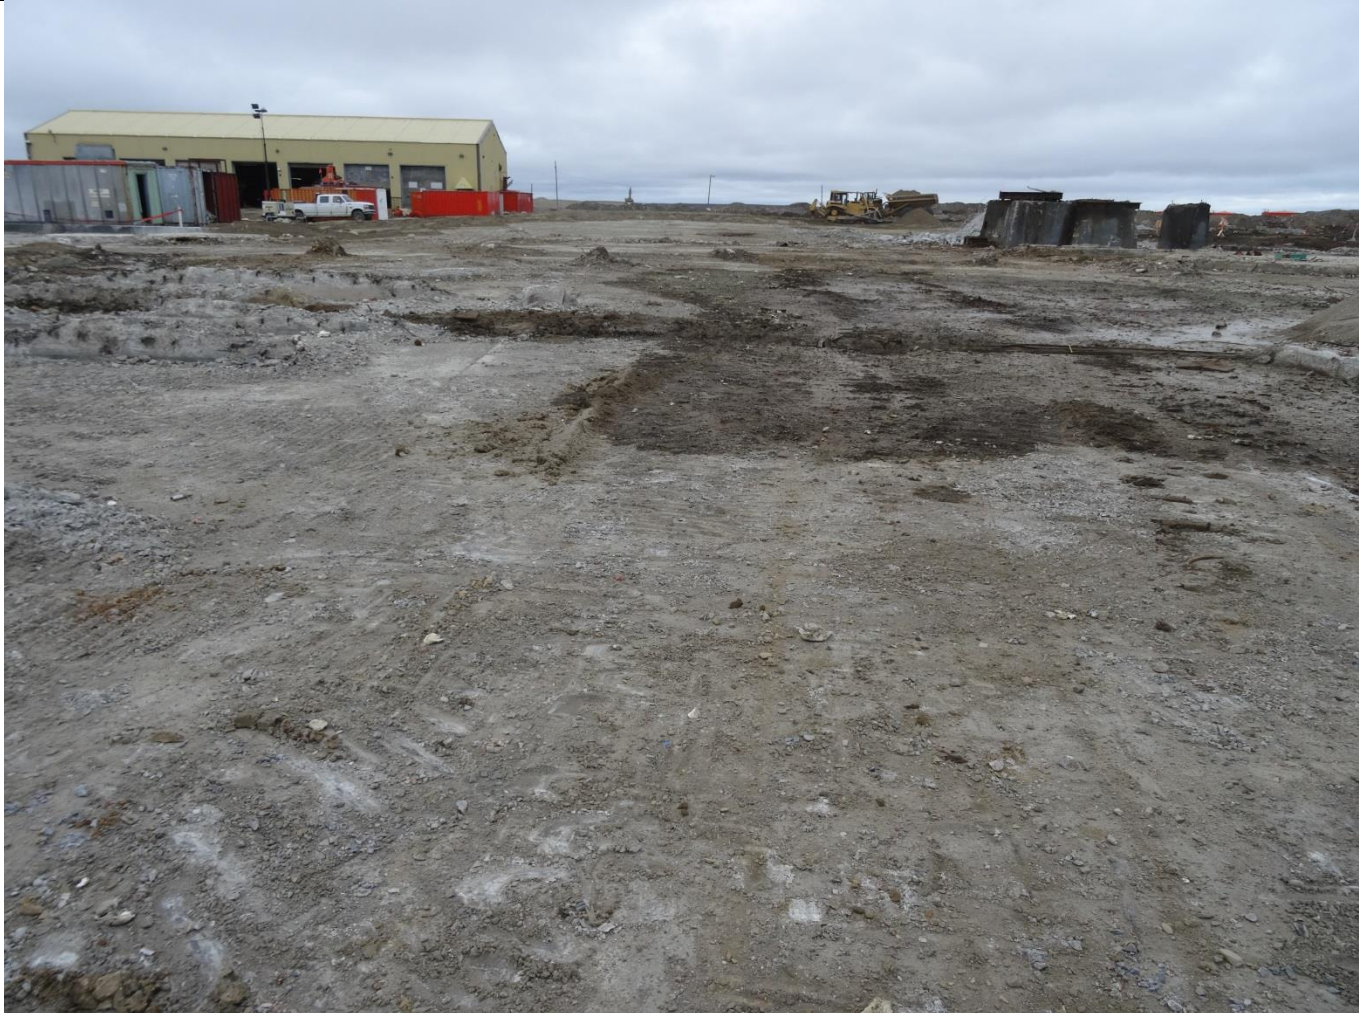
Photo 10

All Debris has been removed and placed in the Land Fill.

Description: #11 Mill, View 1 – Large Concrete Blocks in Top Right of Photo to be Removed – All other Debris Removed into Land Fill

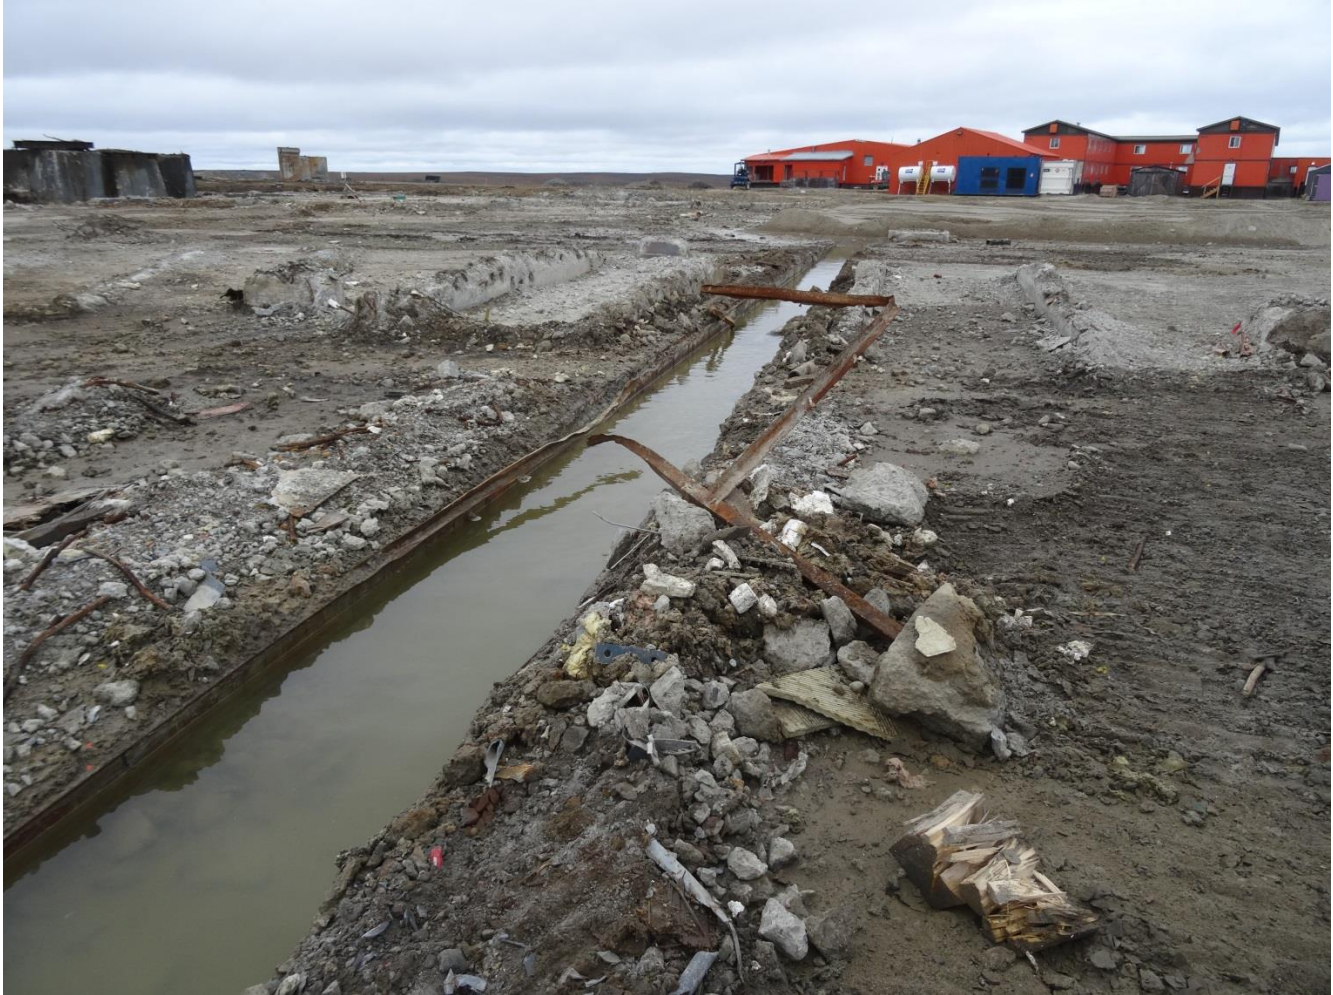
Photo 11

The Concrete Foundation, some Large Concrete Blocks and a Trench in the Concrete Foundation remain in place. The Trench is filled with water that requires draining.

Description: #11 Mill, View 2 – Trench requires Draining and Cover Material

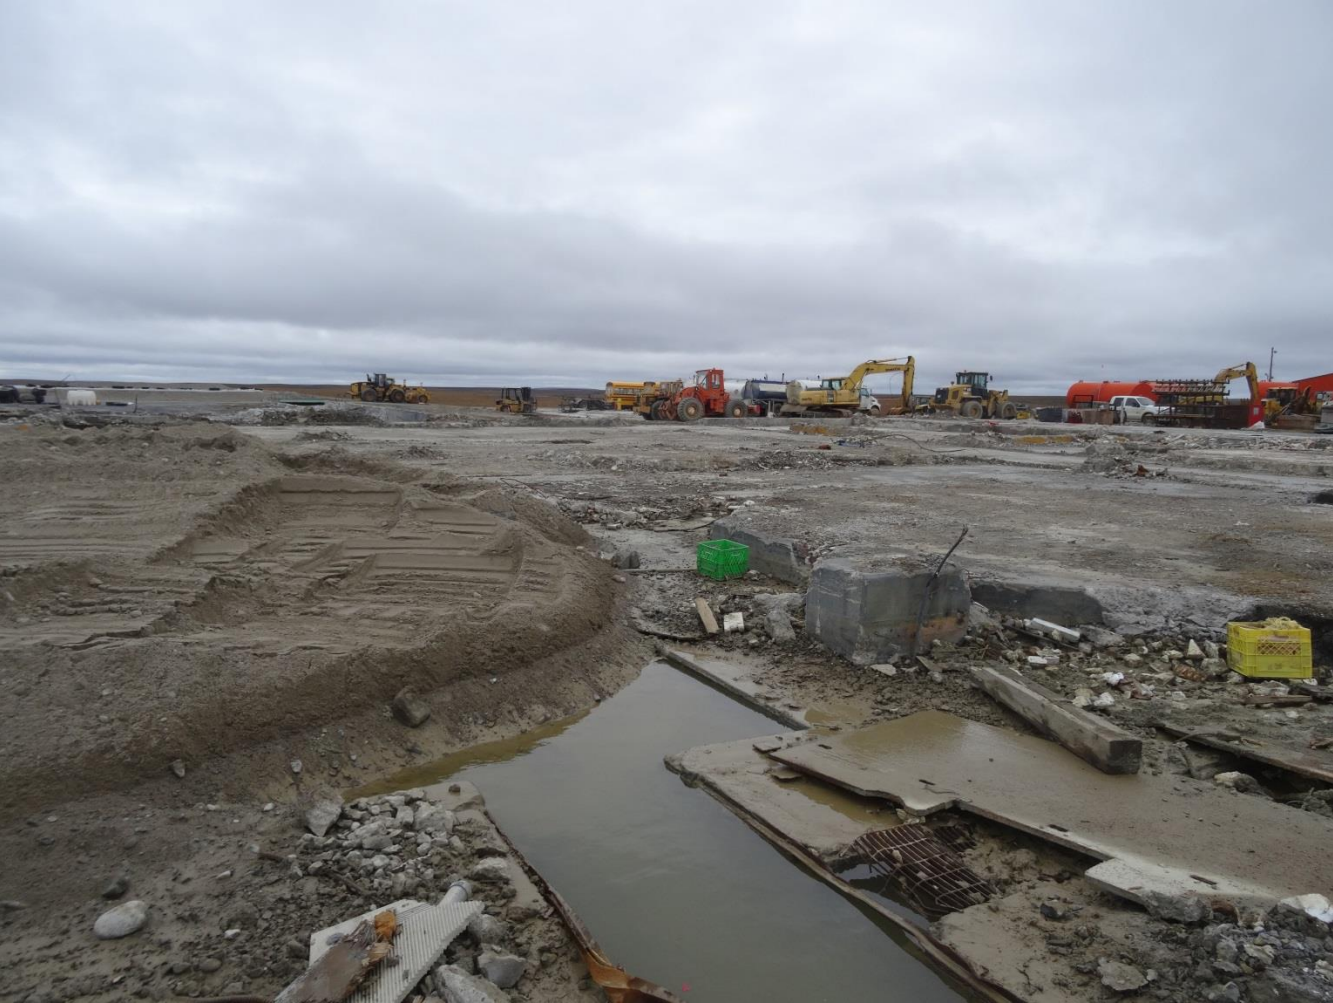
Photo 12

The Concrete Foundation Remains in place

Description: #15 Carpenter Shop – Concrete Foundation Remains – All Debris has been Removed and Placed into the Land Fill

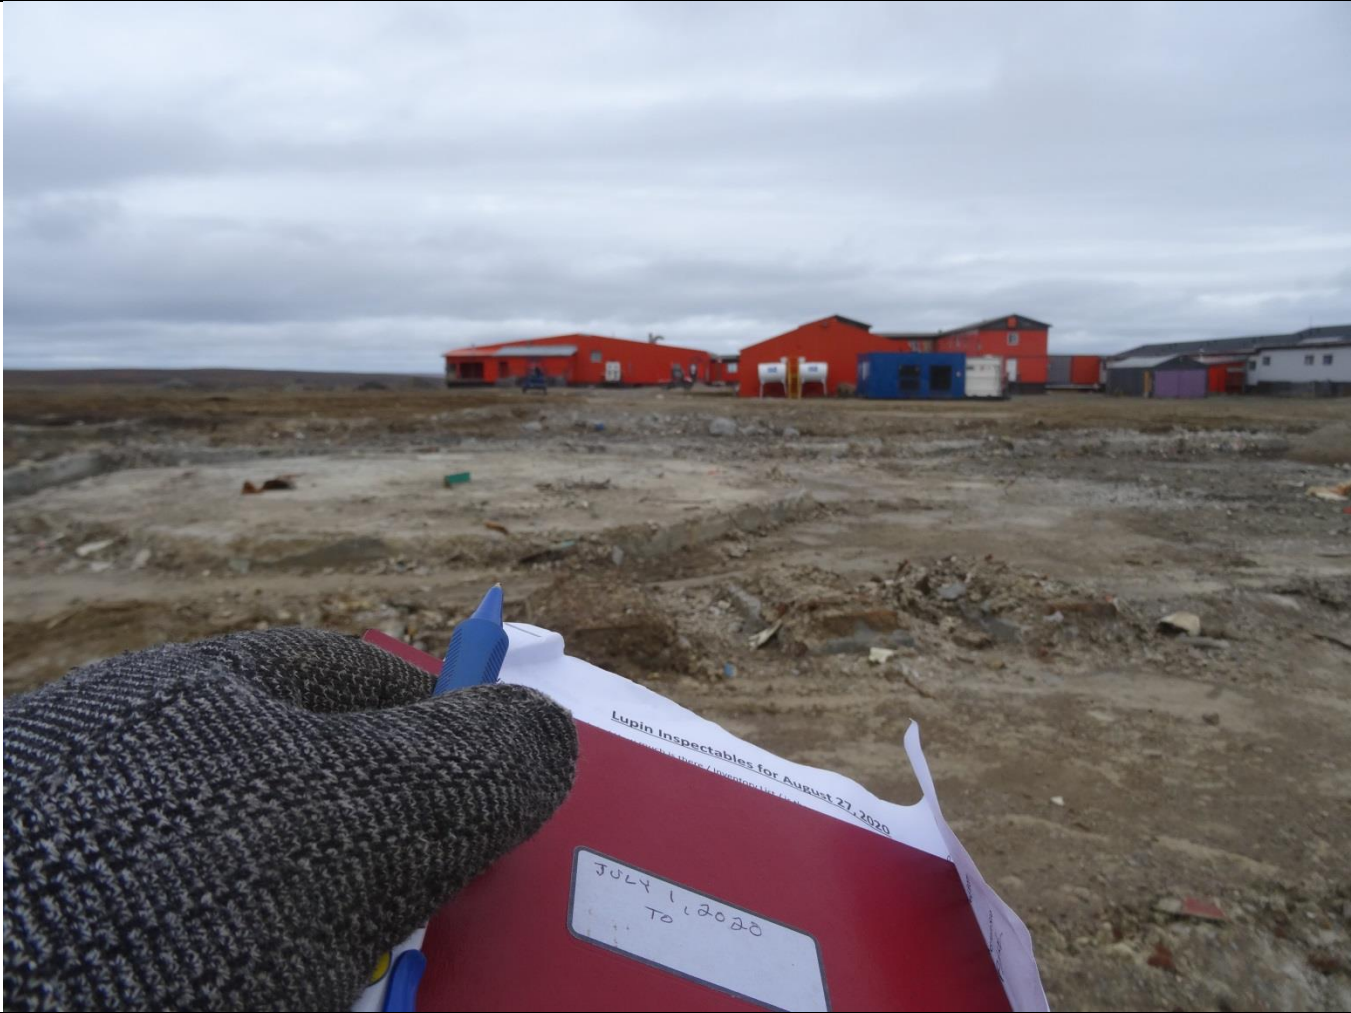
Photo 13

Description: #8 Travel Ways – All Debris has been Removed and Placed into the Land Fill

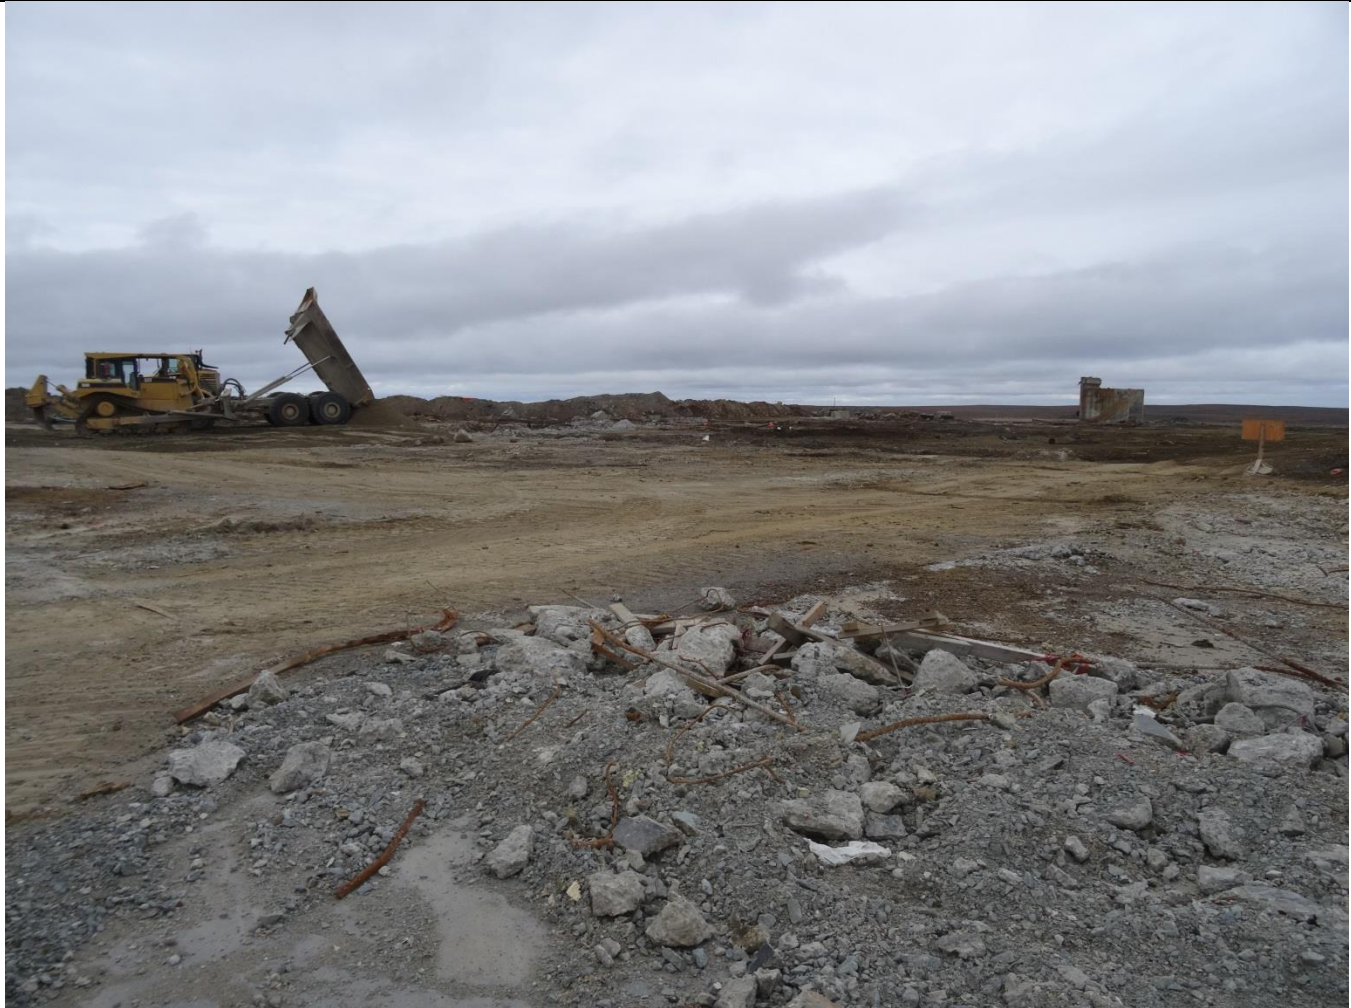
Photo 14

Description: #8 Hoist Room – All Debris has been Removed and Placed into the Land Fill

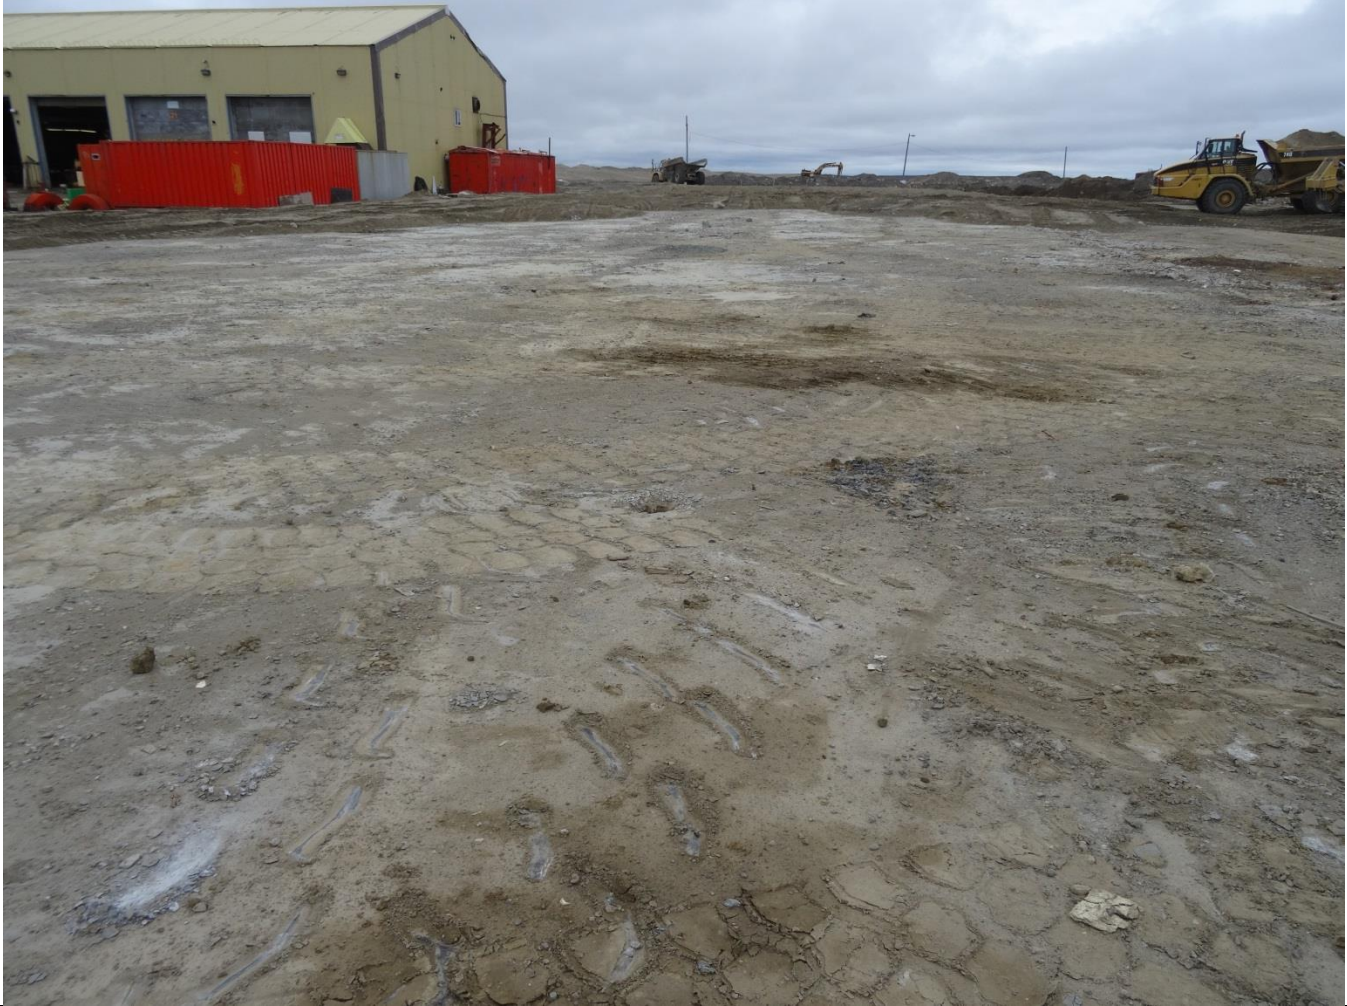
Photo 15

Description: #10 Warehouse – Foreground - All Debris has been Removed and Placed into the Land Fill

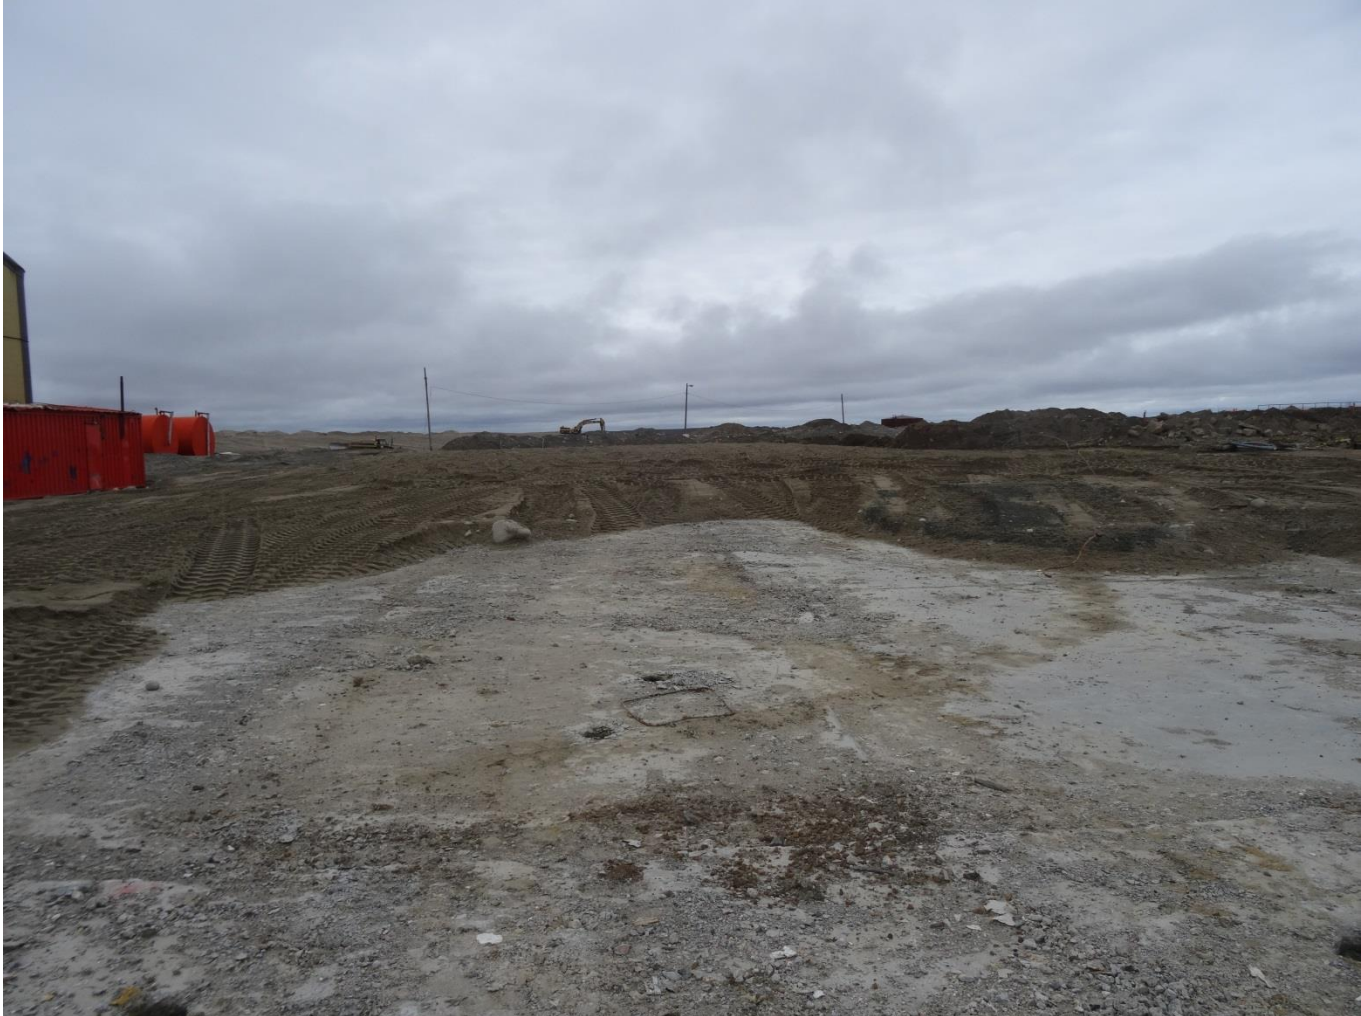
Photo 16

This area has been covered in Sand

Description: #12 Power House – Foreground – All Debris has been Removed and Placed into the Land Fill

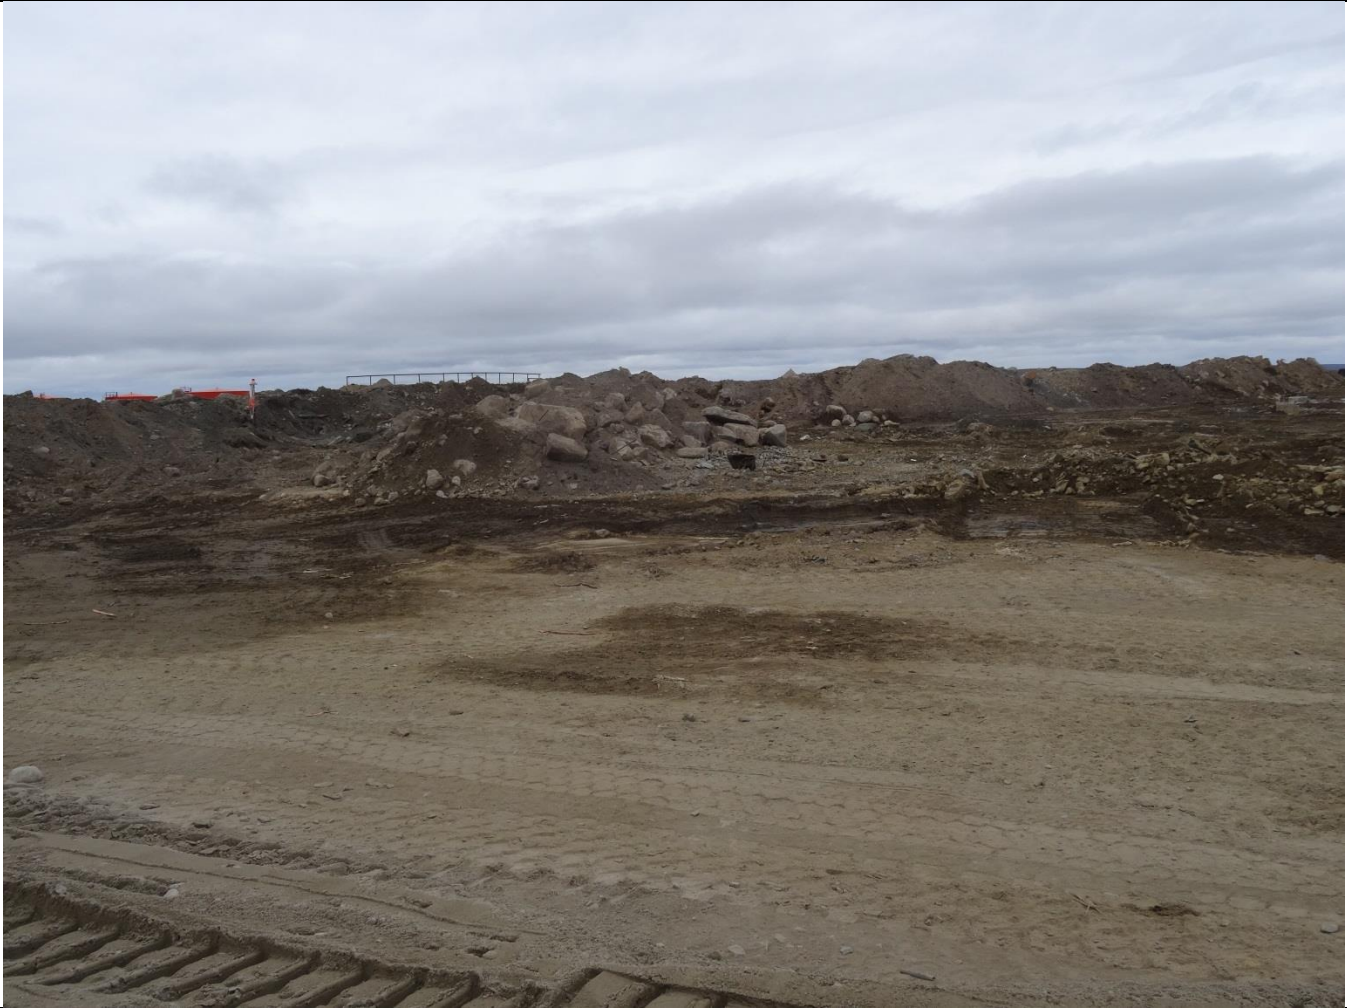
Photo 17

This area has been covered in Sand and only a Pile of Large Rocks remain

Description: #17 Emergency Power House – All Debris has been Removed and Placed into the Land Fill

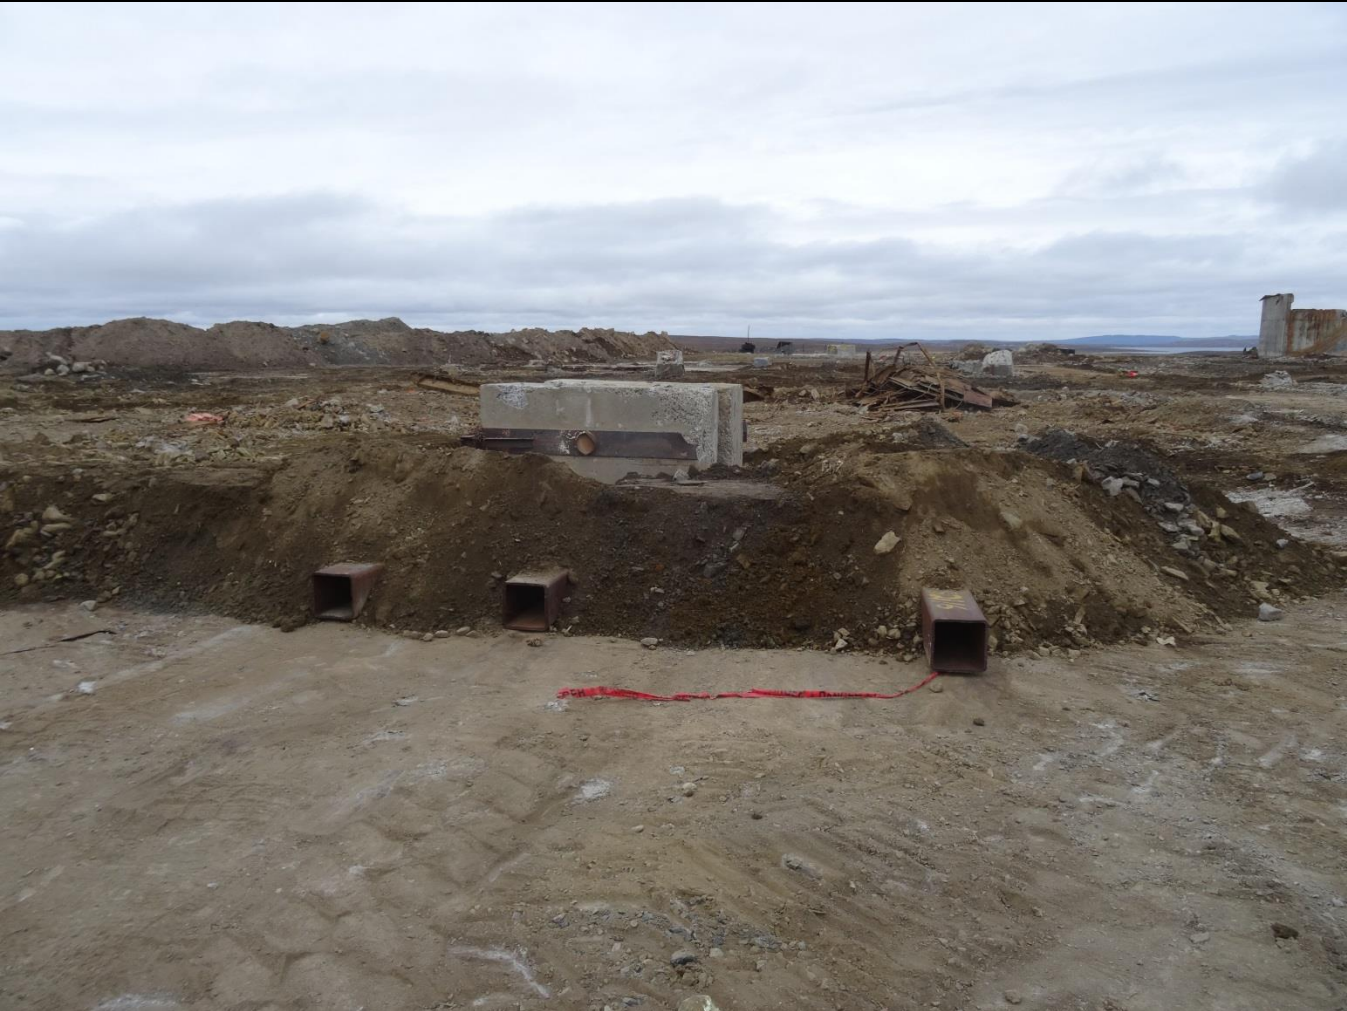
Photo 18

This area has been covered with large Metal Beams and Plates which are covered in Sand and 2 large Concrete Blocks

Description: Shaft Hole – All Debris Removed and Placed into the Land Fill

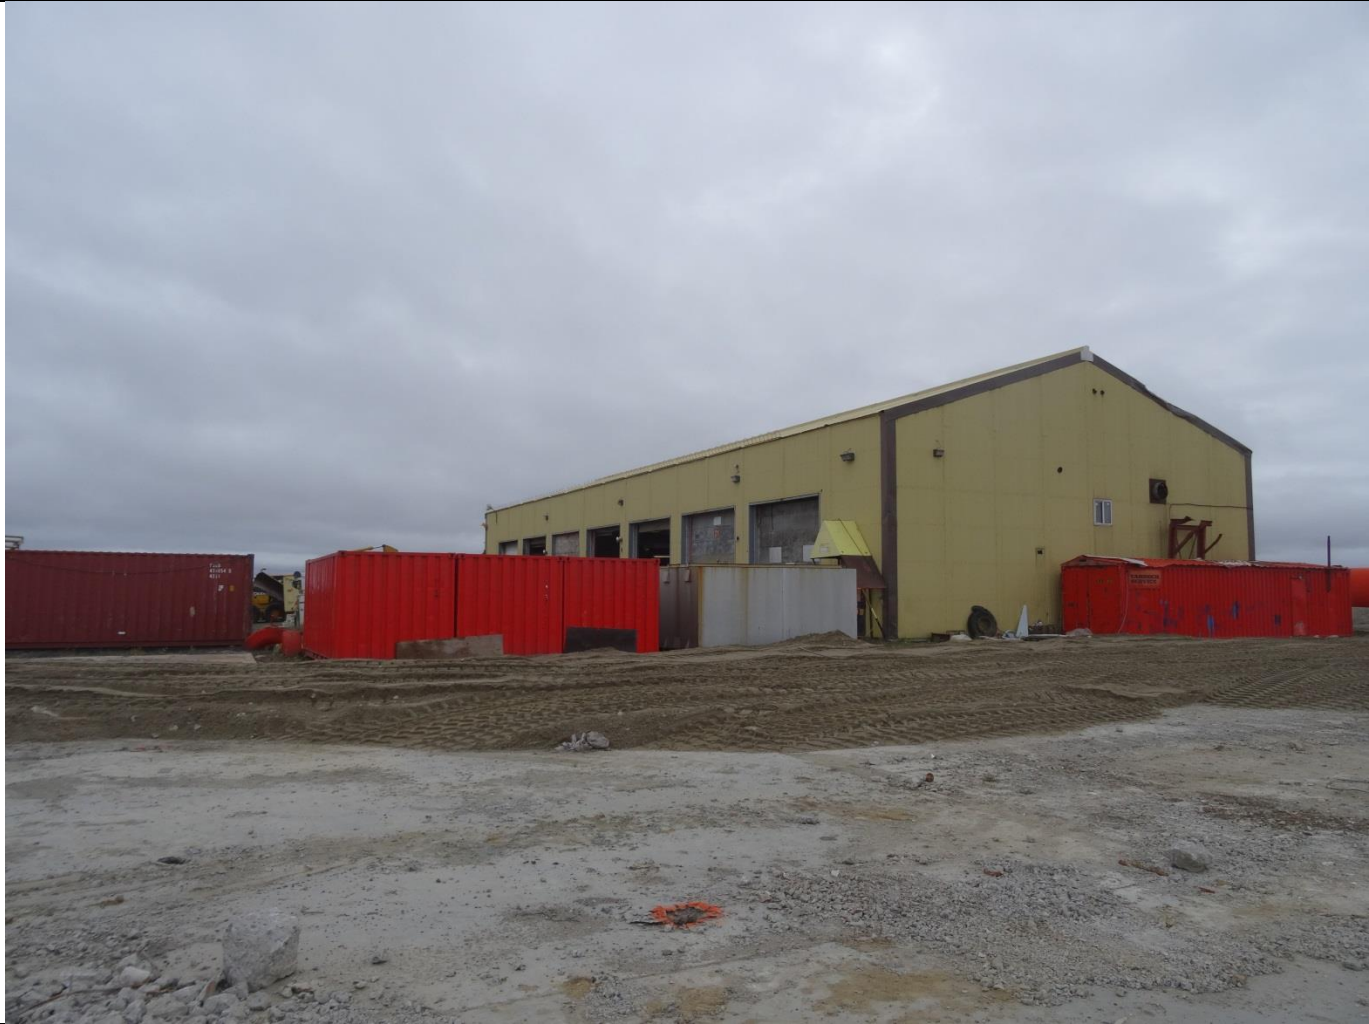
Photo 19

This building remains Standing and in use.

Description: #8 Surface Shop (Yellow Garage) – 1 of 2 Buildings that will remain for at least 5 years

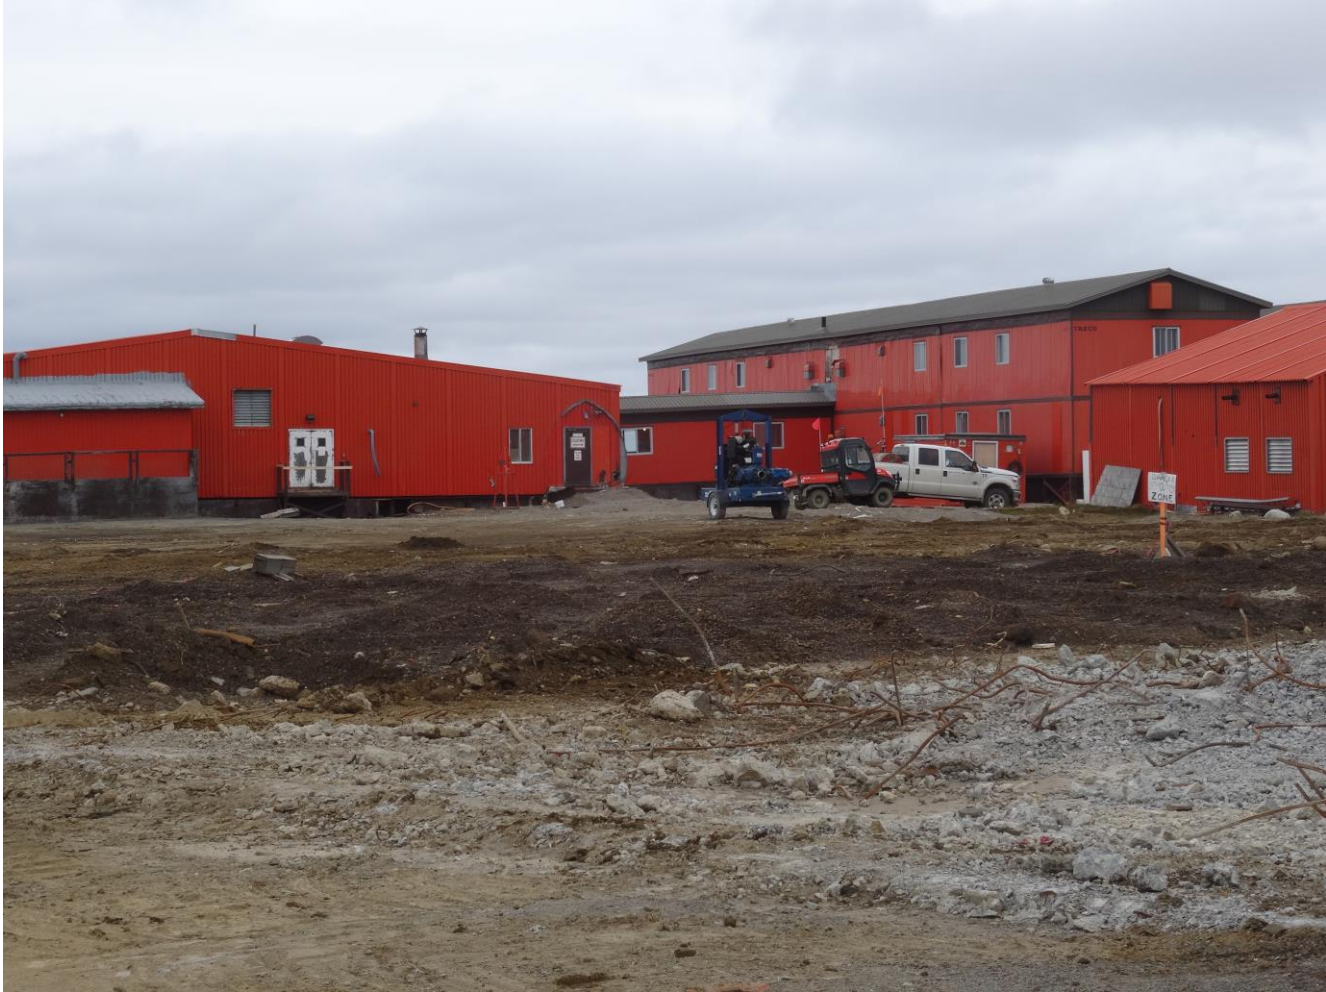
Photo 20

This area has been covered in Sand

Description: #16 Fire House – Dark Sand Area in Foreground – All Debris has been Removed and Placed into the Land Fill

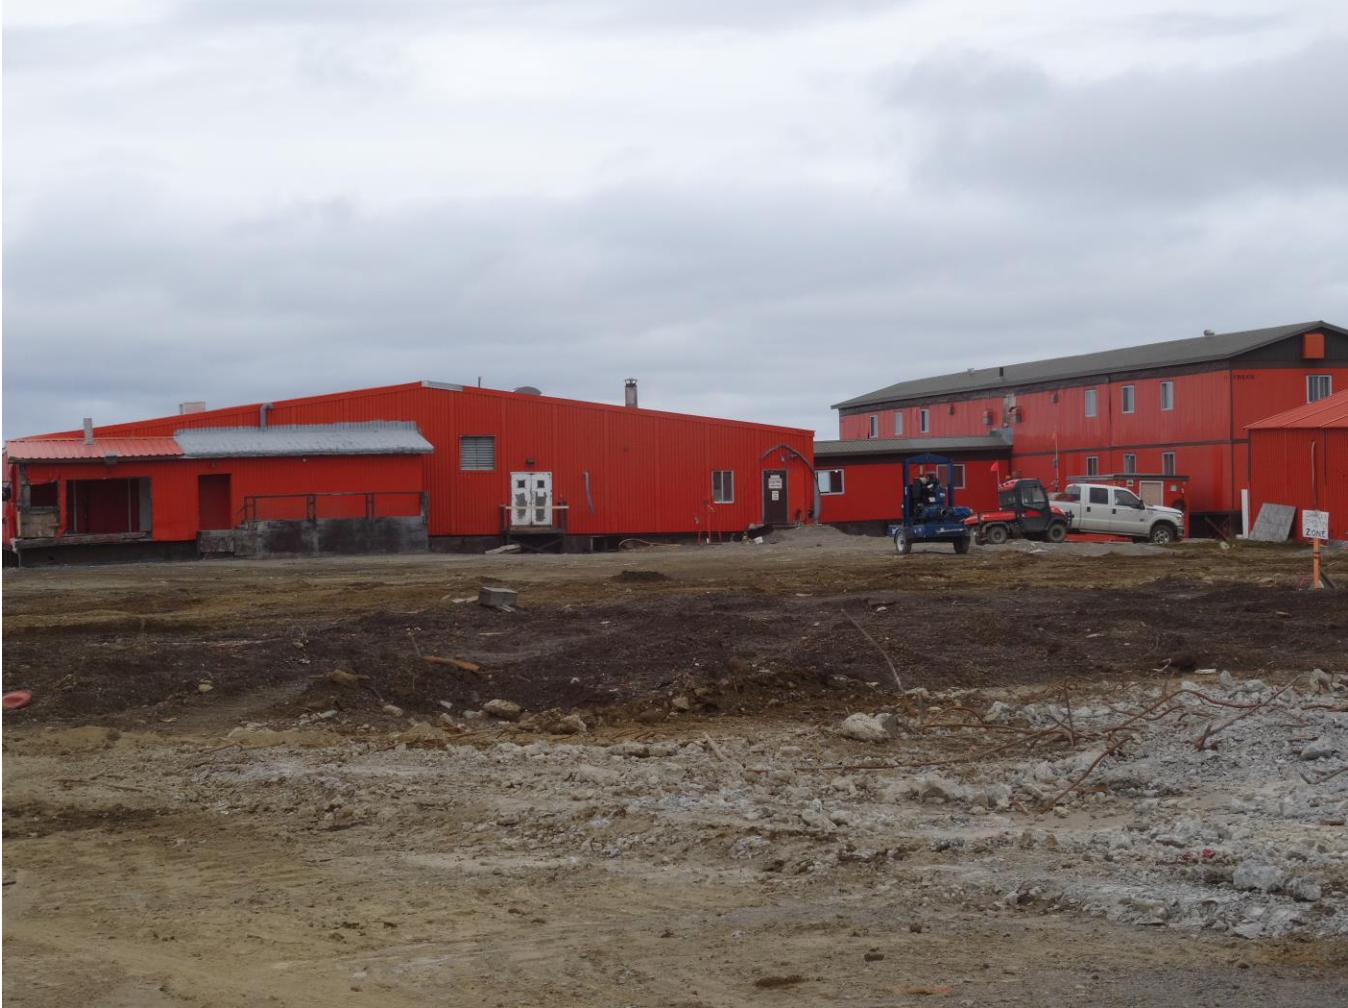
Photo 21

This Building is still Standing and scheduled to be Demolished in 2021

Description: Office/Administration Building - Building on Left Side

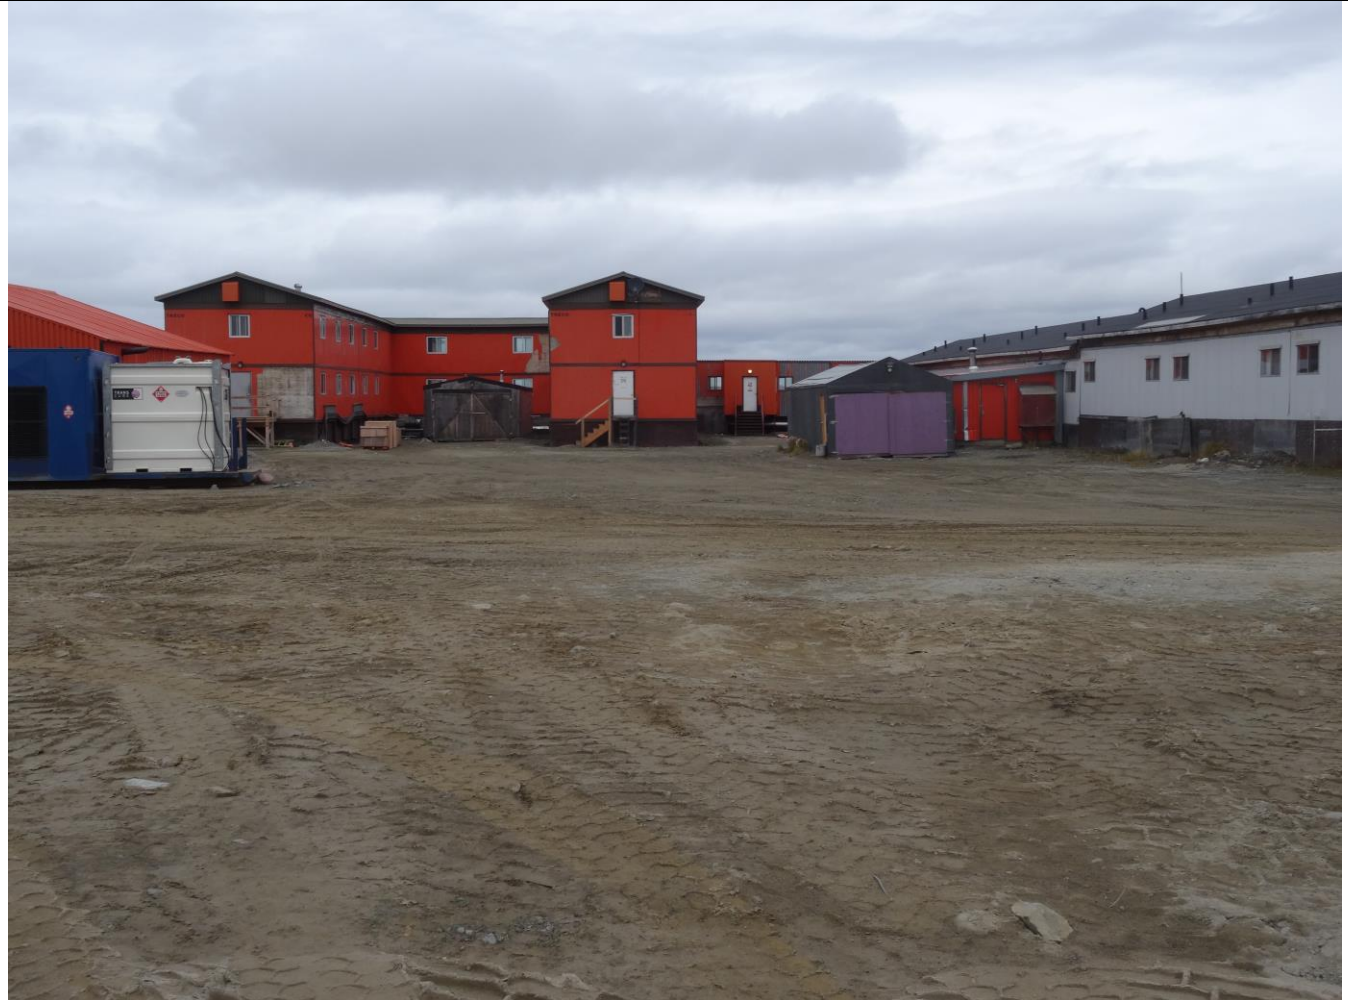
Photo 22

These Buildings are still Standing and scheduled to be Demolished in 2021

Description: 500/600/700/800 Dorm Complexes - Two 2-Storey Buildings in Background with Brown Roofs

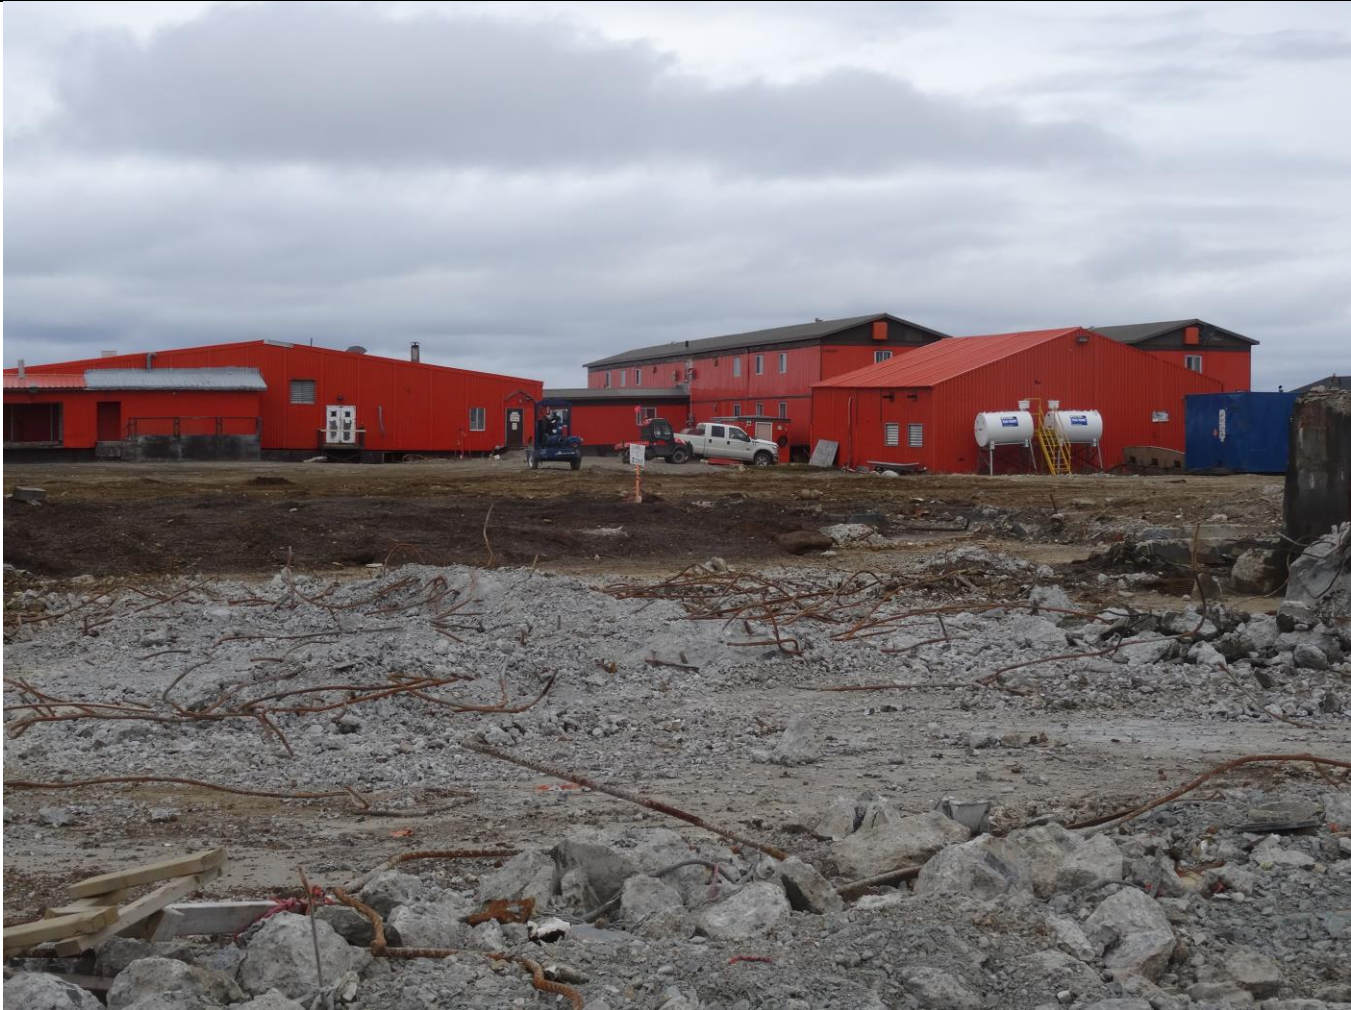
Photo 23

This Building is still Standing and scheduled to be Demolished in 2021

Description: Generator Building for 1300 Dorm – Building on Right with 2 White Fuel Tanks

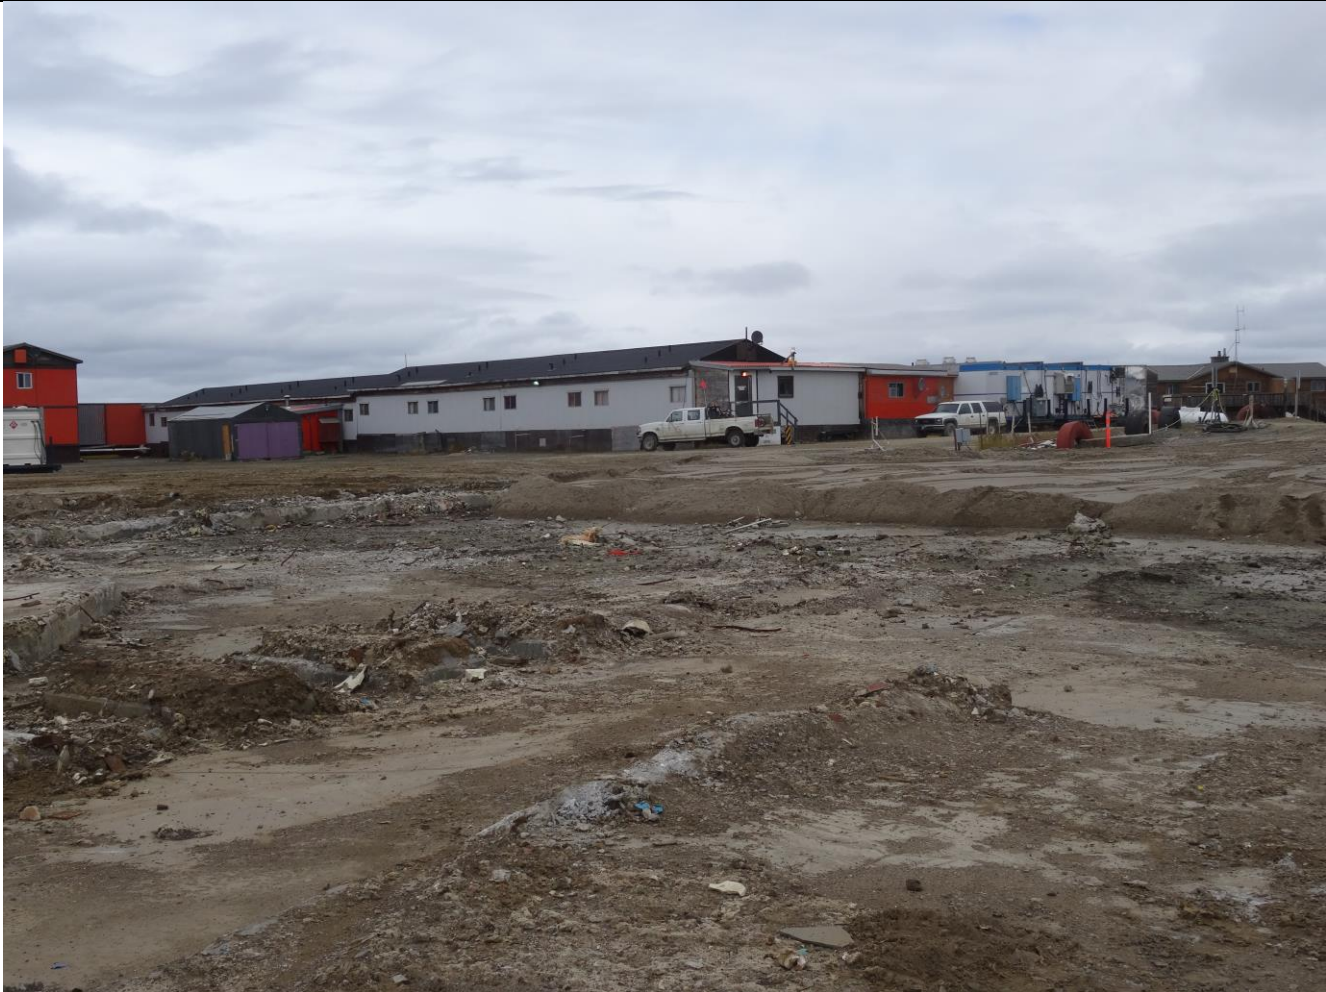
Photo 24

This Building is still Standing and scheduled to be Demolished in 2021

Description: 1300 Dorm Complex – White Building
