WATER LICENCE INSPECTION FORM

| Lupin Mines Inc | | Karyn Lewis | |
| 2AM-LUP2032 | | Project Manager | |
| 2020 July 2 | | Baba Pedersen | |

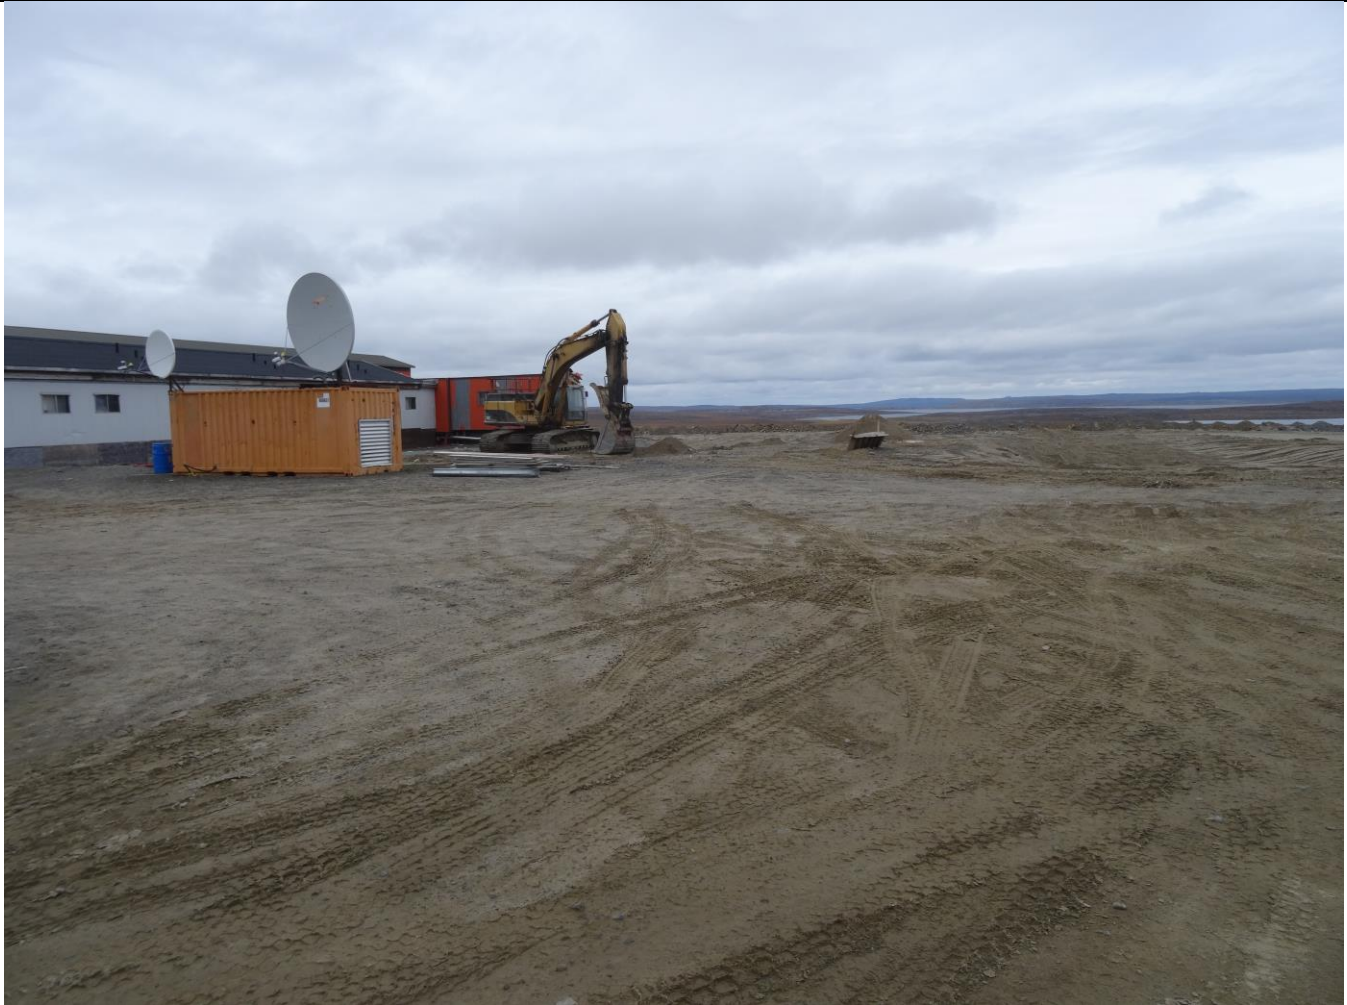
Photo 25

This area has been covered with a Gravel Pad

Description: #4 900/1000/1100/1200 Dorm Complexes – All Debris Removed and placed into the Landfill

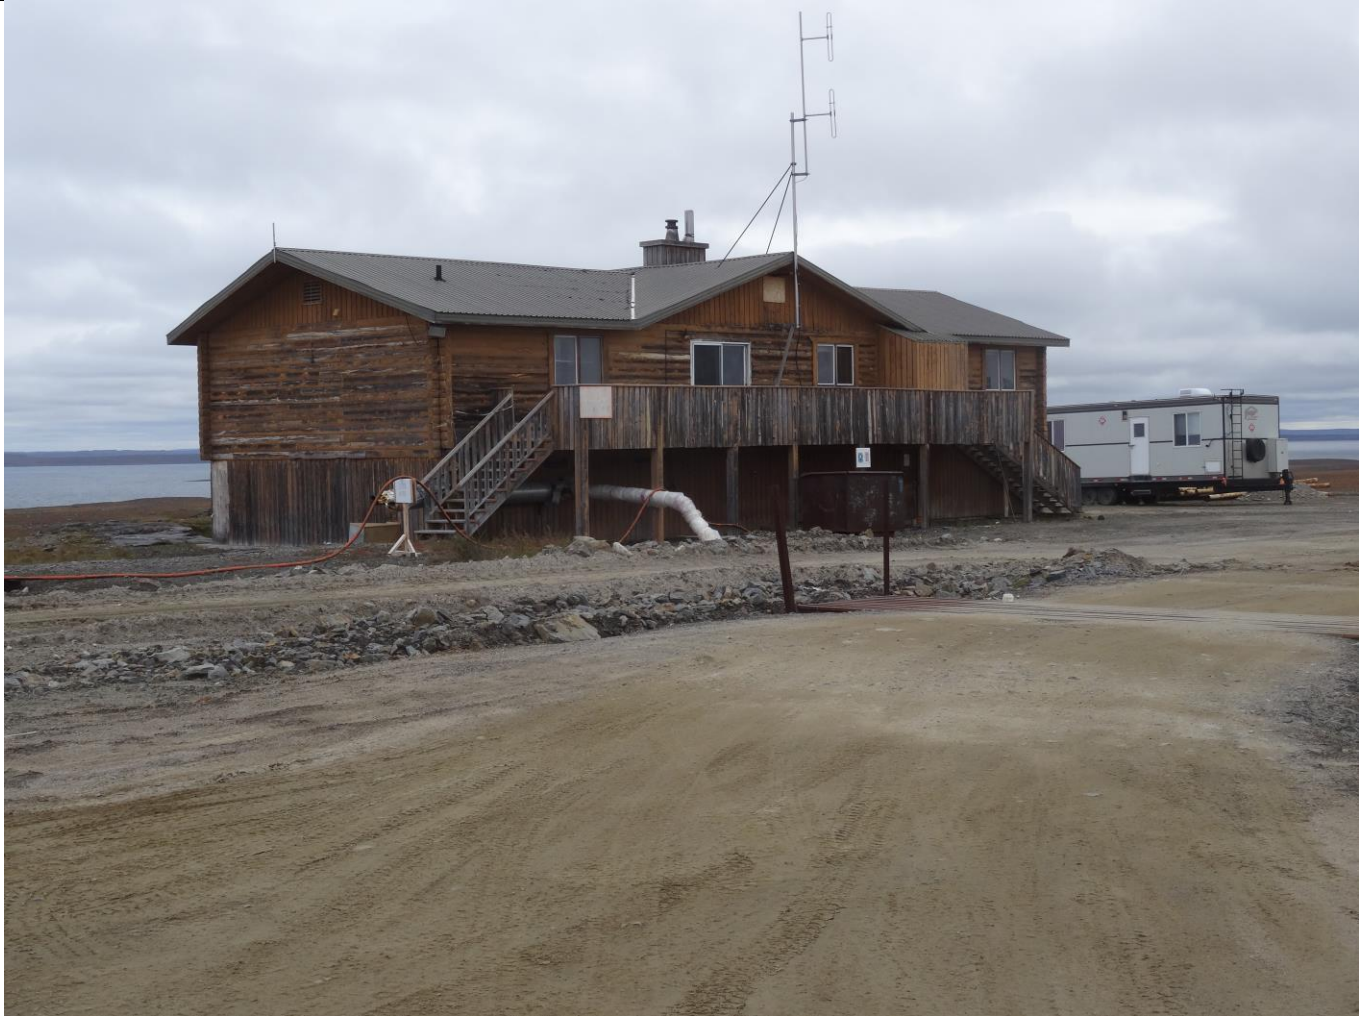
Photo 26

This building remains Standing and in use.

Description: Log Guest House – This is 1 of 2 Buildings that will remain for at least 5 years

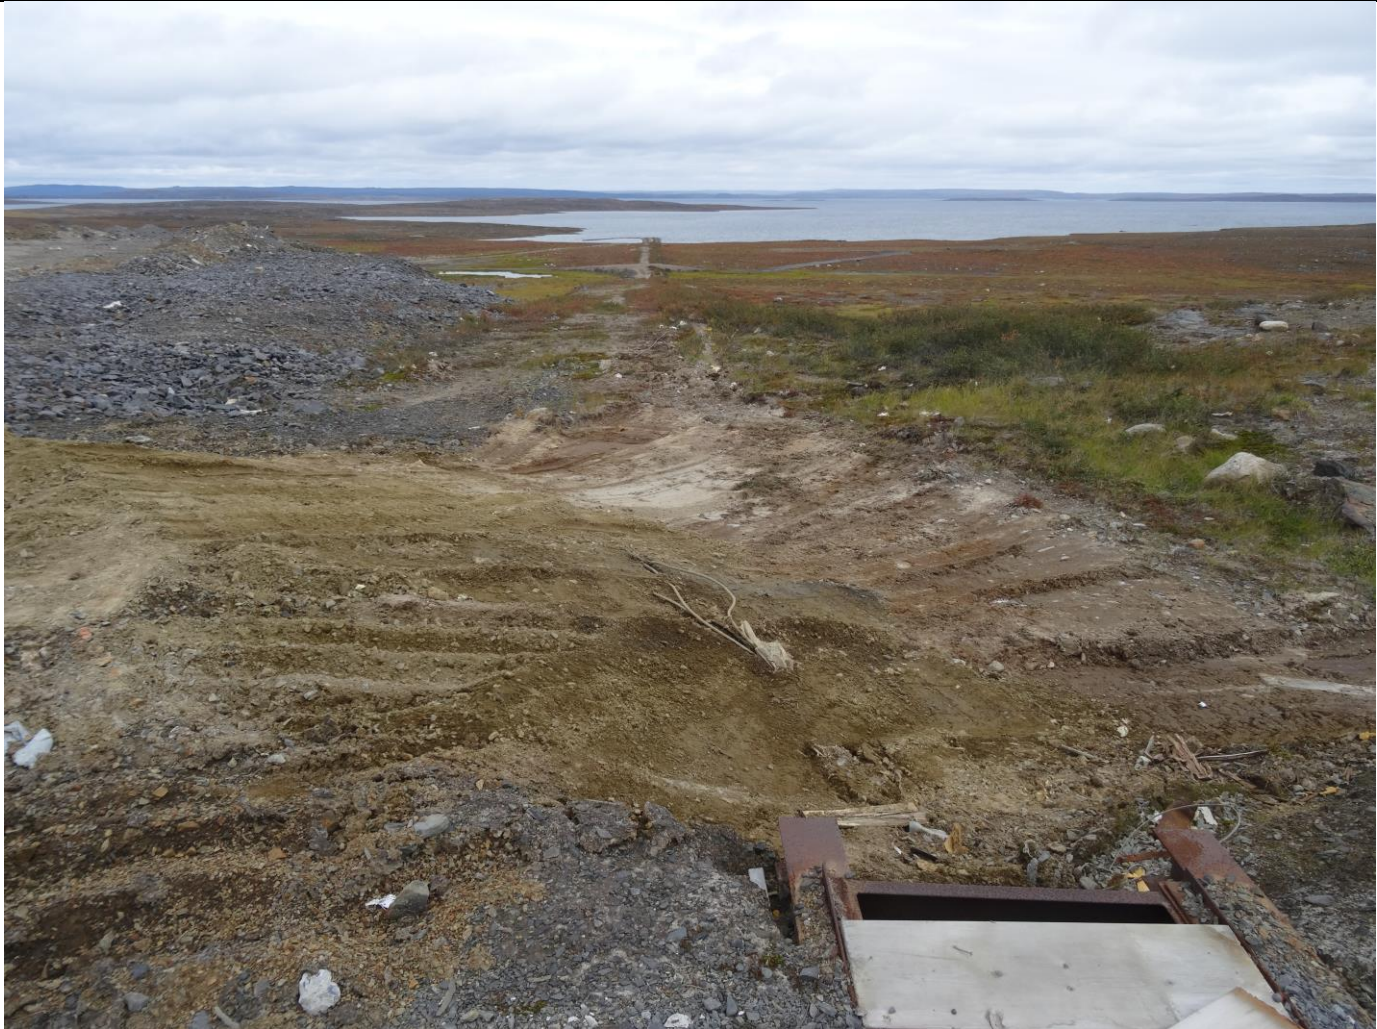
Photo 27

The Water Line has been removed from the Pump House at Contwoyto Lake up to the Log Guest House (approximately 90% of Line).

Description: Water Line – From here all the way down to Contwoyto Lake in the Background – ALL Debris Removed into the Land Fill

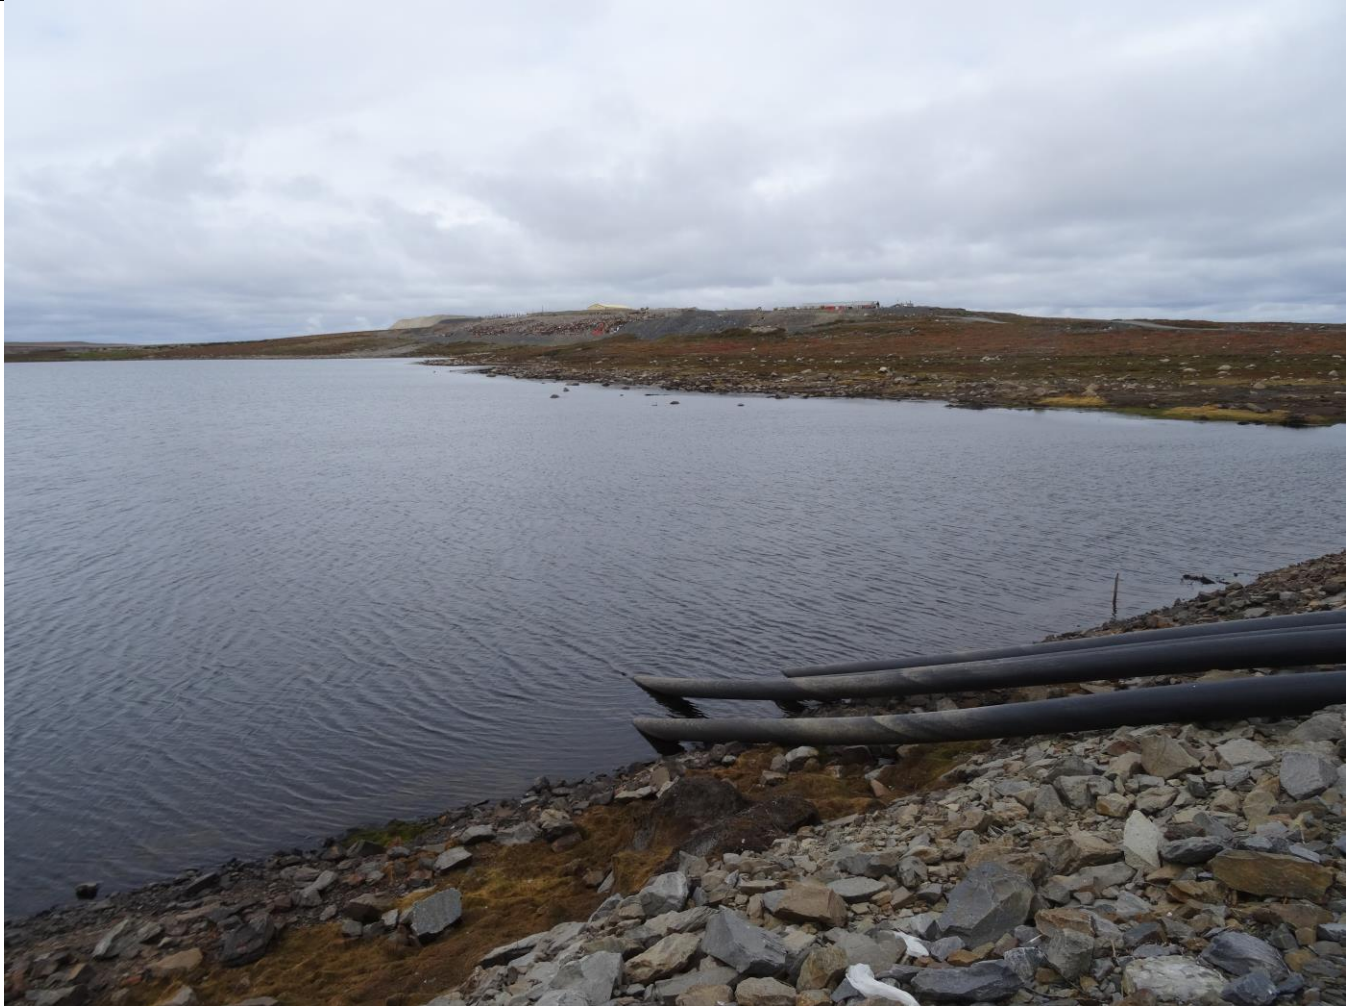
Photo 28

The Decant Program in the Lower Sewage Lagoon is almost complete with only 1 or 2 days left. The levels are the lowest I have ever seen with an estimated 4 meters of Freeboard. After completion, they will then start Decanting the Upper Sewage Lagoon into the Lower Section

Description: Lower Sewage Lagoon

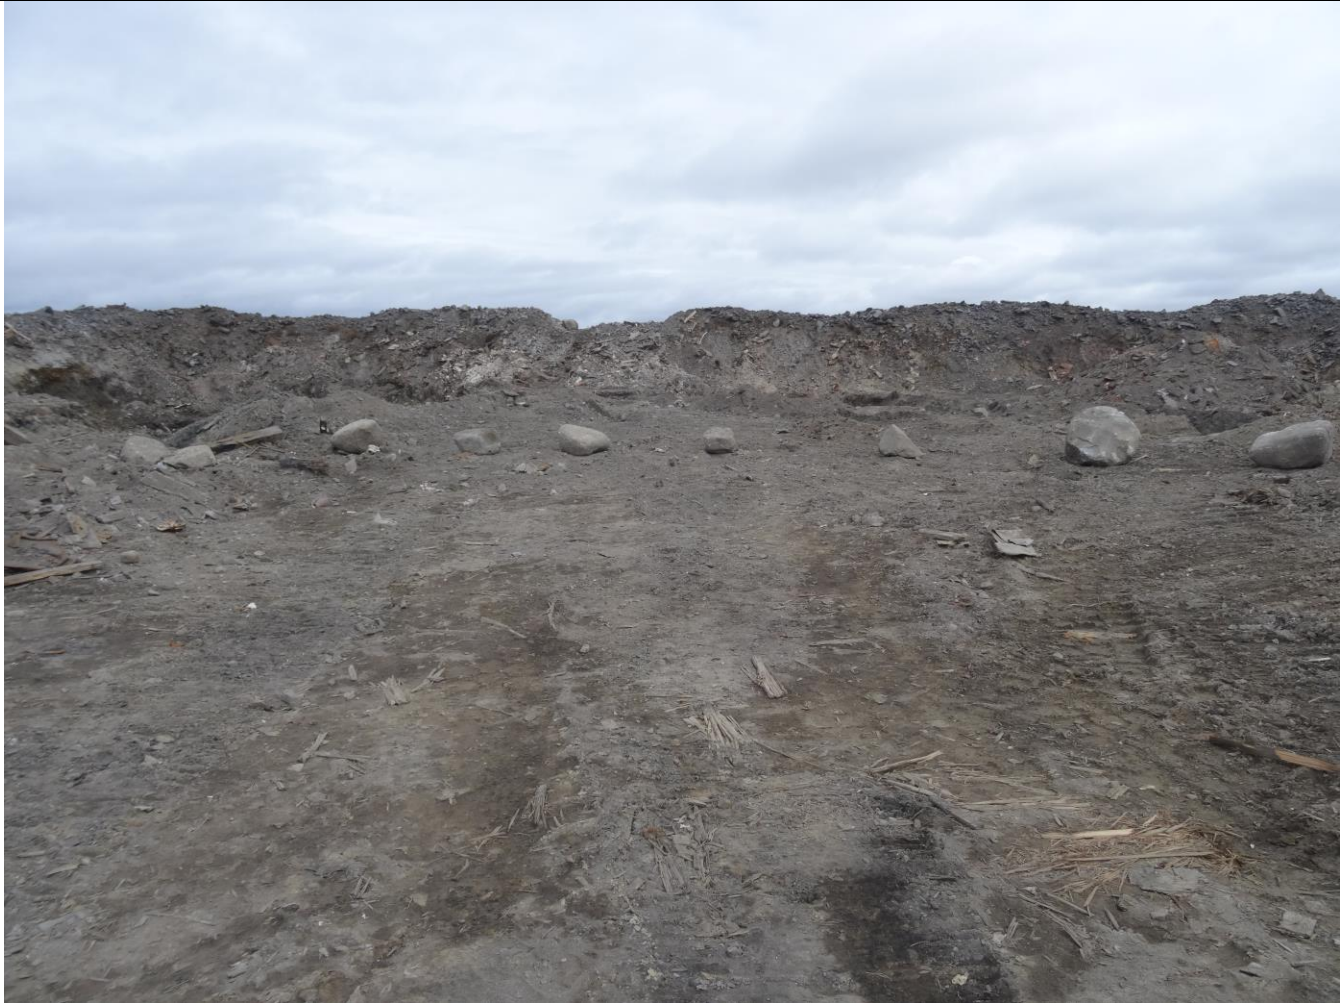
Photo 29

The Burn Pit area is located on an old Historic Dump Site. Nahanni just recently completed a 3 Day Burn Program. Golder is digging a few Test Pits to see how far down the Historic Dump goes.

I walked around the Perimeter of the Burn Pit and could not find any visible Run-off

Description: Burn Pit Area – Entire Area yet to be Excavated, Capped and Covered

This whole area will be excavated and put into the Land Fill in 2021, then the area will be Capped and Covered

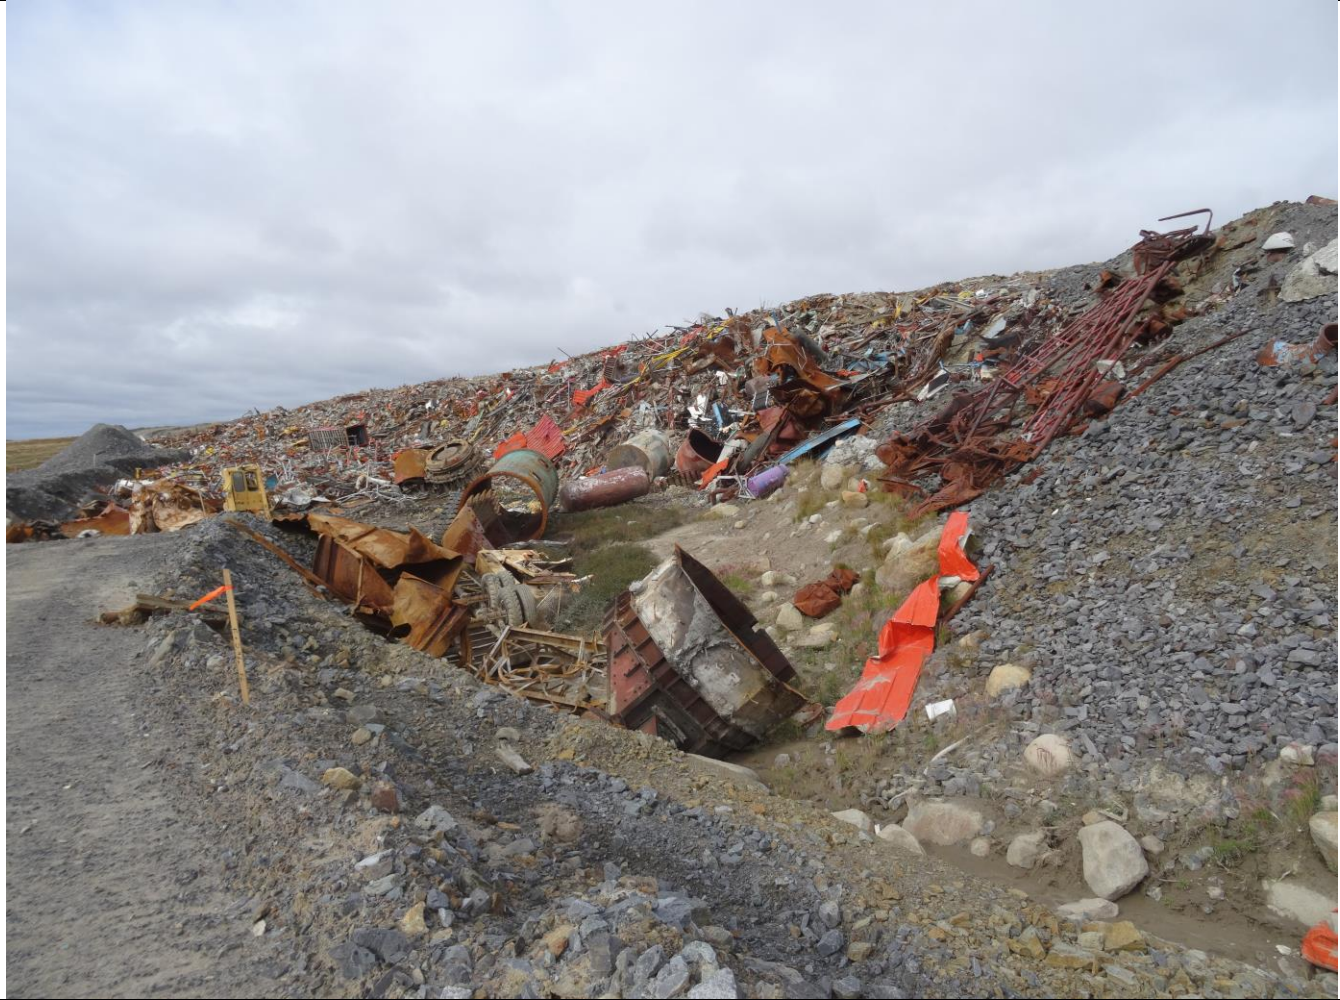
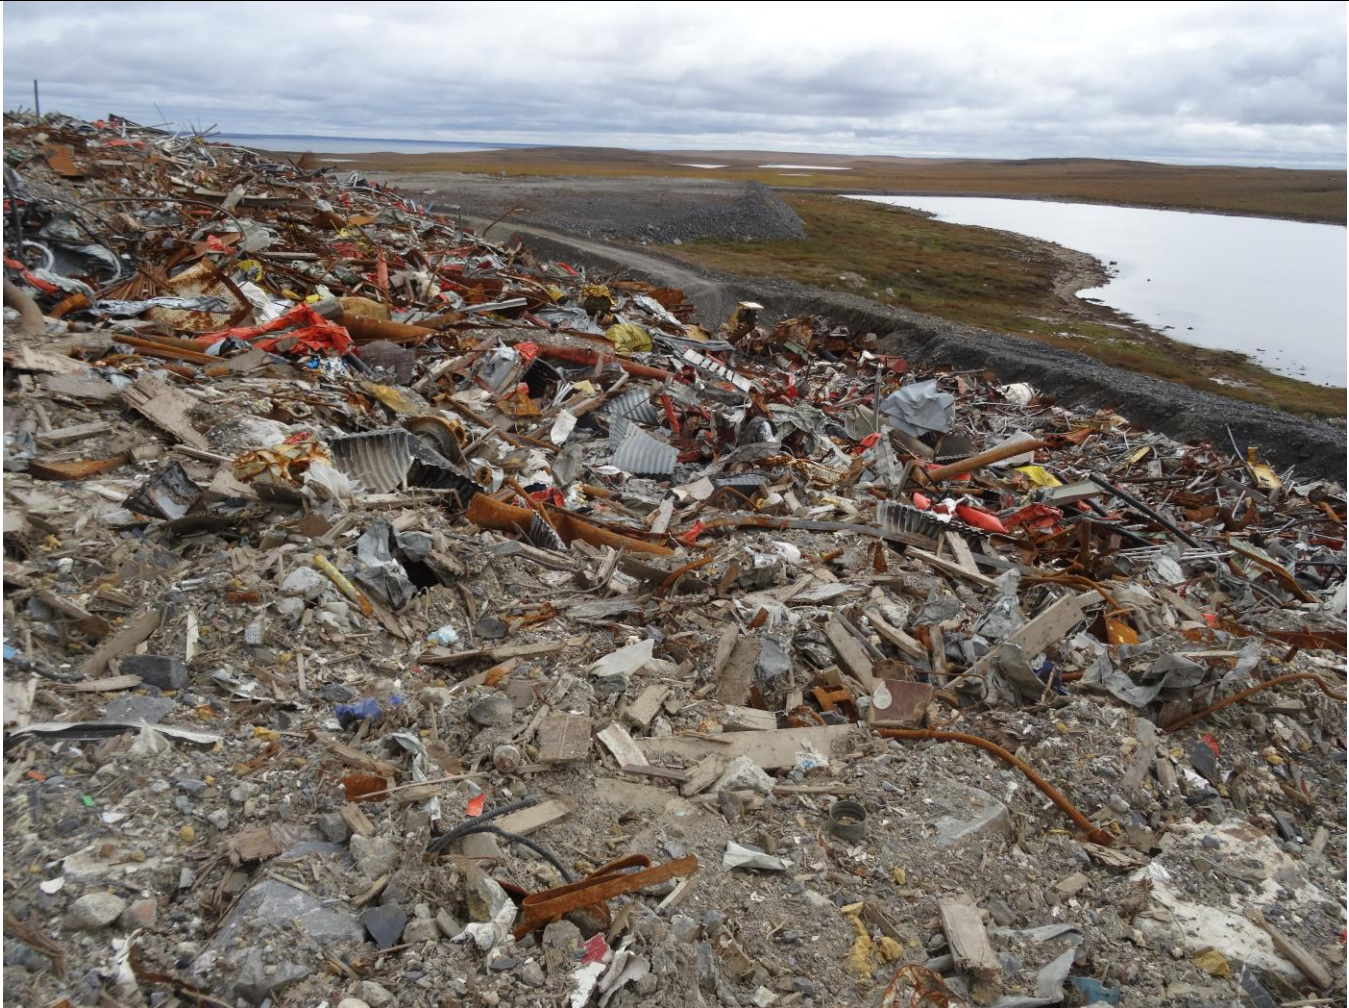
The Land Fill area is actively being used and filled up. I walked and viewed the area from the Bottom, Middle Level and the Top.

Nahanni is compacting the material as they go by “Track Packing” with the Excavator and Bulldozer

The Debris is piled in Lifts/Layers that are between 4 and 5 meters thick

They have put a 2 meter layer of Gravel as an Intermediate Fill between the Lifts/Layers of Debris

The Final Cover of Gravel will be a minimum of 2 meters thick when completed

The completed Land Fill will have a 4 to 1 Slope down towards the Lower Sewage Lagoon

Description: Land Fill – Bottom View

Description: Land Fill – Top View

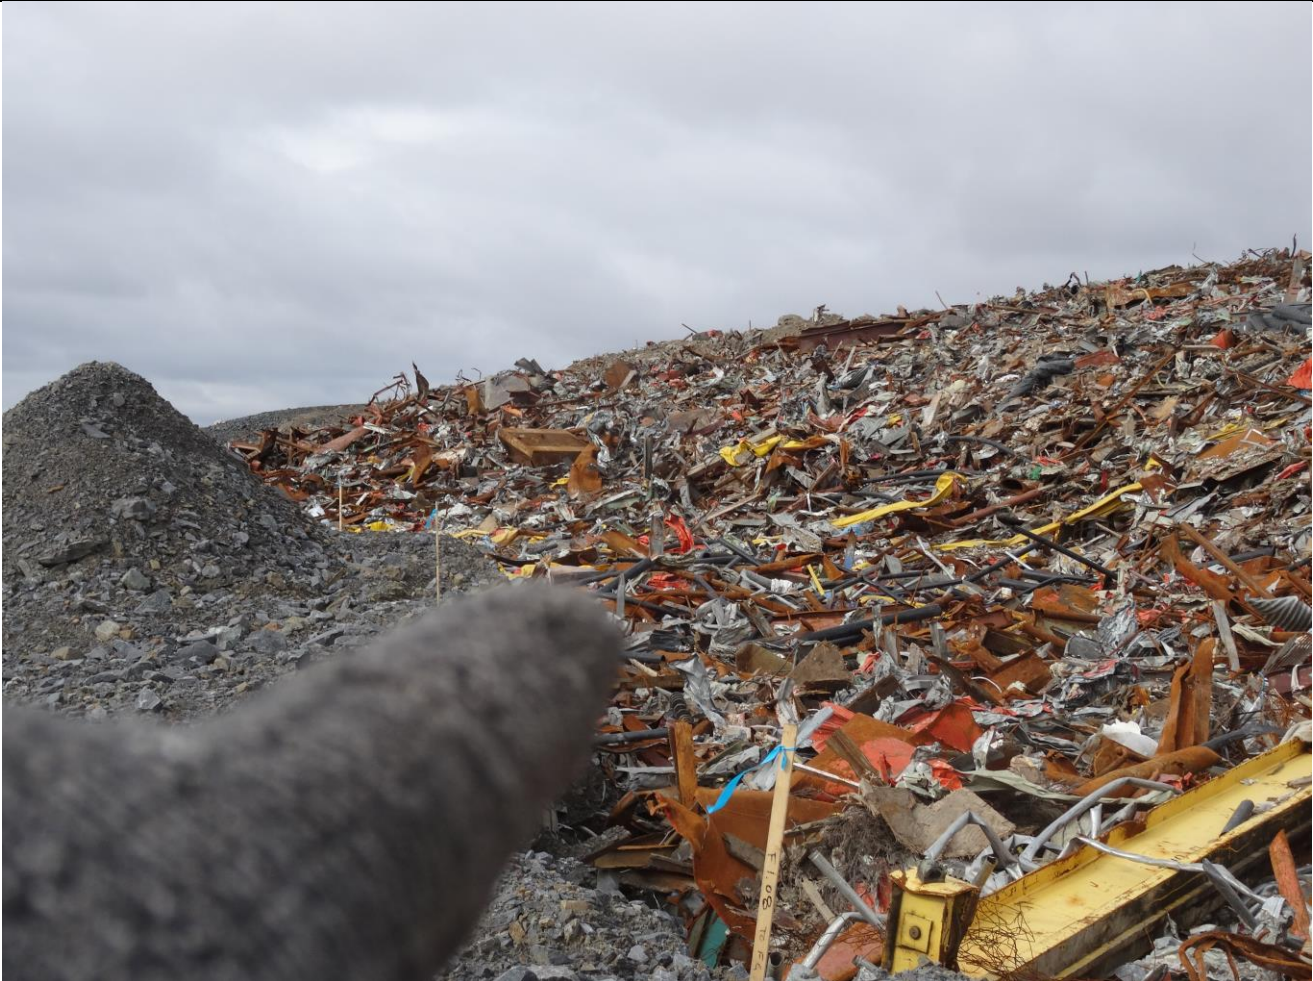
Photo 32

All Asbestos has already been cleaned up and Buried under the Land Fill Area and covered with 3 meters of Gravel

Description: Asbestos Burial Pit– Approximate Location is under the large Brown Box in the Center of the Picture

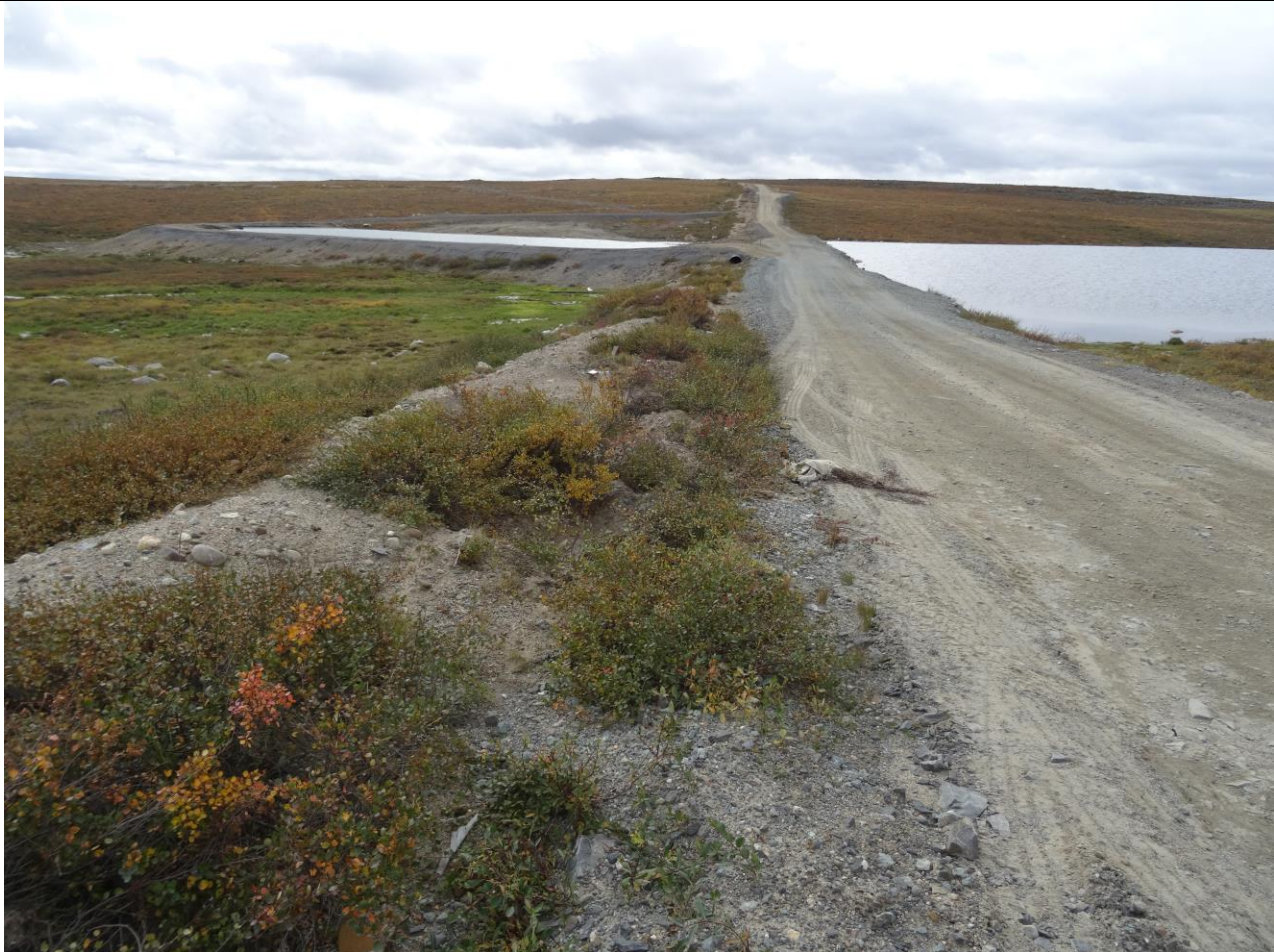
Photo 33

The Tailings Line has been 100% removed. It ran from the Mill Building out to Cell 5 along the side of the road

Description: Tailings Line – was on the Left Side of the Road – All Debris Removed and placed into the Land Fill

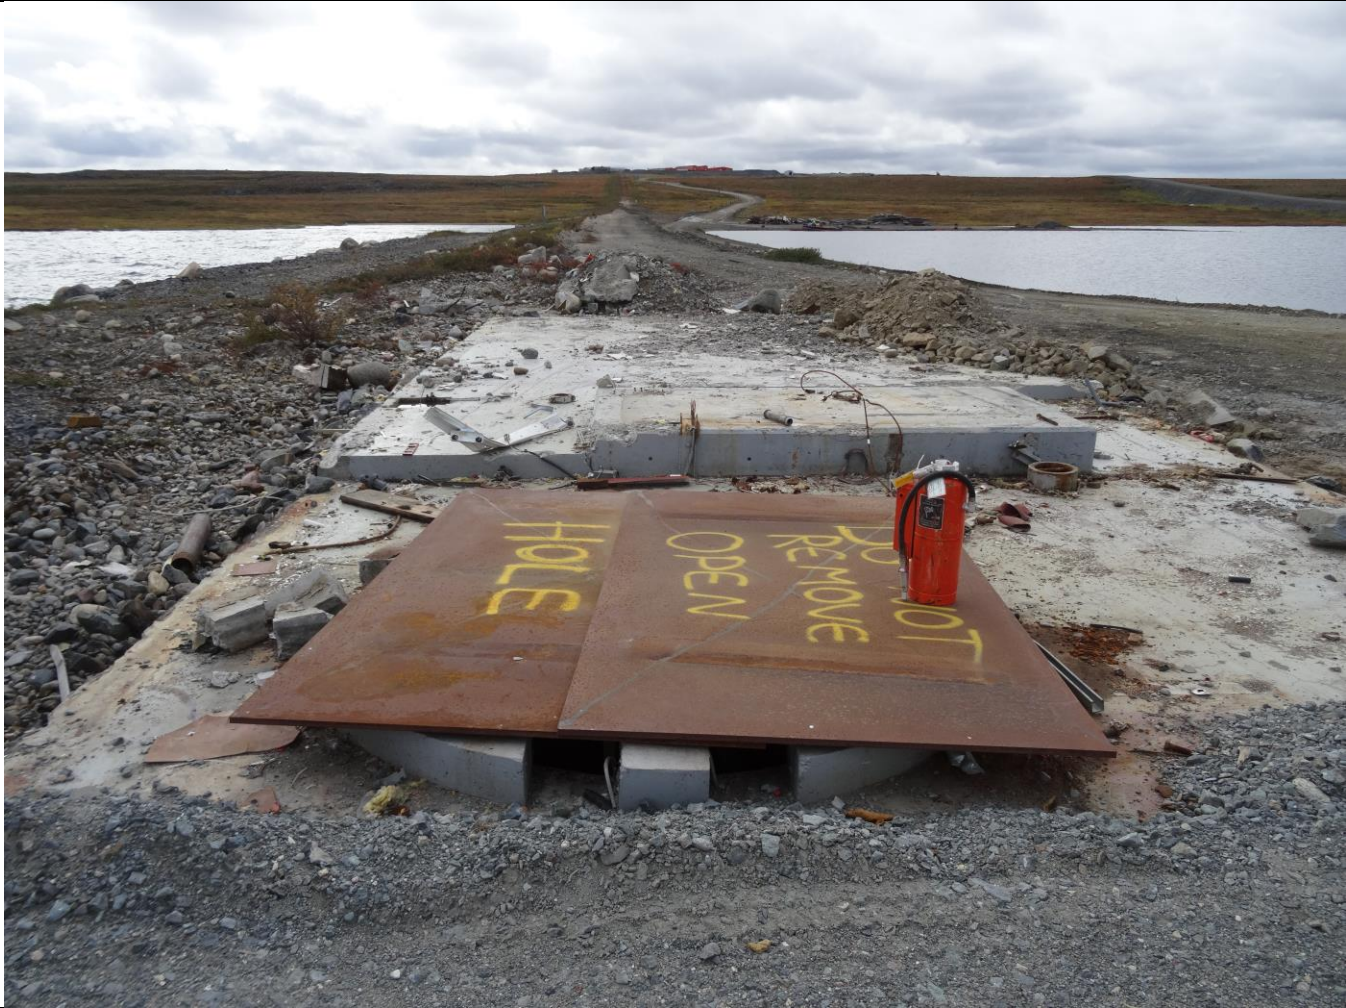
Photo 34

The Building has been Demolished and all Debris has been removed and placed in the Land Fill

The Concrete Foundation remains with 2 large sheets of Metal covering a Hole with “Do Not Remove – Open Hole” Spray Painted on the Metal Sheets

Description: Water Pump House at Contwoyto Lake Concrete Foundation Remains – Debris Removed to Land Fill
