# 2AM-LUP2032 LUPIN MINE SITE 2022 ANNUAL REPORT

Nunavut Water Board

Frazer Bouchier, President & CEO Mandalay Resources

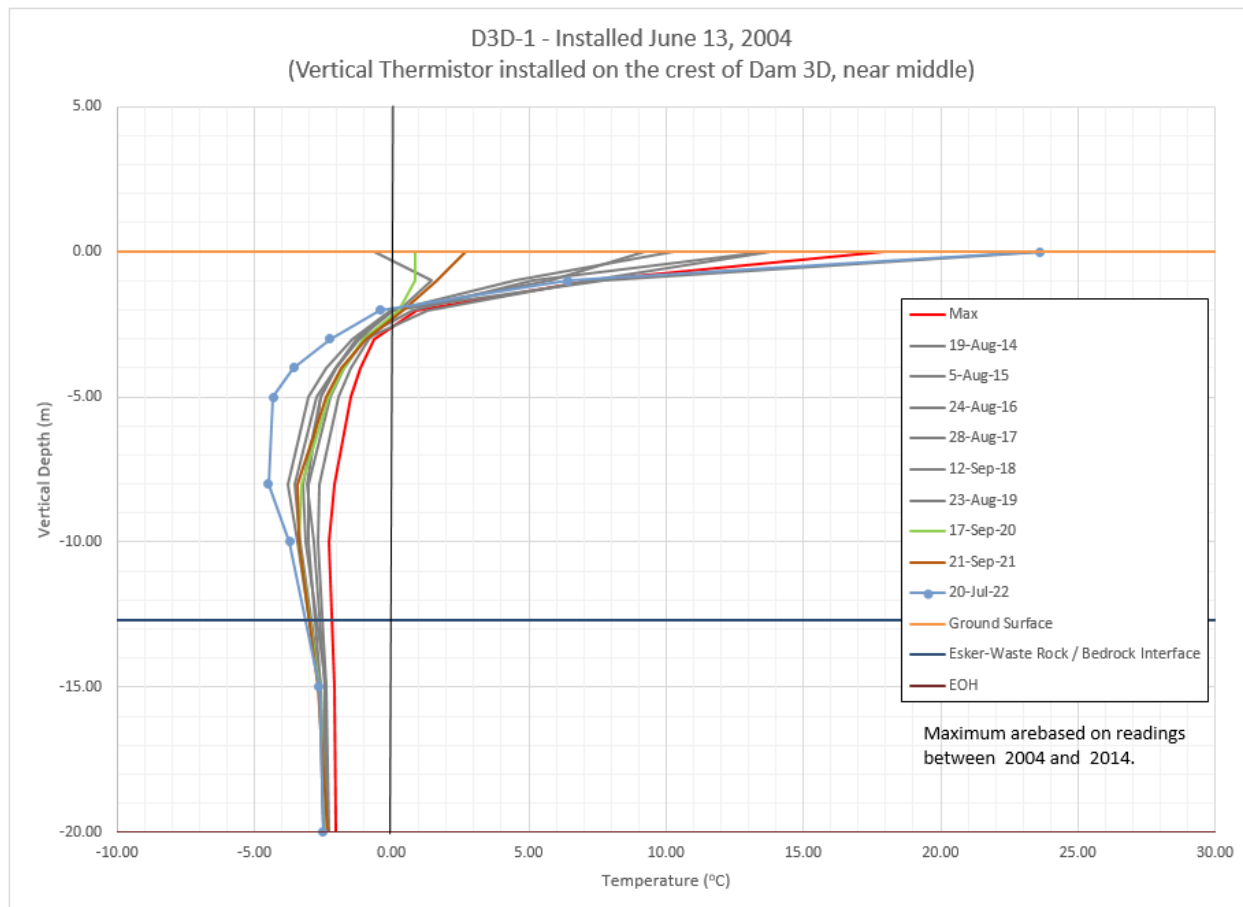
**Figure 3-4: Thermistor Reading for Dam 3D**

For the internal dams, there are two thermistors which are also less than 20m deep in Dam K and Dam 3D. These were not historically monitored as rigorously as the ones installed in the perimeter dams, and only have recent data from 2014. Readings from the one functional thermistor are shown in the figure below. The active layer is observed to be around 2m, as interpolated by the 0°C gradient line. The variations between the data set is less than 2°C and generally occur below the historical maximum.

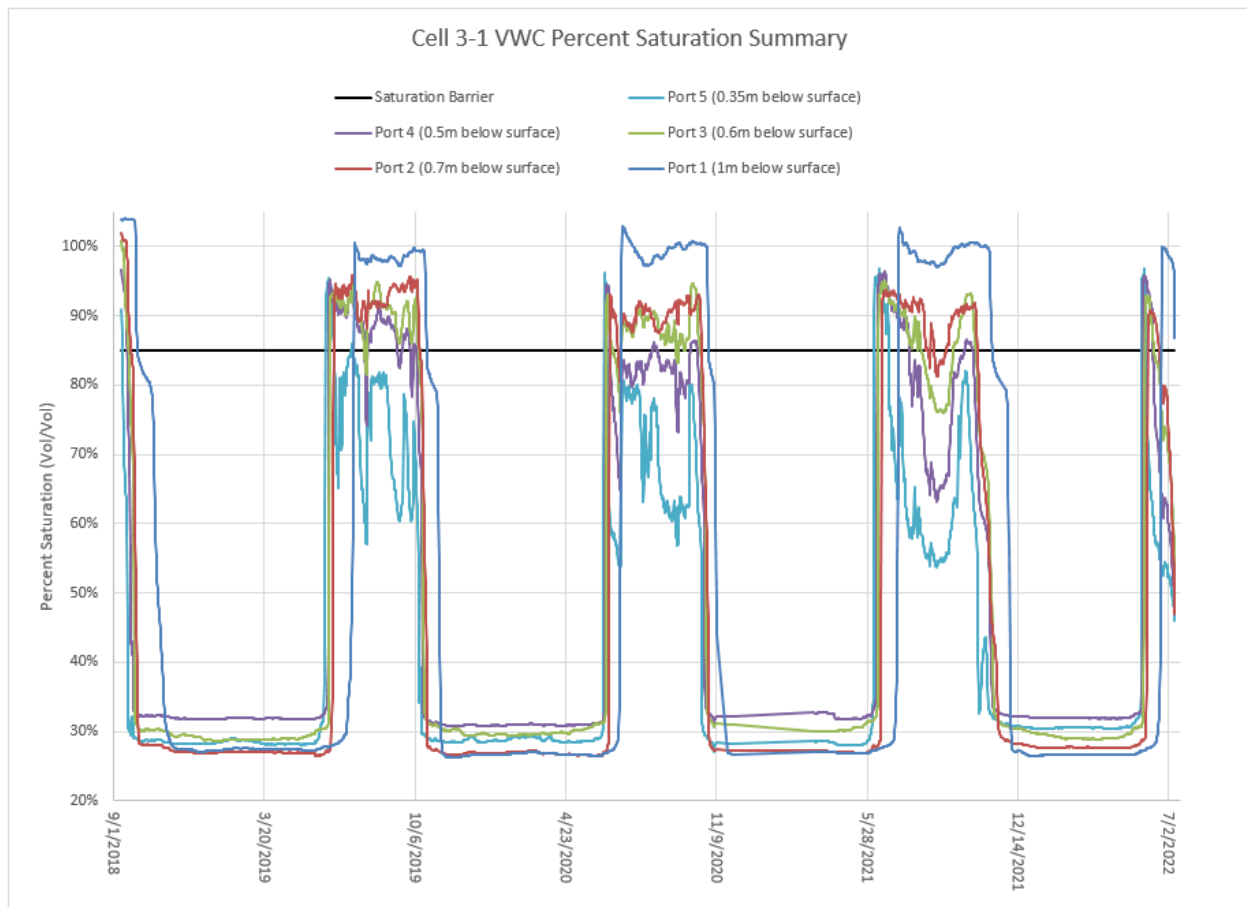
**Figure 3-6: Cell 3-1 Port 1 VWC Result**

The figure below shows the percentage saturation for VWC in Cell 3. The majority of the sensors show frozen conditions between October and June. There is a spike in percentage of saturation in the top sensors in June signaling overall thawing. The 2022 data indicates that the lower portion of the cover, as shown by Ports 1 and 2, is generally above 85% saturation once thawed. The upper portion cover as shown in Port 3 to 5 showed a variable trend between 57% to 86% saturation, mostly related to surface evaporation and rehydration from rain. It is assumed that the tailings remain to be inert as the lower portion of the cover is above 85% saturation.

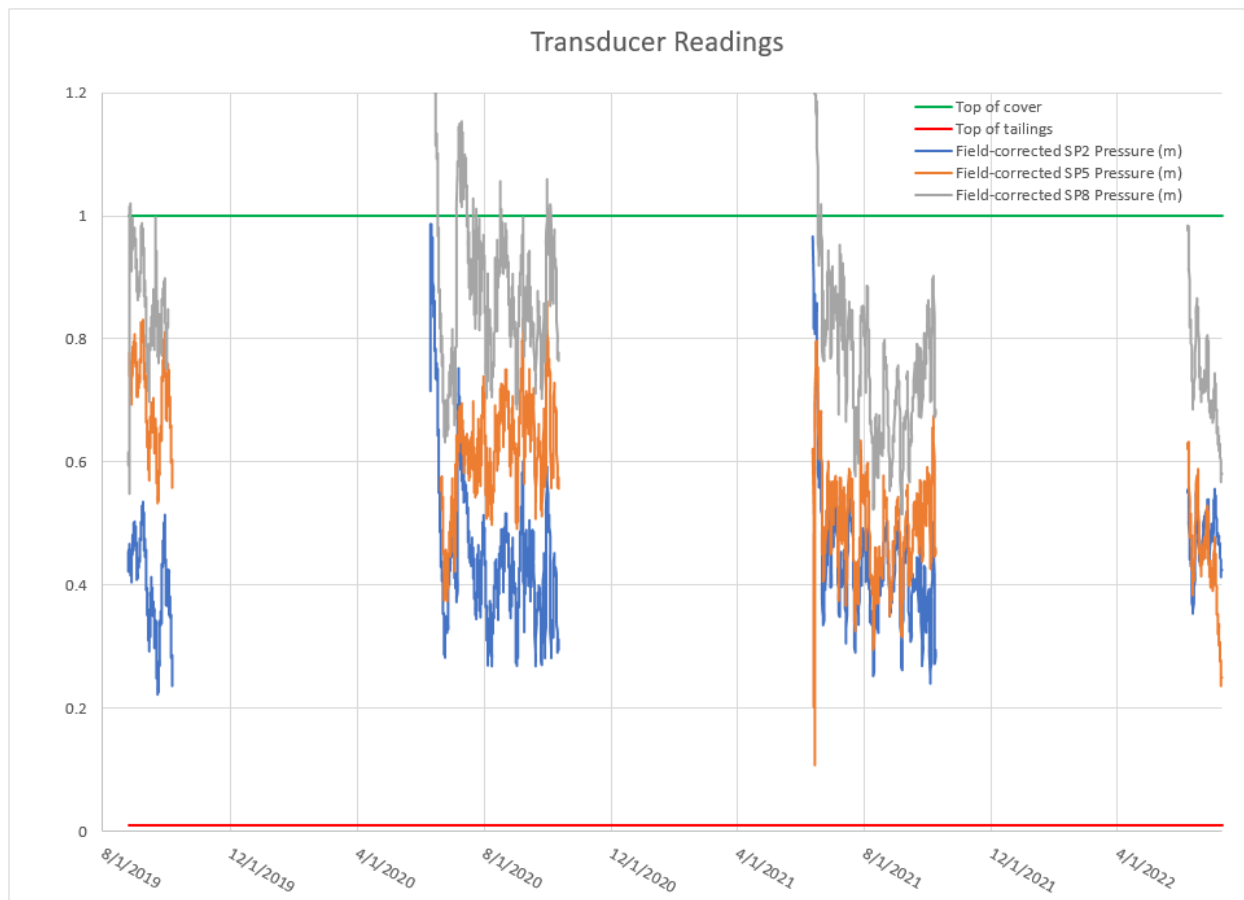
**Figure 3-7: Transducer Results**

ponding above the cover. According to the transducers data, the cover and tailings are reporting to be saturated at these locations, indicating the cover is functioning as designed.

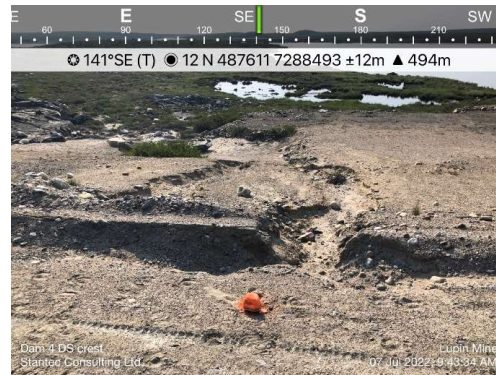
to historical conditions. Fresh erosional features were identified on the downstream embankment at Dam 4. These features were repaired by the end of inspection. Historical, minor erosional features resulting from water runoff on the crests and embankments of dams were observed. These minor erosional features appeared to be relatively unchanged when compared to historical conditions.

Photo 20: Looking southeast at the upstream slope of Dam 4 with erosion gully.

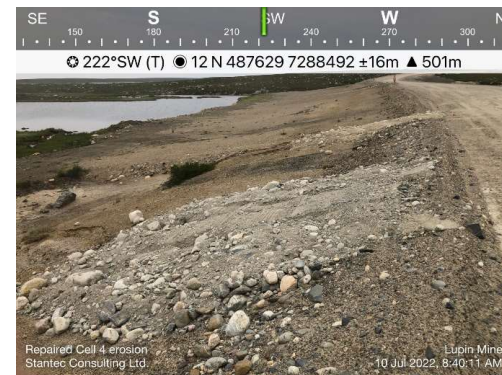
Photo 21: Looking southwest at the downstream crest of Dam 4 with the repaired completed over the erosion gully.

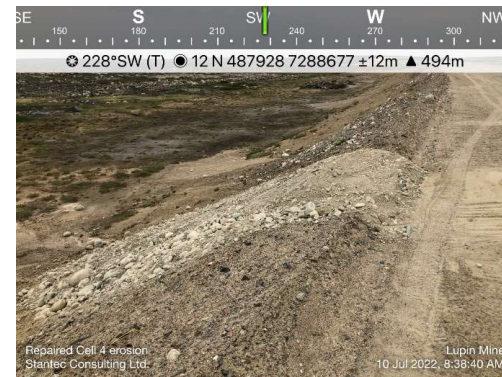
Photo 24: Looking southwest at the downstream crest of Dam 4 with the erosion repaired.

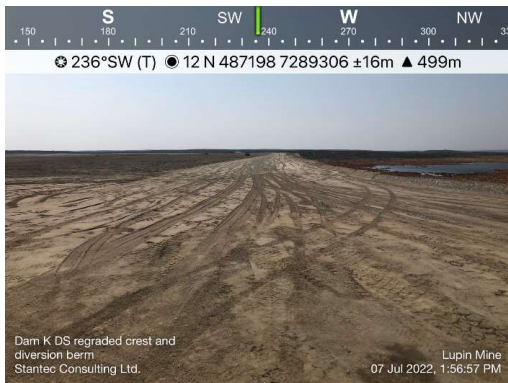
JDS, DMS, and Stantec personnel noted the formation of erosional gullies on the face of K Dam upon arrival to site in 2022. Erosional gullies were backfilled with a mix of clean esker sand and gravel-sized particles in June 2022 in response to observations of erosional gully formation. Material added to K Dam appeared to be stable upon observation during the DSI site visit.

Photo 36: Looking southwest at the regraded crest and diversion berm of Dam K.

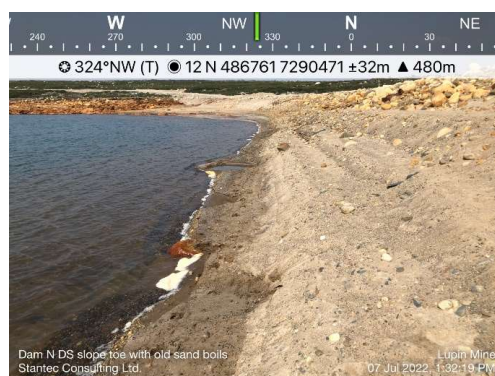
Photo 46: Downstream slope of Dam N with old sand boils near the north abutment.
