WATER LICENCE INSPECTION FORM

Licensee		Licensee Representative	
Lupin Mines Inc		Karyn Lewis	
Licence No. / Expiry		Representative's Title	
2AM-LUP2032		Project Manager	
Land / Other Authorizations		Land / Other Authorizations	
Date of Inspection		Inspector	
2020 July 2		Baba Pedersen	
Activities Inspected			
<input type="checkbox"/> Camp	<input type="checkbox"/> Drilling	<input type="checkbox"/> Mining	<input type="checkbox"/> Construction
<input type="checkbox"/> Roads/Hauling	<input type="checkbox"/> Other:	<input checked="" type="checkbox"/> Other: Reclamation Security	<input type="checkbox"/> Reclamation
<input type="checkbox"/> Fuel Storage

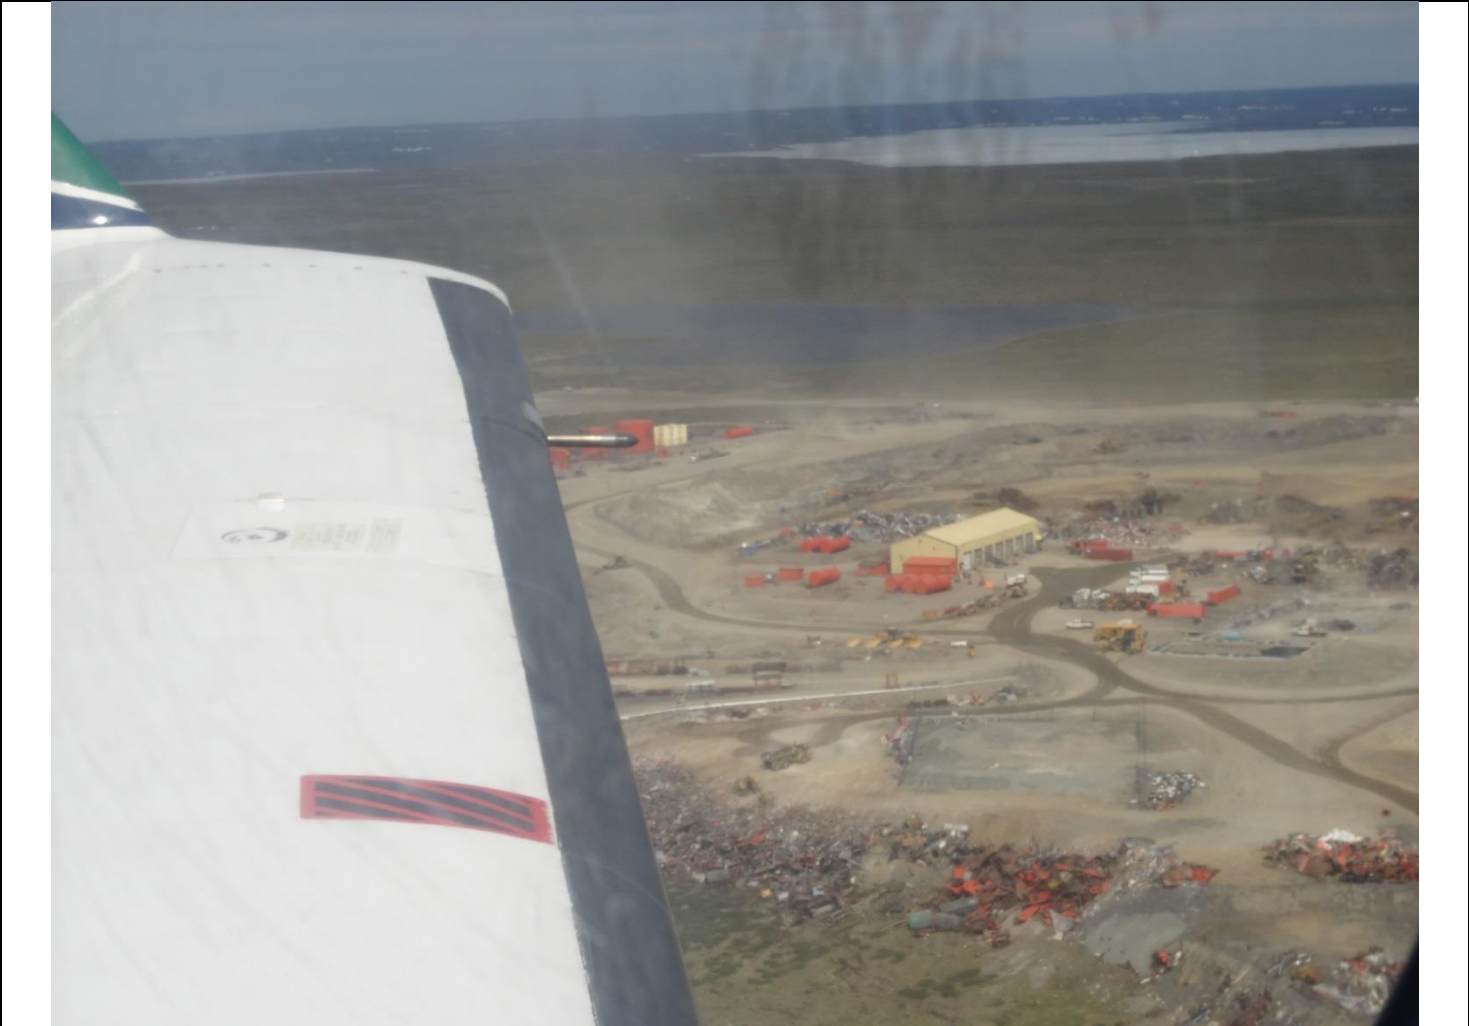
Photo 3

Description: Lupin Mine Site as at 2020 July 2 – View 1 as an “AFTER” Photo for comparison

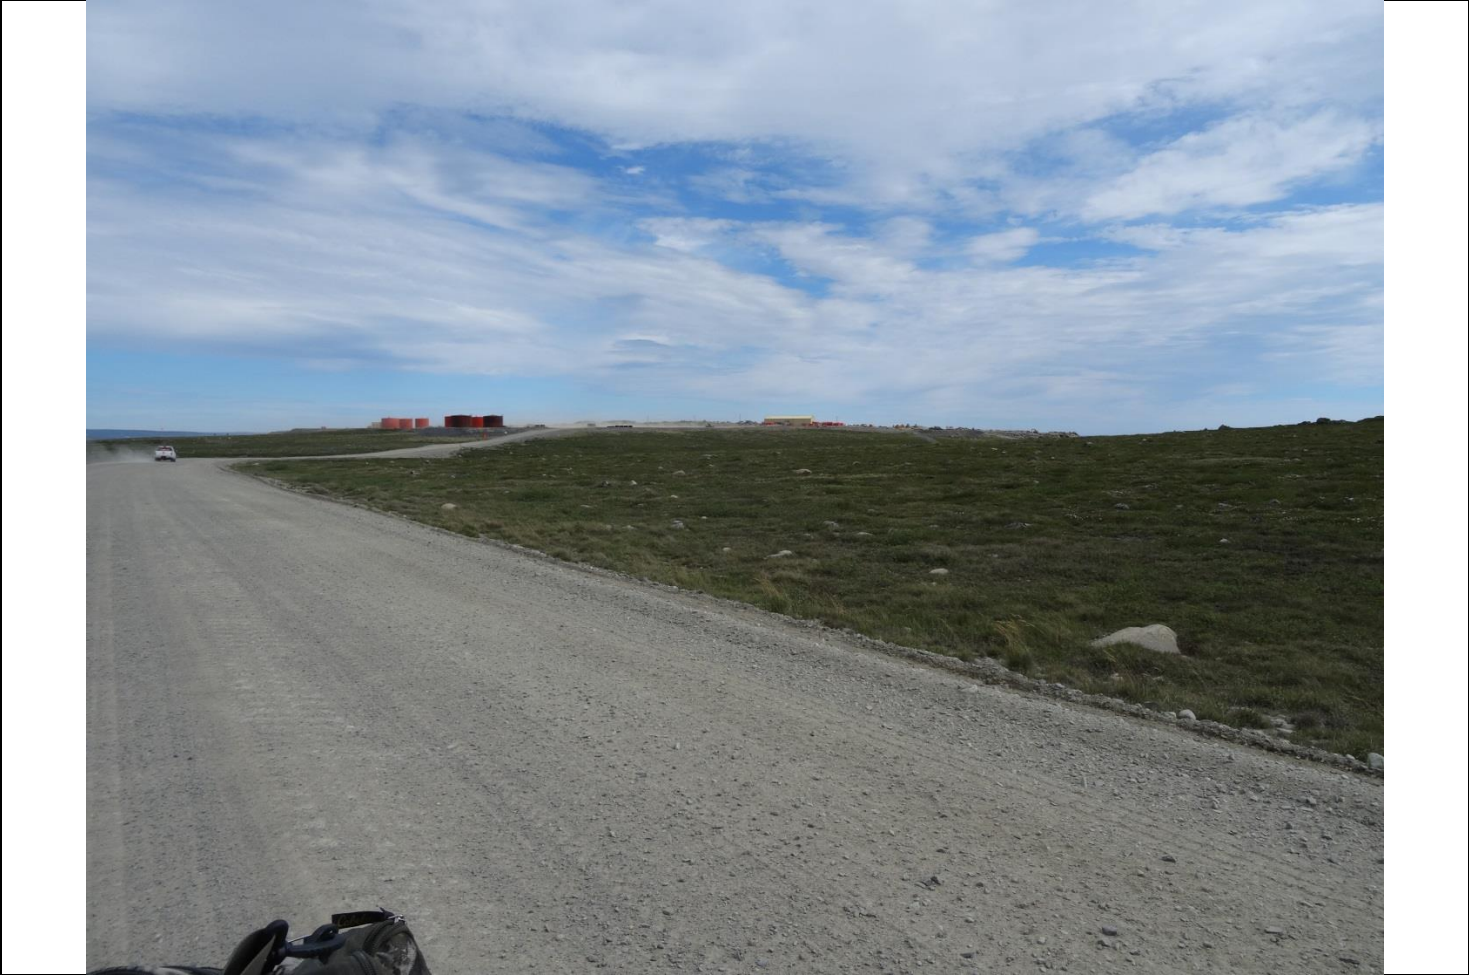
Photo 4

Description: Lupin Mine Site as at 2020 July 2 – View 2 as an “AFTER” Photo for comparison

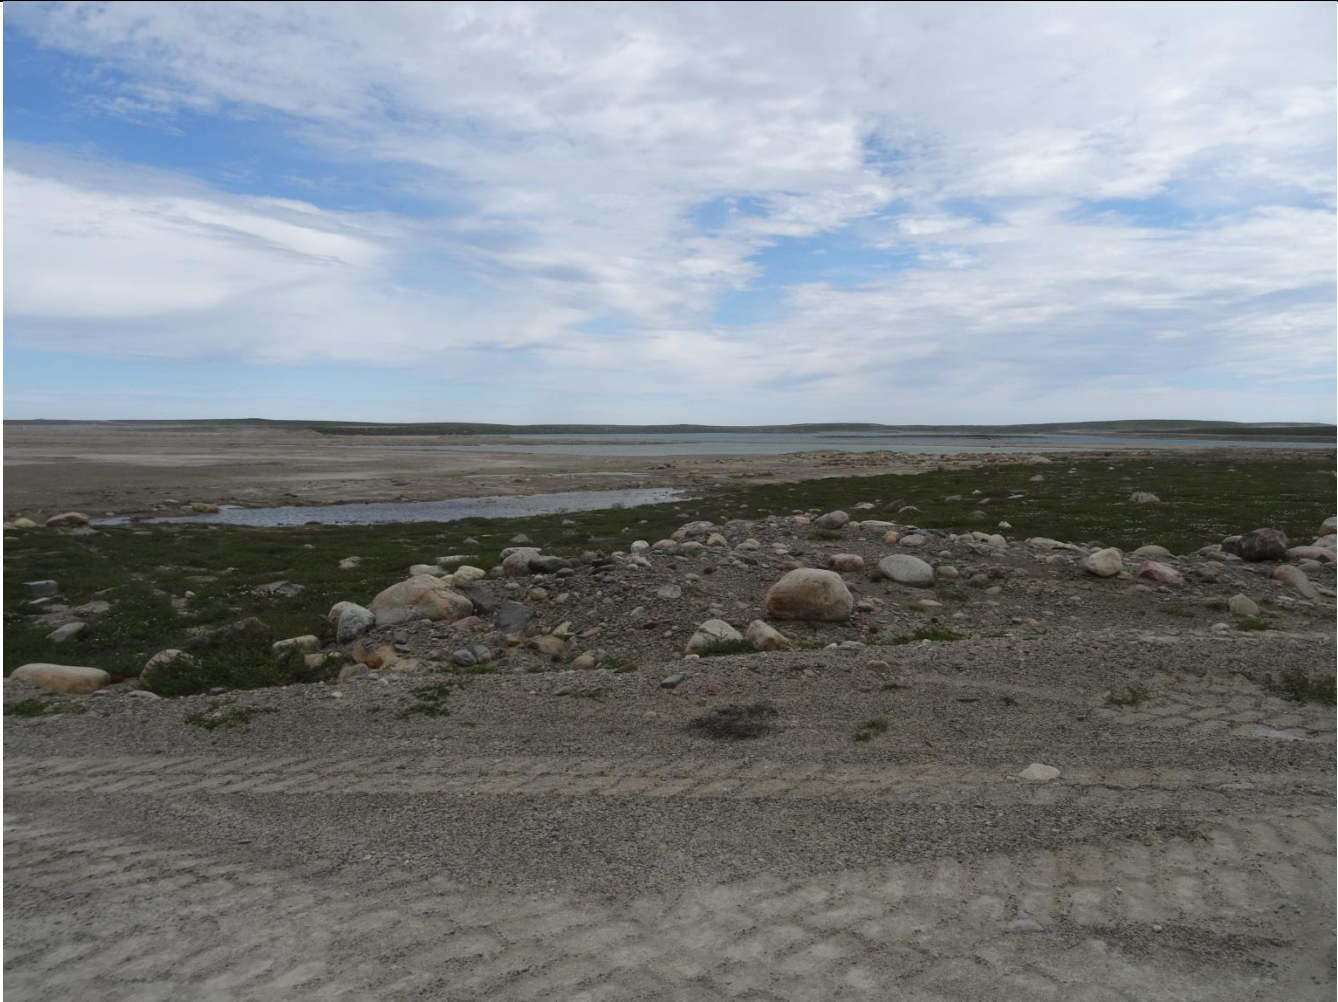
Photo 7

SECTION 2	<input checked="" type="checkbox"/> Comments	<input type="checkbox"/> Non-Compliance with Act or Licence	<input type="checkbox"/> Action Required
<p>As part of the report for Confirmation of Work Completed, as it pertains to Reclamation Security, the writer included 2 Photos that were taken of how the Lupin Site appeared as at 2019 Aug 25 (Photos 1 and 2) for a purpose of Comparison and 2 Photos that the writer took on 2020 July 2 (Photos 3 and 4). The writer also has included a snapshot (Photo 5) of an email dated 2020 June 30 provided by the Contractor, Nahanni Construction, to LMI stating the Demolished Items they would like the writer to look at during the Inspection of 2020 July 2.</p> <p>The following is a list of Specific Locations that were observed during this Inspection;</p> <p>TAILINGS FACILITIES AS PER SCHEDULE C, TABLE 4 on Page 29 of the Water Licence</p> <p>Cell 3 (Photos 6 and 7), the June 30 email states that the contractor estimates they are 43% Complete and on site during the Inspection Gord Peckford estimated that they are around 80% Complete. From the writer's observations and photos it does appear that about 80% of the Cell 3 Tailings Area has been covered. The writer did NOT confirm the depth of the cover, nor did the writer see any Aerial Photos.</p>

Description: Cell 3 – View 2

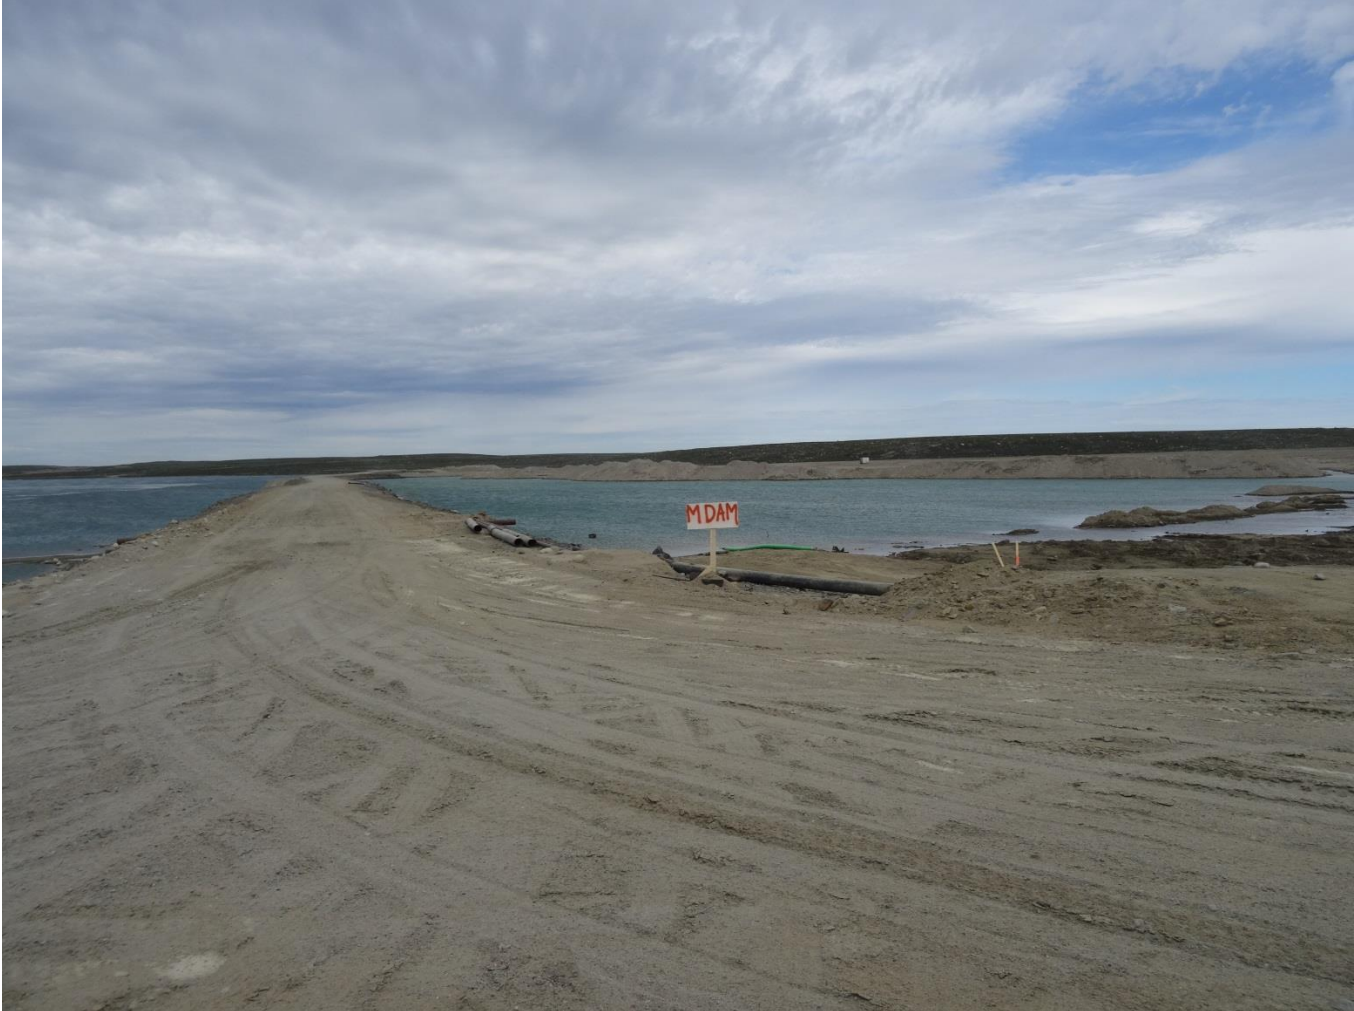
Photo 8

Cell 5 (Photos 8 and 9), the June 30 email states that the contractor estimates they are 52% Complete and on site during the Inspection Gord Peckford estimated that they are around 80% Complete. From the writer’s observations and photos it does appear that about 80% of the Cell 5 Tailings Area has been covered. The writer did NOT confirm the depth of the cover, nor did the writer see any Aerial Photos.

Description: Cell 5 – View 1

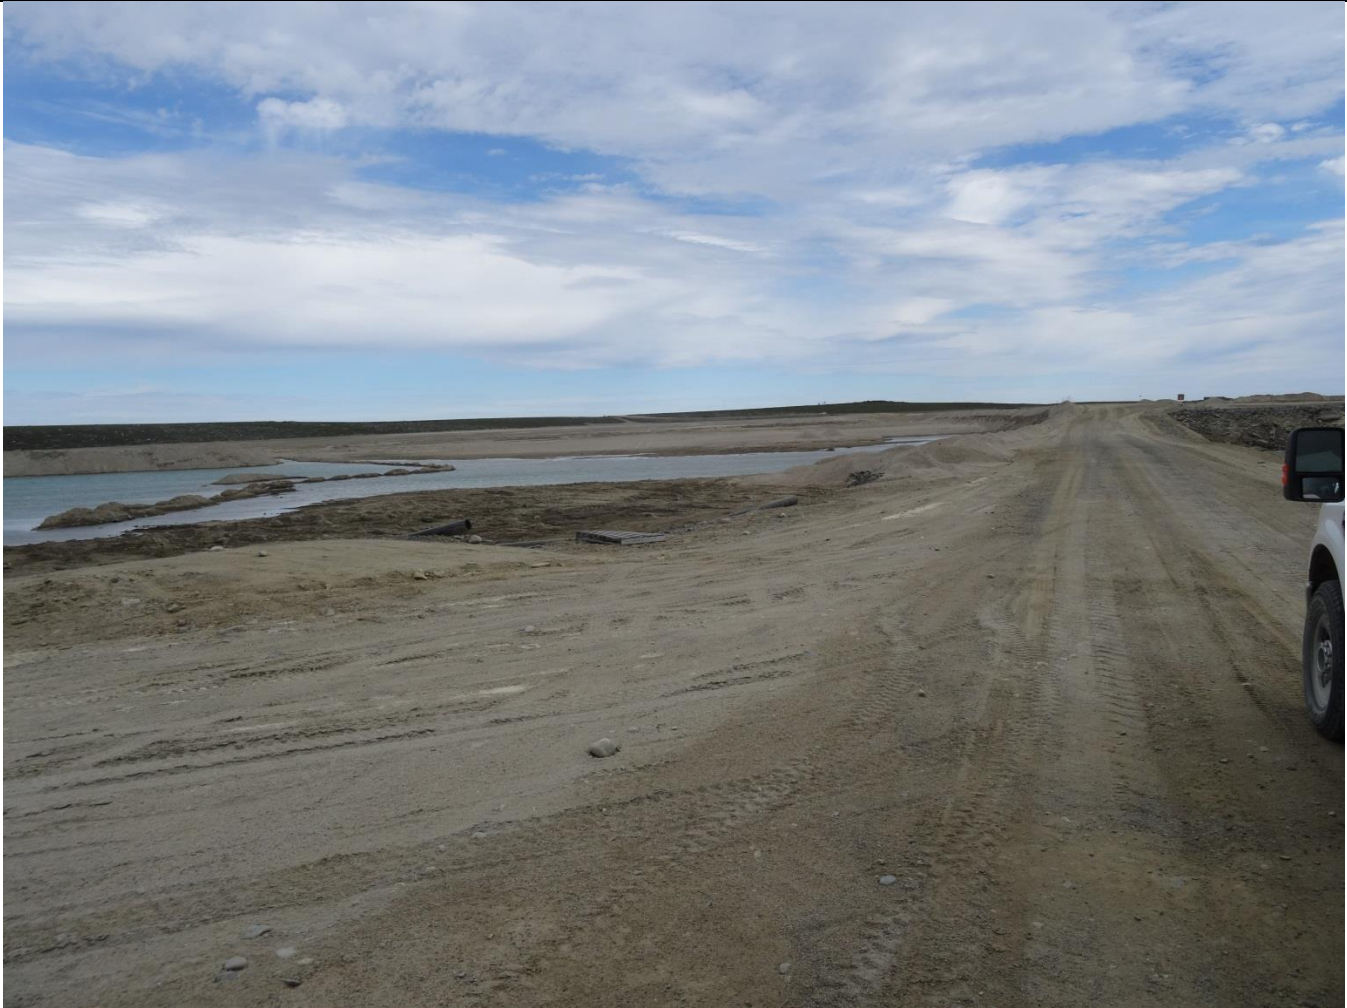
Photo 9

Description: Cell 5 – View 2

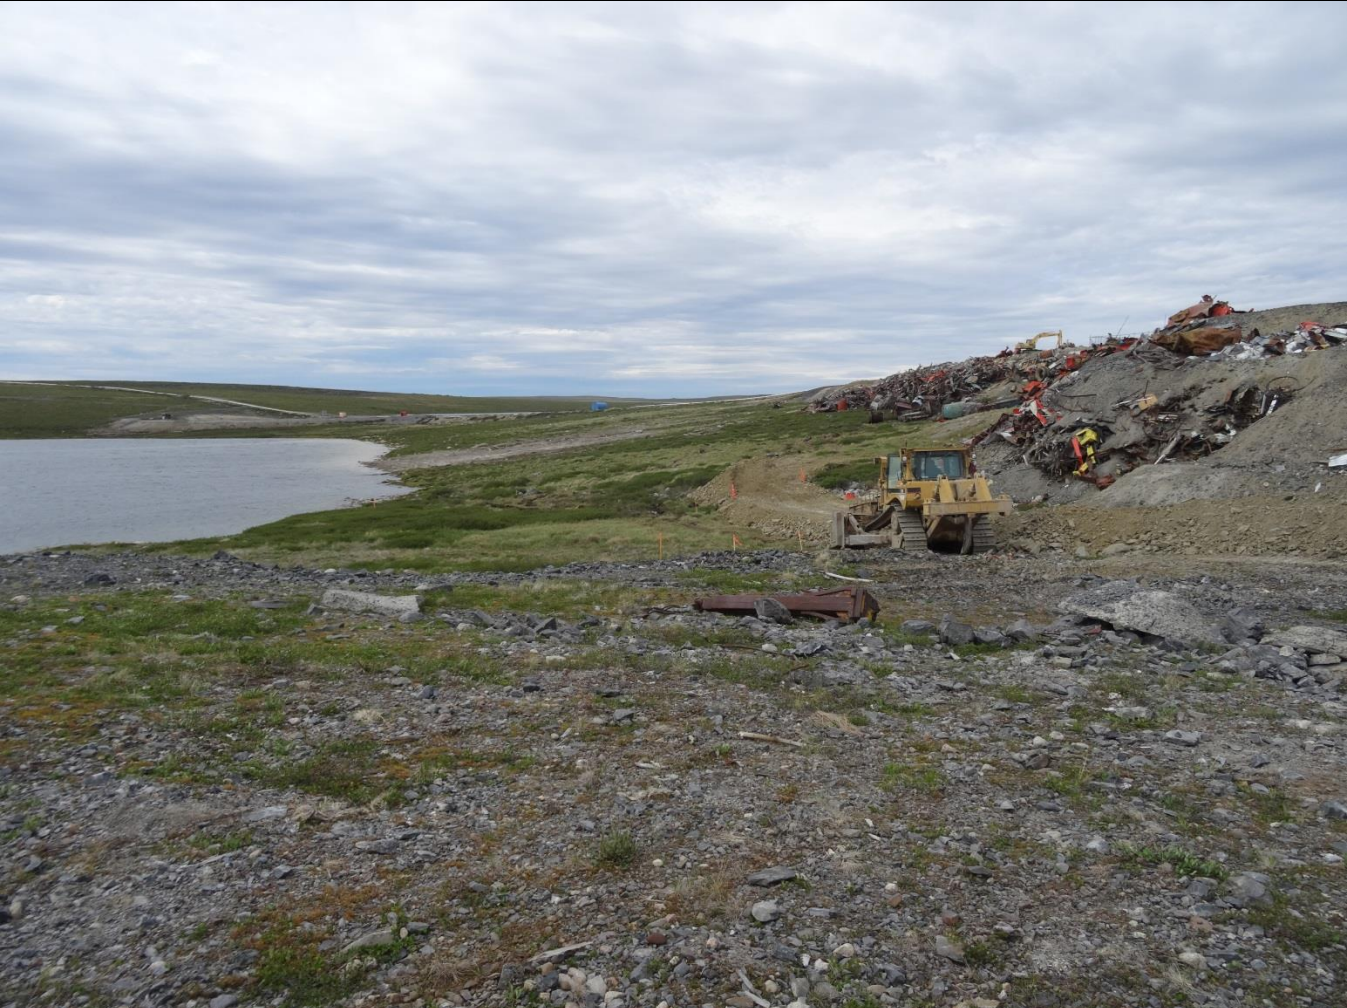
Photo 10

Landfill Area Construction (Photos 10, 11 and 12), The writer walked the entire perimeter of the Temporary Land Fill area where contents of the various Building Demolishens are being stored. To the best of the writer’s knowledge, it does appear that the contractor has Decontaminated all the Oil, Fuel & Glycol Systems, as well all Asbestos Containing Materials appear to have been Removed. The writer did NOT see an Itemized Inventory List nor did the writer see where the removed Used Oils and Asbestos were being Stored. The writer did observe work in progress on the construction of the permanent Land Fill Area.

Description: Land Fill Area under Construction – View 1

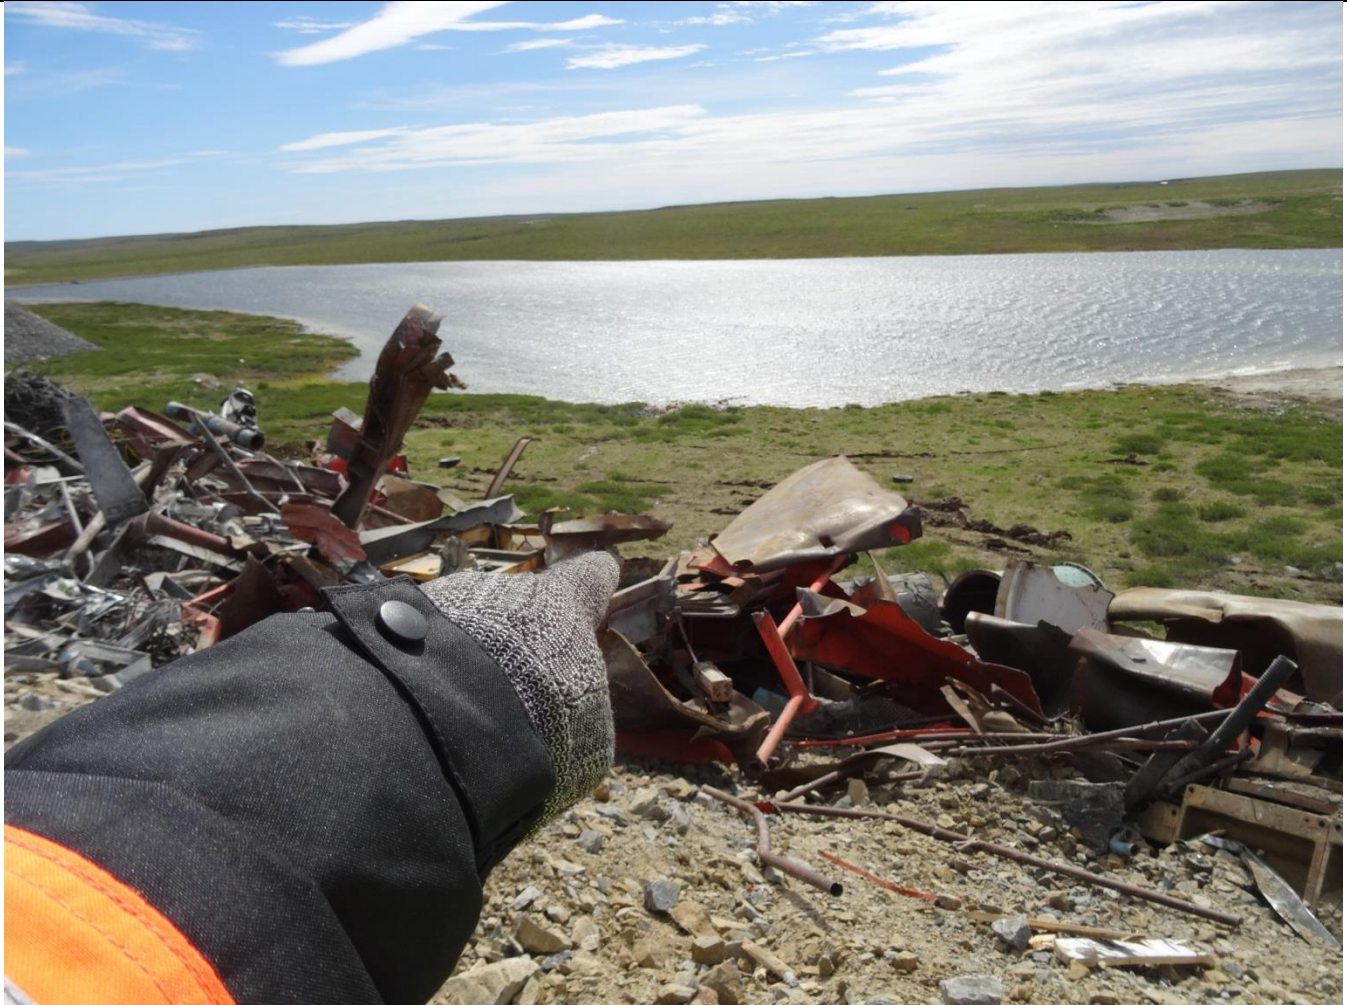
Photo 11

Description: Land Fill Area under Construction – View 2

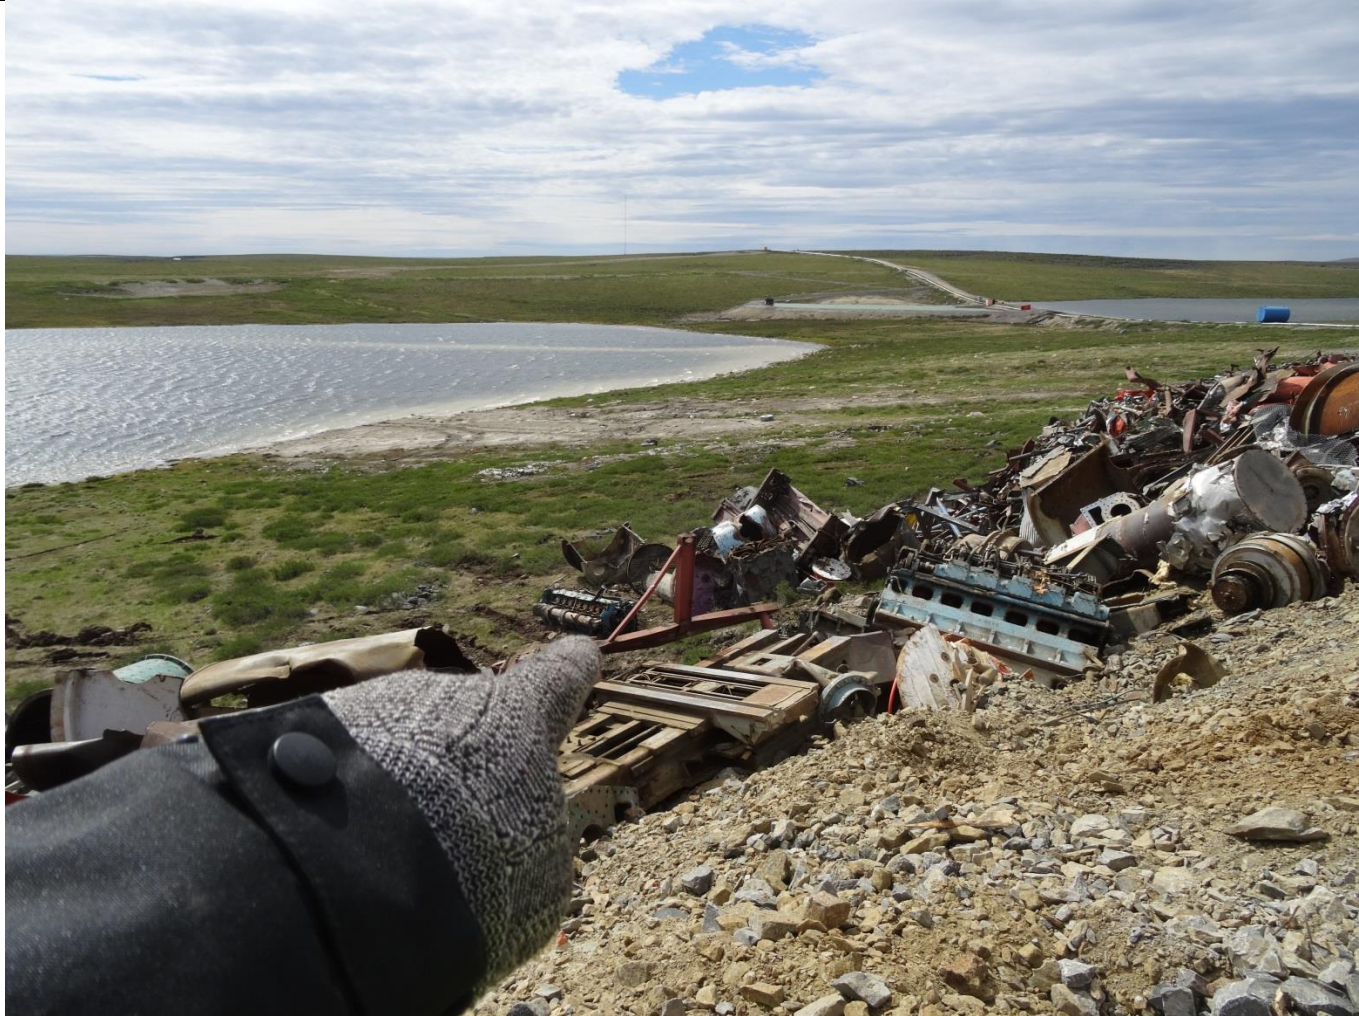
Photo 12

Description: Land Fill Area under Construction – View 3

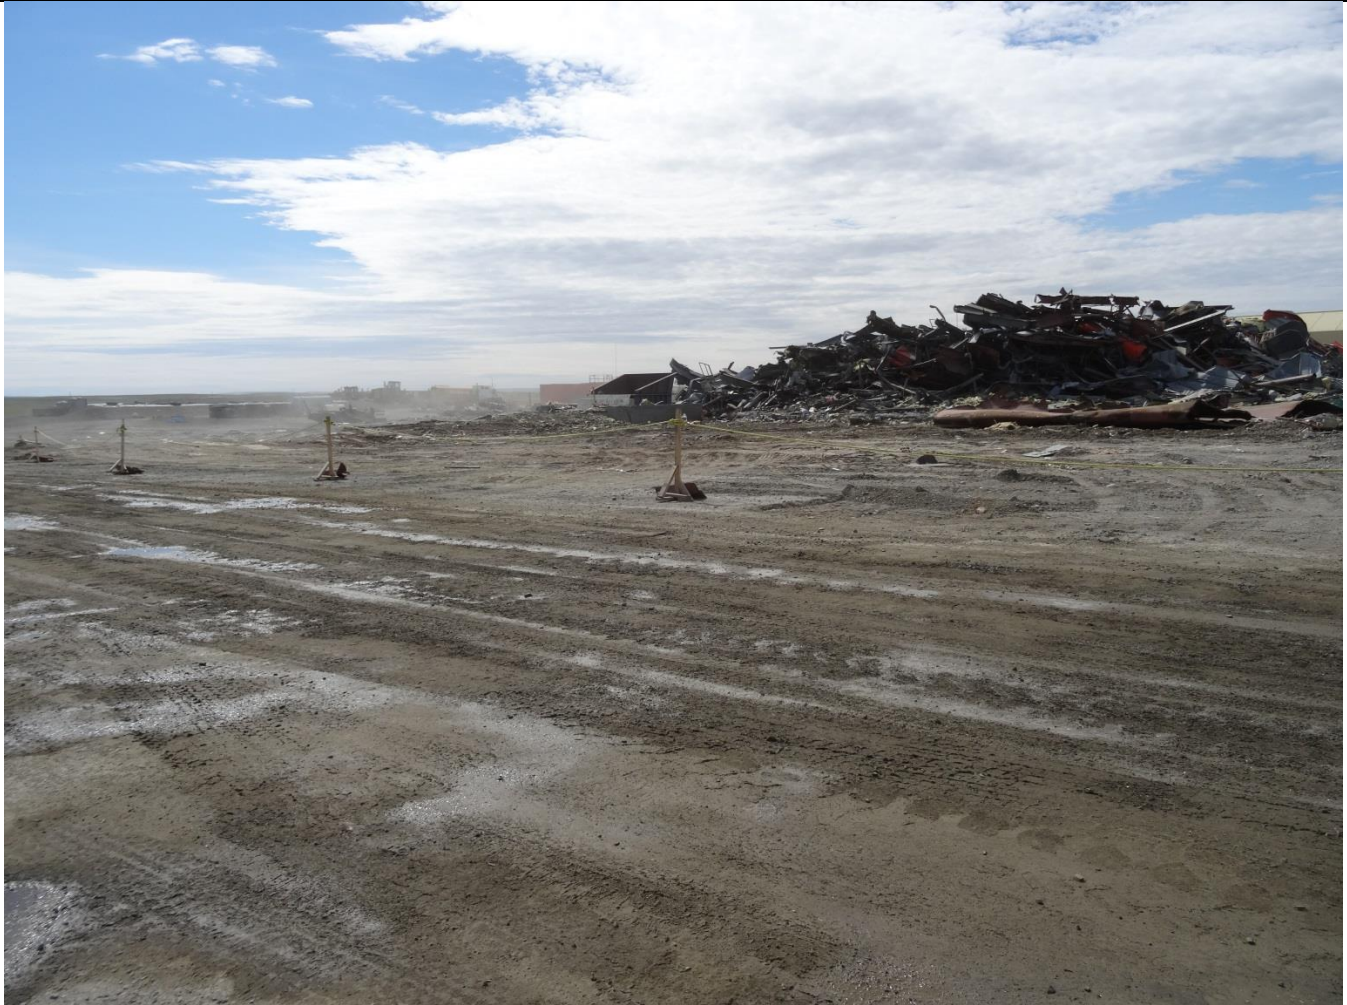
Photo 13

the **Paste Plant (Photo 13)**, 100% Demolished, Debris on Site

Description: Paste Plant

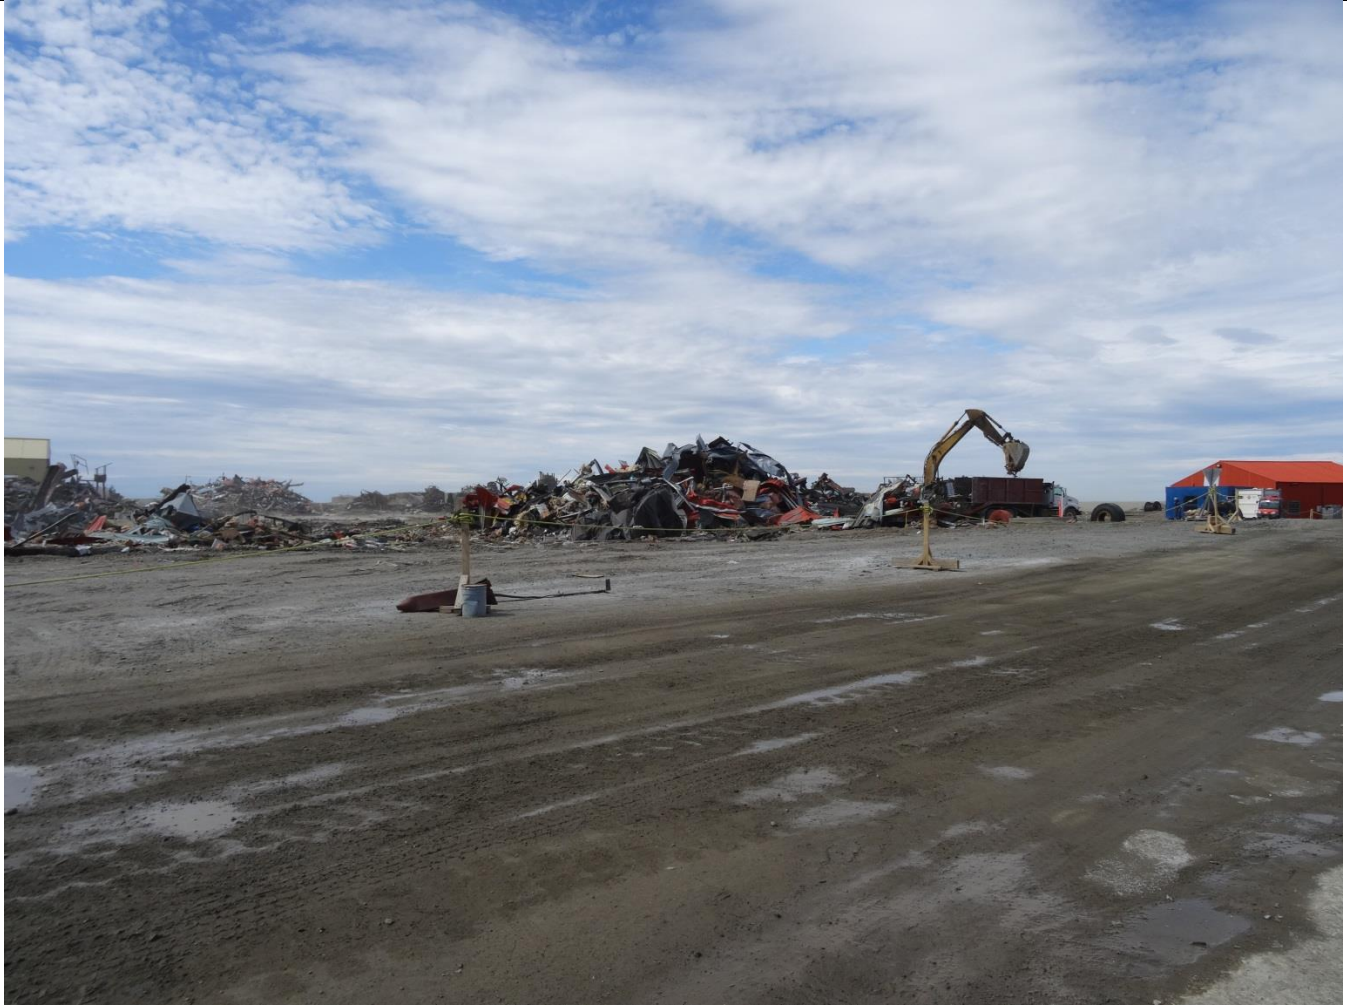
Photo 14

the **Electrical Shop (Photo 14)**, 100% Demolished, Debris on Site in the process of being removed to Temporary Land Fill area

Description: Electrical Shop

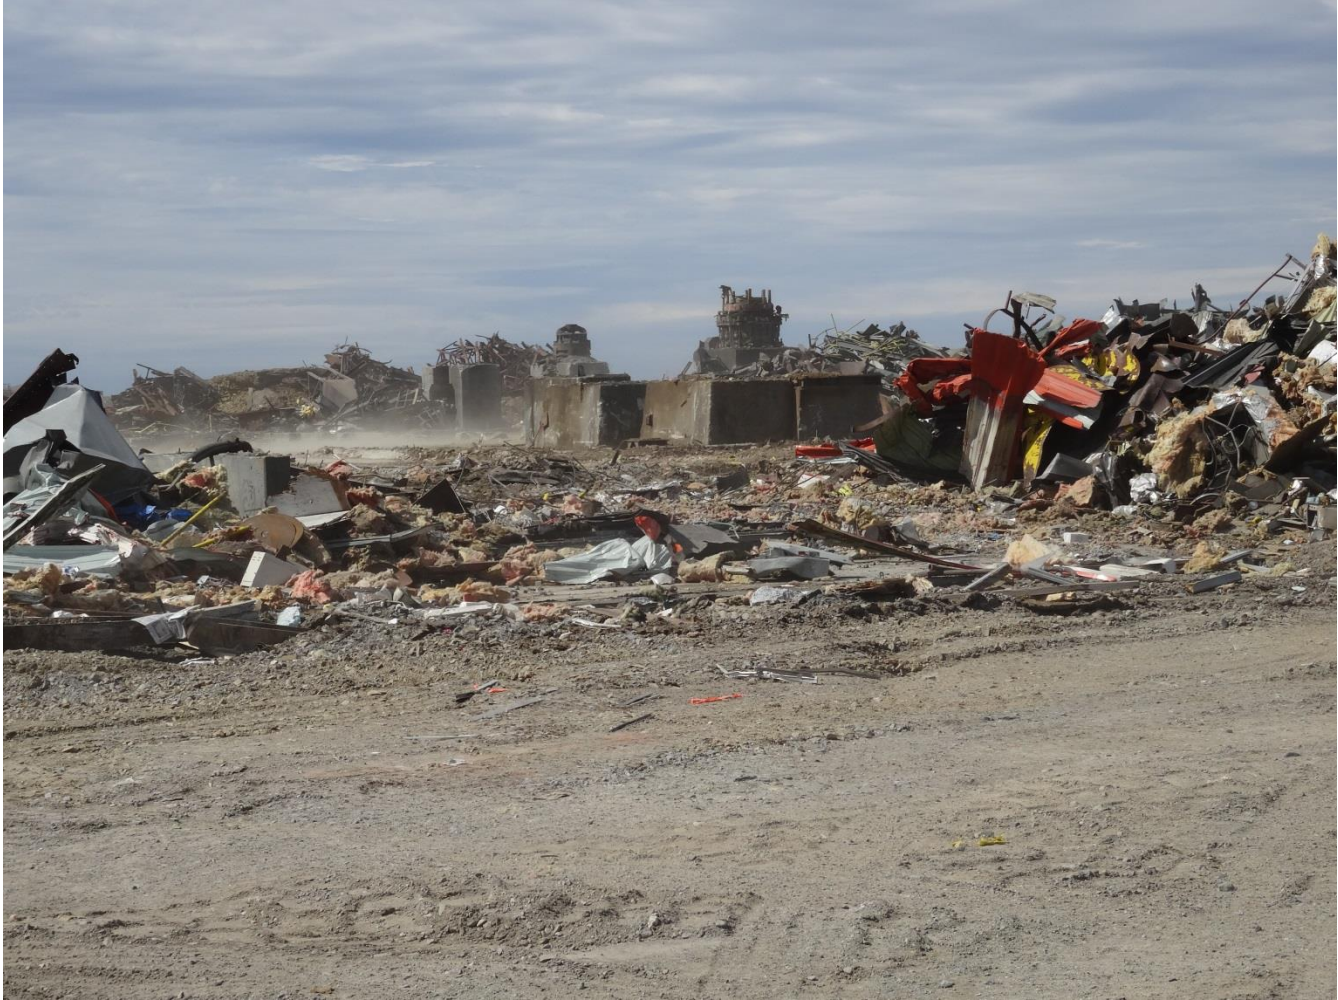
Photo 15

the **Mill Building (Photo 15)**, 100% Demolished, Debris on Site

Description: Mill Building

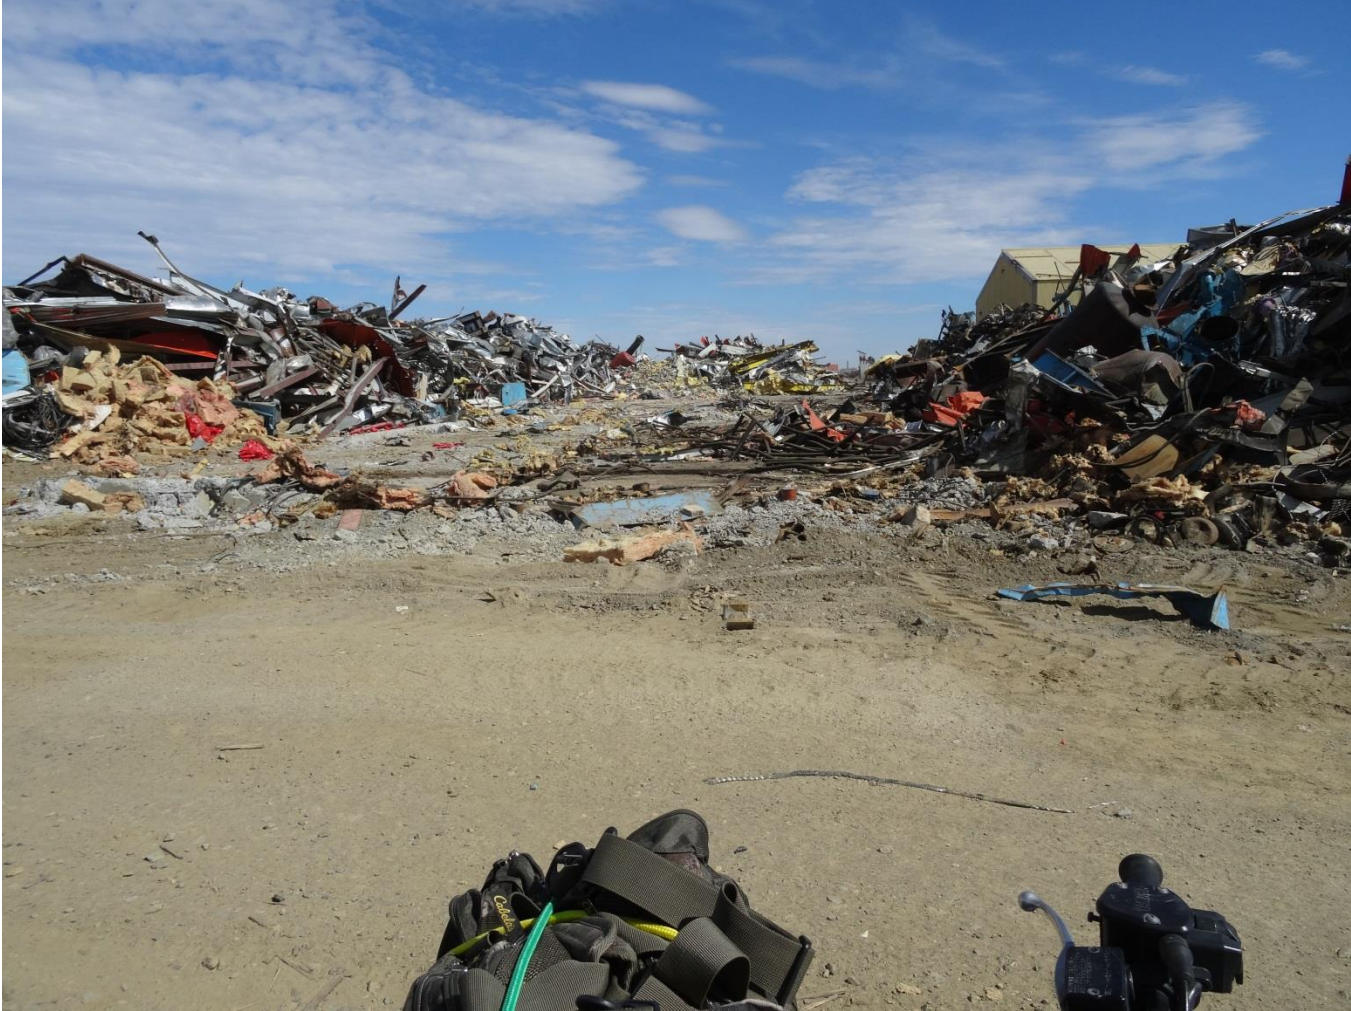
Photo 16

the **Power House (Photo 16)**, 100% Demolished, Debris on Site

Description: Power House

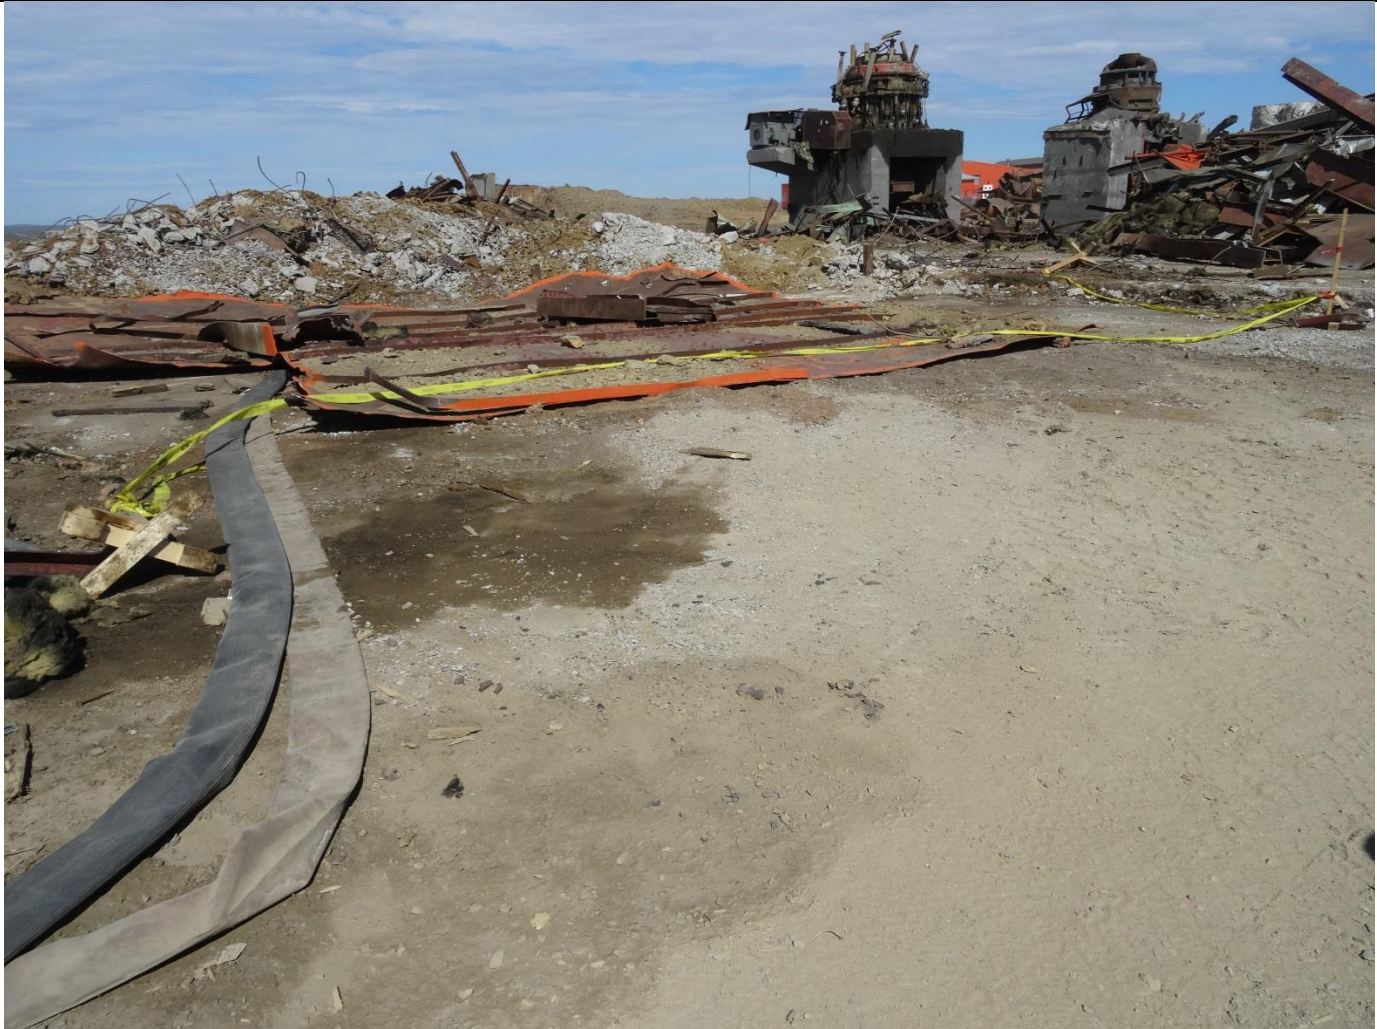
Photo 17

the **Head Frame (Photo 17)**, 100% Demolished, 100% Debris Removed, there is a large Steel Plate Covering the Shaft Hole

Description: Head Frame

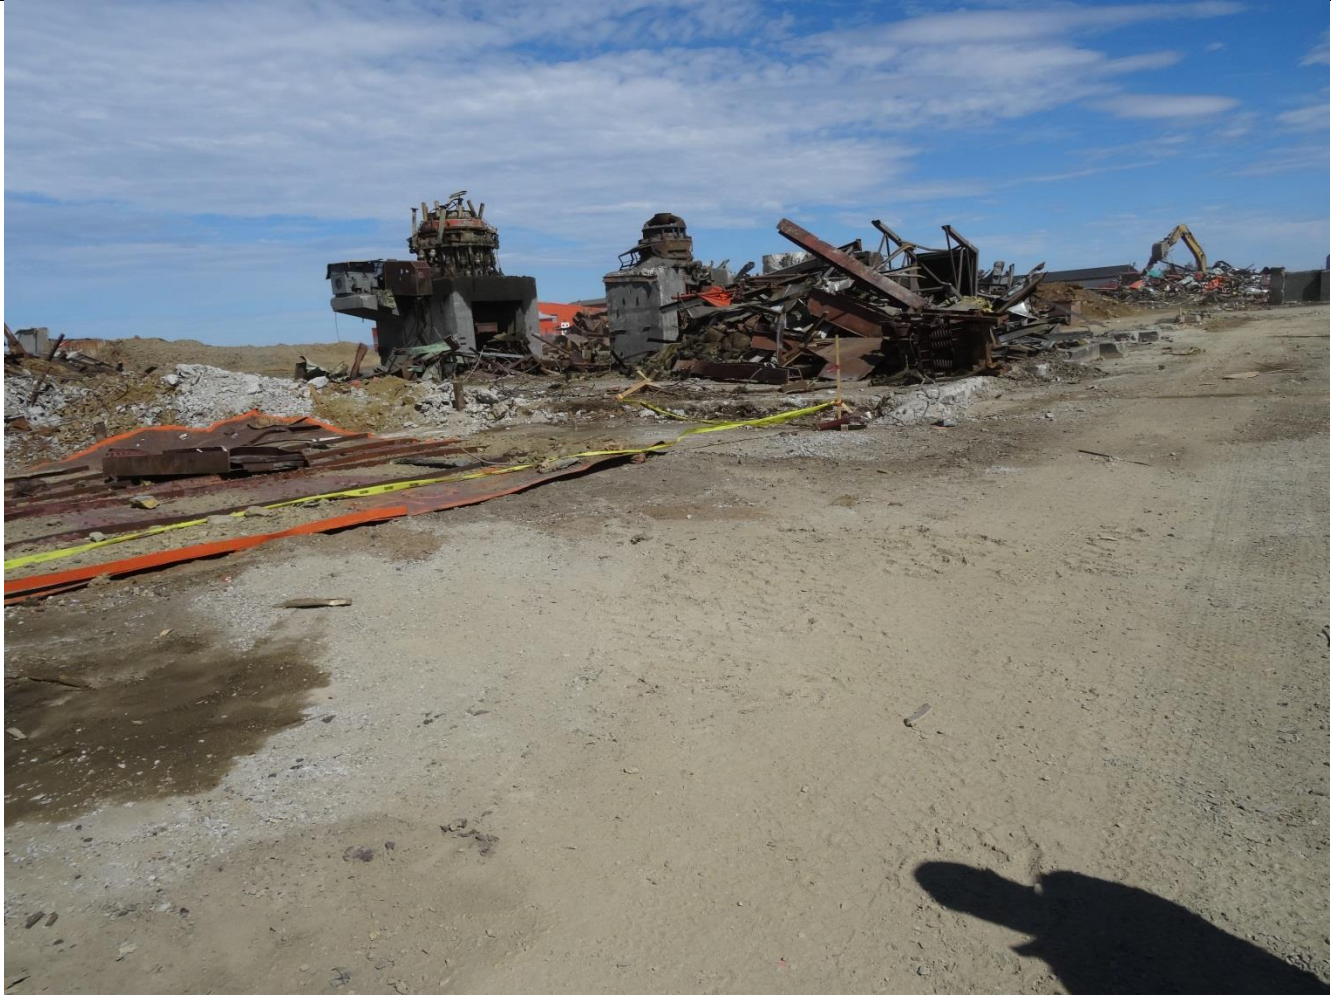
Photo 18

the **Shaft House (Photo 18)**, 100% Demolished, 100% Debris Removed

Description: Shaft House

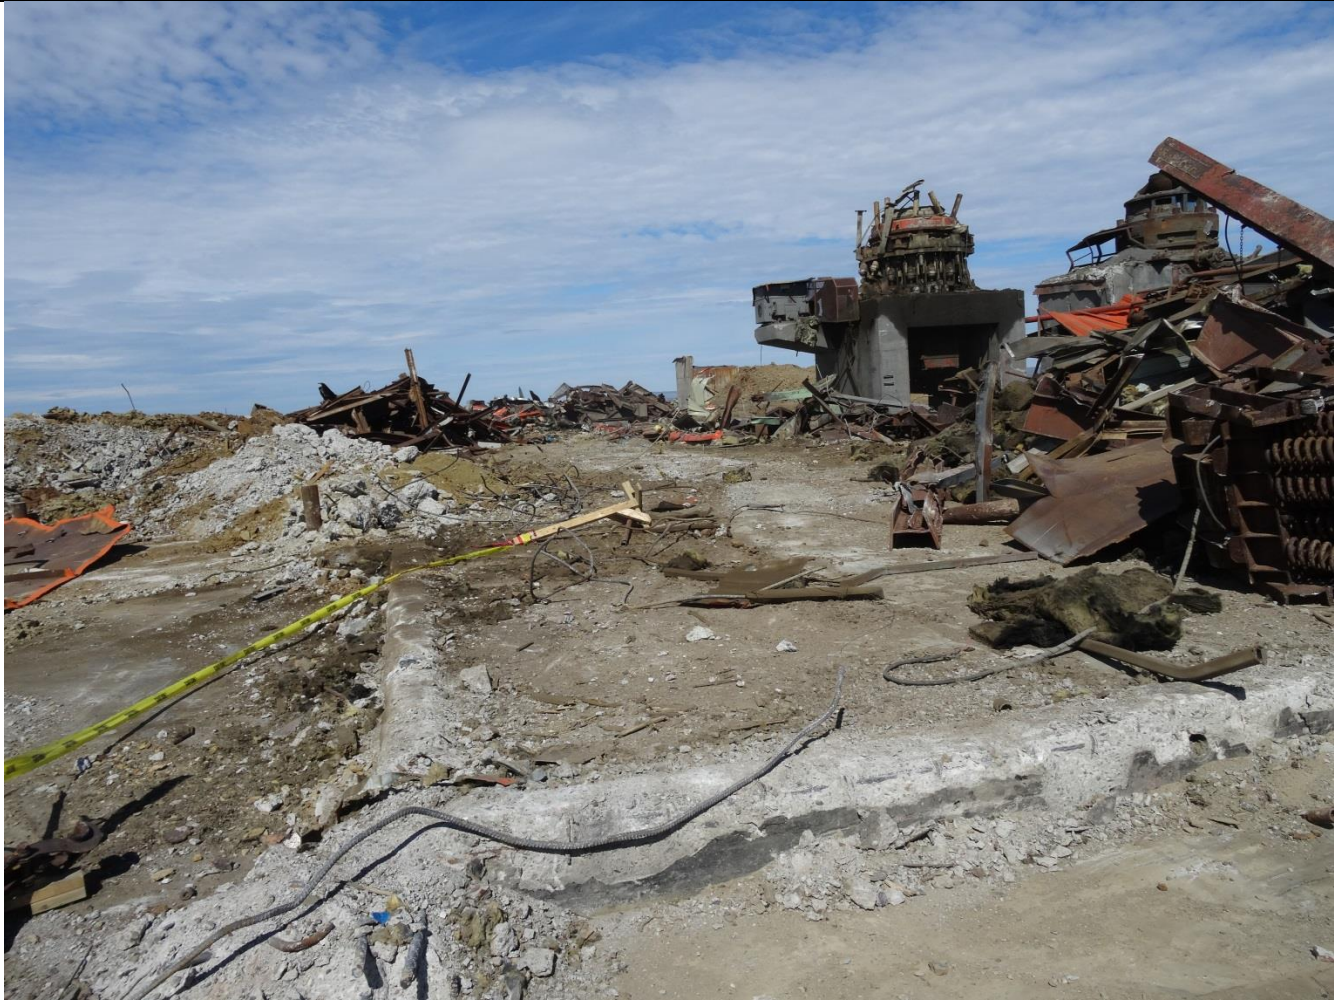
Photo 19

the **Hoist House (Photo 19)**, 100% Demolished, Debris on Site

Description: Hoist House in Background

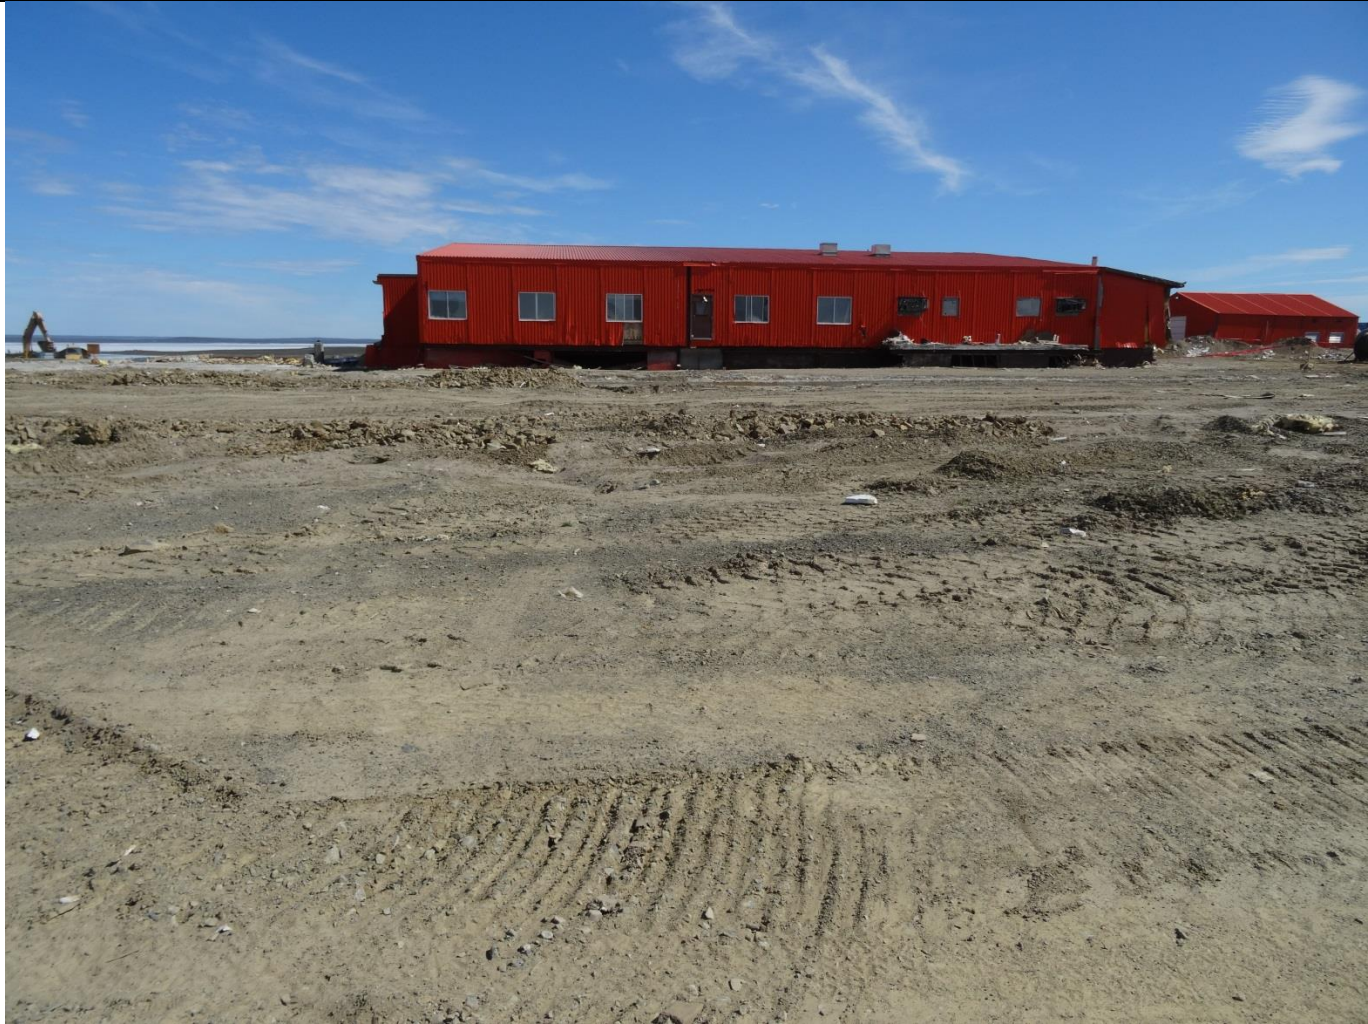
Photo 20

the **Kitchen/Gymnasium and 100-400 Block (Photos 20 & 21)**, 100% Demolished, 100% Debris Removed

Description: Kitchen/Gymnasium/100-400 Block – View 1
