WATER LICENCE INSPECTION FORM

Licensee		Licensee Representative	
Lupin Mines Inc		Karyn Lewis	
Licence No. / Expiry		Representative's Title	
2AM-LUP2032		Project Manager	
Land / Other Authorizations		Land / Other Authorizations	
Date of Inspection		Inspector	
2020 July 2		Baba Pedersen	
Activities Inspected			
<input type="checkbox"/> Camp	<input type="checkbox"/> Drilling	<input type="checkbox"/> Mining	<input type="checkbox"/> Construction
<input type="checkbox"/> Roads/Hauling	<input type="checkbox"/> Other:	<input checked="" type="checkbox"/> Other: Reclamation Security	<input type="checkbox"/> Reclamation
<input type="checkbox"/> Fuel Storage

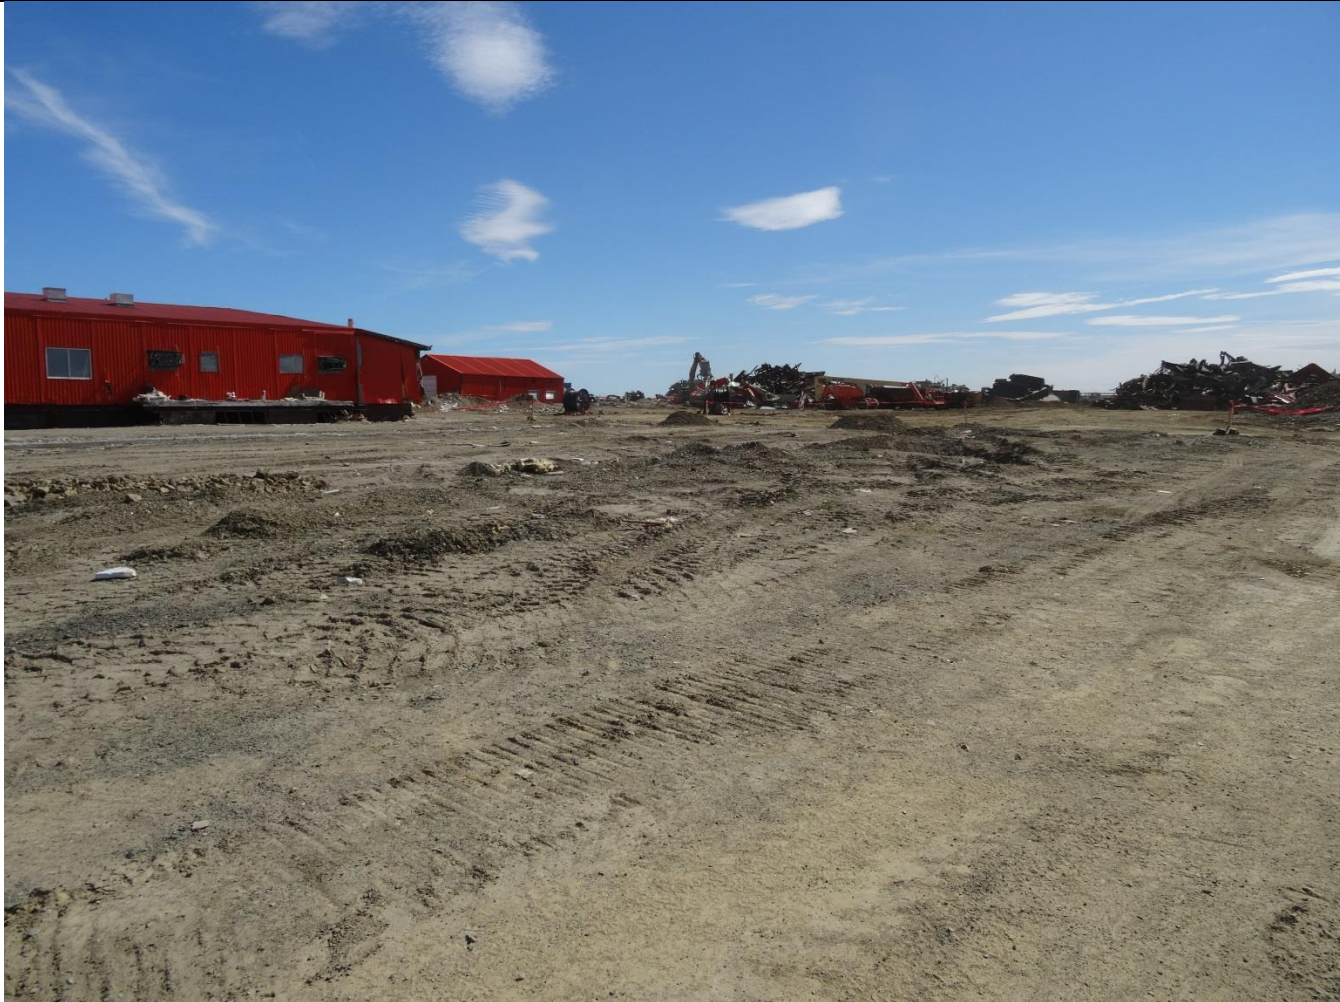
Photo 21

the **Kitchen/Gymnasium and 100-400 Block (Photos 20 & 21)**, 100% Demolished, 100% Debris Removed

Description: Kitchen/Gymnasium/100-400 Block – View 2

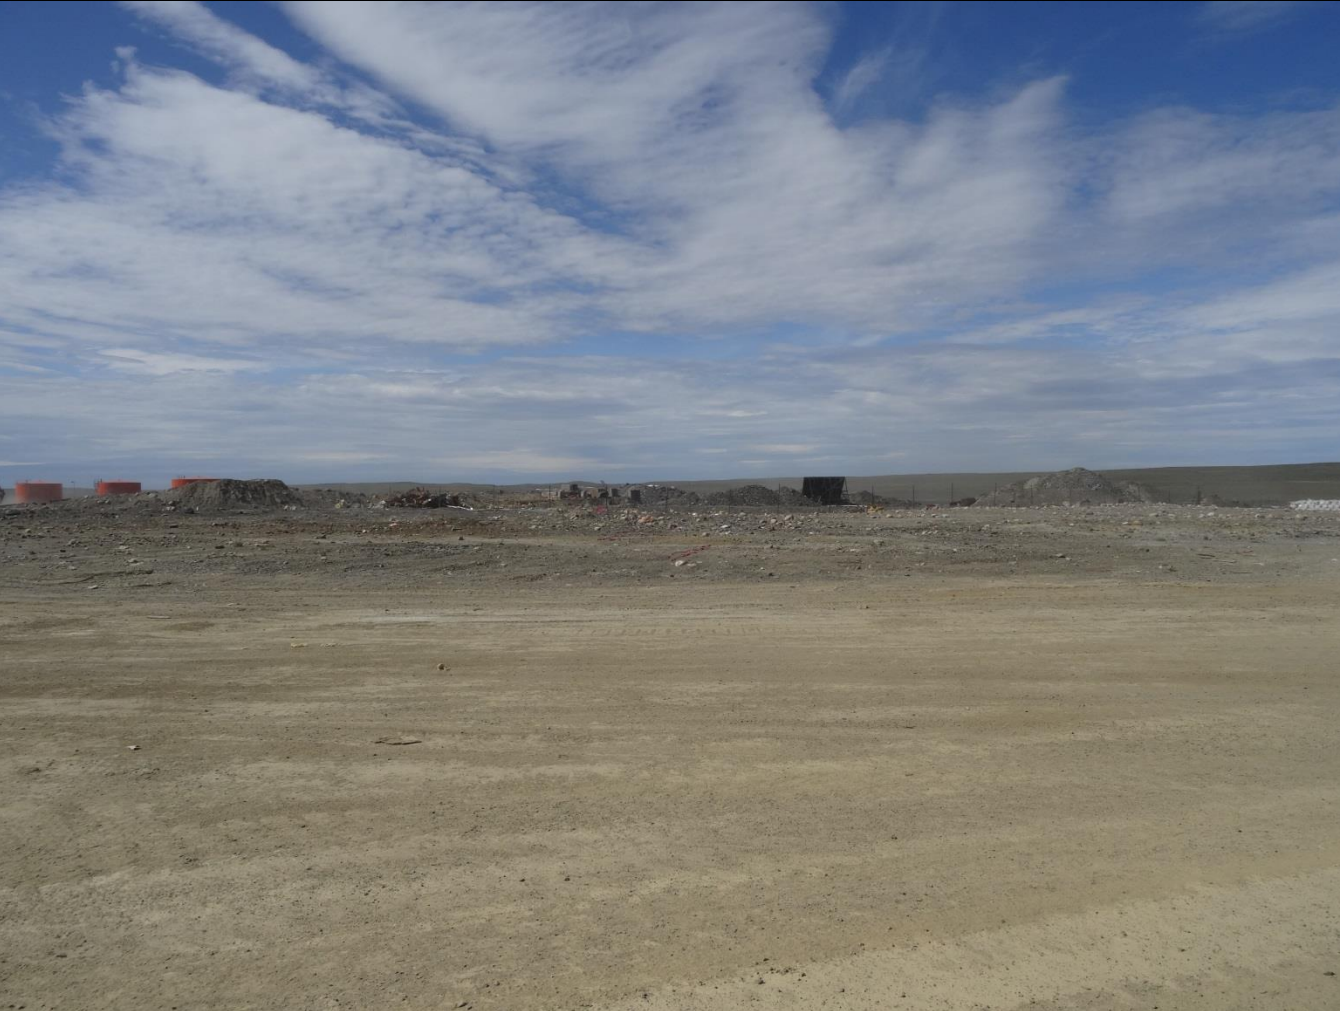
Photo 22

the **Fresh Air Vents (Photo 22)**, 100% Demolished, 100% Debris Removed

Description: Fresh Air Vents

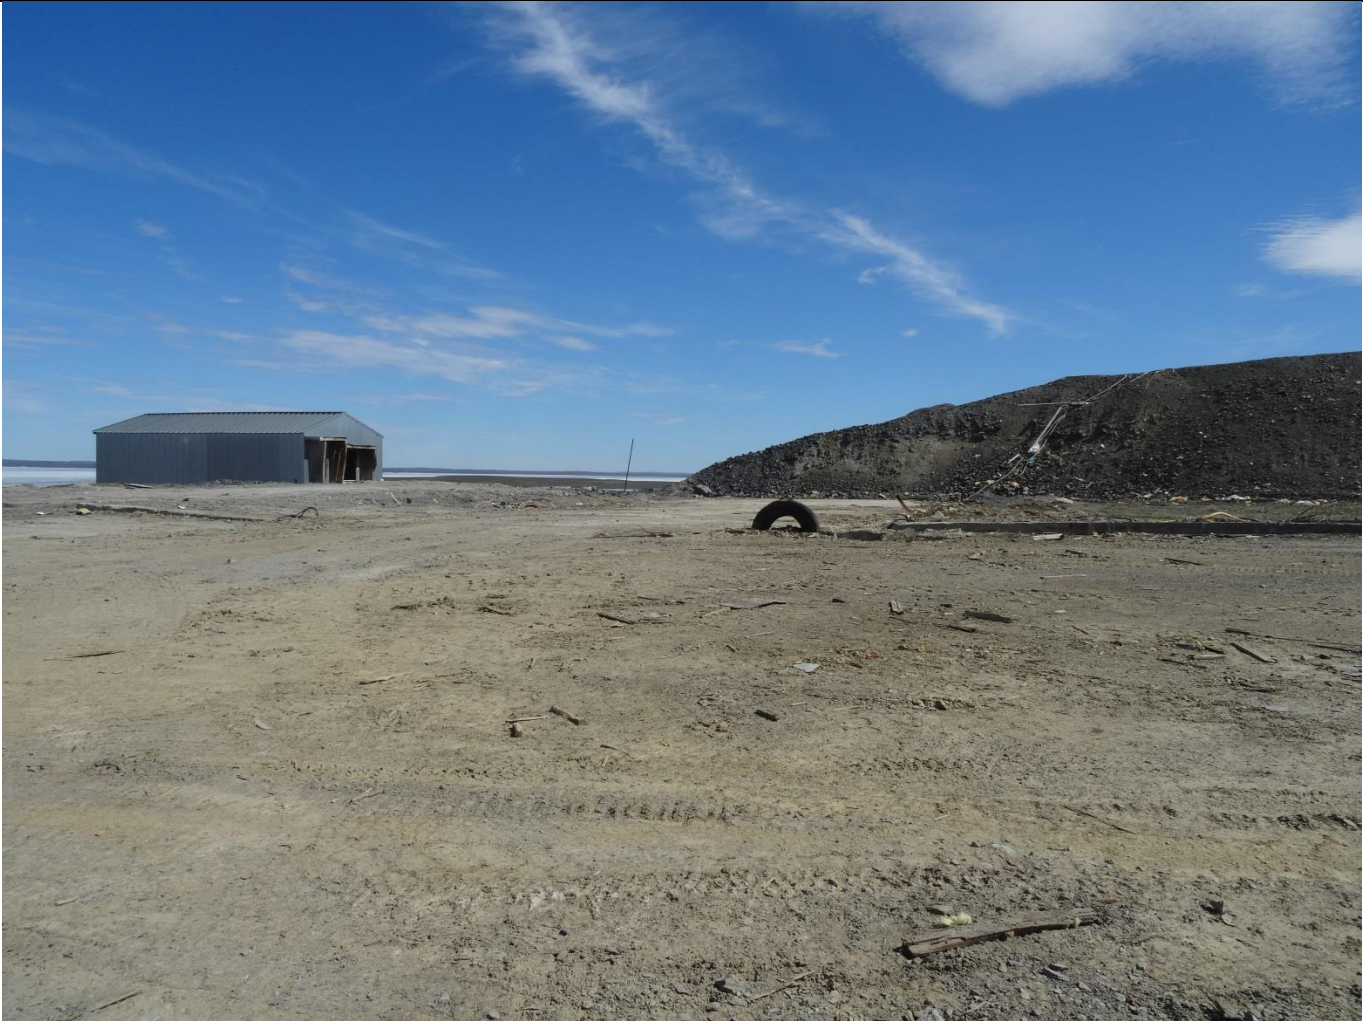
Photo 23

the **RTL Shop (Photo 23)**, 100% Demolished, 100% Debris Removed

Description: RTL Shop

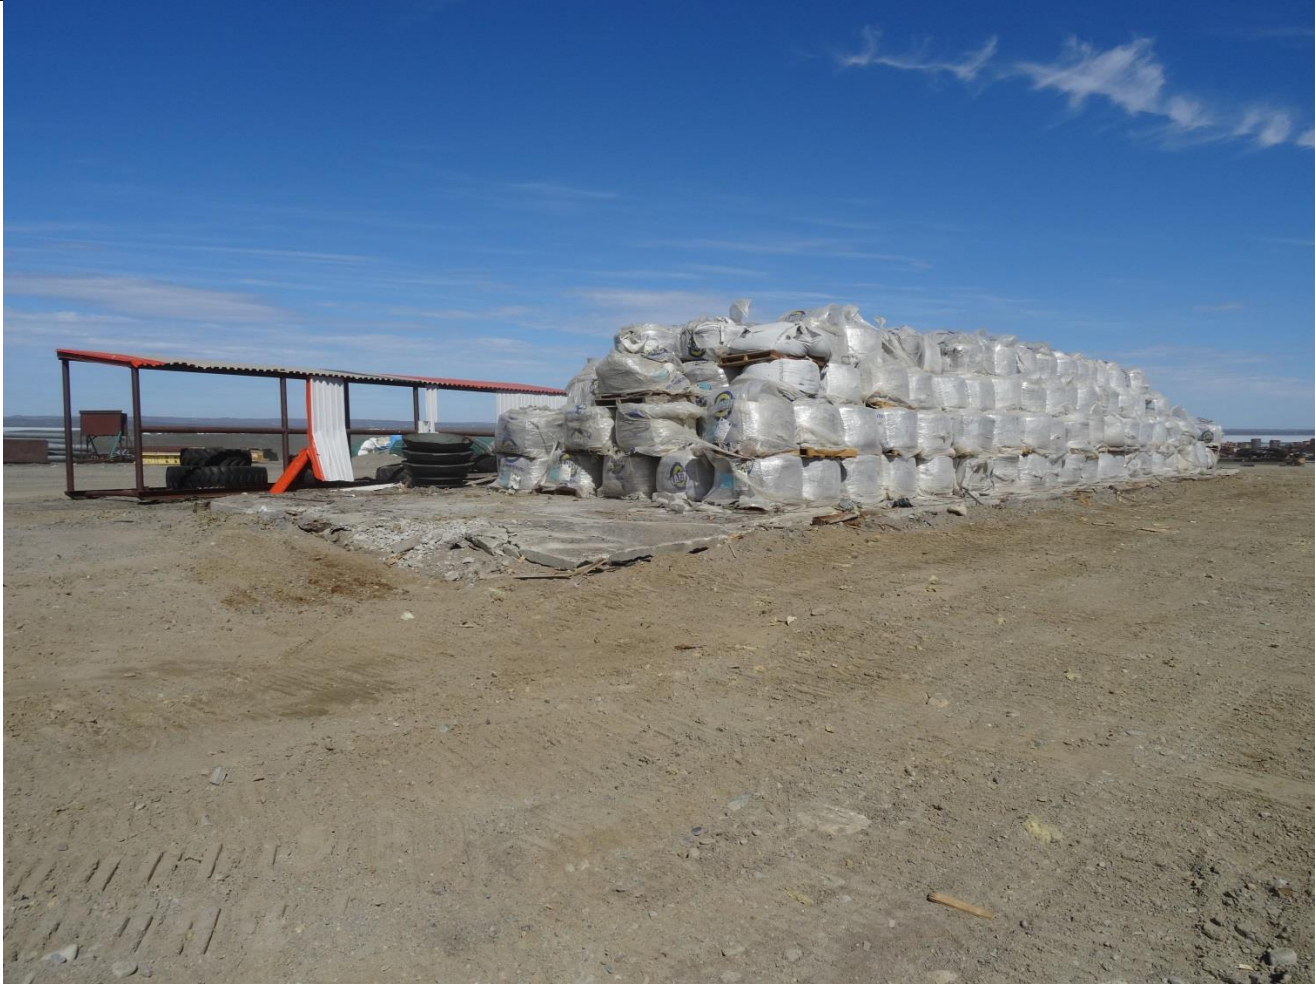
Photo 24

the **Surface Storage Building #2 (Photo 24)**, 100% Demolished, 100% Debris Removed

Description: Surface Storage Building #2

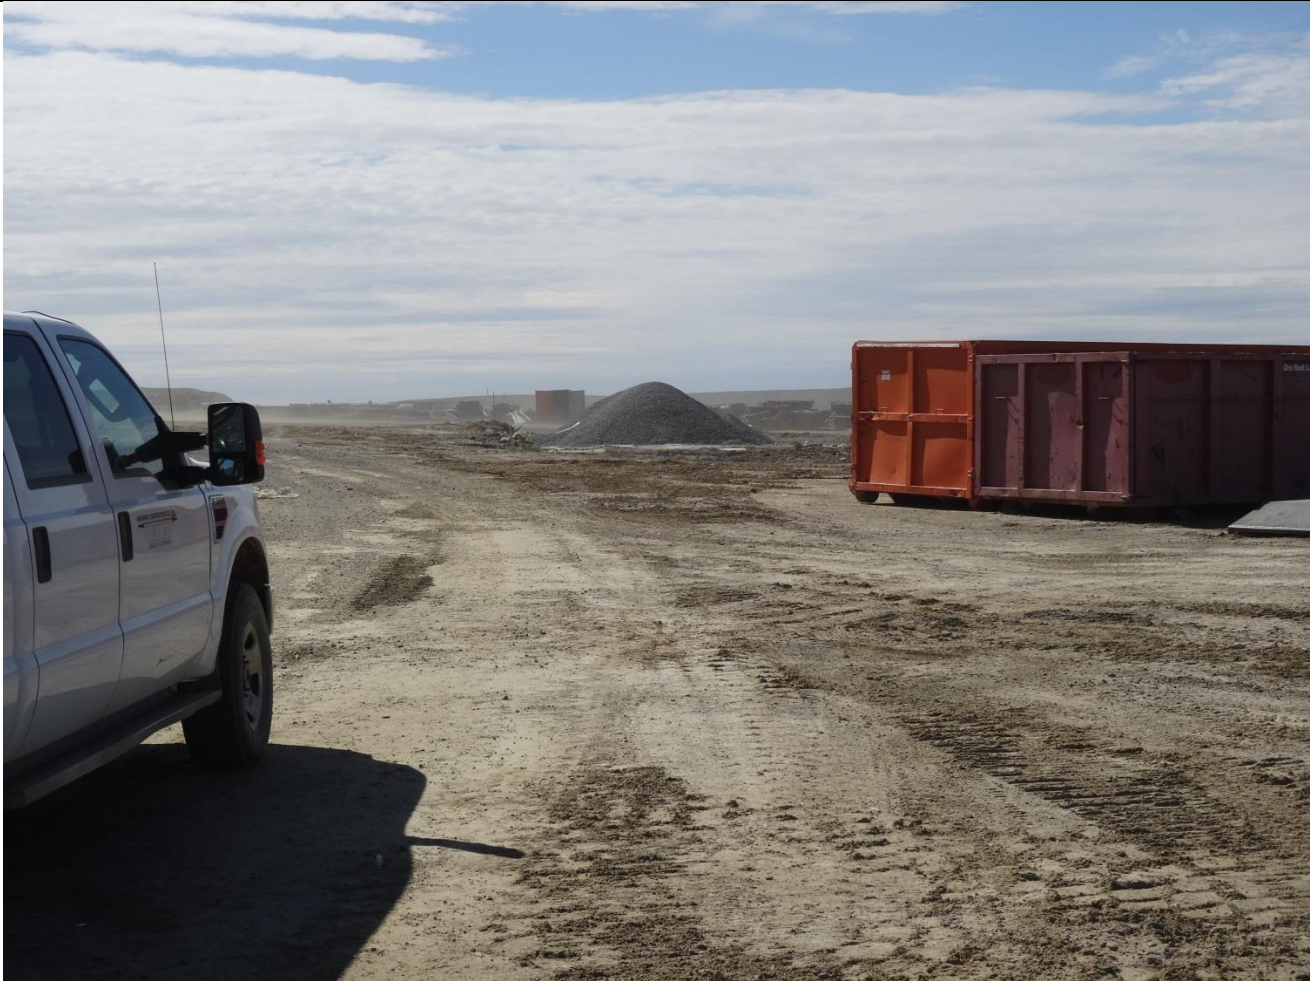
Photo 25

the **Surface Storage Building #1 (Photo 25)**, 100% Demolished, 100% Debris Removed

Description: Surface Storage Building #1

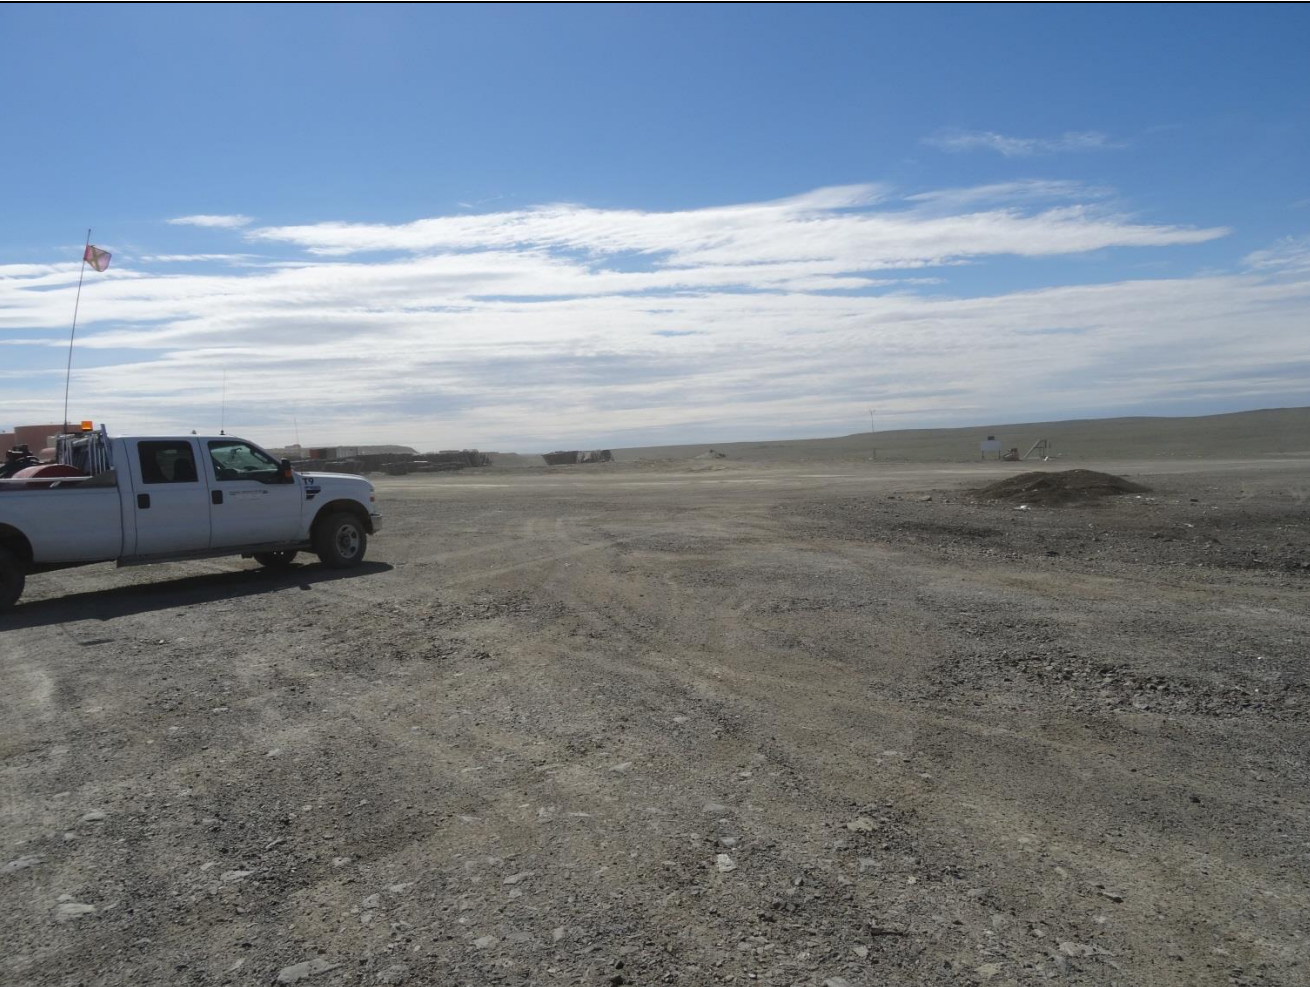
Photo 26

and the **old Airport Weather Station Building (Photo 26)**. 100% Demolished, 100% Debris Removed

Description: Old Airport Weather Station Building
