# 2023 Dam Safety Review

## Lupin Mine Tailings Containment Area (TCA)

**Lupin Mines Inc.**

**SLR Consulting (Canada) Ltd.**

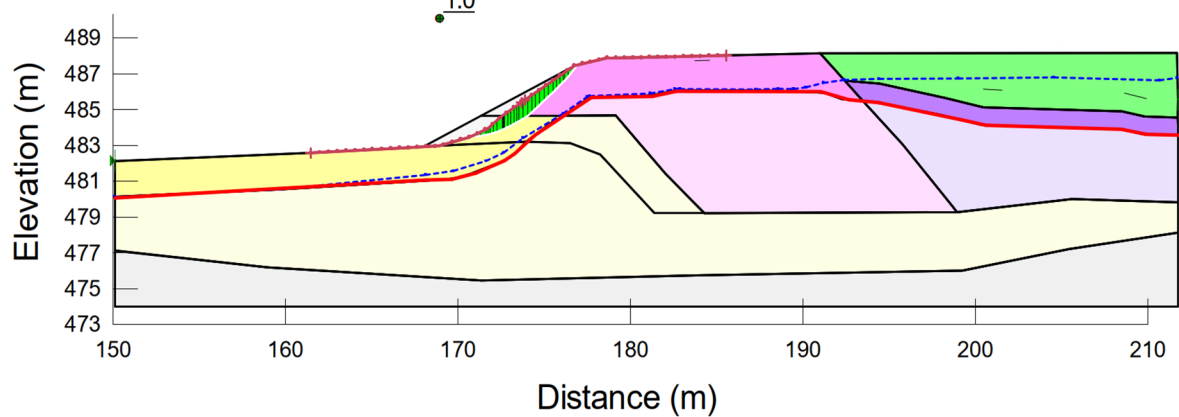
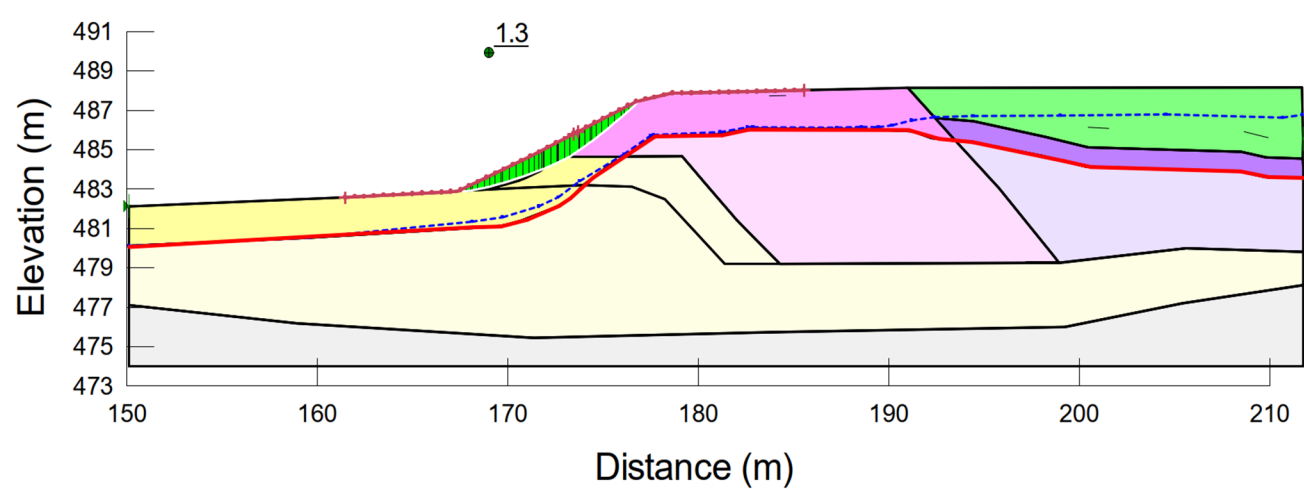
- Both stability analyses found the existing slope of M Dam not meeting the minimum requirements. Holubec recommended flattening to 2.5H:1V to get a FS of 1.9 while Stantec recommended a slope of 2.1H:1V to get a FS of 1.3
- The Holubec analysis (2005) and previous DSR (SRK, 2016) state that M Dam is founded on tailings.

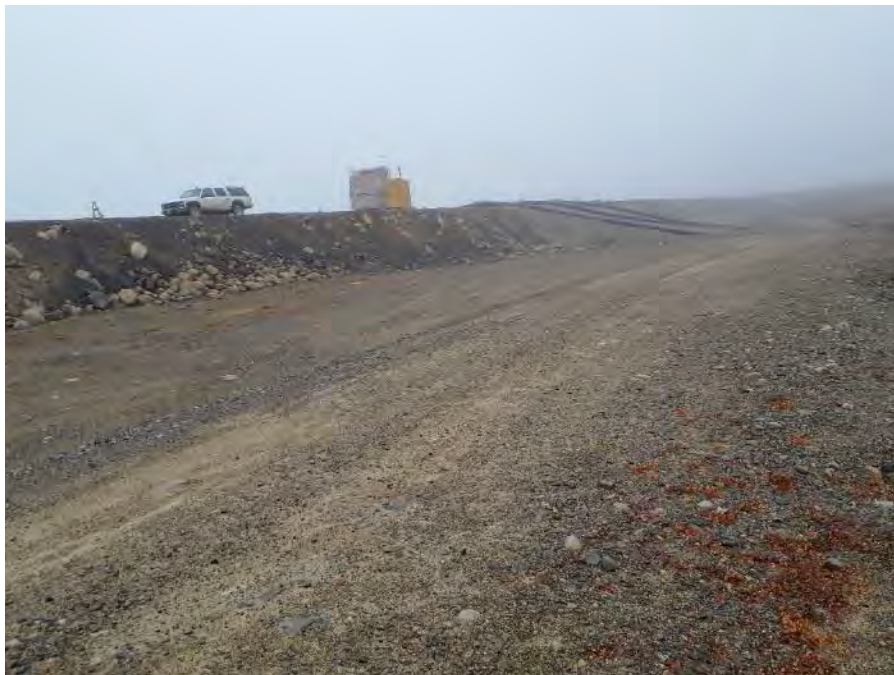
**Photo 2: Dam 1A downstream slope, syphon pipes (Fig. A1 ID#11)**

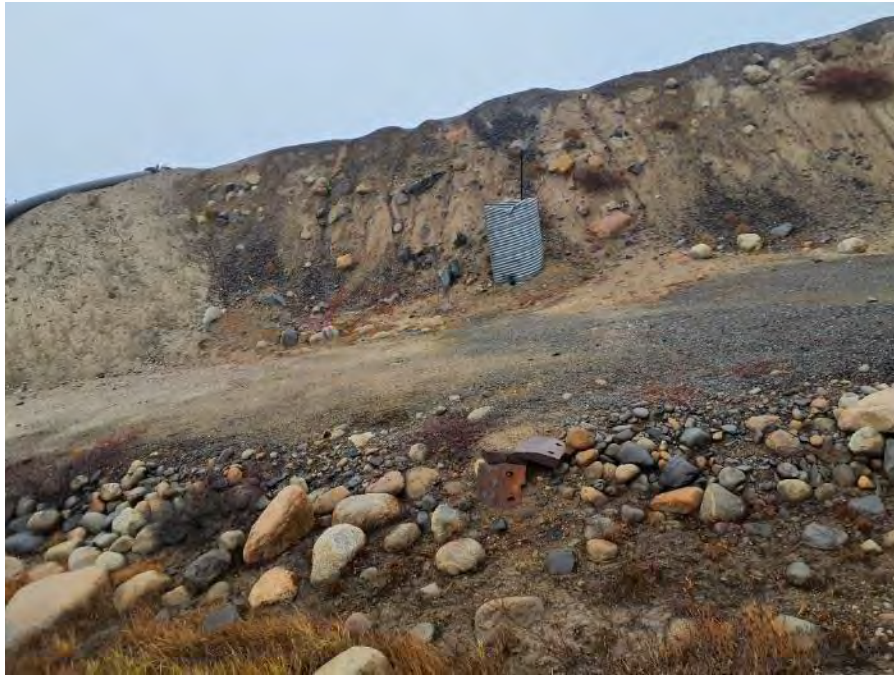
**Photo 3: Dam 1A downstream slope erosion from runoff (Fig. A1 ID#13)**

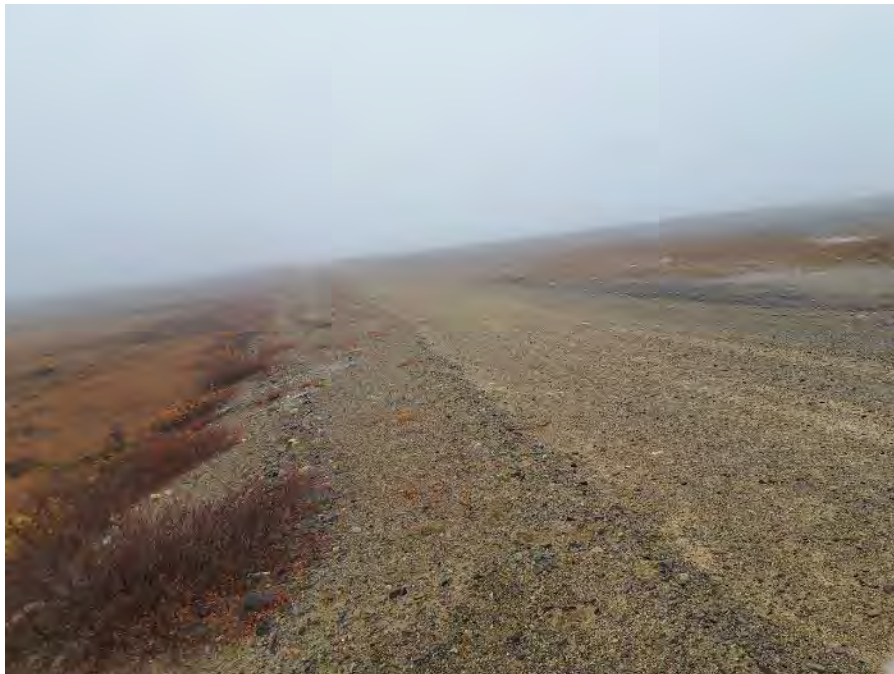
**Photo 10: Dam 1C crest and downstream slope, facing north (Fig. A1 ID#29)**

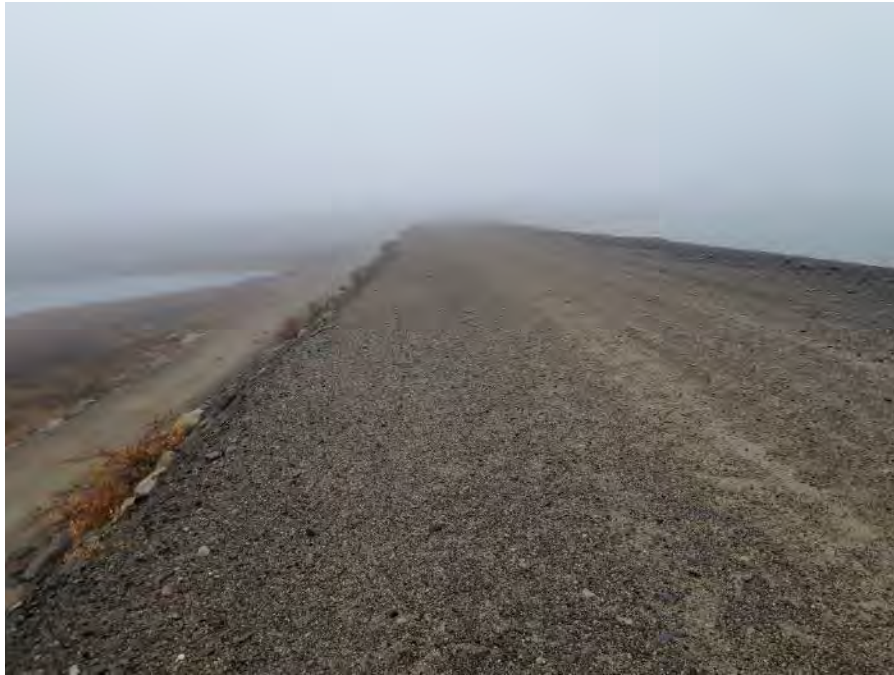
**Photo 11: Dam 2 crest in good condition (Fig. A1 ID#5)**

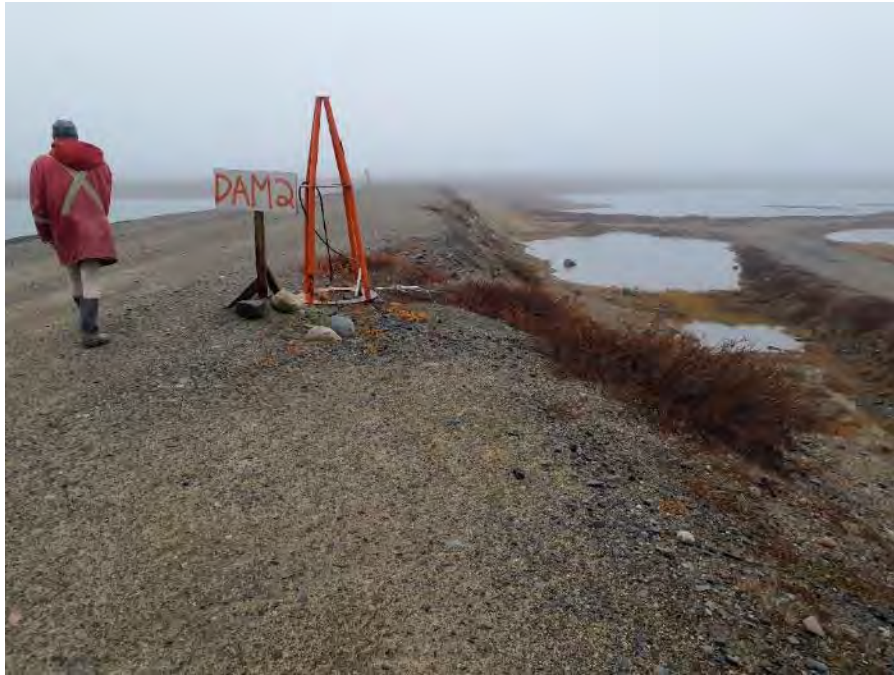
**Photo 13: Dam 2 downstream slope and north seepage collection pond (Fig. A1 ID#1)**

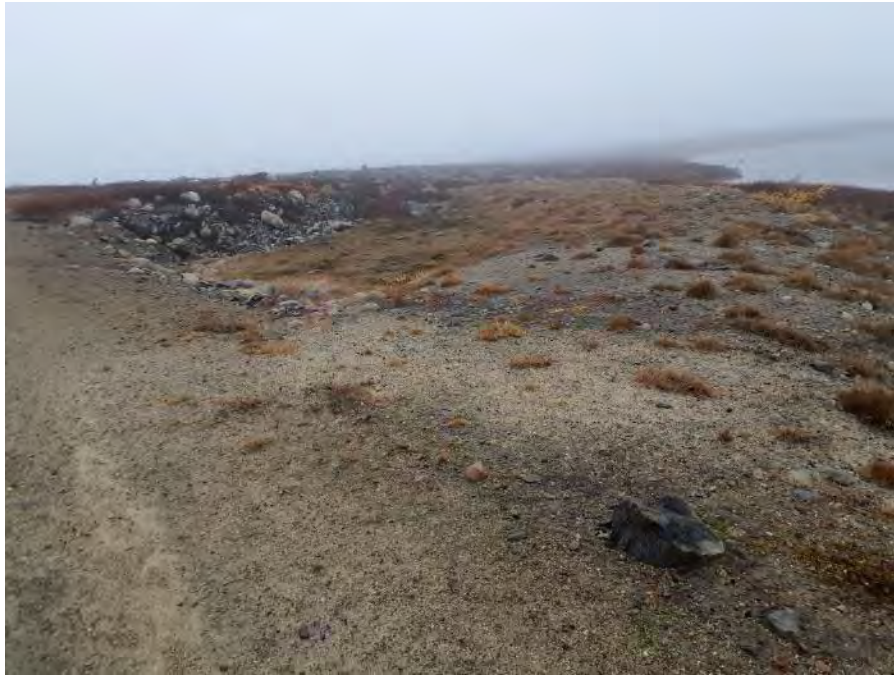
No seepage was observed from the downstream dam toe. However, it is understood that historically seepage reported from the dam abutments and was captured and pumped back from two small ponds. At the time of the visit, the southern seepage pond was dry while the northern pond remained (**Photo 15**).

**Photo 15: Dam 2 south seepage collection pond, now dry (Fig. A1 ID#6)**

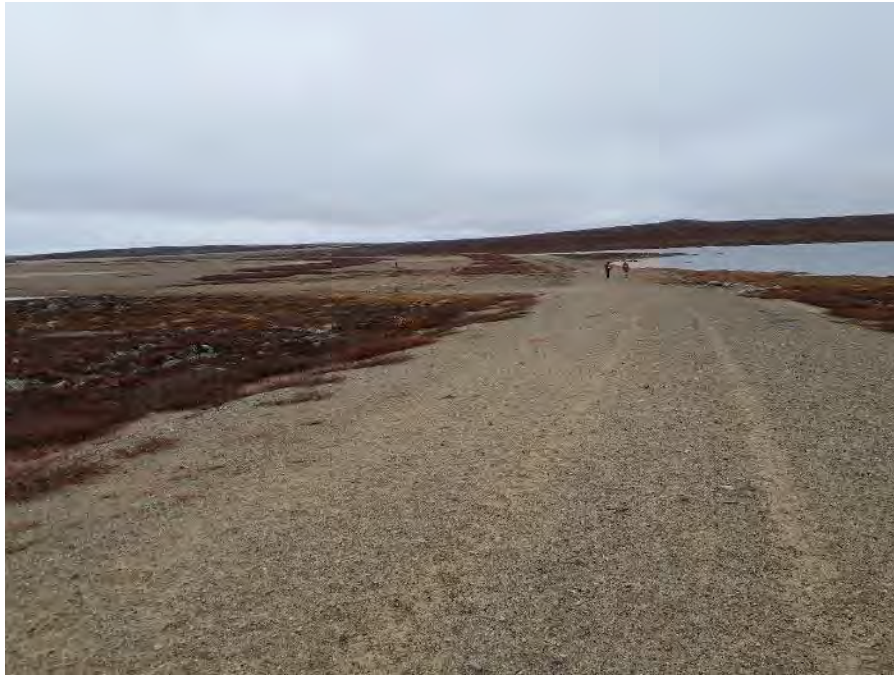
Dam 3 was generally in good condition. The actual location of the dam was hard to gauge as the covered tailings generally sloped towards the north and then gradually became steeper where the TCA abuts Boomerang Lake (**Photo 17**). The upstream slope has been buried by the tailings cover and a swale has been constructed parallel to the upstream side of the dam (**Photo 18**). Drainage chutes have been constructed at different locations to allow surface runoff to drain into the Lake (**Photo 19, 20**). Perhaps as a result of this, less erosion was observed on the outer slope of this dam.

**Photo 17: Dam 3 crest facing north from left abutment (Fig. A1 ID#55)**

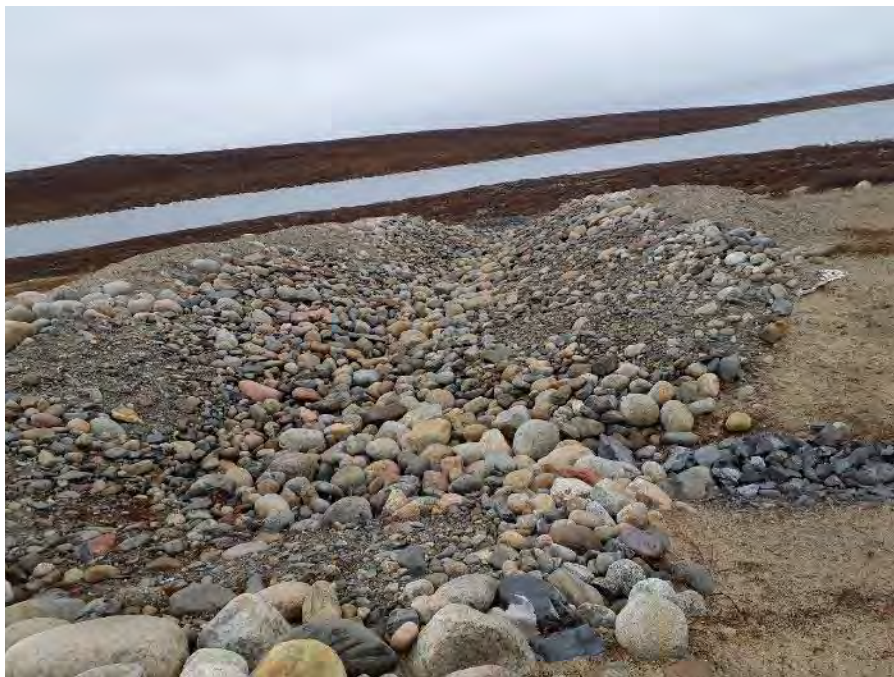
**Photo 20: Dam 3 drainage channel in downstream slope, facing north (Fig. A1 ID#60)**

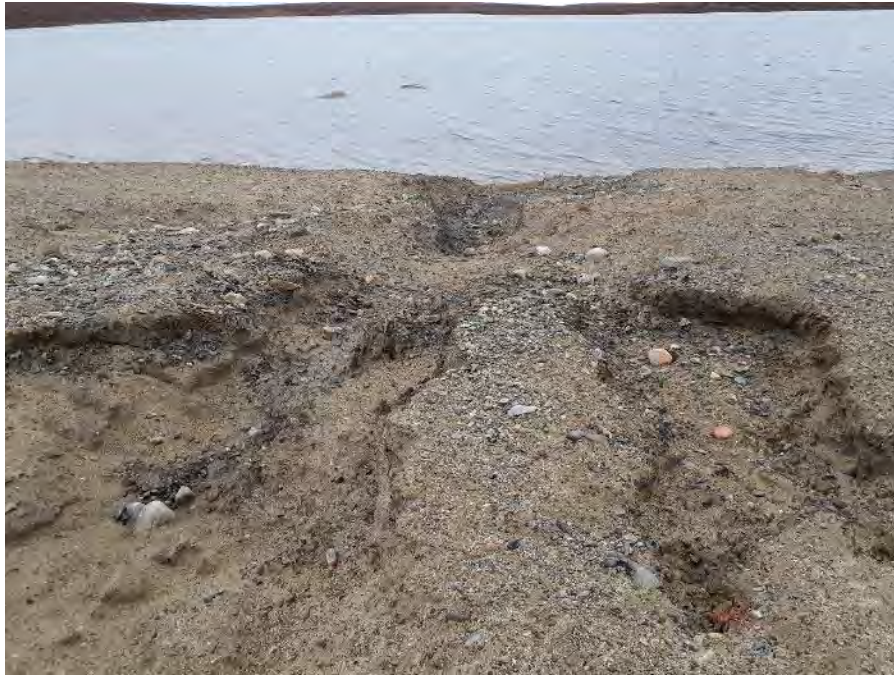
is comprised of esker sand and gravel with a shallower slope of around 2.5H:1V. Erosion rills were noted in this section of the dam outside of drainage chutes (**Photo 21**).

**Photo 21: Dam 3 erosion rill in downstream slope, facing northeast (Fig. A1 ID#58)**

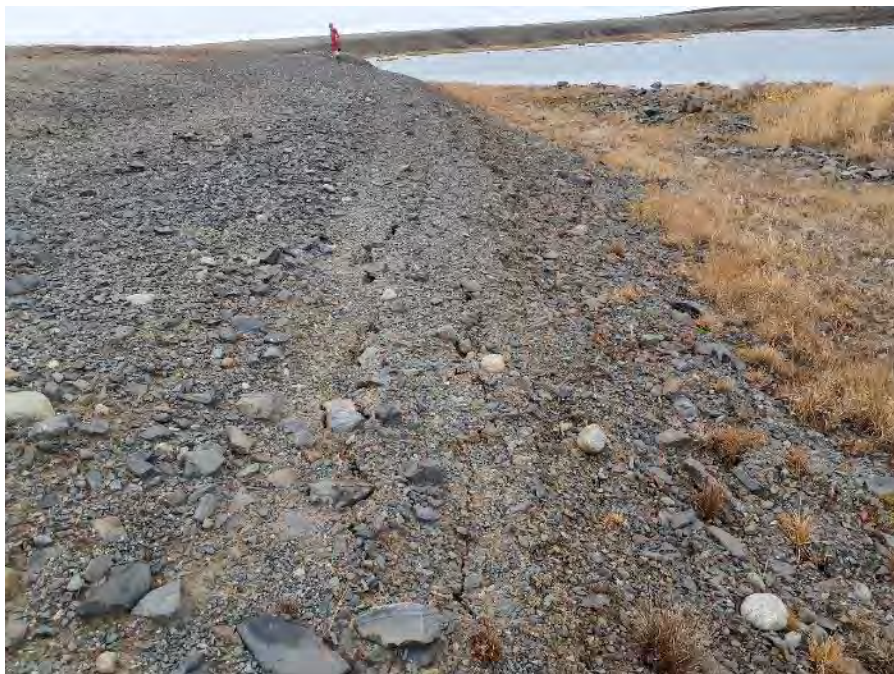
**Photo 22: Dam 3 longitudinal cracks near downstream toe, facing west (Fig. A1 ID#61)**

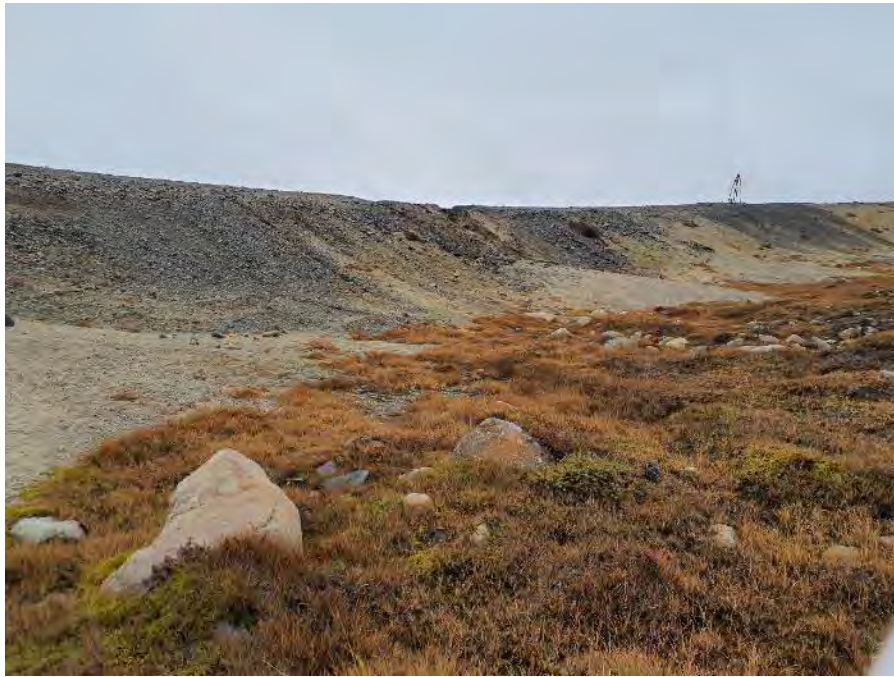
**Photo 27: Dam 4 downstream slope erosion rills and sediment fans at toe (Fig. A1 ID#47)**

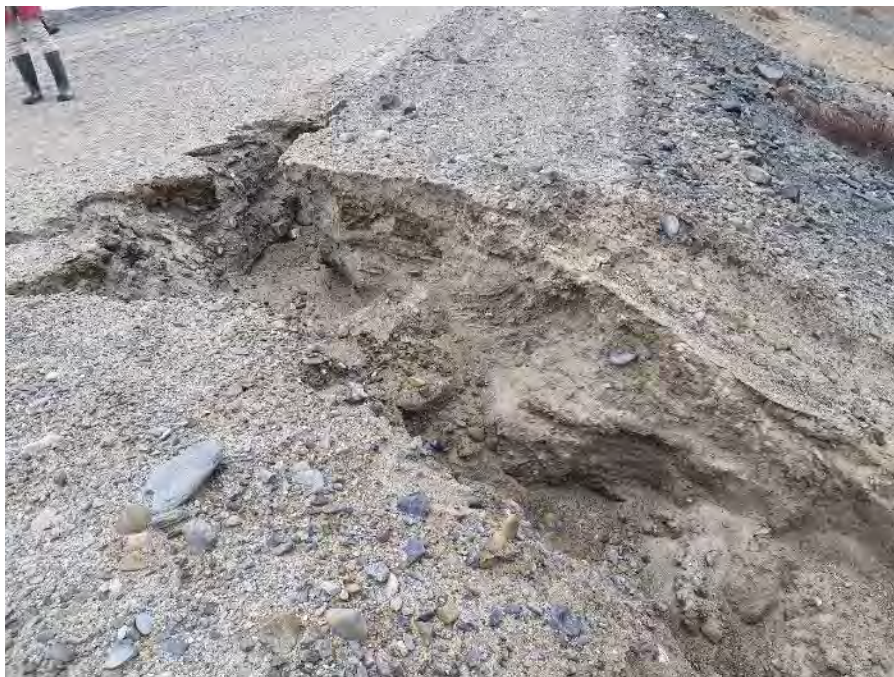
**Photo 28: Dam 4 erosion rill in crest and downstream slope, facing east (Fig. A1 ID#49)**

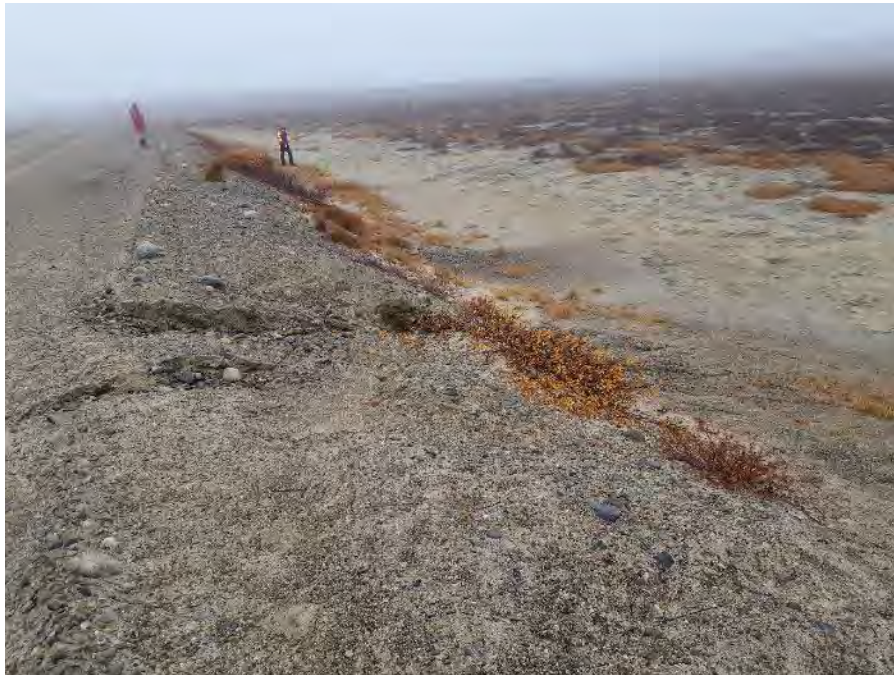
**Photo 33: Dam 6 erosion rill in downstream slope, potential windblown tailings outside of TCA, facing southeast (Fig. A1 ID#32)**

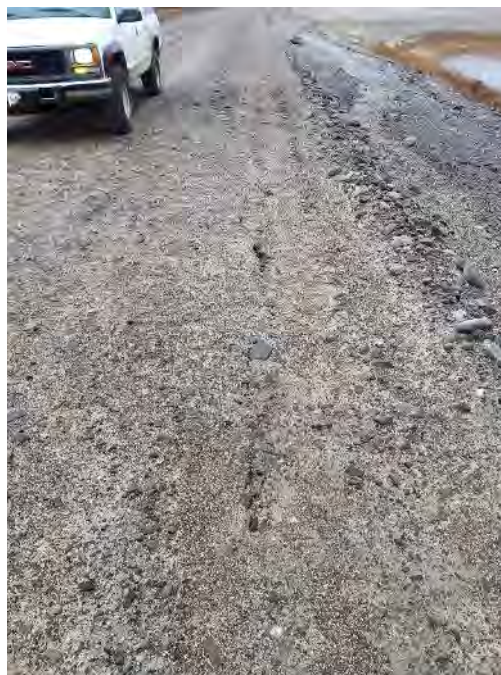
**Photo 34: Dam 6 longitudinal cracks near upstream shoulder of crest, facing northwest (Fig. A1 ID#35)**

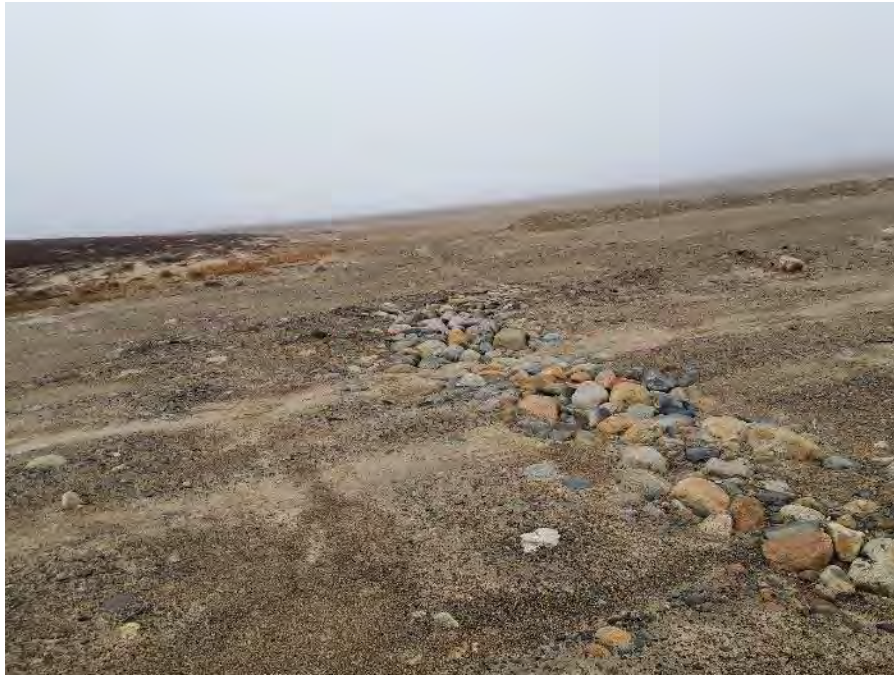
**Photo 35: Dam 6 former erosion channel repaired with cobble riprap (Fig. A1 ID#30)**

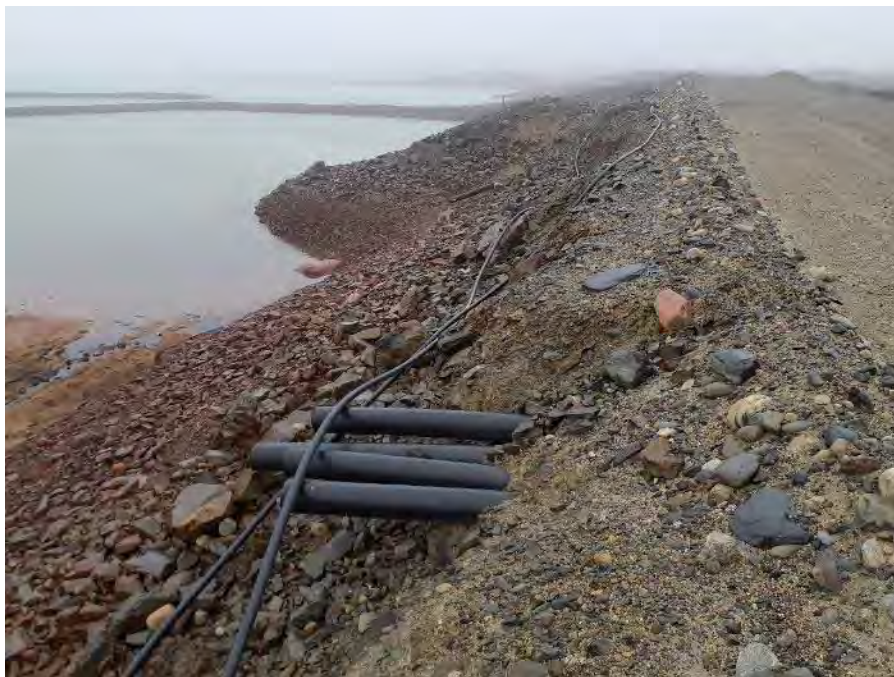
**Photo 42: J Dam, four 0.2m diameter pipes throughgoing the dam for overflow control, appear undersized (Fig. A1 ID#83)**

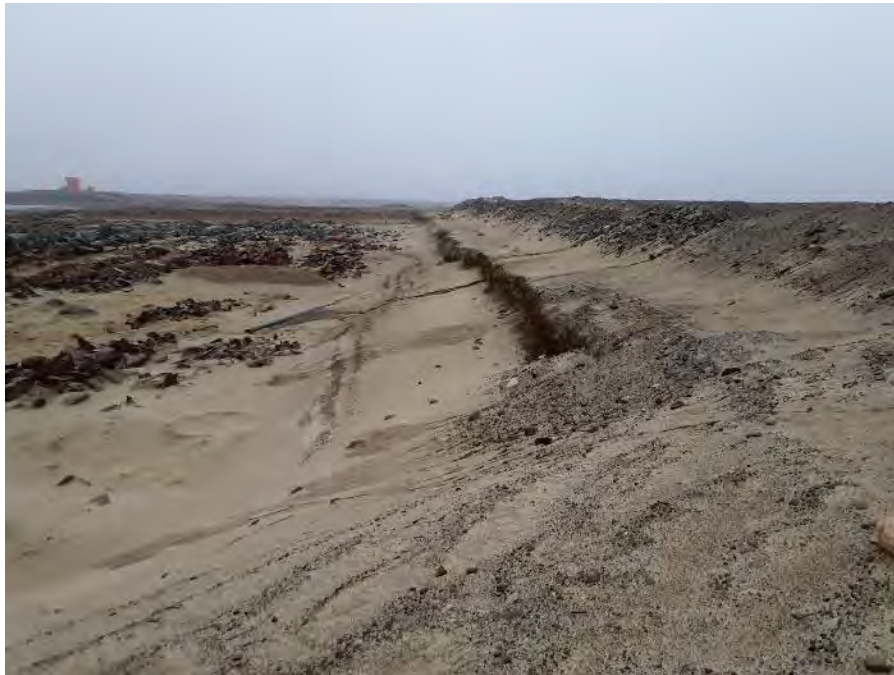
**Photo 43: J Dam upstream slope erosion/scour at high water mark, facing southwest (Fig. A1 ID#101)**

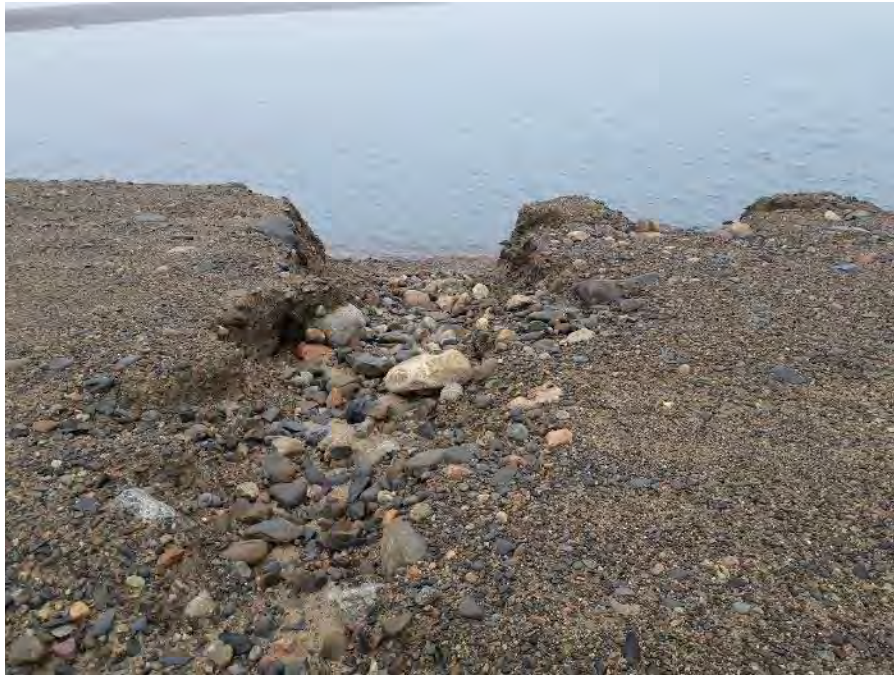
**Photo 47: L Dam downstream slope erosion rill, facing east (Fig. A1 ID#88)**

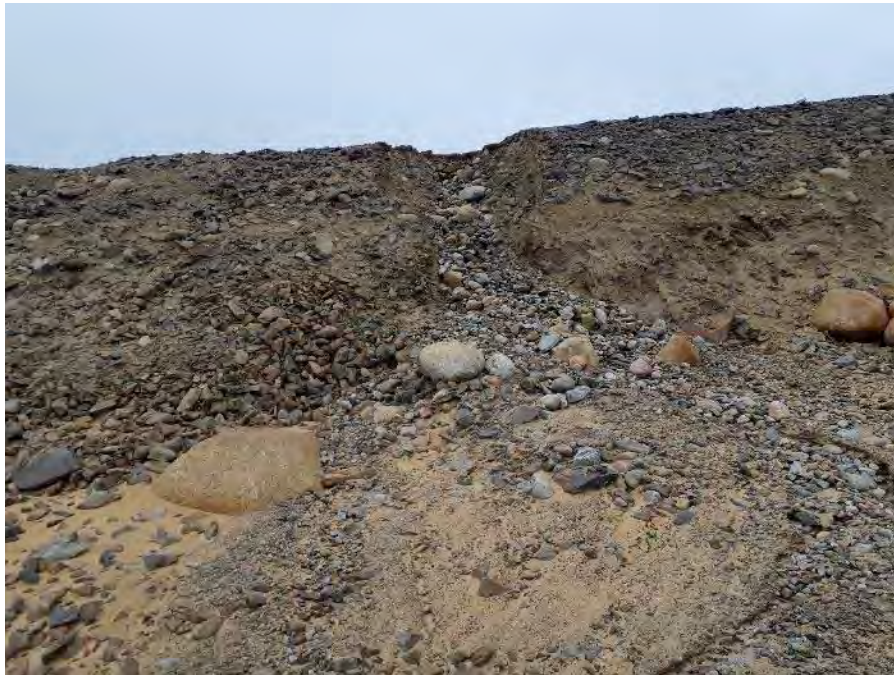
**Photo 53: M Dam erosion rill in downstream slope, facing northeast from toe (Fig. A1 ID#72)**

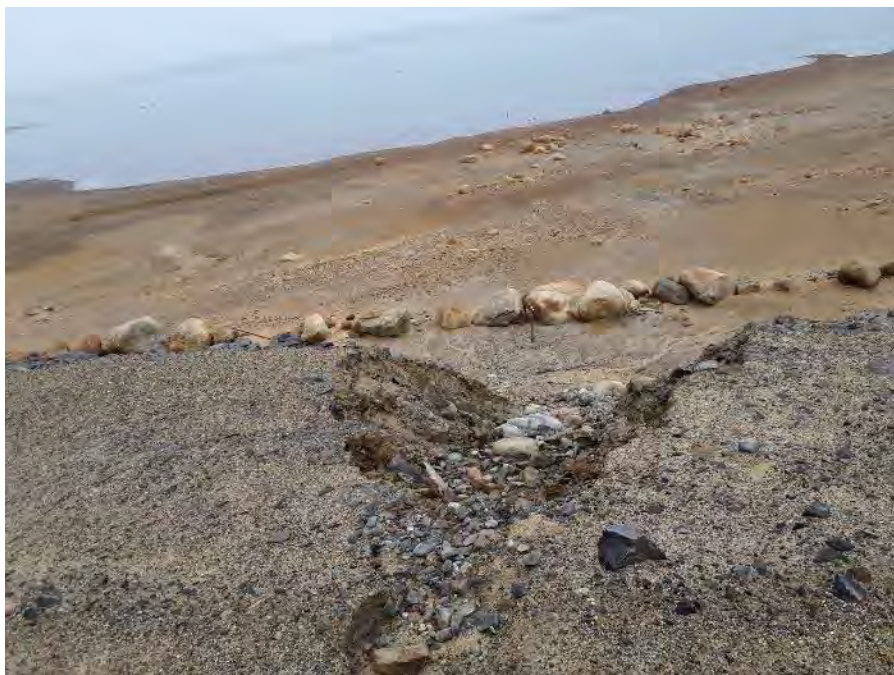
**Photo 54: M Dam erosion rill facing southwest from crest, exposed tailings in background (Fig. A1 ID#79)**

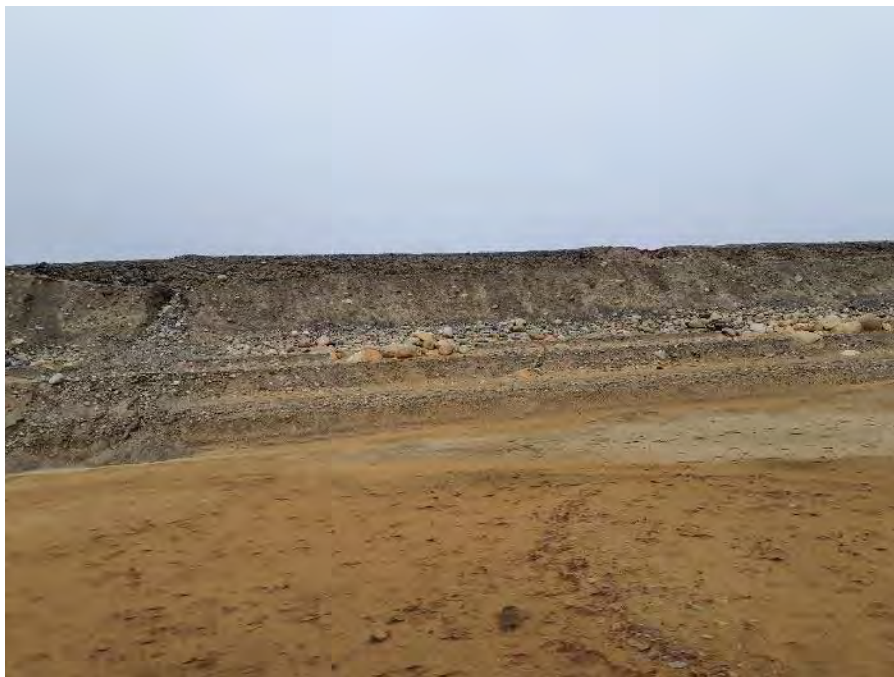
**Photo 58: M Dam downstream slope, facing northeast, exposed tailings in foreground (Fig. A1 ID#75)**

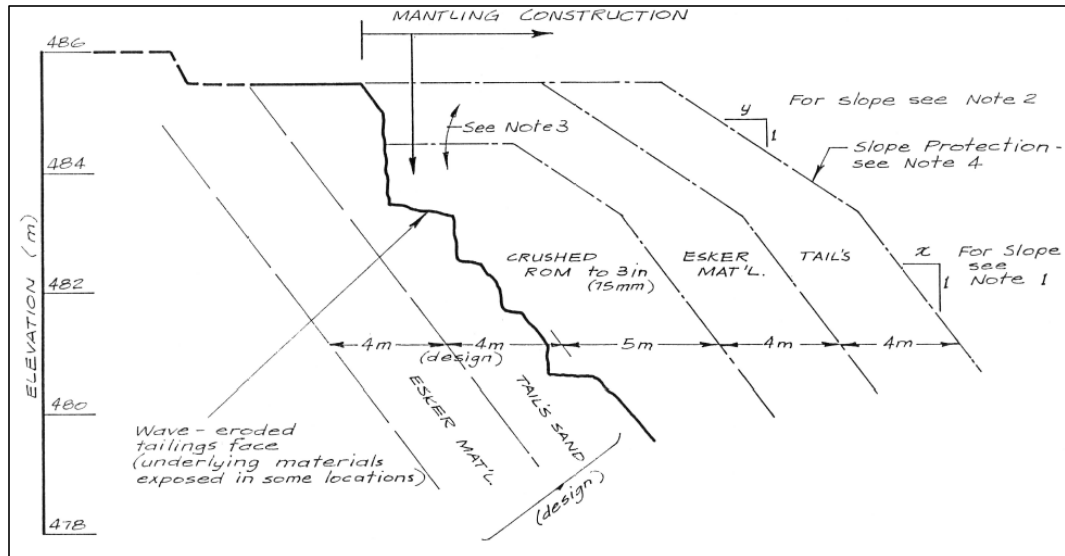
**Figure 16: J Dam Repair (after Golder 1987)**

The Golder 1987 inspection report of J Dam (Golder, 1987) indicated there was a leak in the dam somewhere, and divers were retained to complete inspections of the upstream and downstream sides of the dam. The investigation resulted in no evidence of flow and no fine material deposits suggestive of material-laden flows entering still water were located; however, a sinkhole was noted on the upstream side of the dam. A face armouring design was prepared and implemented on the upstream face to elevation 483.6 m which consisted of crushed Run of Mine (ROM) faced with a zone of esker sand and gravel which was faced with a thickness of tailings material. Whereas the function of the tailings was to reduce seepage, the underlying zones were to function as filter layers to bridge the gradation of the course, open voided ROM section to the new zone of tailings material. Figure 16 provides a schematic of the proposed repair.

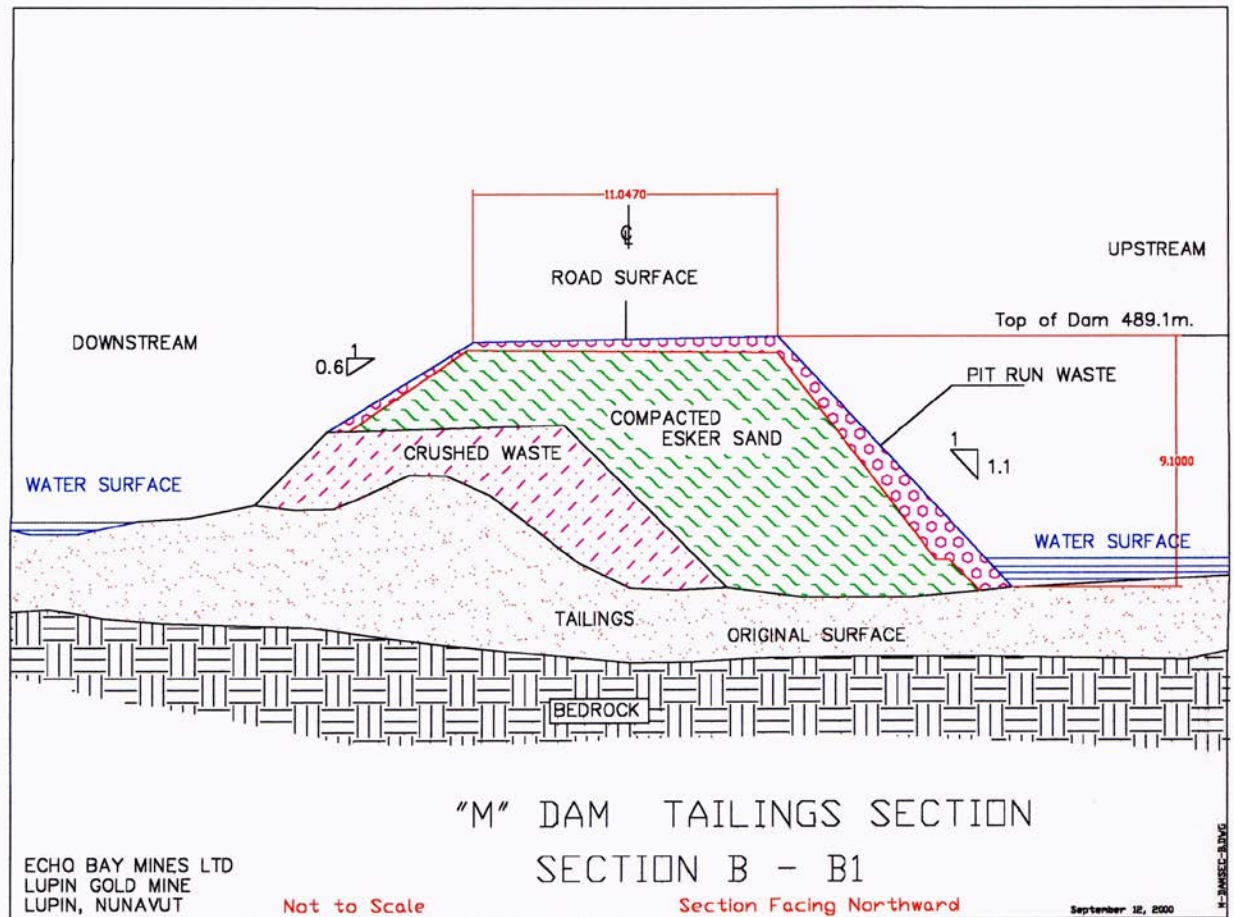
Figure 20: M Dam – Typical Section (EBM 2001)

The tailings within the foundation may not be providing adequate foundation support; and with water upstream and downstream of the dam, it may not have been possible for permafrost to re-establish in the foundation, or the depth of thaw (the active layer) may be greater than in other areas.
