To:	Karyn Lewis, Project Manager Lupin Project	From:	Alvin Tong, P.Eng. Jim McKinley, Ph.D., P.Eng.
	Mandalay Resources Corporation Suite 330, 76 Richmond Street Toronto, ON M5C 1P1		Stantec Consulting Ltd, 200-325 25 Street, Calgary, AB T2A 7H8
File:	Lupin Gold Project – 129500081	Date:	October 15, 2019

Reference: 2AM-LUP1520 Technical Meeting Commitment Number 10 Response – Cover Data from Lupin Mine Tailings Containment Area

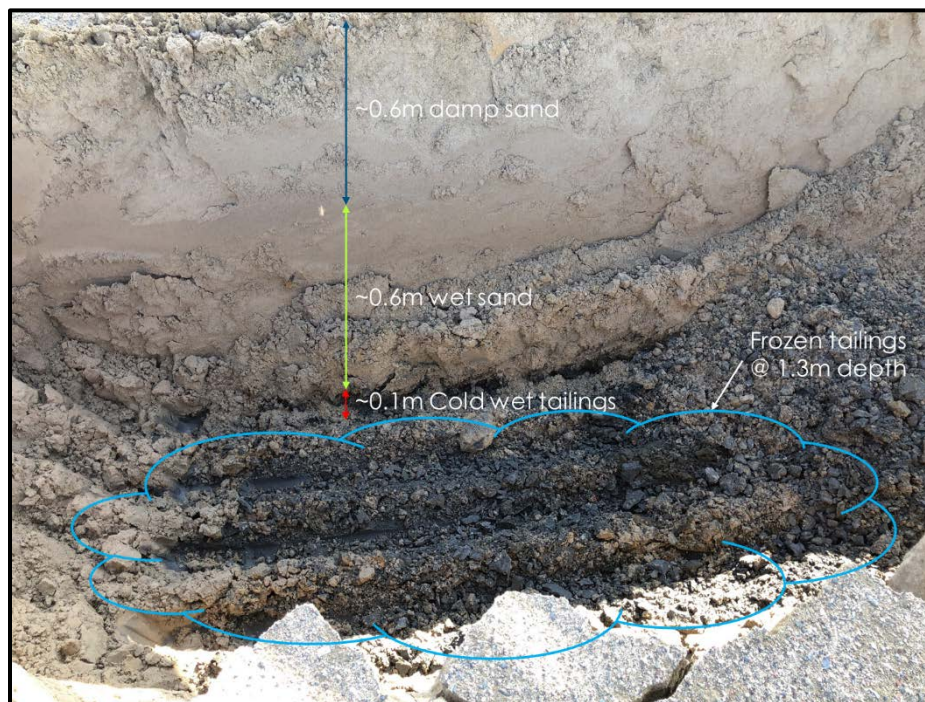
Test Pit 1 Photograph and Descriptions

Test Pit 1 was excavated within Cell 2, which was covered in 2004. The cover material was observed to be a well graded sand with some gravel. Wet material was encountered approximately 0.6 m below ground surface (bgs). A thin layer of cold, wet tailings was encountered approximately 1.2 m bgs and frozen tailings was encountered approximately 1.3 m bgs. No oxidized tailings were observed in the test pit. A photograph of the test pit is provided below.

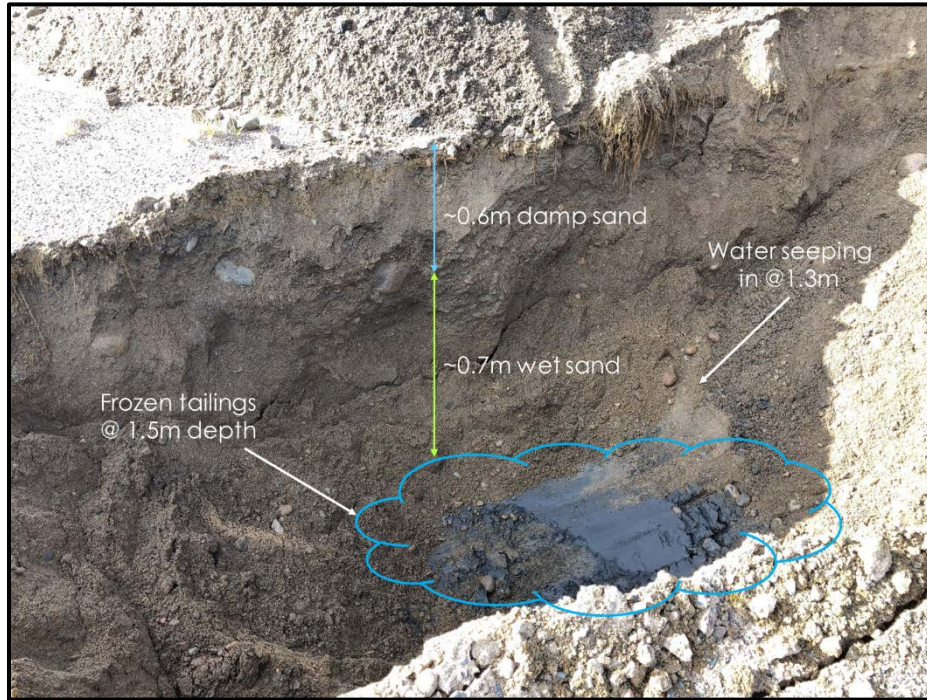
Test Pit 2 Photograph and Descriptions

Test Pit 2 was excavated within Cell 1, which was covered in 1995. The test pit is located approximately 30 m southwest of standpipe P-7. The cover material was observed to be a well graded sand and gravel with cobbles. Wet material was encountered approximately 0.6 m bgs, which generally corresponds with the water level measured in standpipe P-7 at 0.83 m bgs. A layer of cold wet tailings was encountered approximately 1.3 m bgs and frozen tailings was encountered approximately 1.5 m bgs. No oxidized tailings were observed in the test pit. Groundwater was observed seeping into the test pit at approximately 1.3 m bgs. A photograph of the test pit is provided below.
