LUPIN MINES INCORPORATED
(a wholly-owned indirect subsidiary of Mandalay Resources Corp.)

**RE: 2020 Annual Geotechnical Inspection – Lupin Mine Tailings Containment Area, Nunavut
Lupin Mine, Nunavut, License Number 2AM-LUP2032**

This document entitled 2020 Lupin Mine Tailings Area Inspection was prepared by Stantec Consulting Ltd. ("Stantec") for the account of Lupin Mines Inc. (the "Client"). Any reliance on this document by any third party is strictly prohibited. The material in it reflects Stantec's professional judgment in light of the scope, schedule and other limitations stated in the document and in the contract between Stantec and the Client. The opinions in the document are based on conditions and information existing at the time the document was published and do not take into account any subsequent changes. In preparing the document, Stantec did not verify information supplied to it by others. Any use which a third party makes of this document is the responsibility of such third party. Such third party agrees that Stantec shall not be responsible for costs or damages of any kind, if any, suffered by it or any other third party as a result of decisions made or actions t

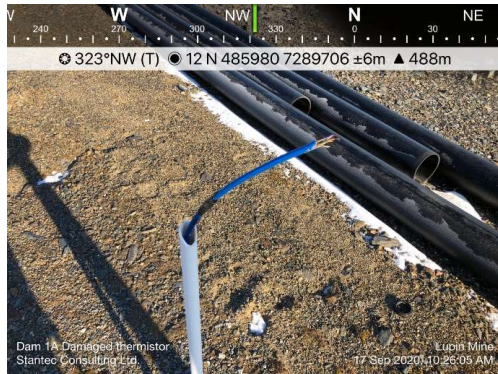
Photo 3b: View of the damaged thermistor.

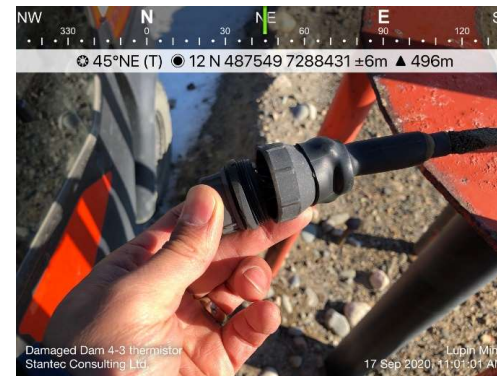
Photo 18: View of the damaged thermistor

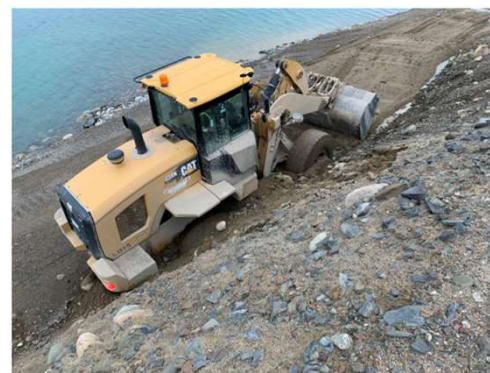
Dam M was repaired with a reinforcement buttress and crest surface backfill in 2016 (Norwest 2016). The toe of the buttress has experienced some wave erosion at the HWM. The water level rose in 2019 freshet and by this year the buttress toe along with the riprap were submerged and localized minor sloughing was observed. During 2020 closure activities, seepages were observed along the toe at the old buttress crest. Engineering instruction was provided to the contractor to place additional fill to limit the seepage. During the construction, the loader got stuck and caused a minor localized failure at the downstream face when it tried to free itself. This was observed by the EOR representative and documented in an incident report. Further repair was suspended until the contractor could provide a different construct method.

Dam M	2.2	Sloughing in localized sections of the buttress due to raised water level during 2020 freshet. A construction incident has caused a localized minor failure to the downstream face of the dam.	Repair the sloughed section of the buttress and the localized failed section once the water level is lowered. Re-slope the buttress to 2H:1V design for final closure.	Minor erosion at the downstream toe above the riprap protection	Repair the eroded toe areas.
Dam N	0.8 ⁽²⁾	A shallow channel was constructed to manage 2020 freshet. It was backfilled under engineering oversight. Material was stockpiled on the dam in preparation for cover placement.	Monitor the water level behind Dam N and lower the water when practicable to yield minimum 1m freeboard. Monitor the dam around the stockpile for deformation.	Minor wave action erosion at HWM.	Monitor the water level behind Dam N and lower the water when practicable to yield minimum 1m freeboard.

Photo 46: Looking down at the incident on the Dam M buttress where localized failure caused by the equipment, near the junction of Dam N.

Photo 47: Looking at localized failure caused by the equipment near the junction of Dam N

1. Upon recommencement of closure activities in 2021, the localized failed section of Dam M should be repaired.
2. Monitor the seepage at the downstream toe of the divider dyke for erosion and potential instability. Repair as needed in 2021 when access is available.
3. Monitor the proximity of the breached location in Dam L for any seepage and potential instability. Repair as needed in 2021 when access is available.
4. Monitor the water level behind Dam N and lower the water level to maintain a minimum 1m freeboard.

1. Upon recommencement of closure activities in 2021, the localized failed section of Dam M should be repaired. LMI will also be carrying out the closure work as per the construction drawings filed with the NWB in July 2020 under Part G, Item 1.
2. Monitor the seepage at the downstream toe of the divider dyke for erosion and potential instability. Repair as needed in 2021 when access is available.
3. Monitor the proximity of the breached location in Dam L for any seepage and potential instability. Repair as needed in 2021 when access is available.
4. Monitor the water level behind Dam N and lower the water level to maintain a minimum 1m freeboard.

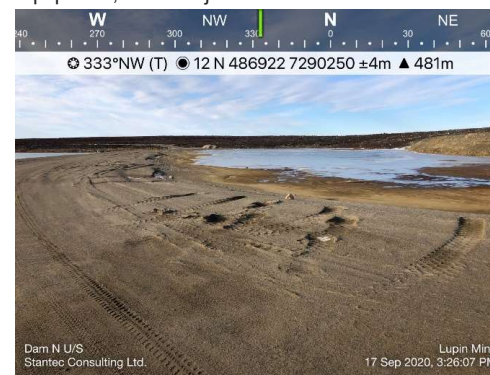
During freshet, a shallow ditch was constructed at the north abutment of Dam N to passively manage the freshet water. This was backfilled after the freshet. Both the construction and backfill were overseen by EOR representative. During the inspection Dam N was observed to be in stable condition, but it had only 0.5m of freeboard between it and Pond 2. This was communicated to LMI site personnel, and the need to increase the freeboard to 1m to meet water license requirement was highlighted. Stantec was later informed that the pond level was lowered after water treatment operations and Cell N freeboard increased to 0.8m prior to winterization.

Photo 49: Looking north at the crest of Dam N and ponding water with approximately 0.8m freeboard.

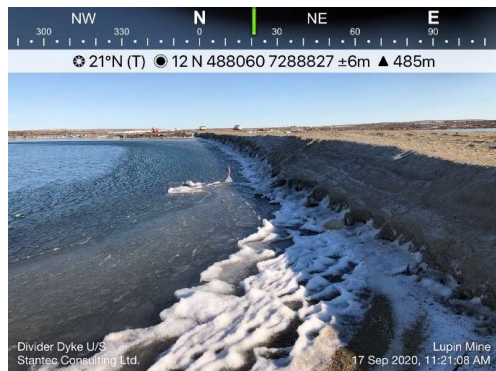
Photo 50: Looking north at the repaired upstream slope and crest of the southern divider dyke.

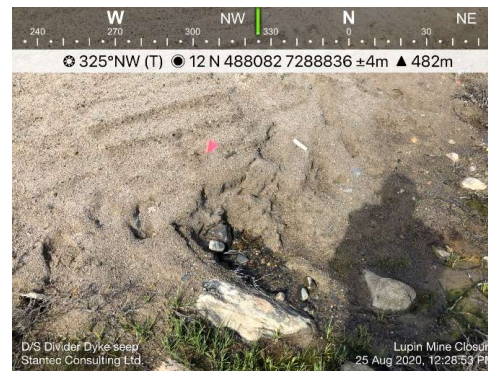
The cracks and erosion observed in the divider dyke were repaired by the newly placed compacted fill. However, new zones of seepage were observed at the newly constructed downstream toe of the divider dyke. These seepages were not observed previously and were monitored during closure activities. The seepages will continue to be monitored until the proposed spillway is constructed in 2021. The seepages are expected to stop once the spillway is constructed to passively manage the water at the closure elevation, which is below the observed seepage zones.

Photo 51: Looking north at the downstream slope and the seepage zones at the toe of the divider dyke.

Photo 52: Looking northwest at one of the seepage zone at the toe.

Divider Dykes	1.7	The dam was raised by 0.8m temporary to manage freshet. The old erosion and crest were repaired. New seepages are	Continue to monitor the seepages until the closure spillway is constructed. Repair any erosion	Erosion, sloughing and cracks along upstream and downstream of the northern portion of the dyke. Uneven	Second priority to complete the repair to the northern section
