WATER LICENCE INSPECTION FORM

| Lupin Mines Inc | | Karyn Lewis | |
| 2AM-LUP2032 | | Project Manager | |
| 2020 July 2 | | Baba Pedersen | |

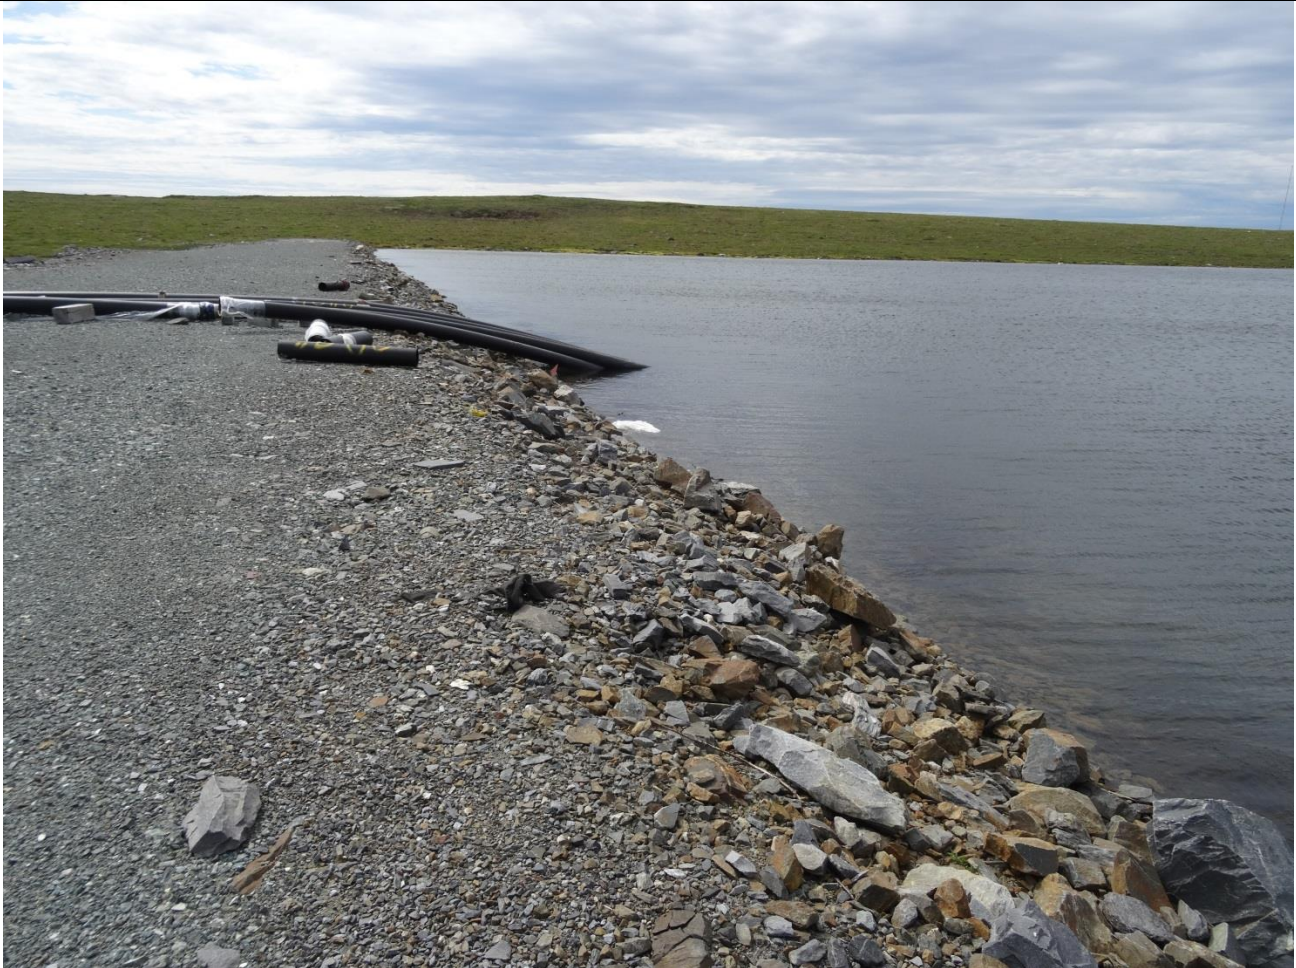
Photo 3

| <p>The Mine Site Reclamation Project is now in full operation. There are approximately up to 84 people on site at any time. The following was observed by the writer:</p> <p>1. The Sewage Lagoon (Photo 3) is within volume limits as it still has more than 1 meter of Freeboard. The writer was informed that the content of the Lagoon has been Sampled recently and LMI is awaiting the Lab Results.</p> <p>2. The Temporary Land Fill Storage Area (Photos 4 through 8) is comprised of only Non-Hazardous Materials and there was no visible Run-off into any bodies of water or streams.</p> <p>3. LMI Mitigation Measures for Dust Control is by the use of a Truck (as seen in Photo 9) watering all Roads. During very strong winds (Photos 10 and 11) windblown dust has the potential of traveling long distances, hence the use of a water truck is needed to minimize the risk of windblown dust.</p> | | | |

Description: Sewage Lagoon

| SECTION 3 | <input type="checkbox"/> Comments | <input type="checkbox"/> Non-Compliance with Act or Licence | <input checked="" type="checkbox"/> Action Required |
|---|---|---|---|
| <div><div>1. Sewage Lagoon Sample Results from the Lab <b>MUST</b> be provided to the writer for approval prior to Decanting.</div><div>2. The Temporary Landfill Storage Area is in an acceptable state. The writer walked the entire area and the perimeter and found no major concerns.</div><div>3. LMI <b>MUST</b> pay constant attention to Dust Control Mitigation Measures in order to minimize the effects of windblown dust getting into any Bodies of Water.</div><div>4. The writer has no concerns with the Incineration of Camp Food Waste.</div><div>5. The writer has no concerns with Potable Water retrieval or Consumption Levels.</div><div>6. LMI <b>MUST</b> inform the Nunavut Water Board <b>IN WRITING</b> if there are to be any changes in the Approved Project Schedule.</div><div>7. Where required, Sample Station Signage is to be Repaired or Replaced prior to the next scheduled Inspection.</div></div> | | | |

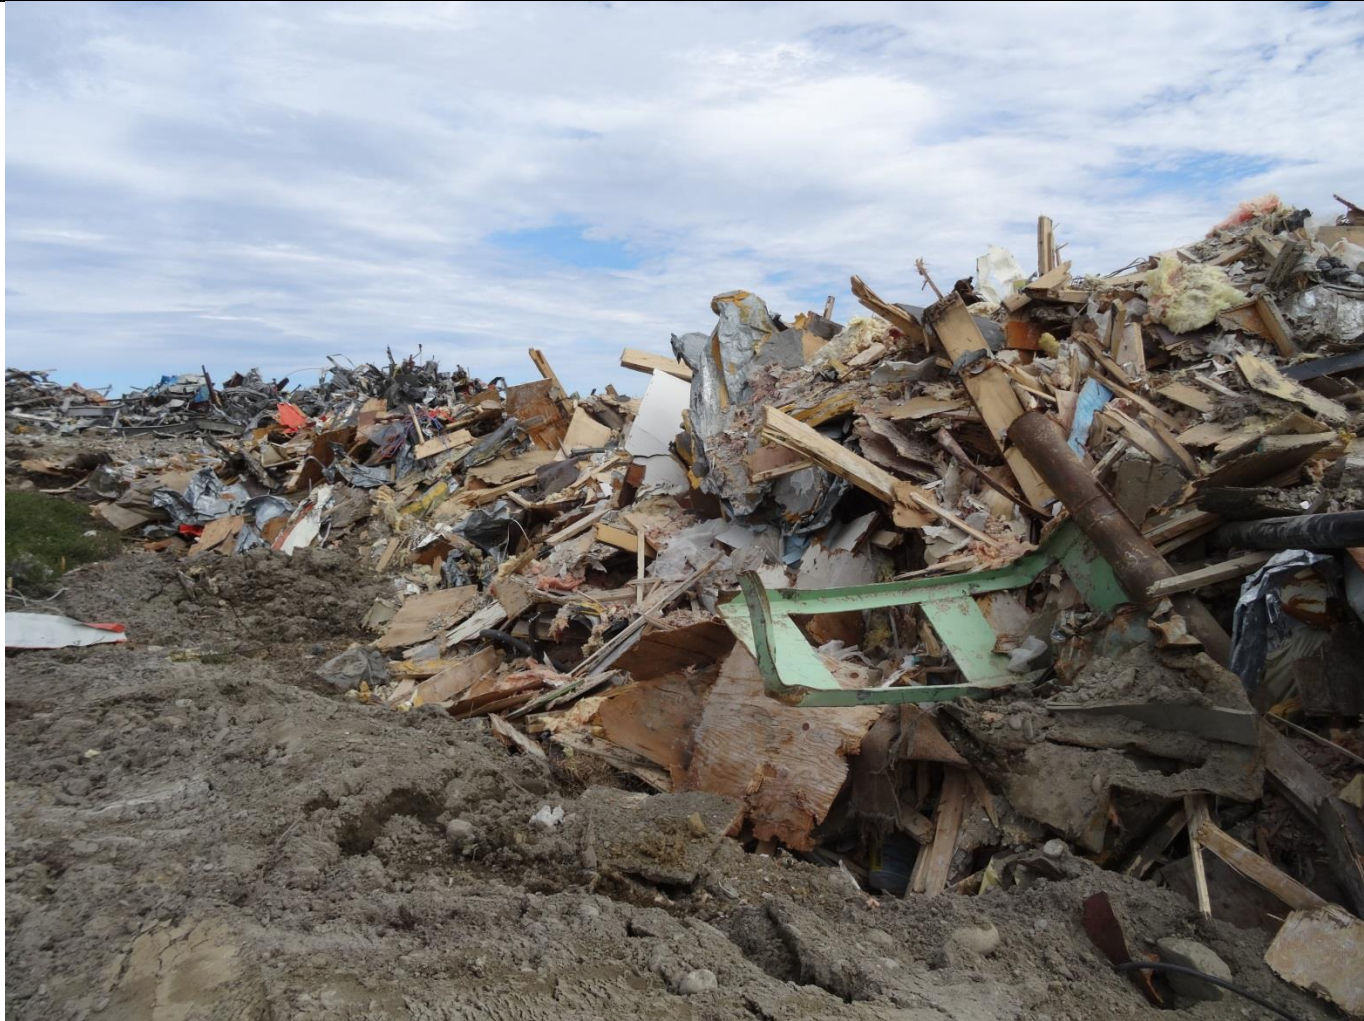
Photo 5

Description: Temporary Storage of Demolished Debris – View 2

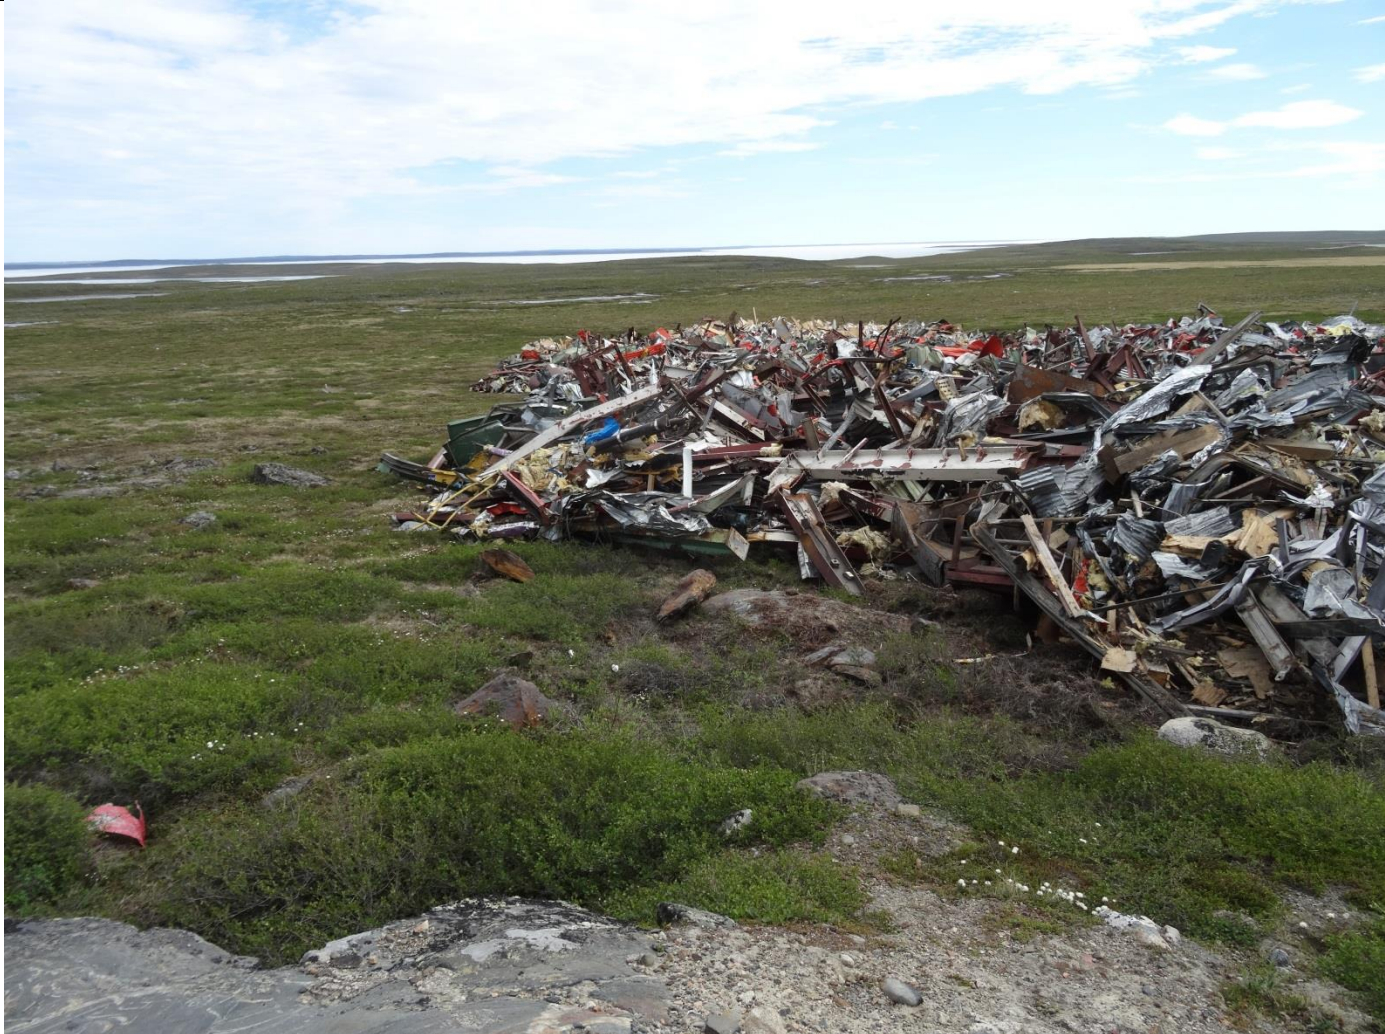
Photo 6

Description: Temporary Storage of Demolished Debris – View 3

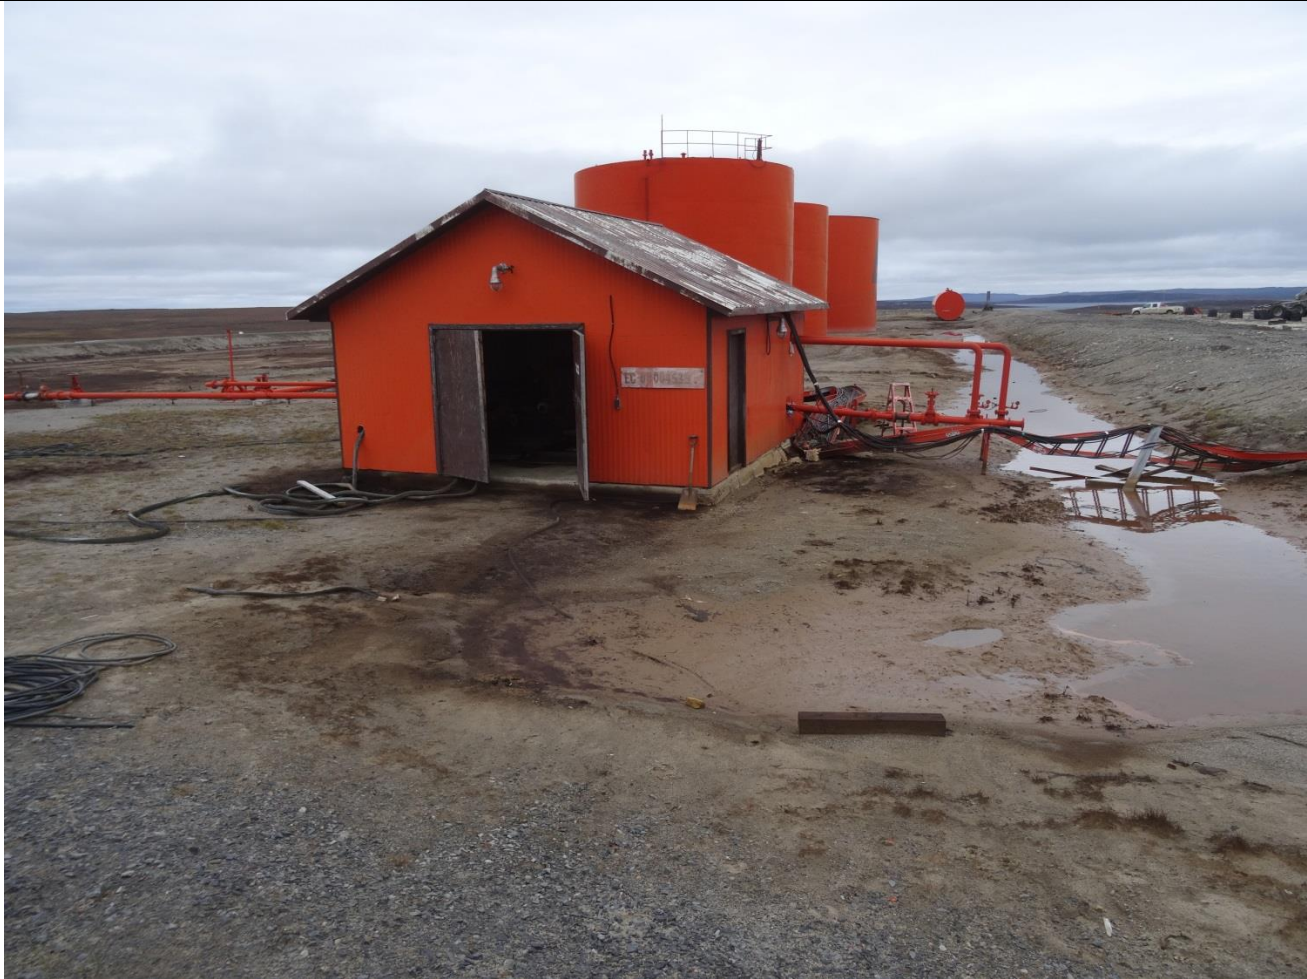
Tanks M-16, M-17, M-18, M-19, M-20, M-21 and M-22 have been Cleaned and Decommissioned, but remain Standing

The Main Pump Shack Remains in Place within the Tank Farm

Pump Station #1, Pump Station #2 and all associated Pipeline located just Outside the East Side of the Tank Farm have all been Cleaned, Dismantled and Placed in the Land Fill

Description: Main Tank Farm – View 1

Description: Main Tank Farm – View 2

Description: Main Tank Farm – View 3 – Showing Pump Shack

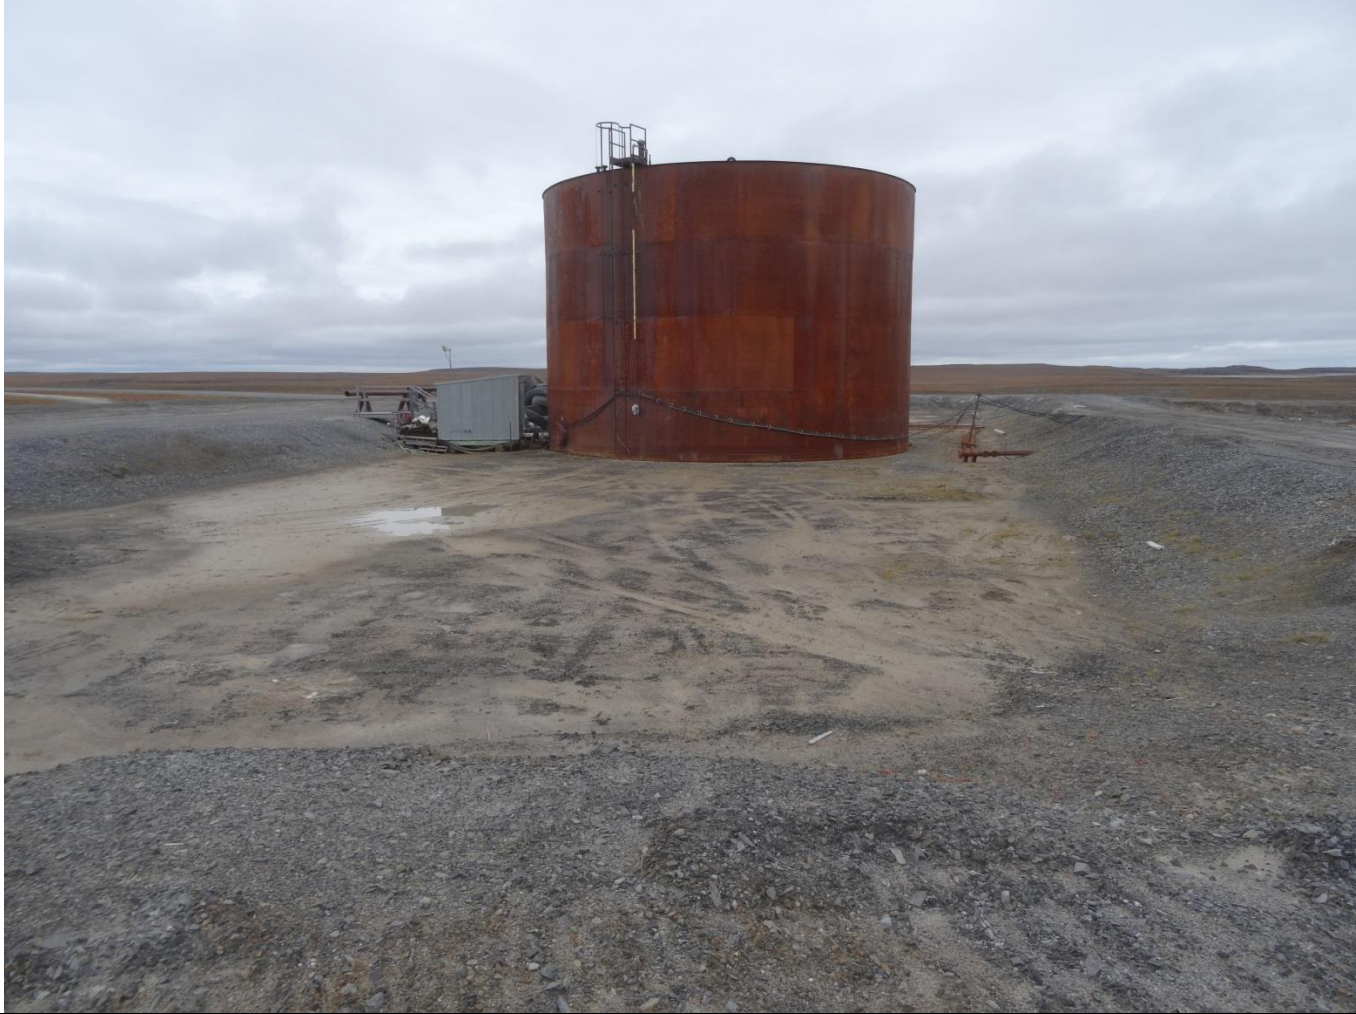
Photo 6

The M-14 Tank has been Cleaned, Dismantled and Placed in the Land Fill including it's associated Pipeline

The M-15 Tank is Still Standing and contains approximately 382,000 Ltrs of Jet-A Fuel, it,s associated Pipeline and Pump Station Remains in Place.

Description: Jet-A Tank Farm

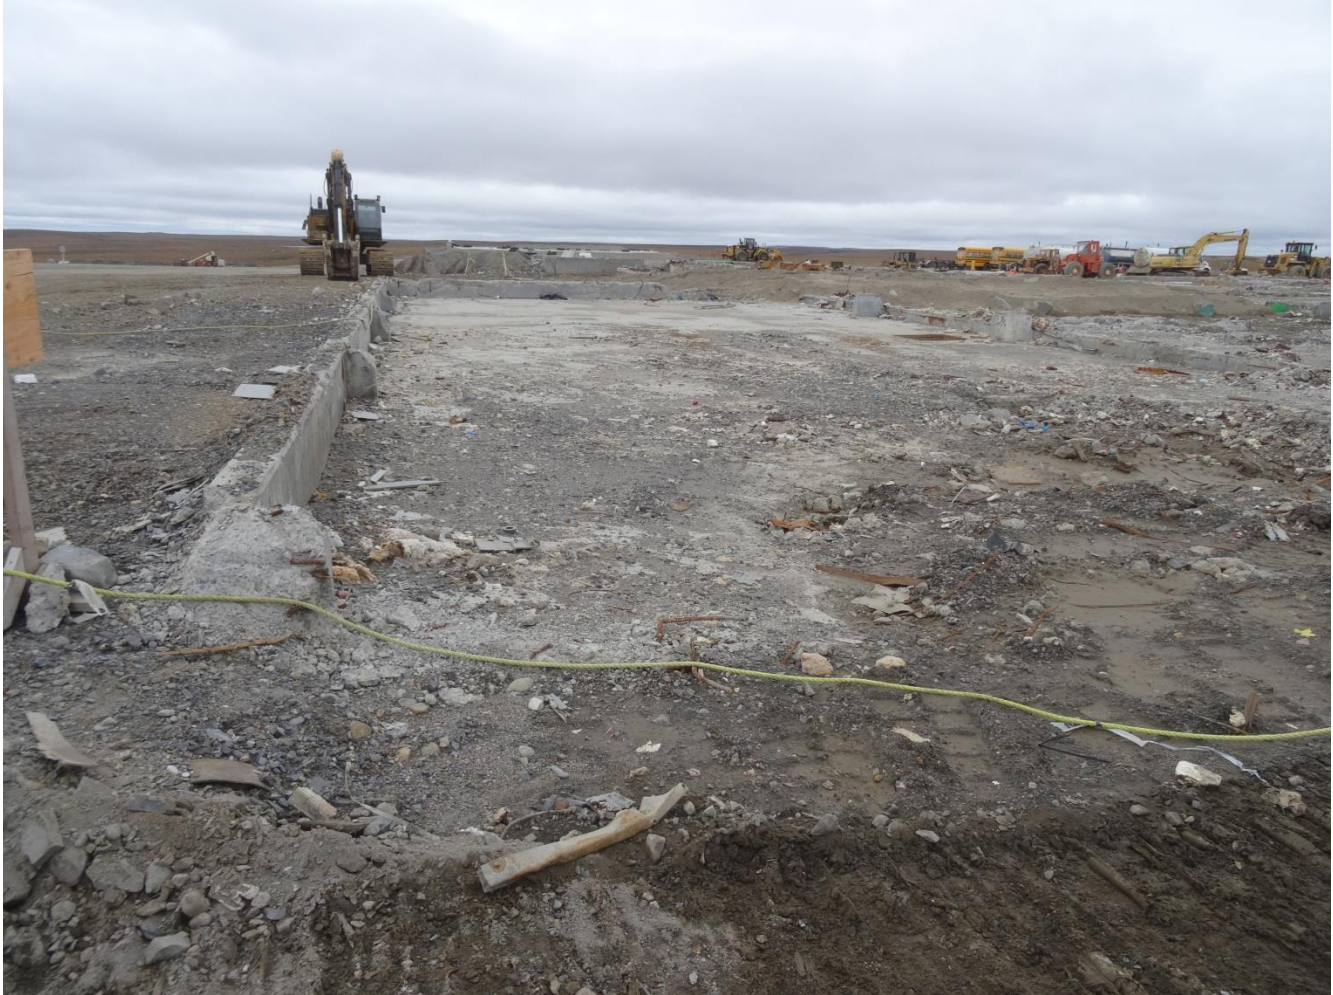
Photo 9

All Debris has been removed and placed in the Land Fill

The Concrete Foundation Remains in place

Description: #19 Batch Plant, aka Paste Plant – Concrete Foundation Remains – All Debris Removed and Placed into the Land Fill

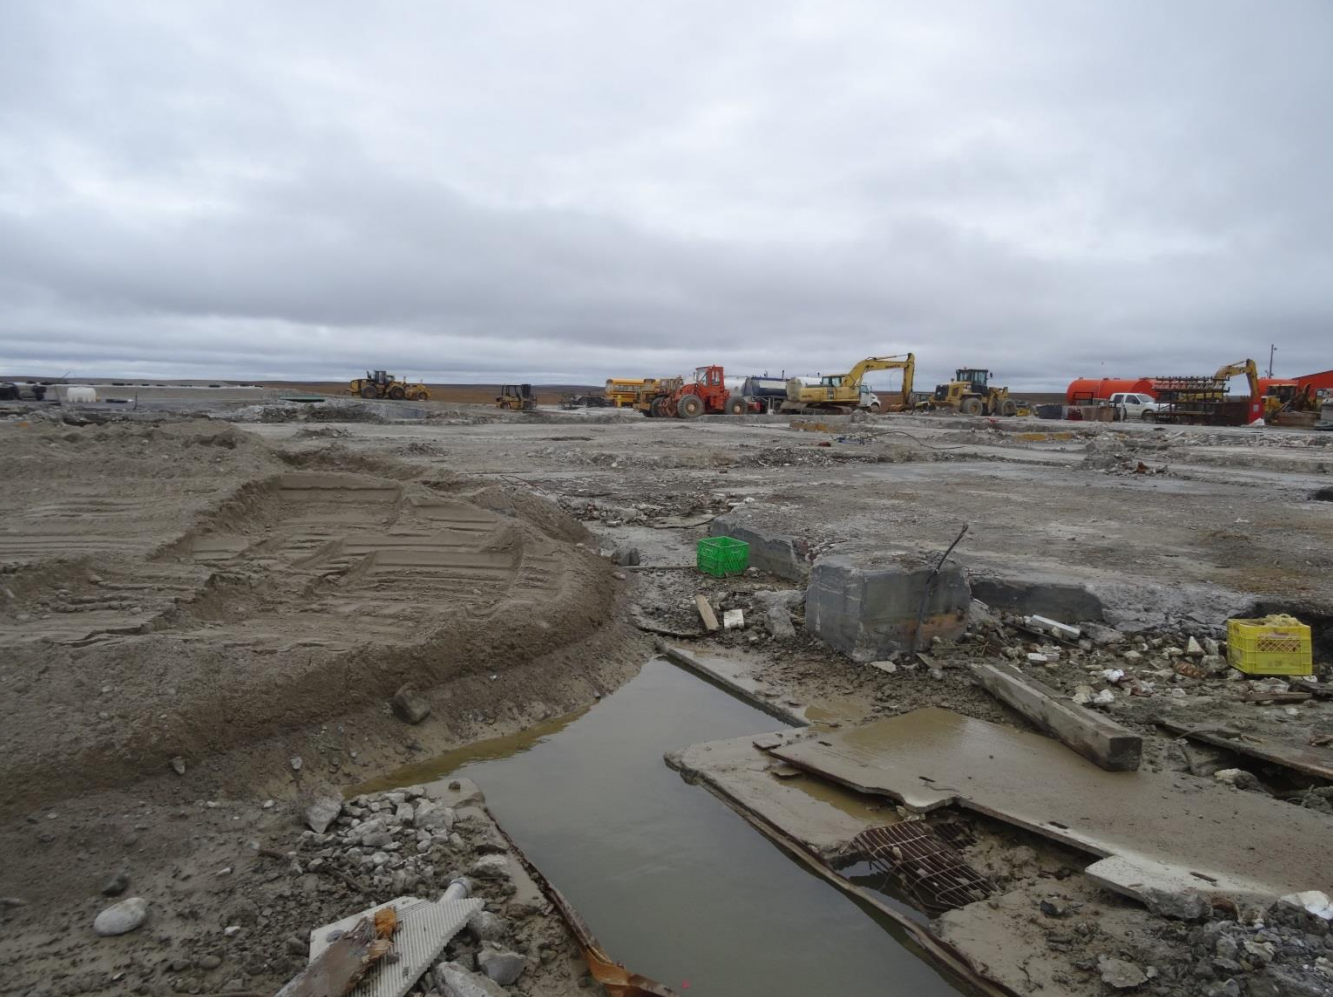
Photo 12

The Concrete Foundation Remains in place

Description: #15 Carpenter Shop – Concrete Foundation Remains – All Debris has been Removed and Placed into the Land Fill

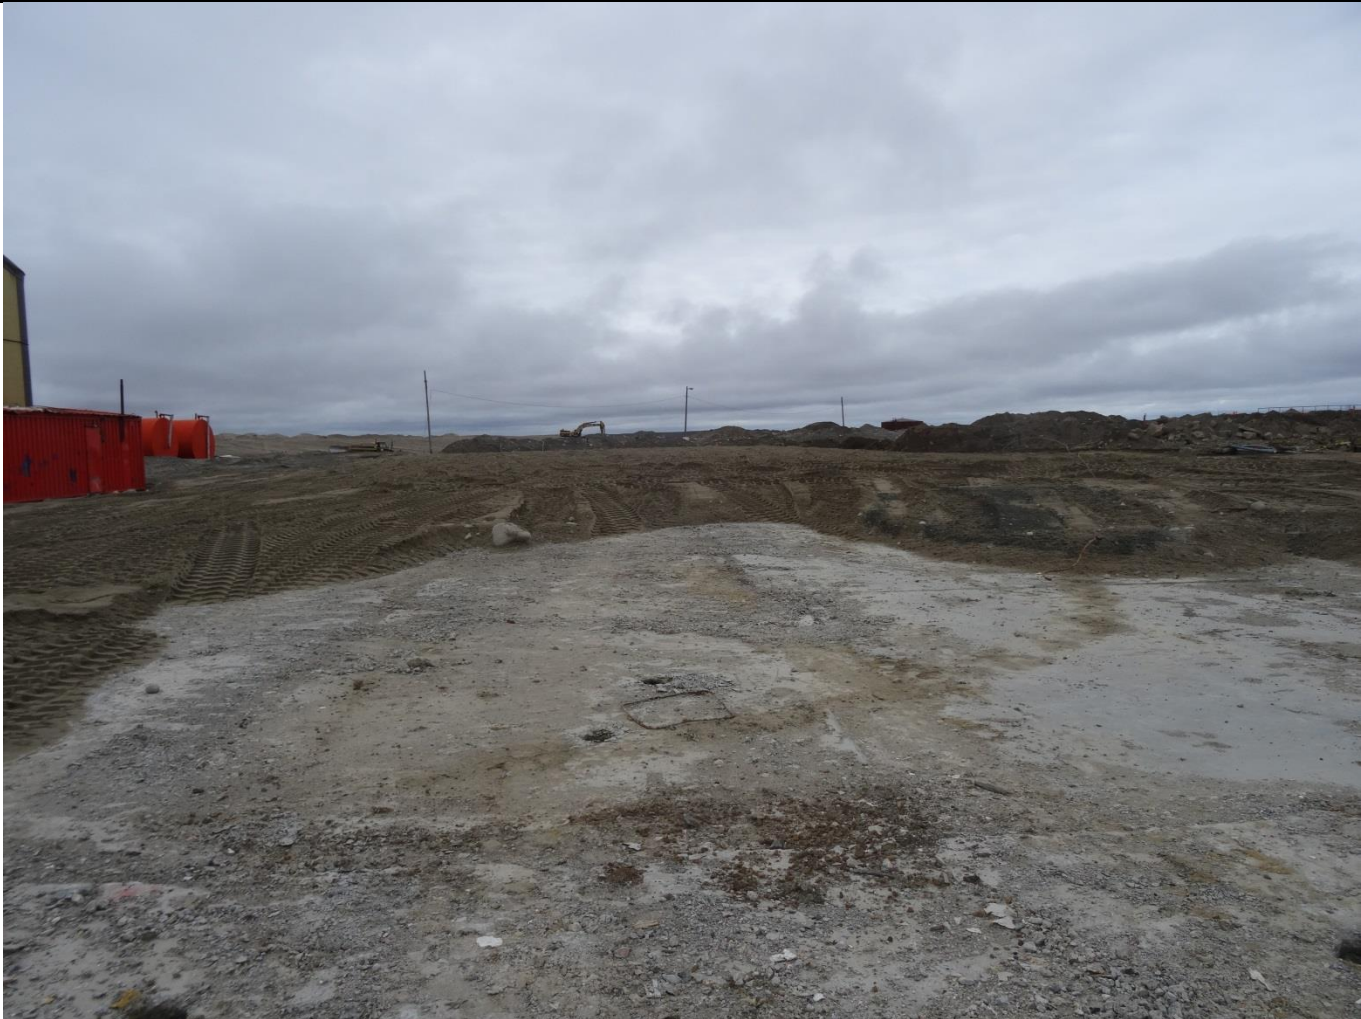
Photo 16

All Debris has been removed and placed in the Land Fill

This area has been covered in Sand

Description: #12 Power House – Foreground – All Debris has been Removed and Placed into the Land Fill

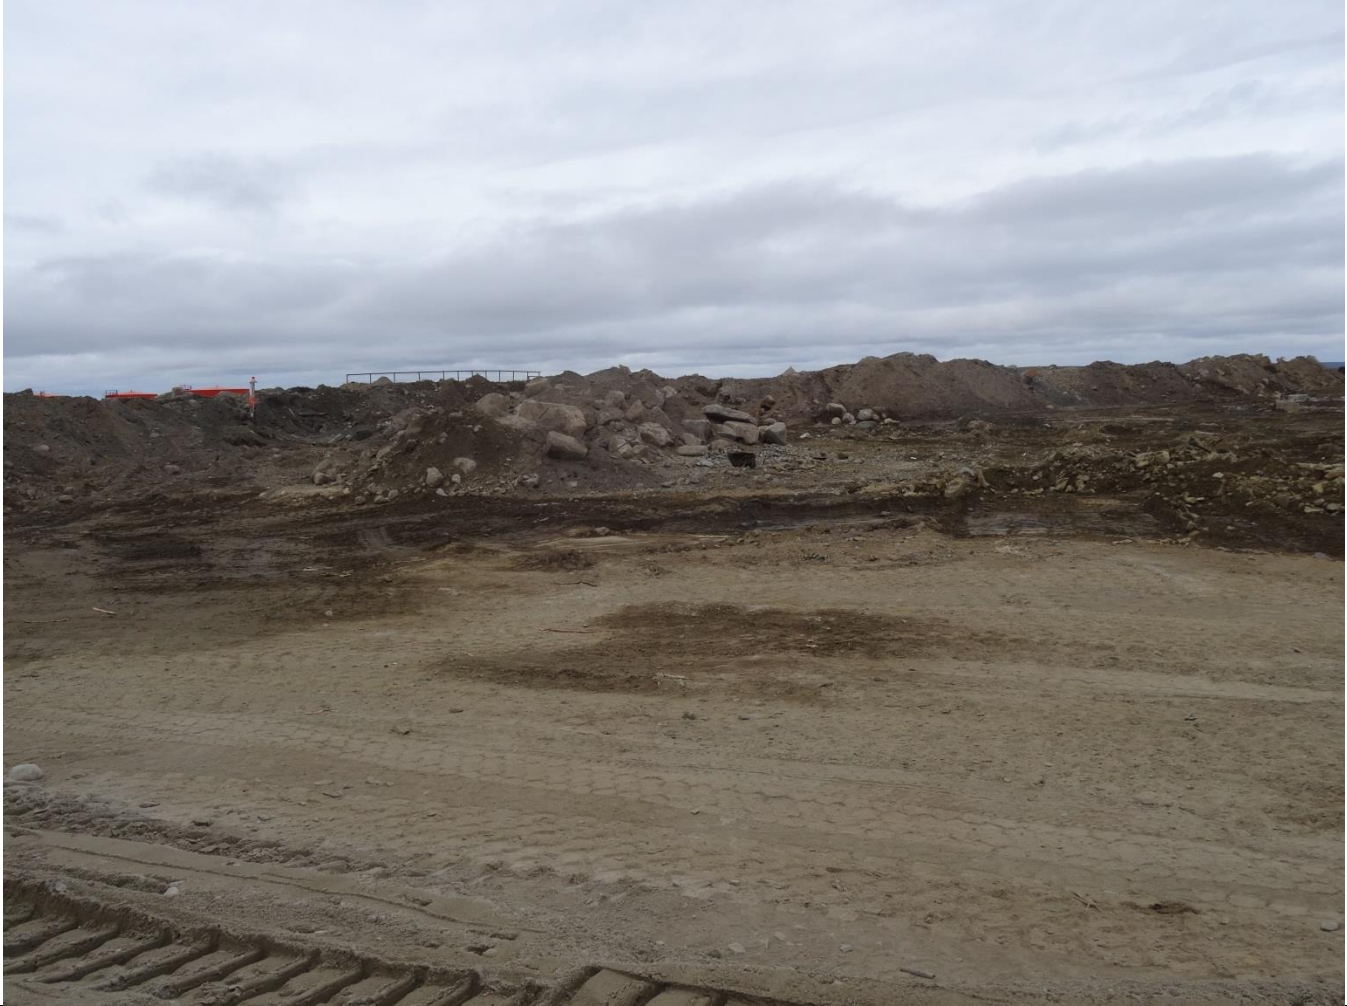
Photo 17

This area has been covered in Sand and only a Pile of Large Rocks remain

Description: #17 Emergency Power House – All Debris has been Removed and Placed into the Land Fill

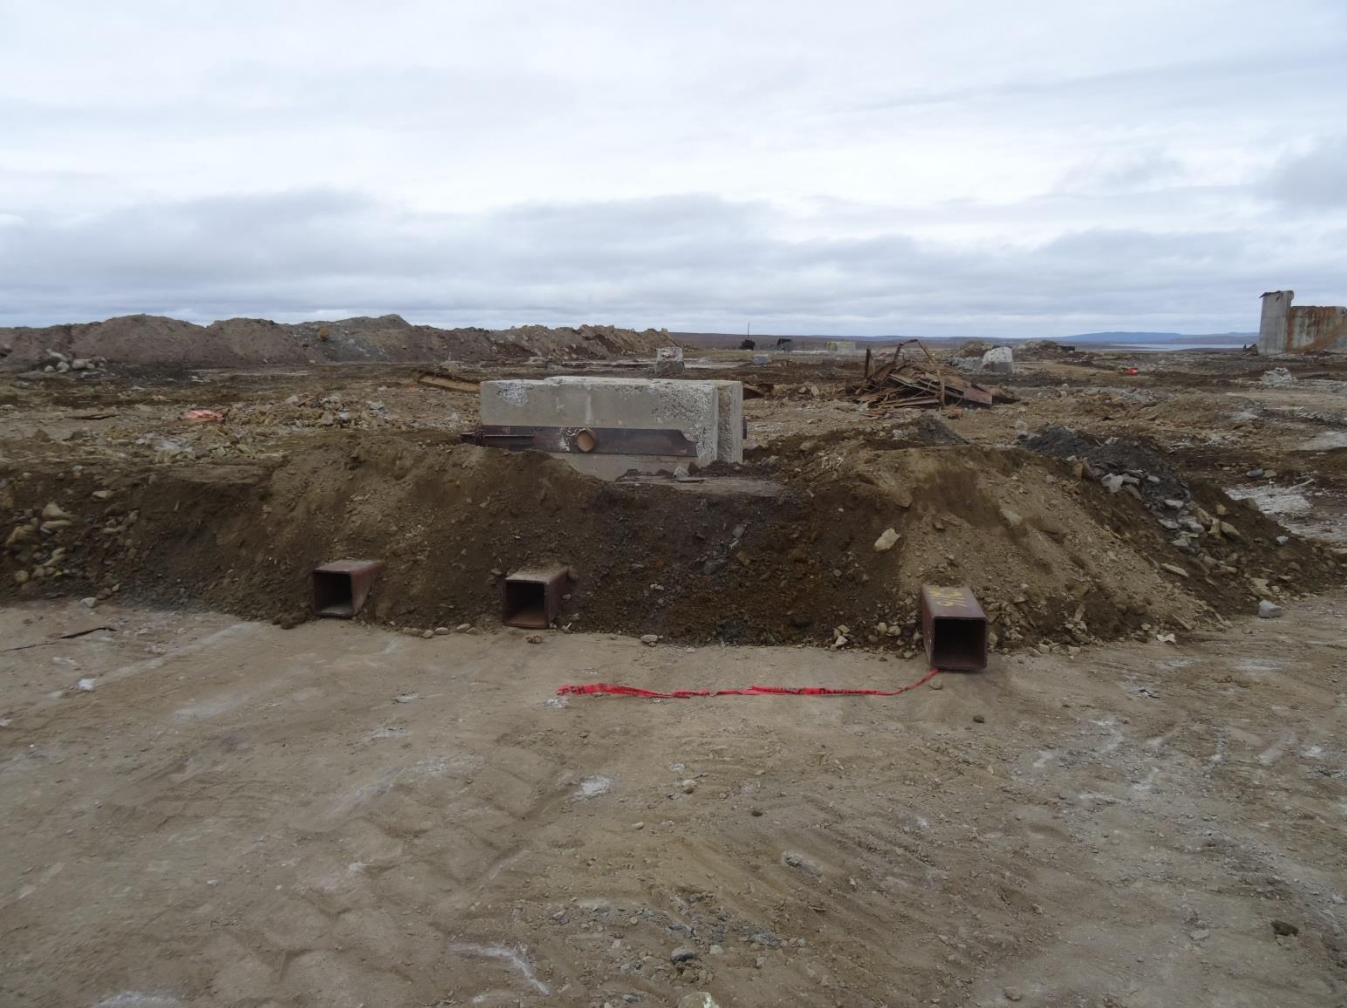
Photo 18

This area has been covered with large Metal Beams and Plates which are covered in Sand and 2 large Concrete Blocks

Description: Shaft Hole – All Debris Removed and Placed into the Land Fill

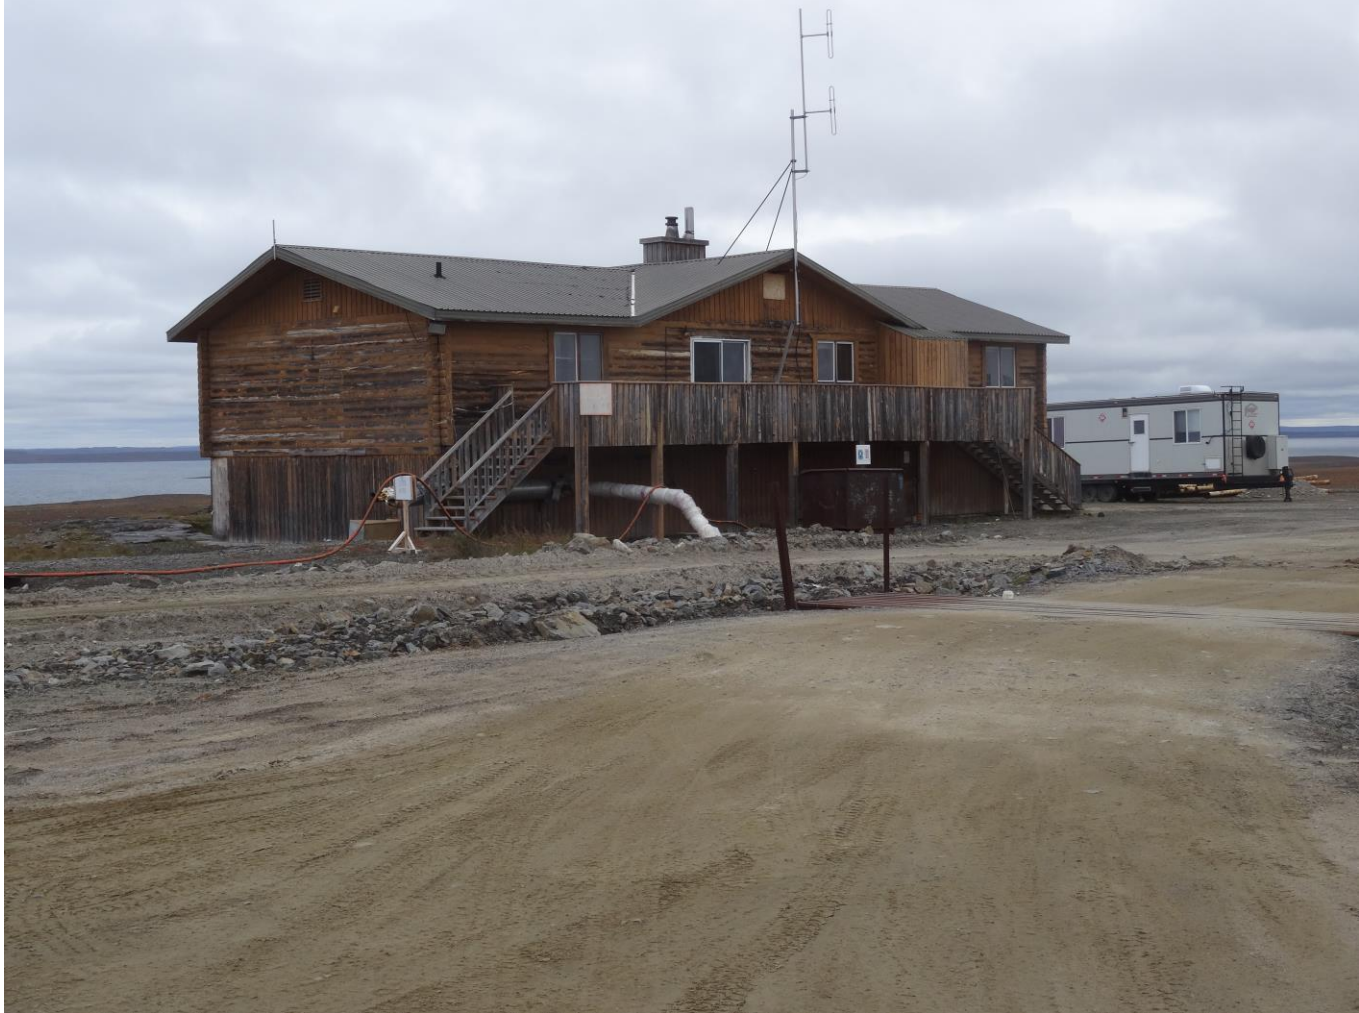
Photo 26

This building remains Standing and in use.

As per Gord Peckford, this is 1 of 2 Buildings that will remain standing for at least 5 years

Description: Log Guest House – This is 1 of 2 Buildings that will remain for at least 5 years

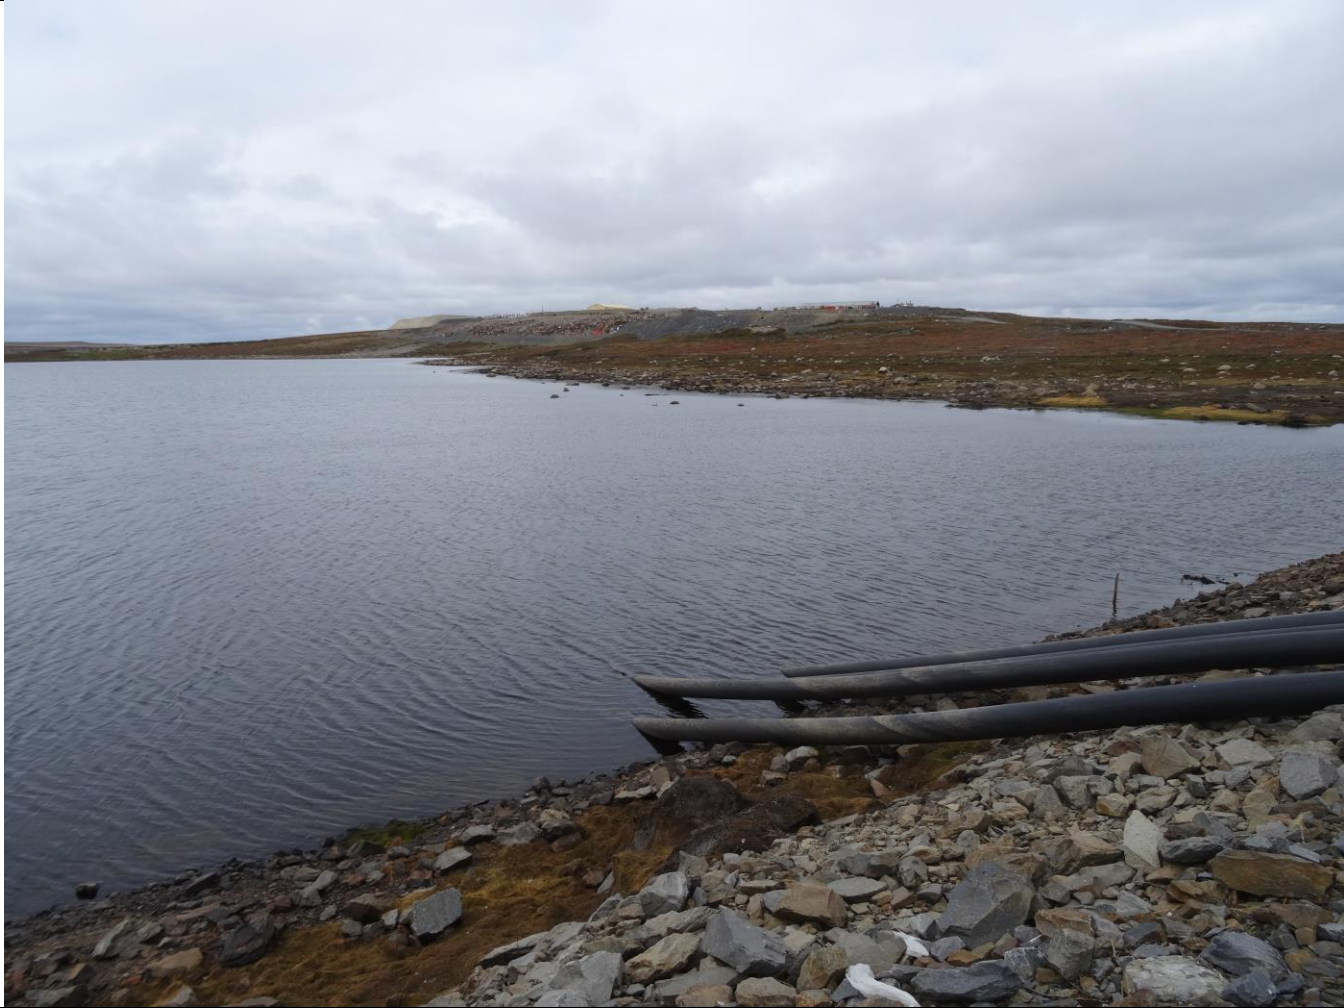
Photo 28

The Decant Program in the Lower Sewage Lagoon is almost complete with only 1 or 2 days left. The levels are the lowest I have ever seen with an estimated 4 meters of Freeboard. After completion, they will then start Decanting the Upper Sewage Lagoon into the Lower Section

Description: Lower Sewage Lagoon

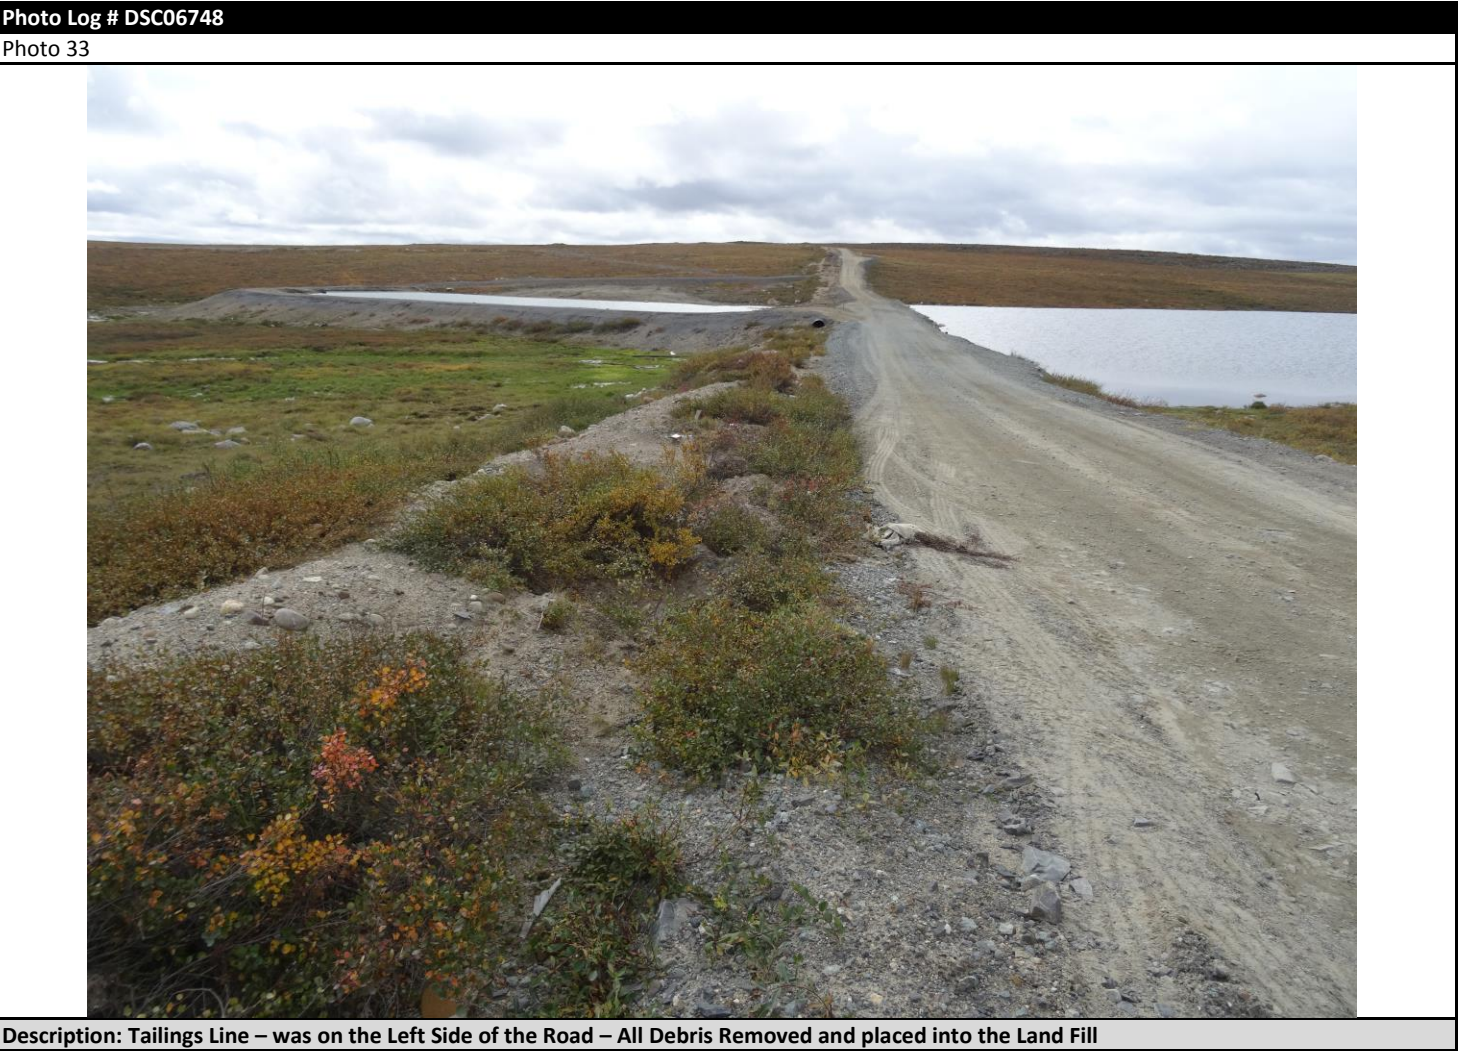
The Tailings Line has been 100% removed. It ran from the Mill Building out to Cell 5 along the side of the road  
All Debris has been removed and placed in the Land Fill

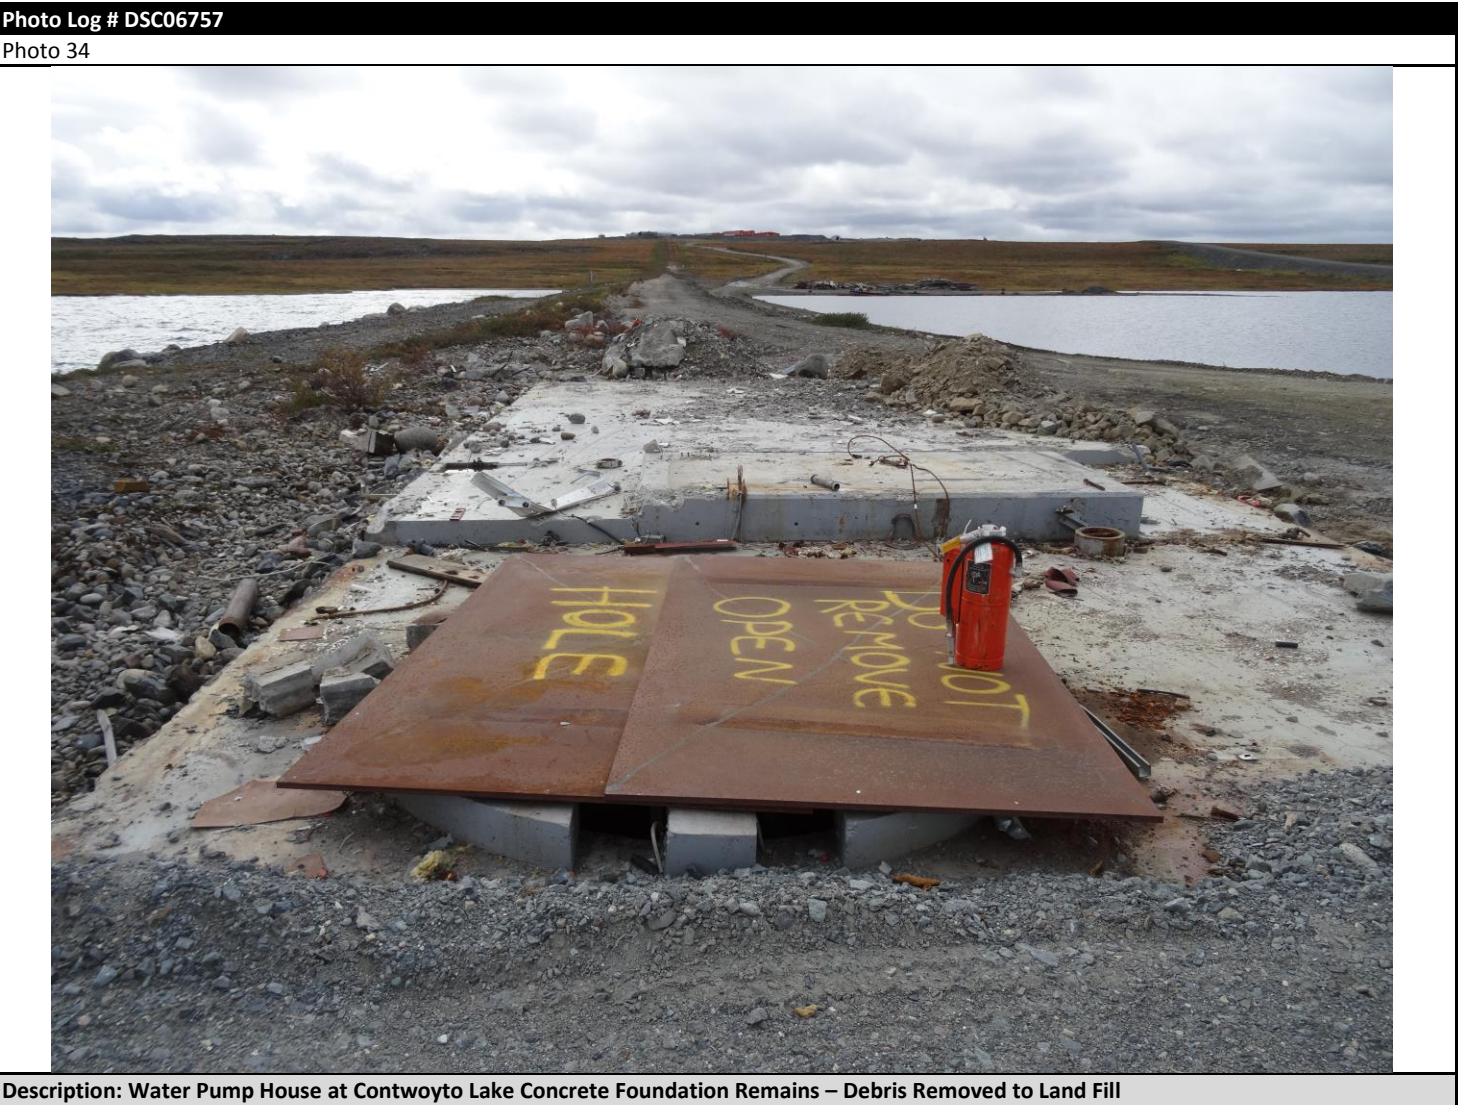
The Building has been Demolished and all Debris has been removed and placed in the Land Fill  
The Concrete Foundation remains with 2 large sheets of Metal covering a Hole with “Do Not Remove – Open Hole” Spray Painted on the Metal Sheets
