ECHO BAY MINES LTD.

2000 GEOTECHNICAL INSPECTION OF PERIMETER TAILINGS DAMS

LUPIN MINE NUNAVUT

PROJECT NO.: 0256-001-01
DATE: OCTOBER 3, 2000

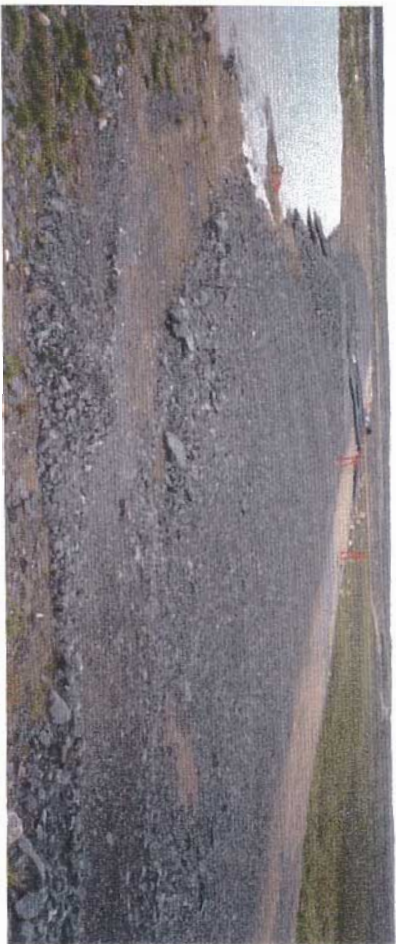
View of the upstream side and crest of Dam #1A.

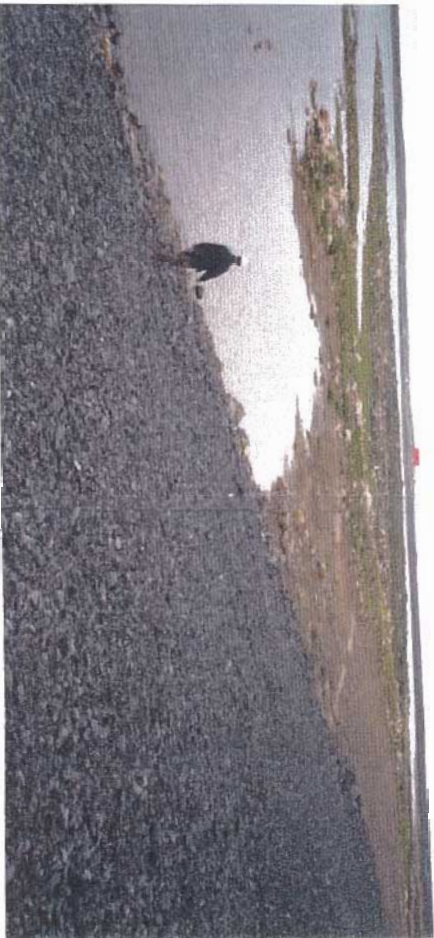
A view of the water level on the upstream side of the south abutment of Dam #1A.

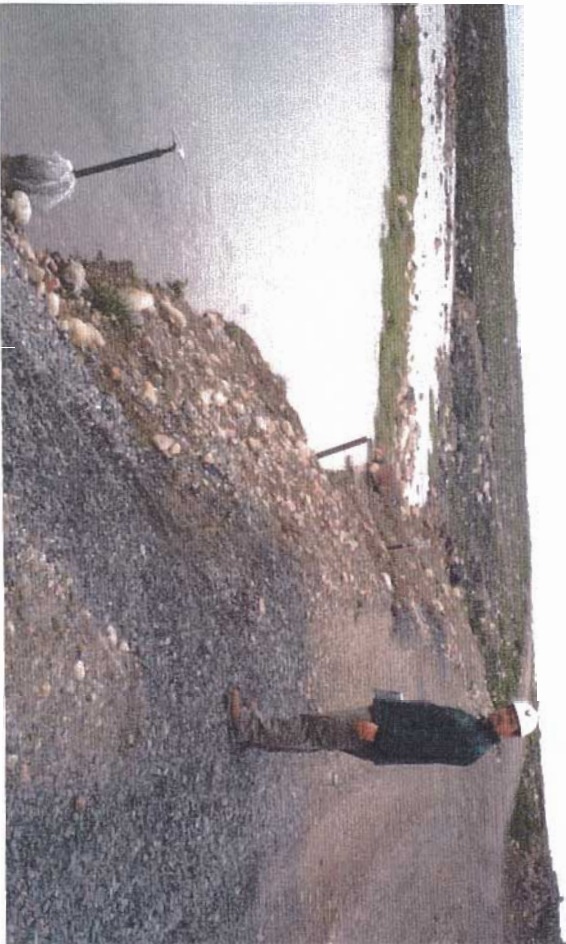
View of the downstream side of the access road berm at the toe of the dam. Dark grey angular blast material has been previously placed in a number of the small erosional scarps. A number of these scarps are continuing to erode back into the access road, probably because the blast material was installed too steep.

- Some longitudinal cracking and slumping is still occurring adjacent to the erosional gullies previously formed adjacent to the siphon pipes at the downstream access road berm. Cracks need to be graded over and the downstream side slope should be flattened to prevent further slumping from occurring.

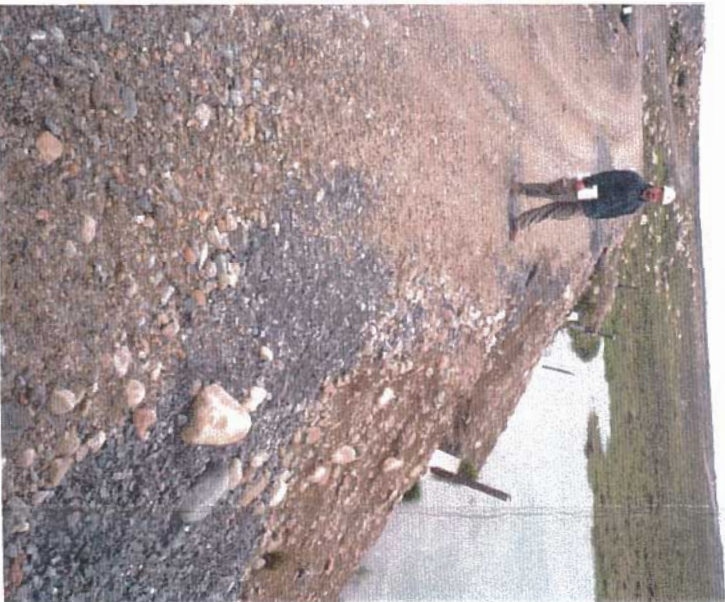
View of some previously noted cracking at the toe of the access road berm.

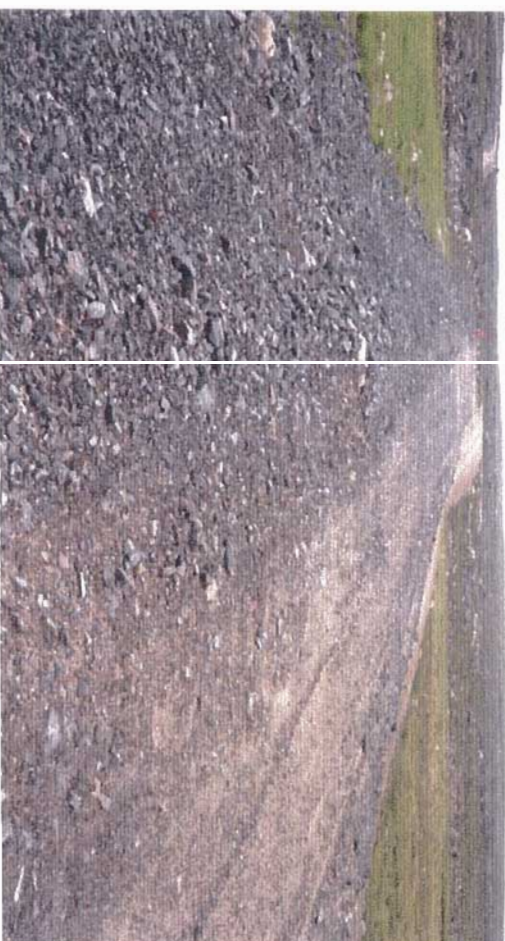
View of the crest and the upstream side. The crest is somewhat disturbed by rutting from vehicle traffic. In addition, the riprap on the upstream side is relatively undulating. This dam does not currently impound any water.

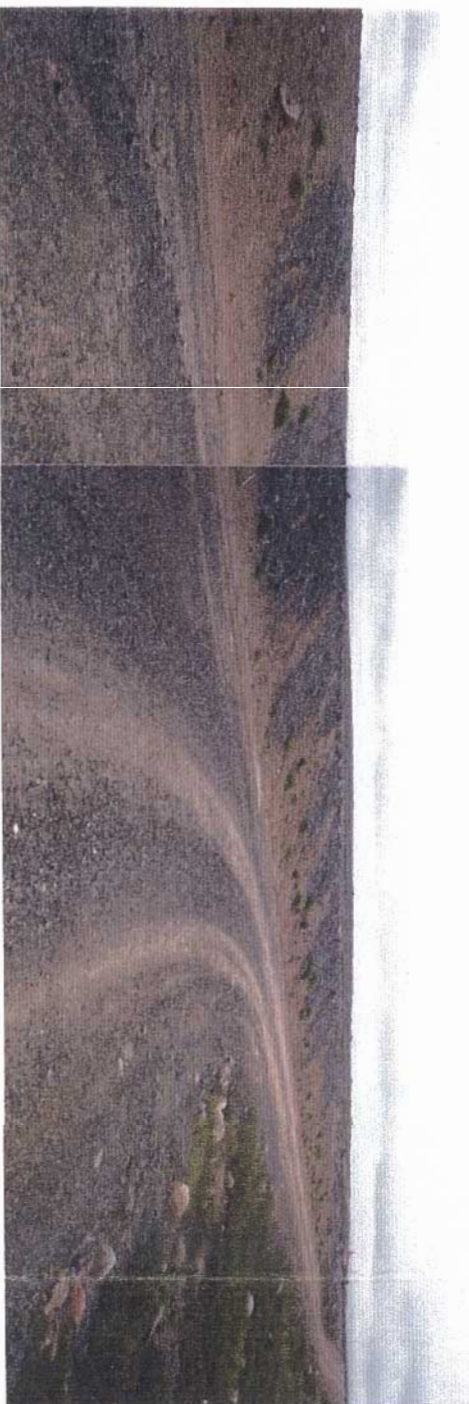
Two shot panoramic of the downstream side of Dam #1B.

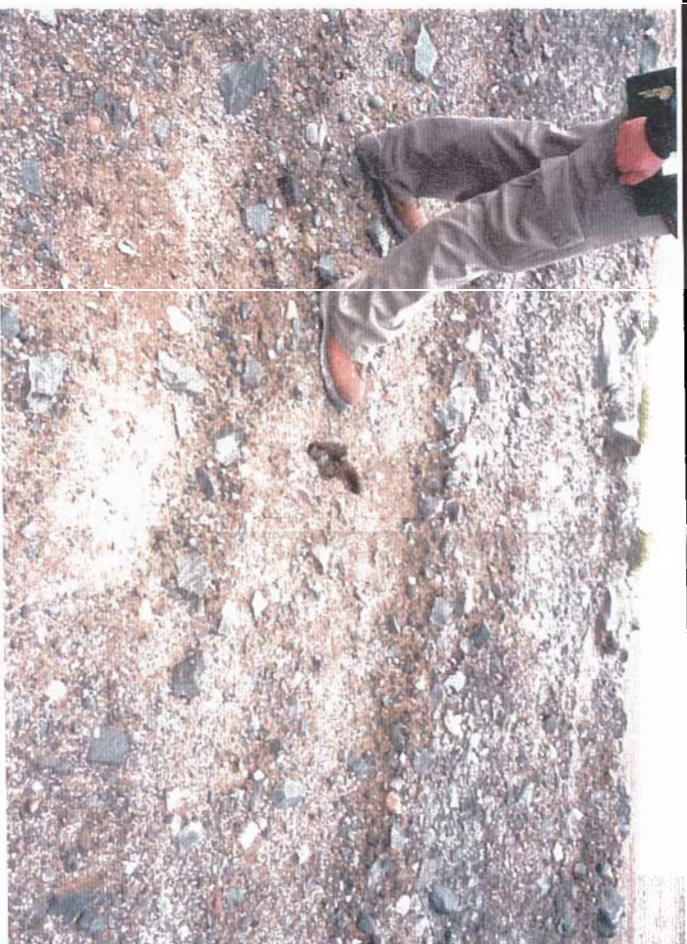
View of a small sink hole located in the downstream third of the crest of the dam. This small sink hole is approximately 8 to 10 inches long.

LOCATION:	West side of Pond 2.
FUNCTION:	Minor perimeter closure for water retention; pond level is below dam base elevation thus currently functioning only as a road embankment.
LENGTH:	+/- 200 m
MAX HEIGHT:	+/- 2.5 m above d/s tundra.
AS-BUILT ELEVATION:	485.4 m (485.83 m by GPS kinematic survey)
CREST WIDTH AND CONDITION:	5 to 6 m wide; surfaced with esker material so that this dam may also function as a roadway for access around the perimeter of the area. Small sinkhole observed on the crest. Crest condition is good, no cracking evident but vehicle traffic rutting is apparent.
RIPRAP:	Run of Mine rockfill; variable sizes; undulating; disturbed in areas but in good condition overall.
BACKSLOPE:	Approx. 1.5H:1V with some runoff erosion rills and a toe-of-slope roadway berm. No cracking observed.
SEEPAGE:	No comment possible; no water head being retained by the structure.
MAINTENANCE RECOMMENDATIONS:	<i>Grade crest to remove slight settlement trough and small sink hole.</i>

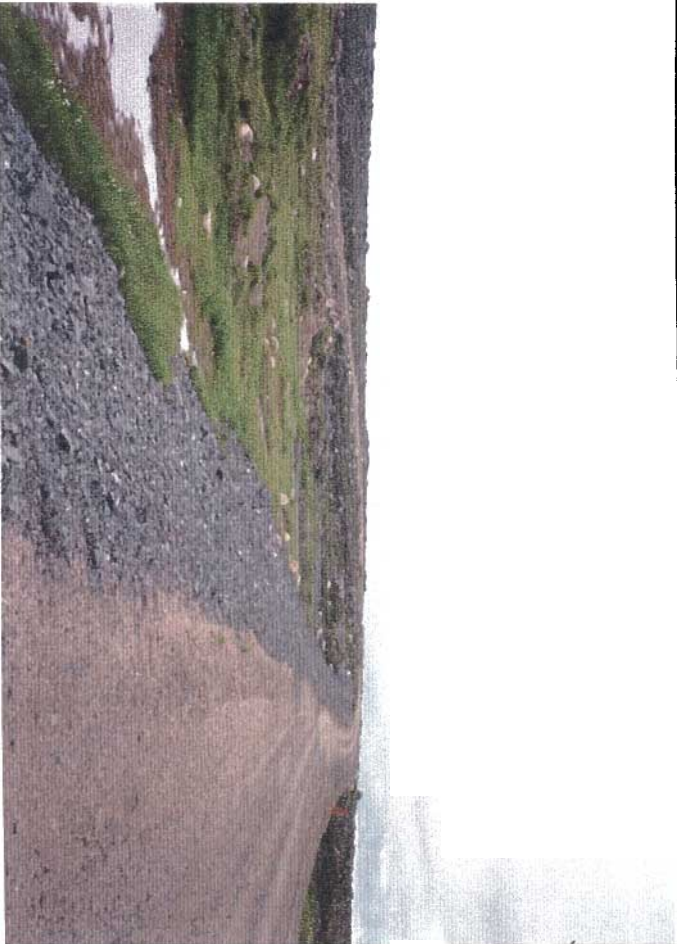
View of two small ponds located on the upstream side of the southern portion of Dam #1C. The small pond located in the midpoint of the dam (on the left hand side of the photo), is a bit smaller than it was last year. The pond in the background of the photo appears to approximately the same size.

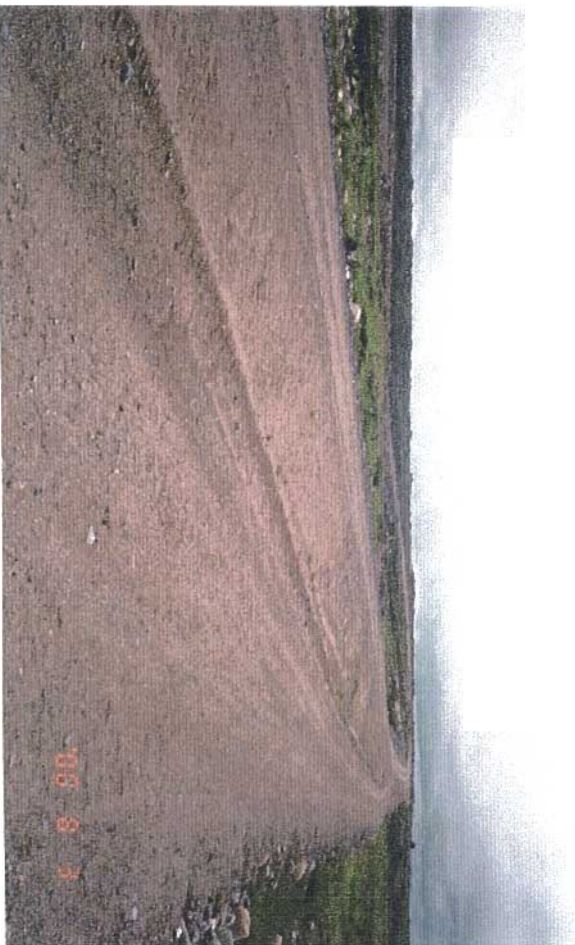
View of the downstream side of Dam #1C.

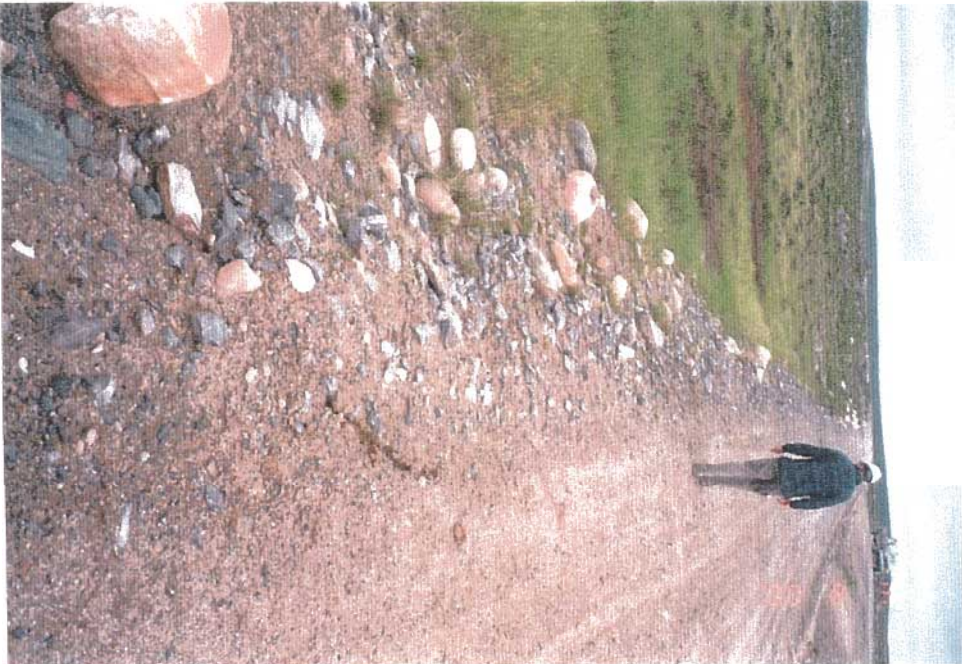
View of a minor settlement trough and cracking at the downstream side of the access road toe berm.

- Grade over the minor cracking and small settlement holes on the downstream access road berm and backslope.

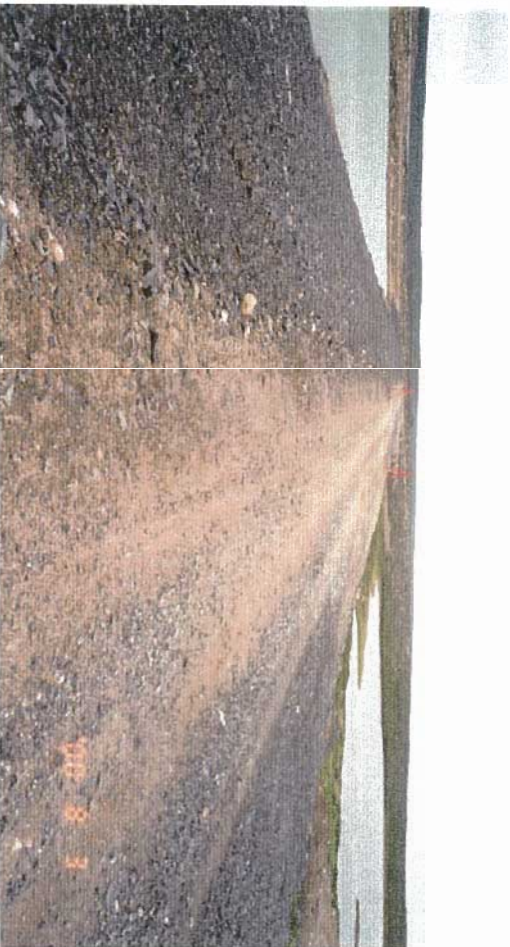
View of the crest of Dam #2, which appears to be in generally good condition and is graded smooth.

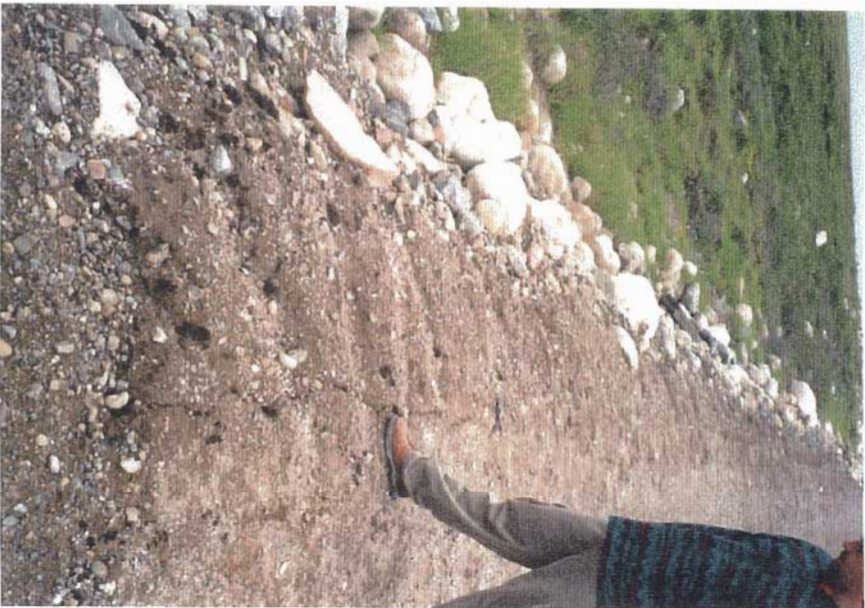
View of a thin longitudinal crack located right at the downstream edge of the berm on the downstream toe of Dam #2. This crack has a trace distance of approximately 15 to 18 meters along the toe. Some small associated settlement troughs are located adjacent to this crack.

- Grading required on toe berm access road to cover over minor cracking situated on the downstream side.

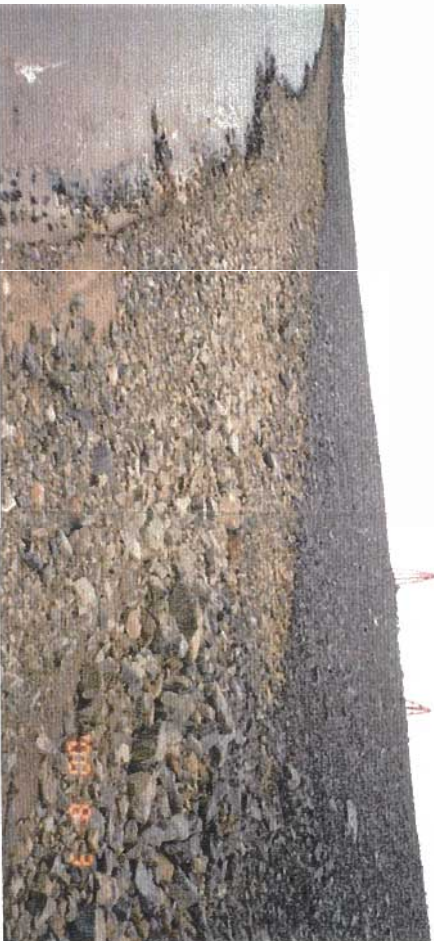
View of the riprap on the upstream side. There is a marked change in colour in the riprap from the dark grey material on the upper portion to the light tan colour on the lower third of the slope. There is a slight scarp formed where the water has been lapping, approximately at the contact of the dark grey to the light tan riprap.

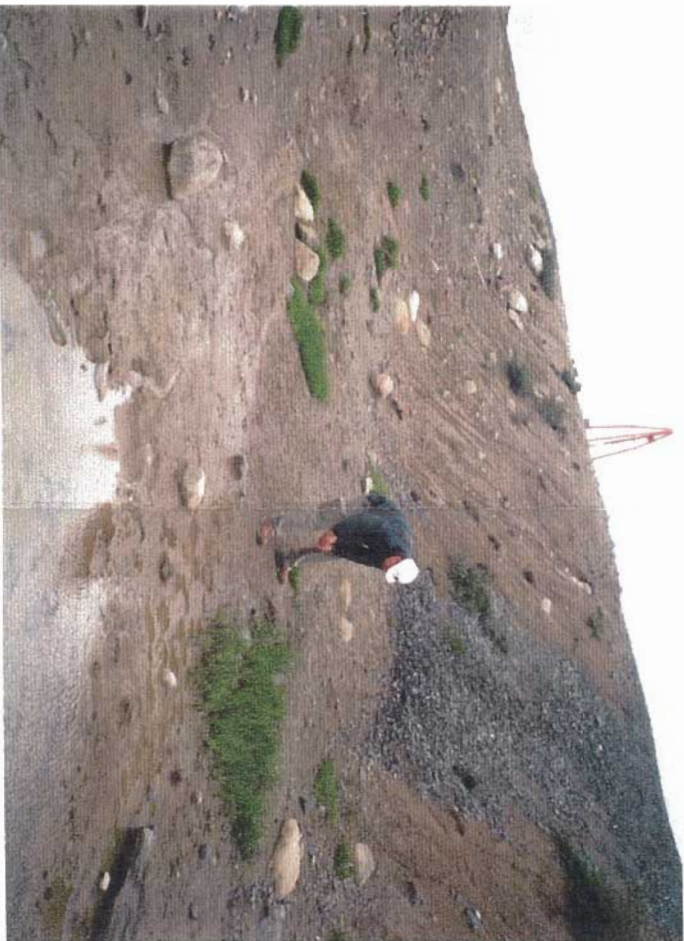
View of a small seepage discharge point occurring near the north abutment of Dam #2. The water is discharging just immediately to the left of the green vegetation patch. The flow is estimated at 1 to 2 litres per minute.

- Very small amount (<1 l/min) of seepage observed again at the toe of the north abutment. Surveying of the seepage point elevation last year indicated it was higher than the upstream pond level. Continue to monitor seepage for any increases in quantity and to observe if seepage water contains any sediment.

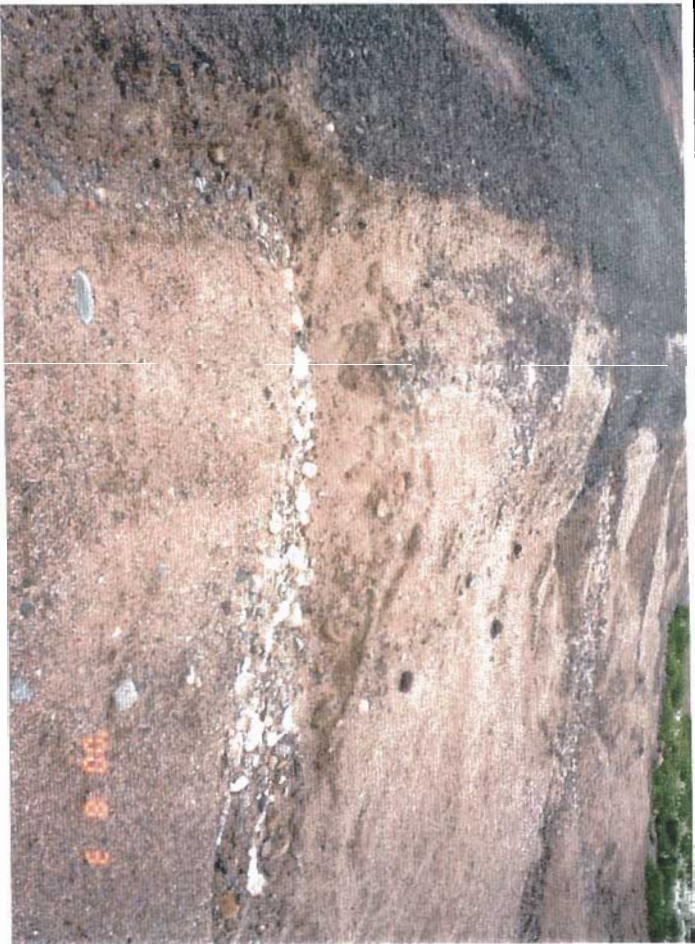
View of one small erosional gully located at the toe of Dam #3. This erosional gully is approximately 3 meters long by 1 meter wide and is armoured with some cobbles and boulders. In the background, the remnants of two previous erosional gullies can be seen.

- Three erosional gullies have been formed near the toe, south of the bend in the dam. These should be backfilled and graded to prevent surface runoff concentration.
- Small swale situated near the southern portion of Dam 3 should be armored properly, if required for discharge of surface runoff water.
- Flatten toe slope or apply some riprap to the downstream slope along the northwestern portion of the dam (where Dam 3 contacts Boomerang Lake), where tension cracks are currently located.

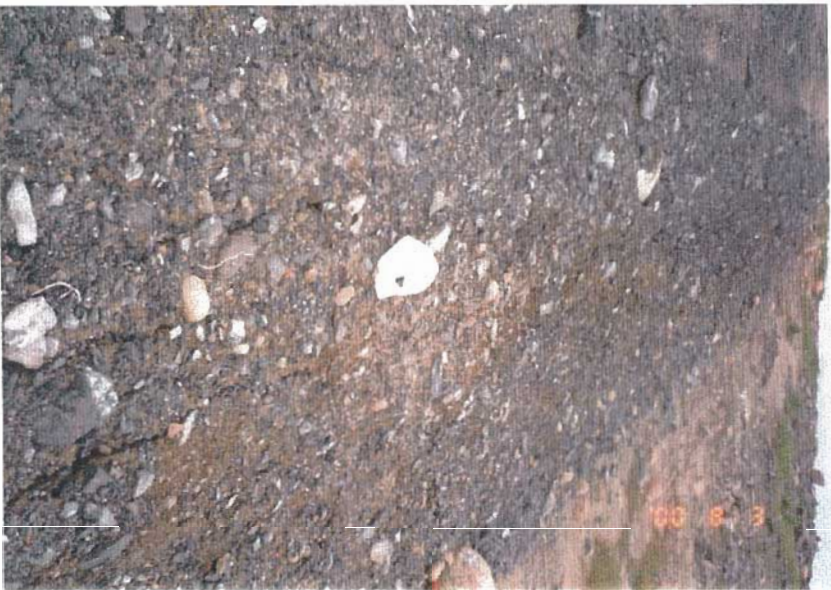
View of 2 to 3 parallel tension cracks found at the toe of Dam #3. This is on the steep northwest portion of the dam. Cracks at this location had been noted in previous inspections.

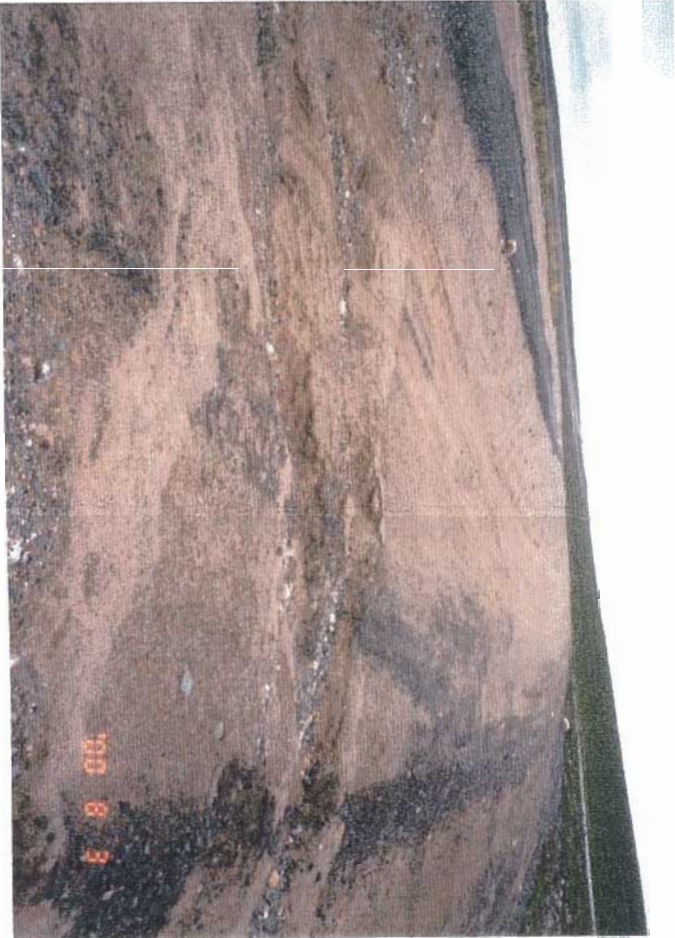
View of another erosional gully which is formed right across the crest of Dam #3. This one is located approximately 20 meters south of the bend in the dam. Again, this small erosional gully should be graded over and/or back filled to prevent any further concentration of run off water and further erosion.

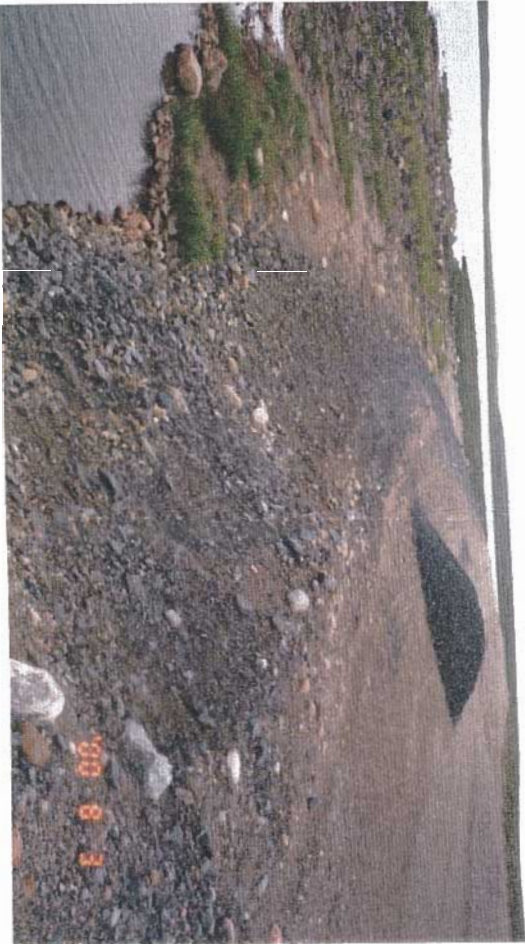
View looking southeast, at the toe of Dam #3. There is a pile of a crushed angular material stock piled here, probably going to be used for back filling of either a crest road or perhaps a downstream toe area.

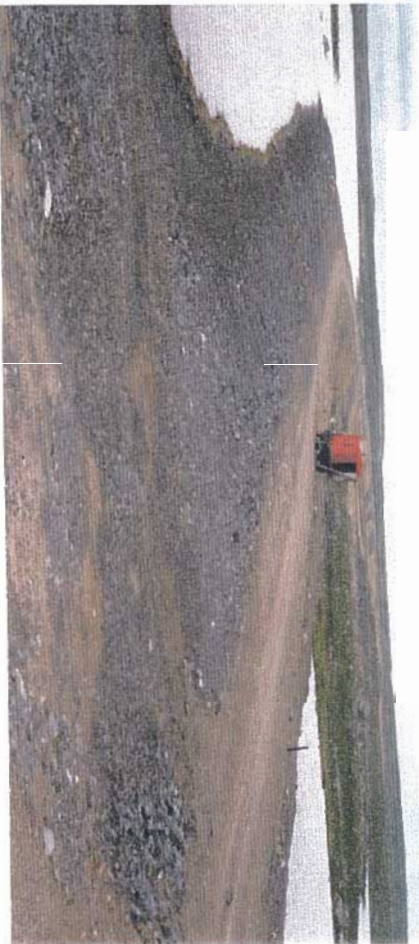
Overall view of Dam #4 looking towards the east/southeast. The generator truck is located on the crest of the Dam and is currently pumping water back over top of the dam.

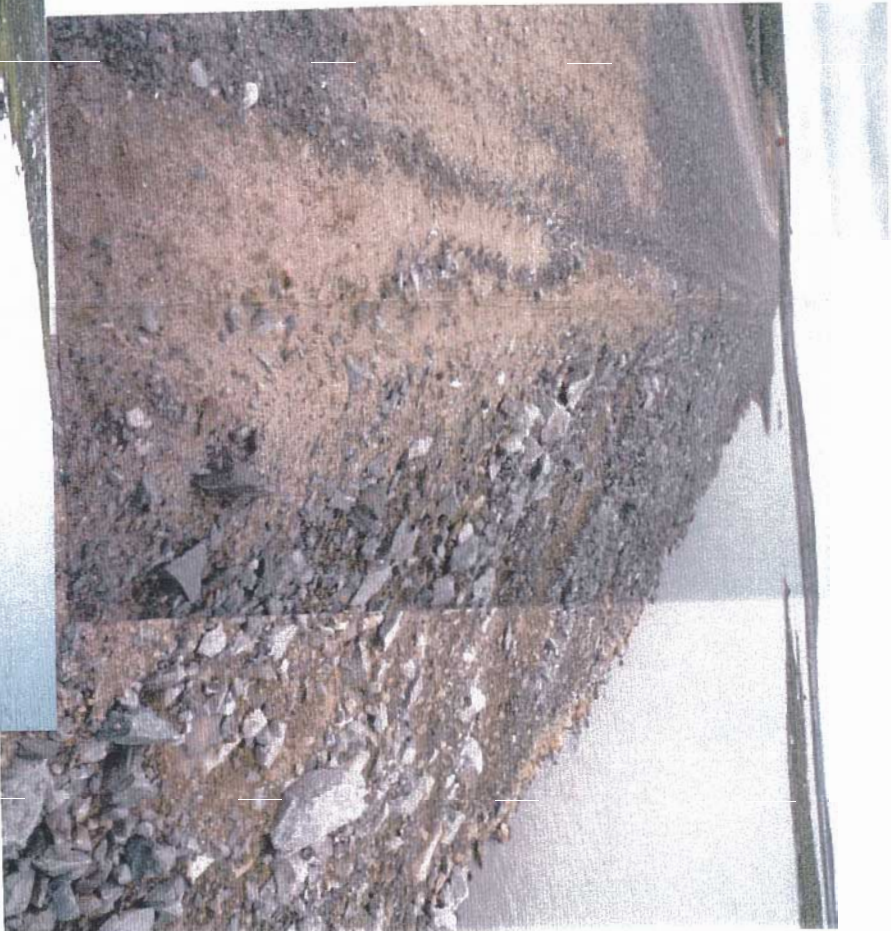
Two shot panoramic of some of the disturbances on the upstream side riprap of Dam #4. This disturbance has been noted in previous inspections.

RECOMMENDATIONS: Grade crest to remove traffic ruts. Repair disturbed rip rap on the upstream side and investigate if underlying liner has been disturbed as well.

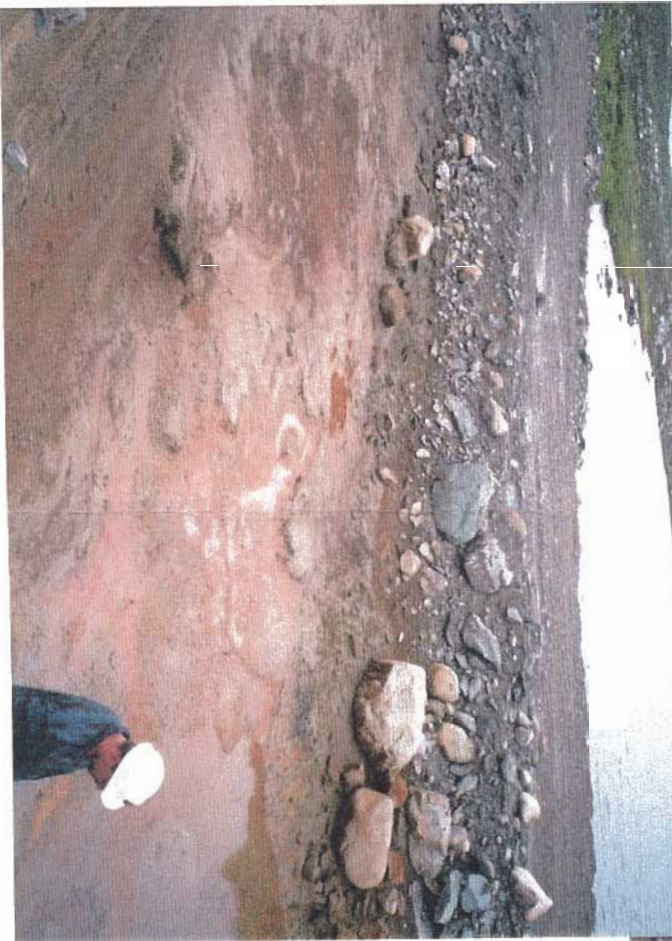
View along the toe of Dam #4 towards its west abutment.

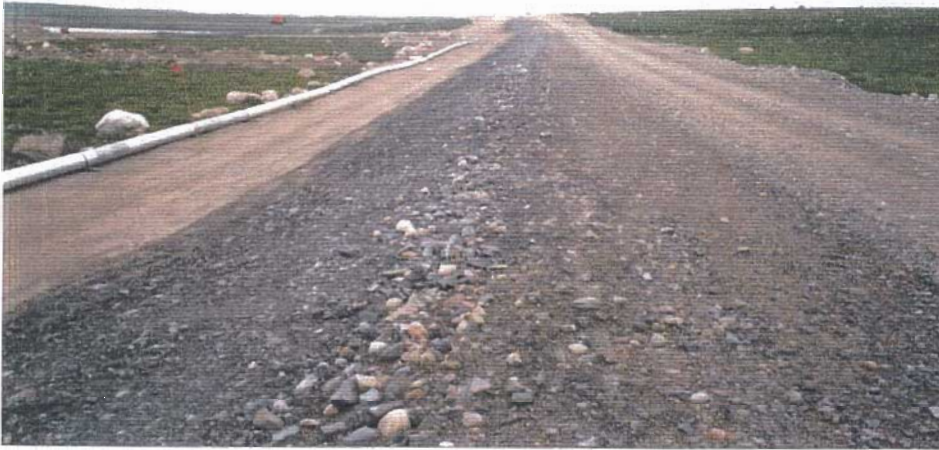
View of the upstream side riprap and a portion of the crest of the dam, looking towards the southeast.

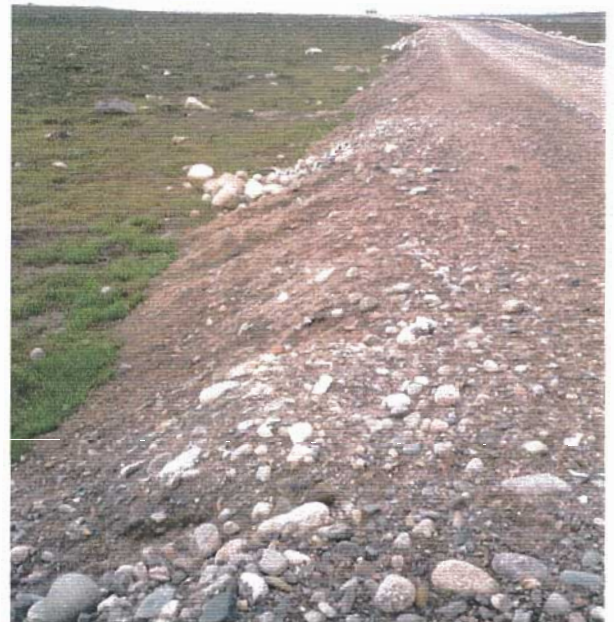
View of the downstream toe of Dam #5.

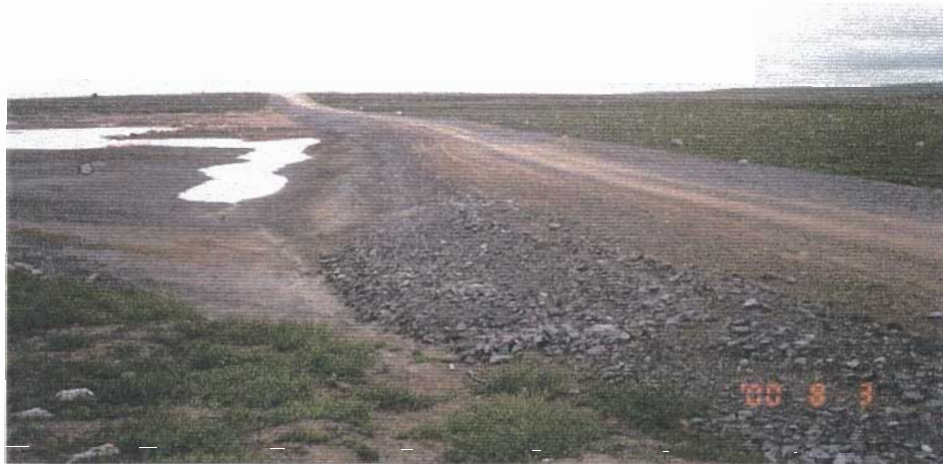
View of the upstream side and crest of Dam #6.

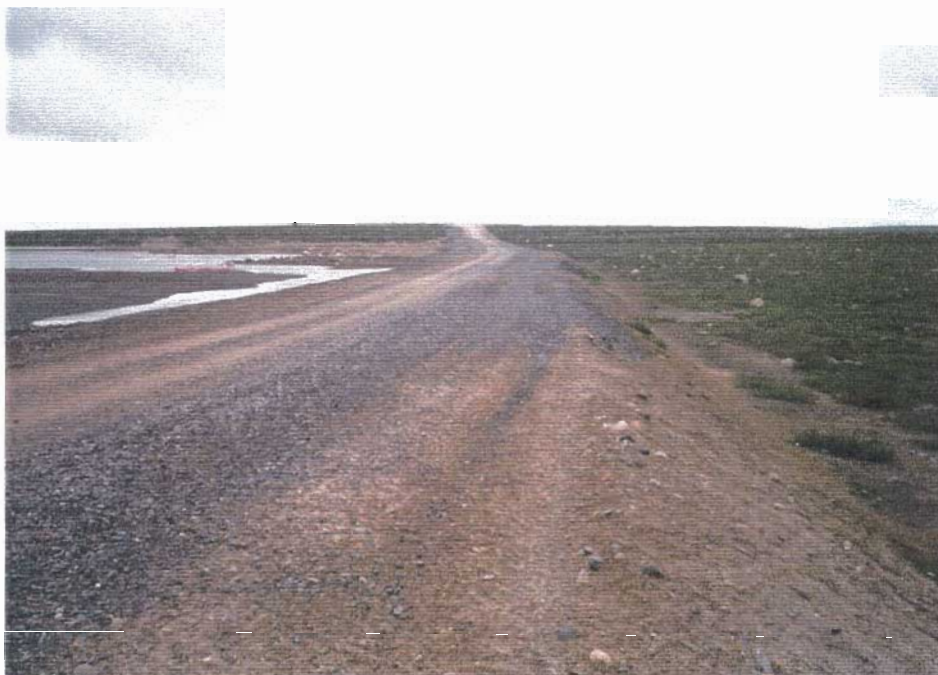
View of the downstream toe of Dam #6.
