**RE: Echo Bay Mines Ltd., Lupin Gold Mine, Contwoyto Lake, NT.; Water Licence
NWB1LUP0008; 2001 Annual Geotechnical Inspection**

2001 GEOTECHNICAL INSPECTION OF PERIMETER TAILINGS DAMS

LUPIN MINE NUNAVUT

PROJECT NO.: 0256-003-02
DATE: SEPTEMBER 26, 2001

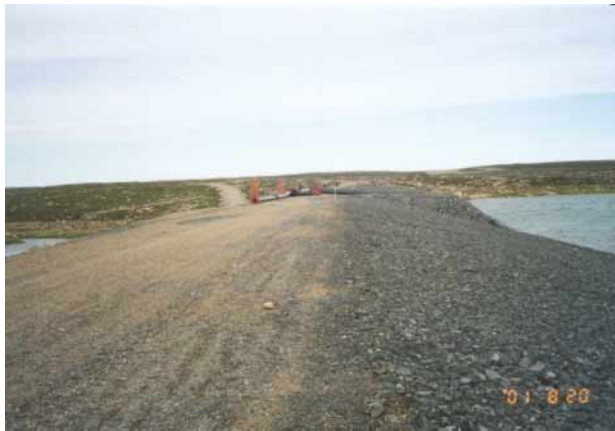
View of the crest on the upstream of Dam #1A looking north. There are no signs of cracking, deformation, or erosion except for one minor sinkhole.

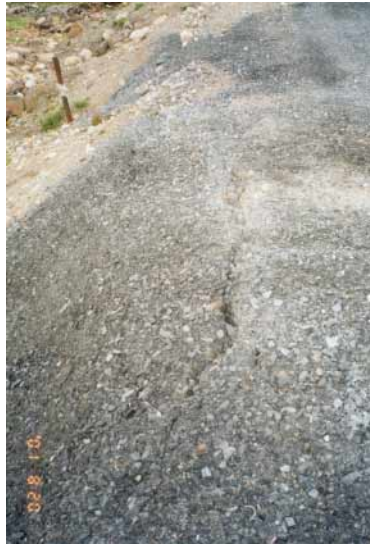
View of some cracking near the toe..

≠ Some longitudinal cracking and slumping is still occurring adjacent to the erosional gullies previously formed adjacent to the siphon pipes at the downstream access road berm. Cracks need to be graded over and the downstream side slope should be flattened to prevent further slumping from occurring.

RECOMMENDATIONS: Cracks on the downstream toe need to be graded over. Downstream toe side slope needs to be flattened to prevent recurrence of cracking.

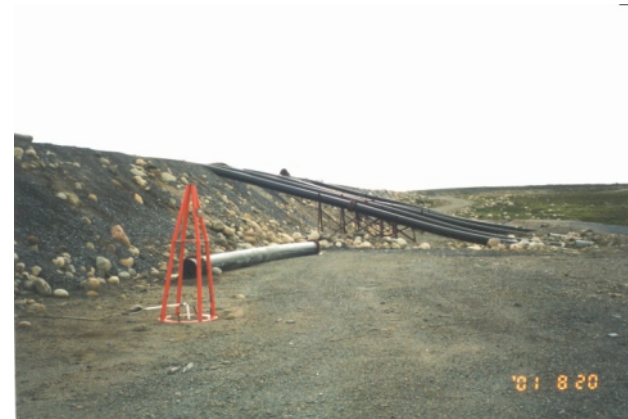
View looking back along the toe and the backslope of Dam 1A. No signs of seepage, settlement or erosional concerns other the minor cracking were noted.

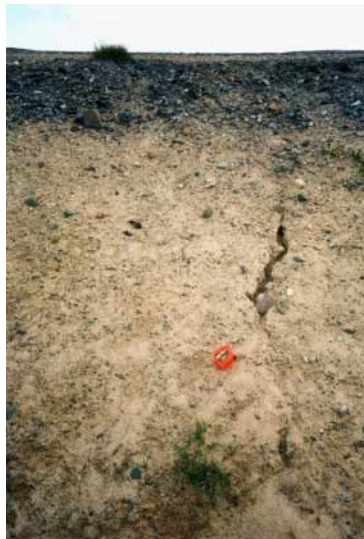
View of a thin erosional gully located on the downstream side of Dam 1B. This erosional gully is located about 30 meters south of the north abutment of this dam. The erosional gully is some 3 centimetres wide.

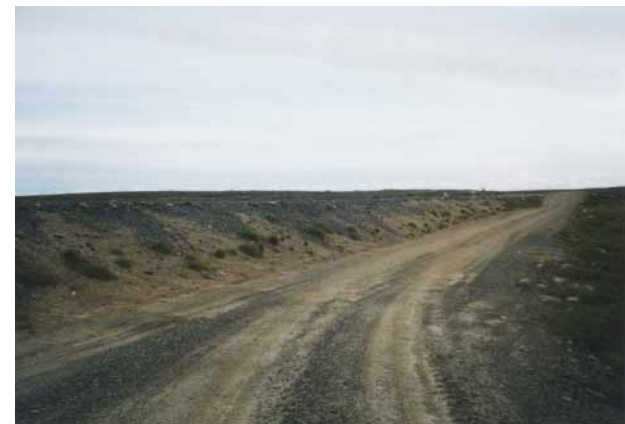
Another view of the downstream side of Dam 1B. There are no changes with the condition of Dam 1B and it appears to be in satisfactory condition.

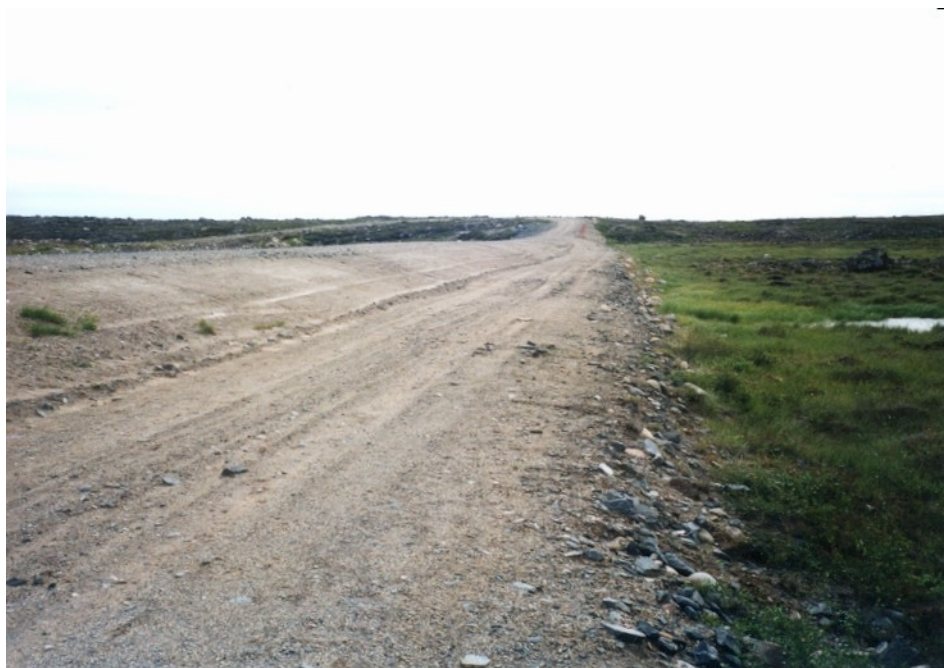
View taken along the access road berm and along the toe towards the south. No signs of seepage at the downstream toe were noted.

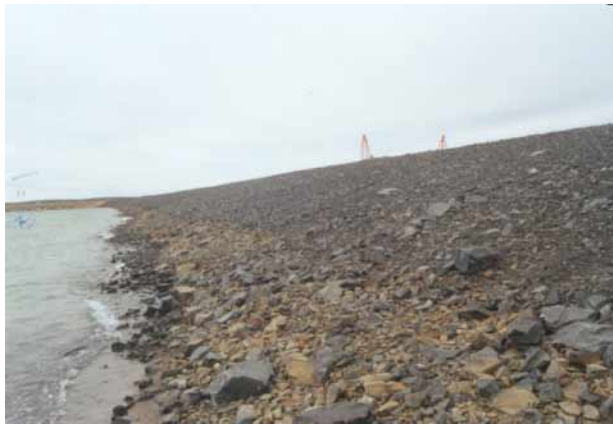
View of the upstream side of this dam. As previously noted, there is a small scarp formed at the contact of the light brown to the grey material.

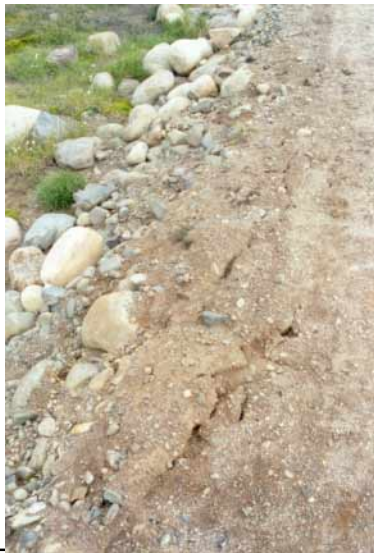
View of some minor crest edge cracking located along the downstream edge of the access berm.

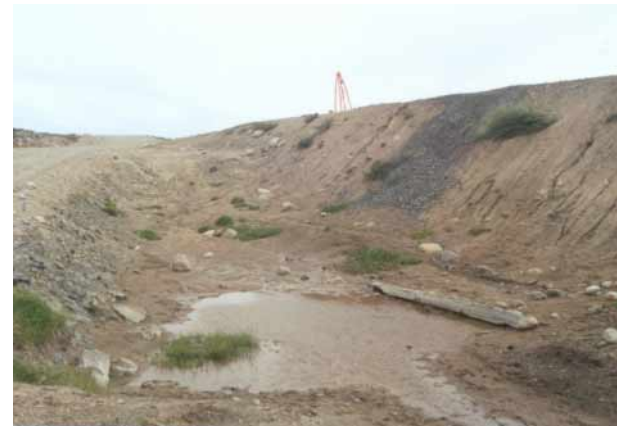
Shows the small pond and seepage discharge which is occurring over towards the north abutment of Dam #2. There has been a seep going on here for the last few years.

≠ Very small amount (<1 l/min) of seepage observed again at the toe of the north abutment. Surveying of the seepage point elevation two years indicated it was higher than the upstream pond level. Continue to monitor seepage for any increases in quantity and to observe if seepage water contains any sediment.

RECOMMENDATIONS: Continue to monitor north abutment toe for seepage quantity.

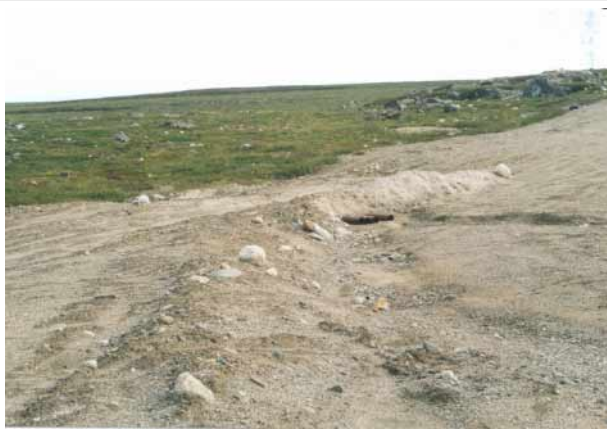
Shows four small diameter pipes that have been placed in a previously noted erosional gully. A properly constructed swale should be located here instead.

SEEPAGE:	None observed.
MAINTENANCE RECOMMENDATIONS:	Replace the four small diameter steel pipes that serve as a culvert on the southern end of the crest. Replace with a properly graded swale, appropriately armoured to drain surface runoff. Backfill and grade over the two erosional gullies situated along the toe and 20 m depression near the curve. Flatten the backslope along Boomerang Lake for the northwest part of the dam.
CONCLUSIONS:	The dam is in good condition.

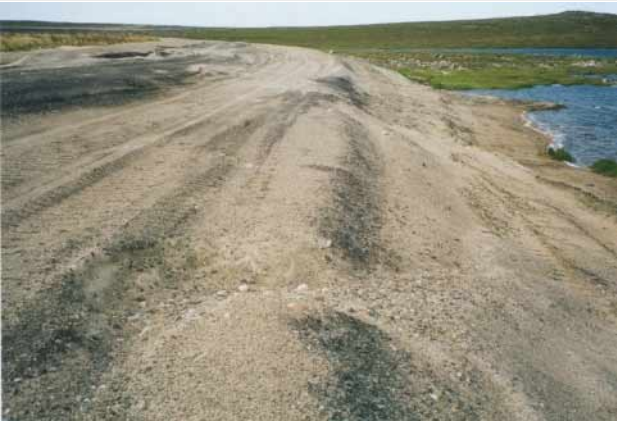
Shows an erosional gully approximately 1 metre wide by perhaps 0.4 metres deep in the foreground of this photo.

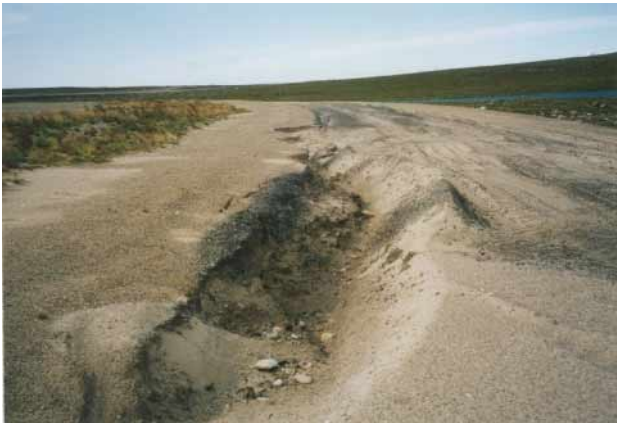
Shows a depression formed approximately 8 metres back from the crest edge for Dam 3. This depression is approximately 1 to 1.2 metres wide and extends over a distance of some probably 20 metres. This erosional gully should be back filled.

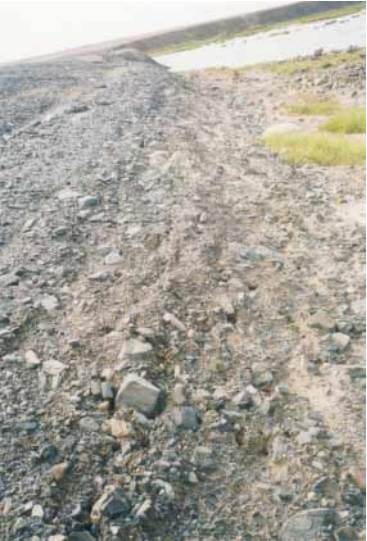
Shows some cracking located at the toe which runs in a discontinuous manner for perhaps 20 to 30 metres.

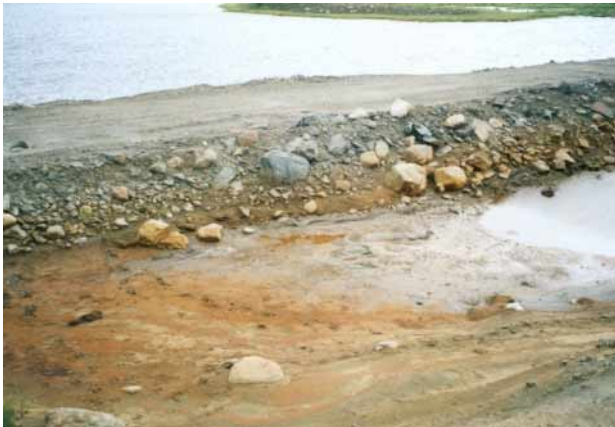
Shows a close up of the area where the seepage discharge is incoming from the downstream side.

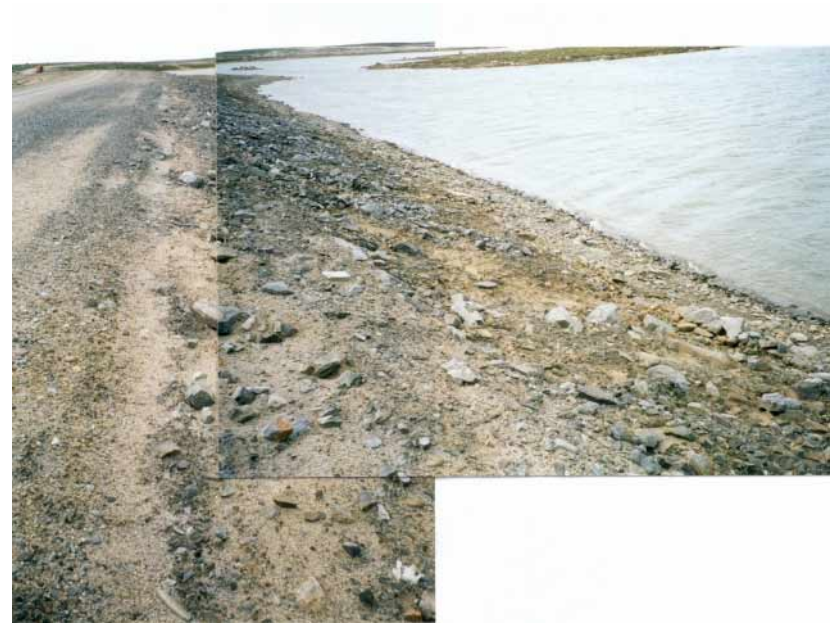
View of the disturbed area on the upstream side of the Dam 4. As can be seen, some of the light brown sandy material is sticking through where the dark grey riprap has been disturbed.

RECOMMENDATIONS: Repair disturbed rip rap on the upstream side and investigate if underlying liner has been disturbed as well.

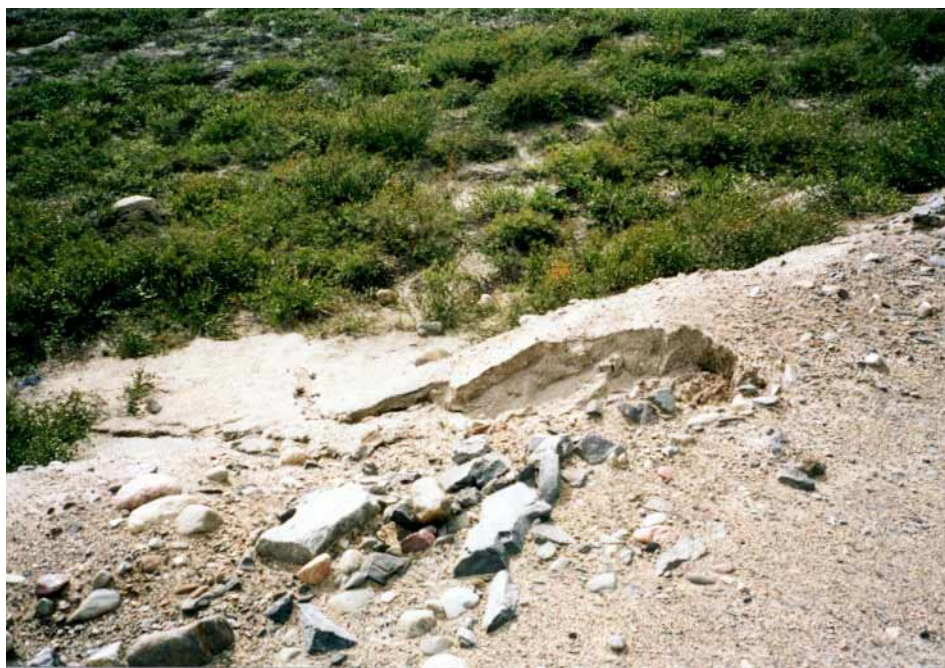
Shows a shallow erosional gully located some 20 metres east of the west abutment of this dam, located at the toe.

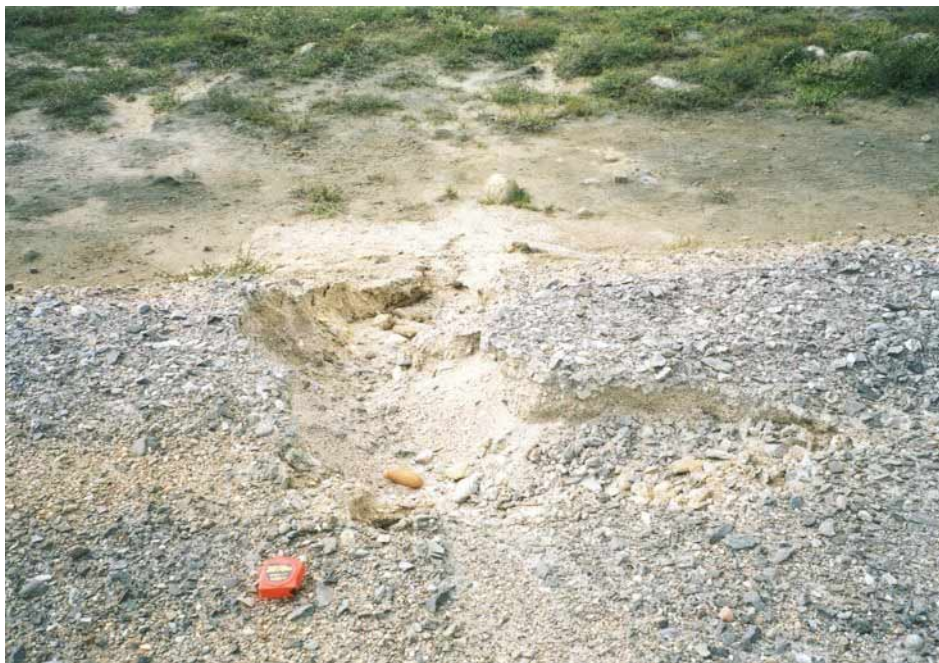
Shows an erosional gully situated at the toe of Dam 6. This gully is located approximately some 20 metres south of the north abutment. This gully is approximately 1 metre wide by approximately 0.5 metres deep.
