PROJECT	Annual Inspection of Perimeter Tailings Dams
TITLE	Dam 1A Inspection Photos
PROJECT No	0256-004-02
DWG No	Figure 5
REV	0

PROJECT	Annual Inspection of Perimeter Tailings Dams
TITLE	Dam 1B Inspection Photos
PROJECT NO	0256-004-02
FIGURE NO	Figure 6

PROJECT	Annual Inspection of Perimeter Tailings Dams
TITLE	Dam 2 Inspection Photos
PROJECT No	0256-004-02
DWG No	Figure 8
REV

To:	Echo Bay Mines Ltd.	Fax No.:	provided at site
Attention:	Mr. Dave Hohnstein	CC:	none
From:	Mr. Jim Cassie, P.Eng.	Date:	August 13, 2002
Subject:	2002 Annual Inspection of Tailings Dams – Maintenance Requirements		
No. of Pages (including this page):	3 Pages	Project No:	0256-004-01

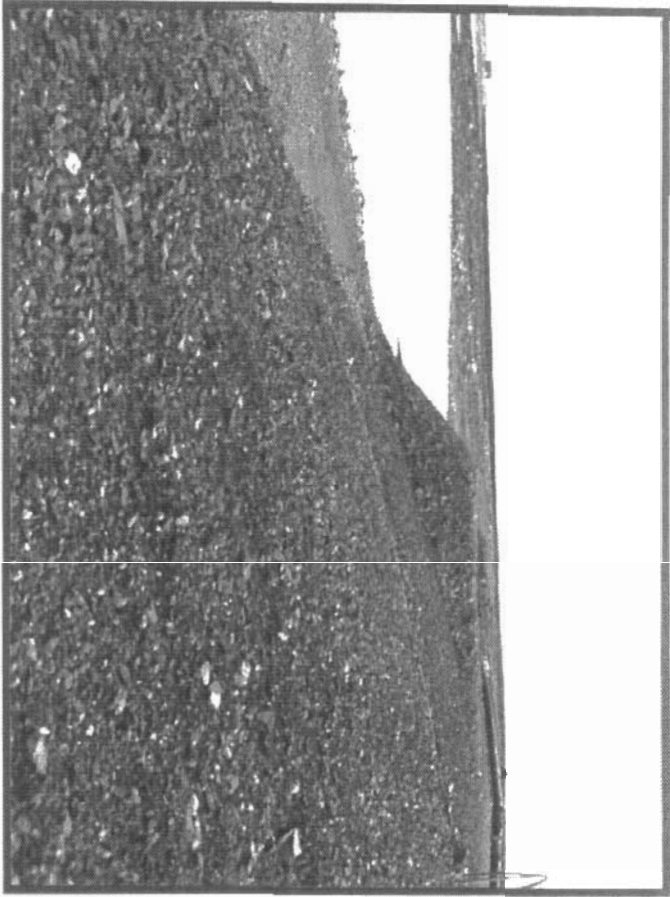
Photo 63 shows a view of the upstream side. These slopes appear to be a consistent grade.

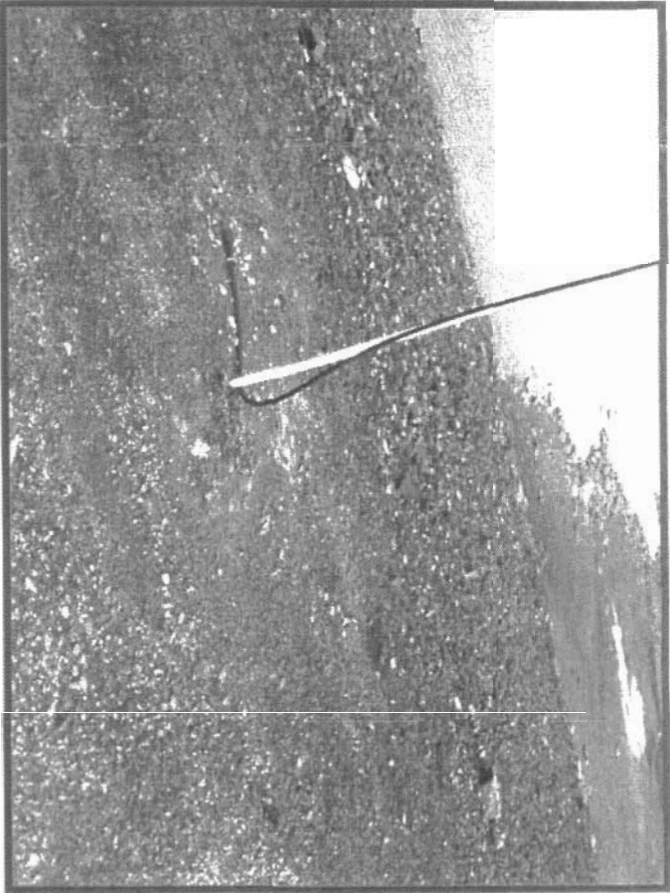
Photo 66 shows a small sinkhole just immediately to the right of the thermistor installed previously. This sinkhole had been noted previously.

- One small sinkhole situated on the crest that should be backfilled over.
- Some minor cracking and slumping is occurring adjacent to the erosional gullies previously formed adjacent to the siphon pipes at the downstream access road berm.
- No other maintenance suggested beyond these two issues.

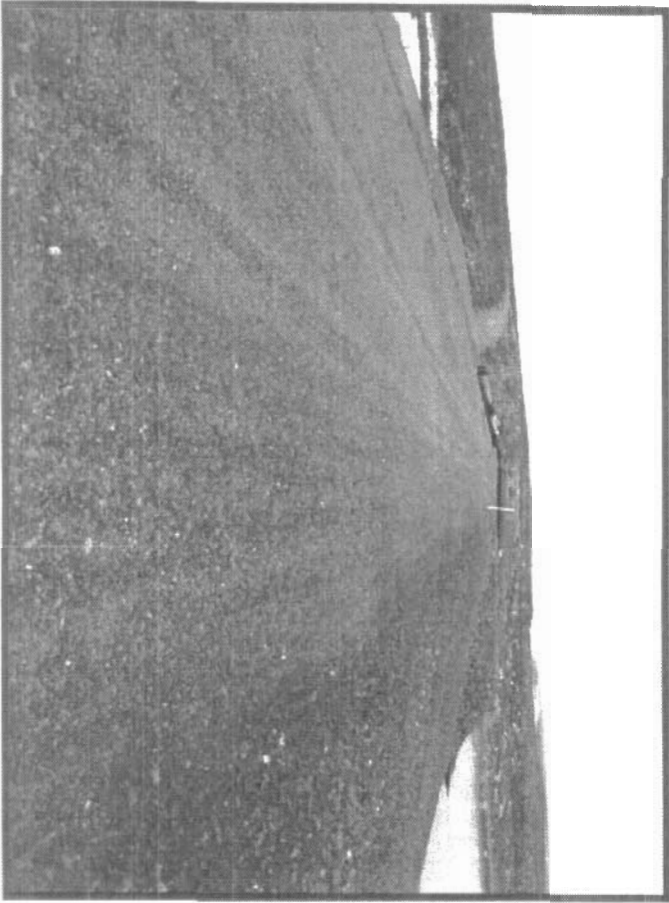
Photo 67 shows a view of the crest looking towards the north abutment. No signs of settlement, deformation or cracking noted on the crest.

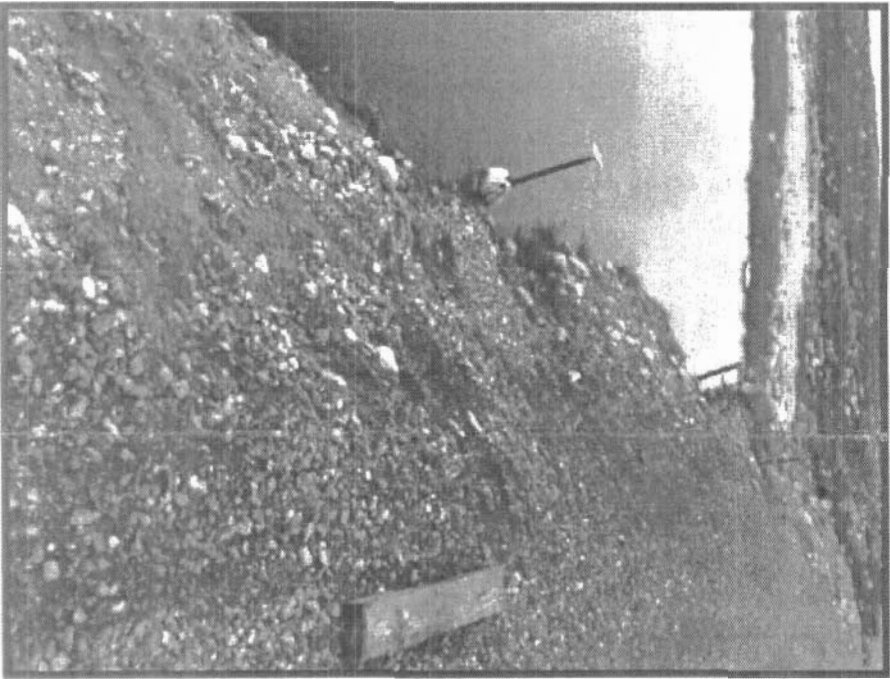
Photo 70 shows the little scarps formed by the retrogression of the material right at the toe of the access road berm.

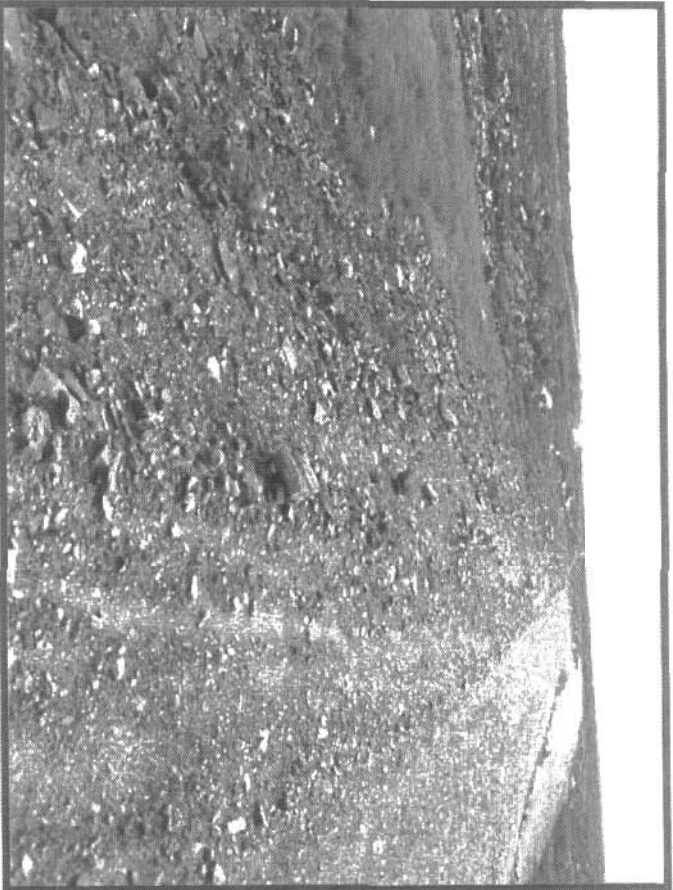
Photo 77 shows some rutting on the crest that progresses over to the upstream side as well.

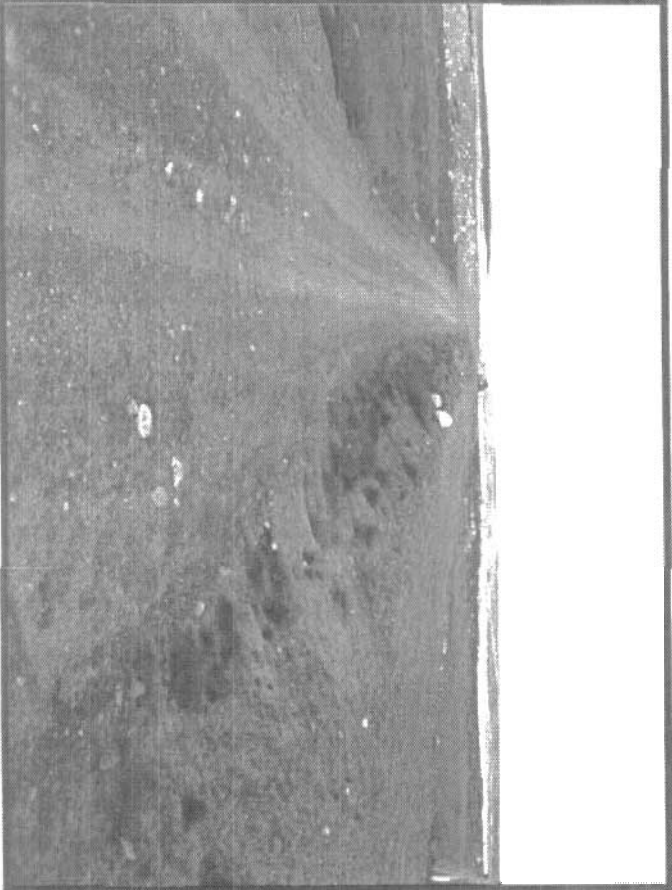
Photo 79 shows the downstream side and the crest of the dam looking towards north. Some minor vegetation is catching onto the slope.

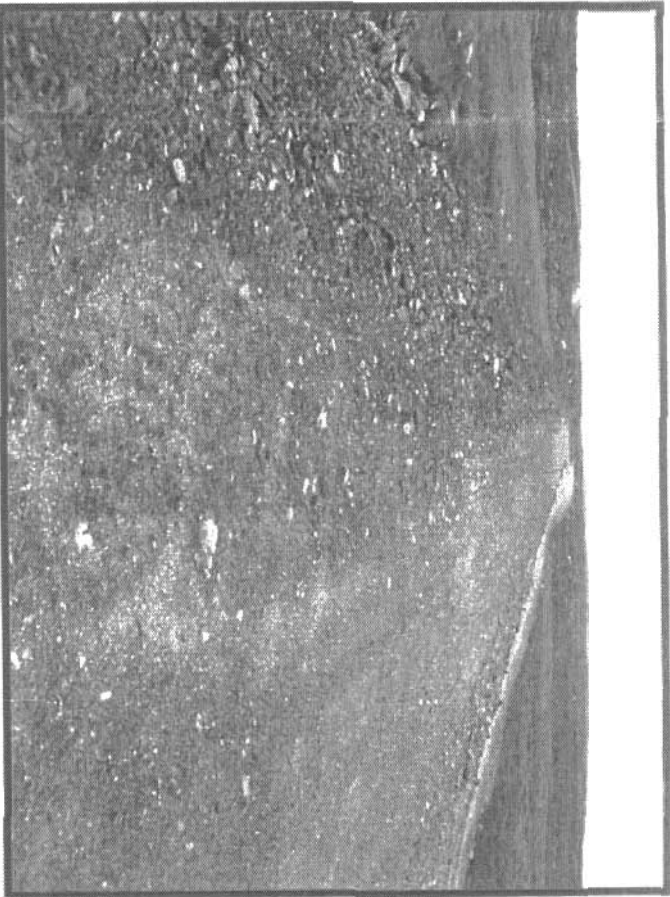
Photo 74 shows a view of the crest and the upstream side. This dam is not retaining any water at the current time.

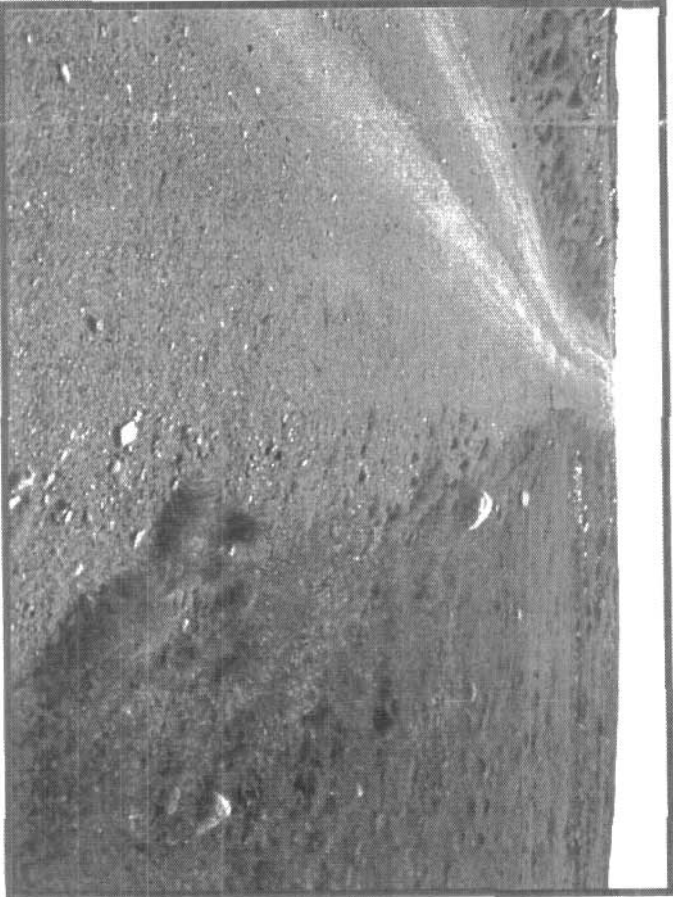
Photo 80 is a view along the downstream toe. No signs of seeping water were noted.

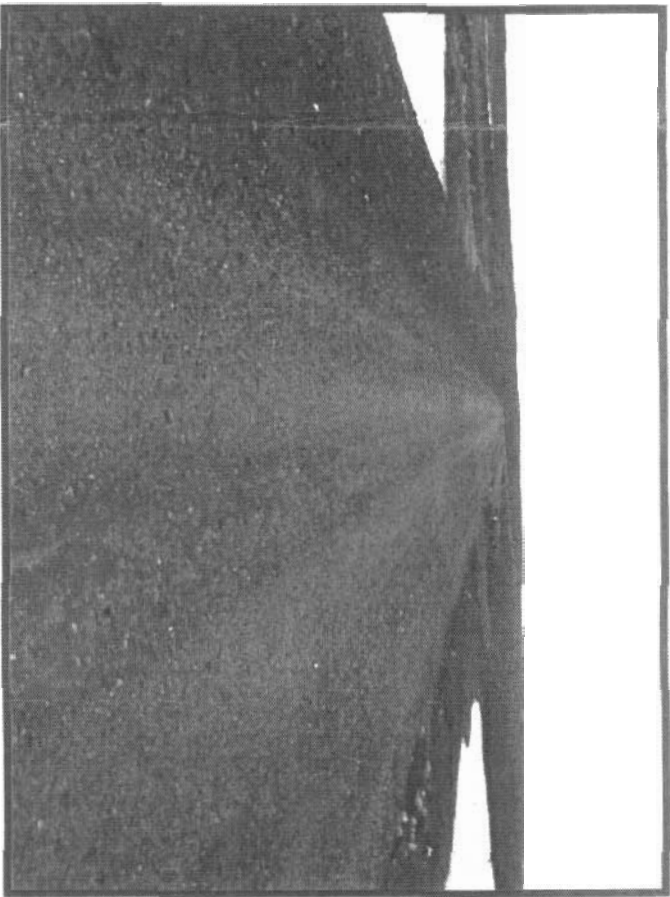
Photo 45 shows a view looking towards the south abutment. The crest appears to be smooth and flat with no signs of cracking or settlement.

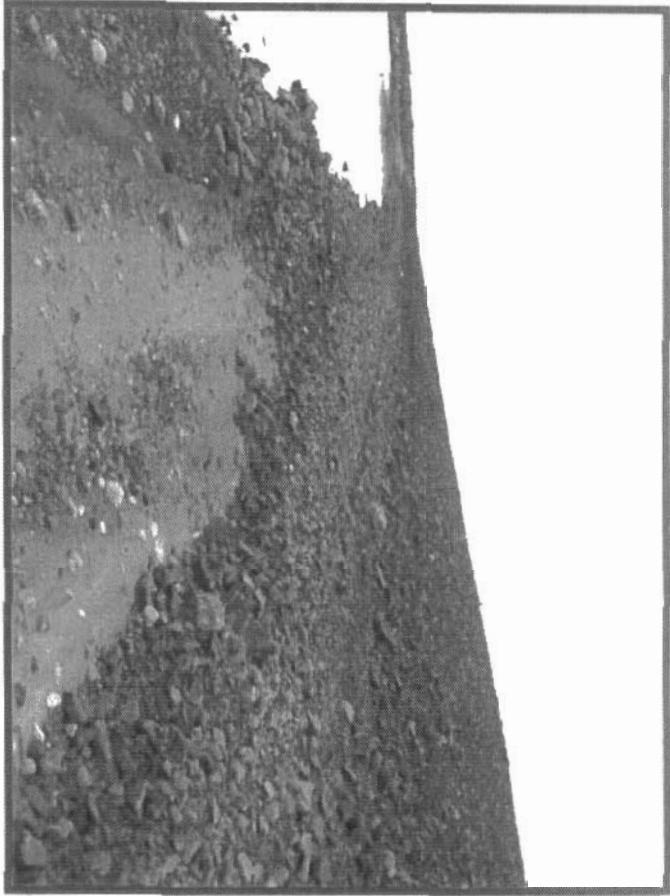
Photo 44 shows a view of the upstream side, taken from waterline perspective. As can be seen and has previously been noted, there are some small scarps at the transition from the light brown to the gray material.

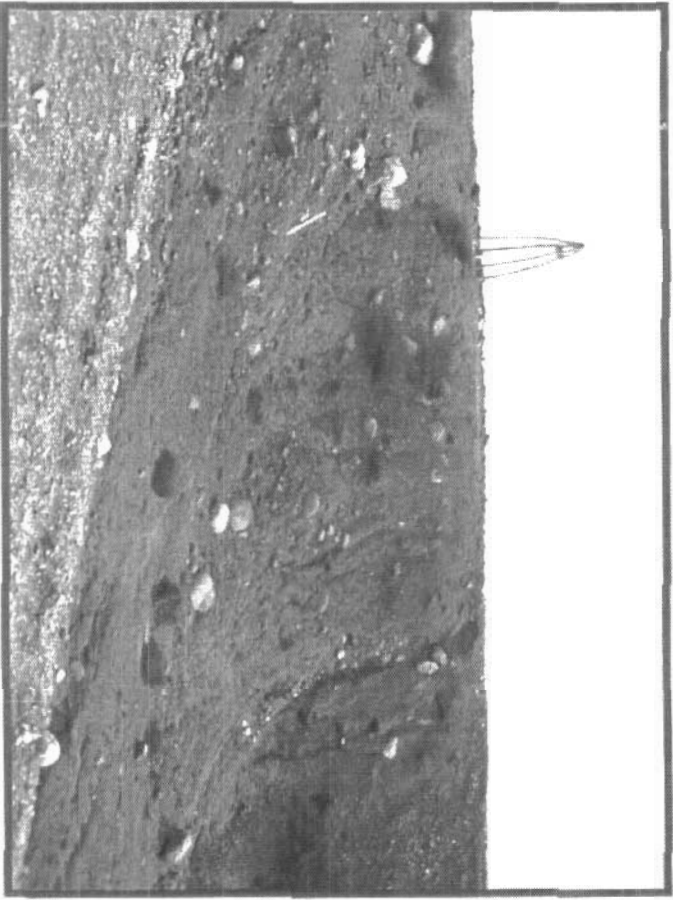
Photo 59 shows one significant erosional gully located on the downstream face at the north abutment.

- Minor erosional gulley on the downstream slope near the north abutment should be backfilled.
- Very small amount (<1 l/min) of seepage observed again at the toe of the north abutment. Continue to monitor seepage for any increases in quantity and to observe if seepage water contains any sediment.

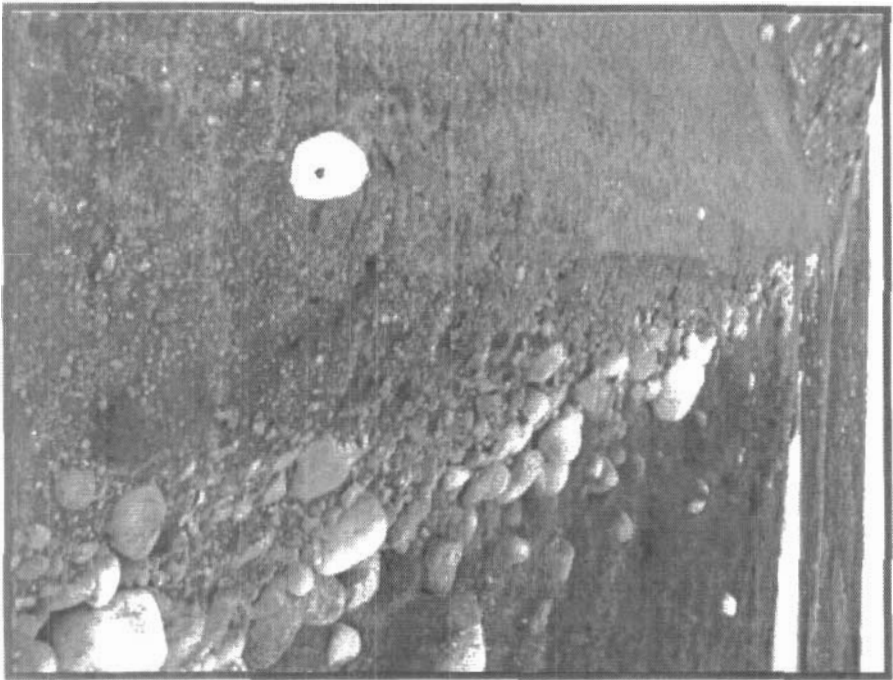
Photo 51 shows some minor cracking along the downstream toe. This cracking has been previously noted.

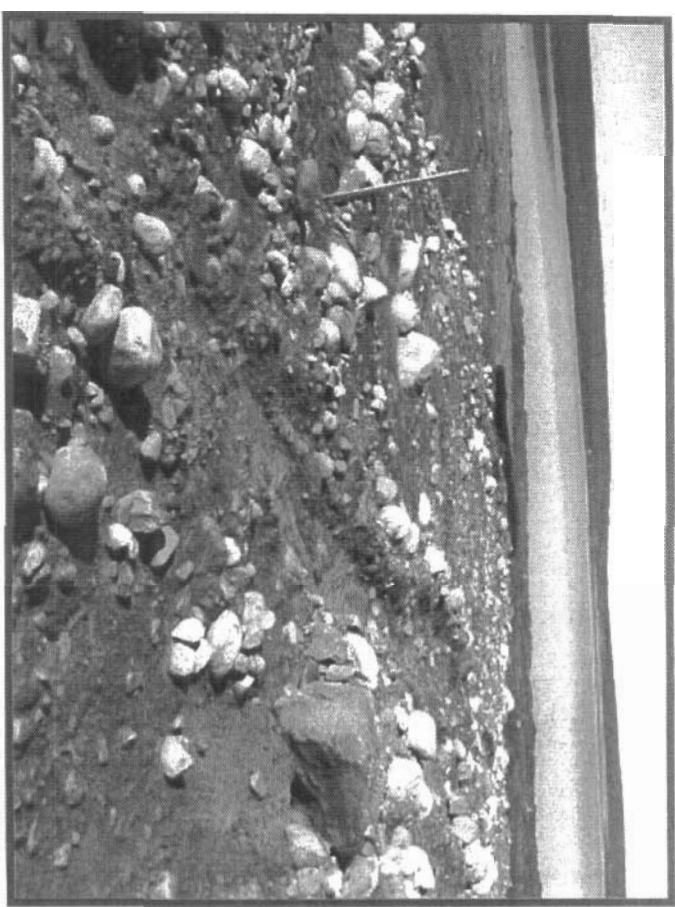
Photo 137 Shows some boulders and cobbles that appear to have been placed in a low swale area. At the current time, the swale work is very disturbed and would likely be ineffective in transmitting any water. The material should be excavated and a proper swale should be laid out.

- An informal "swale", consisting of sand, gravel and cobbles, appears to have been constructed near the southeast corner to convey surface cell water to Boomerang Lake. The swale is poorly constructed and appears ineffective in conveying water to the toe of the dam. The swale should be reconstructed to properly convey water across the dam.

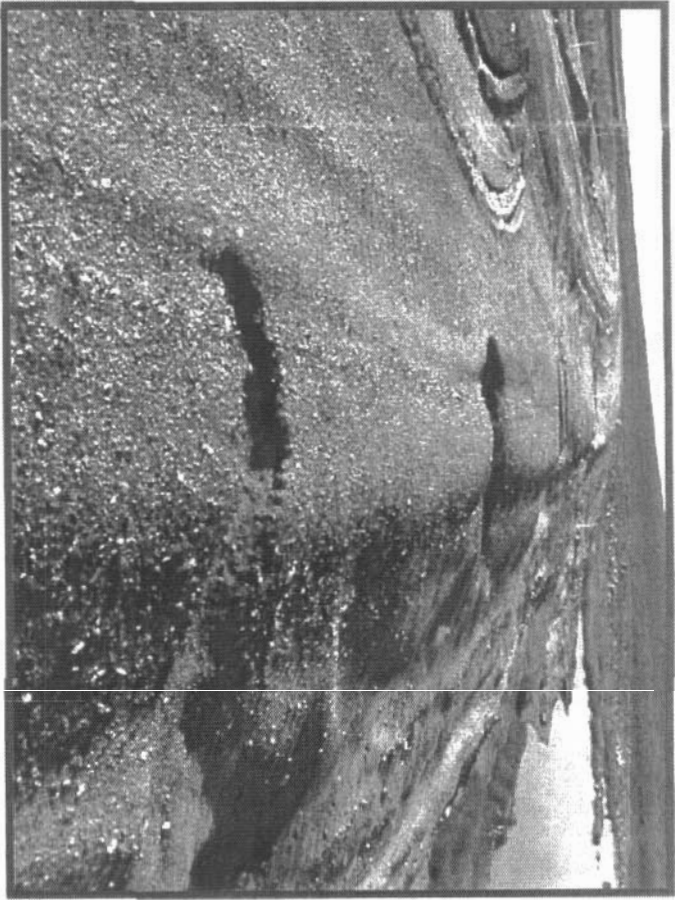
Photo 139 Shows the toe of this dam. There are 6 erosional gullies existing at the edge and progressing to the crest. Each of these gullies should be backfilled.

- Several remnant and possibly new erosional gullies were observed at the toe of the east arm. All of these gullies should be backfilled to prevent any further erosion from occurring.

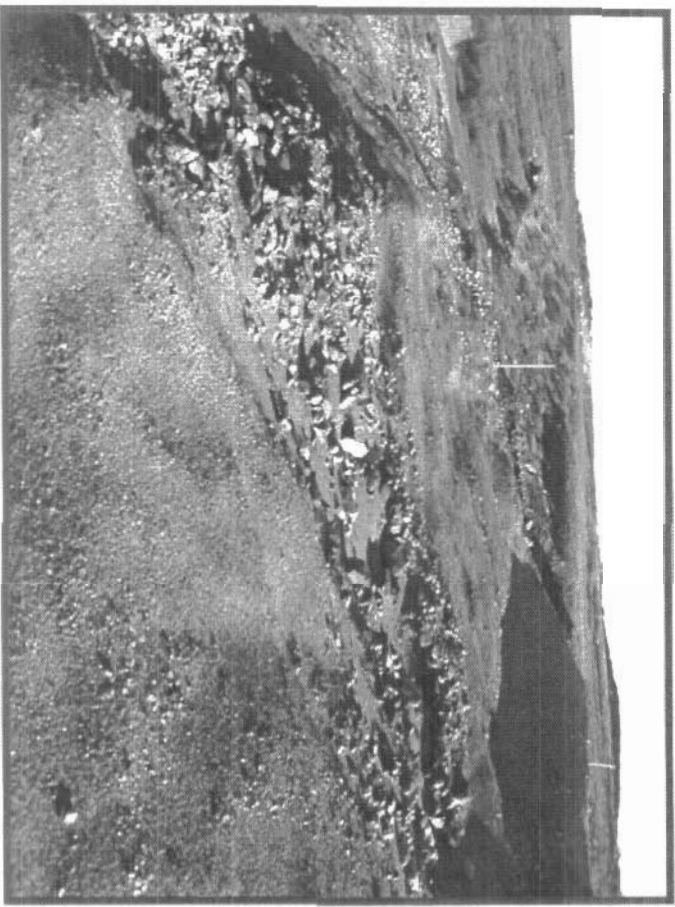
Photo 141 Shows a remnant erosional gully located at the toe.

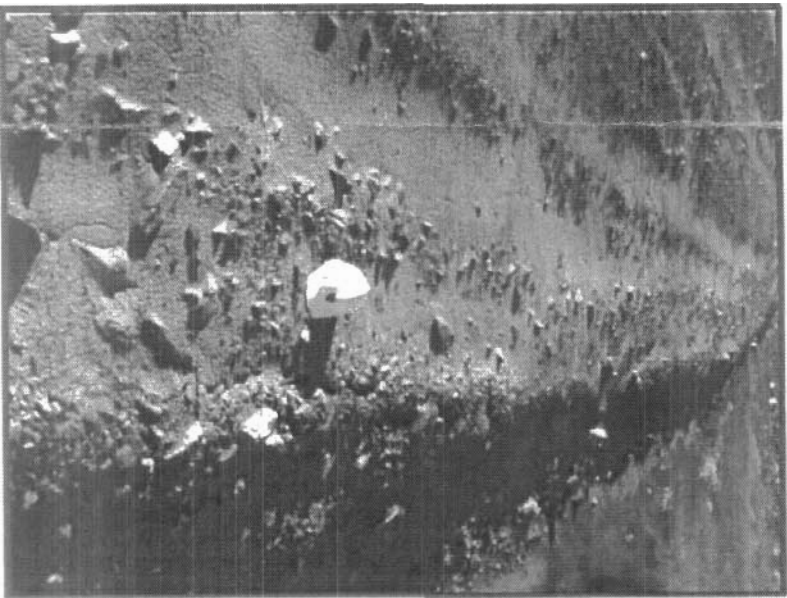
Photo 142 Shows a number of tension cracks within this toe area. The cracks are discontinuous but can generally be observed over a distance of some 10 to 15 m.

- Several longitudinal and oblique tension cracks were noted along the toe of the eastern arm of the dam. The cracks should be graded over to prevent the infiltration of any surface water.

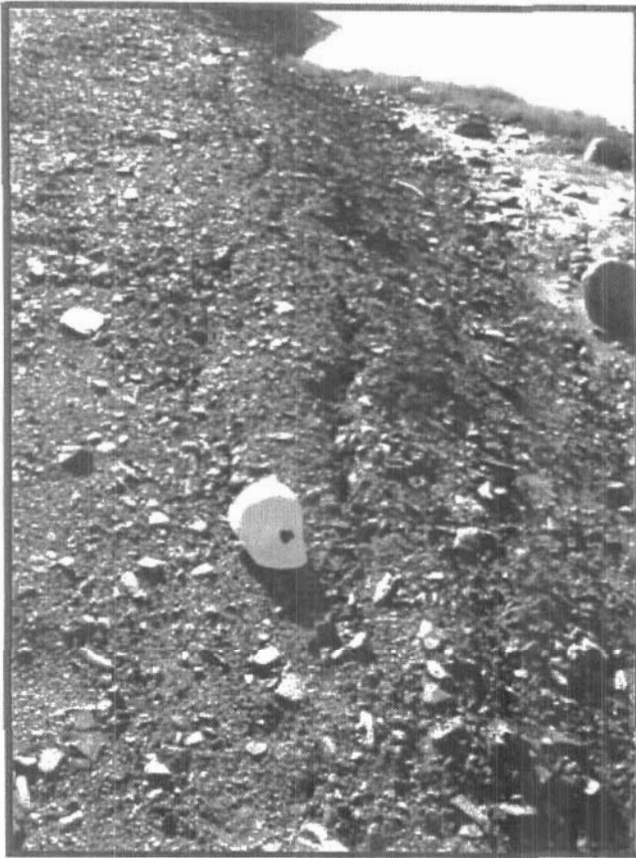
Photo 149 Shows the continuation of longitudinal cracks at the toe. In viewing the morphology and the color of the cracks, it appears that these cracks are opening over time.

- The longitudinal tension cracks at the toe of the northwestern portion of the dam (where Dam 3 contacts Boomerang Lake) appear to opening more and perhaps lengthening in extent. It will be necessary to flatten the toe slope or apply some riprap to the downstream slope along where these cracks are located.

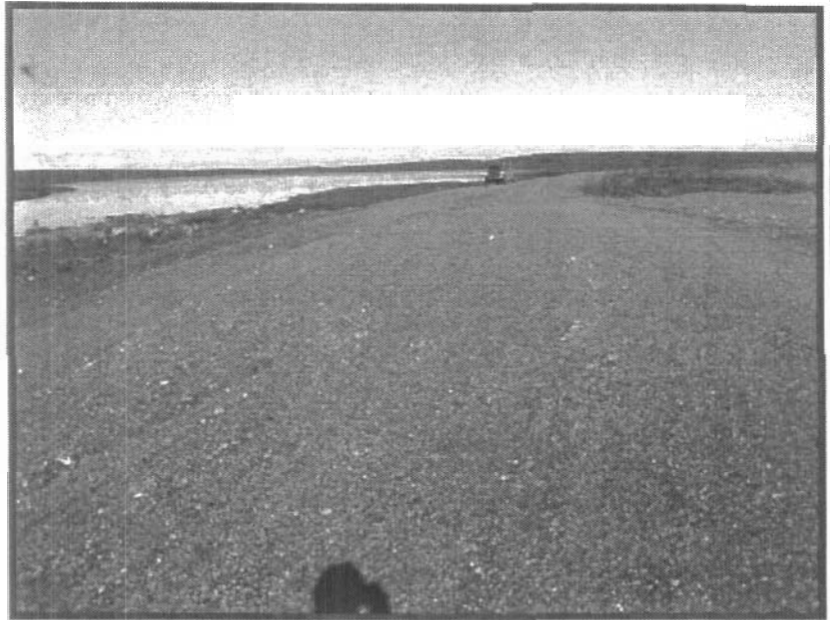
Photo 152 Shows a view of the crest looking back towards the truck.

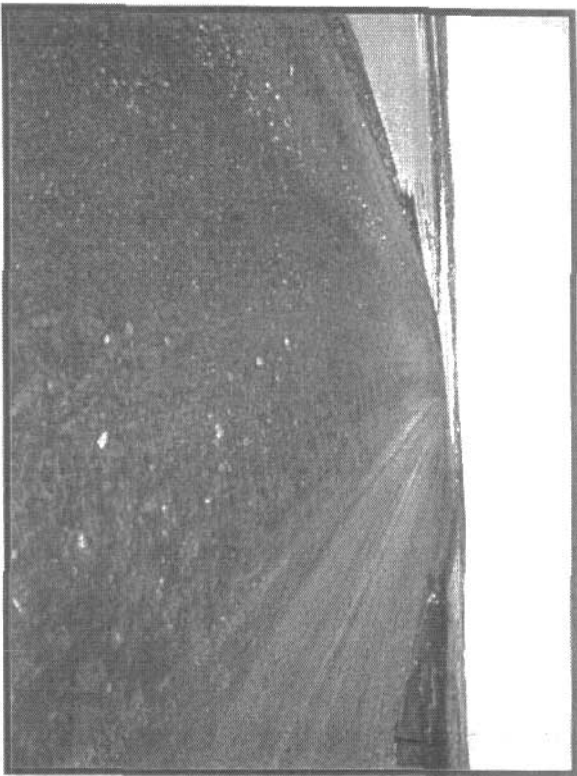
Photo 113 shows a view of the broad, well-travelled crest.

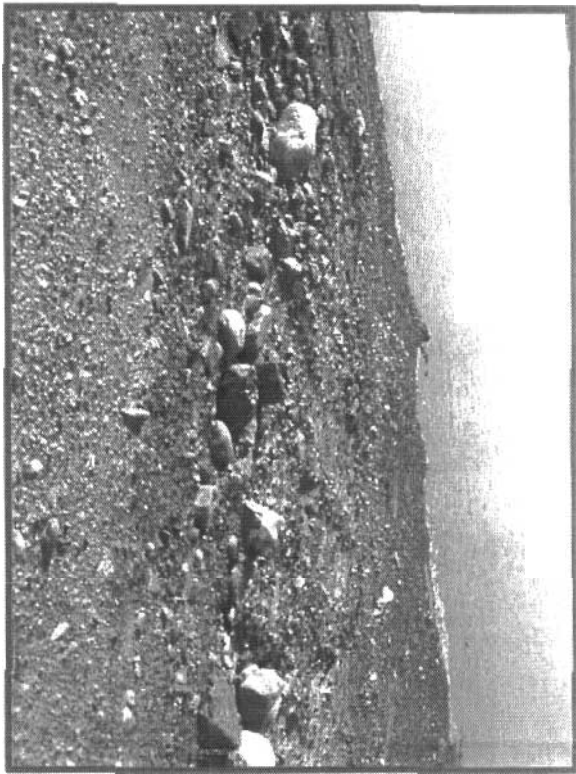
Photo 115 shows some of the disturbed area on the upstream side riprap. It appears that additional material has been placed on the crest and was graded over, perhaps to correct some of the earlier rutting caused by construction activity. The large number of boulders that have segregated out on the side of the fill to confirm appears that assumption.

- Dozer /construction activity on the upstream side has disturbed the rip rap placement, exposing the underlying sand at some locations. Consideration should be given to regrading the materials to an overall consistent slope to prevent the concentration of surface runoff.
- No other maintenance is suggested.

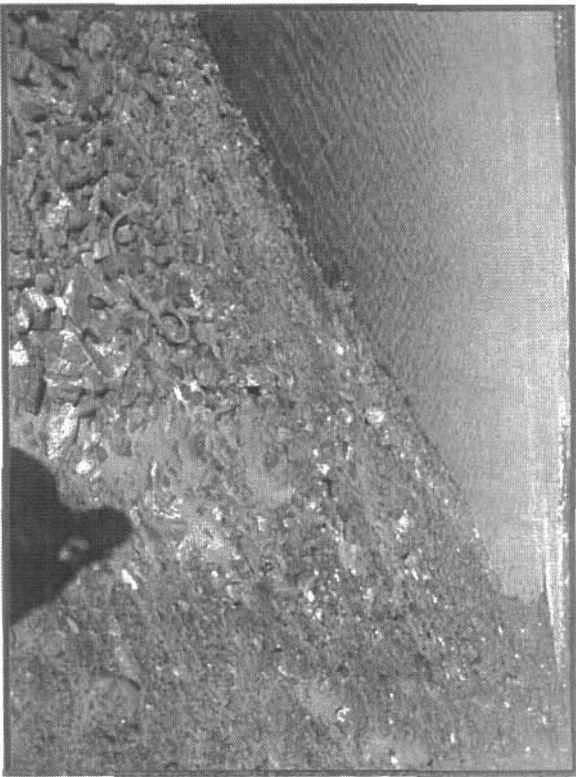
Photo 119 shows another view of the disturbed area on the upstream side, likely as a result of original construction activity.

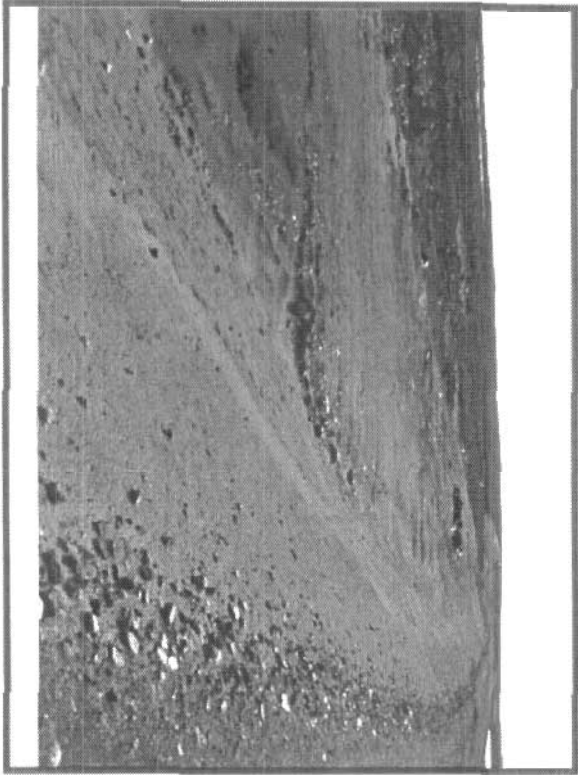
Photo 121 shows a view of the relatively steep toe of this dam, followed by the flat graded area below the toe. No signs of sloughing or significant erosion are noted from this vantage point.

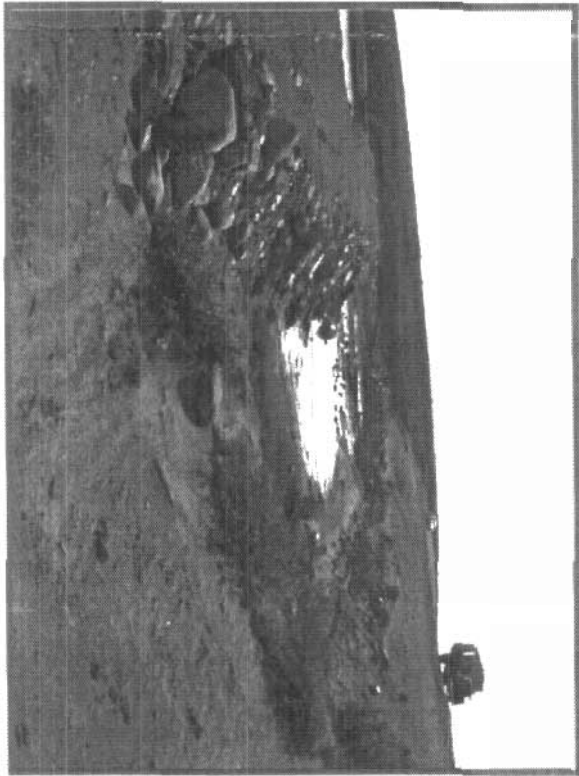
Photo 130 Shows the small pond which is located between the toe of Dam 4 and the small berm on the left of the photo. This area is pumped dry for the following two reasons: 1.) allow inspection of the downstream toe and 2.) to confirm the origin of the water in the pond.

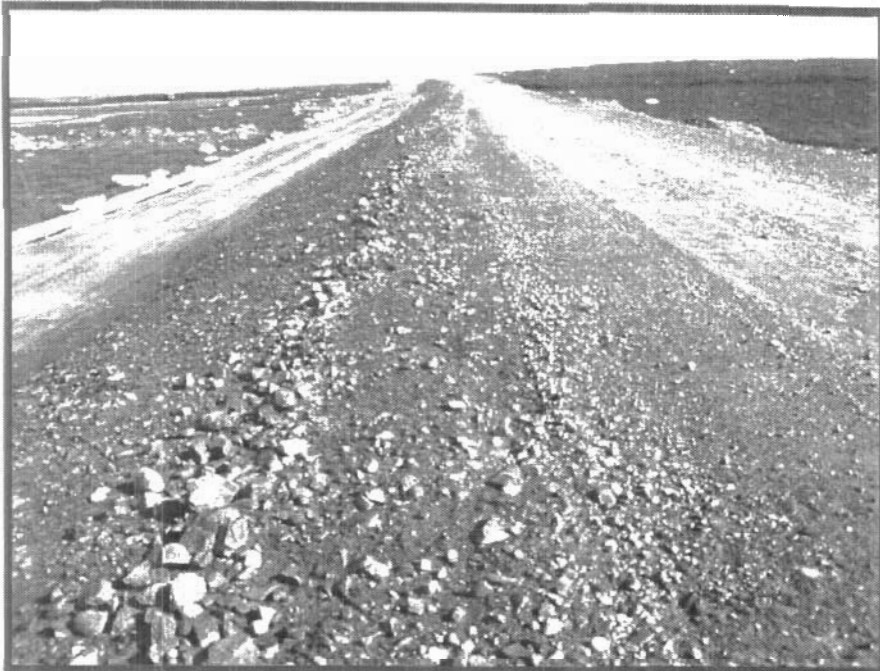
Photo 107 is a view of the broad, well travelled crest looking towards the southeast.

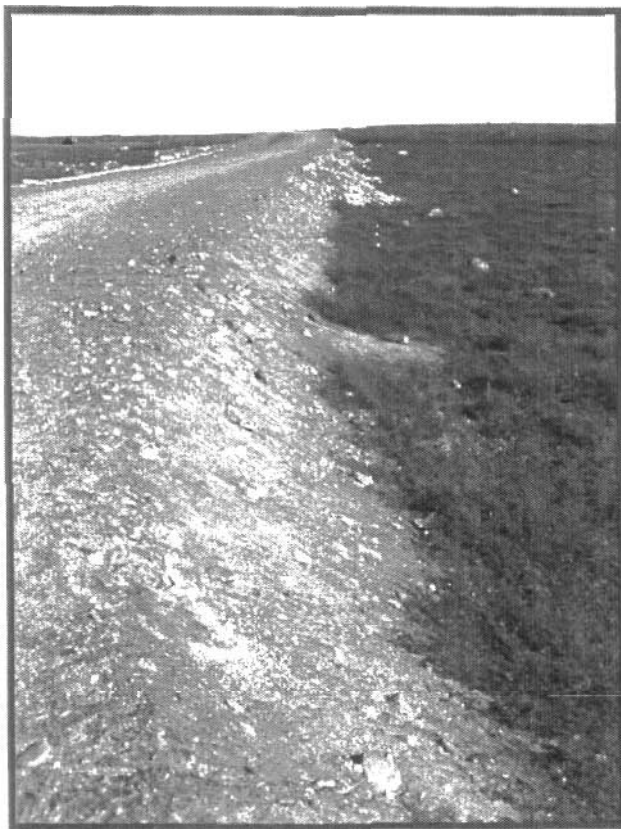
Photo 111 shows a view of the downstream toe looking towards the southeast. There are no signs of cracking, deformation or seepage at the current time.

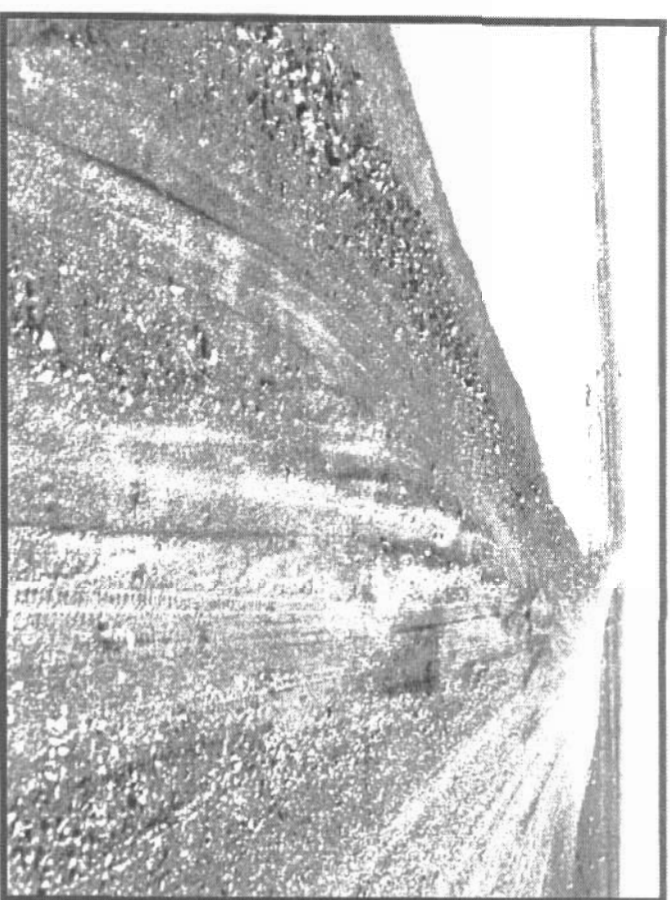
Photo 92 shows some rutting caused by vehicle traffic on the upstream side of the crest, towards its north abutment.

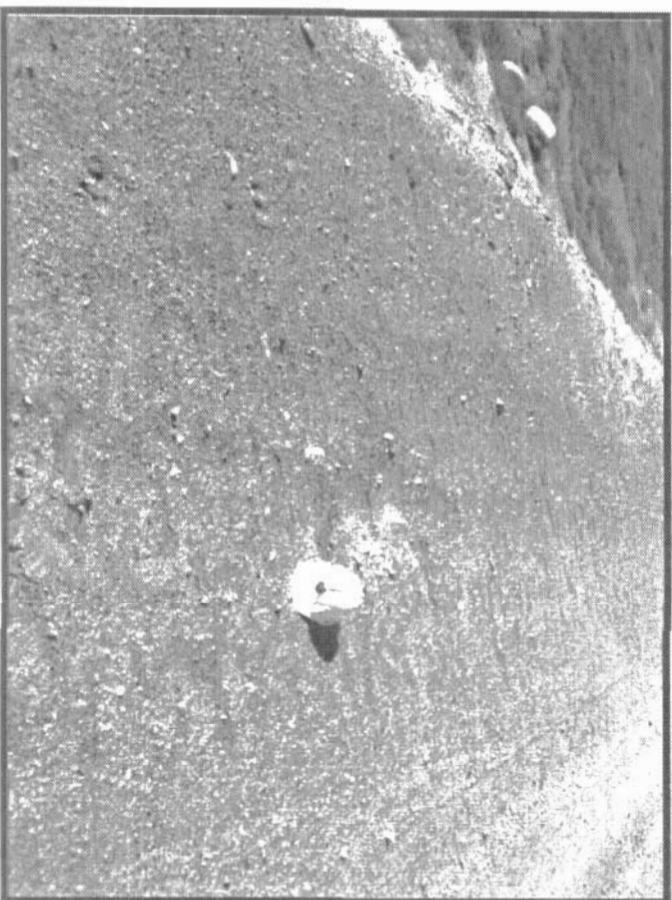
Photo 99 shows one minor sinkhole located near the downstream side of the crest. This sinkhole is located some 50 m north of the south abutment.

- One minor sinkhole in the crest and one erosional gully at the toe (~40 m south of north abutment) should be backfilled and graded.
- No other maintenance is suggested.

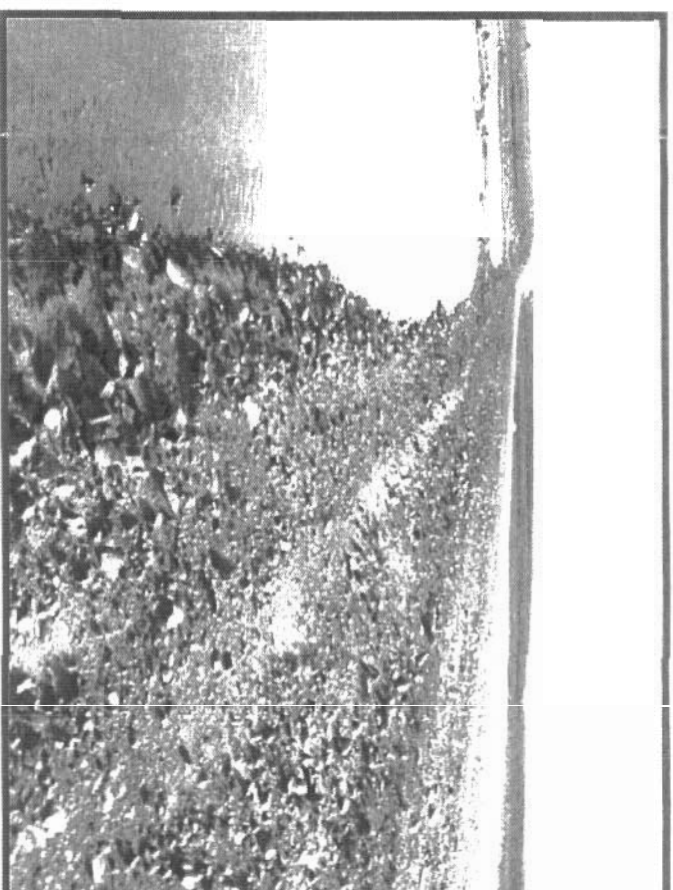
Photo 93 shows a view of the upstream side. From the pond level to the physical crest would be approximately 1.2 to 1.5 m.

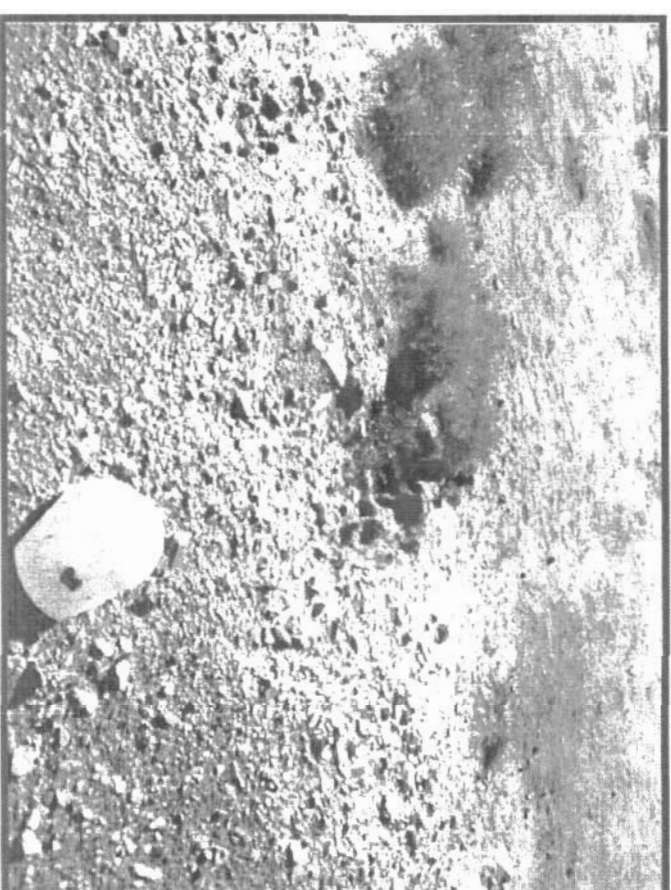
Photo 102 shows a significant erosional gully located on the downstream toe. This gully is located some 40 m south of the north abutment.
