**RE: Echo Bay Mines Ltd., Lupin Gold Mine, Contwoyto Lake, NT.; Water Licence
NWB1LUP0008; 2002 Annual Geotechnical Inspection**

2002 GEOTECHNICAL INSPECTION OF PERIMETER TAILINGS DAMS

LUPIN MINE NUNAVUT

PROJECT NO.: 0256-004-02
DATE: OCOBER 9, 2002

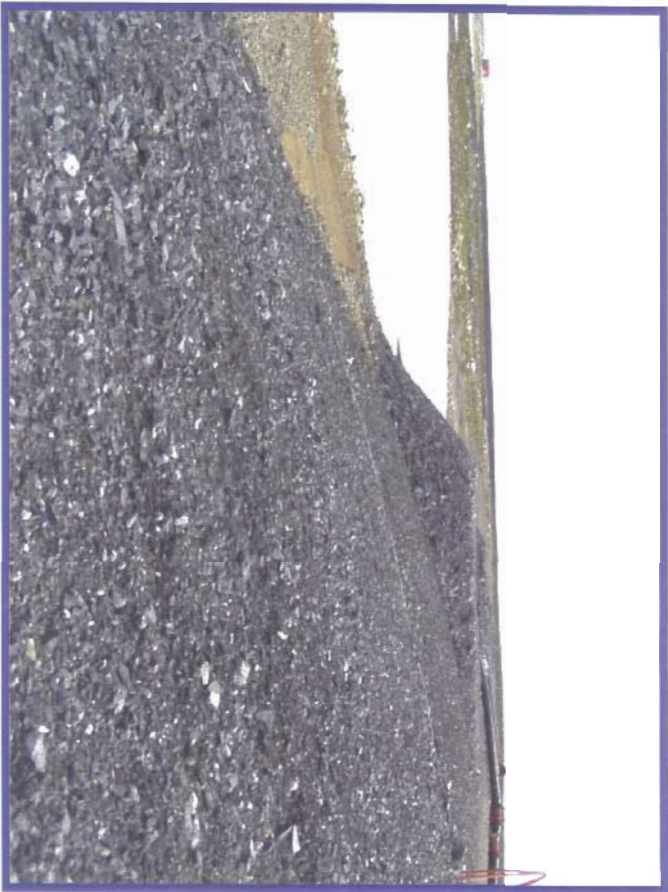
Photo 63 shows a view of the upstream side. These slopes appear to be a consistent grade.

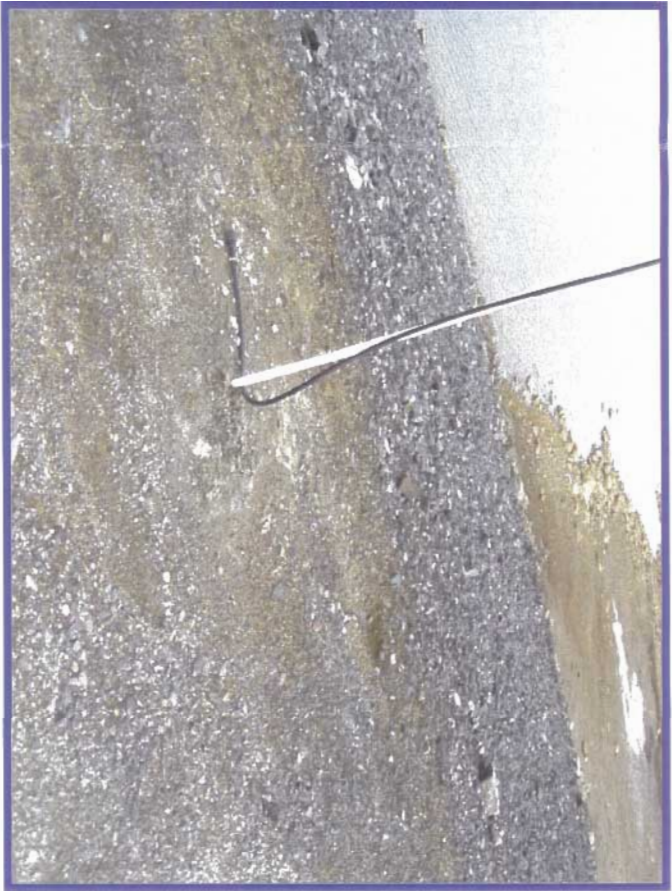
7 to 8 m; surfaced with esker material, but not travelled because of the siphons. One minor sinkhole noted on crest proximal to thermistor installation. No significant cracking evident; condition is good.

Photo 66 shows a small sinkhole just immediately to the right of the thermistor installed previously. This sinkhole had been noted previously.

RECOMMENDATIONS: Minor crest sinkhole to be backfilled. Downstream toe berm sideslope needs to be flattened to prevent recurrence of cracking.

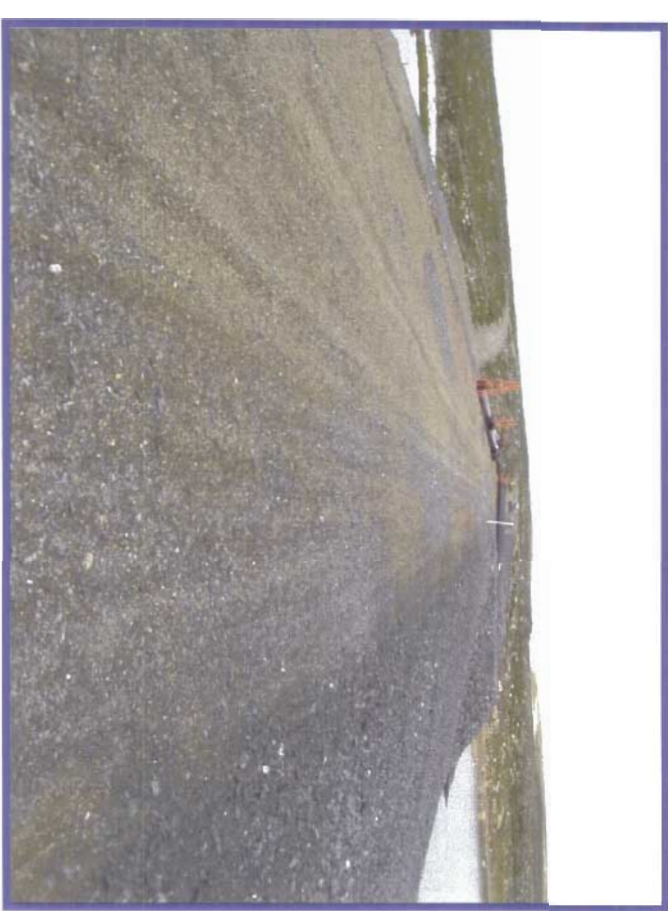
Photo 67 shows a view of the crest looking towards the north abutment. No signs of settlement, deformation or cracking noted on the crest.

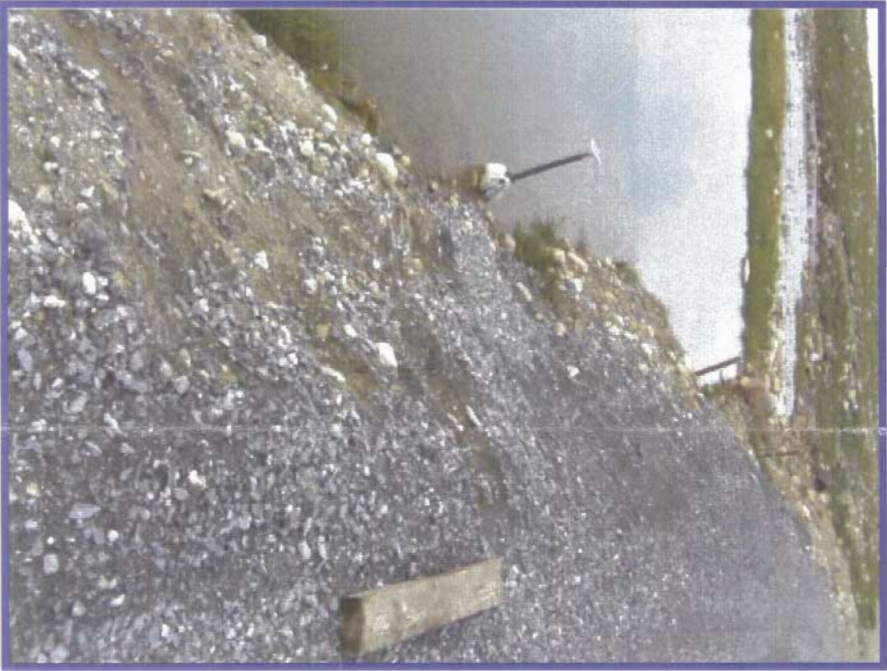
Minor longitudinal cracking and slumping still occurring at oversteepended toe, adjacent to decant pipes.

Photo 70 shows the little scarps formed by the retrogression of the material right at the toe of the access road berm.

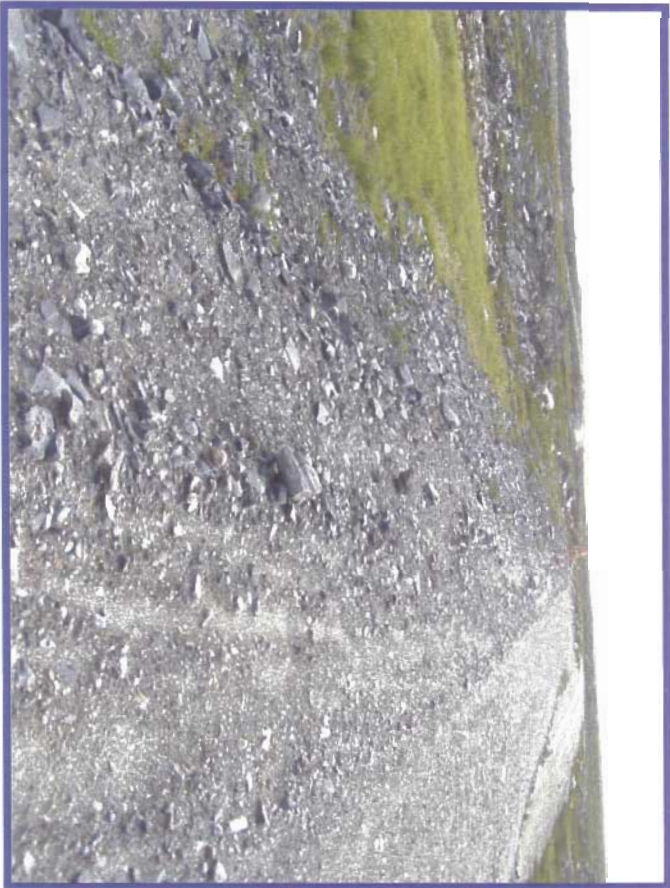
Photo 77 shows some rutting on the crest that progresses over to the upstream side as well.

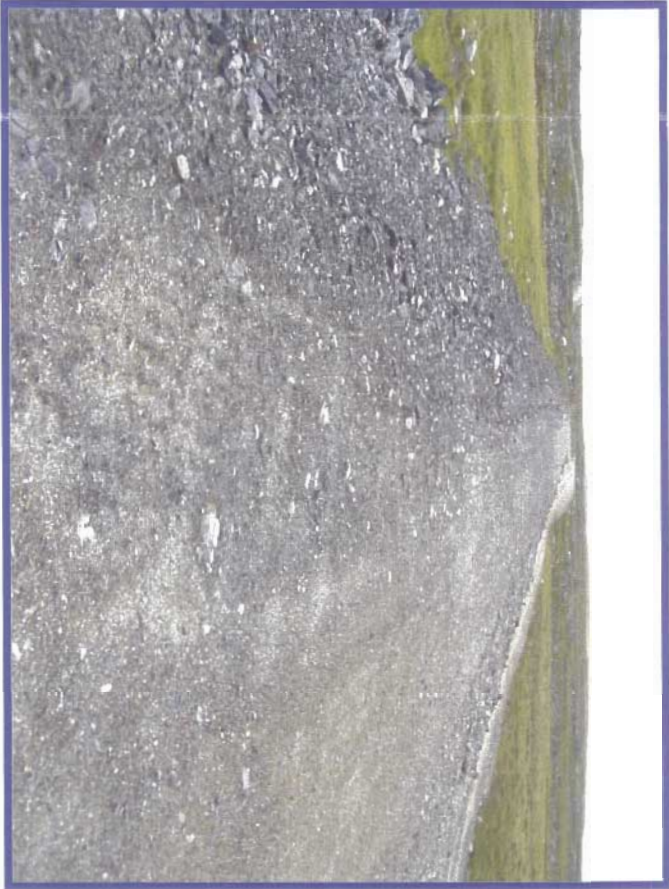
Photo 74 shows a view of the crest and the upstream side. This dam is not retaining any water at the current time.

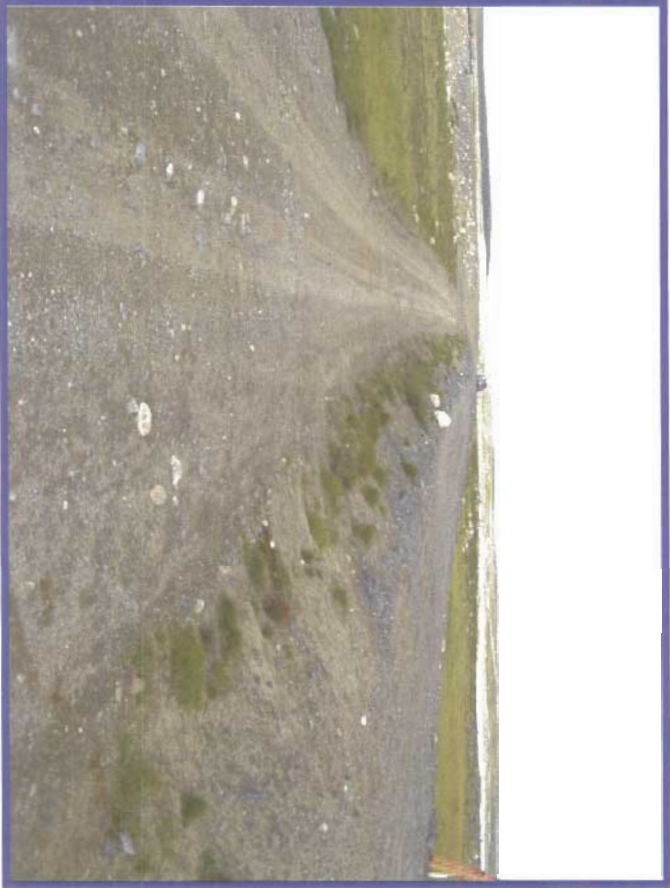
Photo 79 shows the downstream side and the crest of the dam looking towards north. Some minor vegetation is catching onto the slope.

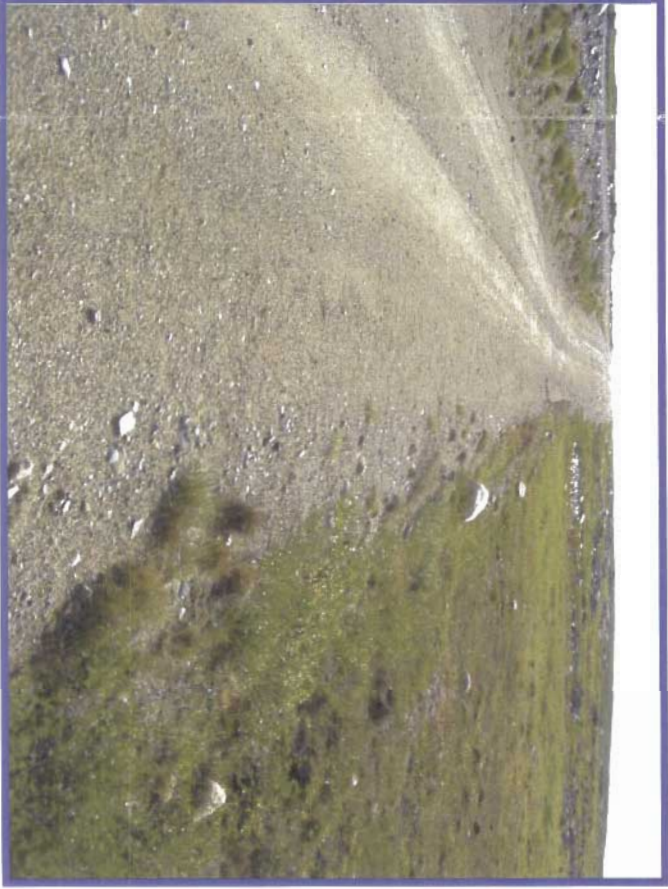
Photo 80 is a view along the downstream toe. No signs of seeping water were noted.

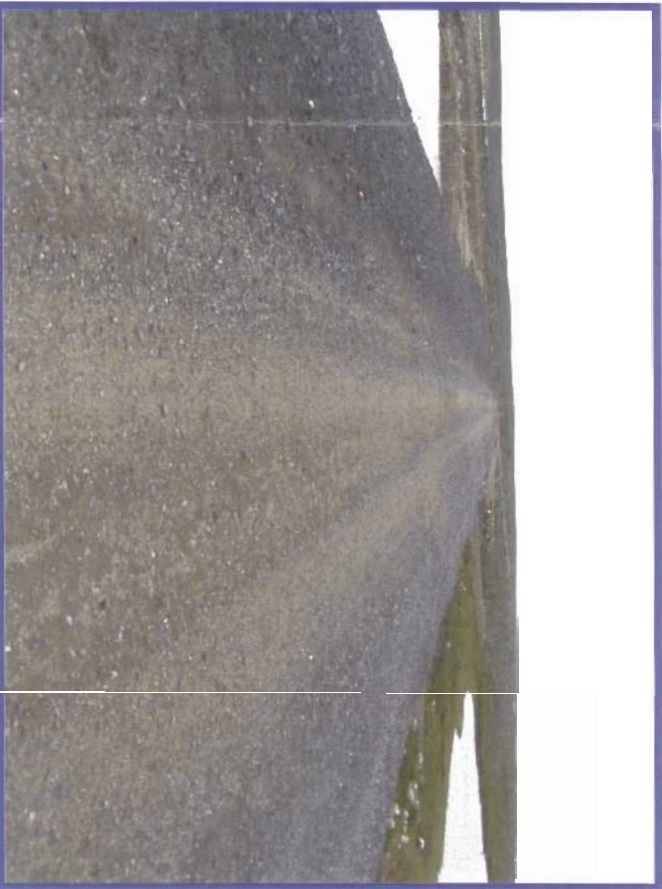
Photo 45 shows a view looking towards the south abutment. The crest appears to be smooth and flat with no signs of cracking or settlement.

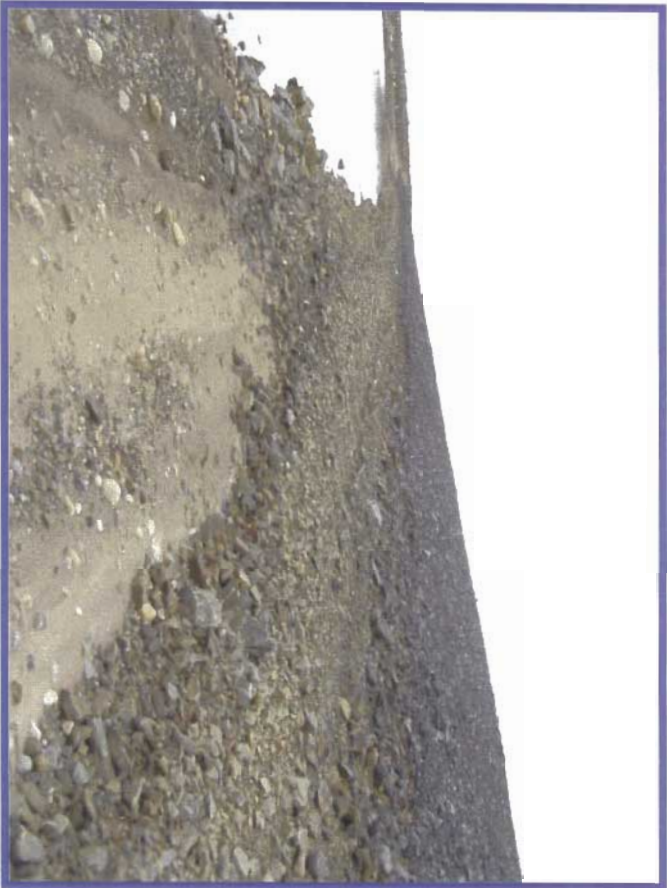
Photo 44 shows a view of the upstream side, taken from waterline perspective. As can be seen and has previously been noted, there are some small scarps at the transition from the light brown to the gray material.

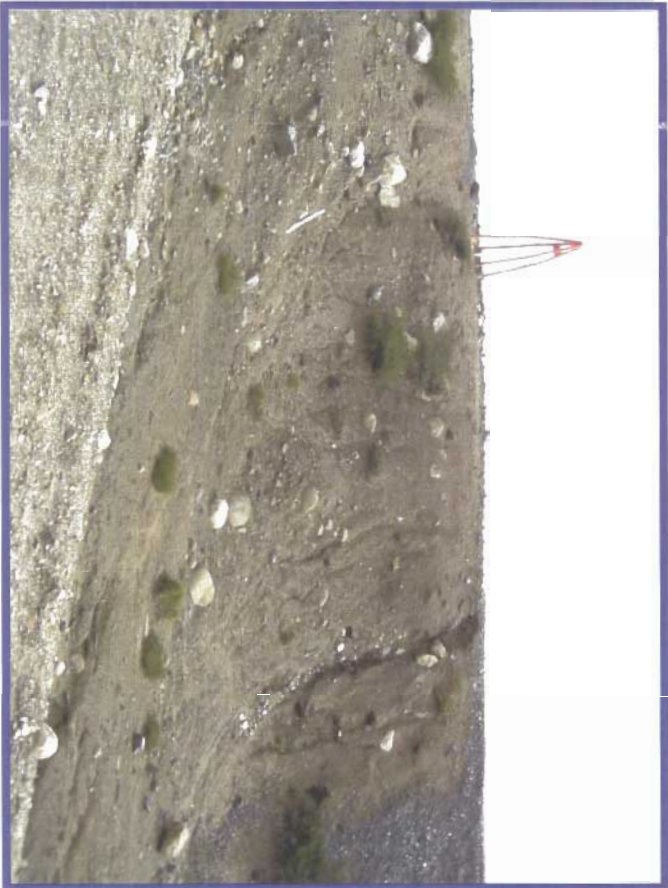
Photo 59 shows one significant erosional gully located on the downstream face at the north abutment.

- Minor erosional gulley on the downstream slope near the north abutment should be backfilled.
- Very small amount (<1 l/min) of seepage observed again at the toe of the north abutment. Continue to monitor seepage for any increases in quantity and to observe if seepage water contains any sediment.

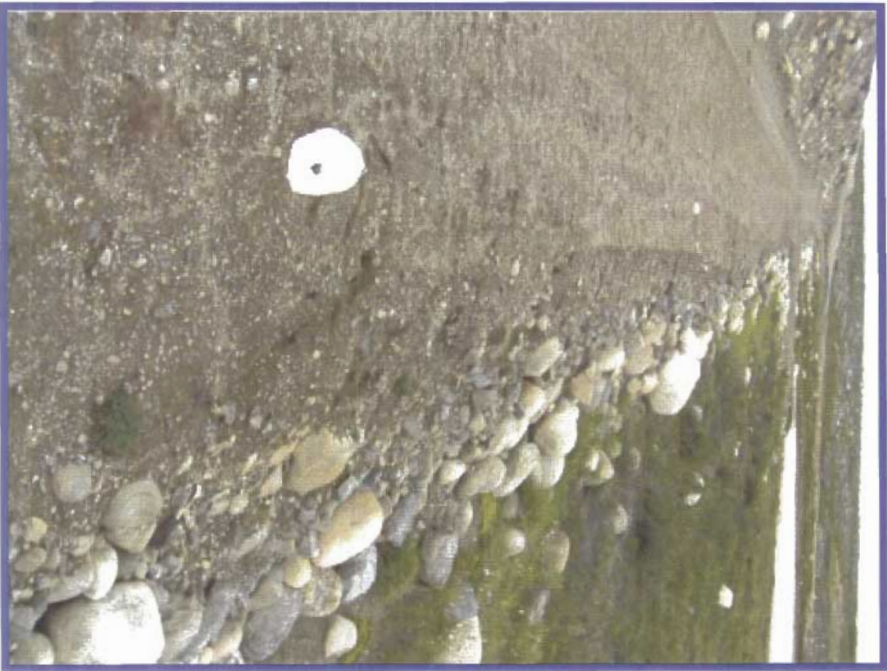
Photo 51 shows some minor cracking along the downstream toe. This cracking has been previously noted.

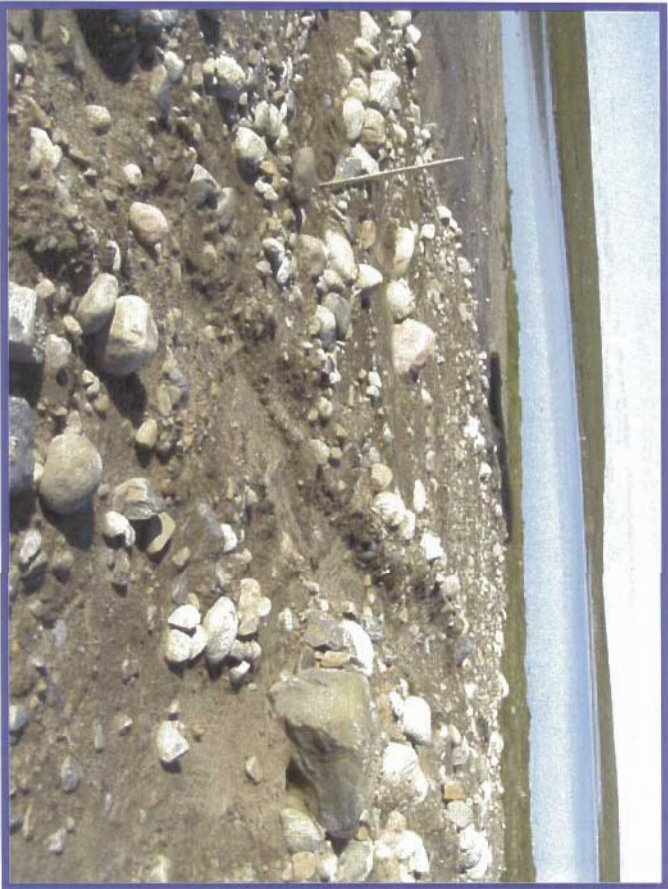
Photo 137 Shows some boulders and cobbles that appear to have been placed in a low swale area. At the current time, the swale work is very disturbed and would likely be ineffective in transmitting any water. The material should be excavated and a proper swale should be laid out.

SEEPAGE:	None observed near the toe of the east arm of the dam.
MAINTENANCE RECOMMENDATIONS:	Replace poorly constructed swale with a properly graded swale, appropriately armoured to drain surface runoff. Backfill and grade over the erosional gullies situated along the east arm of the dam. Flatten the backslope along Boomerang Lake for the northwest part of the dam to prevent cracks from opening any further. Also grade and flatten the toe where cracks are present along the east arm.
CONCLUSIONS:	The dam is in good condition.

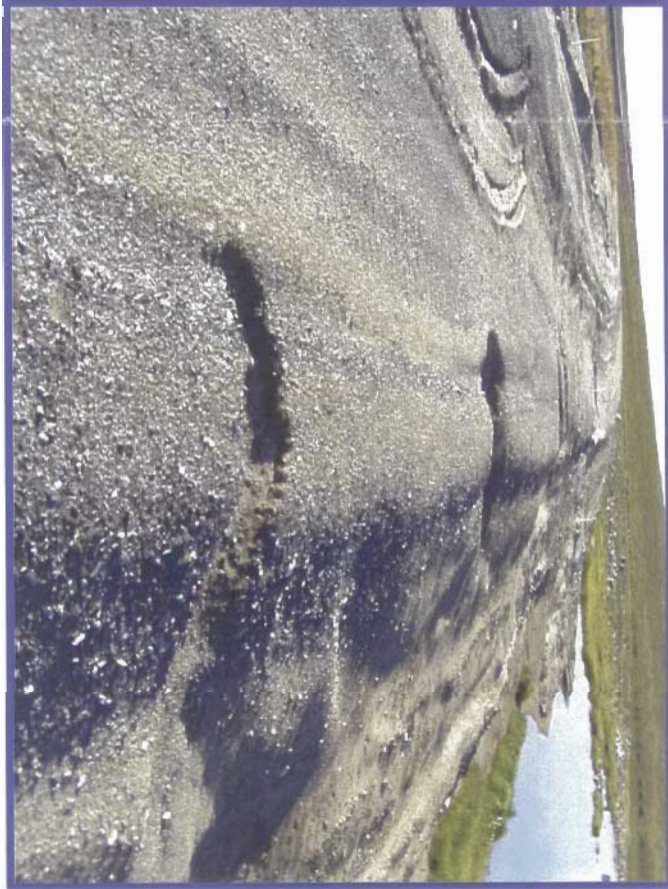
Photo 139 Shows the toe of this dam. There are 6 erosional gullies existing at the edge and progressing to the crest. Each of these gullies should be backfilled.

- Several remnant and possibly new erosional gullies were observed at the toe of the east arm. All of these gullies should be backfilled to prevent any further erosion from occurring.

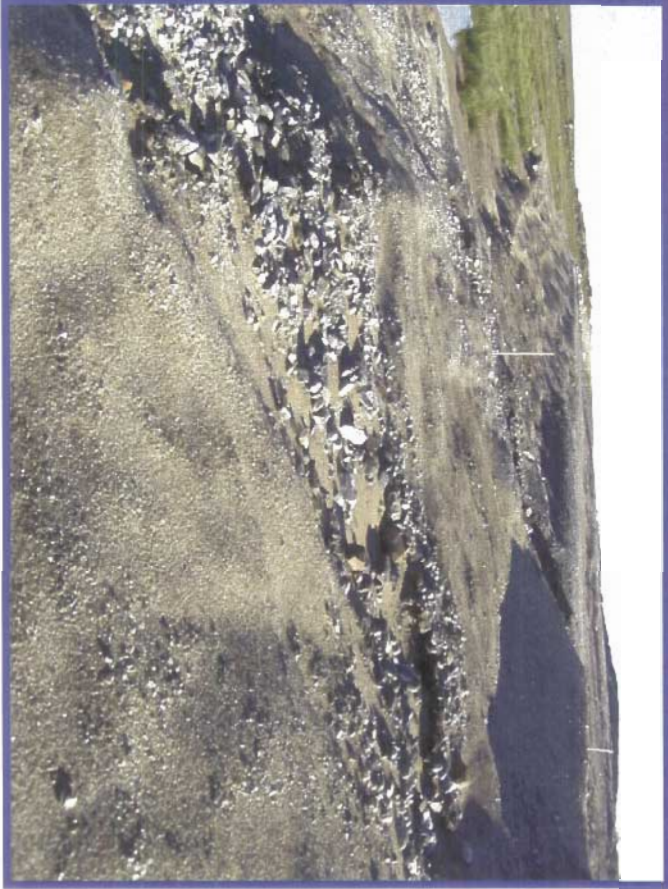
Photo 141 Shows a remnant erosional gully located at the toe.

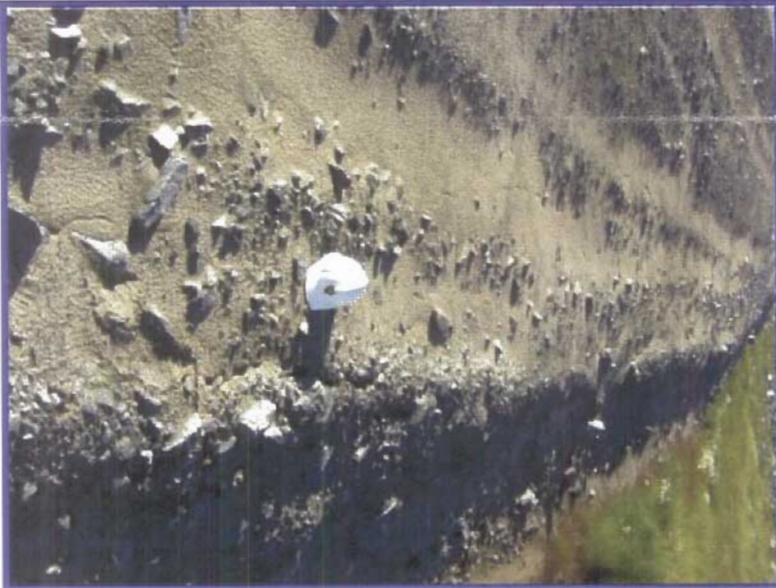
Photo 142 Shows a number of tension cracks within this toe area. The cracks are discontinuous but can generally be observed over a distance of some 10 to 15 m.

- Several longitudinal and oblique tension cracks were noted along the toe of the eastern arm of the dam. The cracks should be graded over to prevent the infiltration of any surface water.

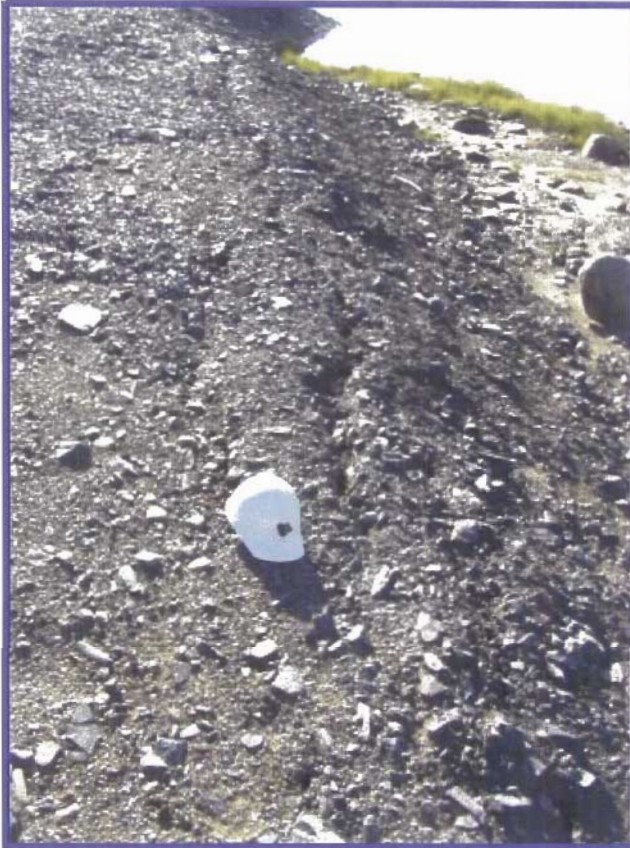
Photo 149 Shows the continuation of longitudinal cracks at the toe. In viewing the morphology and the color of the cracks, it appears that these cracks are opening over time.

- The longitudinal tension cracks at the toe of the northwestern portion of the dam (where Dam 3 contacts Boomerang Lake) appear to opening more and perhaps lengthening in extent. It will be necessary to flatten the toe slope or apply some riprap to the downstream slope along where these cracks are located.

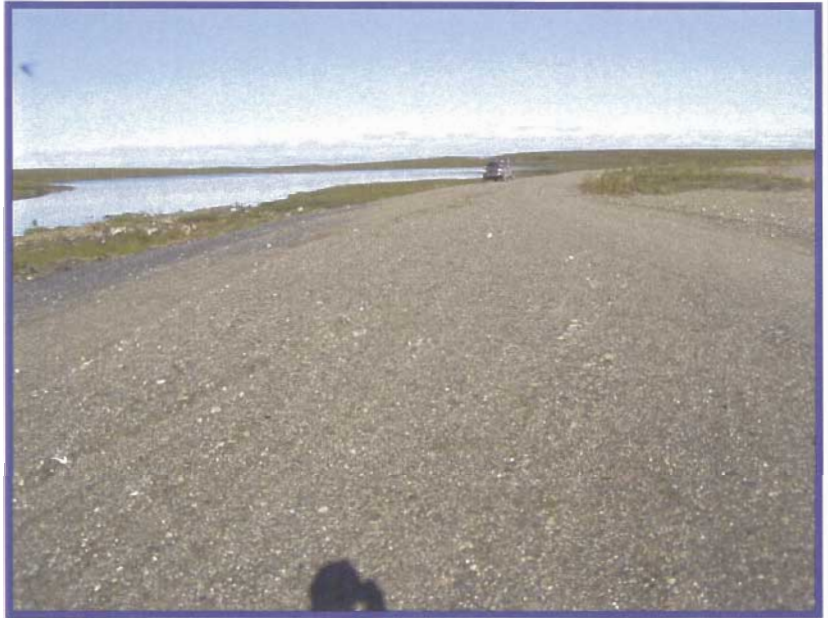
Photo 152 Shows a view of the crest looking back towards the truck.

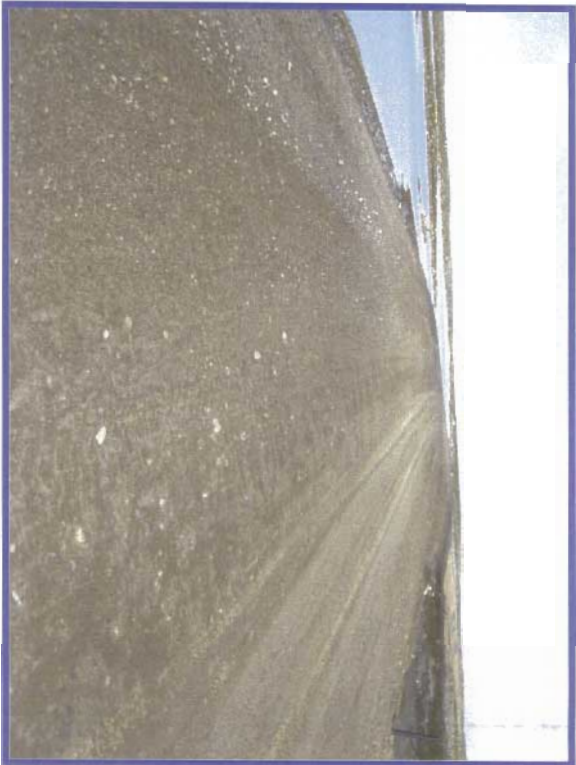
Photo 113 shows a view of the broad, well-travelled crest.

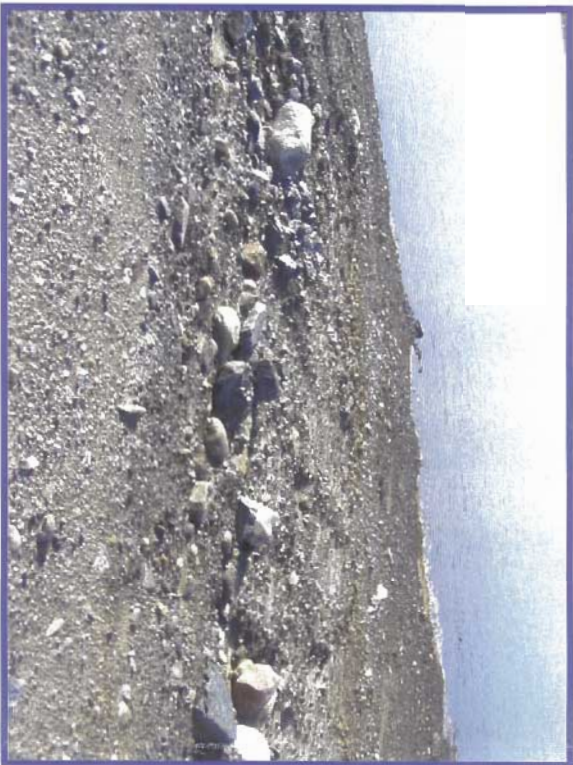
Photo 115 shows some of the disturbed area on the upstream side riprap. It appears that additional material has been placed on the crest and was graded over, perhaps to correct some of the earlier rutting caused by construction activity. The large number of boulders that have segregated out on the side of the fill to confirm appears that assumption.

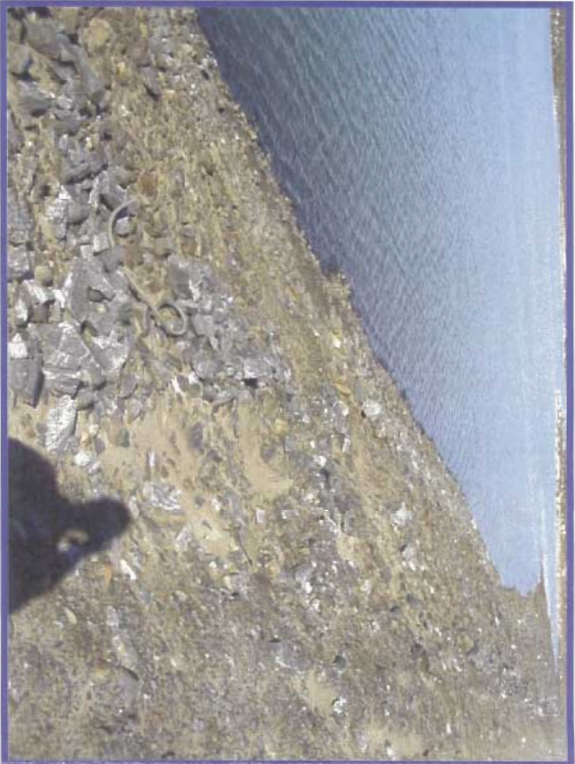
Photo 119 shows another view of the disturbed area on the upstream side, likely as a result of original construction activity.

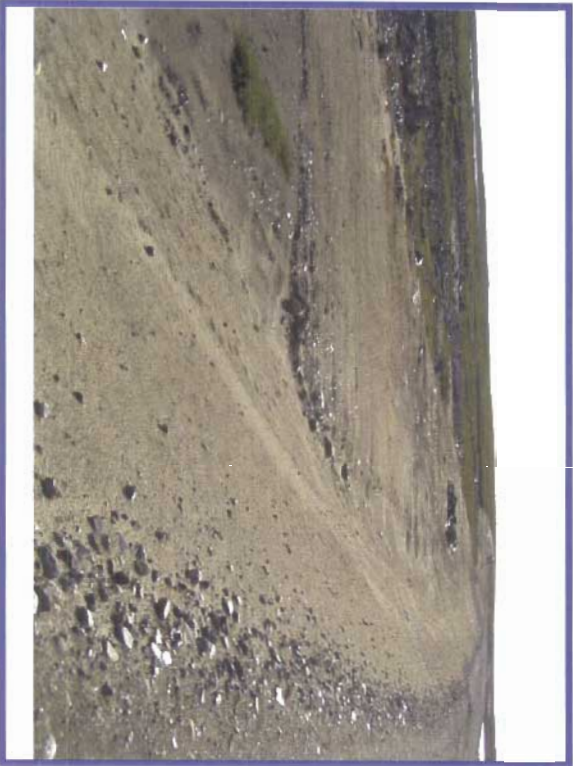
Photo 121 shows a view of the relatively steep toe of this dam, followed by the flat graded area below the toe. No signs of sloughing or significant erosion are noted from this vantage point.

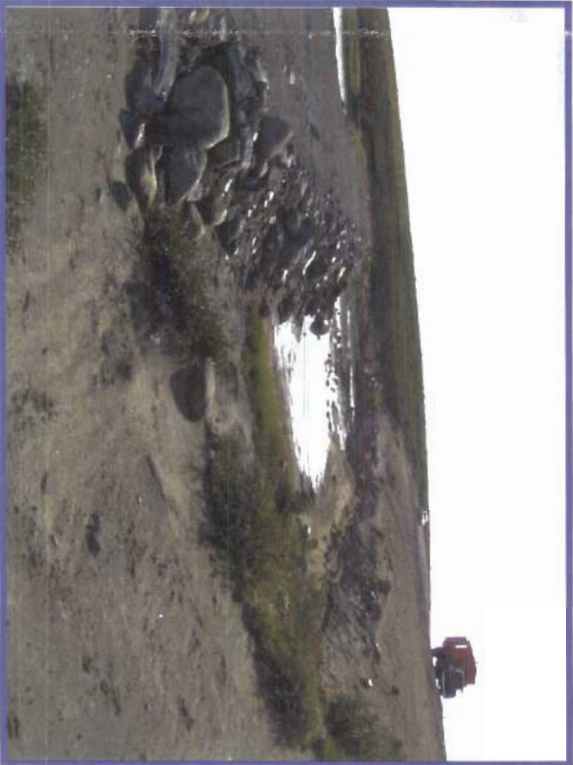
Photo 130 Shows the small pond which is located between the toe of Dam 4 and the small berm on the left of the photo. This area is pumped dry for the following two reasons; 1.) allow inspection of the downstream toe and 2.) to confirm the origin of the water in the pond.

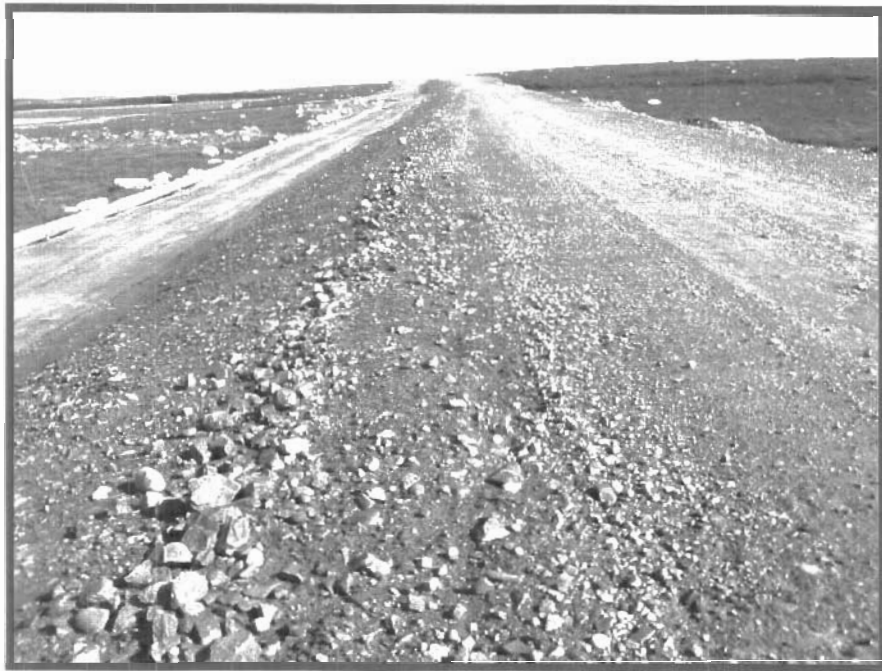
Photo 107 is a view of the broad, well travelled crest looking towards the southeast.

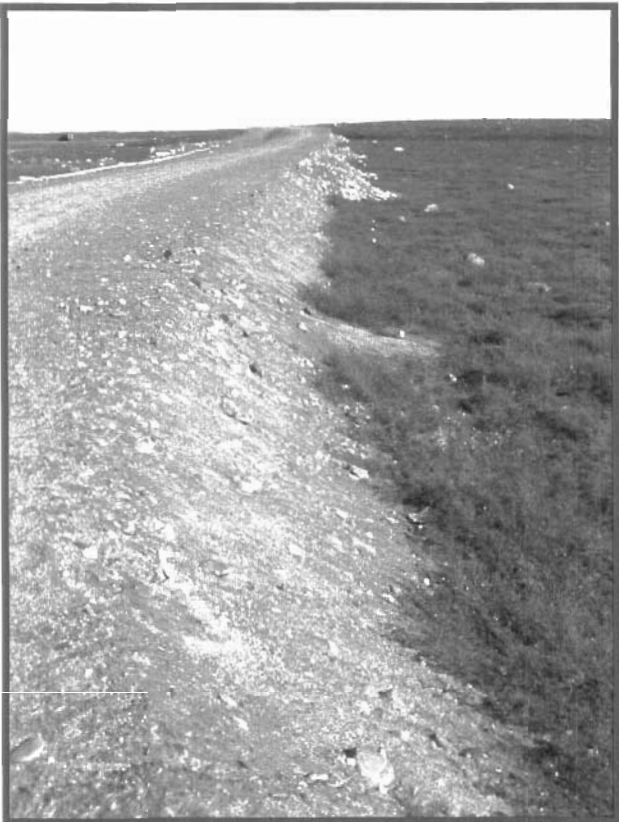
Photo 111 shows a view of the downstream toe looking towards the southeast. There are no signs of cracking, deformation or seepage at the current time.

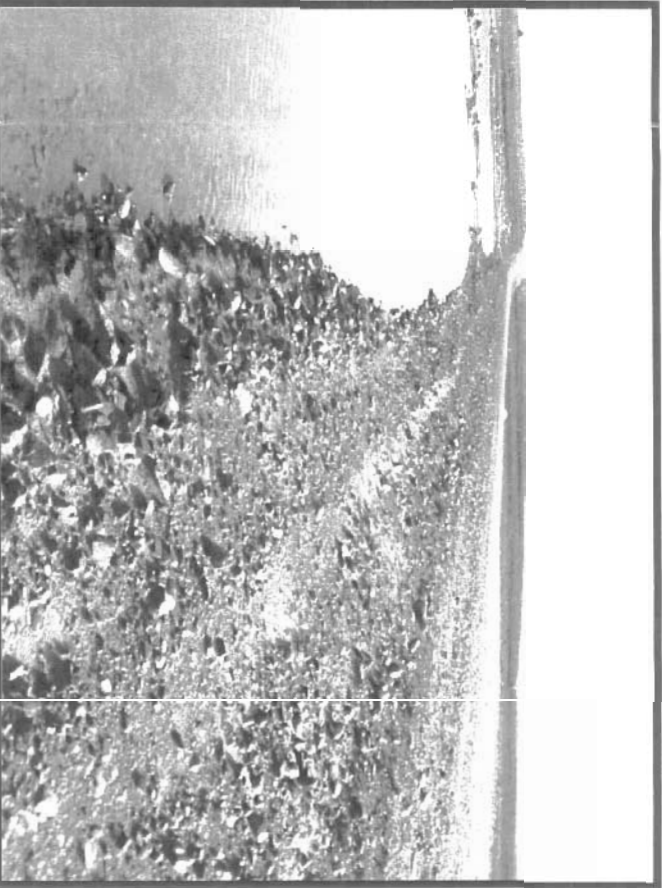
Photo 92 shows some rutting caused by vehicle traffic on the upstream side of the crest, towards its north abutment.

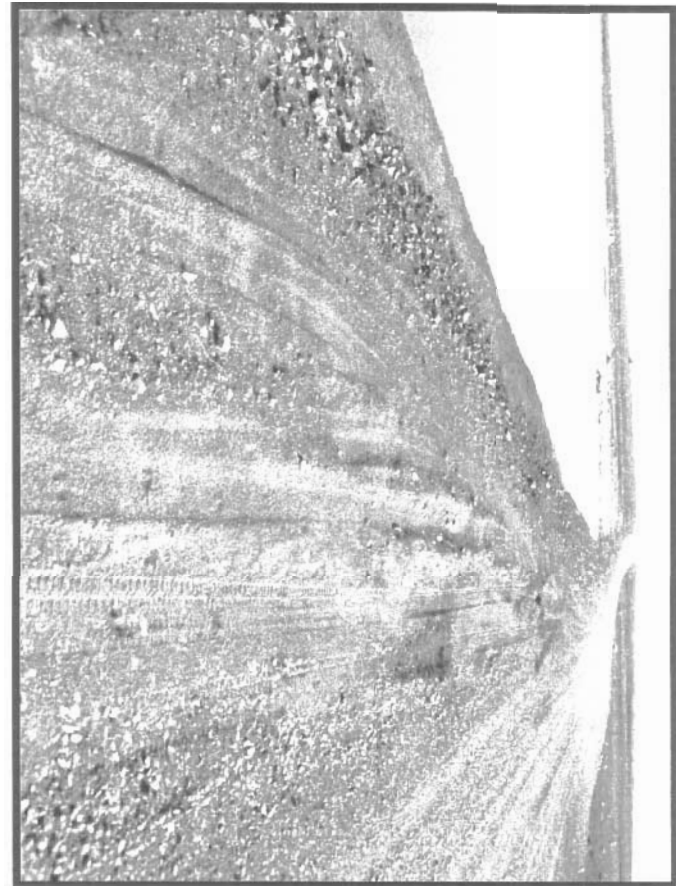
Photo 99 shows one minor sinkhole located near the downstream side of the crest. This sinkhole is located some 50 m north of the south abutment.

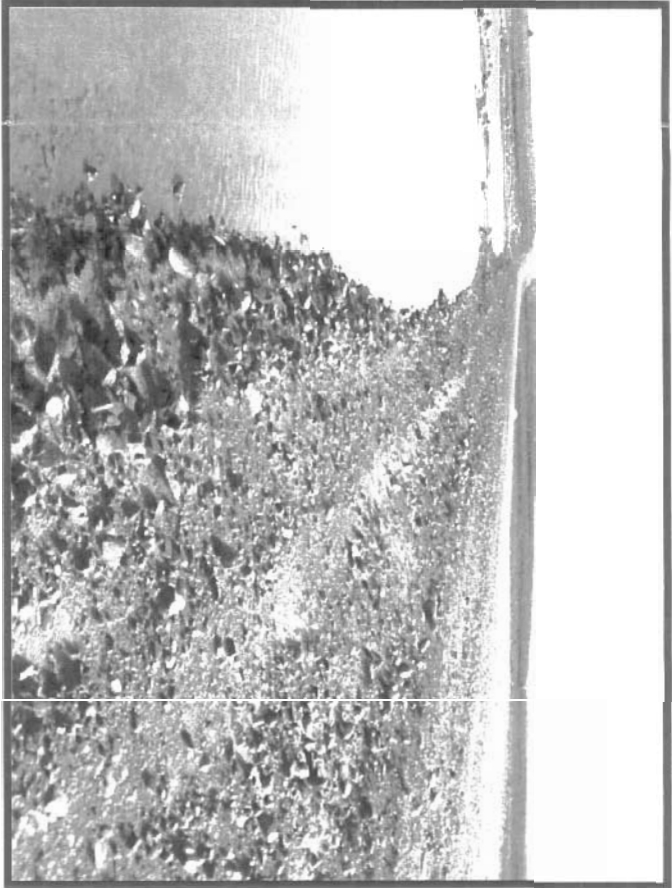
Photo 102 shows a significant erosional gully located on the downstream toe. This gully is located some 40 m south of the north abutment.

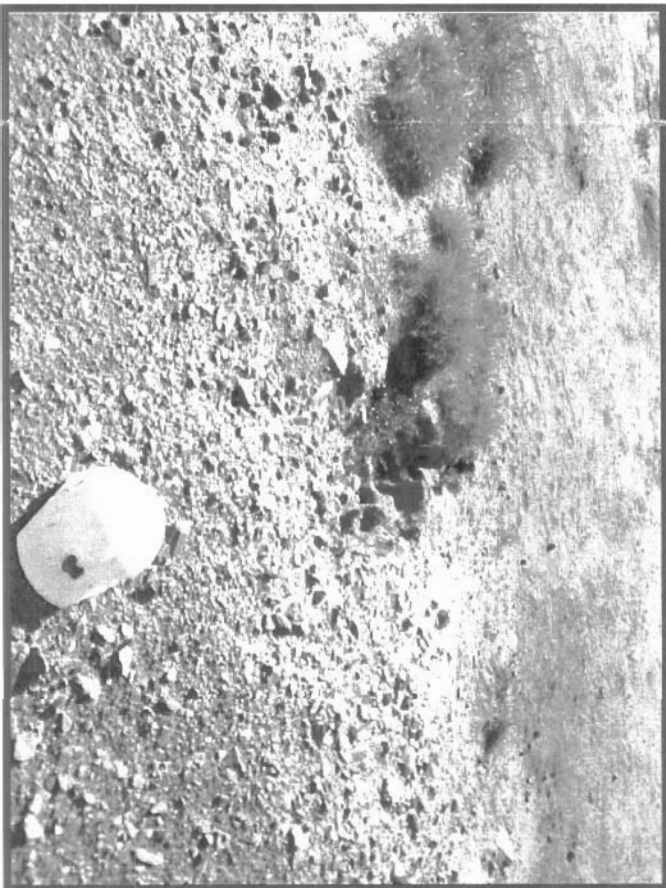
Photo 93 shows a view of the upstream side. From the pond level to the physical crest would be approximately 1.2 to 1.5 m.

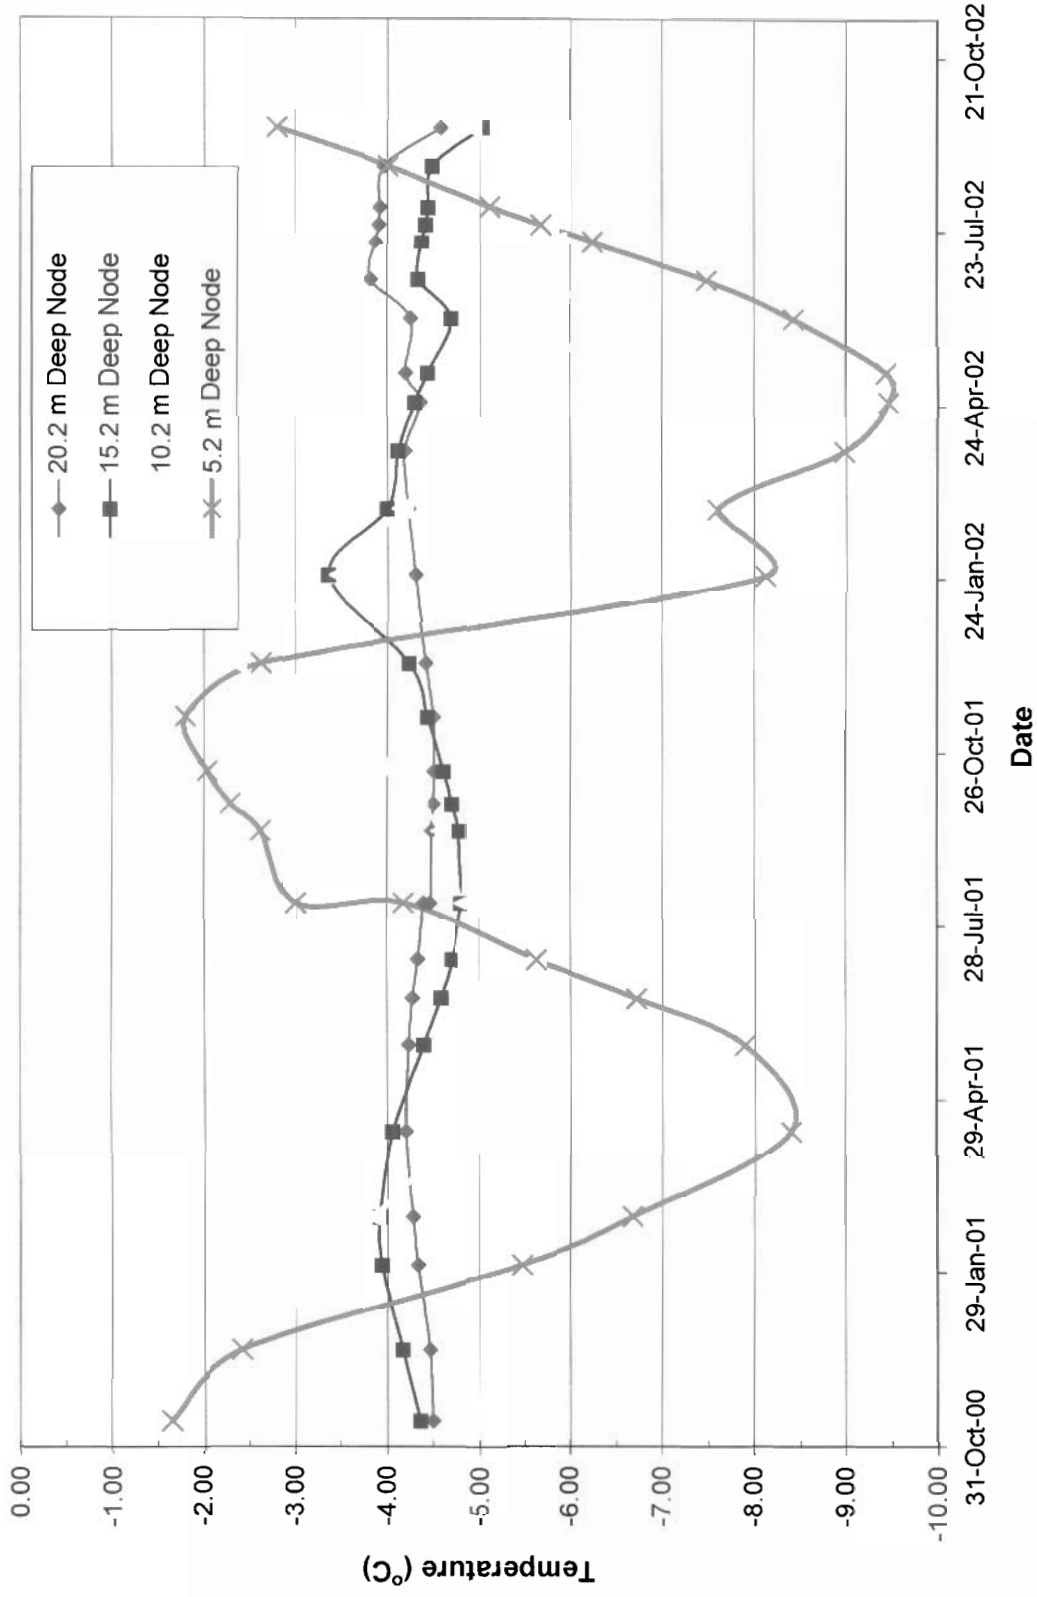
Long Term Plot for Deep Nodes in D2-00-2
(Downstream side of crest of Dam 2, north end)

INSTRUMENTATION:	Thermistor D2-00-02 is located at the north end of the crest. Active layer depth was greater than 2.2 m in October 2001 and mid-September 2002. Temperatures at depth are subzero. Below 5 m depth (approximate bottom of embankment fill), temperatures are colder than -1.5°C . At depth, foundation zone appears to be cooling over the longer term.

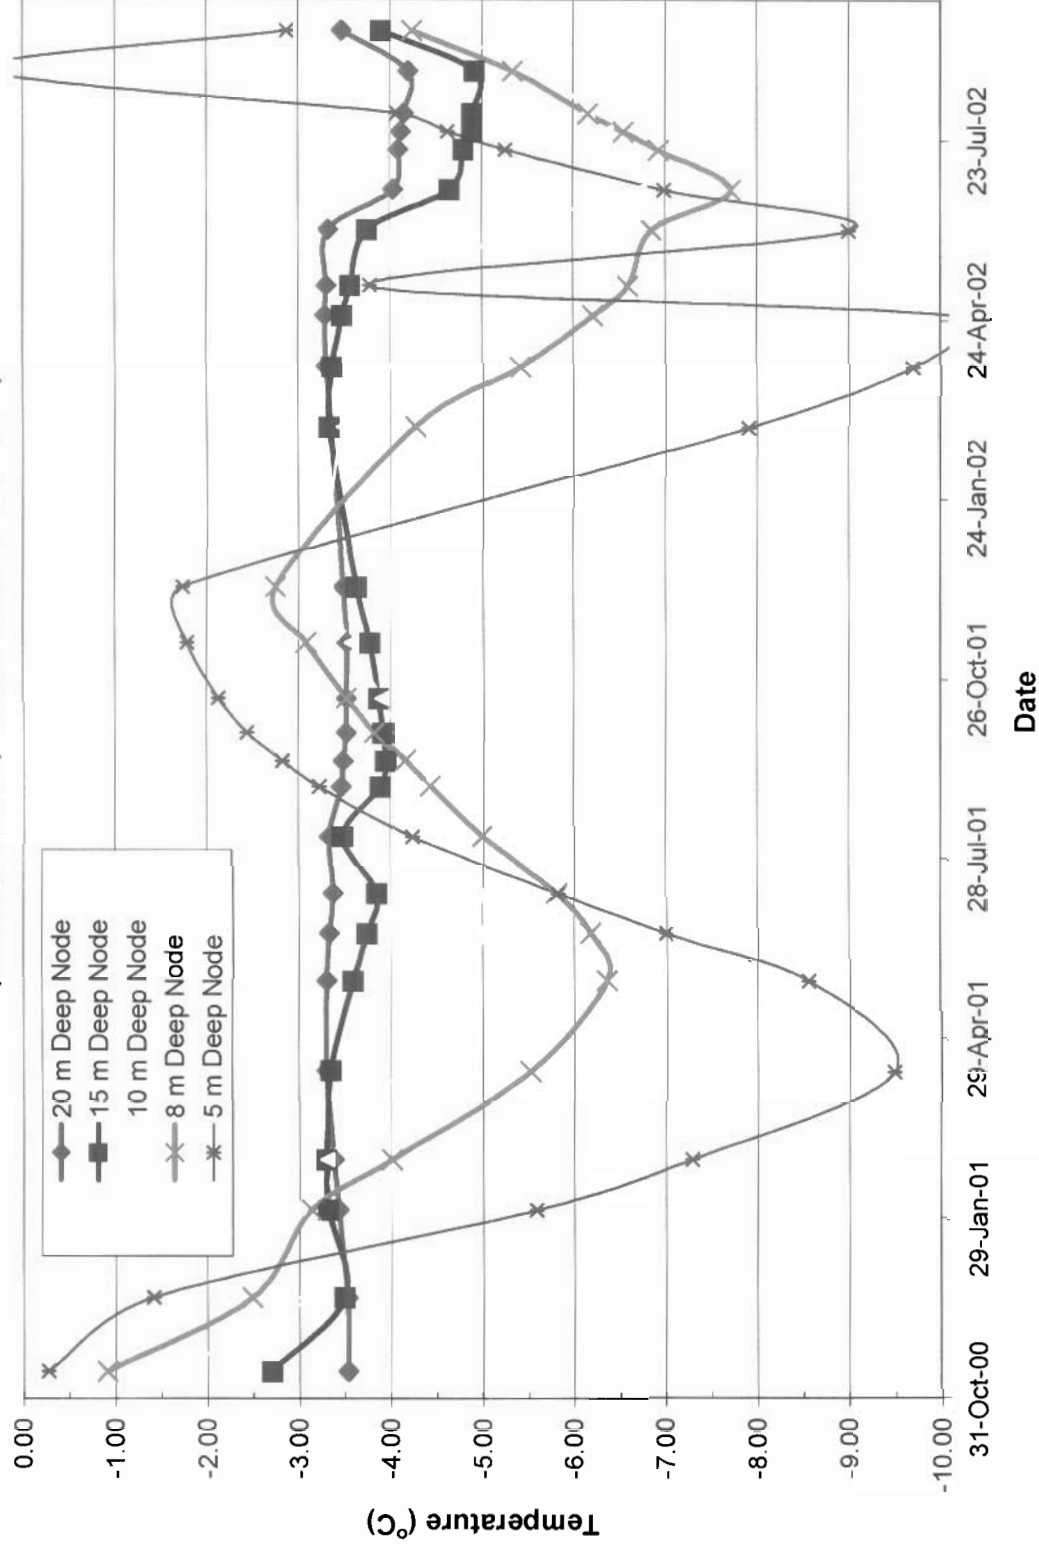
**Long Term Plot for Deep Nodes on D2-00-3
(Crest of Dam 2, mid to north end of dam)**

INSTRUMENTATION:	Thermistor D2-00-03 is situated near the mid-point of the dam. Active layer depths of greater than 2 m in October 2001 and 3 m in August 2002. One warm temperature reading recorded on August 26, 2002 at a depth of 5 m. Following reading after that warm reading was subzero again. Unsure if reading was an error or if some seepage at this depth may have occurred.
MAINTENANCE RECOMMENDATIONS:	Backfill one erosional gulley on the backslope, situated towards the north abutment. Monitor Thermistor D2-00-03 to ensure subzero conditions over the short term.
CONCLUSIONS:	The dam is in satisfactory condition. Continue with vigilant monitoring of instrumentation and visual condition assessment.
