## LOWER SEWAGE CONTAINMENT POND DIKE

| PROJECT<br>Annual Inspection of Perimeter Tailings Dams | | |

| PROJECT | ANNUAL INSPECTION OF PERIMETER TAILINGS DAMS | | |

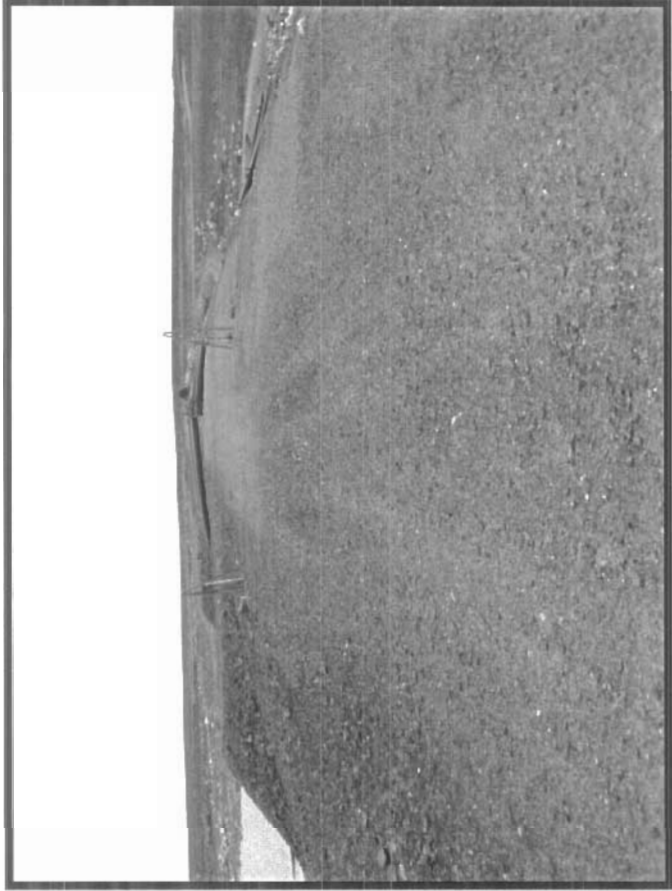
Photo 71 shows the crest of Dam 1A looking towards the south.

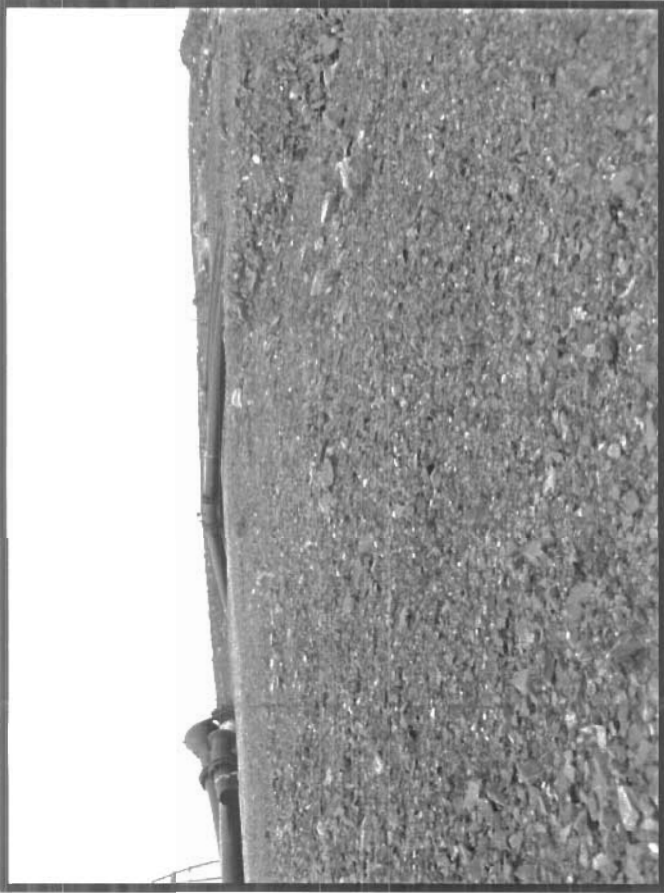
Photo 74 shows a small area on the upstream side that is proximal to the crest, that appears to have some small little scarps in it.

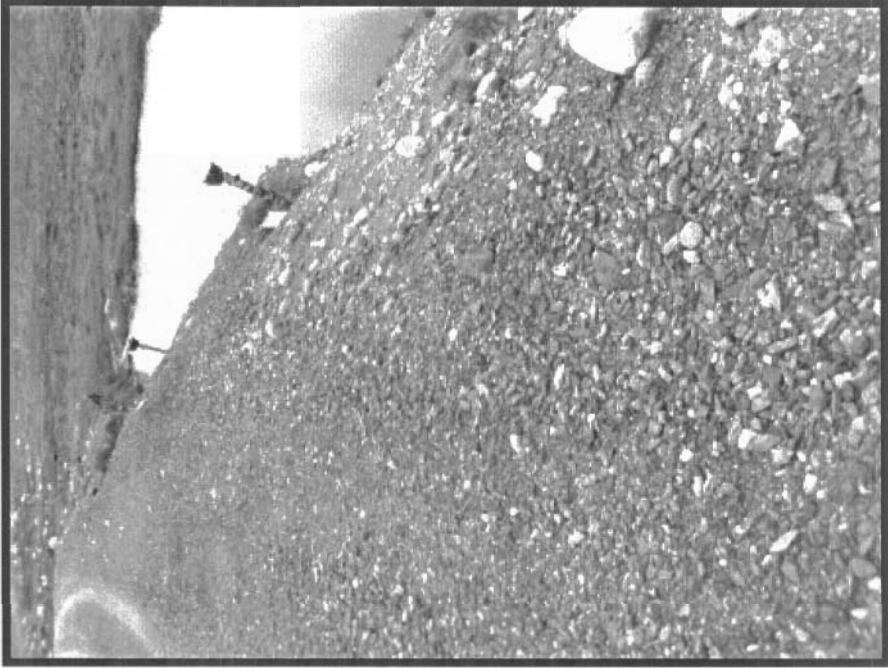
Photo 78 shows some minor cracking and minor settlement within the dark grey angular rockfill placed at the crest edge. This is a result of the relatively oversteepened toe directly proximal to the valve locations.

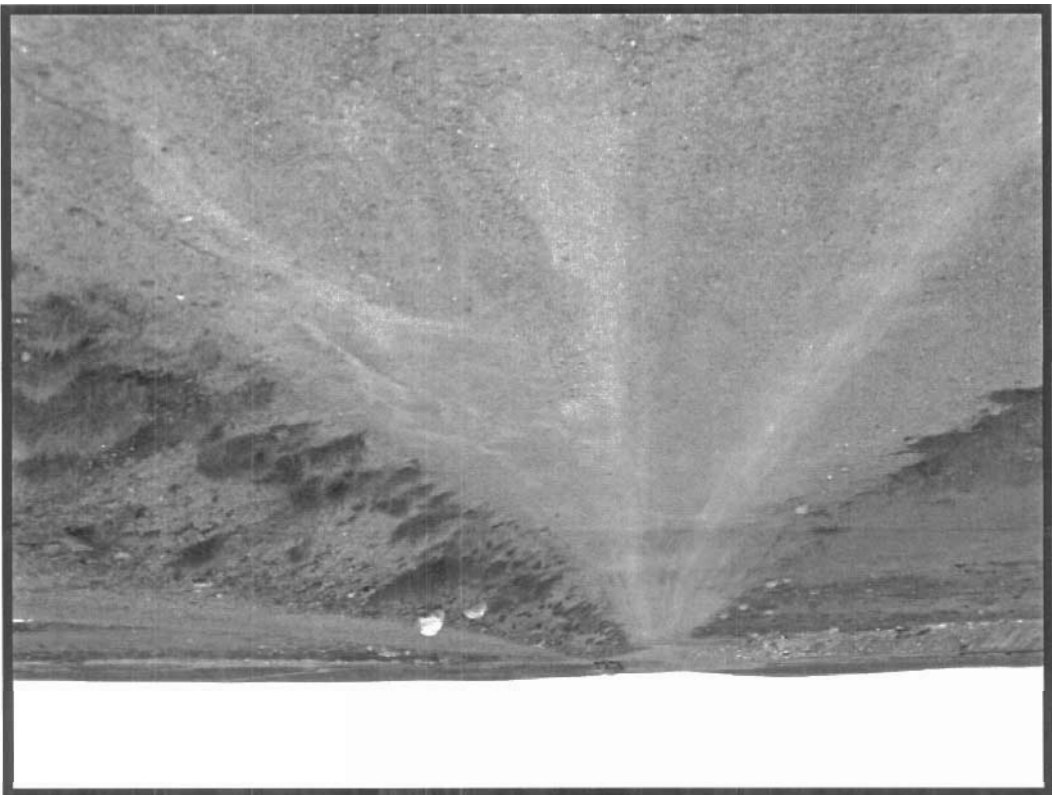
Photo 84 is a view along the toe access road berm on the downstream side. There are no major signs of erosion on the downstream face.

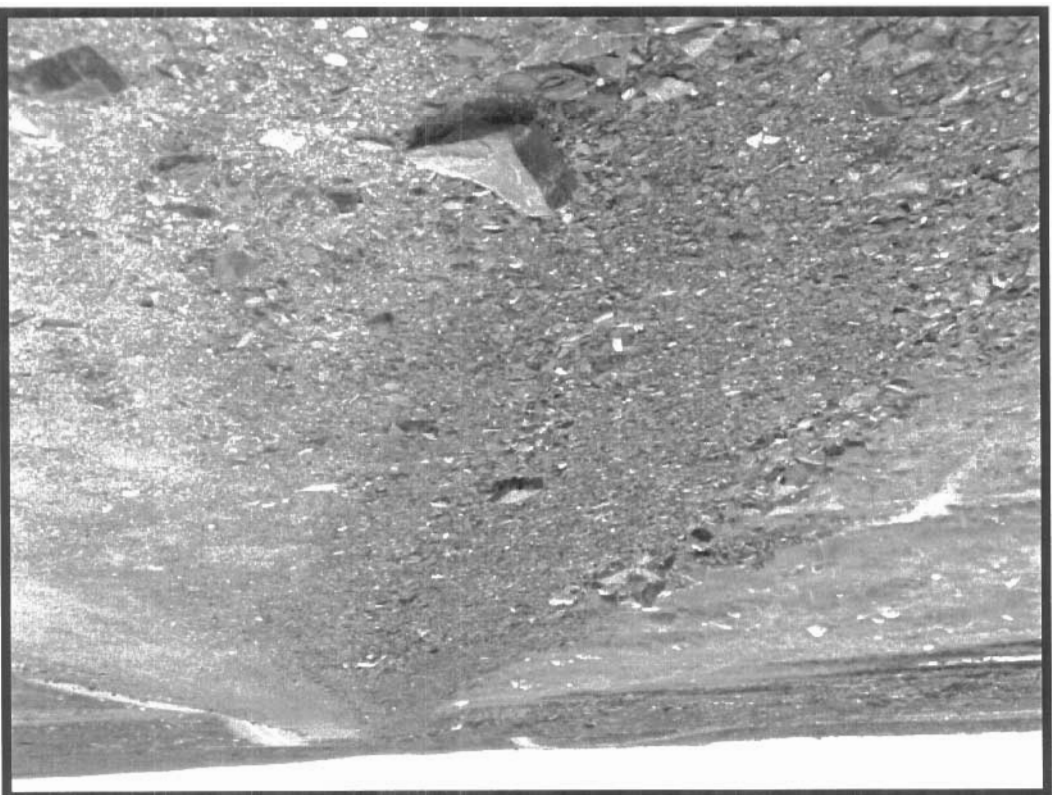
Photo 80 shows the upstream side of this dam. Note the undulating nature of the riprap. This dam does not retain any water at the current time.

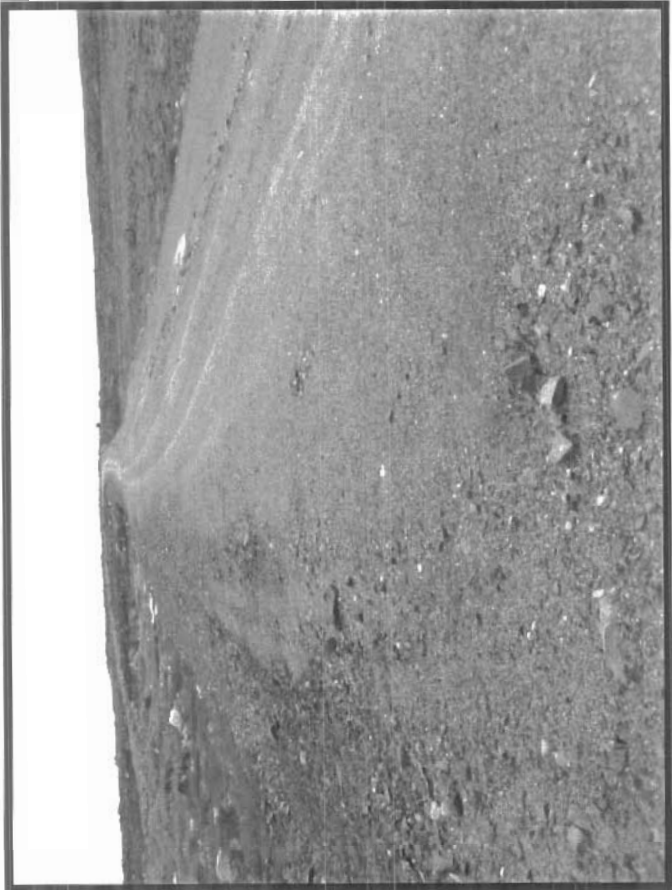
Photo 86 shows the crest and upstream side of this dam.

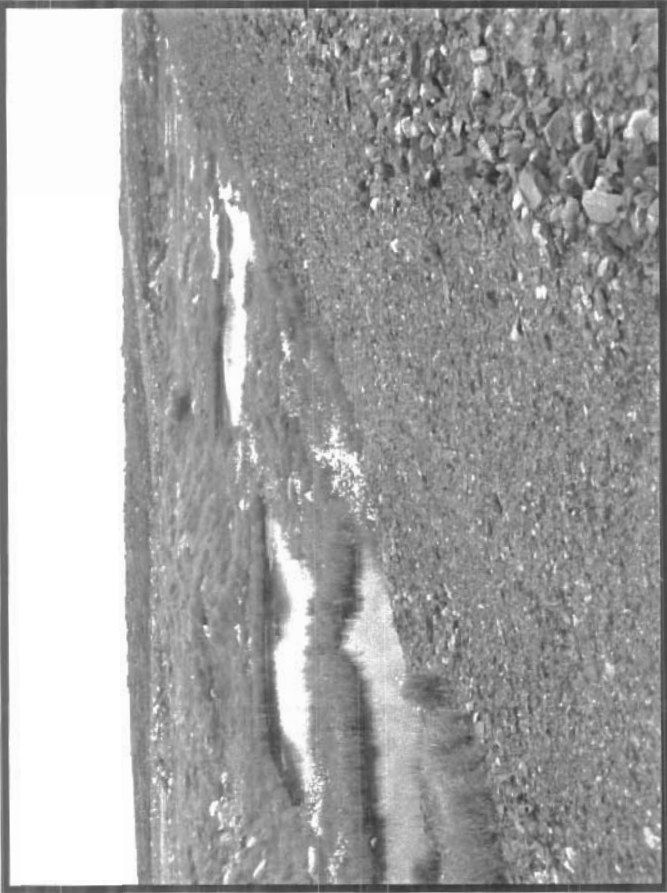
Photo 87 shows a number of small ponds which are located on the upstream side of Dam 1C. There is no large continuous retained pond against this dam.

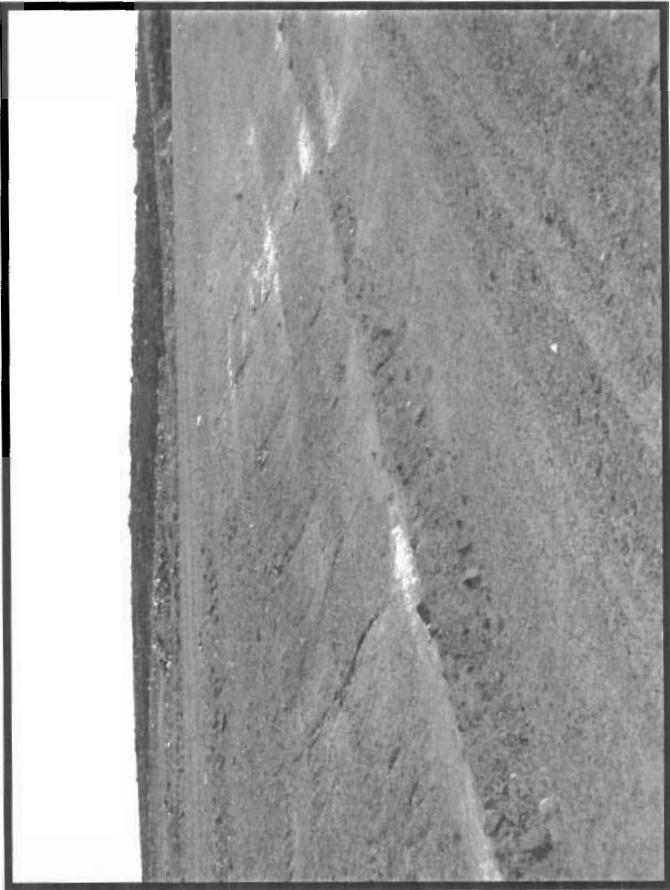
Photo 94 shows some minor erosional gullies on the downstream face.

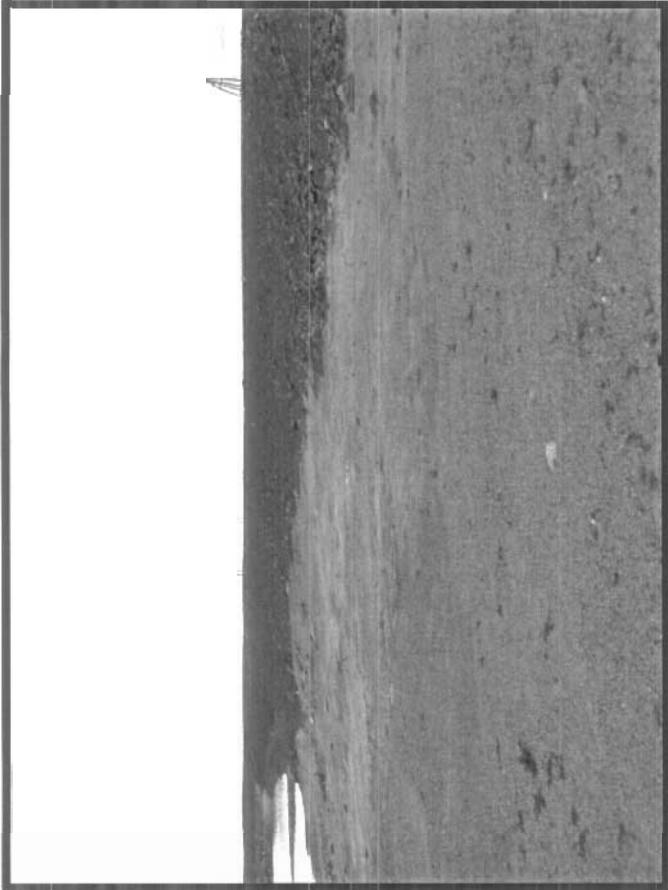
Photo 57 shows a view of the upstream side. The difference in the colour of the two riprap materials are obvious.

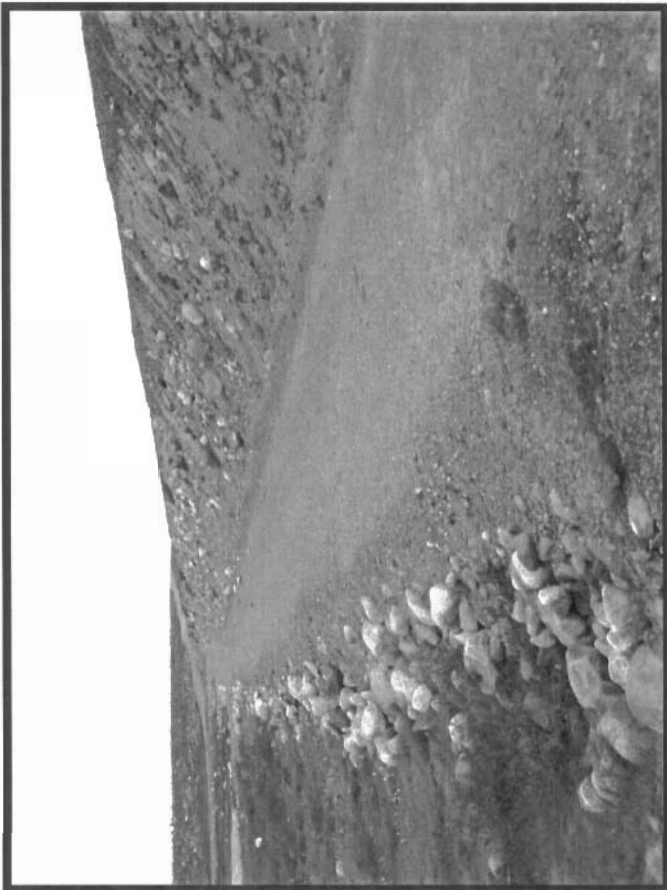
Photo 63 is a view of the downstream toe berm and the downstream side of Dam 2.

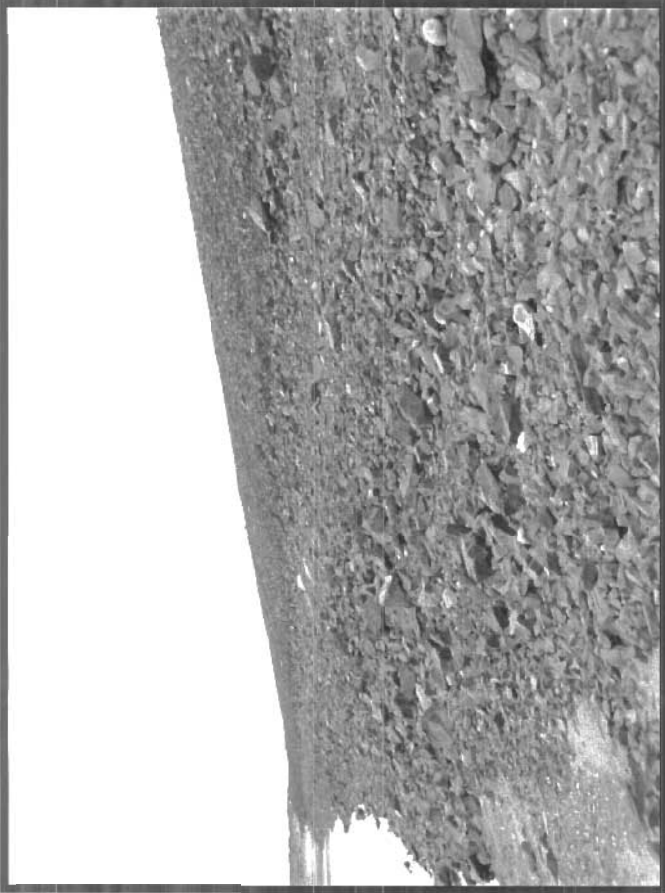
Photo 60 is a view of the upstream side showing an erosional scarp, which is formed at the bottom of the dark grey material. This erosional scarp is located probably some 2 to 2.5 vertical metres below the physical crest.

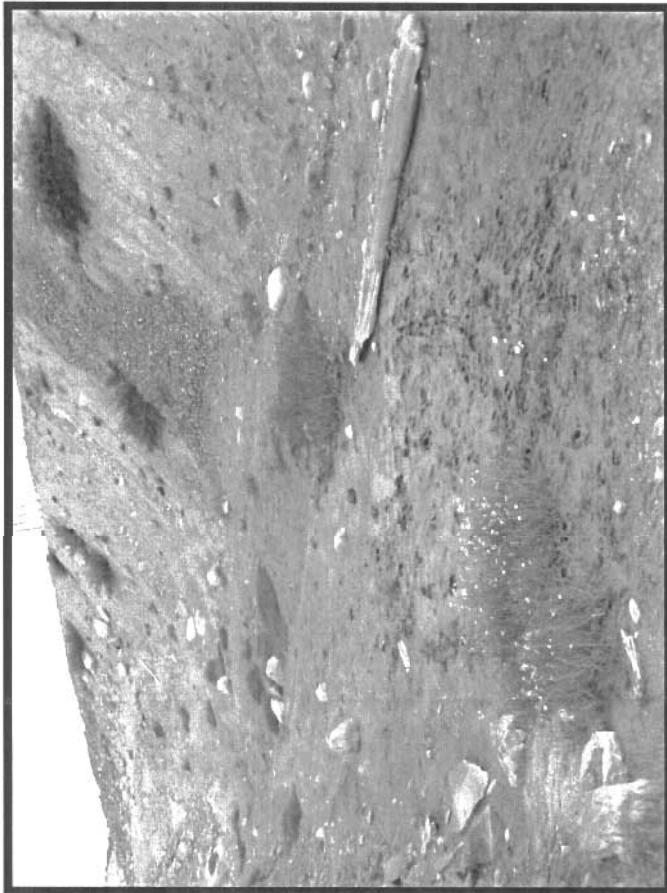
Photo 68 shows a small vegetation patch where typically a small amount of seepage is observed discharging from the toe of the dam. At the current time, there is no running water.
