**KINROSS**  
Gold Corporation

| PROJECT | Annual Inspection of Perimeter Tailings Dams | | | |
| TITLE | Dam 3 Inspection Photos | | | |

**BGC Engineering Inc.**  
AN APPLIED EARTH SCIENCES COMPANY

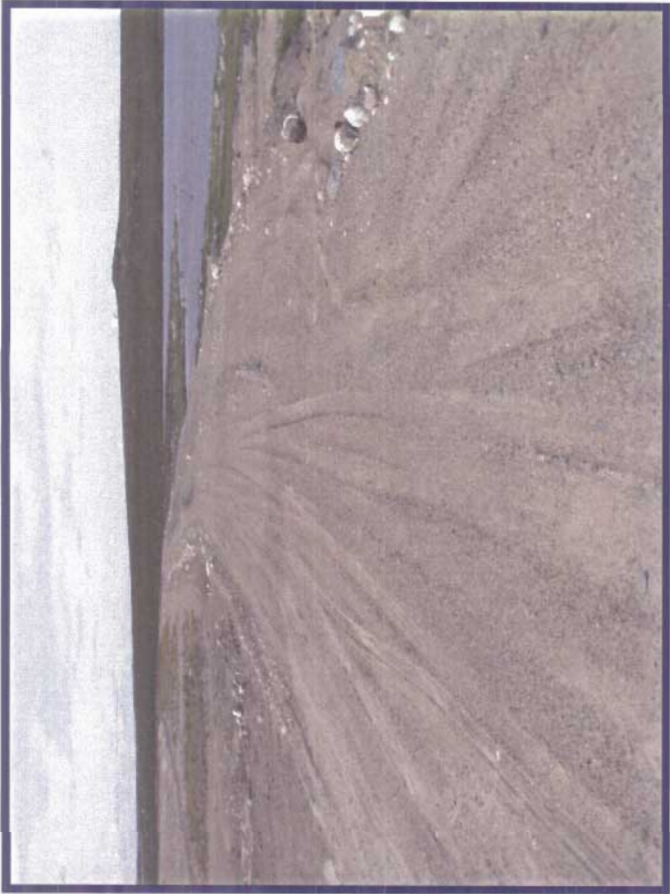
Photo 97 shows a shot of Dam 3 looking towards the north. The erosional gully noted here last year has been graded over and some changes to the crest have been made at the top of this reclaimed area.

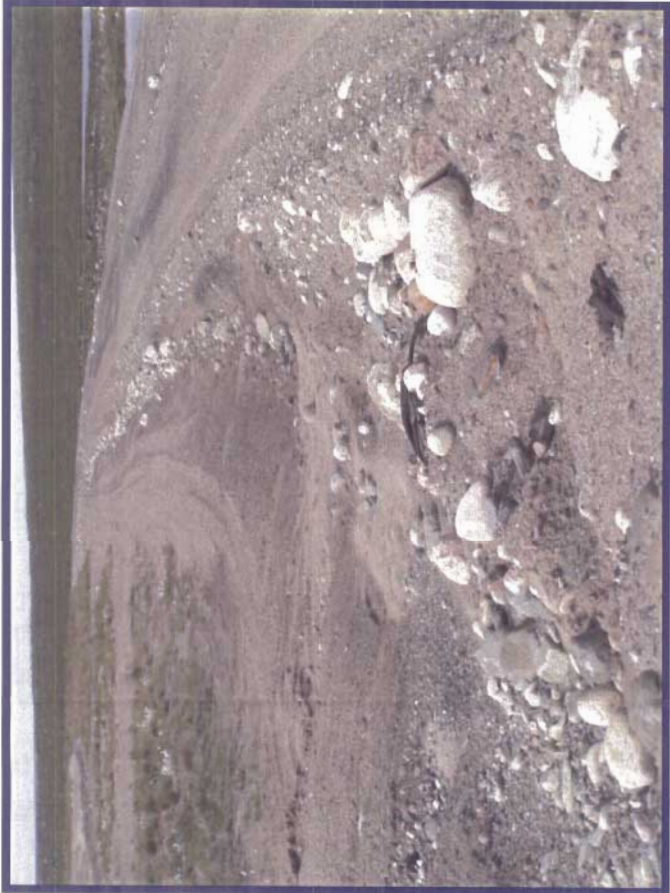
Photo 98 shows where a new ditch has somewhat established just to the upstream side of the access road berm.

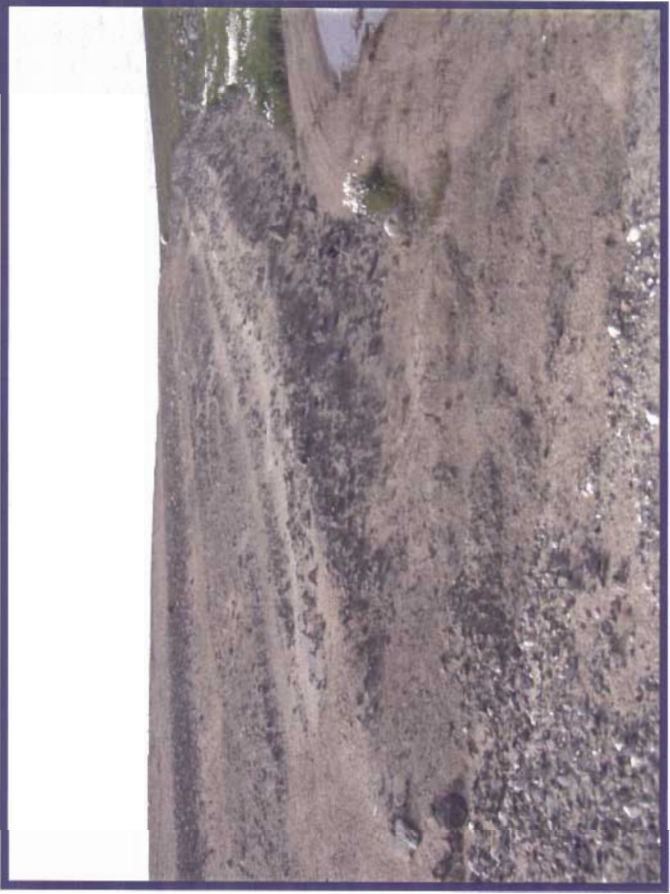
Photo 103 shows a view directly on the toe looking towards the north-northwest.

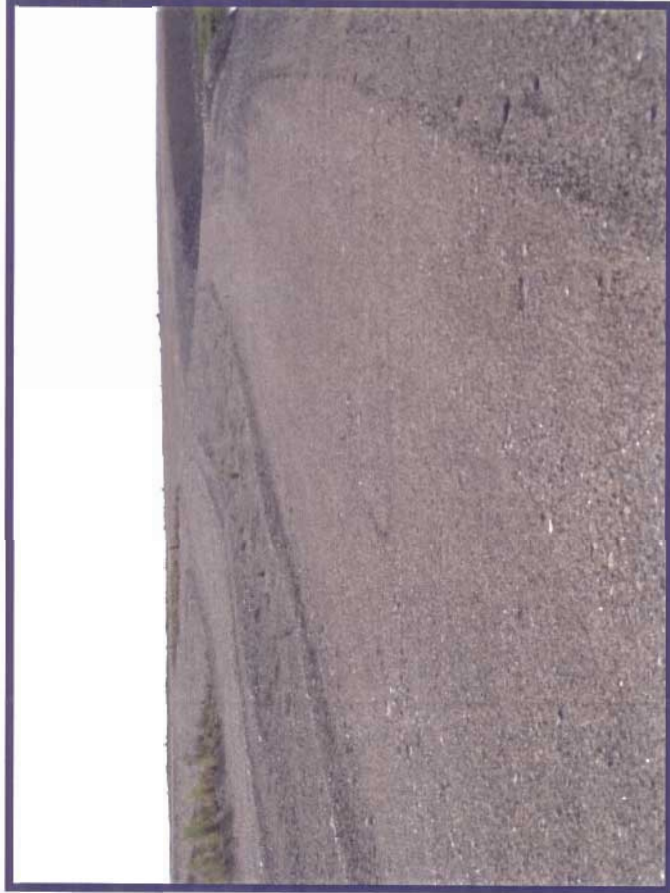
Photo 109 shows the upper crest of the reclaimed area. There are no signs of instability, settlement or cracking noted within these berms.

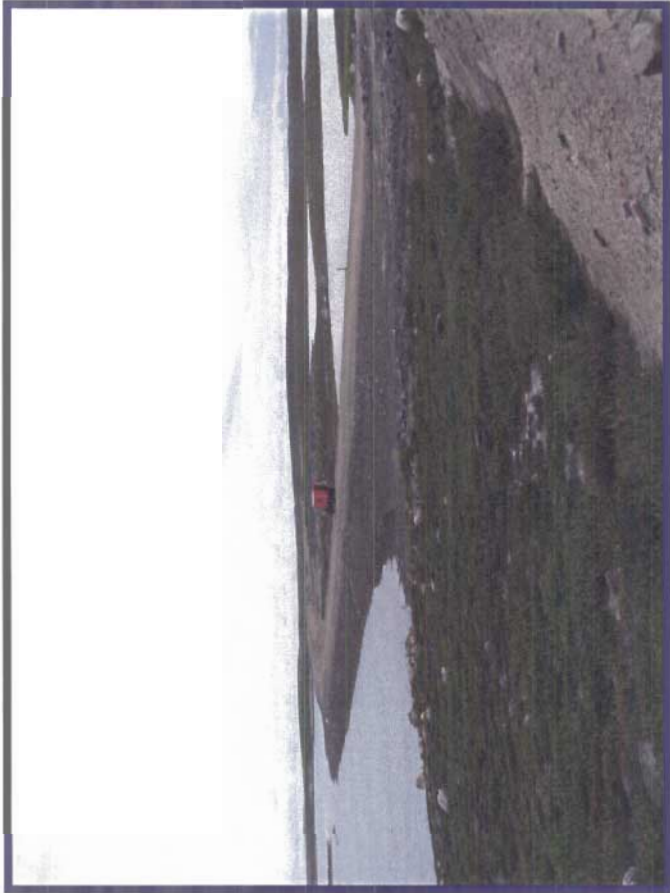
Photo 2 is a view of the crest and upstream side. The pump trunk on the crest is used to drain the water at the toe of Dam 4.

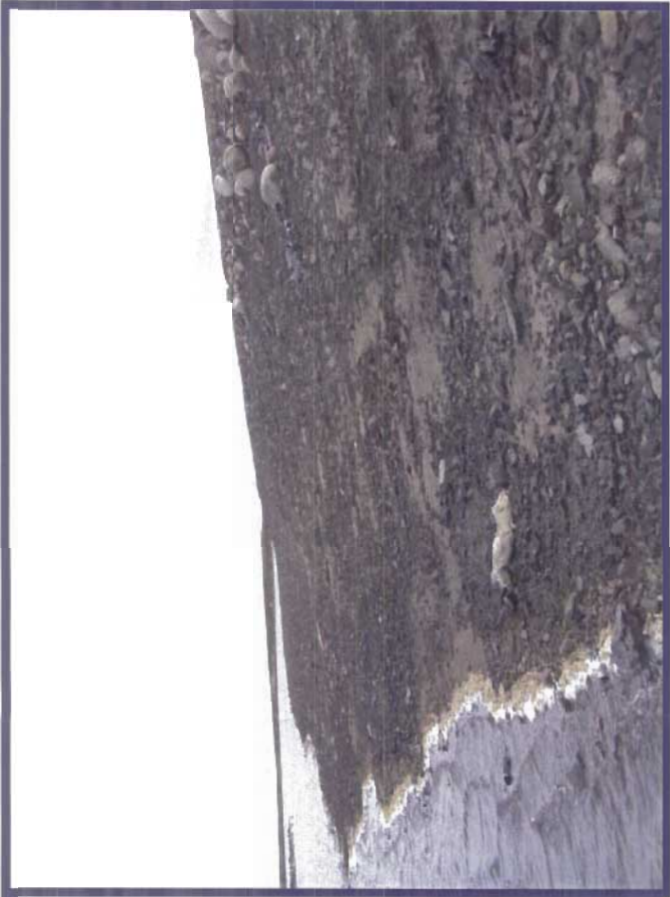
Photo 4 shows the upstream side of this dam. The distance from the current water level to the physical crest of the dam would be approximately 3 metres or just slightly less. There does not appear to be any signs of instability or settlement of the upstream face.

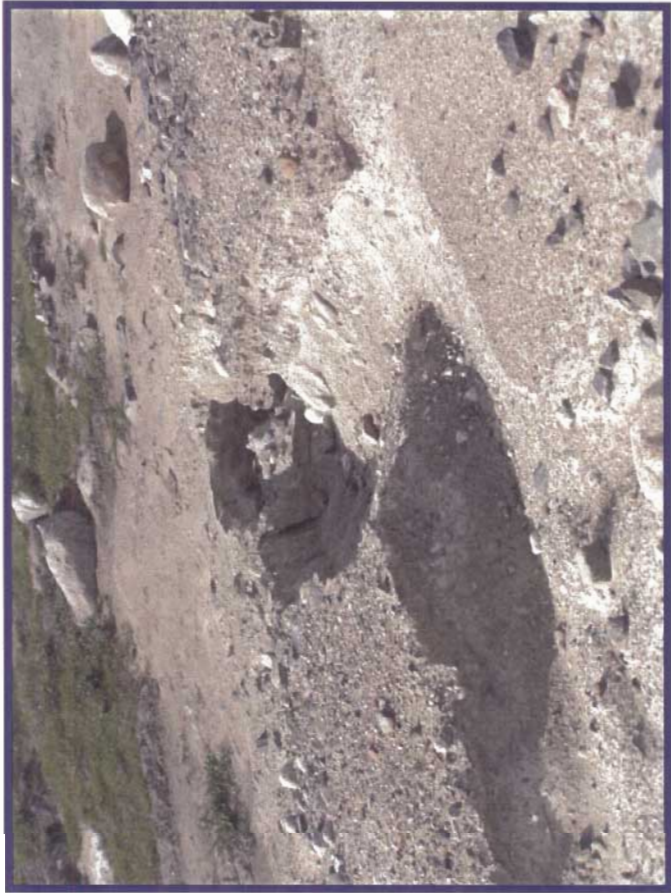
Photo 13 shows an erosional gully on the downstream face. This gully is located approximately 8 to 10 metres west of Thermistor 4-1. This gully should be backfilled to prevent any further erosion.

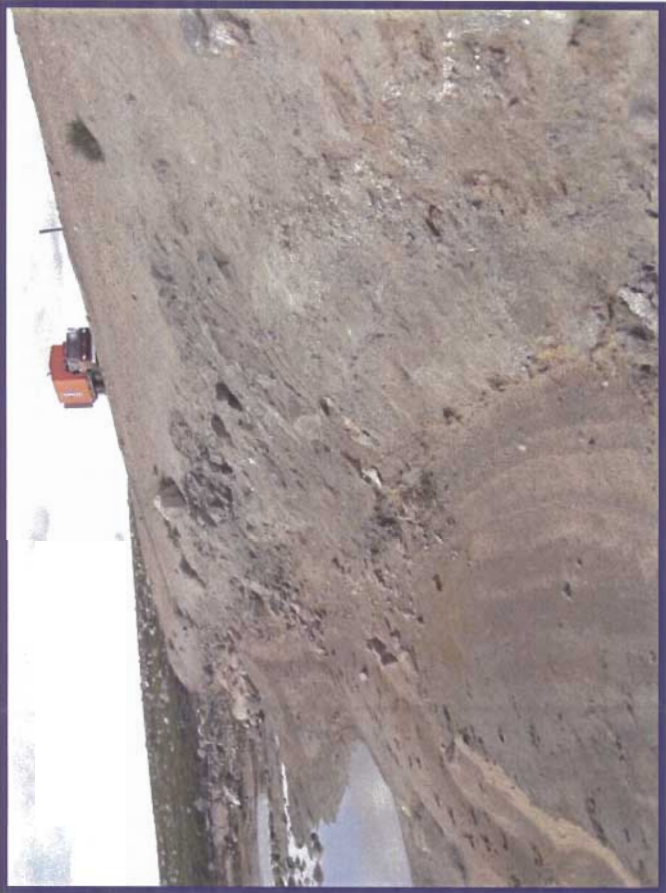
Photo 25 shows the steep toe located just above the seepage collection pond.

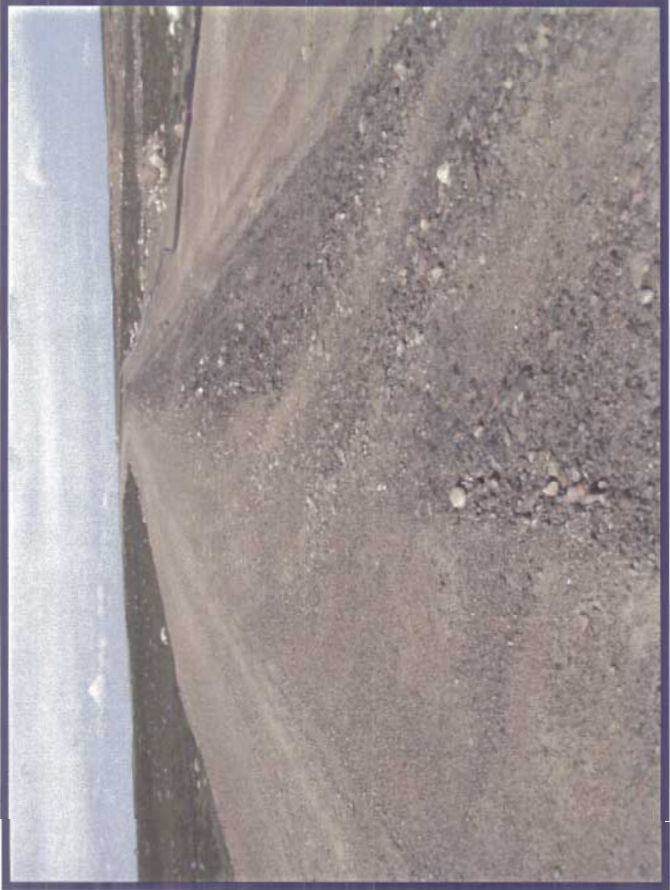
Photo 29 shows a view of the crest and upstream side of Dam 5 looking towards the west abutment. The dam doesn't currently hold any water or tailings.

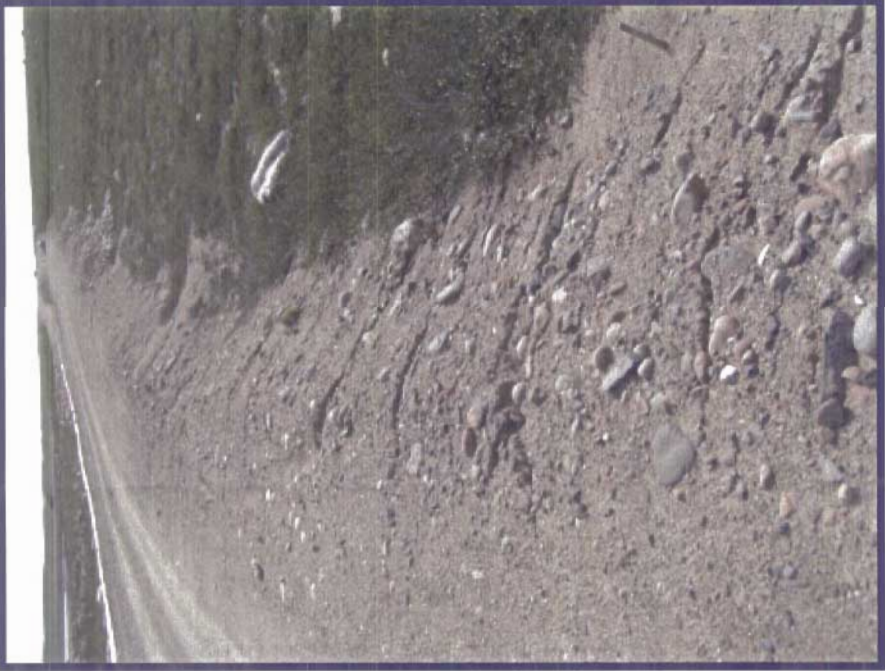
Photo 33 shows some minor erosional gullies located on the downstream side of Dam 5.

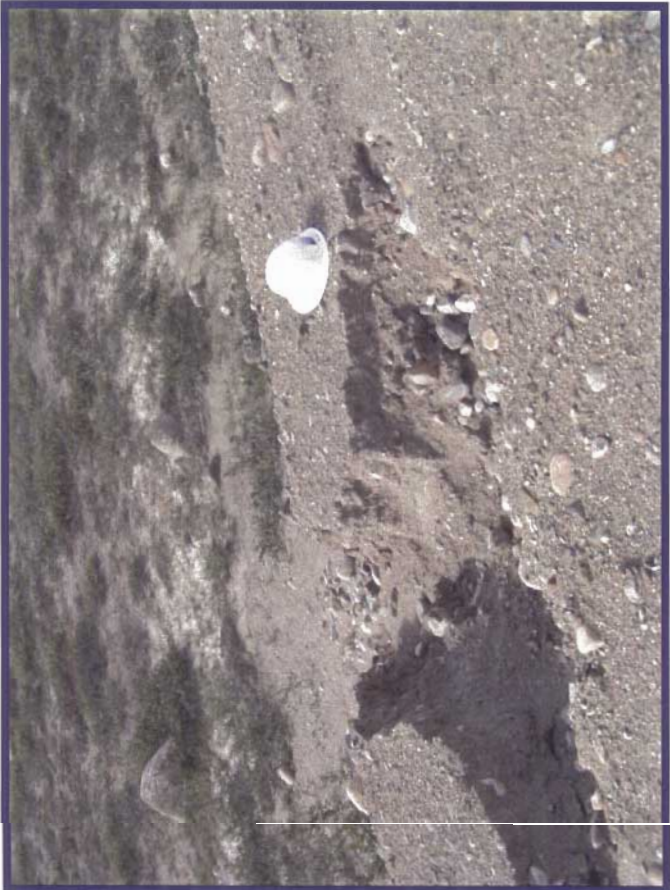
Photo 34 shows a significant erosional gully right in the middle of the downstream face. This gully should be repaired.

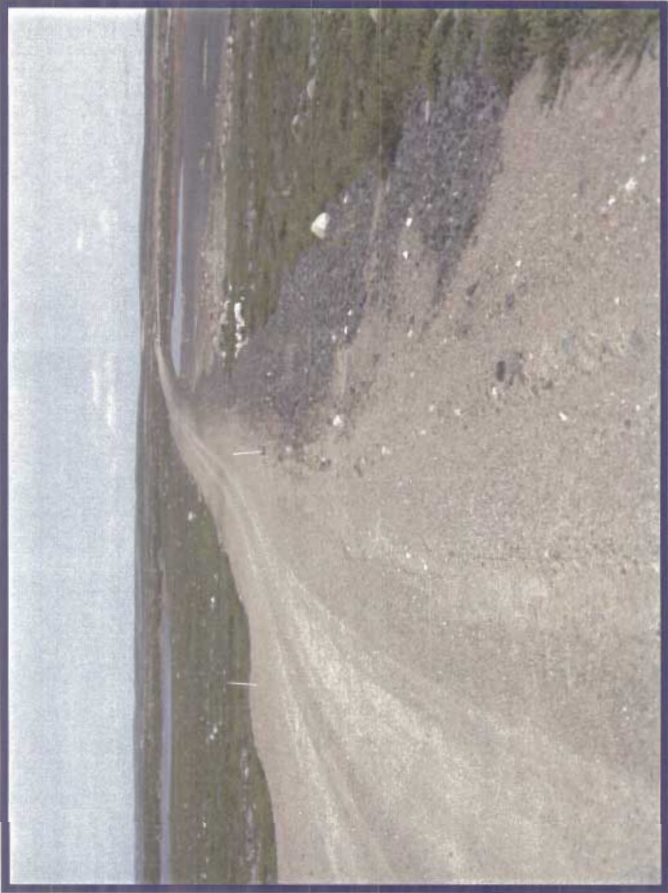
Photo 40 shows a view of Dam 6 taken from its south abutment looking north. There is only a minor pond currently retained at the far north end.

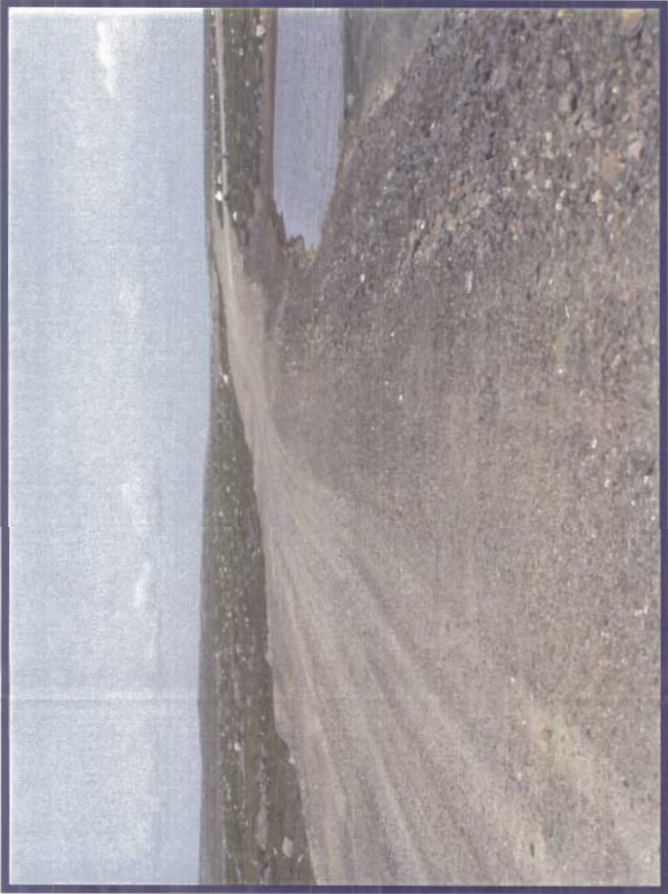
Photo 43 shows the crest over towards the north abutment of Dam 6. Some settlement on the crest has occurred perhaps due to thawing from this pond.

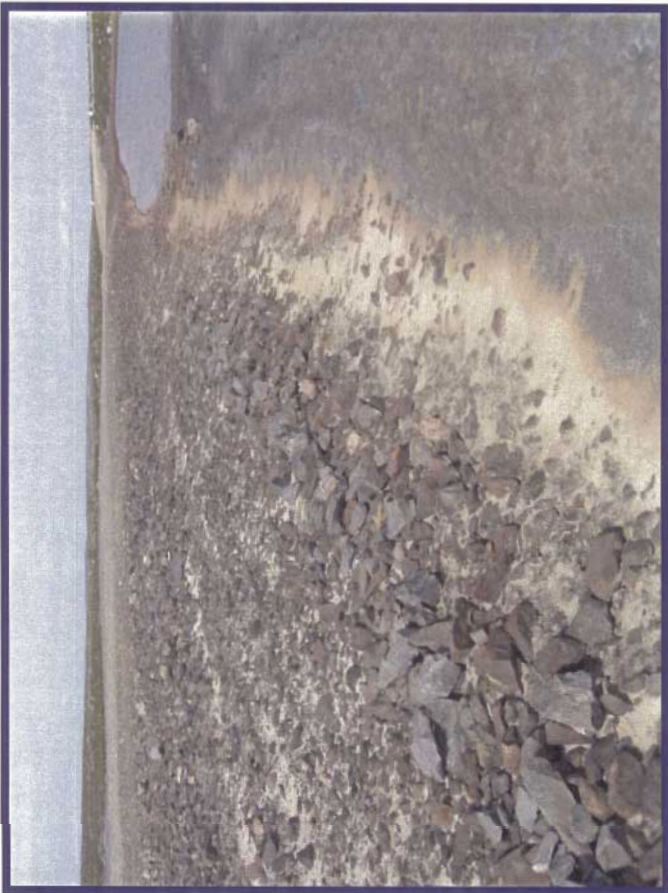
Photo 45 shows some sand which has blown off the crest and has accumulated at the toe of the upstream side against the tailings.

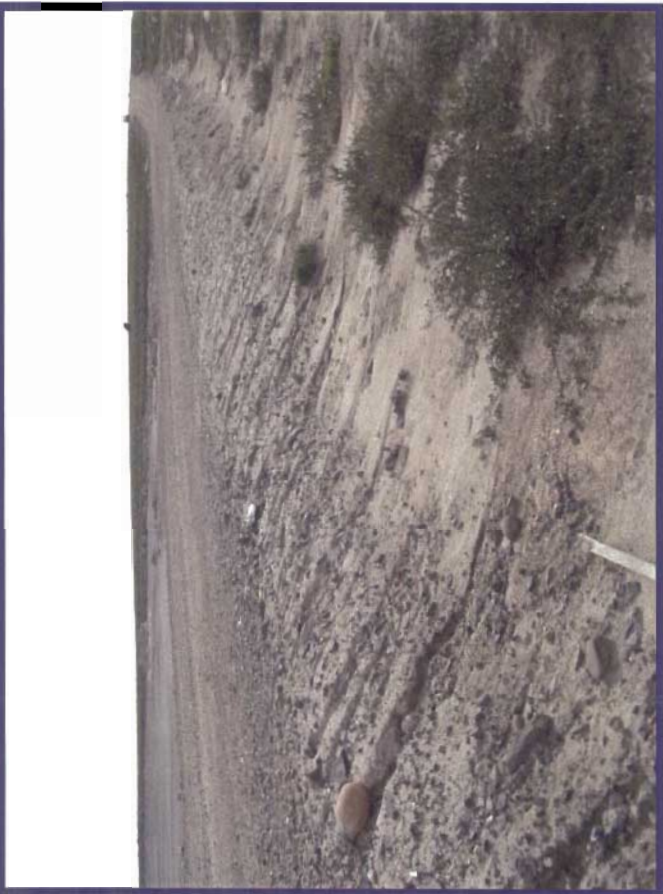
Photo 53 shows some minor erosional gullies located at this toe portion of Dam 6. There are no signs of seepage at this location along the toe.

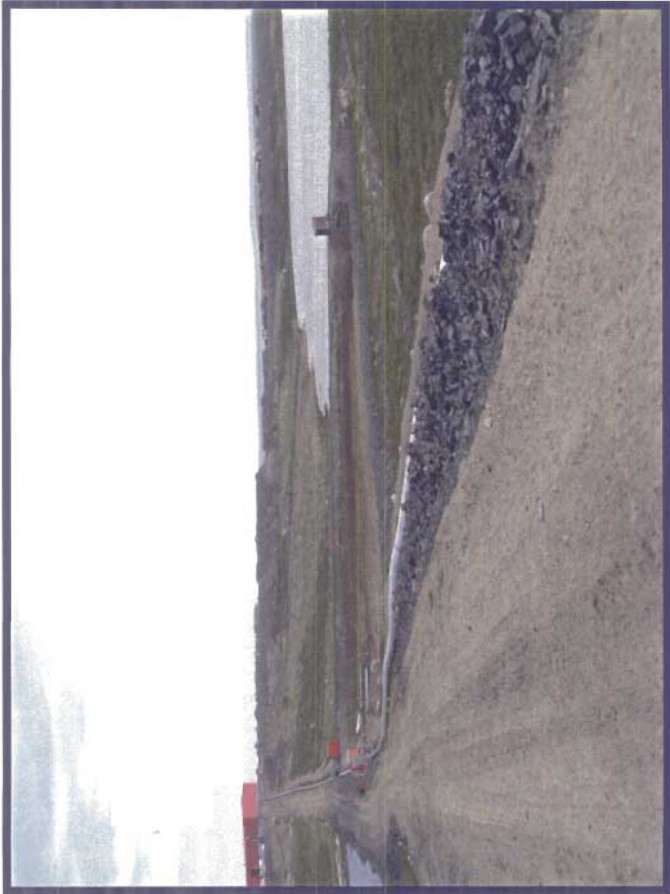
Photo 206 shows an overall view of the dump pond and retention dike. On the far left side is also the access road berm and sewage retention dike.

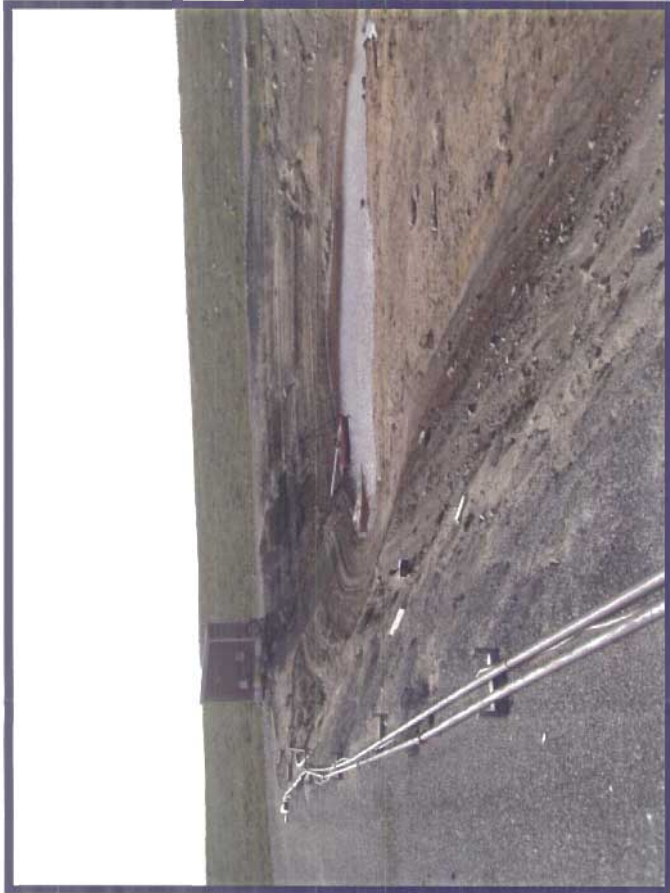
Photo 209 shows the small pond, the floating barge and the pump shack located on the bend of the retention dike.

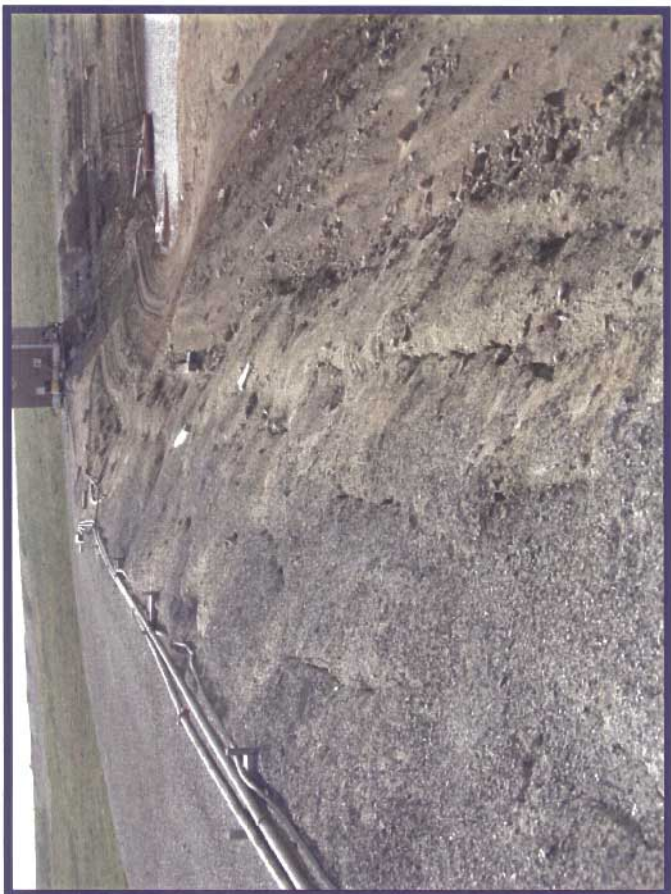
Photo 210 shows numerous longitudinal tension cracks on the inside slope. Each crack has a settlement trough, indicative of the marginal stability of the upstream side. We also have several scarps which were notched by the higher water mark of ponds.

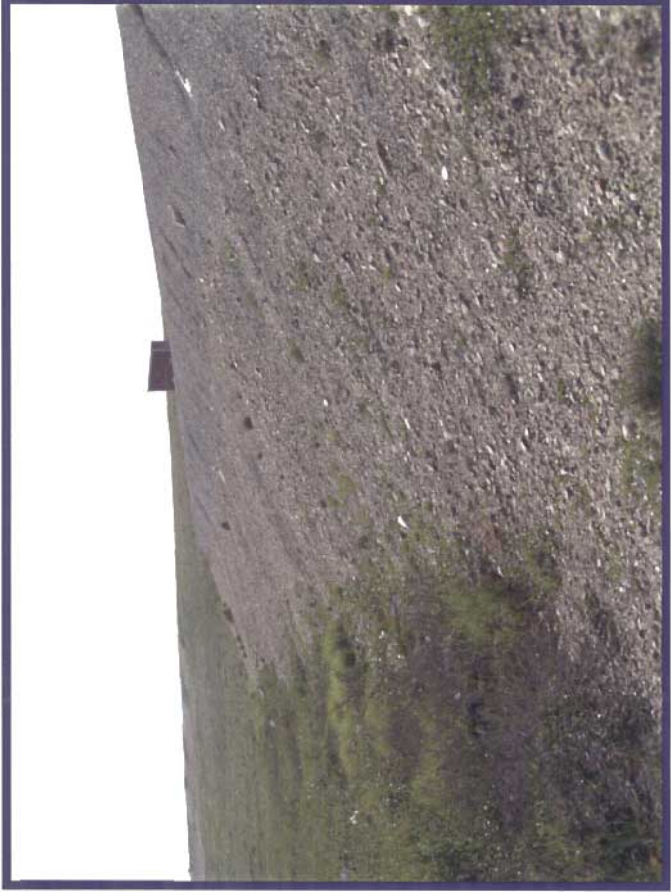
Photo 208 is a view taken along the toe looking towards the east. From this viewpoint there are no indications of seepage at the toe. No seepage would be expected since there is only a very small pond being retained on the upstream side.

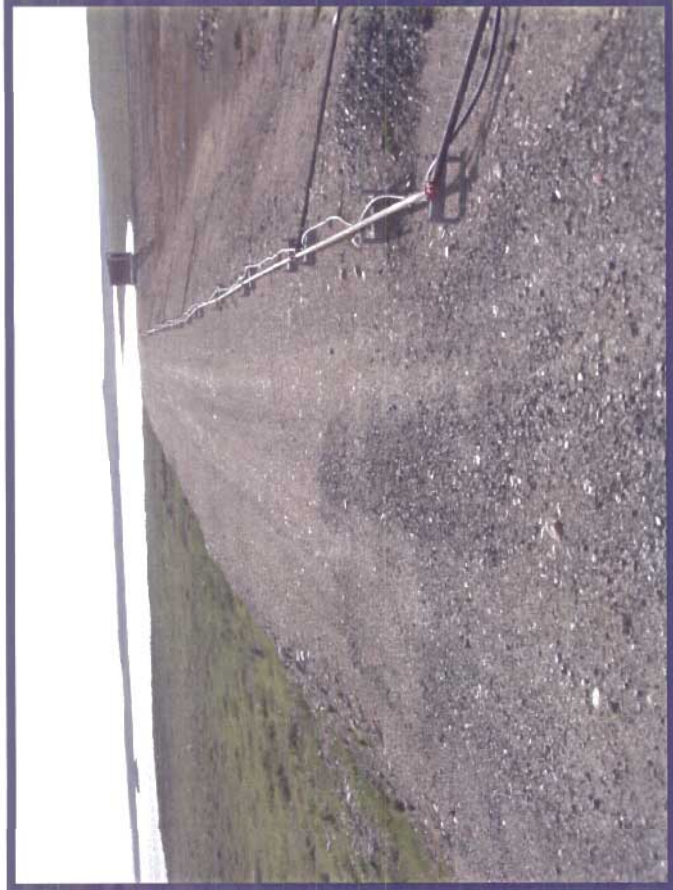
Photo 194 shows the crest of the northern leg of the retention dike. This crest is approximately 4 metres wide. The dike appears to be constructed with esker sand and gravel. There is no riprap on the upstream slope at all.

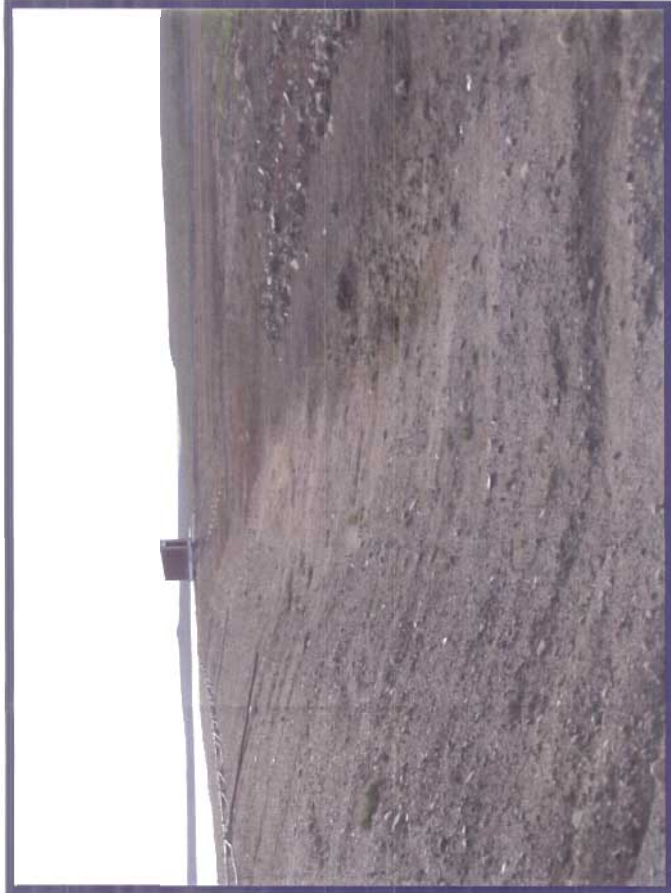
Photo 195 shows a view of the low point on the upstream side of the retention dike. At the current time, there is no water within this area.

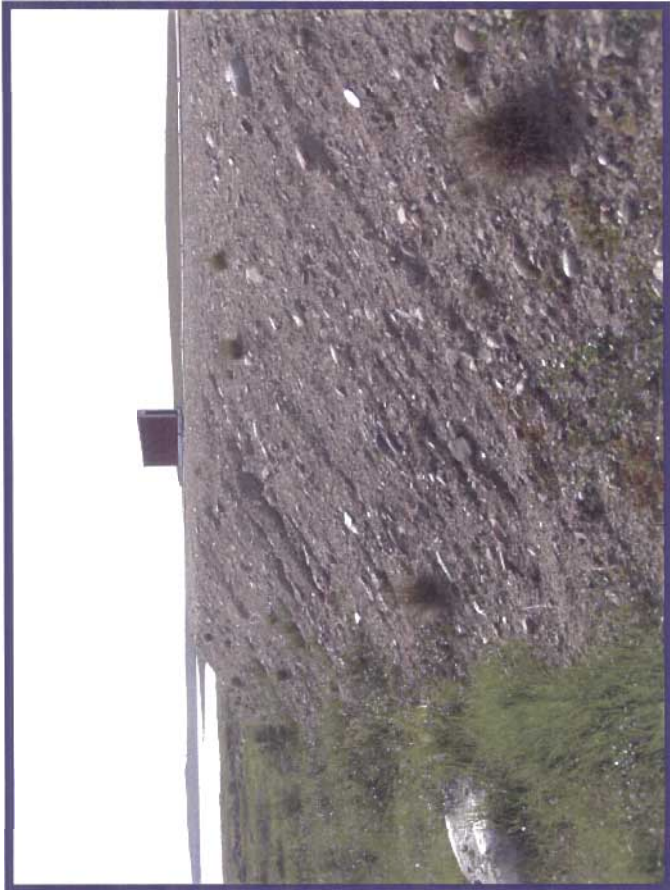
Photo 196 is a photo of the downstream side of the retention dike showing the fill placed directly on native material.

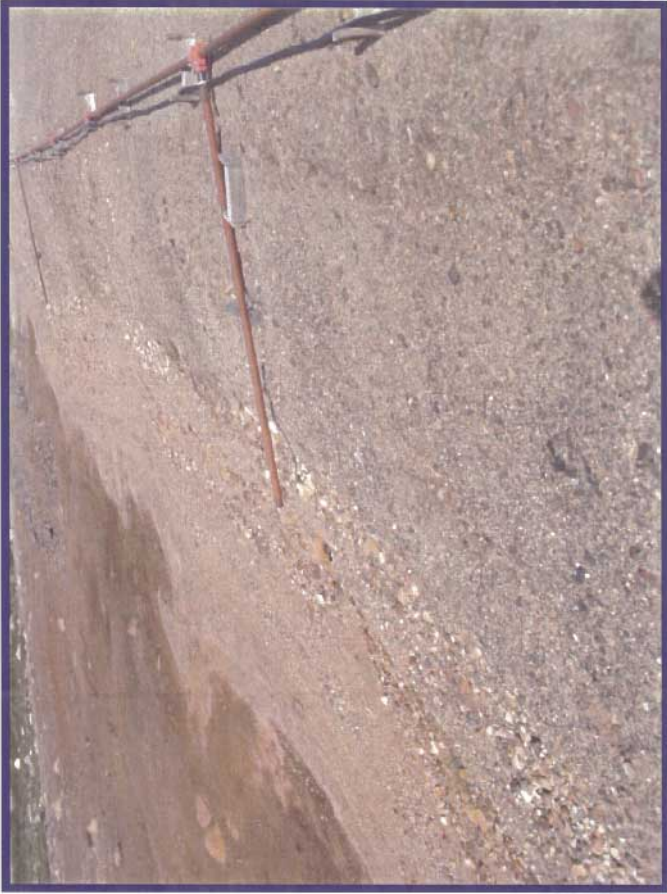
Photo 197 shows a longitudinal tension crack located just left of the steel pipeline. In addition, we see a number of small scarp on the upstream side.

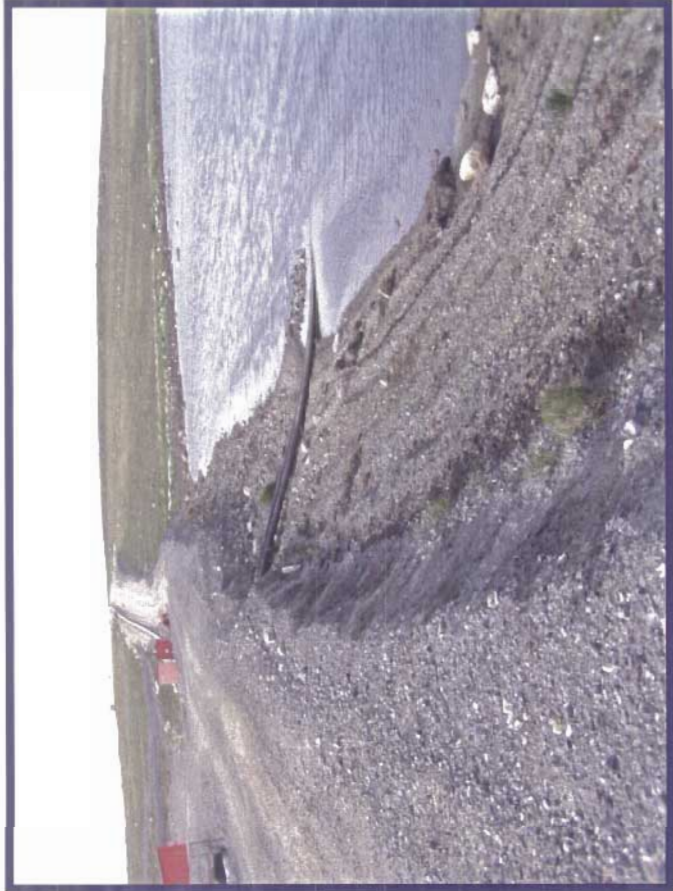
Photo 223 is a view of the upstream side looking towards the south. We see an oversteepened initial part of the slope for the first 1 metre of height. Then we get to a flatter slope where it has been eroded down by higher pond levels.

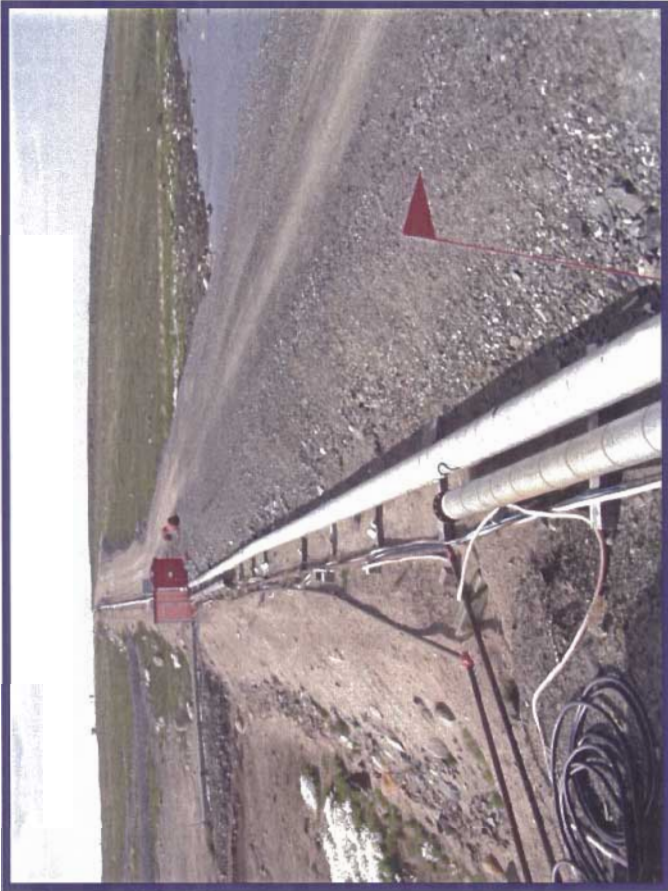
Photo 227 shows the crest, looking towards the south in this viewpoint. The tailings pipeline sits on the lower berm.

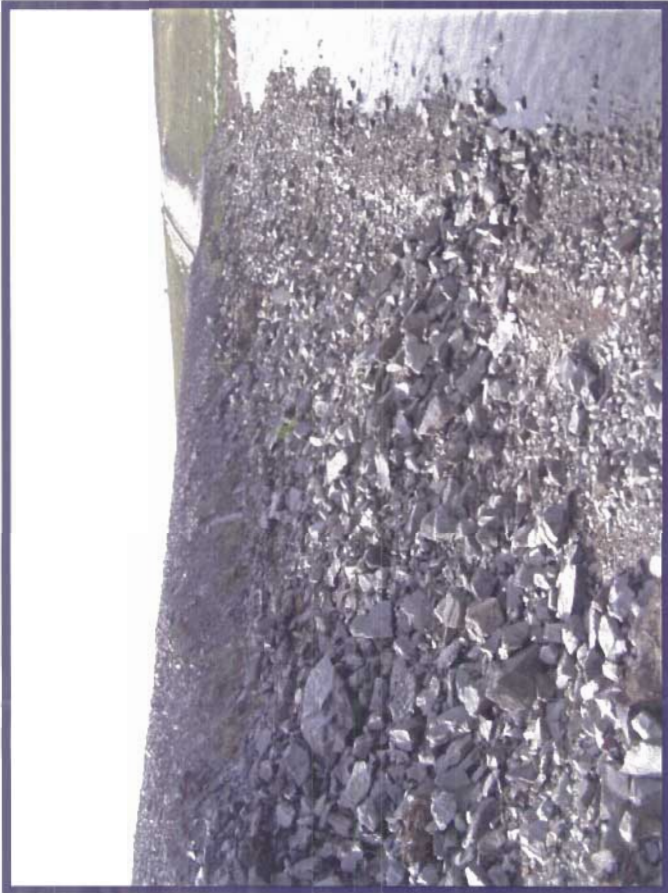
Photo 225 is another view on the upstream side. From the current water level to the physical crest would be approximately 2.5 metres at this particular location.

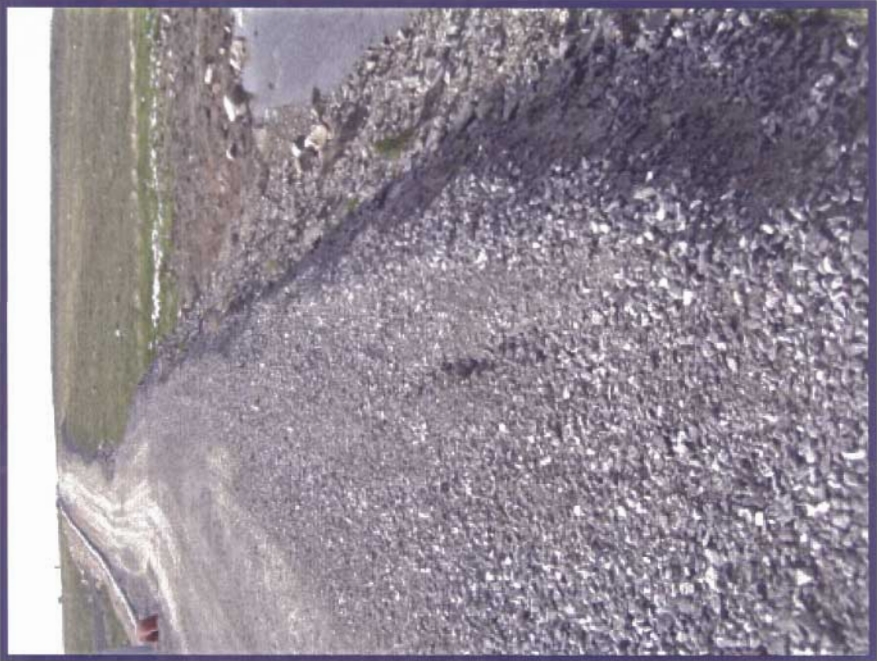
Photo 228 shows a longitudinal tension crack near the crest edge on the upstream side. This crack is related to the oversteepened slope immediately to the right.

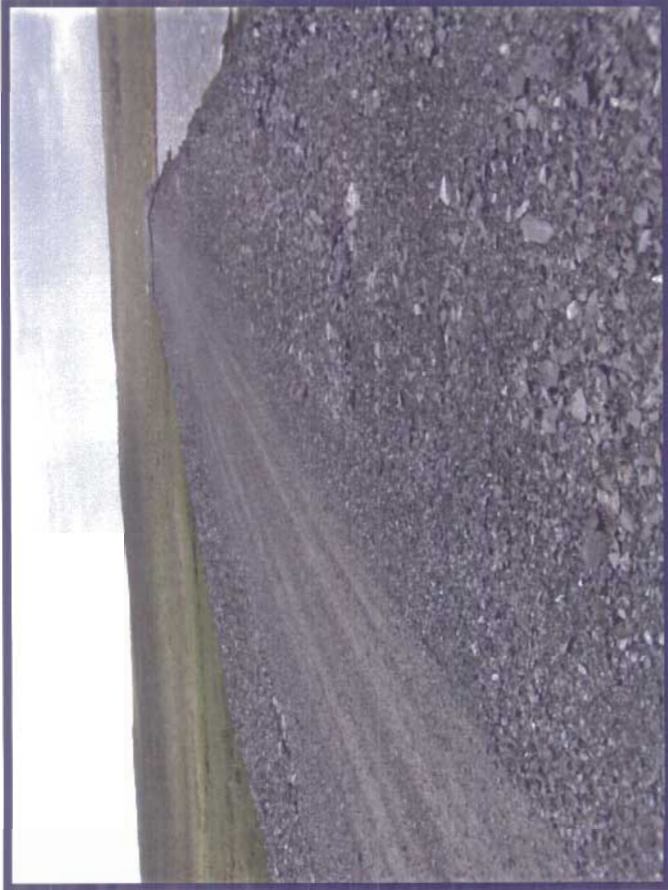
Photo 240 shows a view of the crest of this dike. The entire crest is approximately 14 metres across. The central portion is well traveled. Rockfill armours both sides of this dike.

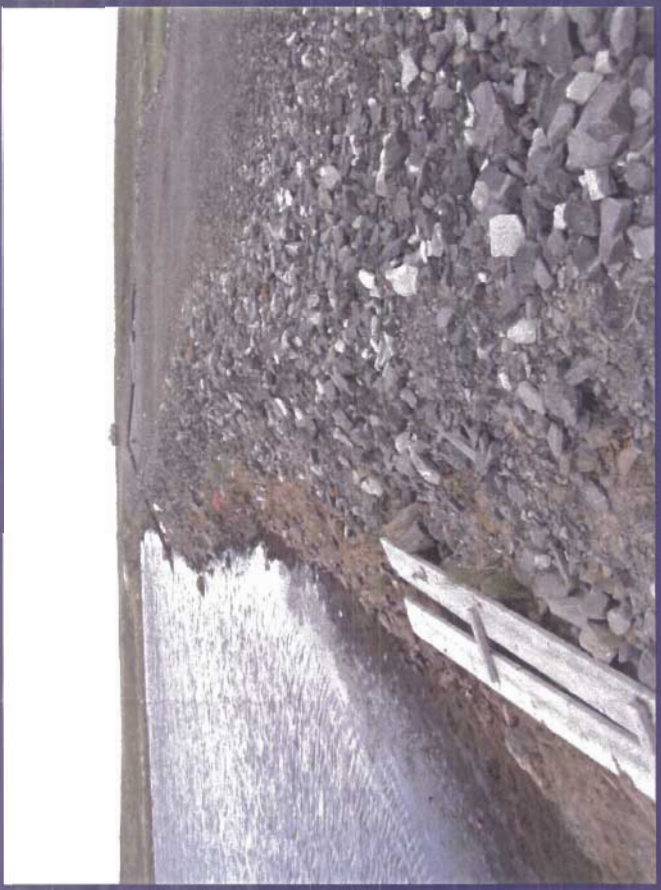
Photo 245 shows the upstream side looking towards the north abutment. We see that vegetation has been washed up to a higher level than the current pond level.

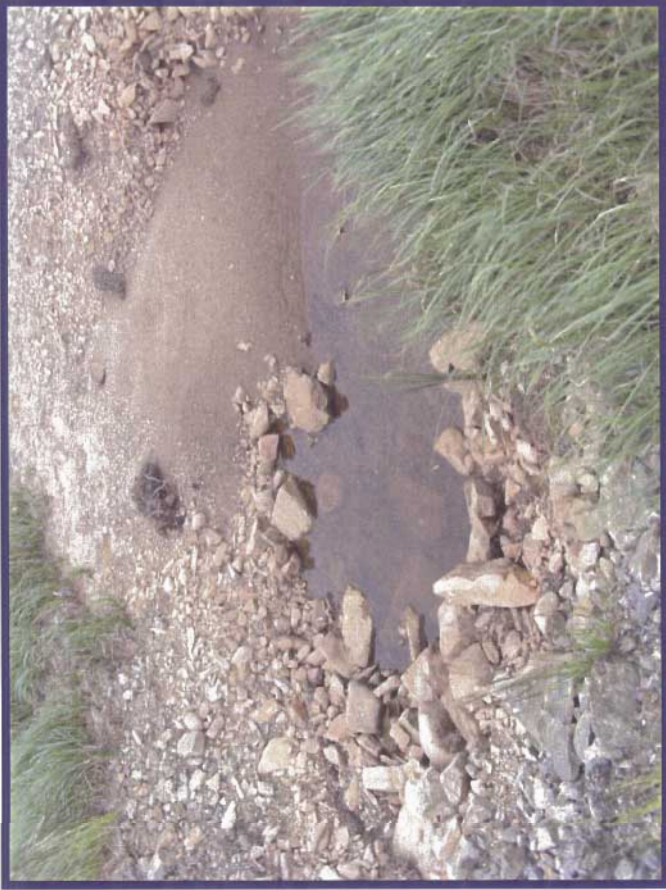
Photo 247 shows some standing water directly at the toe of the dam. There are no indications that the water is flowing into this area. It may be surficial runoff that has drained towards this local low spot.

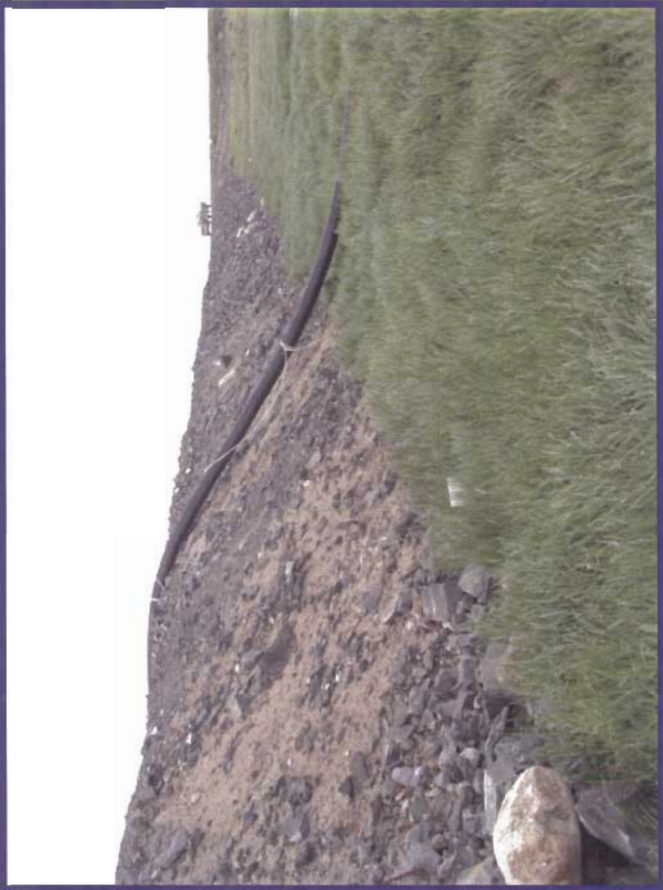
Photo 248 shows a view of the toe of the dike looking back towards the truck at the north abutment. The height of the dike above natural grade is approximately 3 metres at this location.
