**RE: KINROSS Gold Corporation (Echo Bay Mines Ltd.), Lupin Operation
Water License NWB1ULU0008, 2004 Annual Geotechnical Inspection**

2004 GEOTECHNICAL INSPECTION PERIMETER TAILINGS DAMS

LUPIN MINE NUNAVUT

PROJECT NO.: 0256-009-02
DATE: NOVEMBER 8, 2004

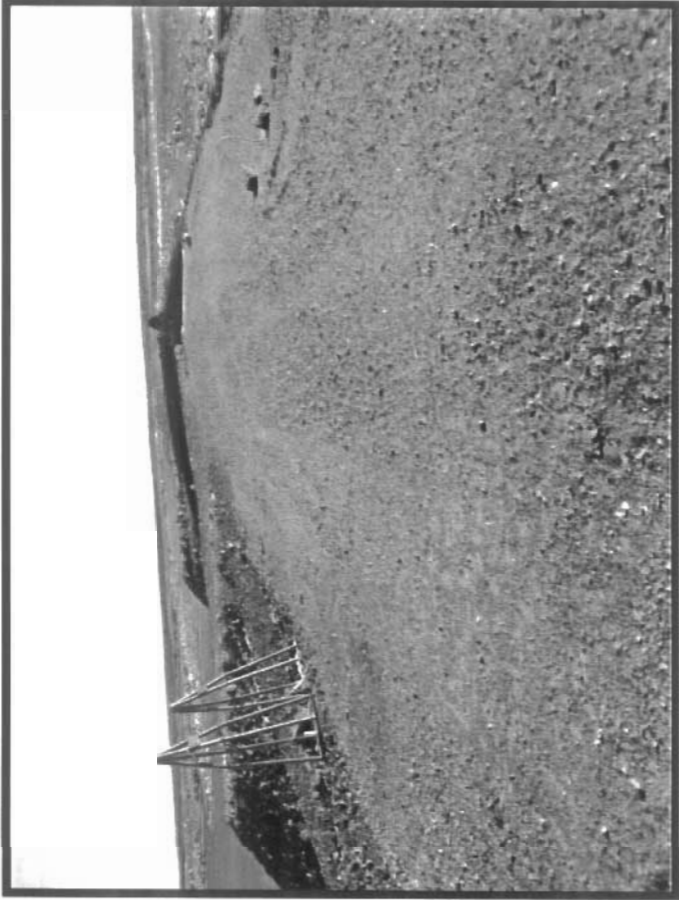
Photo 17 shows a view of the crest looking towards the south abutment.

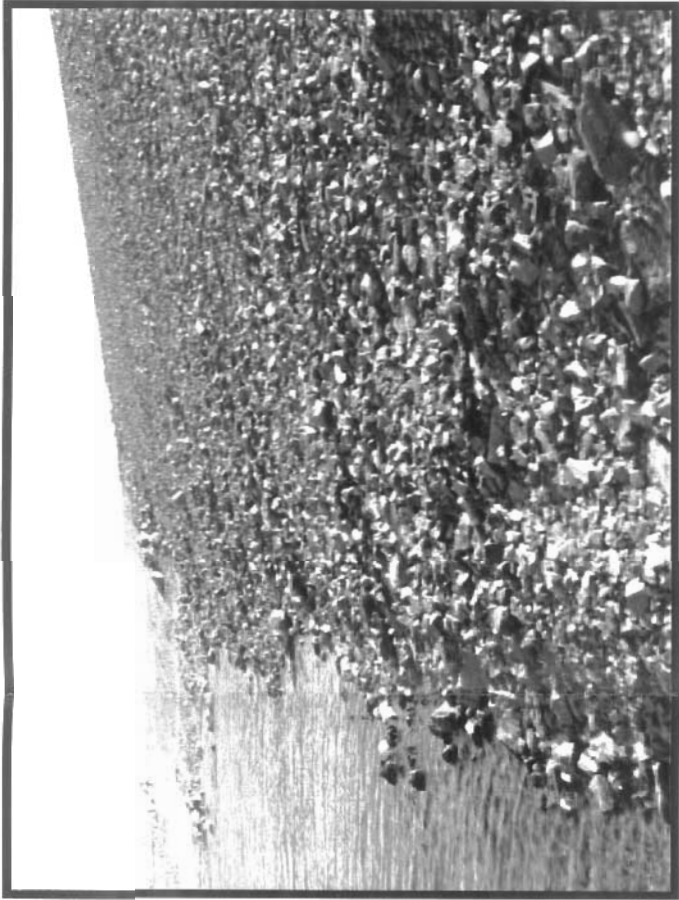
Photo 19 shows a view of the riprap on the upstream side. The distance from the water level to the crest of this dam is approximately 3.5 metres.

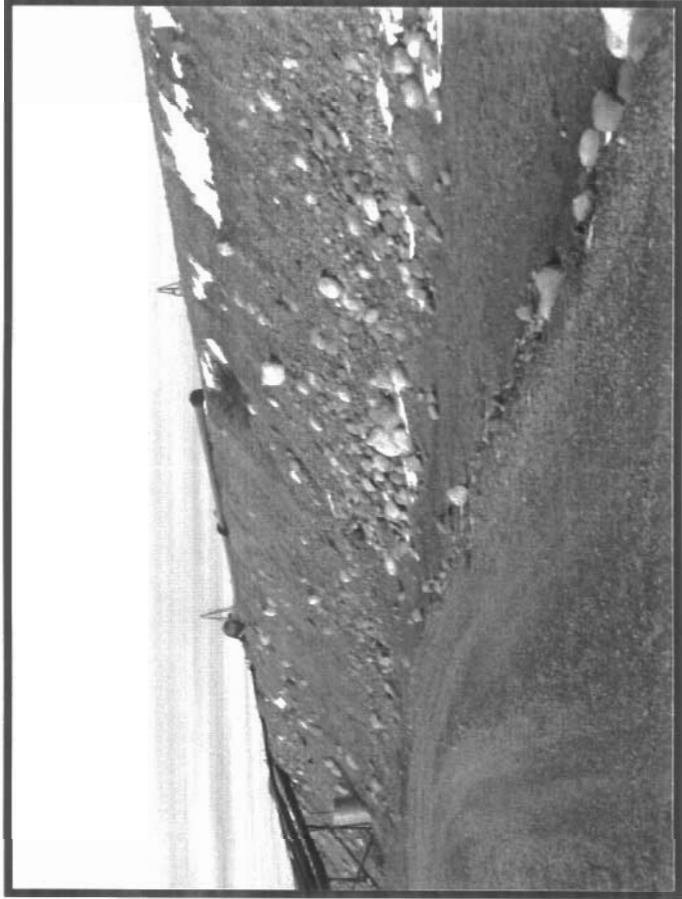
Photo 23 shows the alternating colour pattern of the dark grey angular rock over top of the light brown esker sand and gravel on the downstream slope.

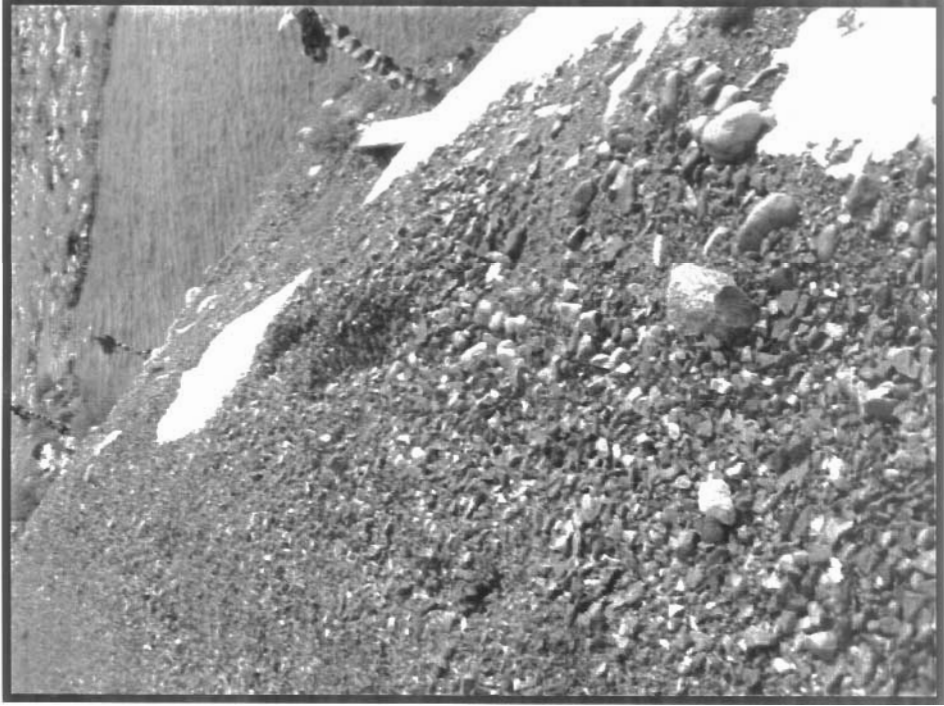
Photo 27 shows some longitudinal cracks formed in the angular rock fill. These cracks were previously noted proximal to the valve locations.

- Minor cracking continues to occur adjacent to the siphon pipes at the downstream access road berm.
- One small sinkhole is located in the access road fill, directly adjacent to the center syphon pipe. This sinkhole should be backfilled.
- No other maintenance is suggested.

Backfill small sinkhole in the toe berm fill adjacent to the center discharge pipe. Monitor minor cracking at toe of downstream berm and repair as required.

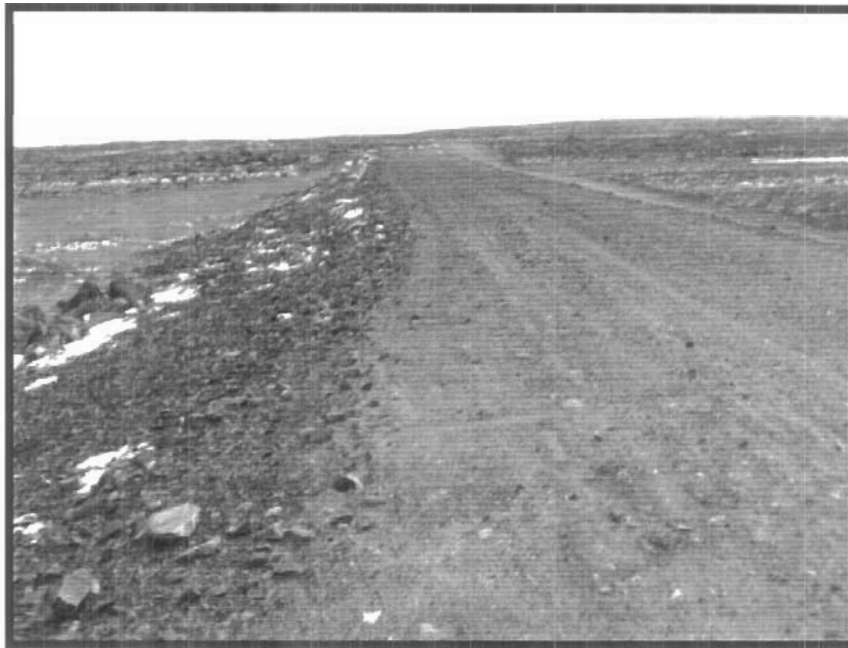
Photo 29 is a view of the crest on the upstream side. As previously noted, the riprap on the upstream side is relatively undulating. This dam does not currently retain any water.

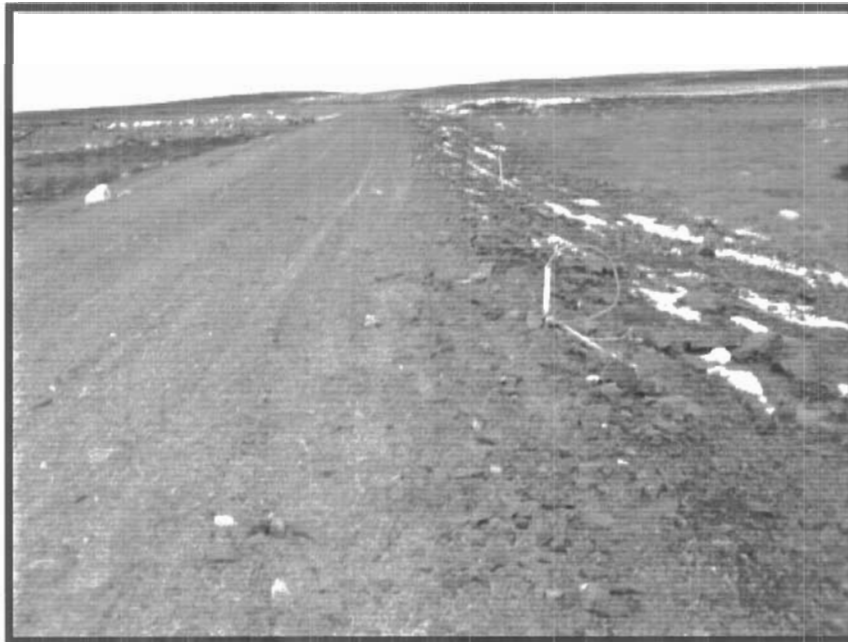
Photo 31 is a view of the crest on the upstream side again looking towards the north.

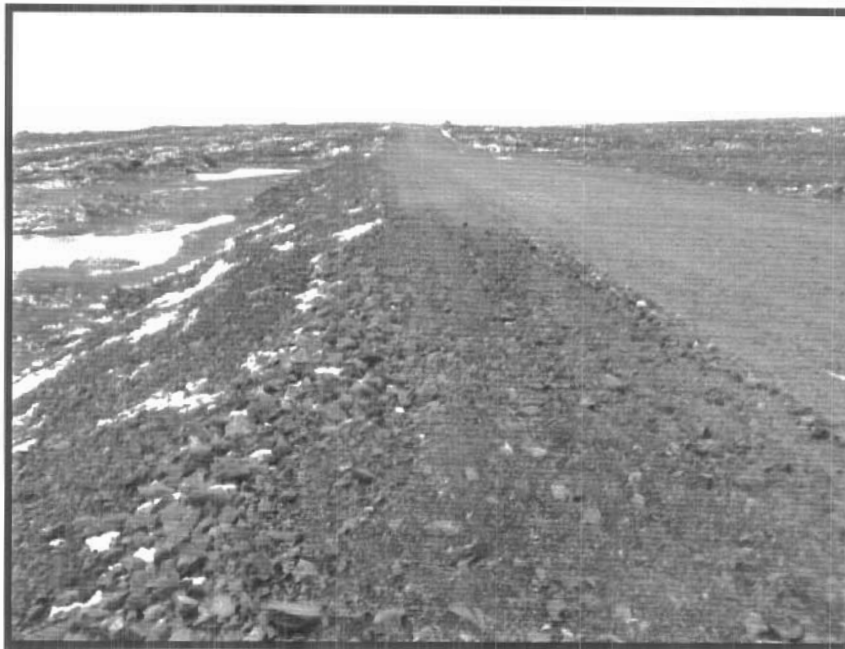
Photo 35 shows the upstream side and the crest. We do have a slight undulating nature to the riprap, likely a result of construction traffic activity.

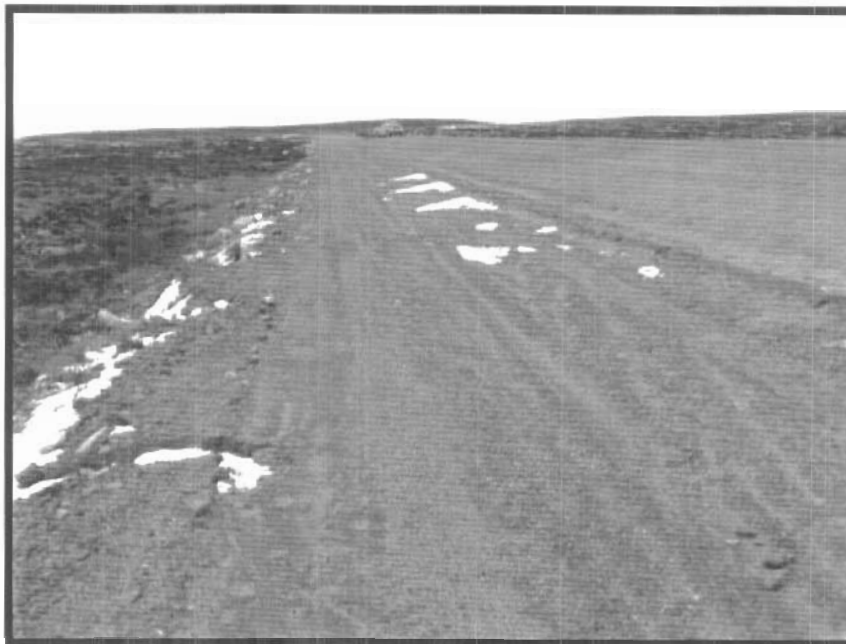
Photo 38 is a view along the access road toe berm. The downstream side has no signs of deformation or cracking from this perspective.

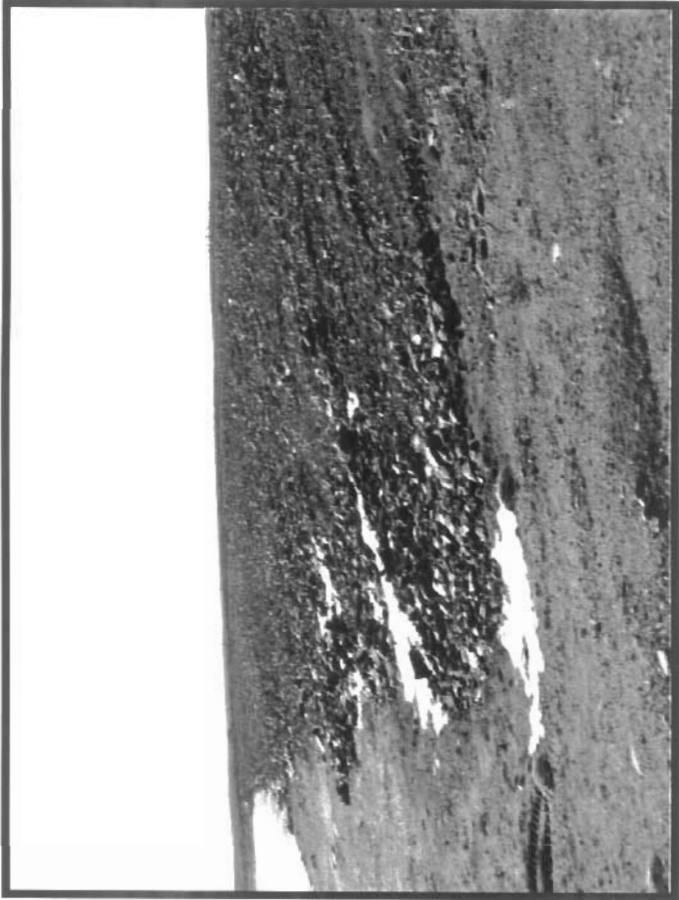
Photo 2 shows a view of the upstream side. The condition of the riprap appears to be satisfactory.

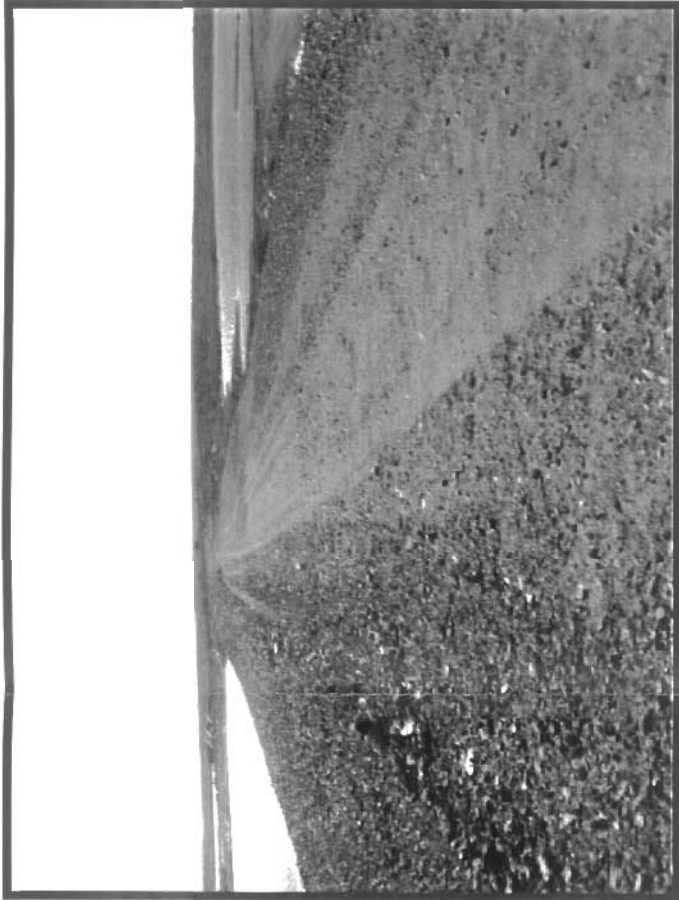
Photo 3 shows the condition of the crest looking towards the south. From this perspective, there are no signs of settlement or cracking.

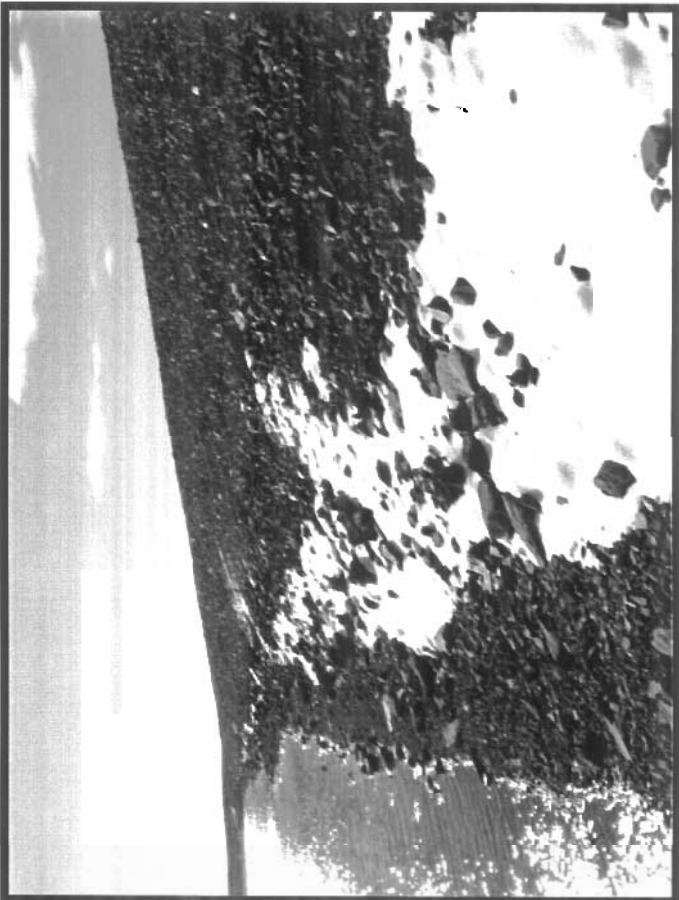
Photo 4 is a view of the upstream side. The distance from the current pond level to the crest is approximately 3.5 metres. Occasional small scarp form at the water level.

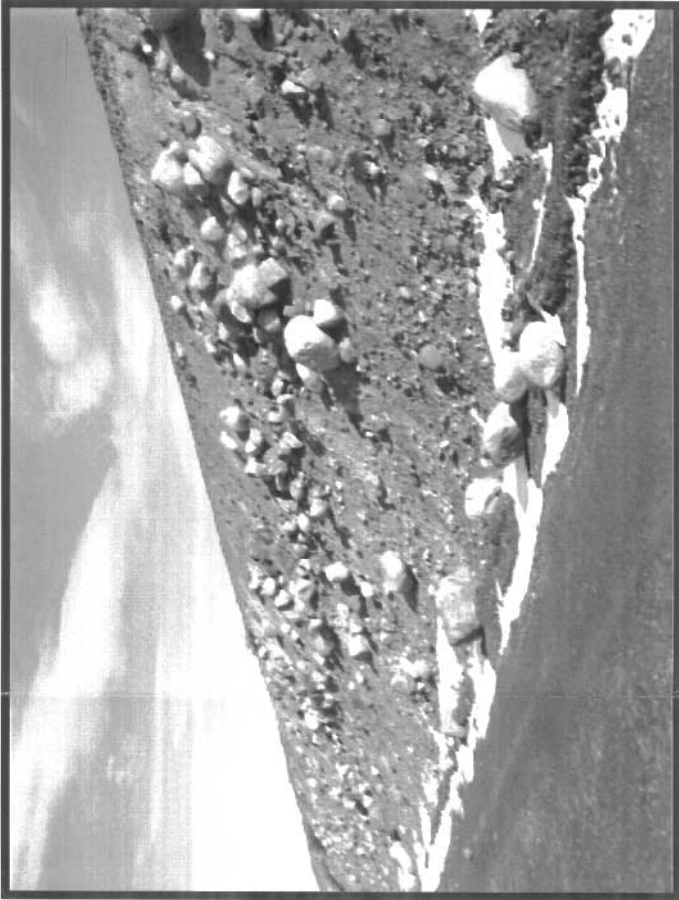
Photo 8 is just another view of the downstream face.

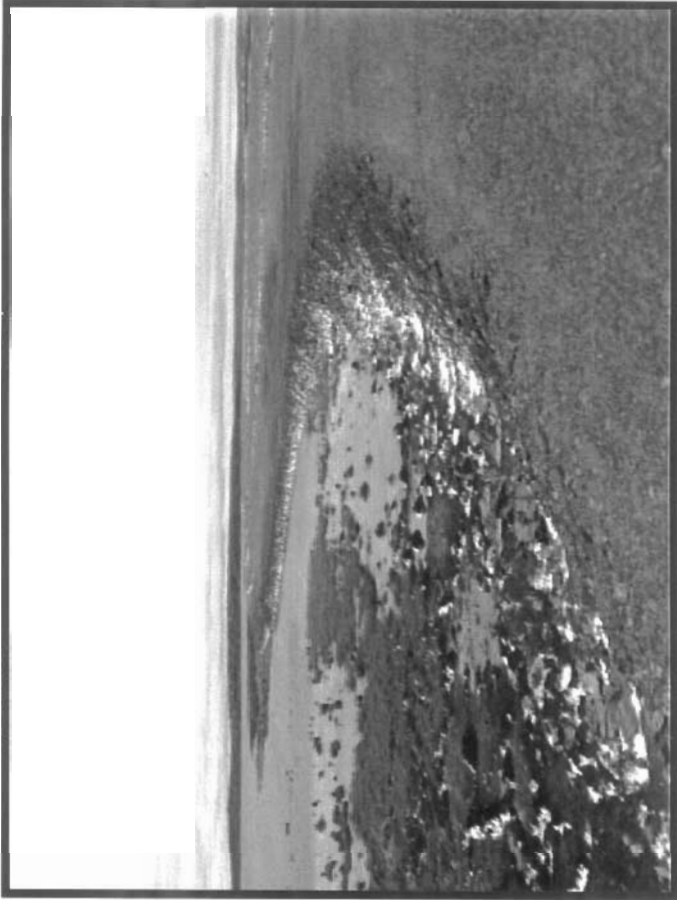
Photo 72 shows a view of Dam 3 with Boomerang Lake on the left.

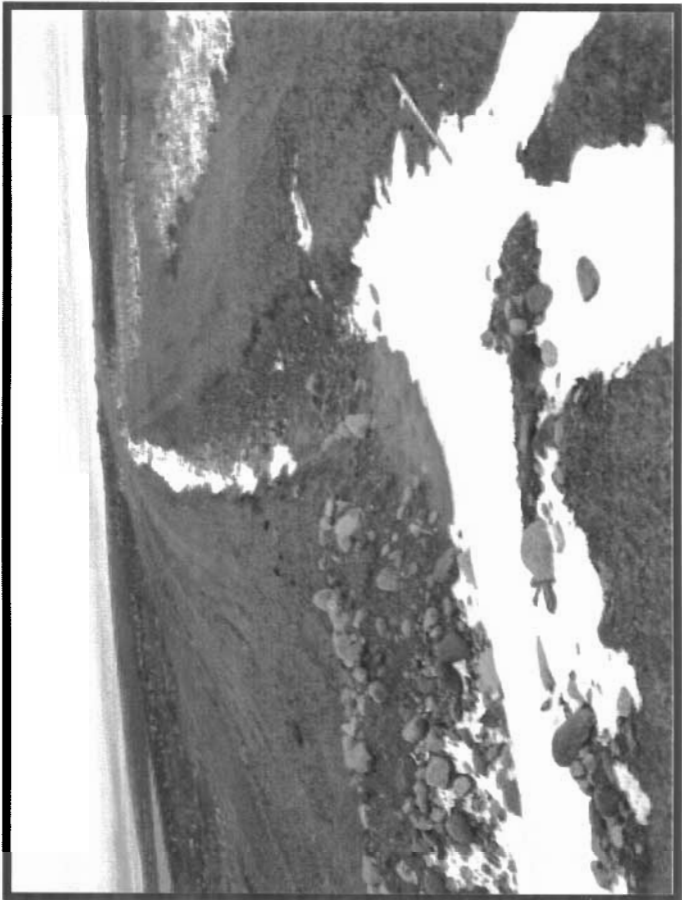
Photo 79 shows a small ditch which runs from the south end towards the north and then bends 90 degrees to the east across the crest of this dam. It is used to direct some of the surficial drainage and from this perspective, looks in satisfactory condition.

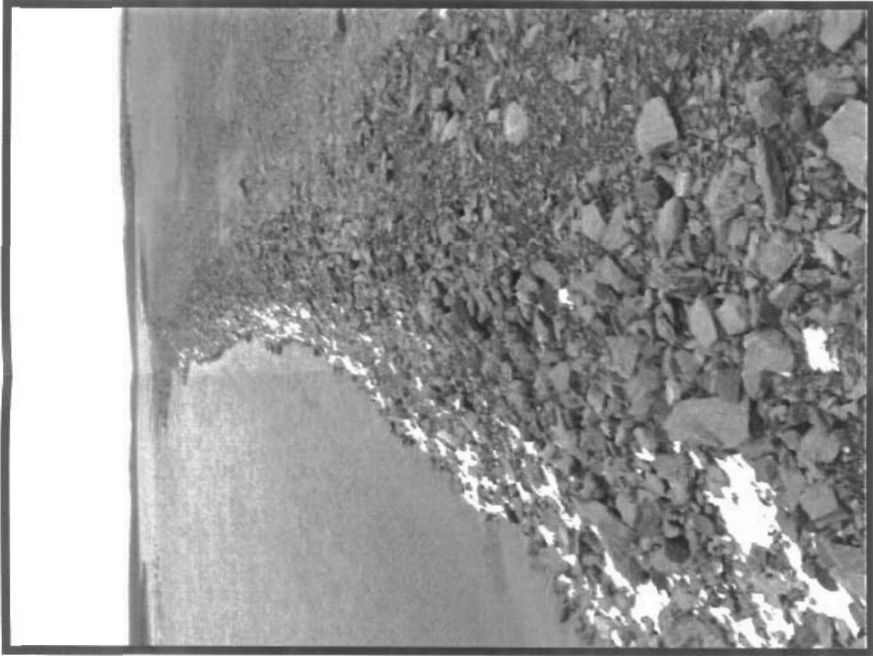
Photo 73 shows the toe edge where it meets Boomerang Lake. This is the area where historically cracking has been seen, No significant sloughs are noted right now.

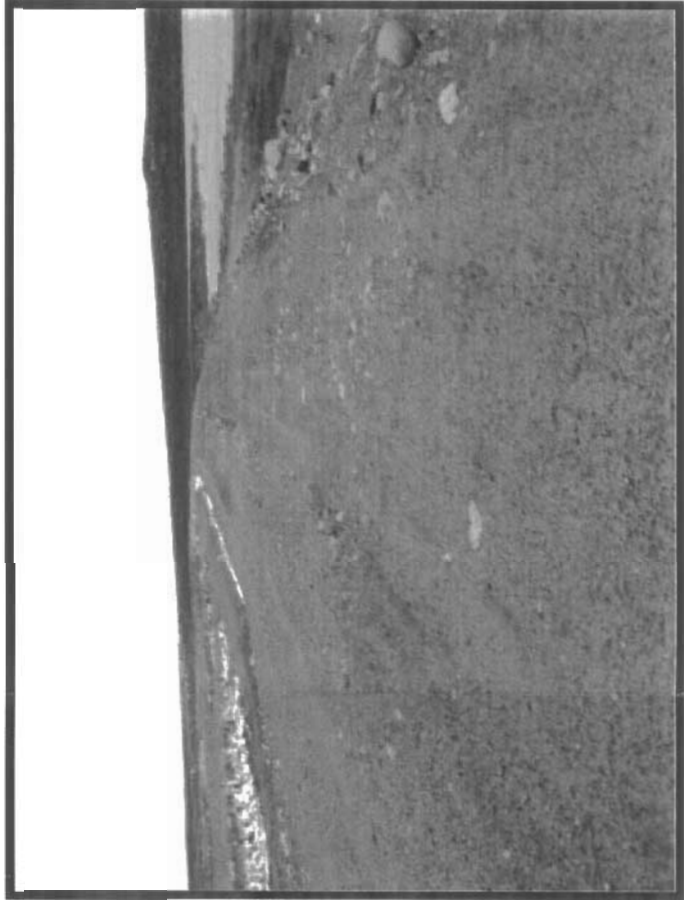
Photo 80 shows the condition of Dam 3 looking towards the north along the toe of this dam. There are no signs of significant erosion or any seepage discharging from this reclaimed dam

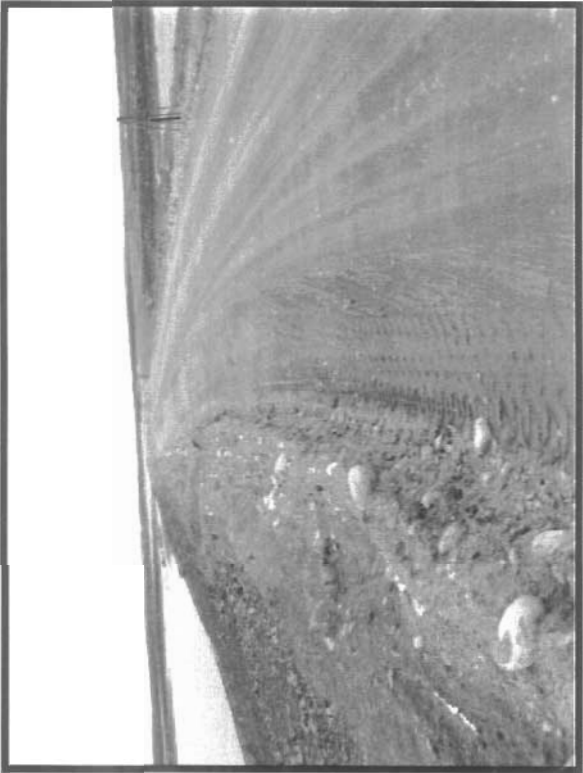
Photo 60 shows a significant windrow which has been formed on the crest of Dam 4 at its west abutment. This crest will have to be regraded to a proper grade to prevent future erosion.

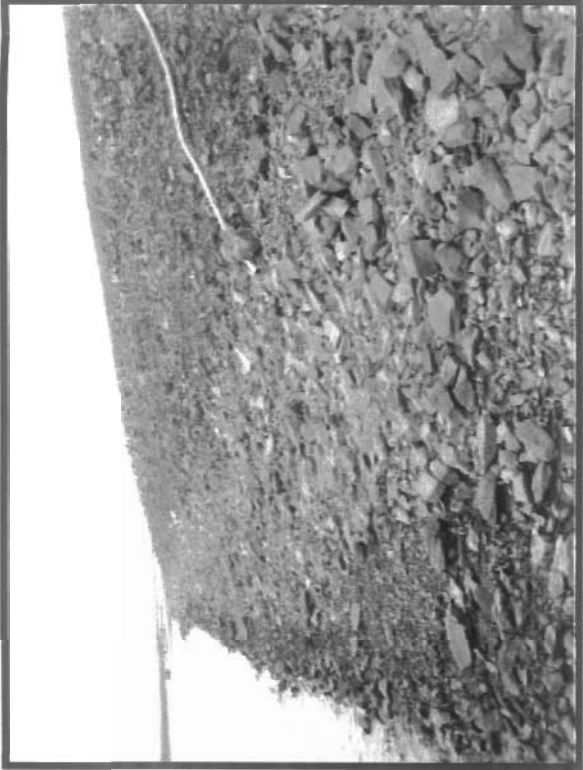
Photo 62 shows the riprap on the upstream side of Dam 4.

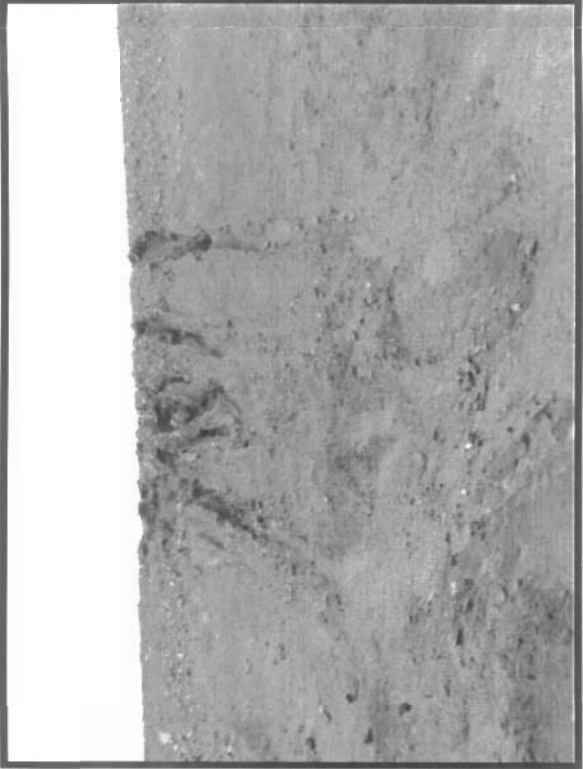
Photo 68 shows four erosional gullies which should be backfilled.

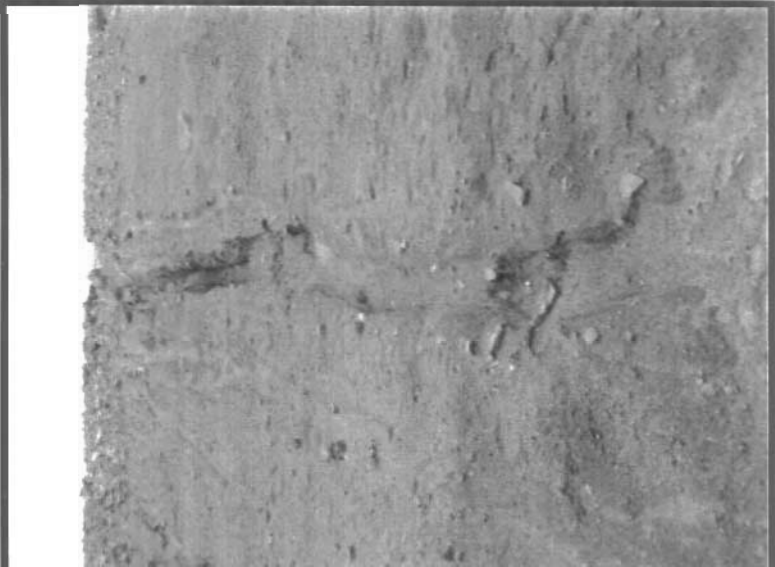
Photo 67 shows a narrow erosional gully which should be backfilled.

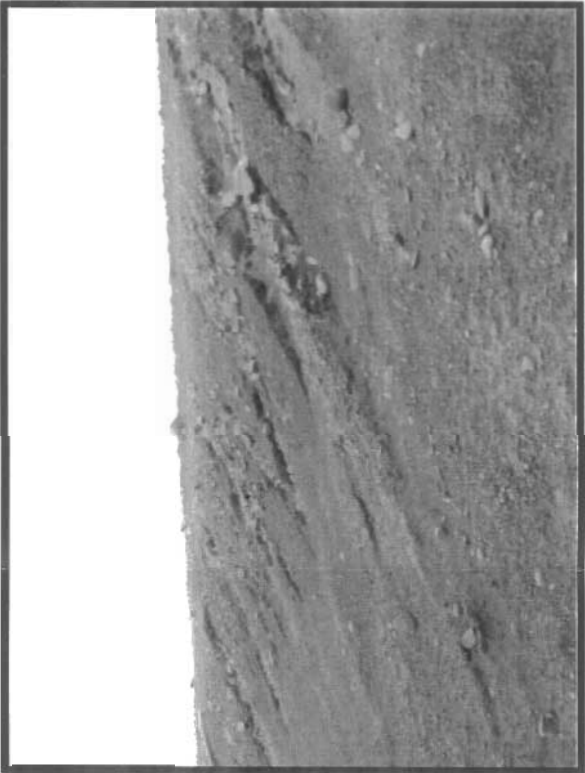
Photo 71 shows a number of erosional gullies right at the west abutment on the downstream side. These should be backfilled to prevent any additional erosion.

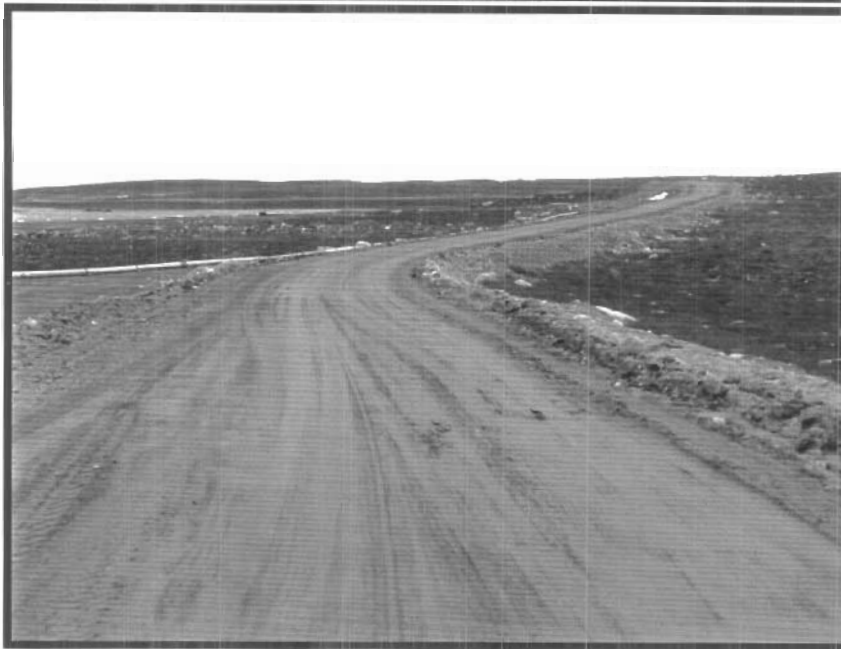
Photo 54 shows the crest of this dam and the downstream side. Windrows have been formed by recent grading activity for vehicle access.

LOCATION:	Southeast corner of Cell 3, just northwest of Dam 4.
FUNCTION:	Minor perimeter closure intended for future tails and water retention; currently functioning as a road embankment.
LENGTH:	250 +/- m
MAX HEIGHT:	1.5 +/- m above d/s tundra.
AS-BUILT ELEVATION:	491.54 m
CREST WIDTH AND CONDITION:	Approximately 8 m wide and esker surfaced so that the dam may also function as roadway. Crest is in generally good condition but windrows have been formed at road edges due to grading.
RIPRAP:	Angular rockfill, maximum particle size from 20 to 30 cm, has been placed on the upstream face. Approximate slope of 3H:1V and in good condition.
BACKSLOPE:	About 1.5 to 2H:1V with till and esker sand. Occasional minor erosional gullies have formed.
SEEPAGE:	No seepage observed. No water head being retained by the structure.
MAINTENANCE RECOMMENDATIONS:	Grade crest windrows to allow good surface drainage and backfill minor gullies on the backslope.

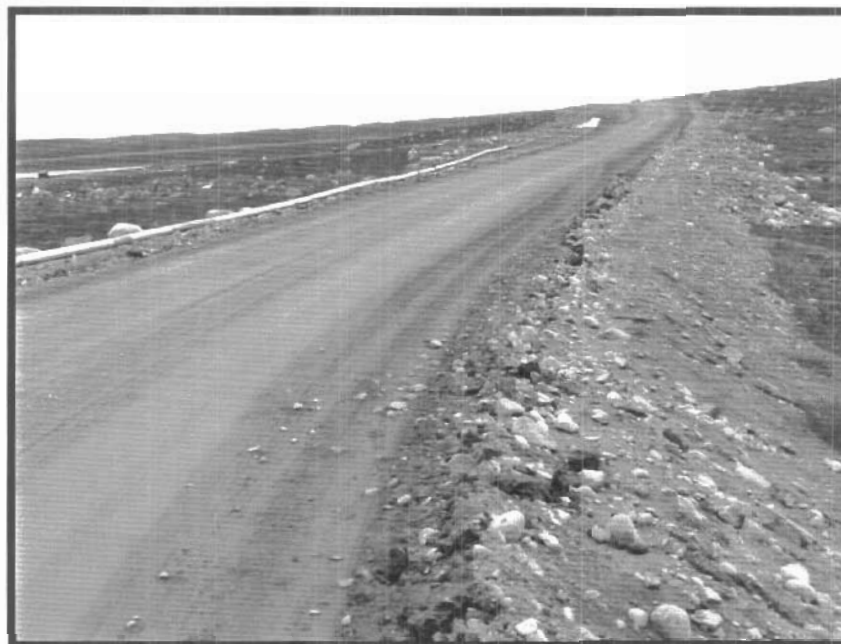
Photo 56 shows the view of the downstream face on the crest.

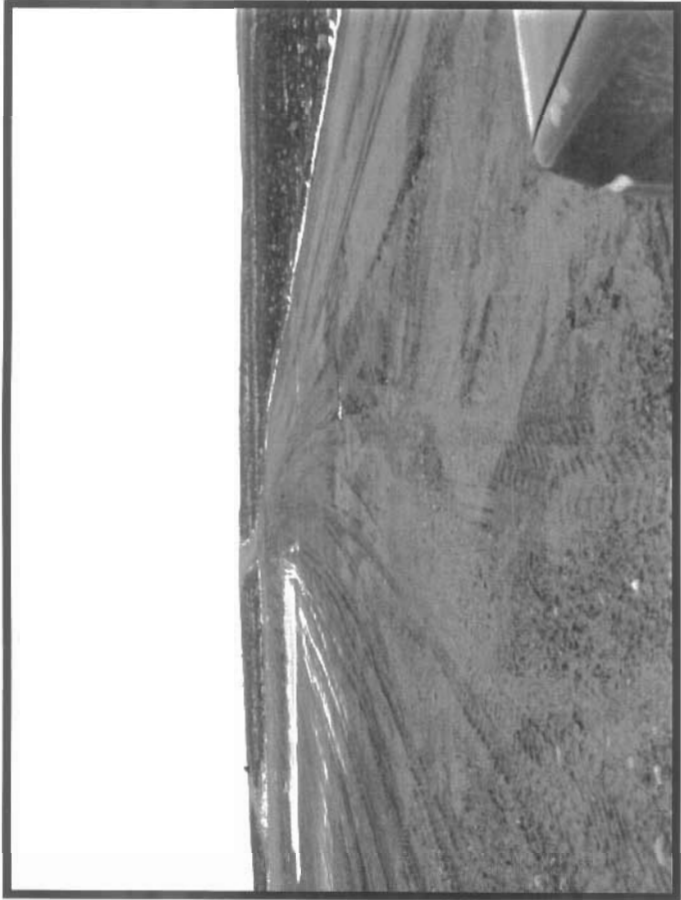
Photo 41 shows the crest of Dam 6 looking towards the south abutment. As can be seen, reclamation and placement of cover has occurred on the upstream side hence, covering over the majority of the tailings.

MAINTENANCE RECOMMENDATIONS:	Cover placement on the upstream side has reduced the freeboard amount on the reclaimed dam. Important to ensure that surface runoff in the spring does not overtop the dam and lead to erosion of the dam.
CONCLUSIONS:	The dam is in good condition but its performance should be monitored during spring freshet and significant rainfall events.

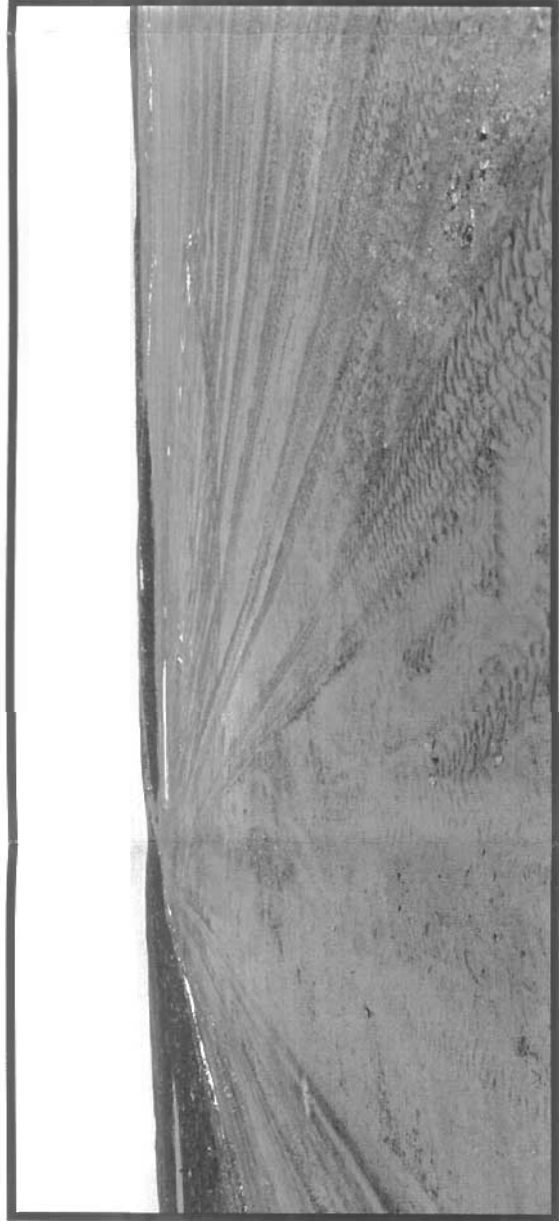
Photo 45 & 46 are a two shot panoramic showing the upstream side and the crest of Dam 6. A local high point exists some 100 metres to the east of this dam. As a result, localized drainage reports to the remnant pond.

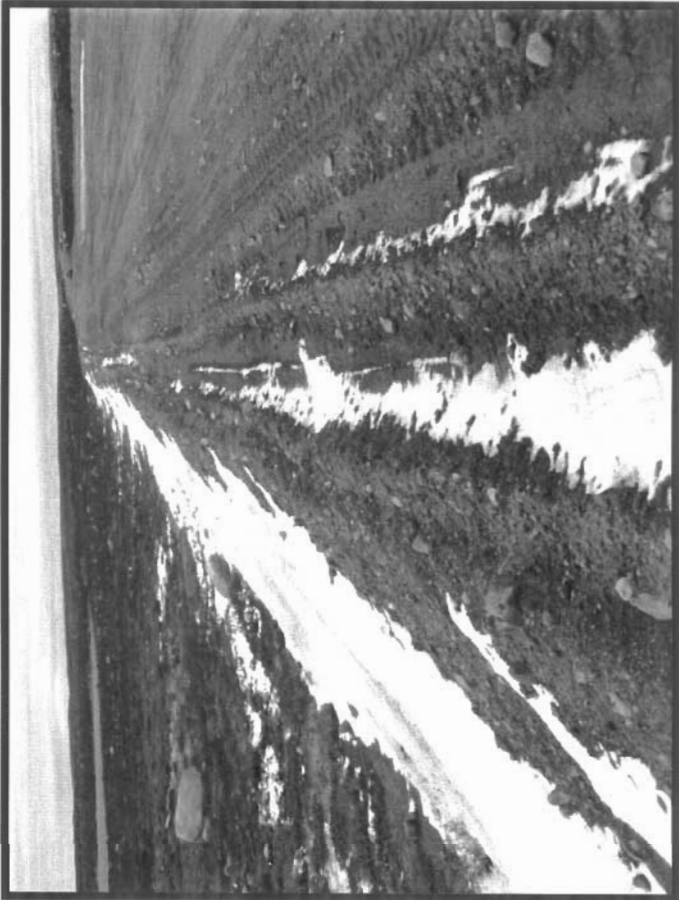
Photo 47 shows a view of the downstream toe looking towards the north. Construction traffic has caused a number of ruts and pushed up some windrows on the toe crest.

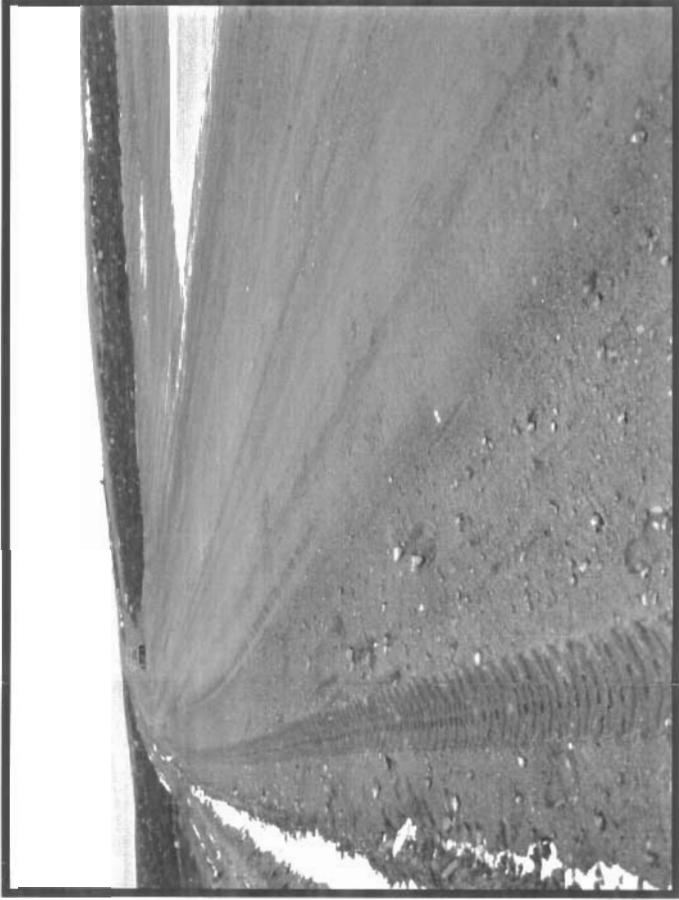
Photo 49 shows a view of the remnant pond versus the crest of this dam.
