KINROSS GOLD CORPORATION LUPIN OPERATION

2005 GEOTECHNICAL INSPECTION PERIMETER TAILINGS DAMS

LUPIN MINE NUNAVUT

PROJECT NO.: 0256-011-01
DATE: OCTOBER 7, 2005

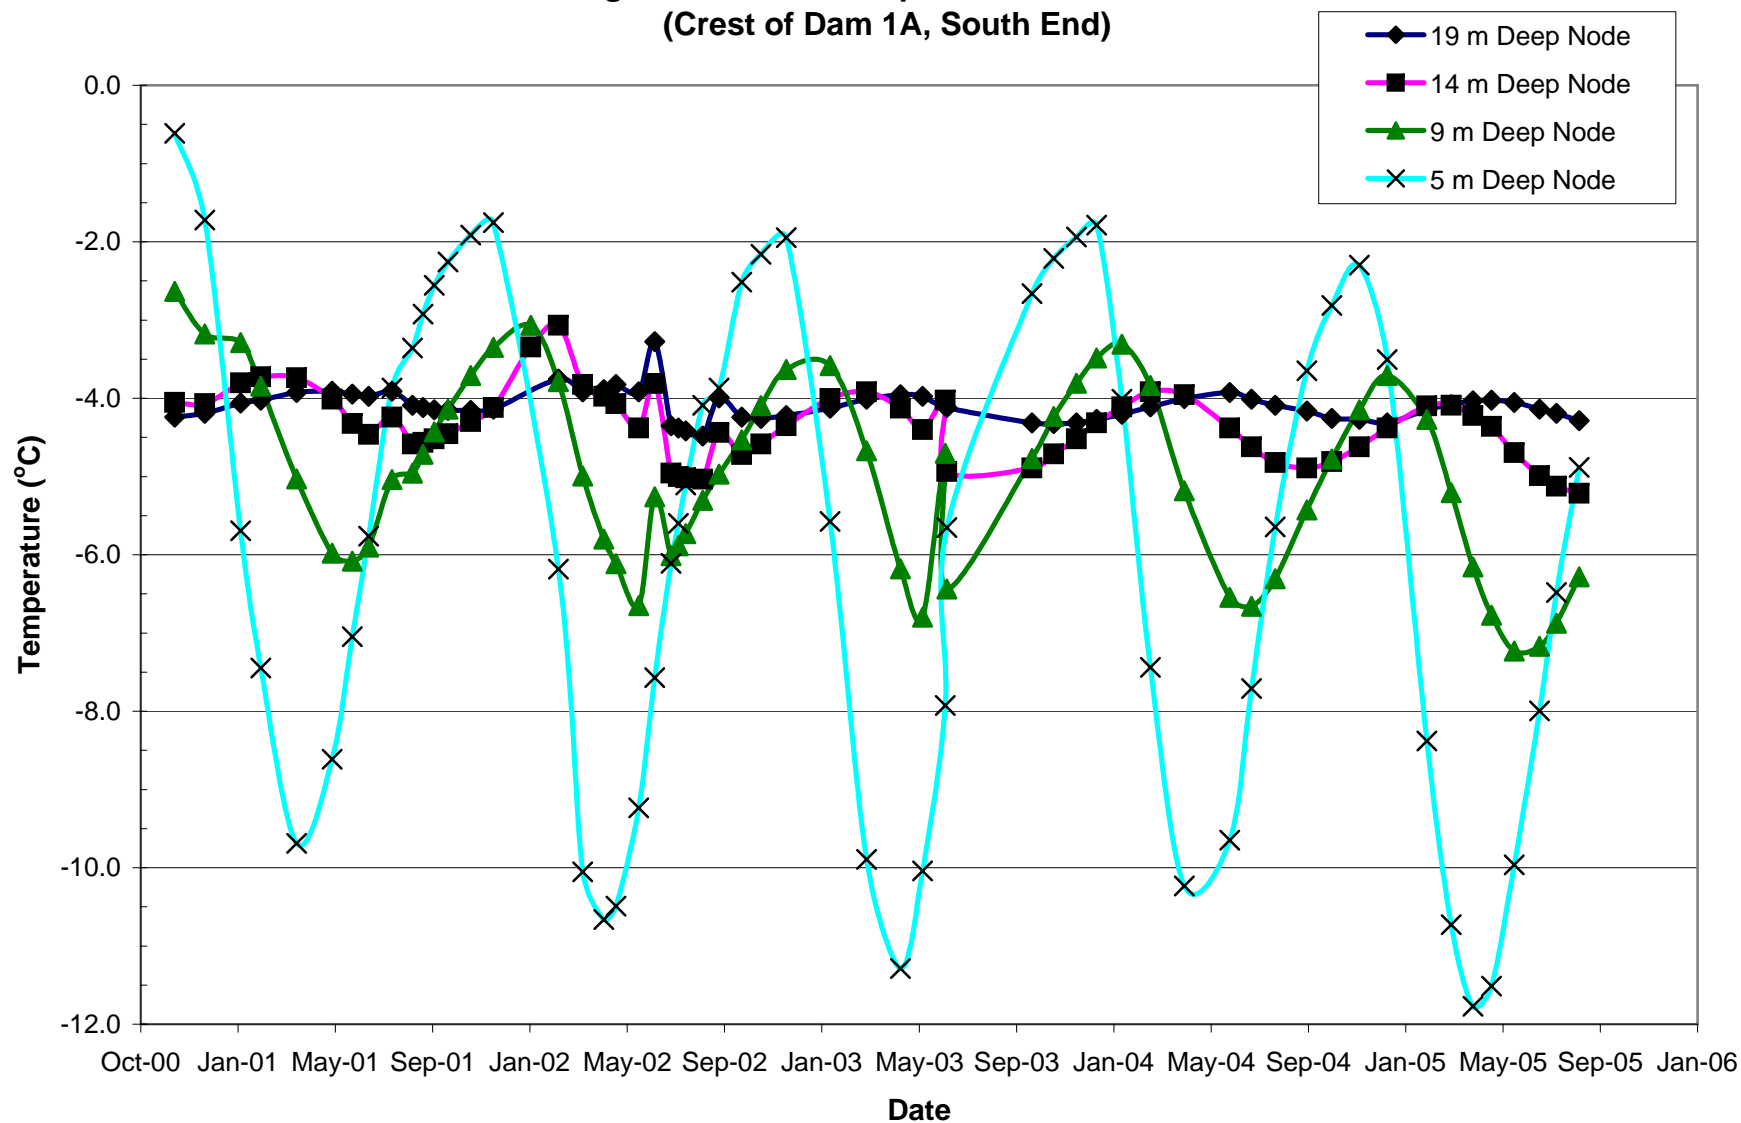
Long Term Plot for Deep Nodes in D1A-00-01
(Crest of Dam 1A, South End)

LOCATION:	West side of Pond 2.
FUNCTION:	Major perimeter closure for water retention; carries siphon pipes for water decant system.
LENGTH:	250 +/- m
MAX HEIGHT:	8 m +/- above d/s tundra.
AS-BUILT ELEVATION:	486.27 m
CREST WIDTH AND CONDITION:	7 to 8 m; surfaced with esker material, but not travelled because of the siphons. No significant cracking evident; condition is good.
RIPRAP:	Run of Mine rockfill; broadly graded; good condition. Minor disturbed area (due to construction traffic possibly) in rip rap at the crest edge.
BACKSLOPE:	Approx. 1.5H:1V; variably armoured with cobbles and boulders; no evidence of cracking.
TOE BERM:	No significant cracking evident; condition is good.
SEEPAGE:	No evidence of seepage.
INSTRUMENTATION:	<p>Thermistor D1A-00-1 is located in the crest, just south of the mid-point of the dam. All nodes below 5 m depth are subzero. Nodes below depth of 9 m (situated approximately below the embankment fill) are equal to or colder than -4°C with no signs of significant warming.</p> <p>Thermistor D1A-00-02 is located in the crest towards the north end of the dam. All nodes below 5 m depth are subzero with no indications of warming at depth. Nodes below a depth of 10.3 m appear to be colder than -4.0°C.</p>

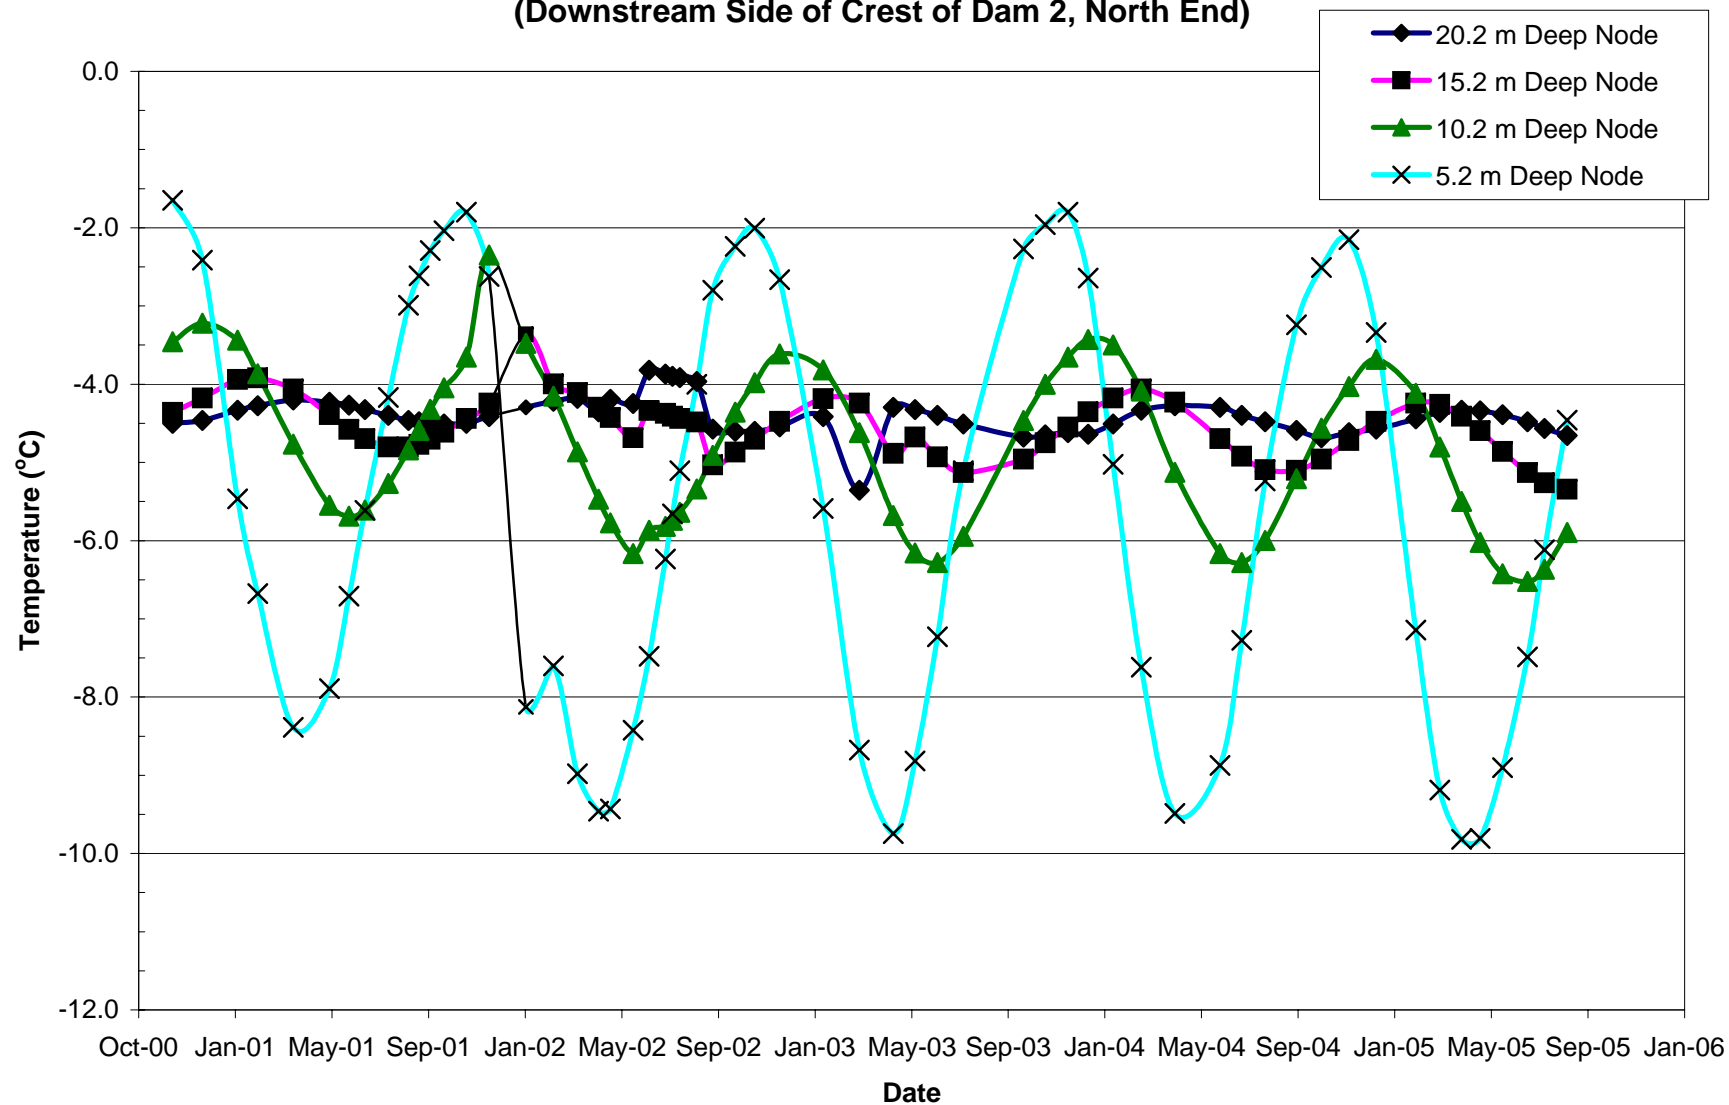
Long Term Plot for Deep Nodes in D2-00-2
(Downstream Side of Crest of Dam 2, North End)

LOCATION:	North end of Pond 2.
FUNCTION:	Major perimeter closure for water retention; natural pond downstream of the dam.
LENGTH:	350 +/- m
MAX HEIGHT:	5.5 +/- m above d/s tundra.
AS-BUILT ELEVATION:	486.30 m
CREST WIDTH AND CONDITION:	Approx. 6 m; surfaced with esker material and used as the primary traffic route. Crest condition is good; no cracking is evident.
RIPRAP:	Run of Mine rock forms convex-upward, gently sloped upstream face; minor erosional scarps formed at previous higher water levels; good condition.
BACKSLOPE:	Approx. 1.5H:1V; a thin (< 1 cm) layer of tailings has been deposited at the toe of this dam.
SEEPAGE:	Seepage (likely resulting from active layer drainage rather than seepage through the dam) observed discharging at the toe of the northeast abutment where it is typically observed.
INSTRUMENTATION:	<p>Thermistor D2-00-02 is located at the north end of the crest. Temperatures at depth are subzero. Below 5 m depth (approximate bottom of embankment fill), temperatures are colder than -2°C.</p> <p>Thermistor D2-00-03 is situated near the mid-point of the dam. Temperatures below 5 m depth are all subzero. Temperatures below 15 m depth are colder than -3.5°C.</p>
