PROJECT ANNUAL INSPECTION OF PERIMETER TAILINGS DAMS		
TITLE DAM 1A INSPECTION PHOTOS		
PROJECT No. 0256-011-01	FIGURE No. 5	REV. 0

BGC Engineering Inc.
AN APPLIED EARTH SCIENCES COMPANY

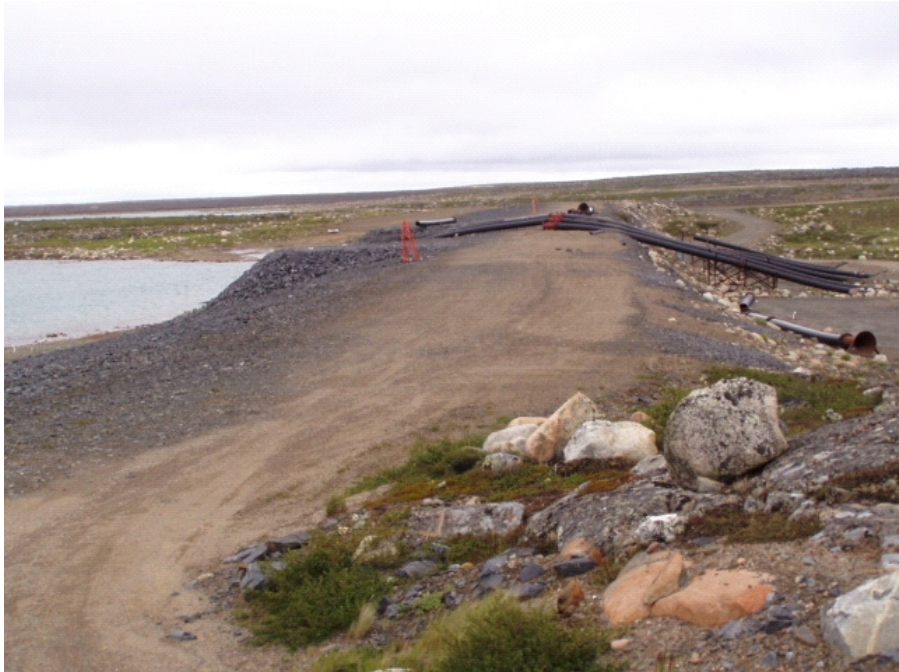
Photo shows the crest of Dam 1A looking towards its south abutment.

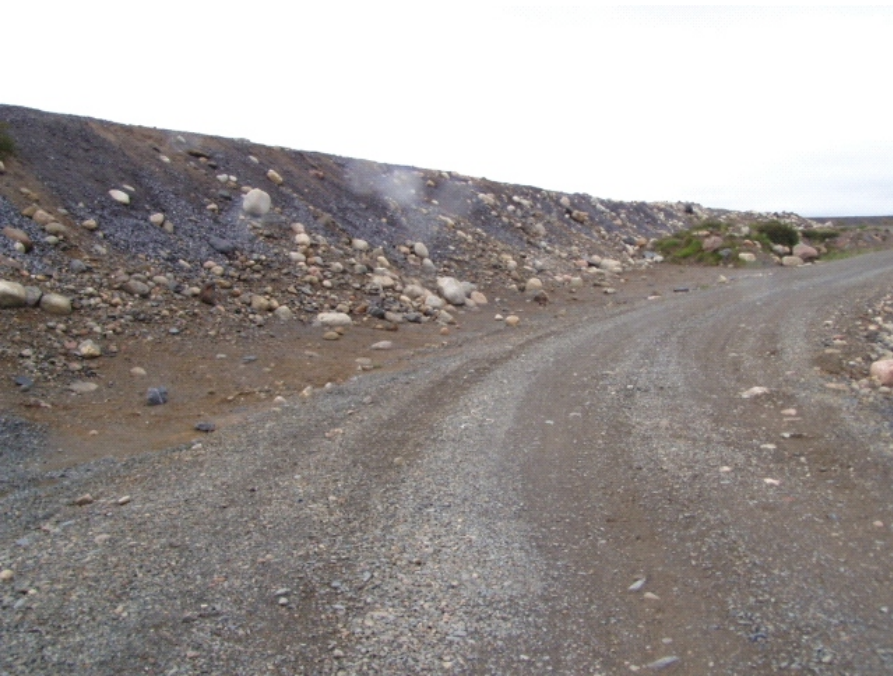
Photo shows the downstream side.

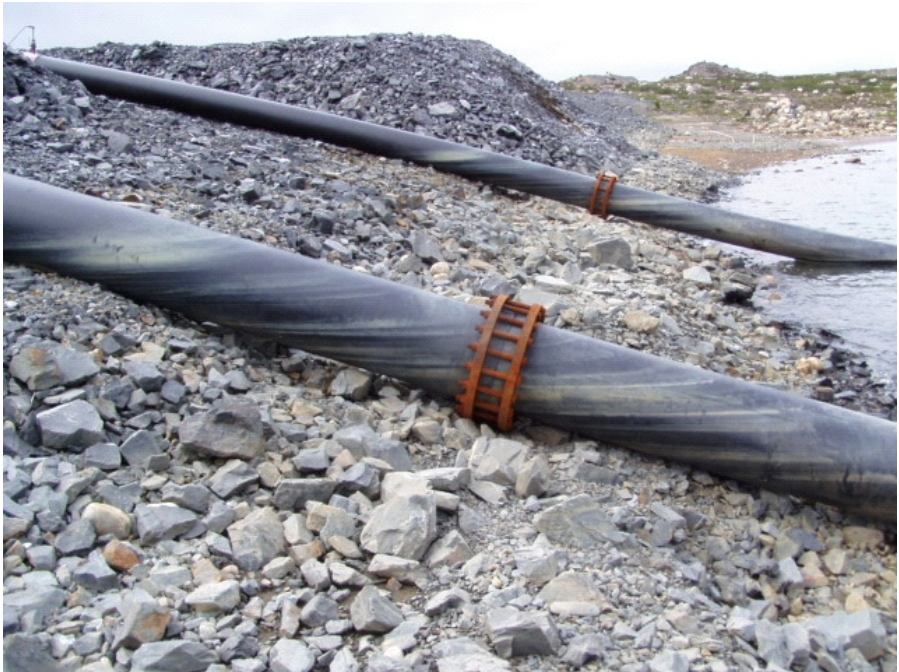
Photo shows the pond on the upstream side of Dam 1A. At the current time, the distance from the head pond to the physical crest is approximately 4.5 m.

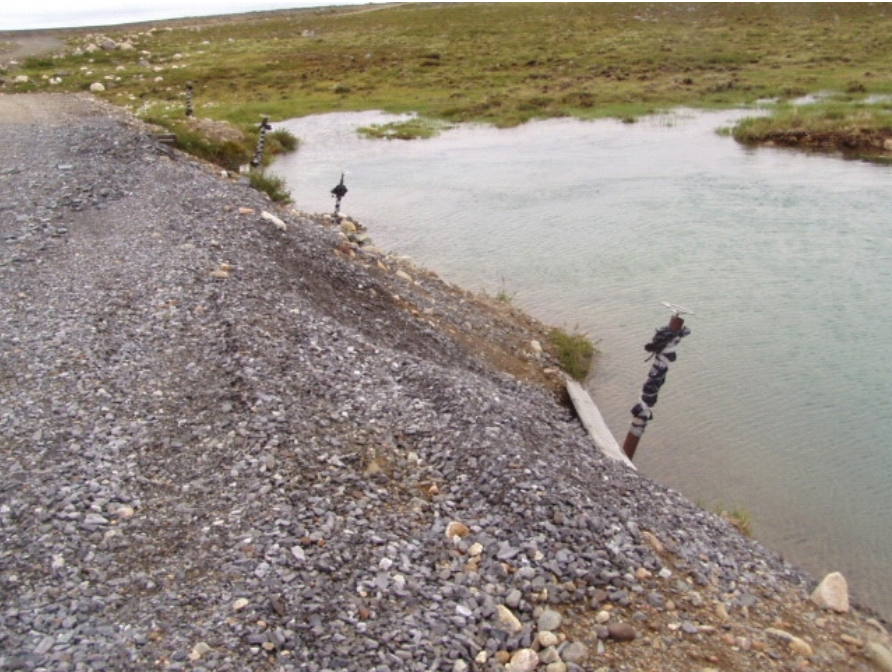
Photo shows the steep face overlooking the valves which come from the discharge pipes. The rockfill slope is oversteepened and there are some longitudinal cracks.
