CLIENT: **KINROSS**
Gold Corporation

BGC Engineering Inc.
AN APPLIED EARTH SCIENCES COMPANY

PROJECT ANNUAL INSPECTION OF PERIMETER TAILINGS DAMS		
TITLE DAM 1B INSPECTION PHOTOS		
PROJECT No. 0256-011-01	FIGURE No. 6	REV. 0

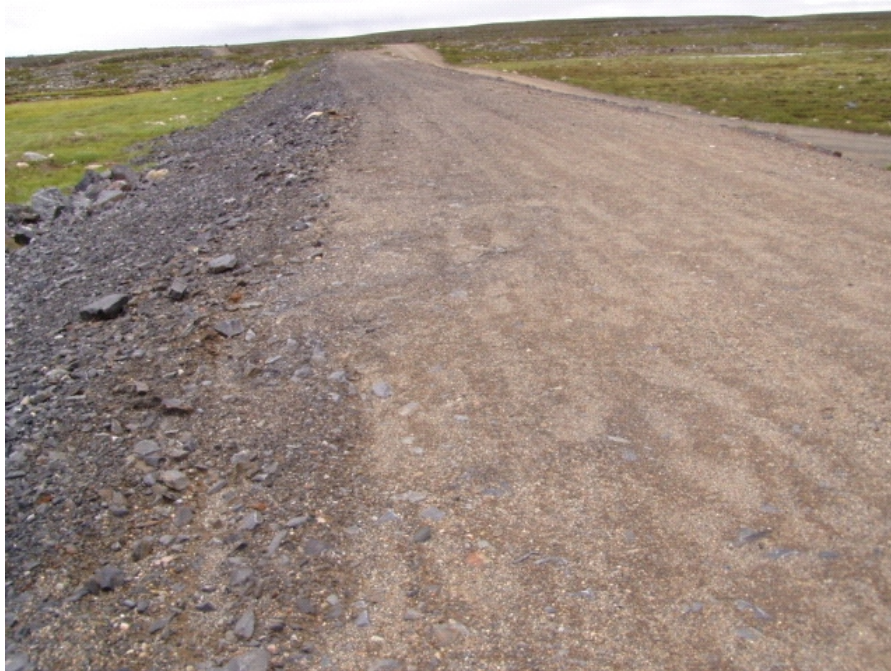
Photo shows the upstream side and crest of this dam. This dam does not retain any water at the current time.

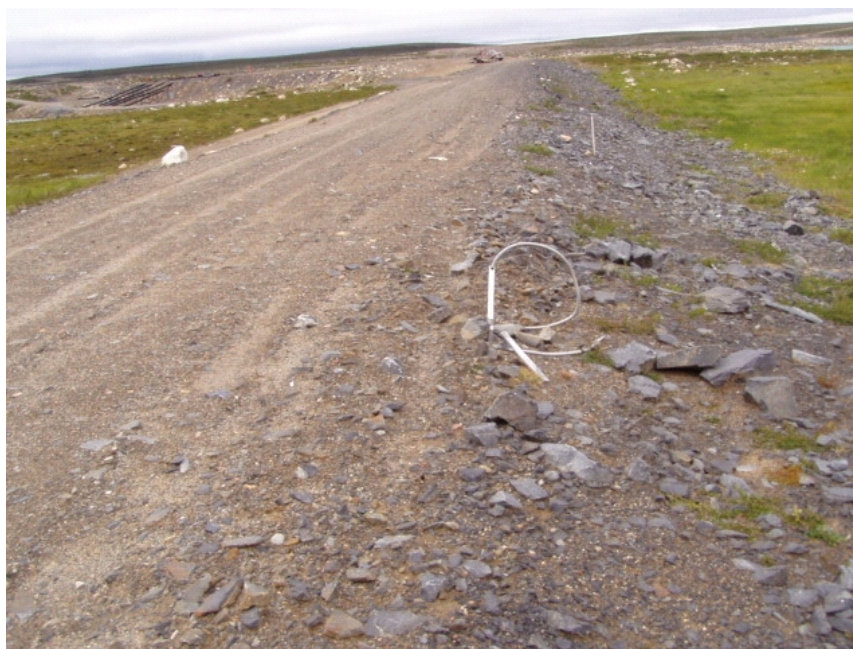
Photo shows the upstream side. No observations of settlement or cracking were noted.
