CLIENT: **KINROSS**  
Gold Corporation

**BGC Engineering Inc.**  
AN APPLIED EARTH SCIENCES COMPANY

PROJECT <b>ANNUAL INSPECTION OF PERIMETER TAILINGS DAMS</b>		
TITLE <b>DAM 1C INSPECTION PHOTOS</b>		
PROJECT No. <b>0256-011-01</b>	FIGURE No. <b>7</b>	REV. <b>0</b>

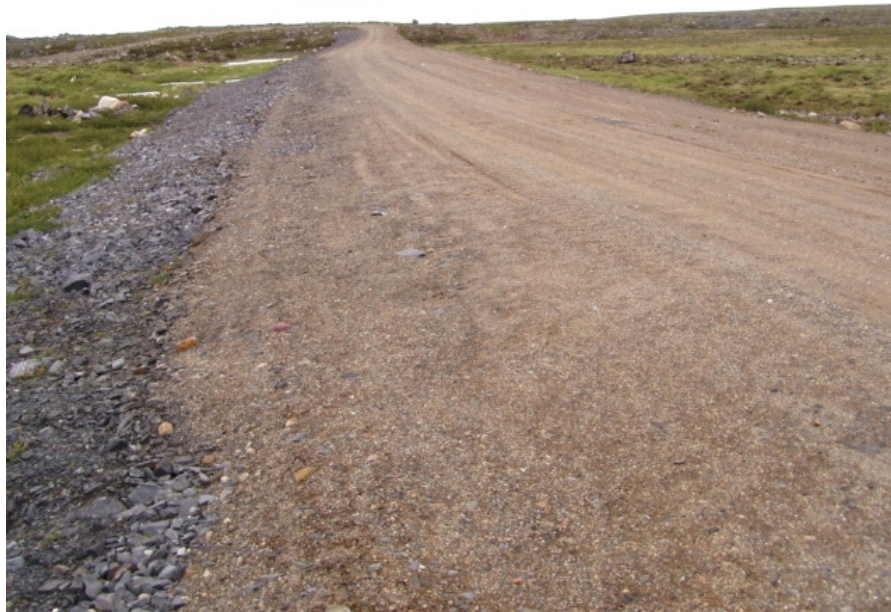
Photo shows the crest on the upstream side looking in the southern direction. There are several small ponds located on the upstream side but no continuous head pond of water is actually retained against this dam currently.

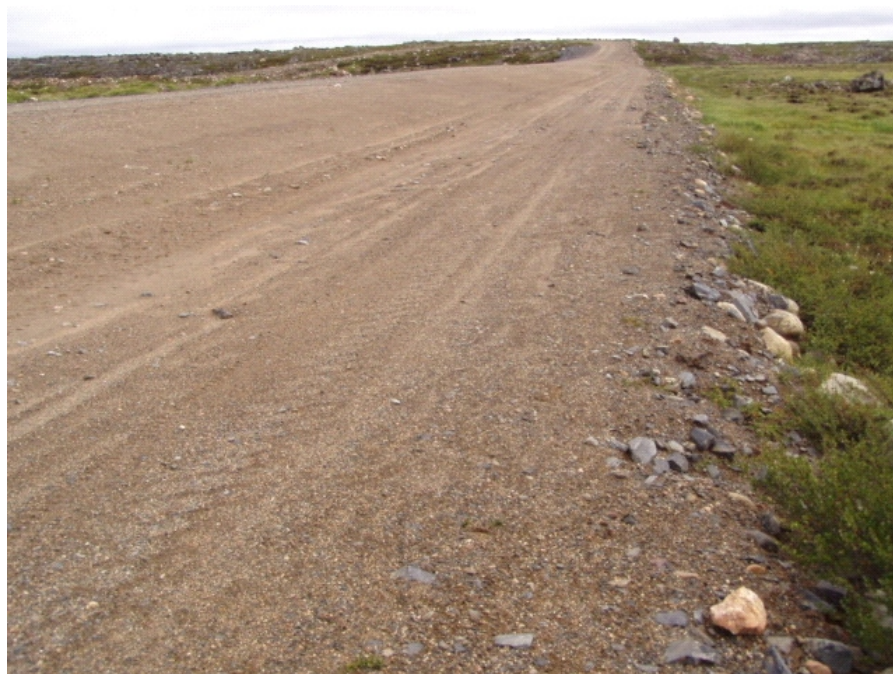
Photo shows the downstream toe. There are no signs of cracking, settlement or seepage.
