<div>PROJECT</div> <div>ANNUAL INSPECTION OF PERIMETER TAILINGS DAMS</div>		
<div>TITLE</div> <div>DAM 3 INSPECTION PHOTOS</div>		
<div>PROJECT No.</div> <div>0256-011-01</div>	<div>FIGURE No.</div> <div>9</div>	<div>REV.</div> <div>0</div>

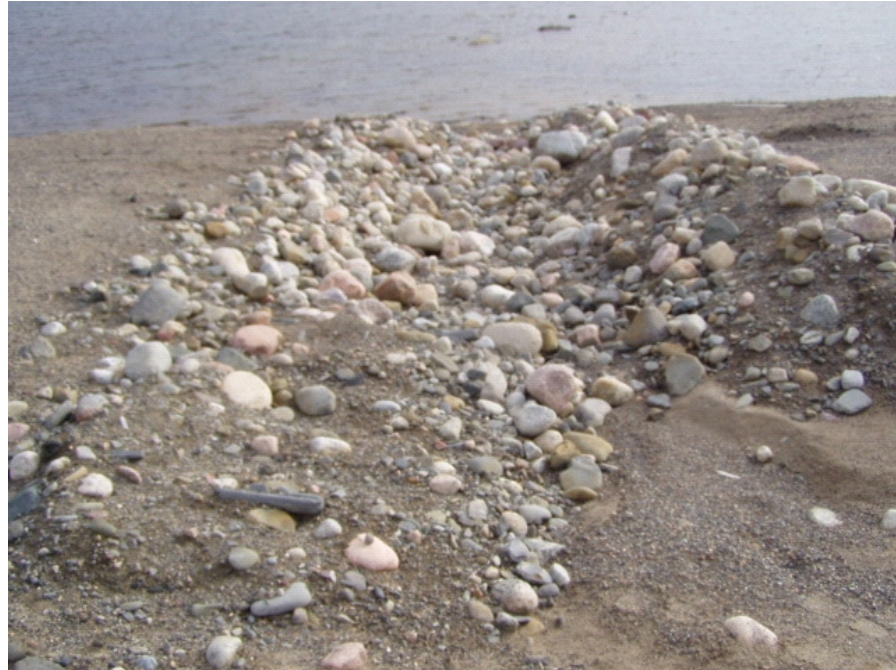
Photo shows the armouring in the swale which then runs down towards Boomerang Lake. Portions of the armouring are somewhat disturbed due to settlement, but overall, it performs its function.

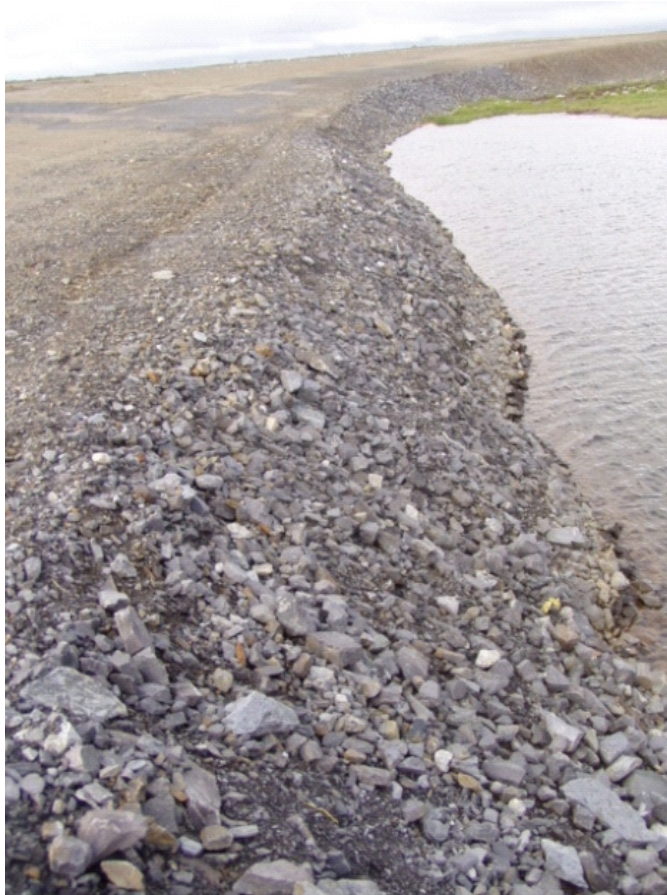
Photo shows the armouring where the end of Dam 3 comes in contact with Boomerang Lake. This riprap and armouring all appear in good condition.

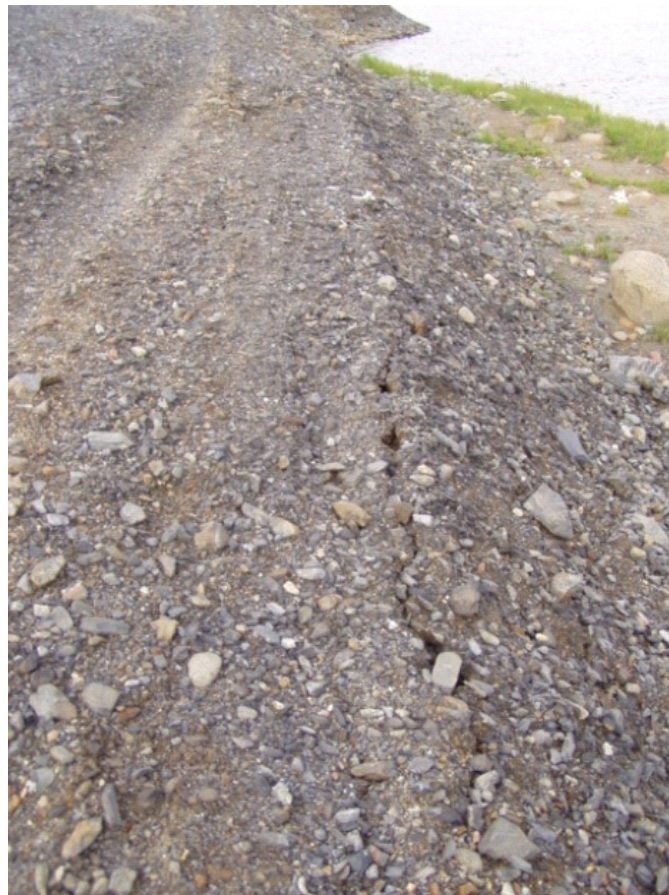
Photo shows a series of parallel longitudinal cracks located directly at the toe. These cracks are related to the oversteepened nature of the material right at the toe.

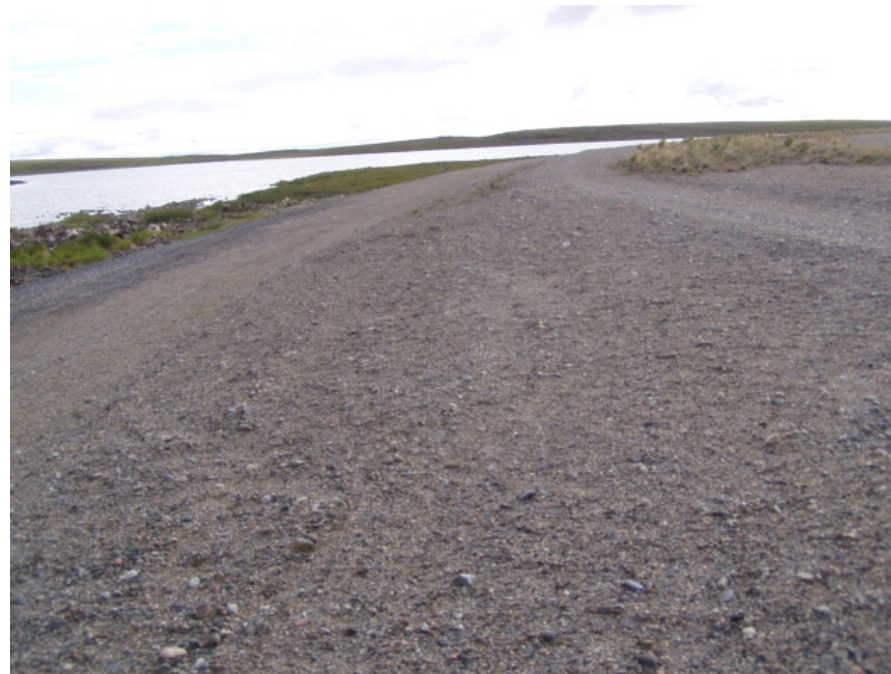
Photo shows the general condition of the grading of the upstream area of Dam #3 where it blends into the reclamation cover.
