PROJECT	ANNUAL INSPECTION OF PERIMETER TAILINGS DAMS	
TITLE	DAM 4 INSPECTION PHOTOS	
PROJECT No.	FIGURE No.	REV.
0256-011-01	10	0

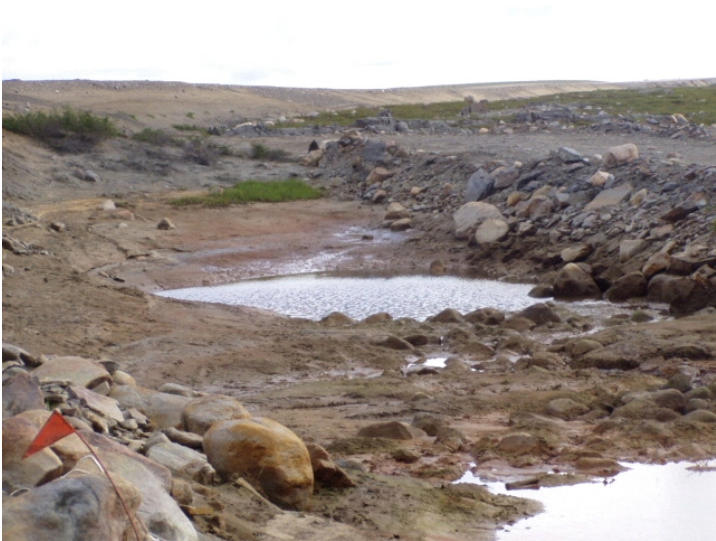
Photo shows the small remnant pond near the east end of the dewatered area. Seepage is coming in from the lake side located on the downstream side of the pond.

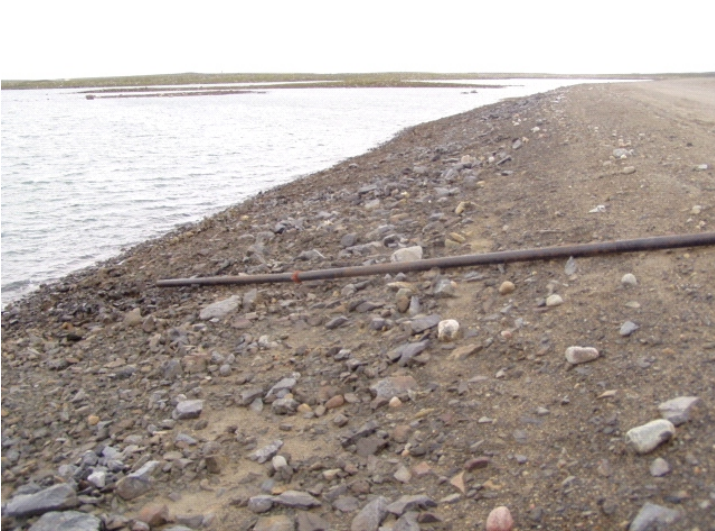
Photo shows the position of the riprap on the upstream side. It is rather undulating as previously noted.

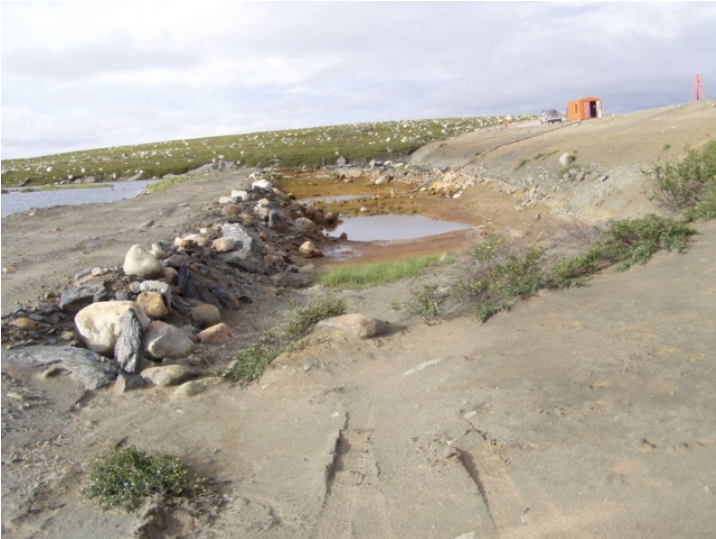
Photo shows the cofferdam area at the toe and the small remnant ponds which remain after pumping.

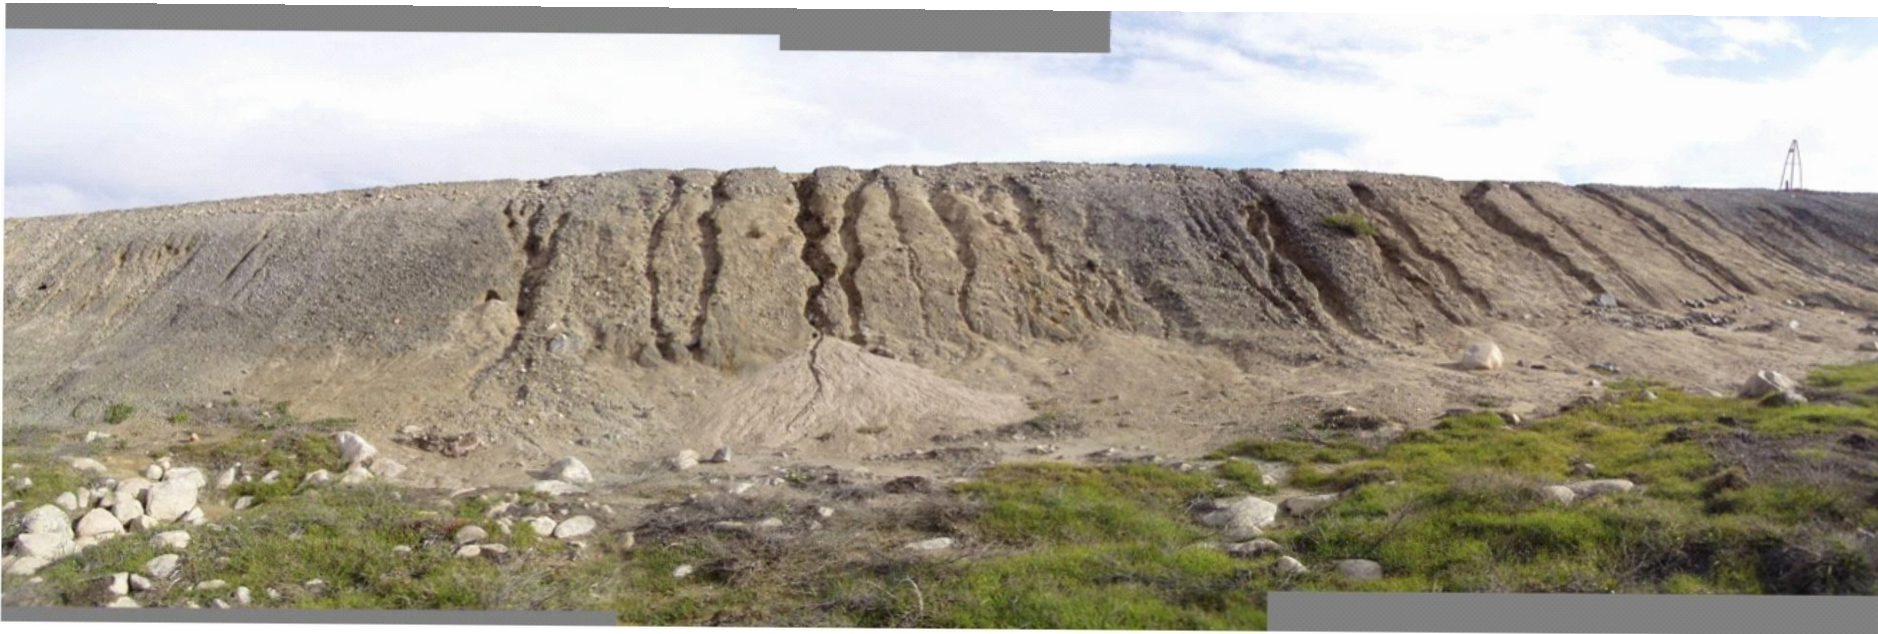
Photo shows a number of erosional gullies located on the downstream face over towards the east abutment. These gullies should all be properly backfilled to prevent further erosion.
