PROJECT **ANNUAL INSPECTION OF PERIMETER  
TAILINGS DAMS**

TITLE **DAM 5 INSPECTION PHOTOS**

PROJECT No.	FIGURE No.	REV.
0256-011-01	11	0

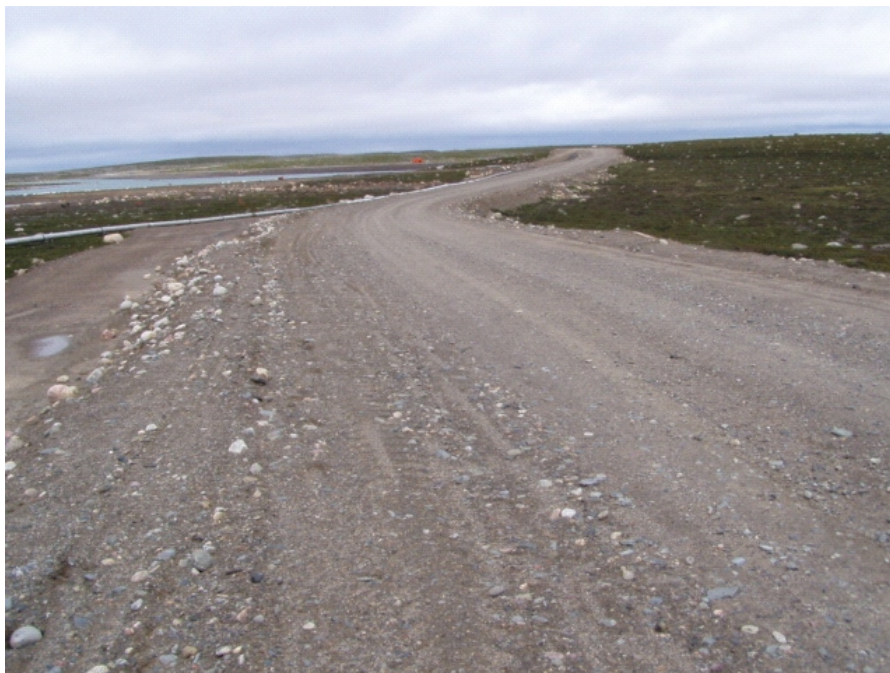
Photo shows the crest on the downstream side. This dam does not retain any solids or water at the current time.

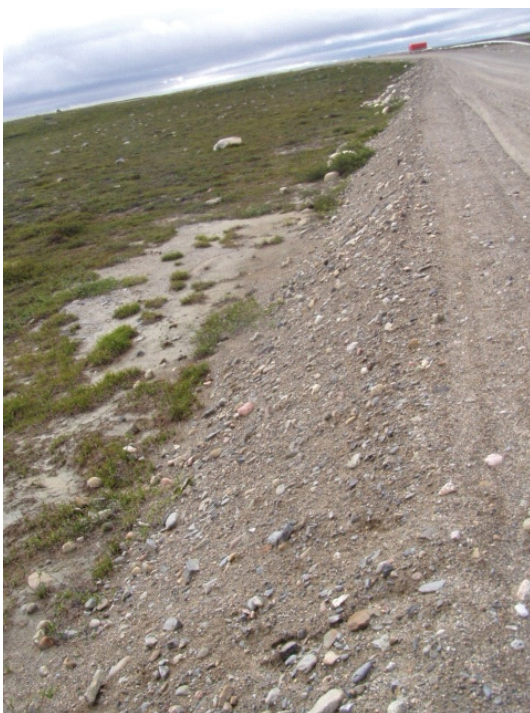
Photo shows the downstream slope of this dam. No signs of erosion or seepage noted from this perspective.
