PROJECT ANNUAL INSPECTION OF PERIMETER TAILINGS DAMS						
TITLE						
DAM 6 INSPECTION PHOTOS						
PROJECT No.	FIGURE No.	REV.				
0256-011-01	12	0

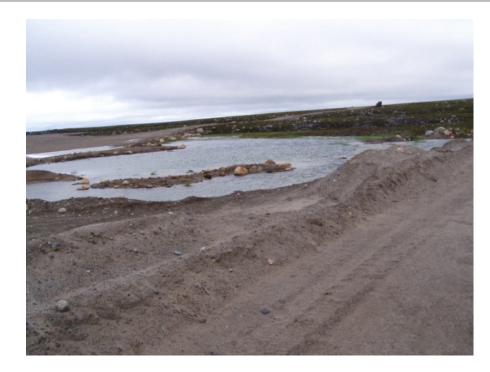
Photo shows a small pond which is being retained on the upstream side at the south abutment of this dam.

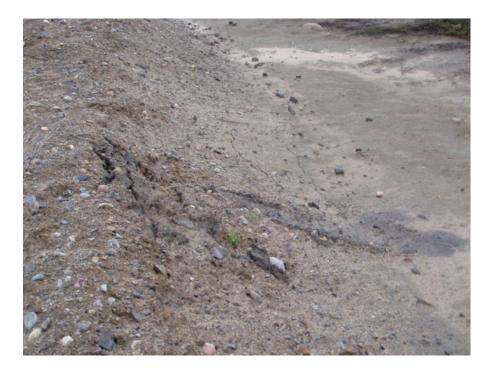
Photo shows two longitudinal cracks at the downstream toe. These cracks may have been due to drying and shrinkage.

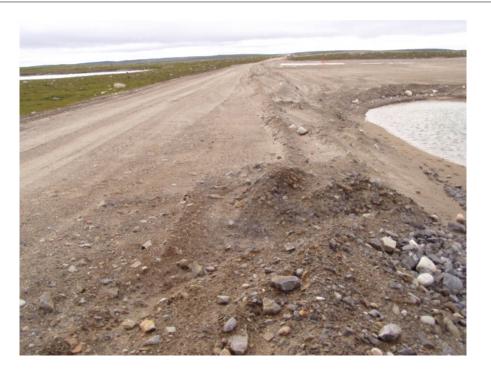
Photo shows the upstream side of the crest looking towards the north abutment.

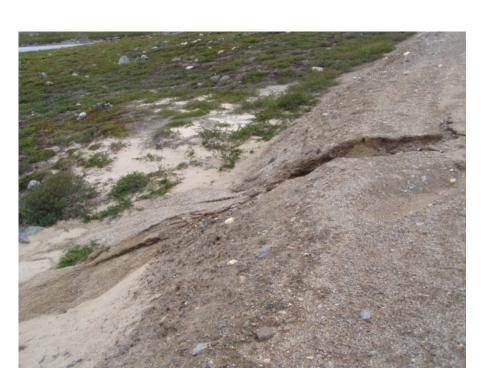
Photo shows another erosional gully at the toe which needs to be repaired.
