| PROJECT | ANNUAL INSPECTION OF PERIMETER TAILINGS DAMS |
| TITLE | DAM 1C INSPECTION PHOTOS |
| PROJECT No. | 0256-012-01 |
| FIGURE No. | 7 |

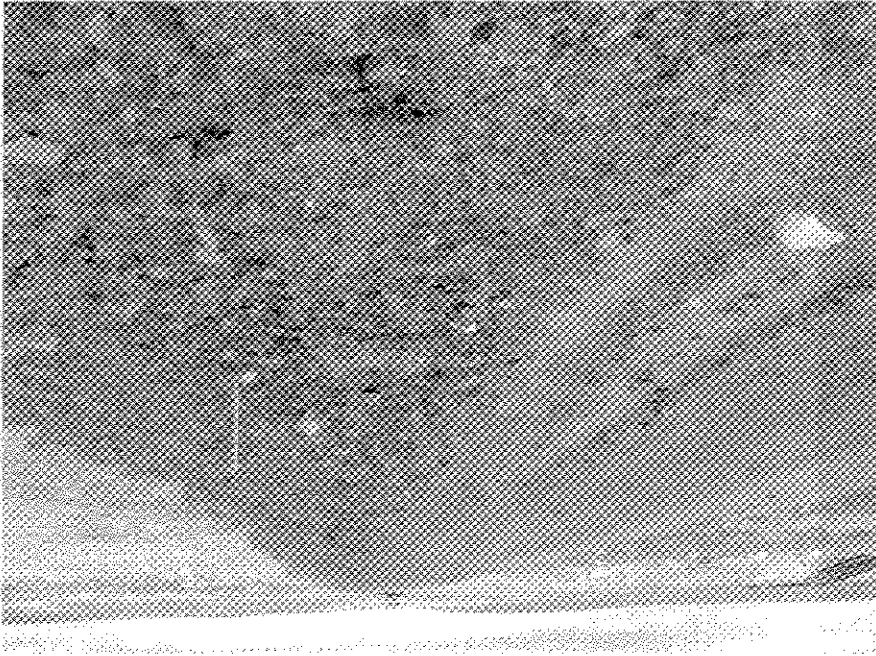
View of the upstream side and crest. It should be noted that this pond does not retain a head of water. The crest appears consistent with no signs of deformations.

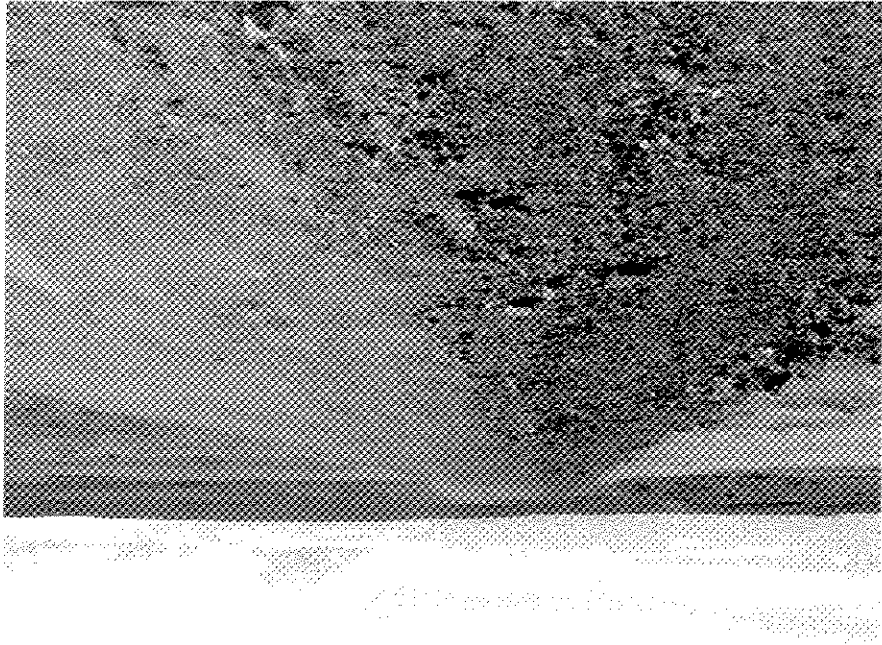
Shows the crest and the upstream side towards the south abutment.

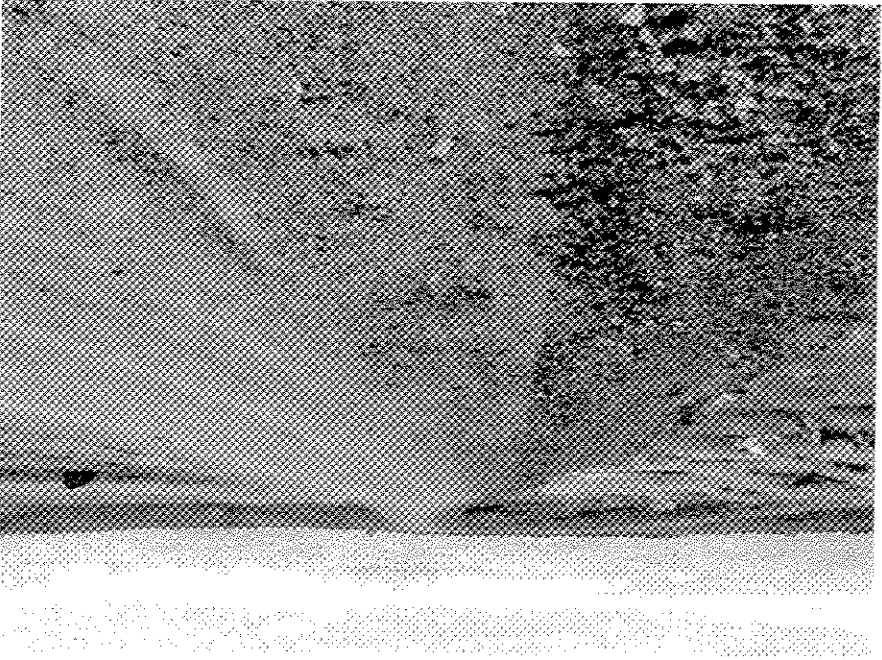
View of the crest and the upstream side looking towards it south abutment. This dam has no retained head pond and only a few small isolated ponds of water are retained by this dam.

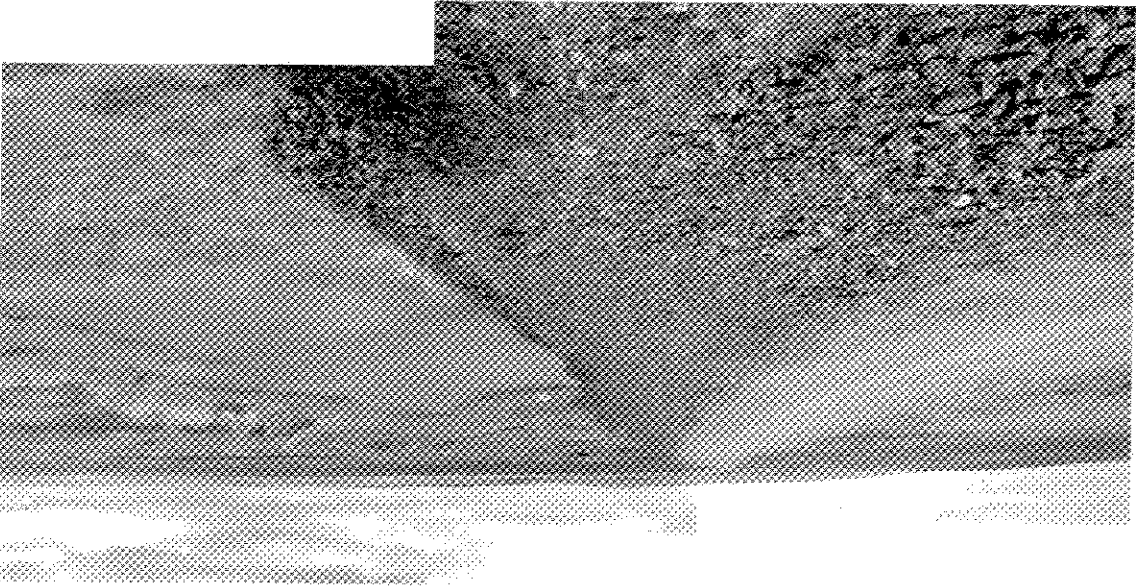
Shows the crest and upstream side and the small isolated pond.

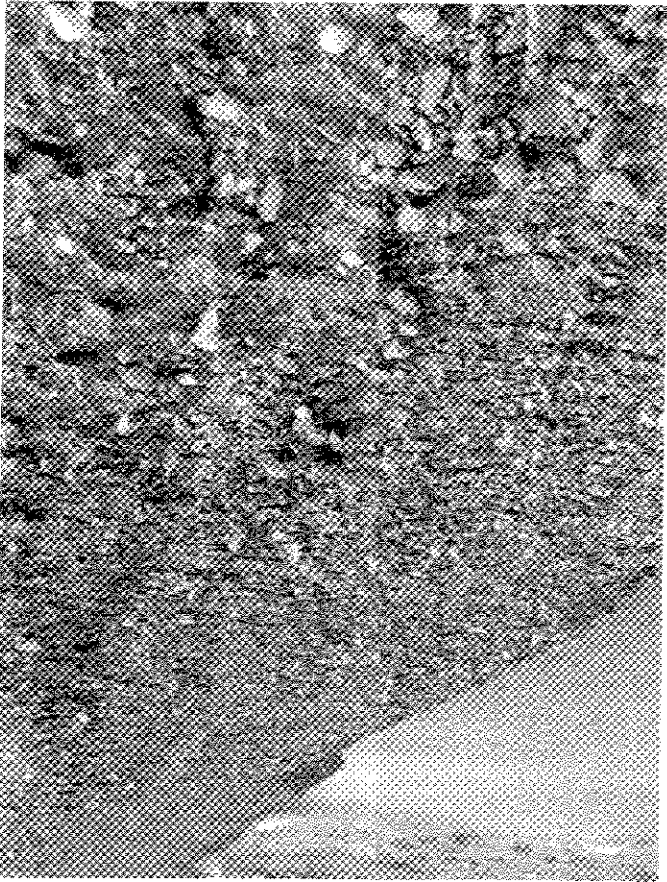
Shows some longitudinal cracks in the riprap on the upstream side.

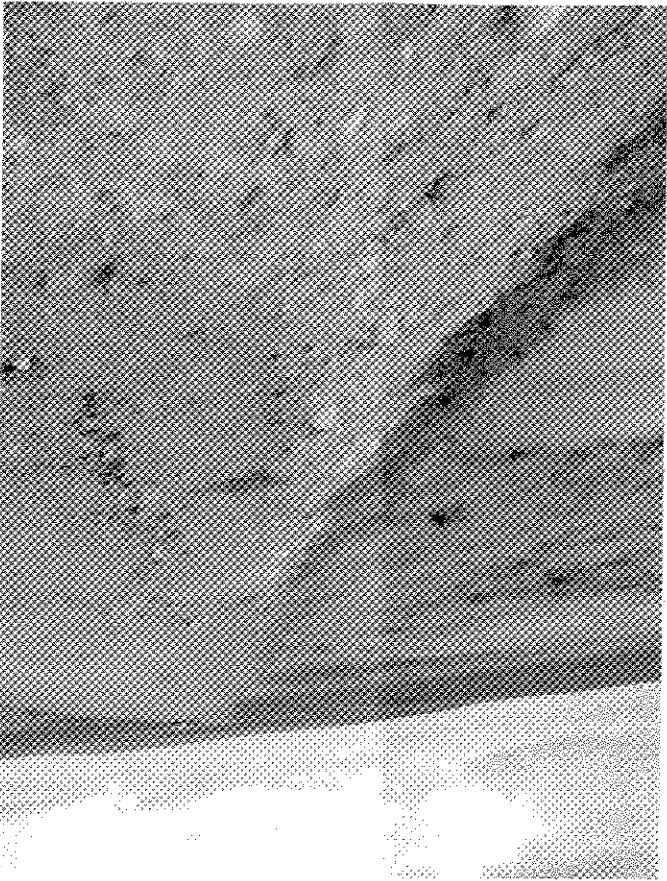
Shows the downstream edge of this dam. No significant concerns are expressed.
