| PROJECT | | ANNUAL INSPECTION OF PERIMETER<br>TAILINGS DAMS | | TITLE | |
| DAM 2 INSPECTION PHOTOS | | | | | |
| 0256-012-01 | | 8 | | 0 | |

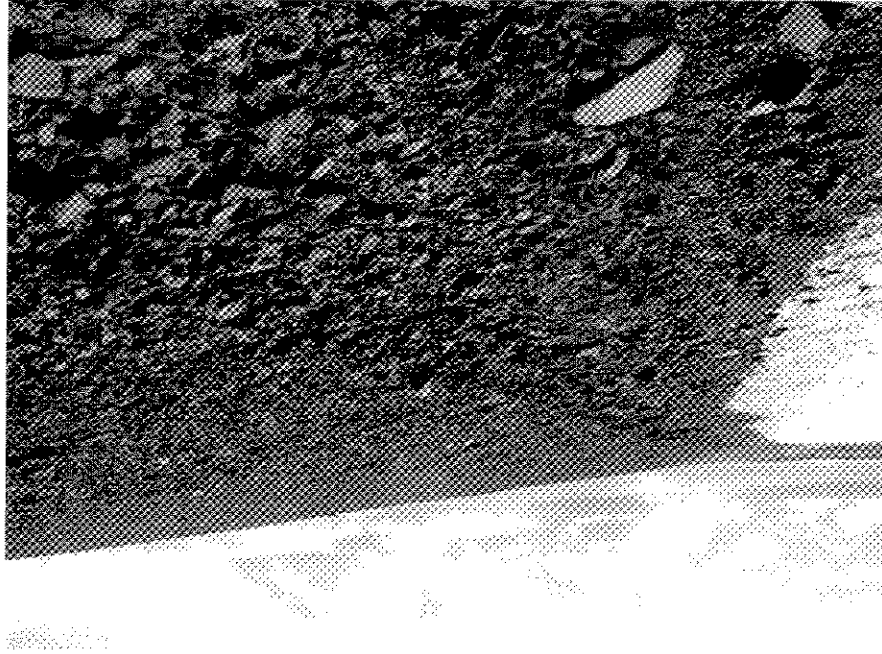
Shows the upstream side located approximately 1 m above the existing pond level.

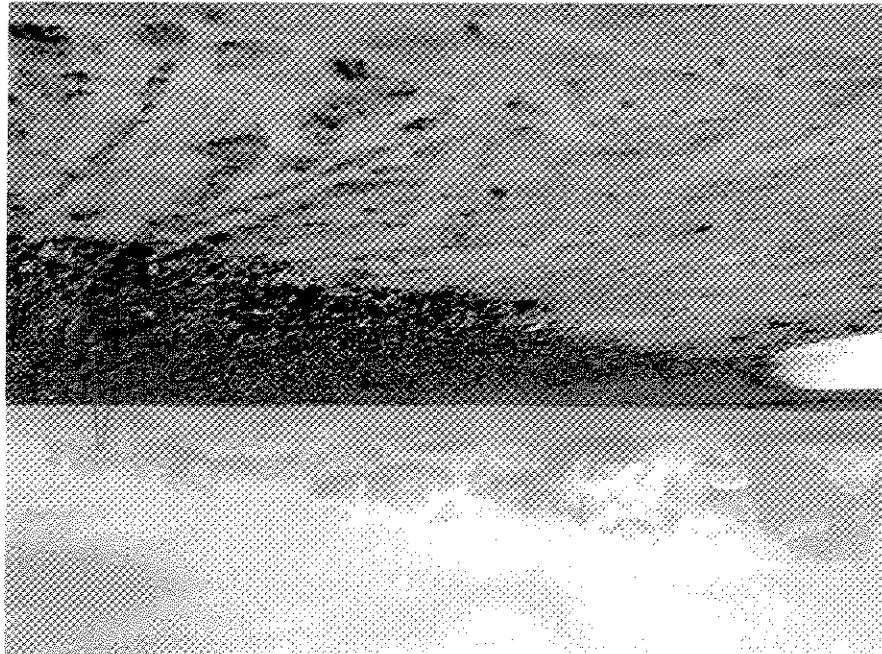
Shows an upstream side of Dam 2.

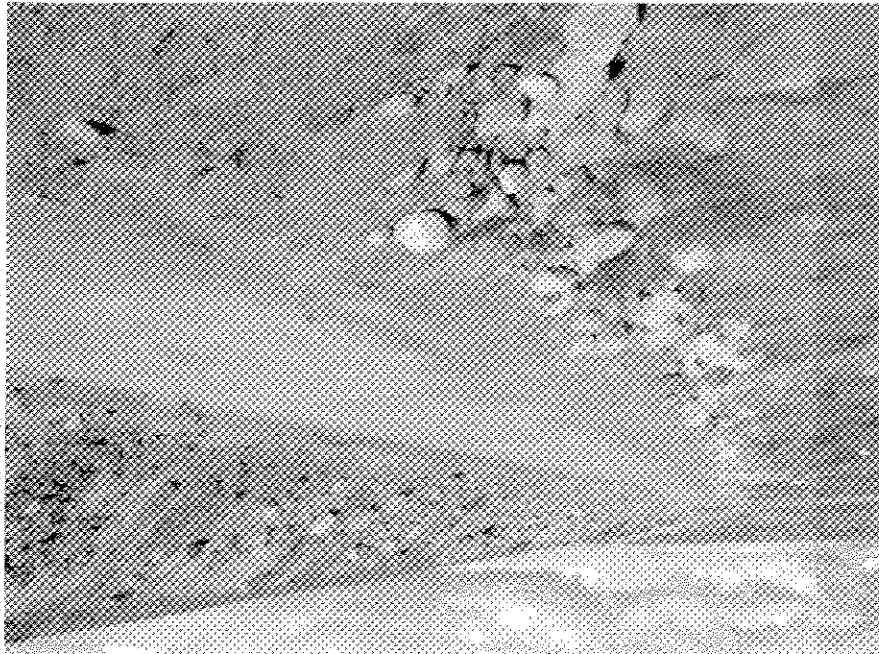
Shows the access road and toe berm located right at the toe of the downstream face.

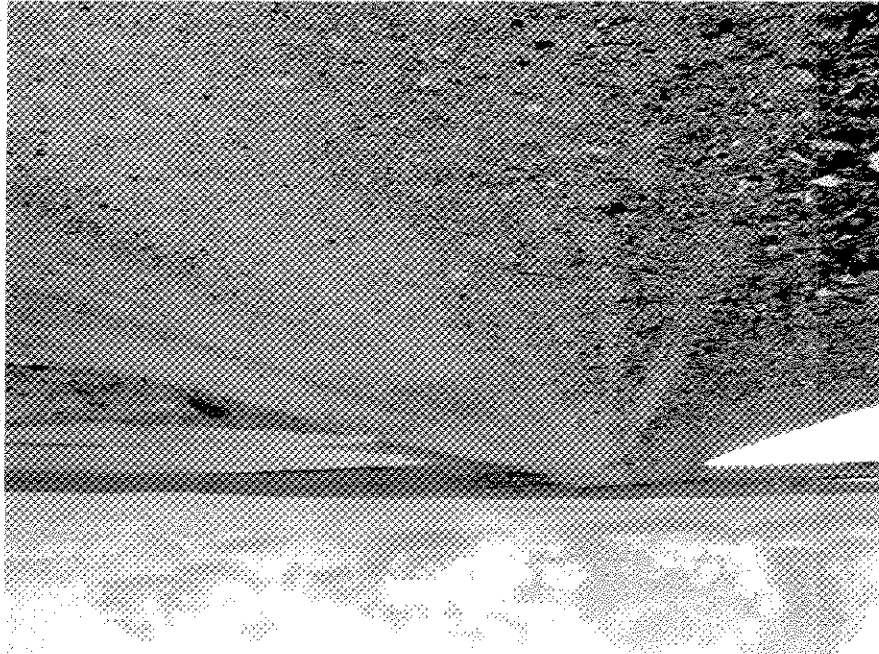
View of the crest looking towards the southwest. No signs of settlement from this location.
