| PROJECT | ANNUAL INSPECTION OF PERIMETER TAILINGS DAMS |
| TITLE | DAM 6 INSPECTION PHOTOS |
| PROJECT No. | 0256-012-01 |
| FIGURE No. | 12 |

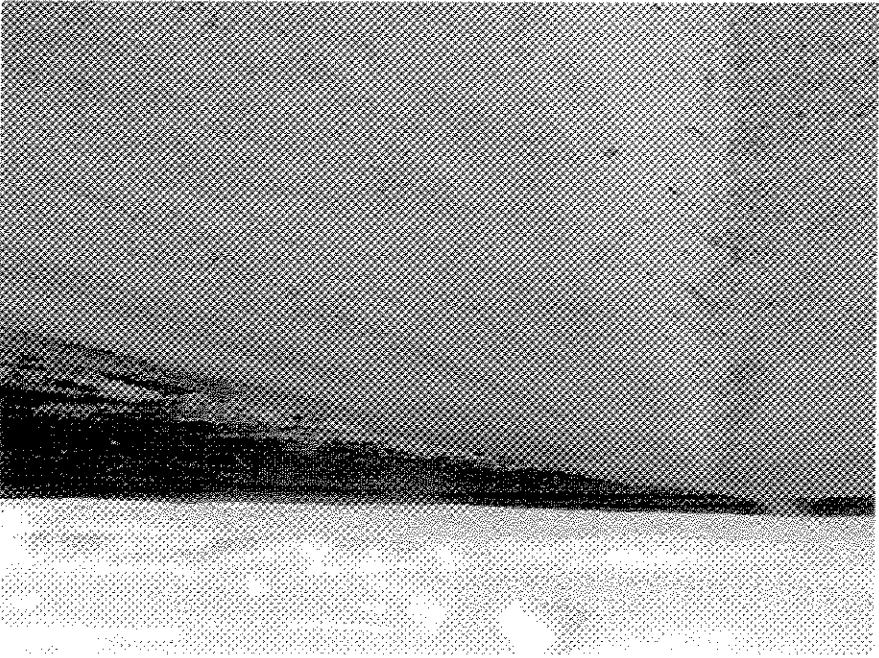
Shows a view of Dam #6 looking towards its south abutment. At the current time, there is no standing water retained by this dam.

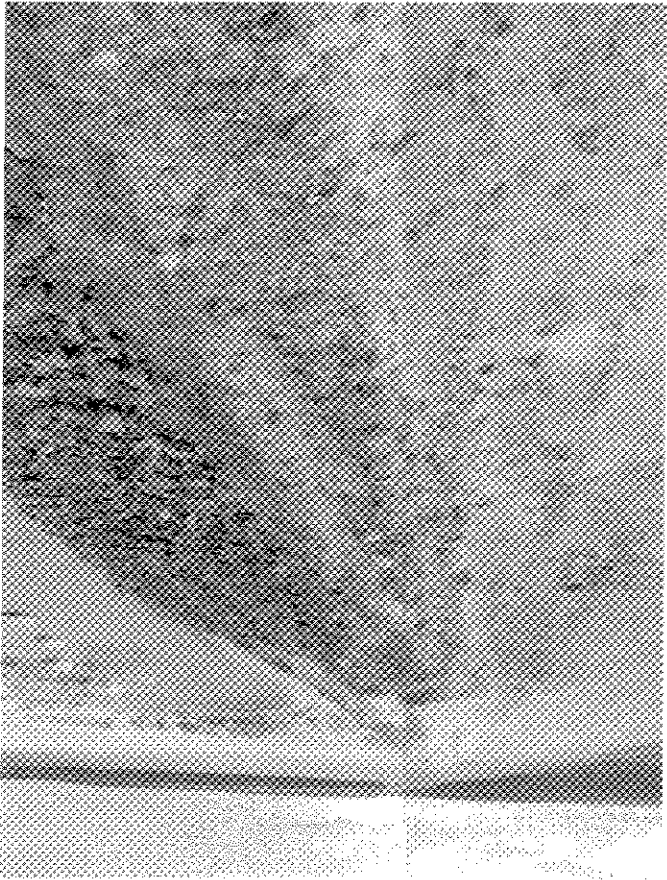
Shows some longitudinal cracks within the fill material located in the berm.

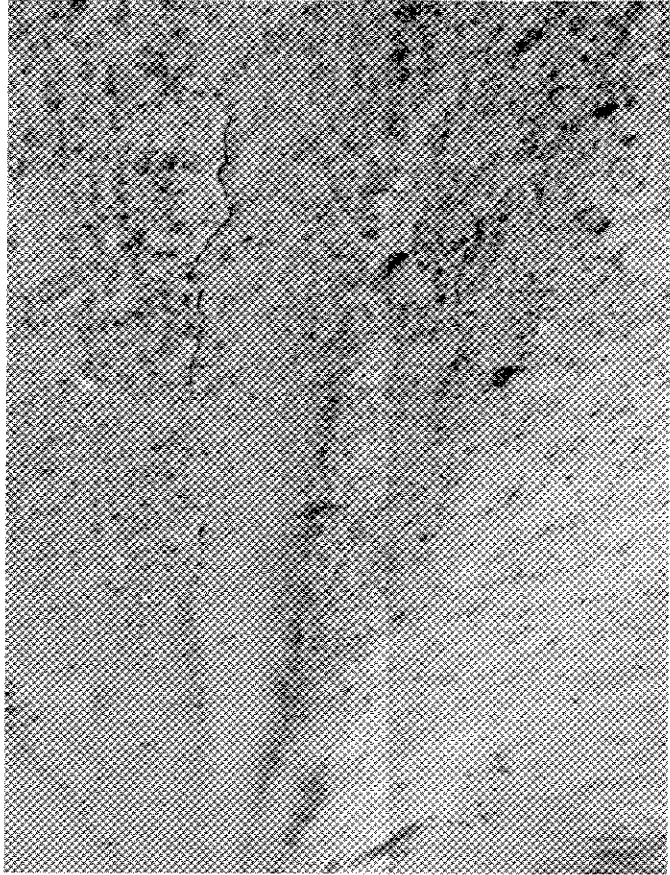
Shows longitudinal cracks located at the downstream toe of the fill.
