**RE: Kinross Gold Corporation, Lupin Mine, Contwoyto Lake, NU.
Water License NWB1LUP0008
2006 Annual Geotechnical Report**

2006 GEOTECHNICAL INSPECTION PERIMETER TAILINGS DAMS

LUPIN MINE NUNAVUT

PROJECT NO.: 0256-012-01
DATE: OCTOBER 10, 2006

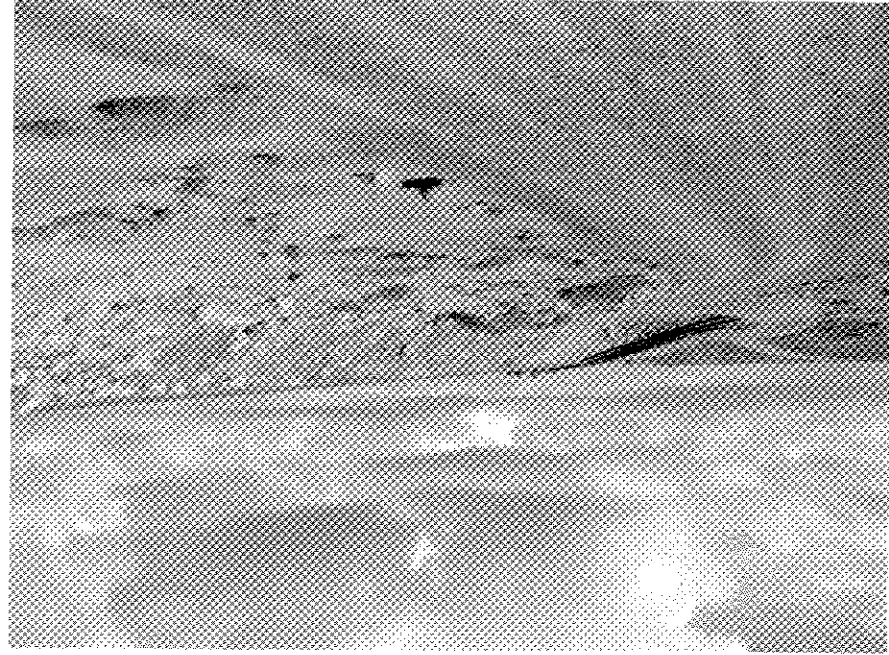
View of the downstream side.

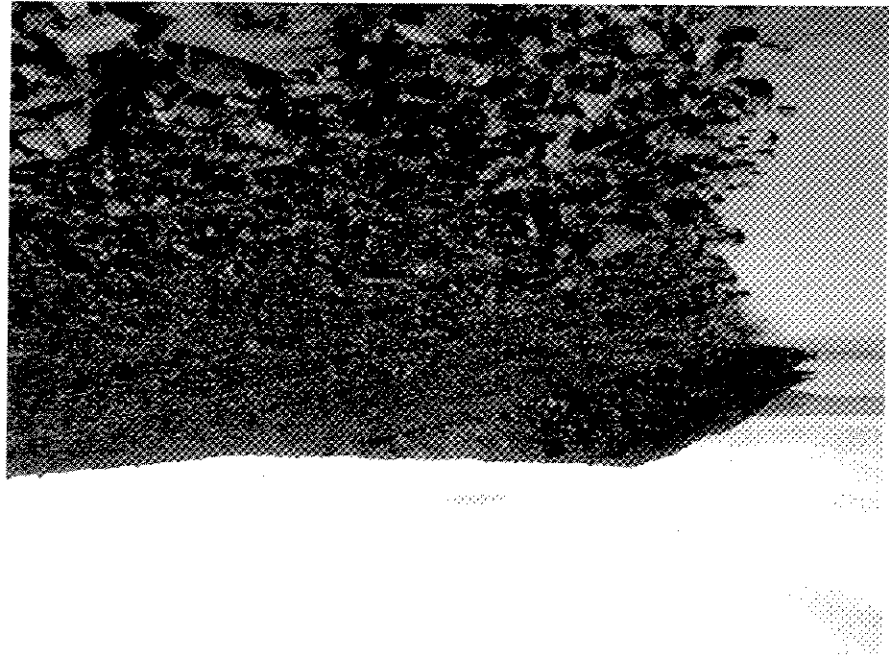
View of the upstream side where the total crest freeboard is approximately 3.5 m.

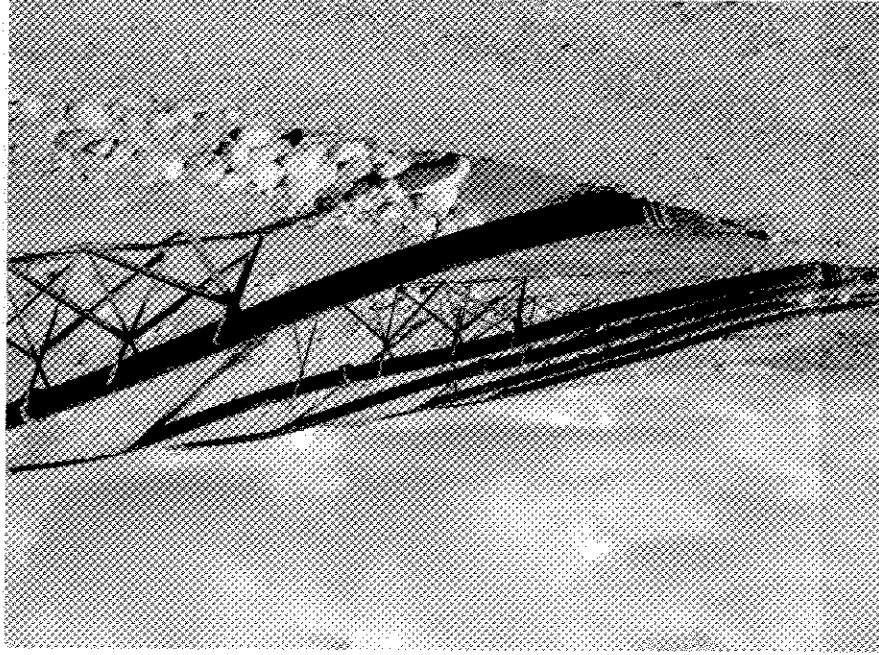
View of the five decant siphons on the downstream side some which

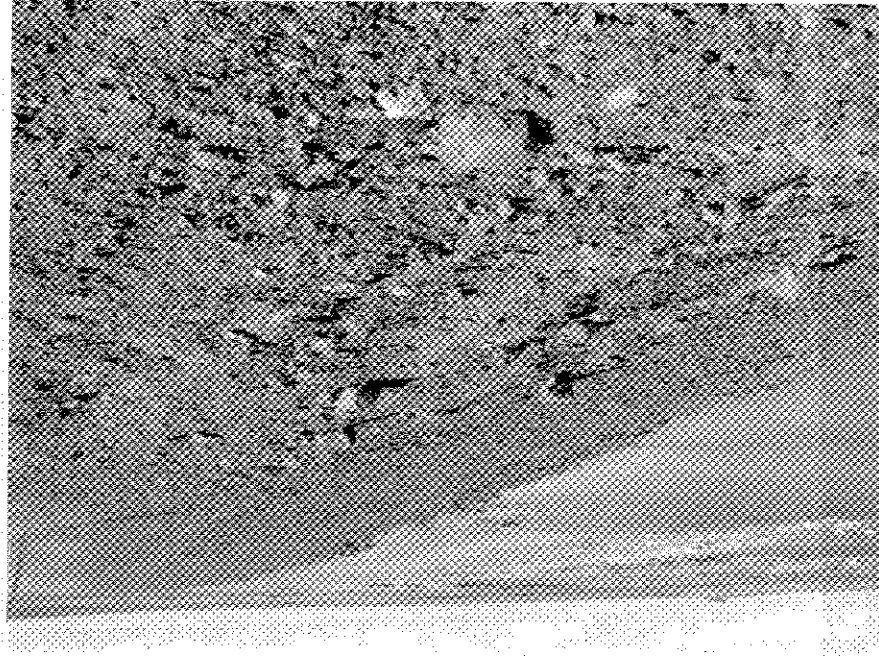
Shows the previously noted disturbed area on the upstream side. There doesn't appear to be any new cracking or deformation associated with this area.

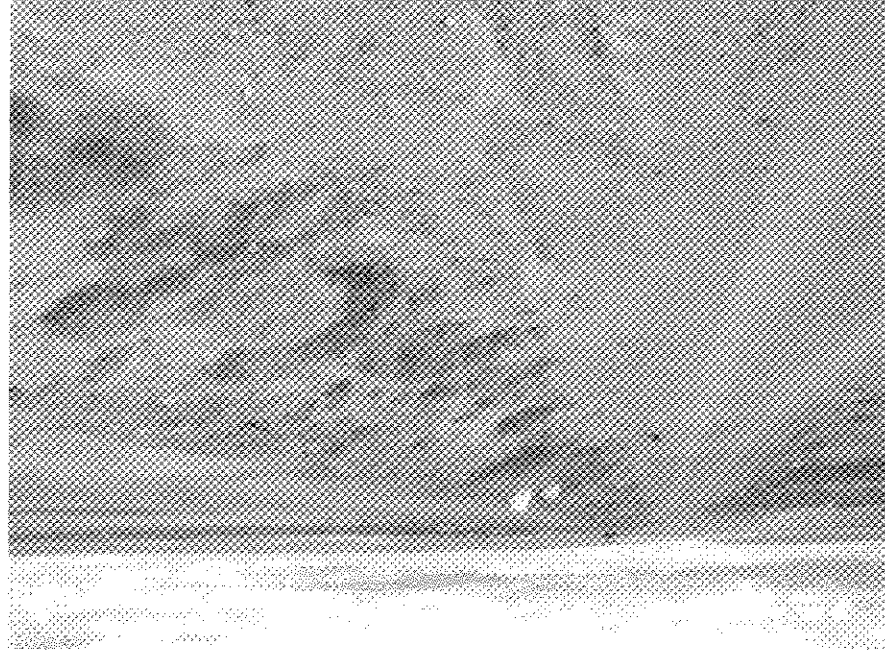
Shows the downstream side, where some vegetation and small shrubs are catching on.

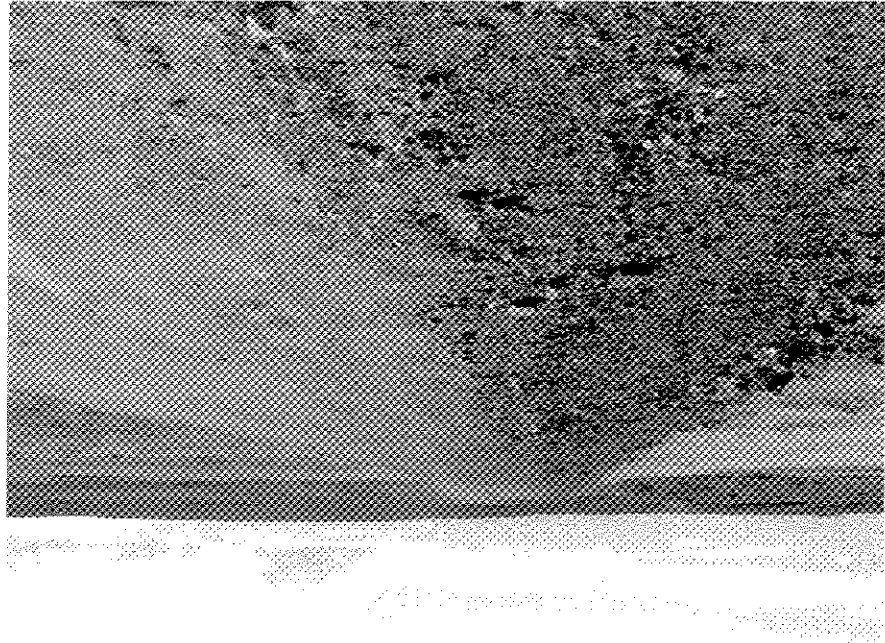
Shows the crest and the upstream side towards the south abutment.

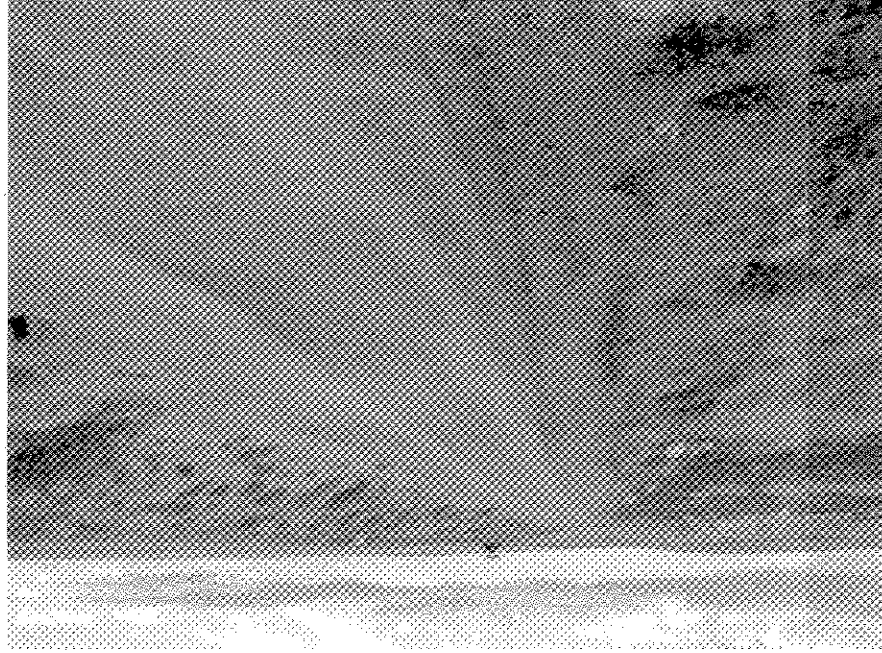
View of the road along the downstream side. No signs of seepage or deformation at this location.

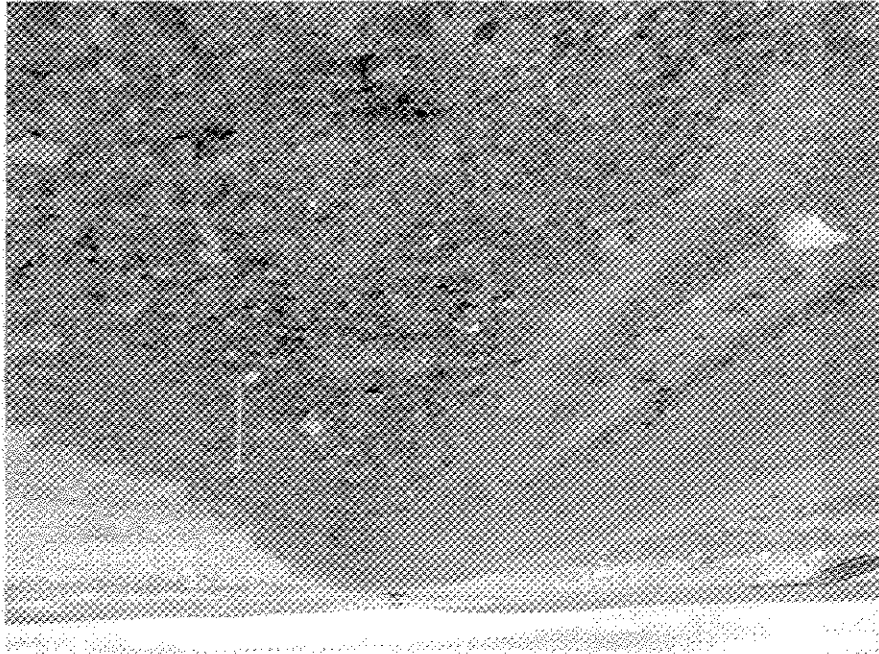
View of the upstream side and crest. It should be noted that this pond does not retain a head of water. The crest appears consistent with no signs of deformations.

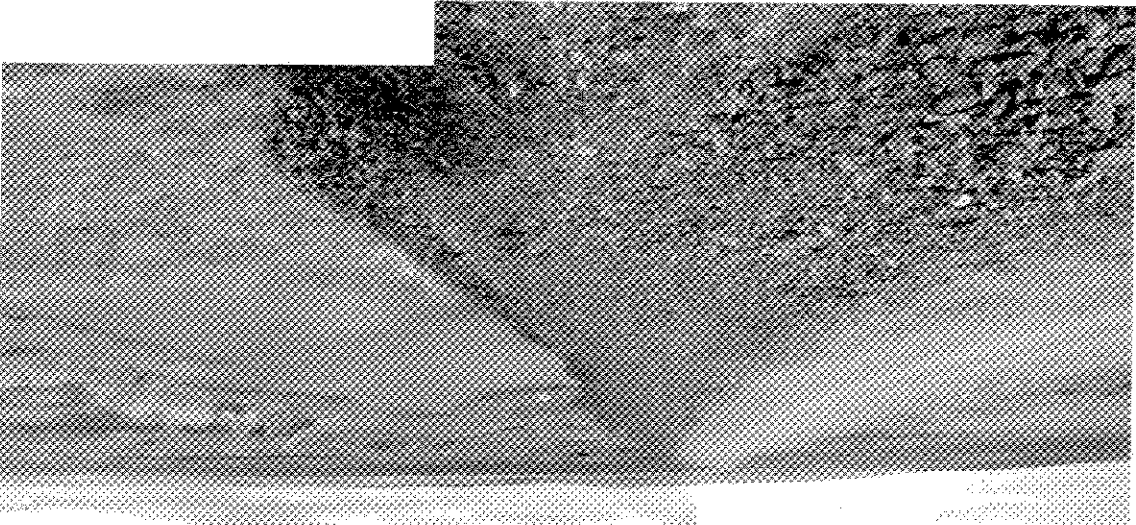
View of the crest and the upstream side looking towards it south abutment. This dam has no retained head pond and only a few small isolated ponds of water are retained by this dam.

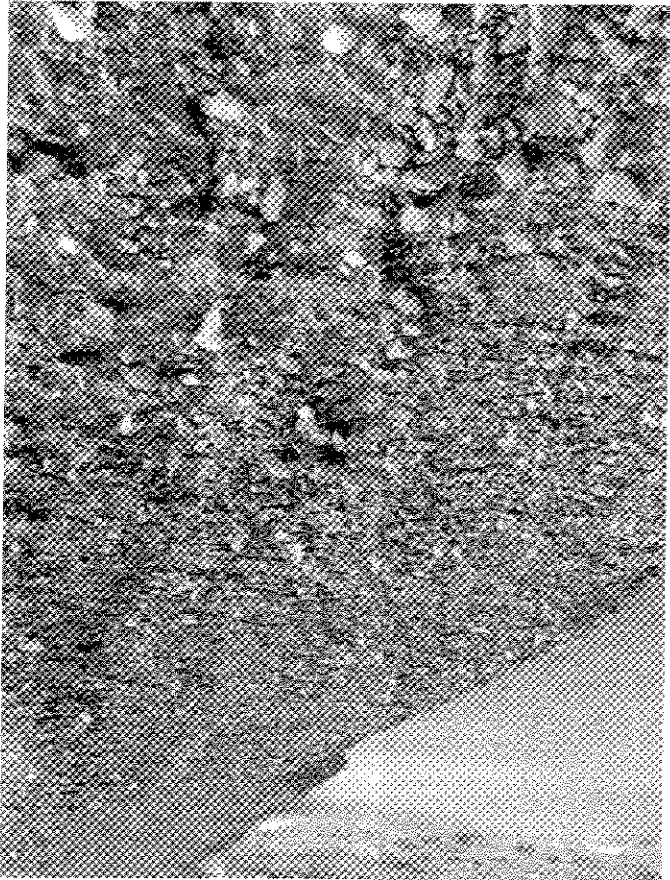
Shows the crest and upstream side and the small isolated pond.

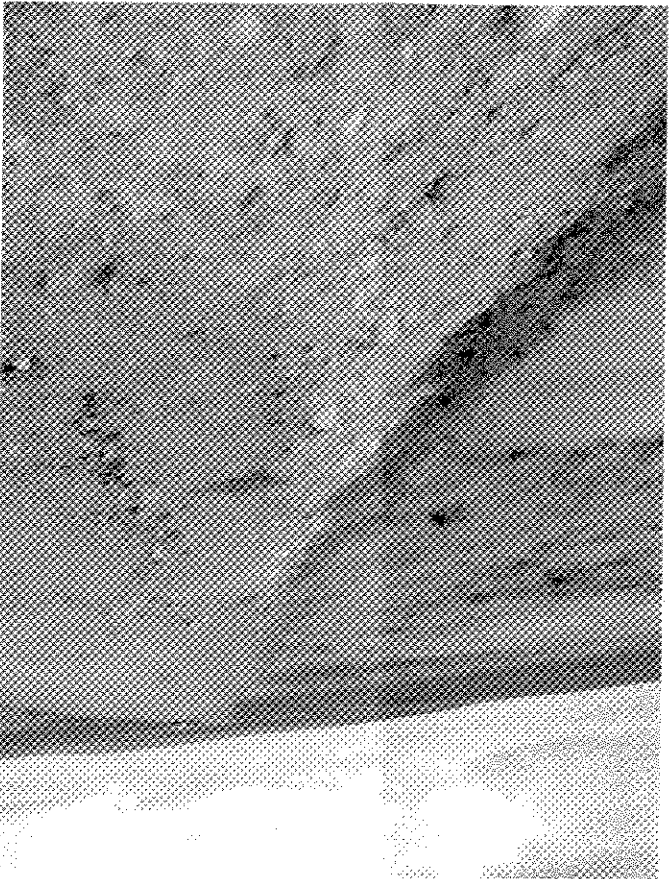
Shows some longitudinal cracks in the riprap on the upstream side.

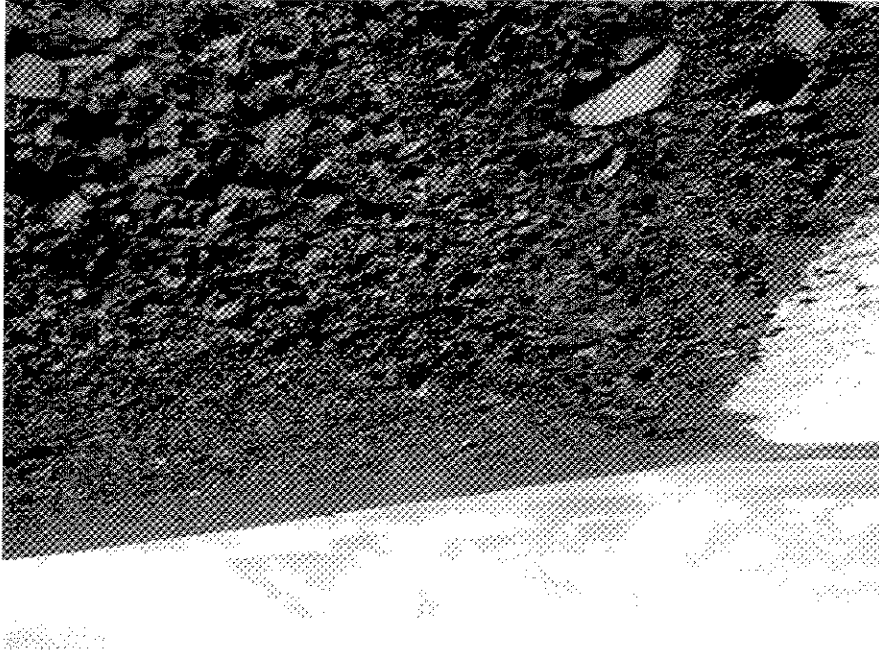
Shows the upstream side located approximately 1 m above the existing pond level.

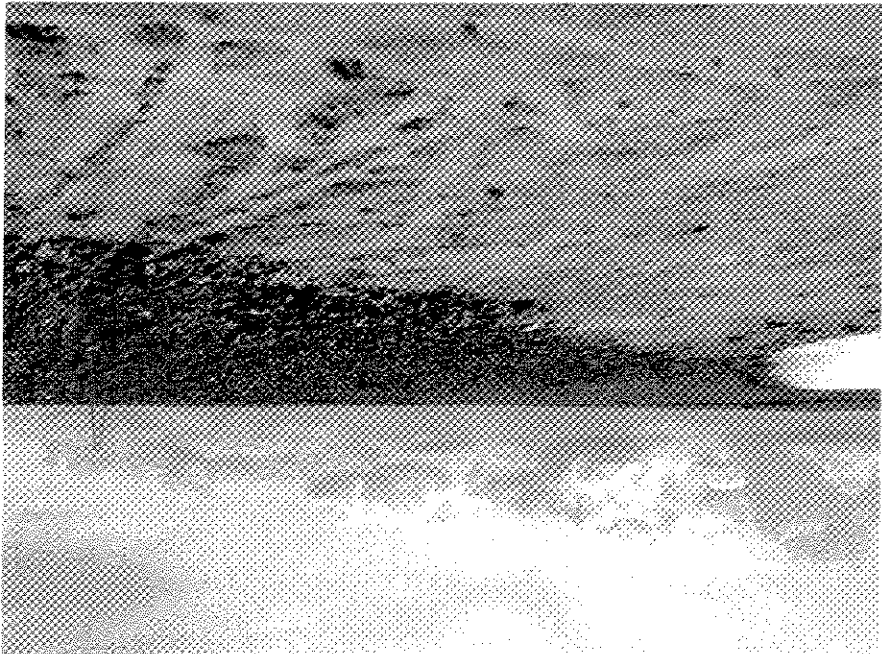
Shows an upstream side of Dam 2.

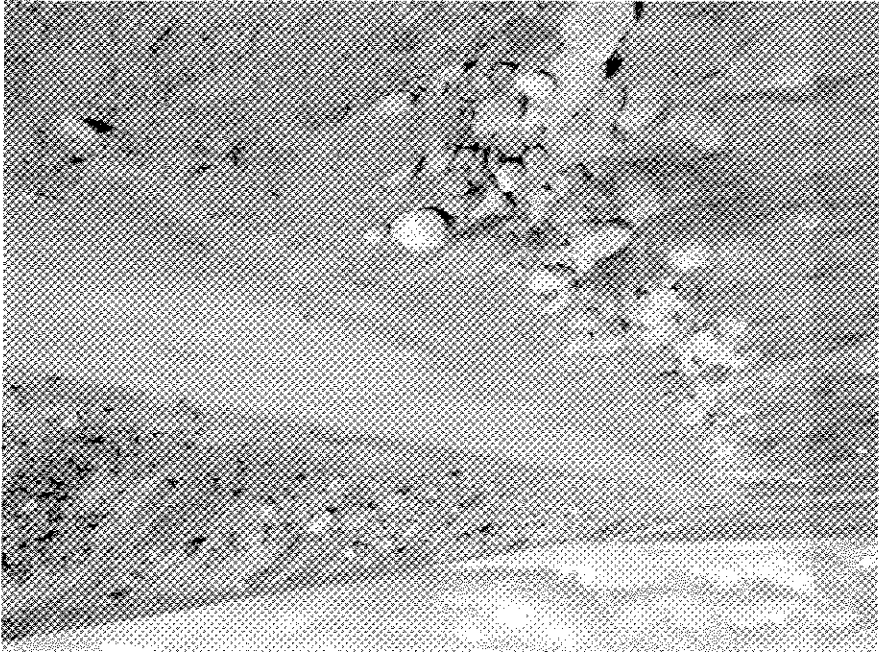
Shows the access road and toe berm located right at the toe of the downstream face.

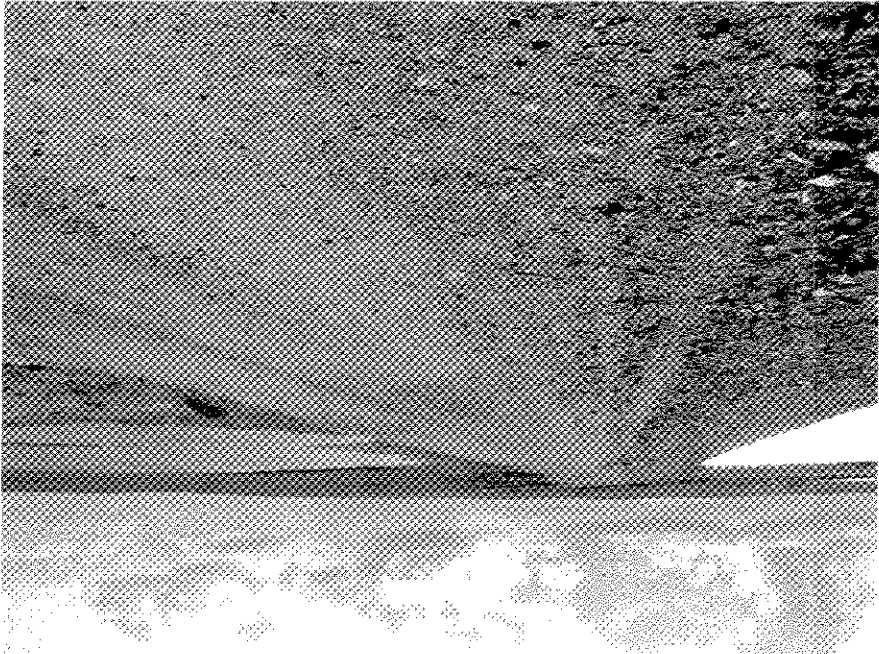
View of the crest looking towards the southwest. No signs of settlement from this location.

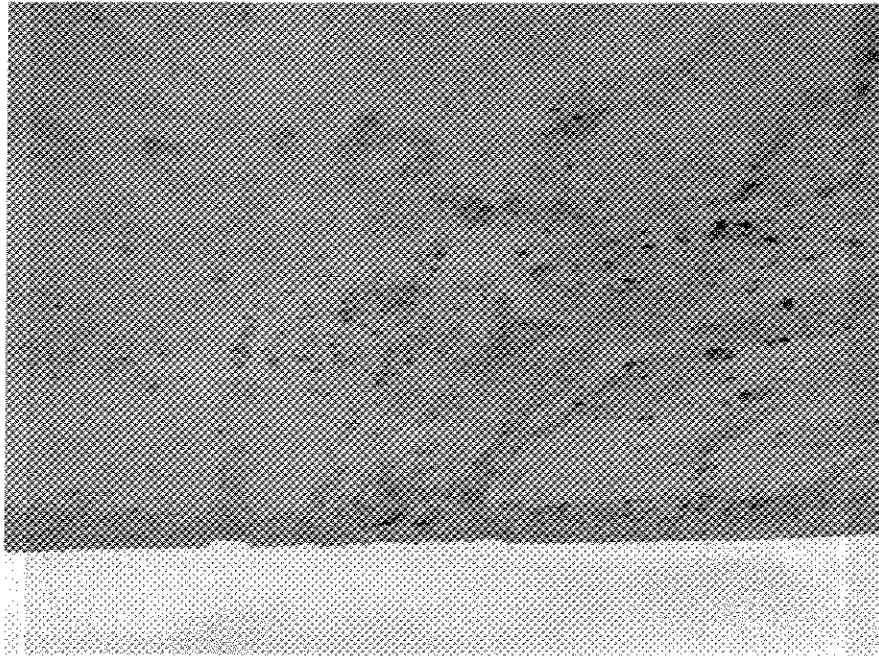
Show several erosional gullies located on the downstream edge of the crest.

- Numerous small to mid-sized erosional gullies located on the downstream side of the crest should be backfilled to prevent additional erosion. One larger sized one is located towards the west abutment where surficial runoff water from the crest is funneled at one point. Some grading required to prevent this from occurring again.
- No other concerns noted or maintenance required.

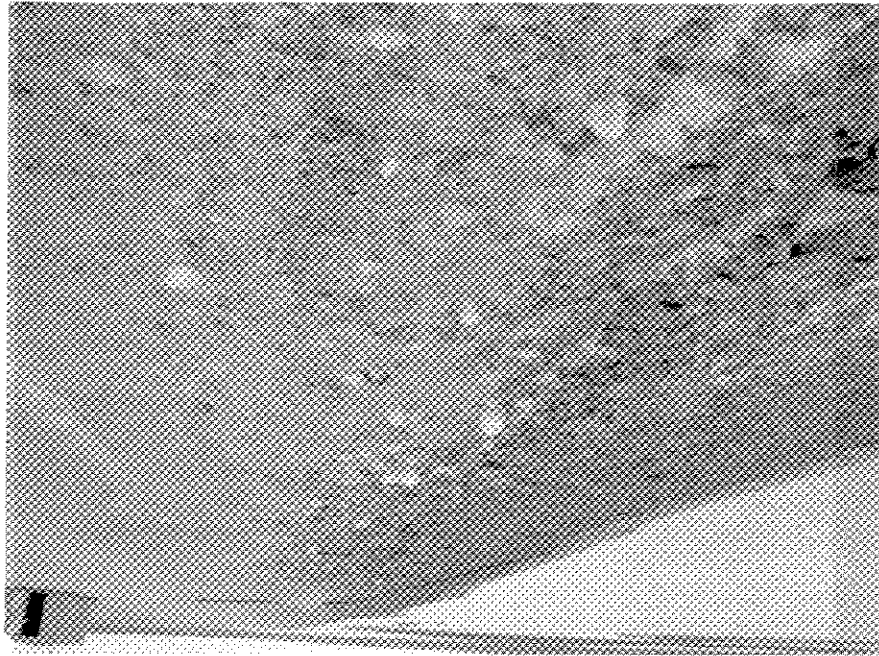
View of the upstream face, which has been disturbed due to vehicle traffic.

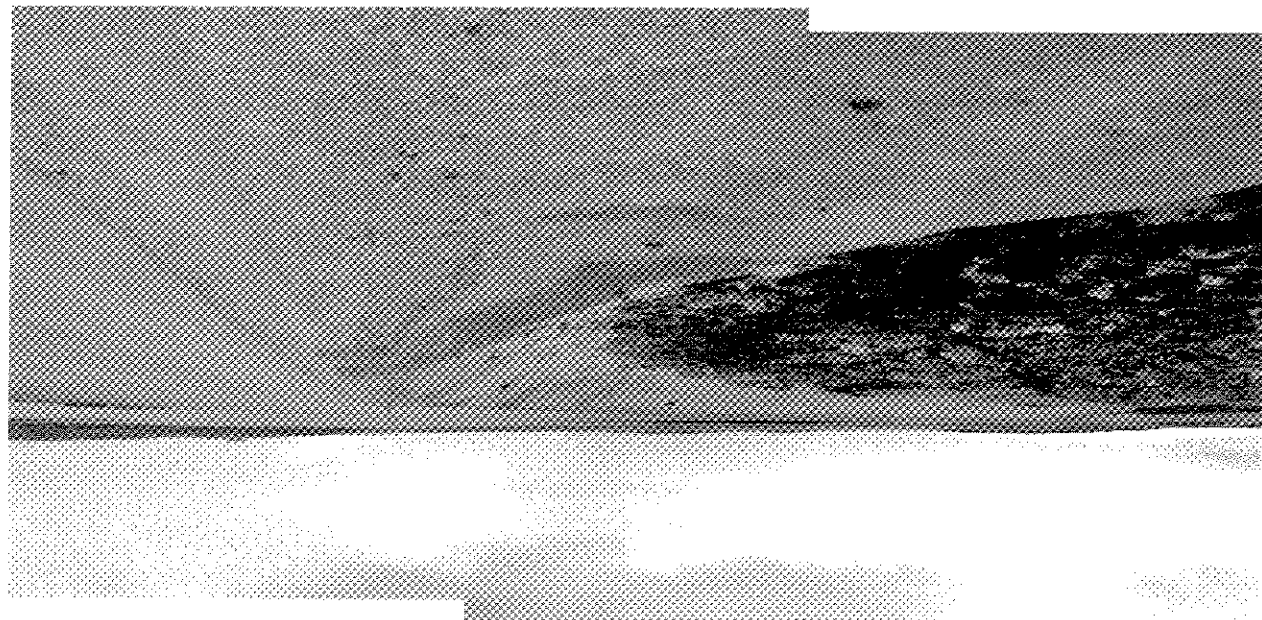
Show a panoramic shot of the downstream face of this dam.

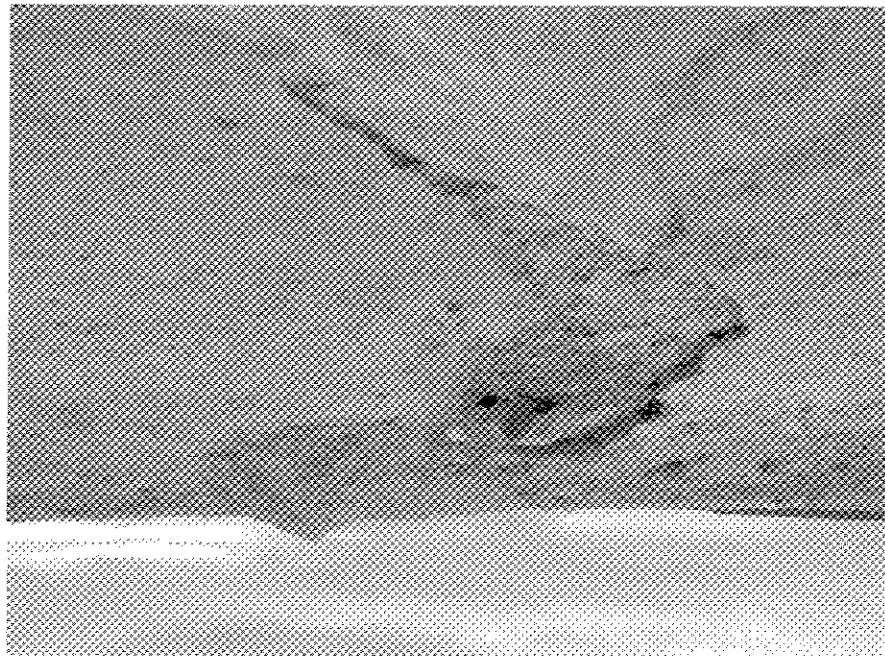
Shows an erosional gully right at the west abutment of this dam. This gully tends to stem from an uphill ditch which focuses the erosional forces of water from the slope above.

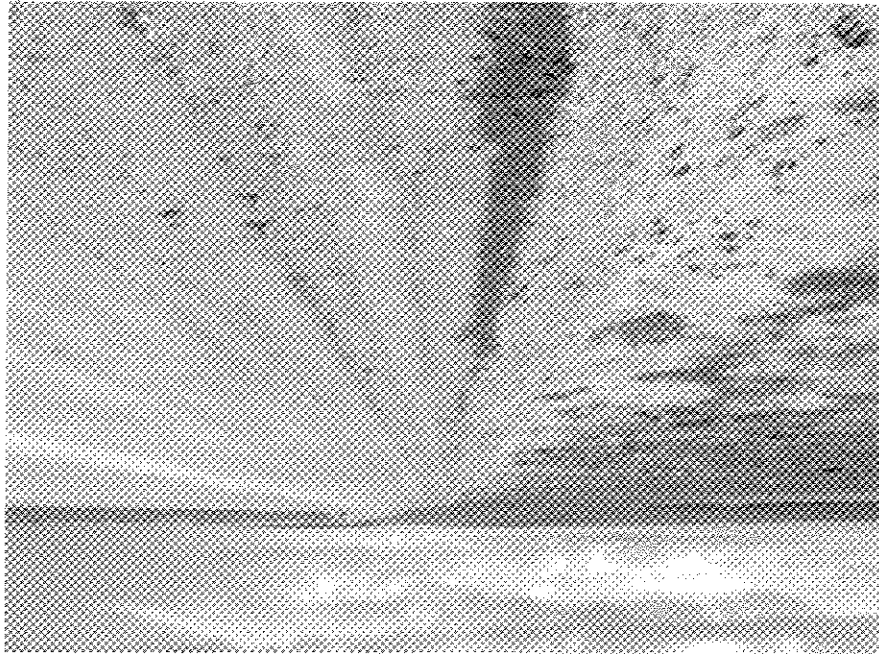
Shows a view of Dam #6 looking towards its south abutment. At the current time, there is no standing water retained by this dam.

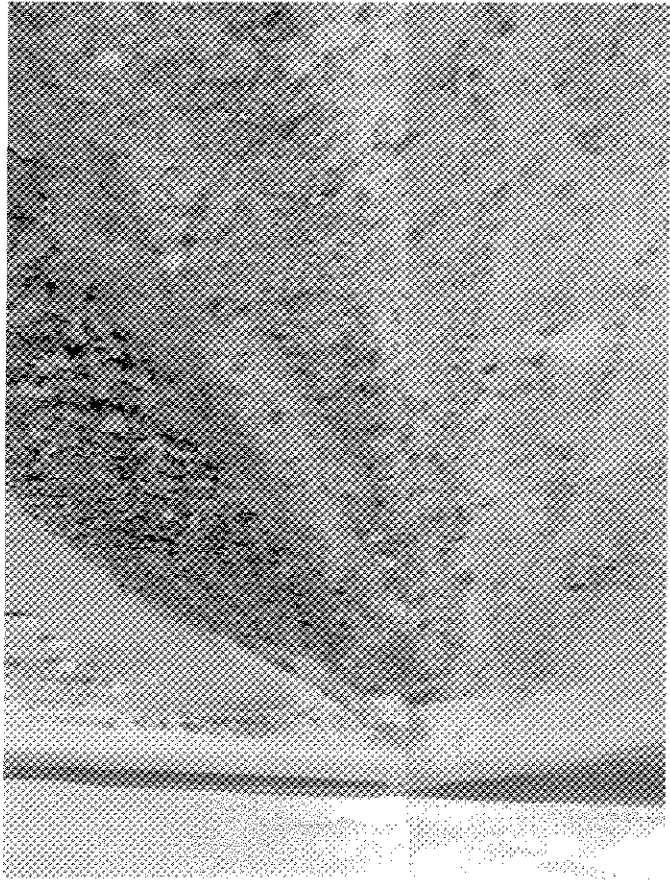
Shows the crest and downstream toe looking towards its north end.

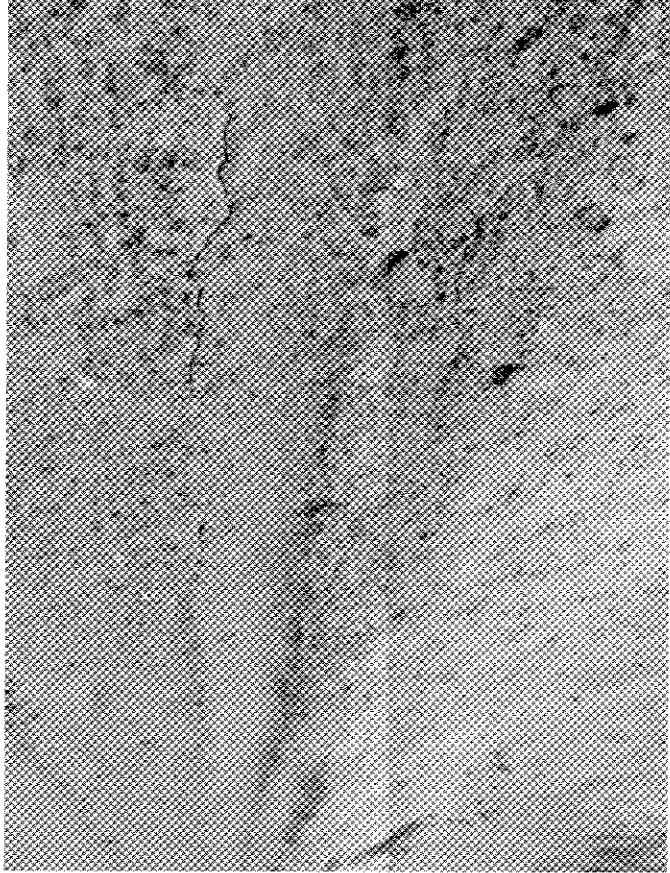
Shows some longitudinal cracks within the fill material located in the berm.
