**ZINIFEX CANADA INC.  
LUPIN OPERATION**

**2007 GEOTECHNICAL INSPECTION  
PERIMETER TAILINGS DAMS**

**LUPIN MINE  
NUNAVUT**

PROJECT NO.: 0385-006-03  
DATE: OCTOBER 31, 2007

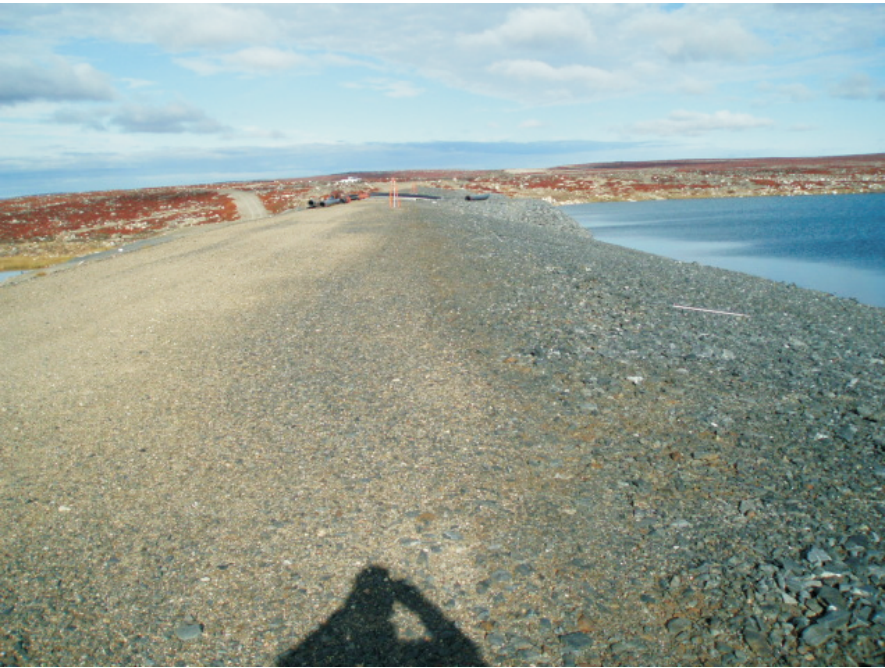
View of the crest and upstream side looking towards the north abutment. No real signs of deformation or settlement noted.

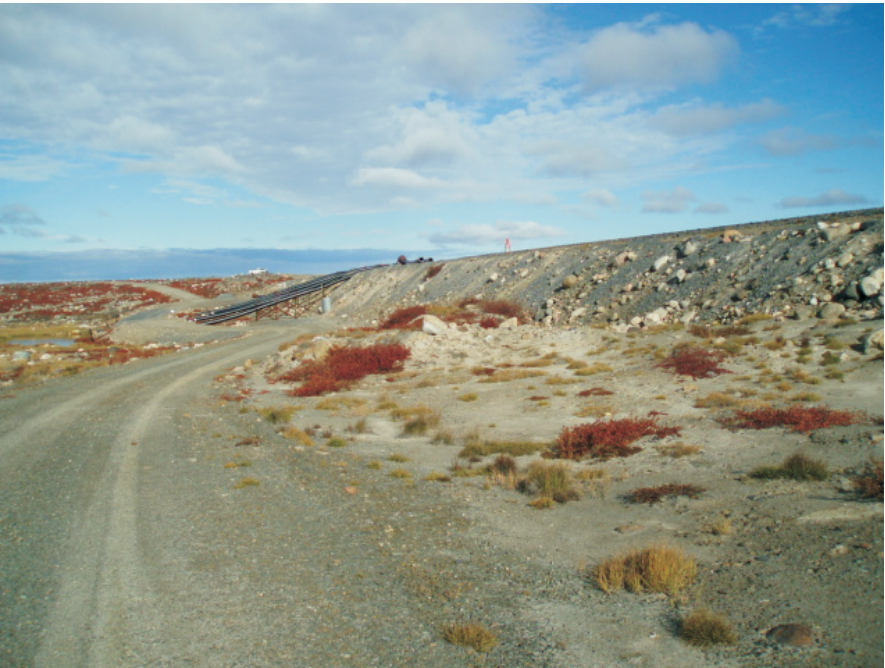
View of the downstream side of 1A with no concerns noted.

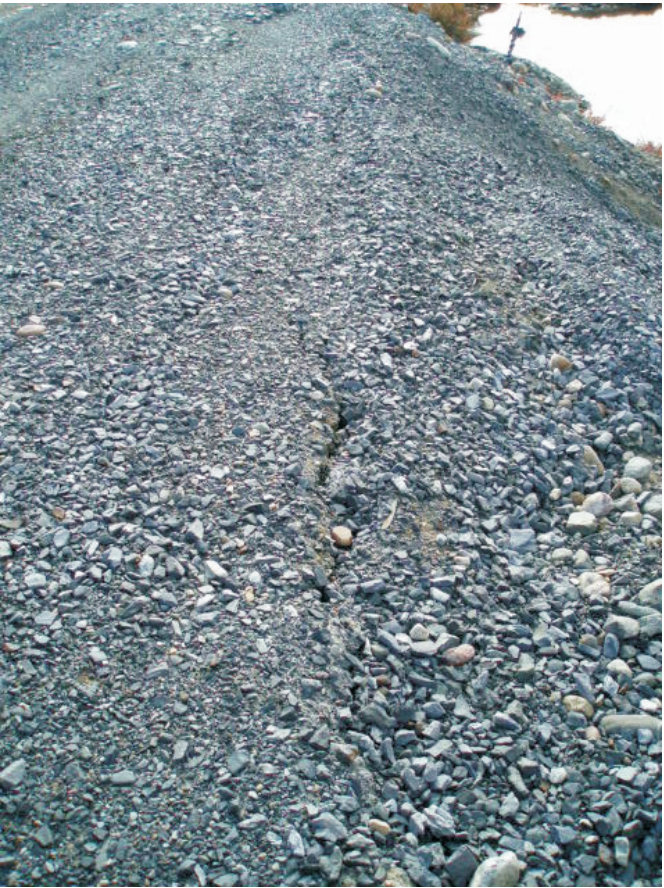
Shows some longitudinal cracking and a small scarp located along this berm edge along the toe.

<b>MAINTENANCE RECOMMENDATIONS:</b>	Monitor downstream edge of the toe for additional cracking and grade with rockfill if more deformation occurs.
<b>CONCLUSIONS:</b>	The dam is in good condition with no evidence of seepage passing through or beneath the dam. Monitor instrumentation regularly and visually inspect downstream toe as Pond 2 level increases.

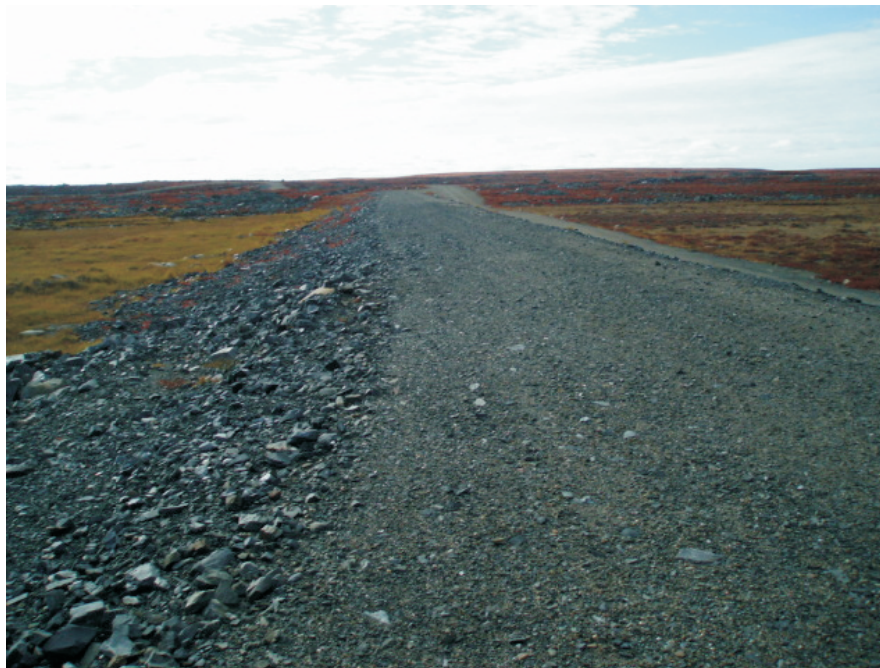
Shows the crest and upstream side of Dam 1B with no signs of deformation or settlement.

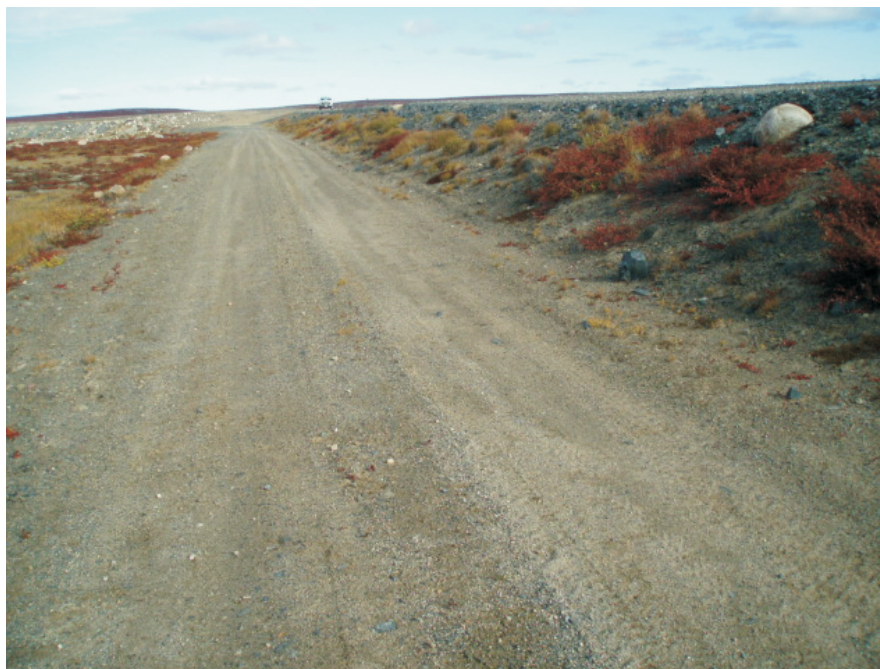
View of the downstream slope showing the little bushes that are catching on.

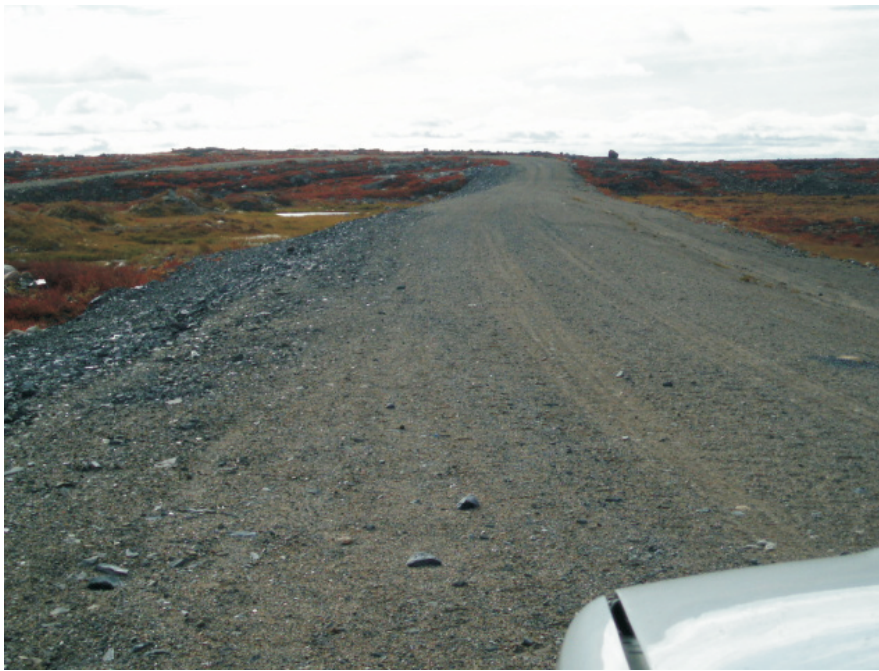
Shows the upstream side and crest of Dam 1C looking towards its south abutment.

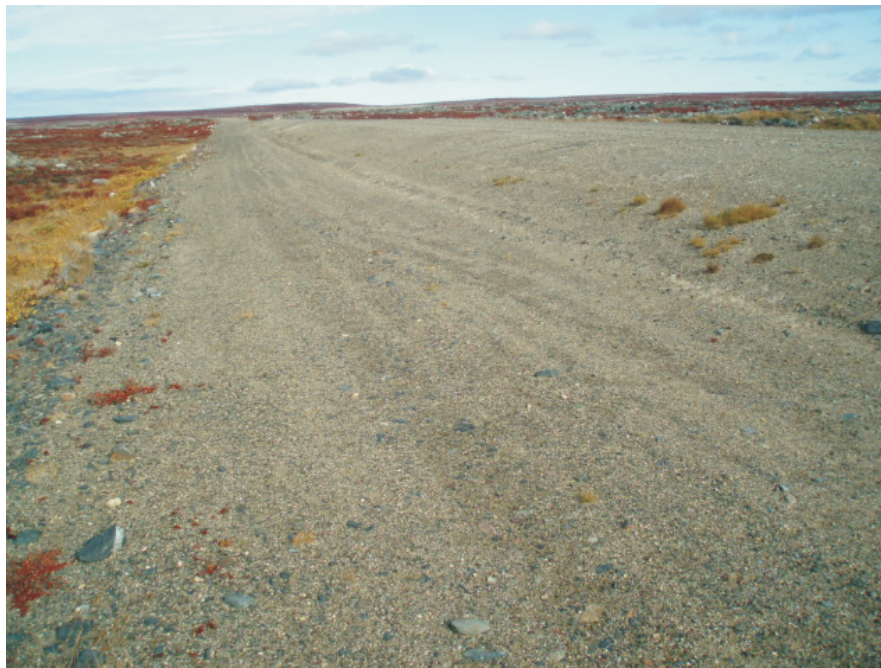
View of the downstream side and the access road and no concerns are noted.

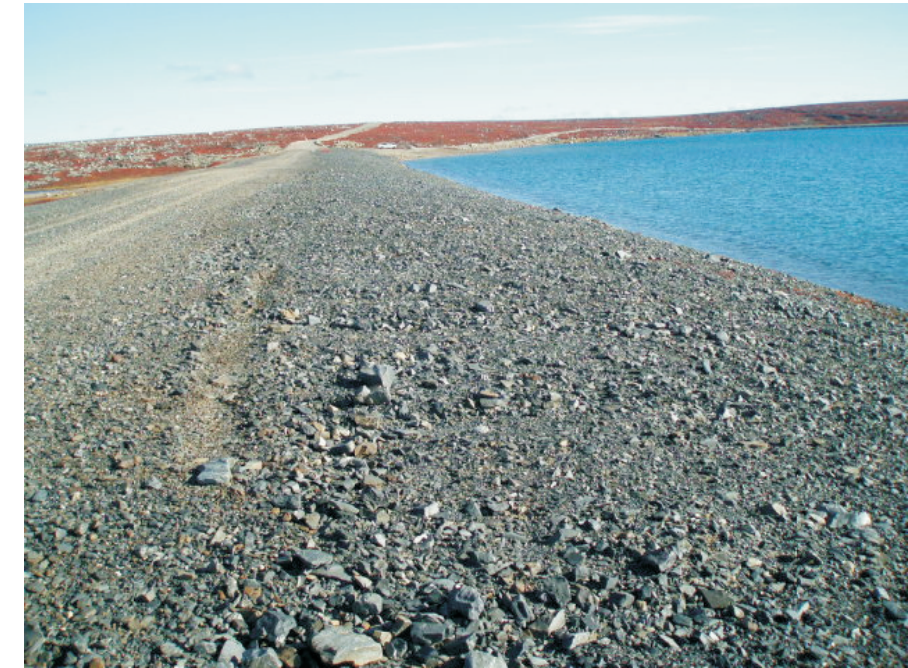
View of the crest and upstream slope looking towards the north abutment. There are no signs of deformation or erosion.

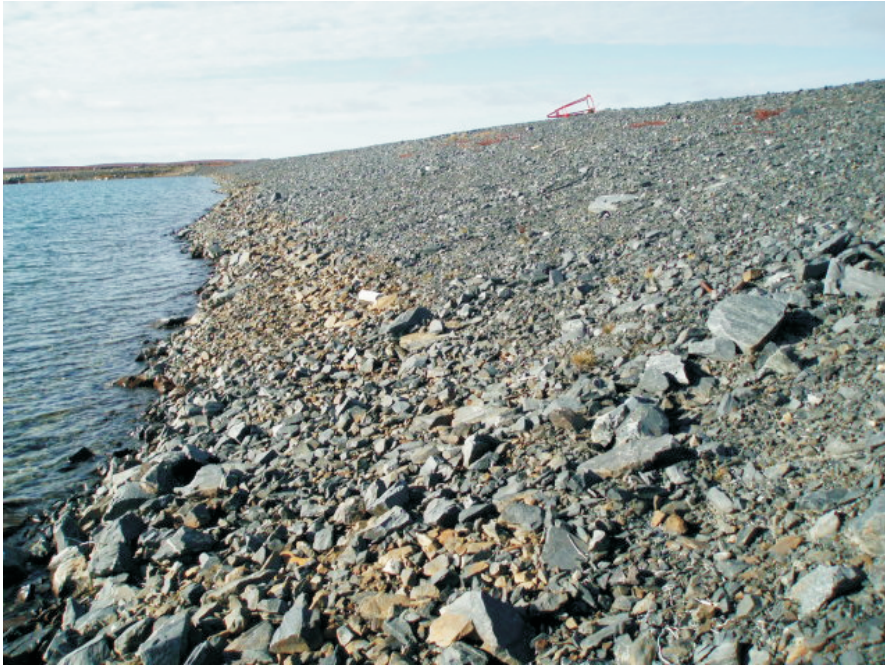
Shows the two colours that appear on the riprap on the upstream side and the small scarp which has formed at the water line.

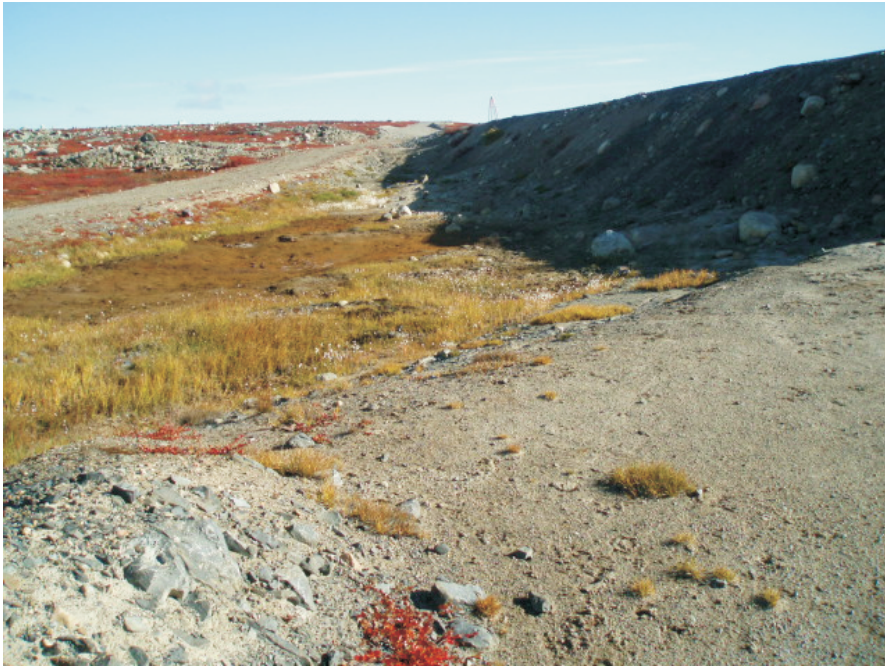
Shows the small pond area which is located over towards the north abutment at the toe. Usually this area is slightly wet with surficial drainage being collected here. But currently, this entire area is dry.

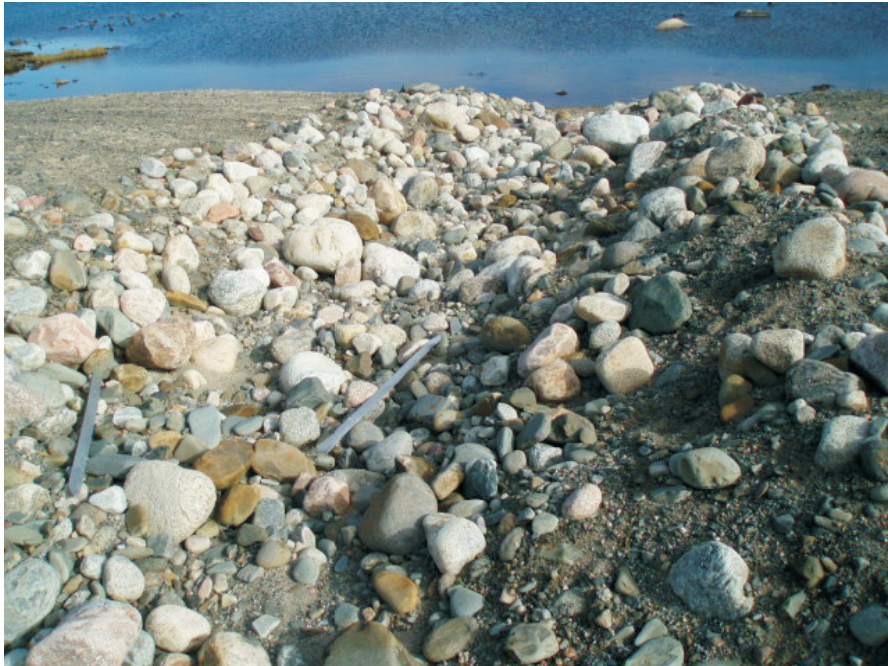
Shows the armoured channel which conveys ditch water across the crest, which appears in satisfactory condition

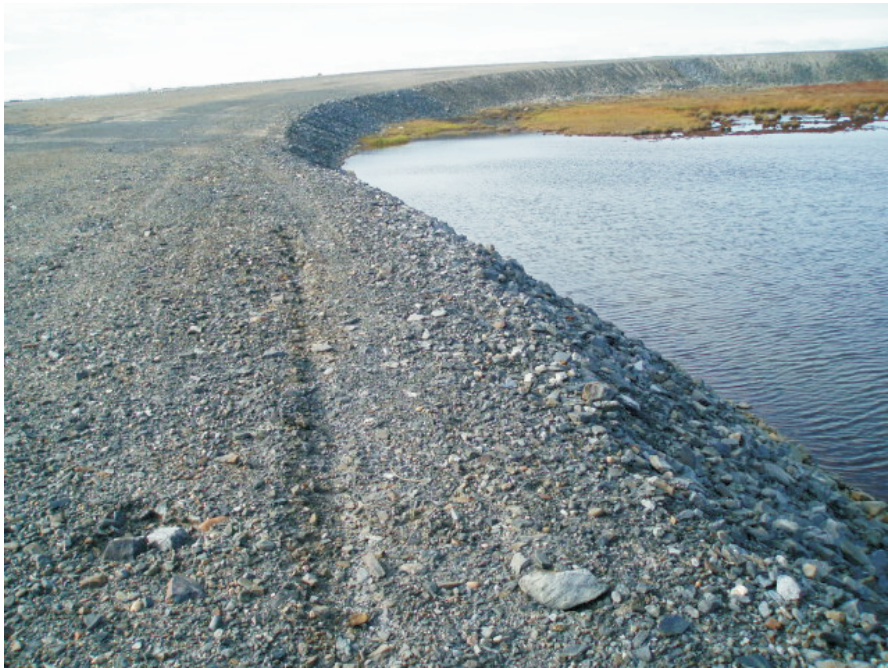
Shows the section of the toe of Dam 3 looking at its confluence with the main haul road. No signs of seepage, significant deformation or erosion were noted.

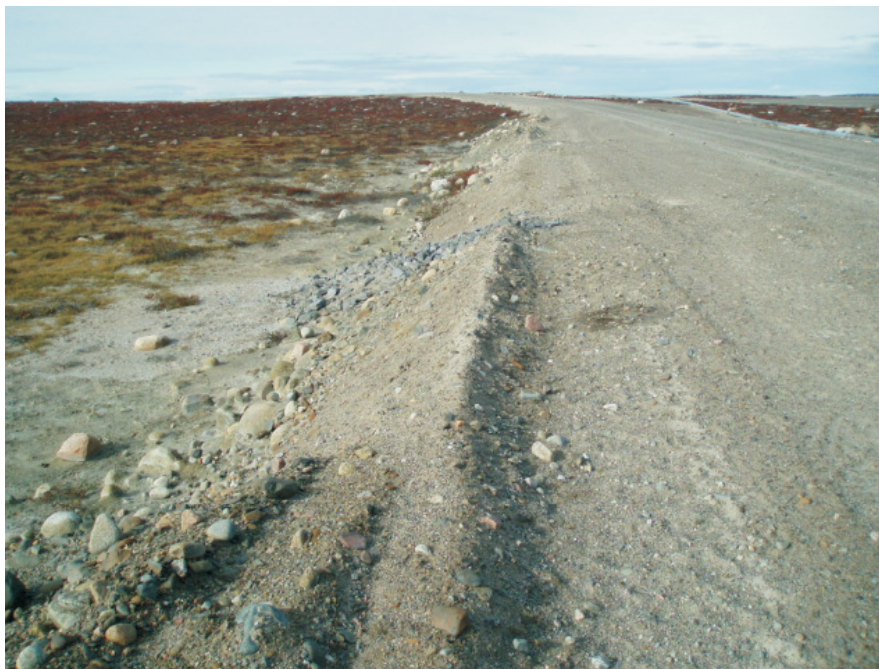
Shows some angular riprap that was previously placed in erosional gullies located at the toe.

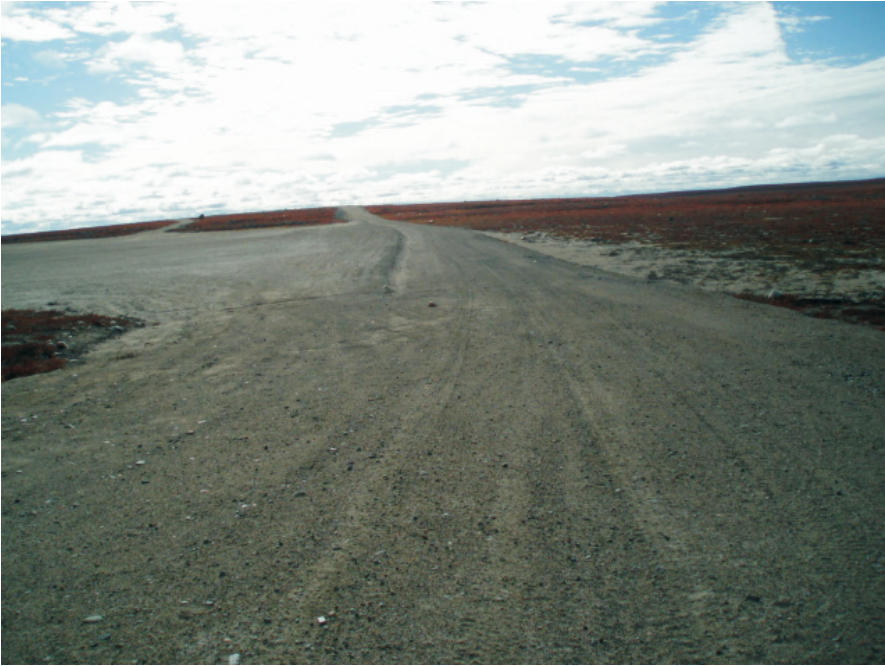
Shows a view of Dam 6 looking towards its south abutment. This area is completely reclaimed and there is no pond retained.

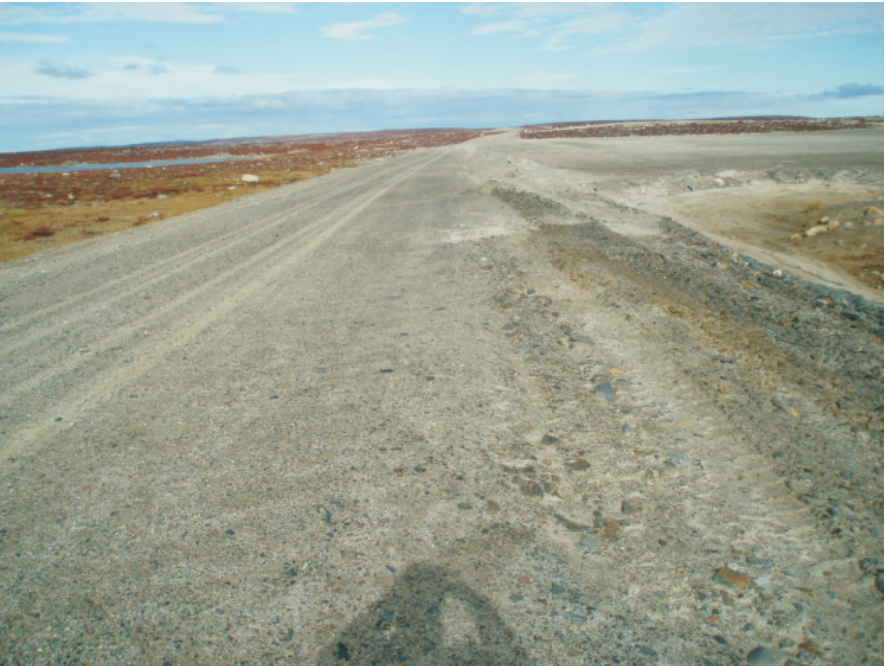
View of the crest looking towards the north abutment. We can see the reclaimed cover sand on the upstream side being .75 m higher than the dam crest.

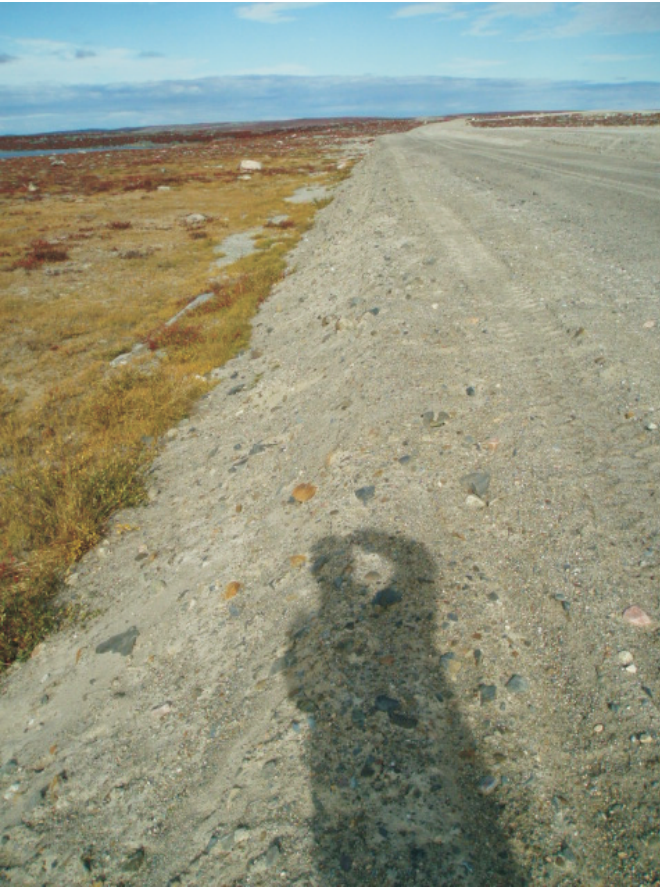
View of the downstream toe where we see some accumulation of wind blown sand in the grasses beyond the toe. No signs of seepage or significant erosion are noted at the toe.
