**OZ MINERALS CANADA LTD.
LUPIN OPERATION**

**2008 GEOTECHNICAL INSPECTION
PERIMETER TAILINGS DAMS**

**LUPIN MINE
NUNAVUT**

PROJECT NO.: 0385-007-03
DATE: DECEMBER 17, 2008

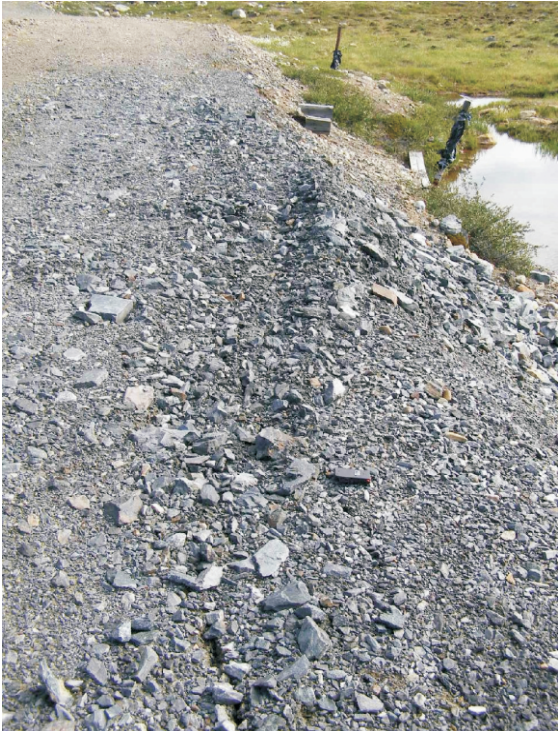
A view of a crack forming on the downstream side of the lower road. The outside shoulder is approximately 1.5 m to 2 m long and is softened from slumping due to erosion of the toe of the road.

SEEPAGE:	No evidence of seepage.
INSTRUMENTATION:	Thermistor D1A-00-1 is located in the crest, just south of the mid-point of the dam. 2008 readings are provided in Appendix I.
MAINTENANCE RECOMMENDATIONS:	Place additional granular fill in the area of cracking on the toe berm and re-grade the surface of the road. Once this is complete, monitor the downstream edge of the toe for additional cracking.
CONCLUSIONS:	The dam is in good condition with no evidence of seepage passing through or beneath the dam. Monitor instrumentation regularly and visually inspect downstream toe as Pond 2 level increases.

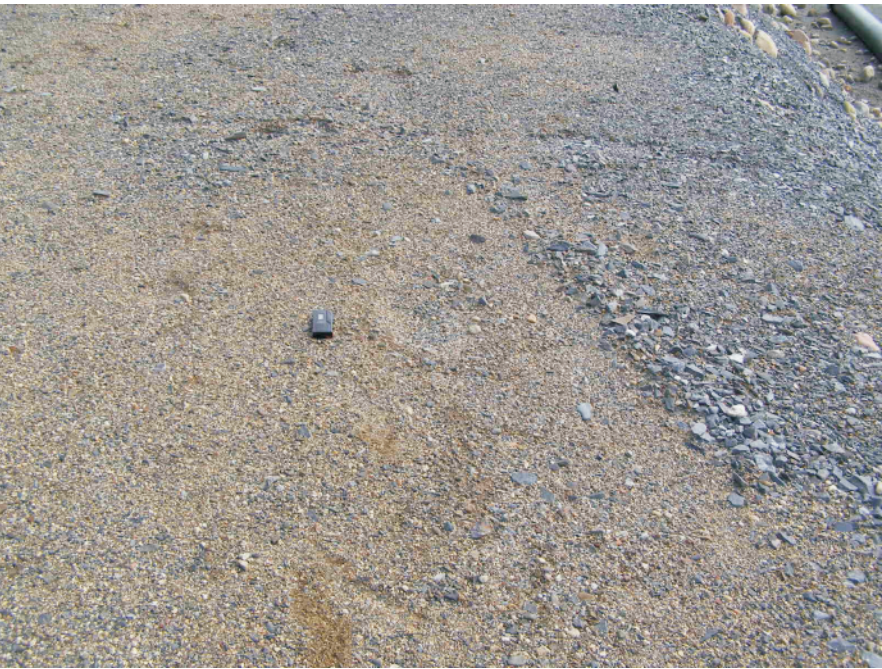
A view of a settlement spot that was noted during the 2007 inspection. It does not appear that any further movement has occurred in this area.

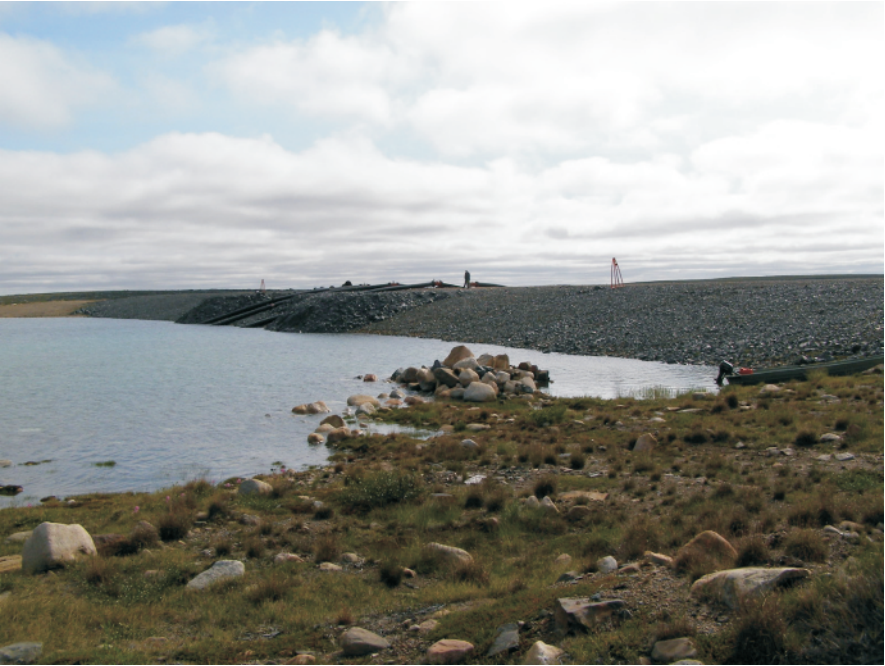
An overview of the upstream face of Dam 1A. There is currently about 3 m of freeboard and the upstream face shows no signs of distress.

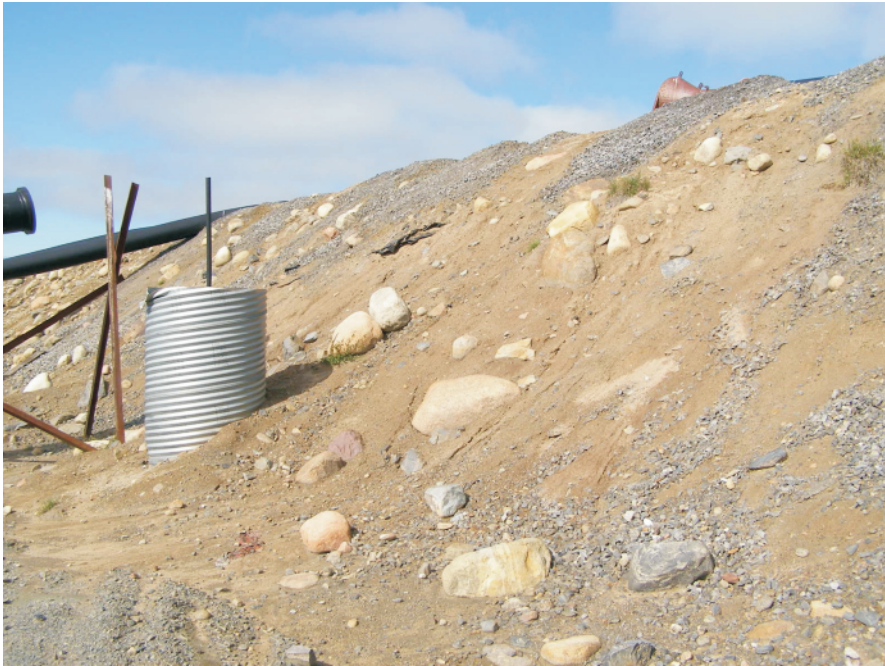
A close-up of the downstream face in the siphon area. Note the steep face and some minor erosion that is occurring on the face.

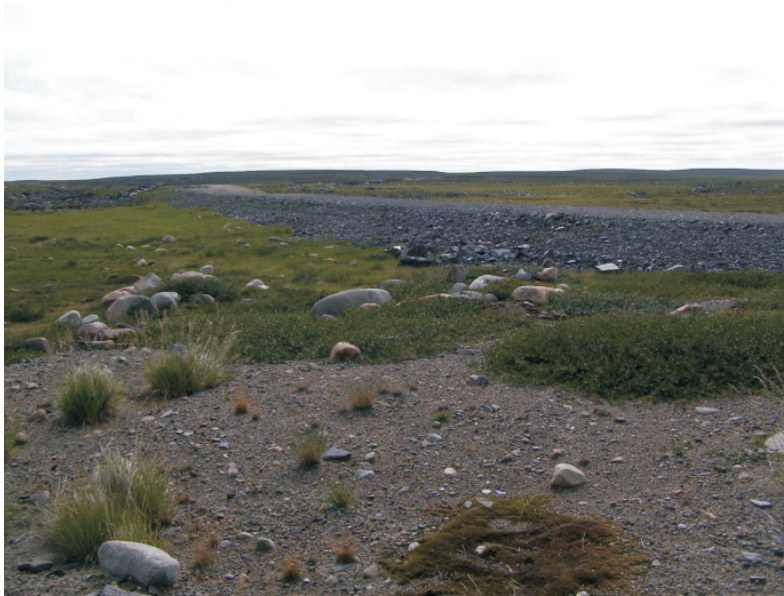
A view of the upstream face of Dam 1B, showing that no water is retained by this dam. The upstream face and crest appear to be in good condition.

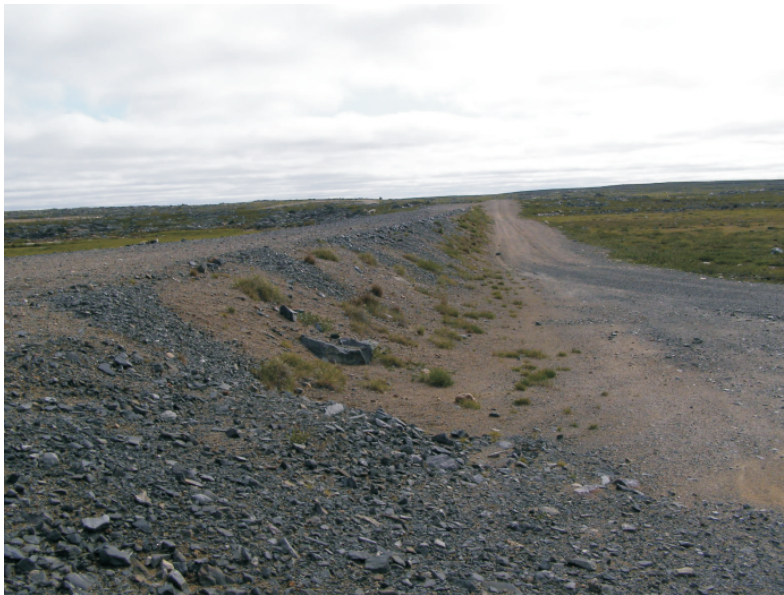
A view of the downstream face of Dam 1B taken from the right abutment. Note the vegetation that is beginning to take hold on the downstream face the dam. A number of animal burrows are evident on the downstream face.

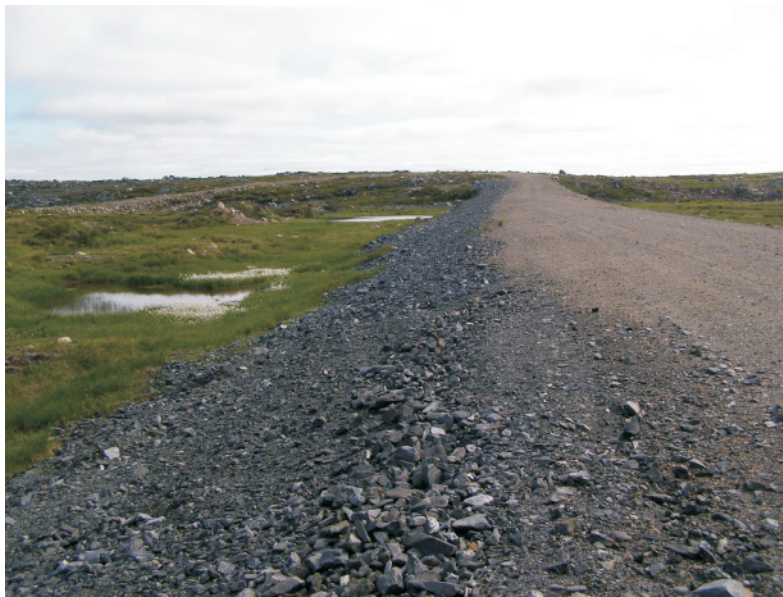
The upstream side and crest of Dam 1C showing the generally good condition and that there is no tailing water retained by this structure.

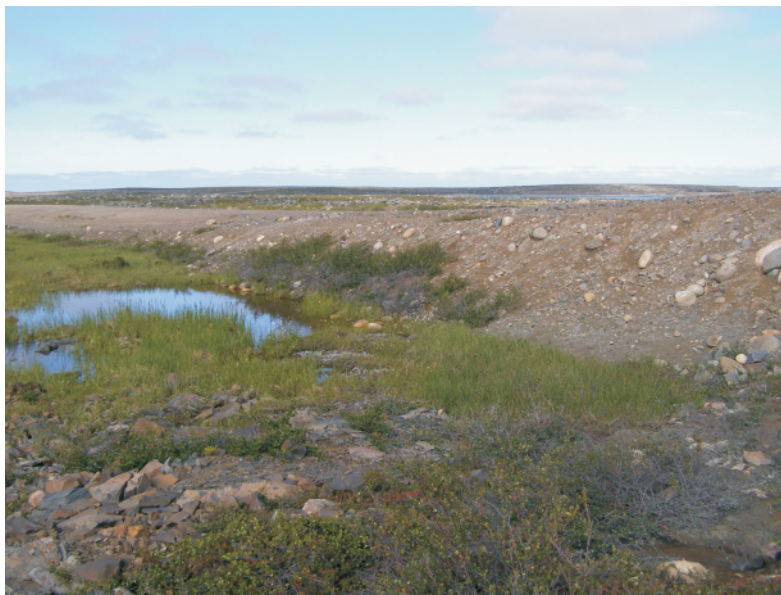
A view of the downstream face of the Dam 1C with a small pond of water adjacent to it, near the left abutment.

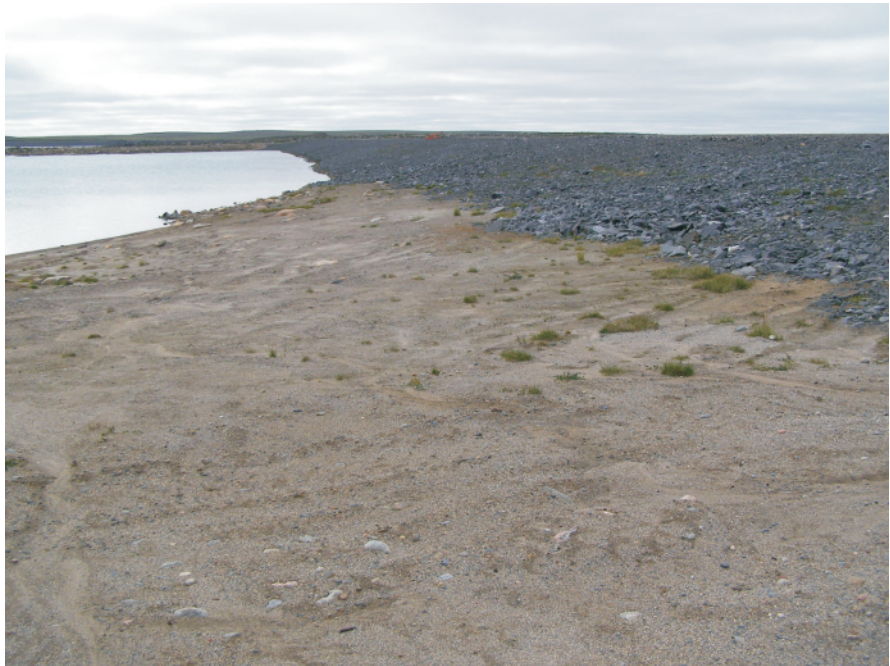
The upstream face of Dam 2 showing the grey riprap on the face of the dam.

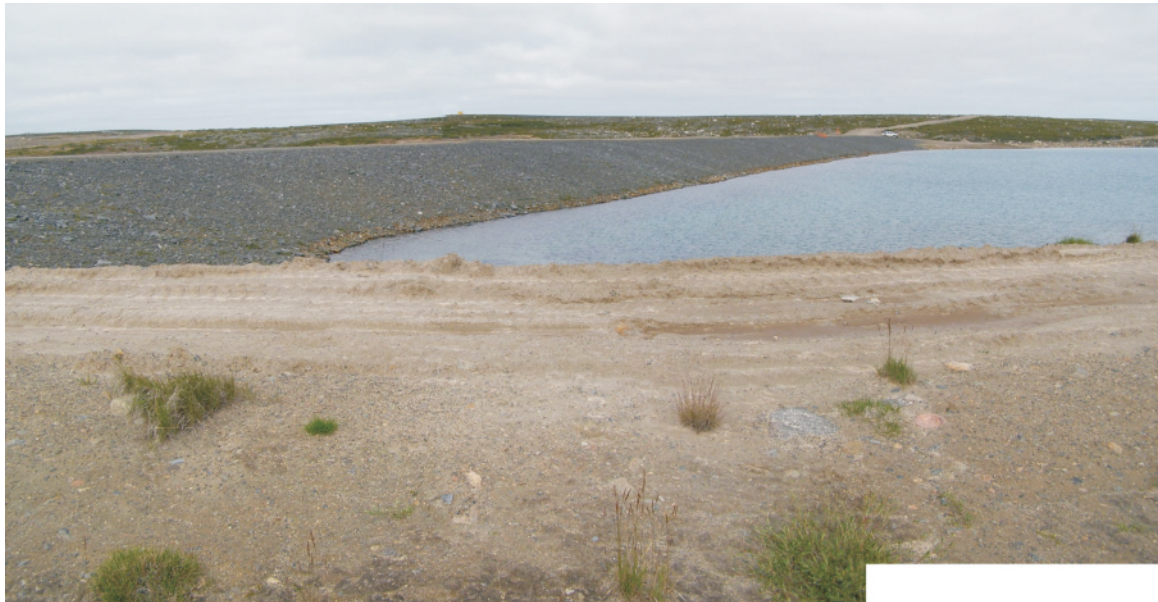
An overview of the upstream face of Dam 2 as seen from the left abutment. Note that the crest and upstream face are in good shape. A small wave erosion scarp is evident near the edge of the water.

MAINTENANCE RECOMMENDATIONS:	The areas of erosion should be backfilled using angular gravel to cobble sized material. The scarp that has formed on the upstream side of the dam should be filled in with appropriately sized rip rap to prevent further erosion. Re-grade the area on the crest near the right abutment so it slopes towards the downstream side.
CONCLUSIONS:	The dam is in satisfactory condition. Continue with vigilant monitoring of instrumentation and visual condition assessment, especially at higher pond levels.

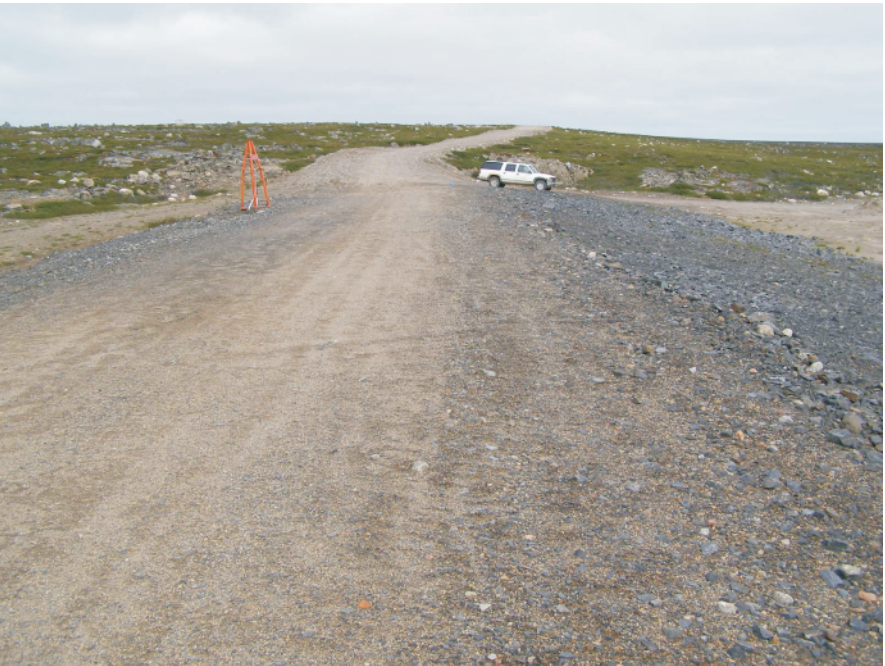
The crest of Dam 2 looking towards the right Abutment .

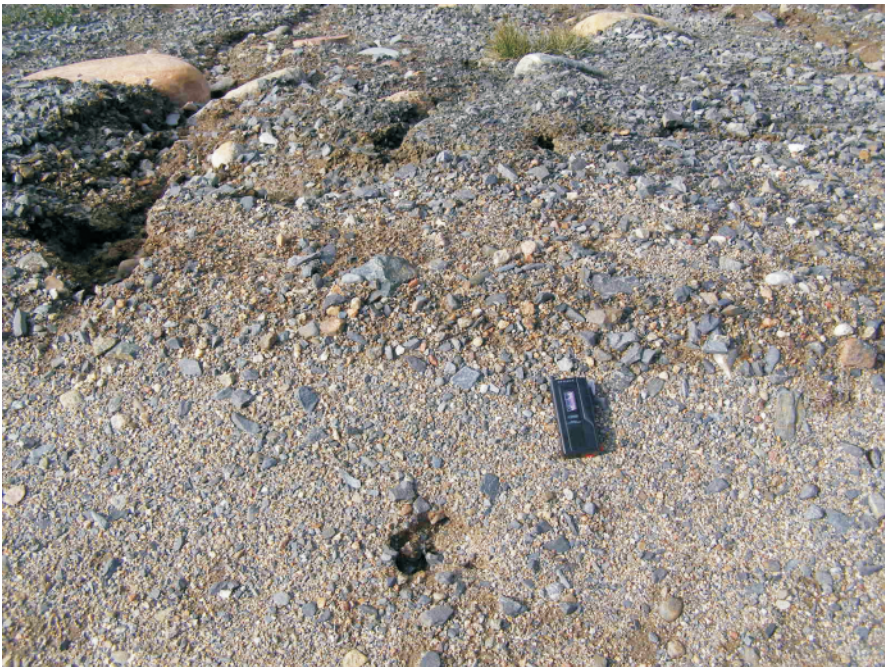
The crest of Dam 2 where a small sinkhole was noted directly above an erosion zone.

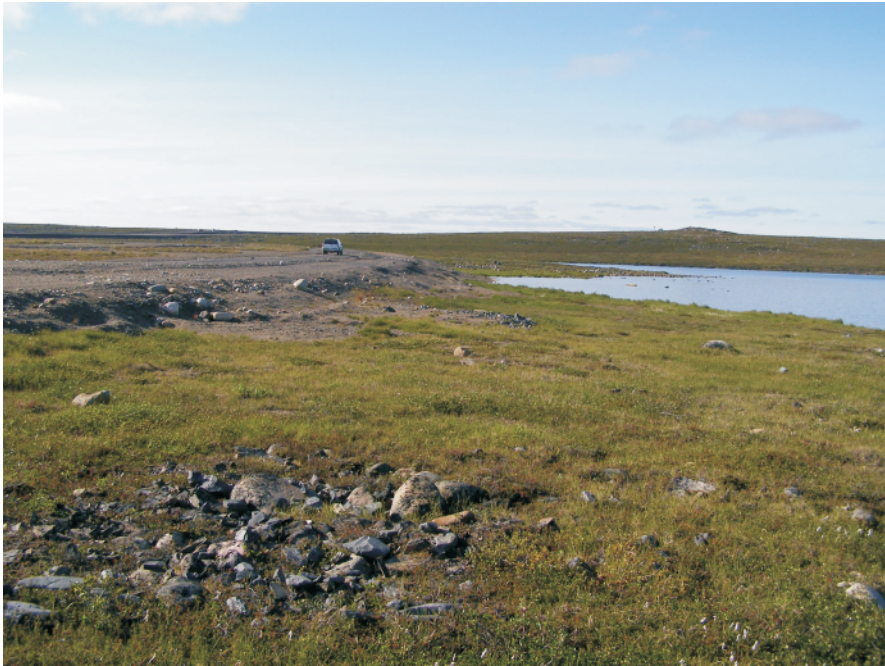
An overview of the downstream side of Dam 3. Note Boomerang Lake located downstream of Dam 3.

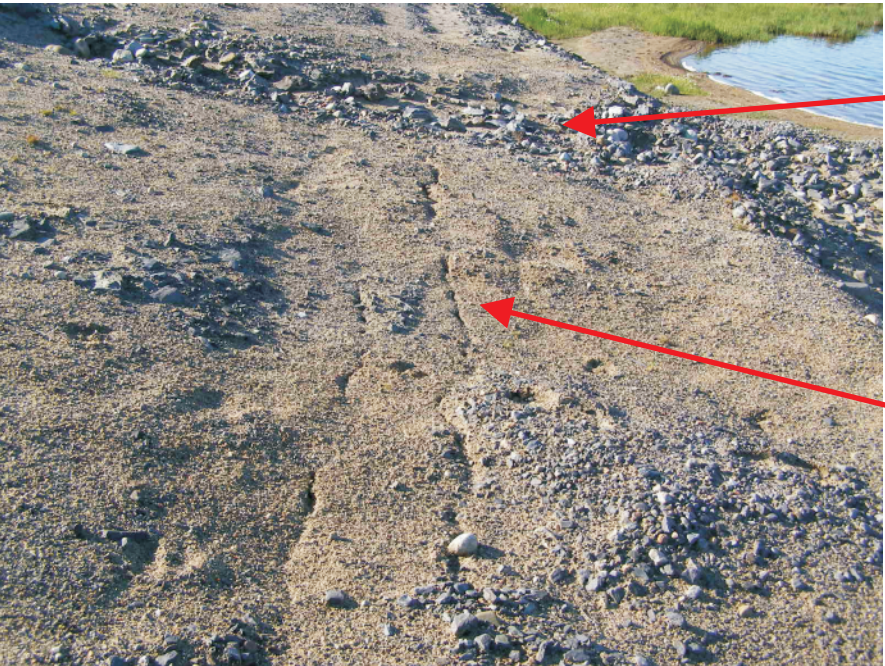
Tension cracks in the toe of Dam 3 near Boomerang Lake. These cracks are located directly adjacent to the erosion gully that can be seen towards the top of the photo.

SEEPAGE:	None observed near the toe of the east arm of the dam.
MAINTENANCE RECOMMENDATIONS:	The cracking on the crest of the dam should be re-graded and the ditch should also be re-graded to remove the accumulated material. The gully in this ditch also needs to be repaired and relined.
CONCLUSIONS:	The dam is in satisfactory condition but repair work to the cracking area and surface water conveyance ditch should be completed. Continue to conduct visual monitoring of cracking.

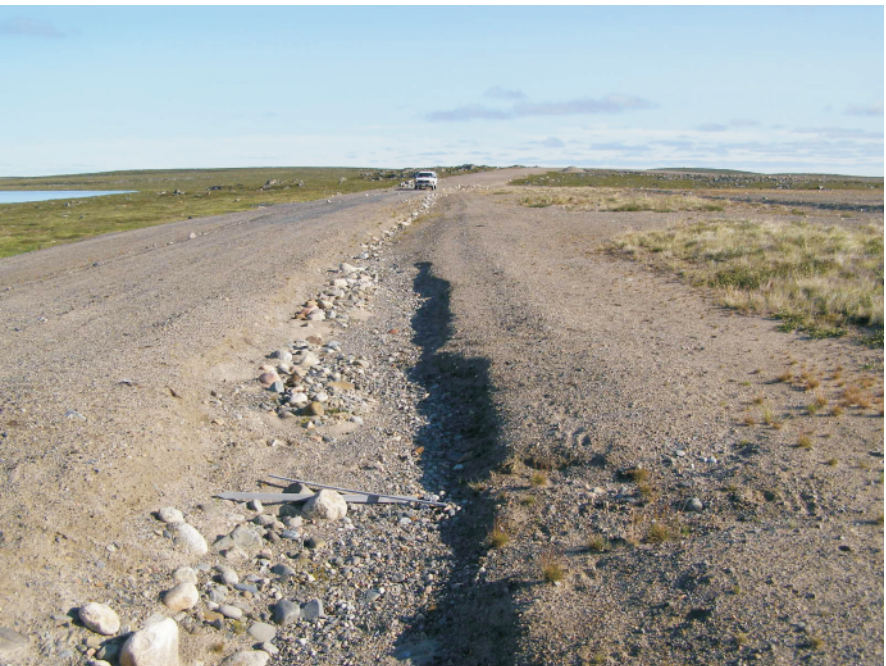
An armoured ditch which collects the run-off coming off the covered tailings area. This ditch is eroding in some sections and needs maintenance.

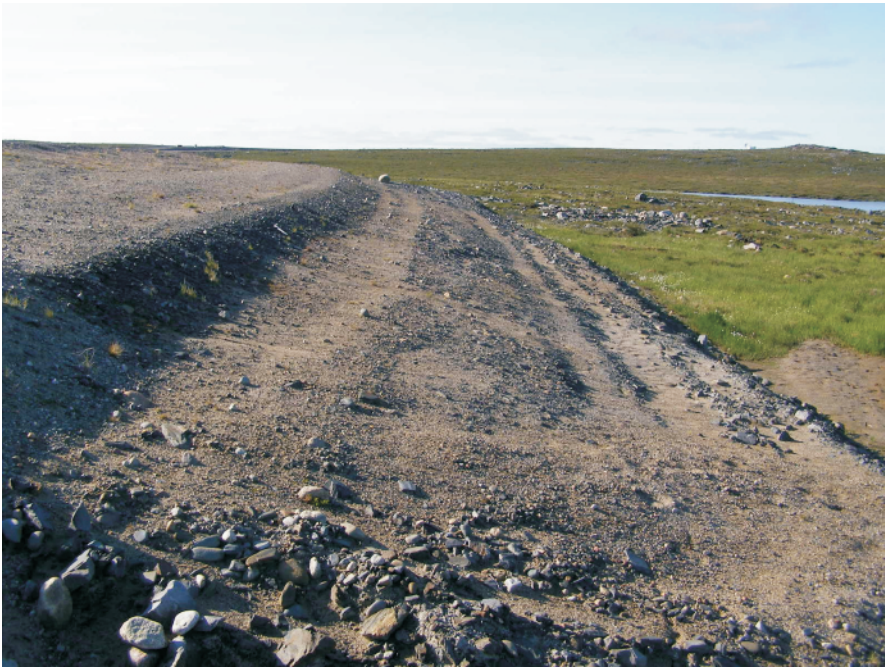
The downstream face of Dam 3. Generally the downstream face is in good condition.

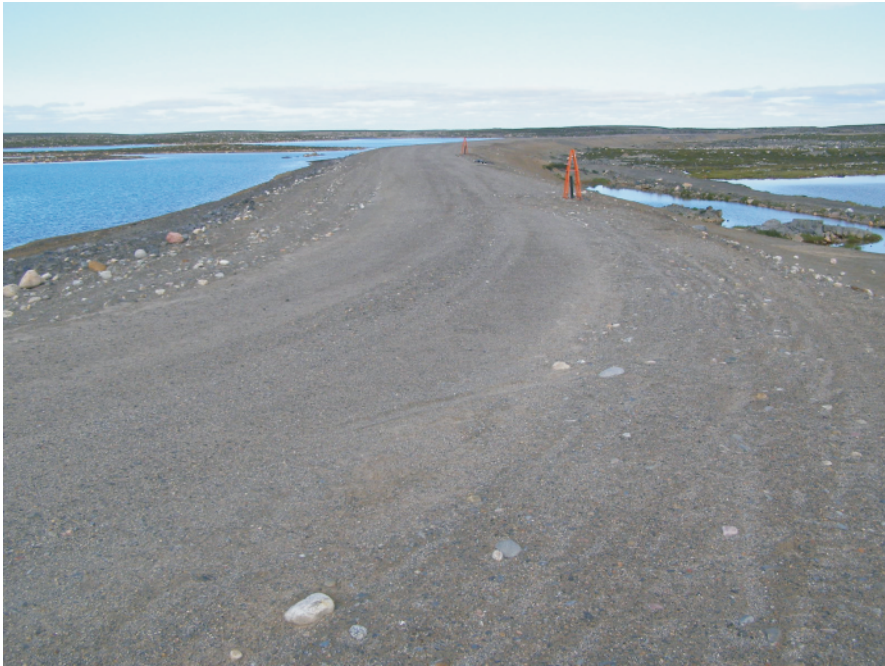
The crest of Dam 4 as seen from the right abutment. The crest is in good condition.

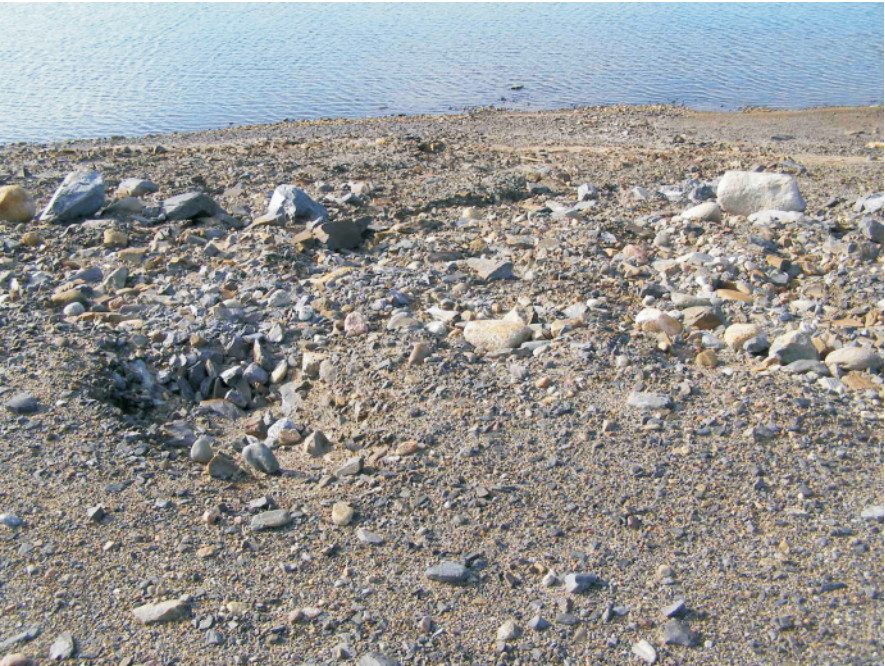
An area of erosion on the upstream face of Dam 4.

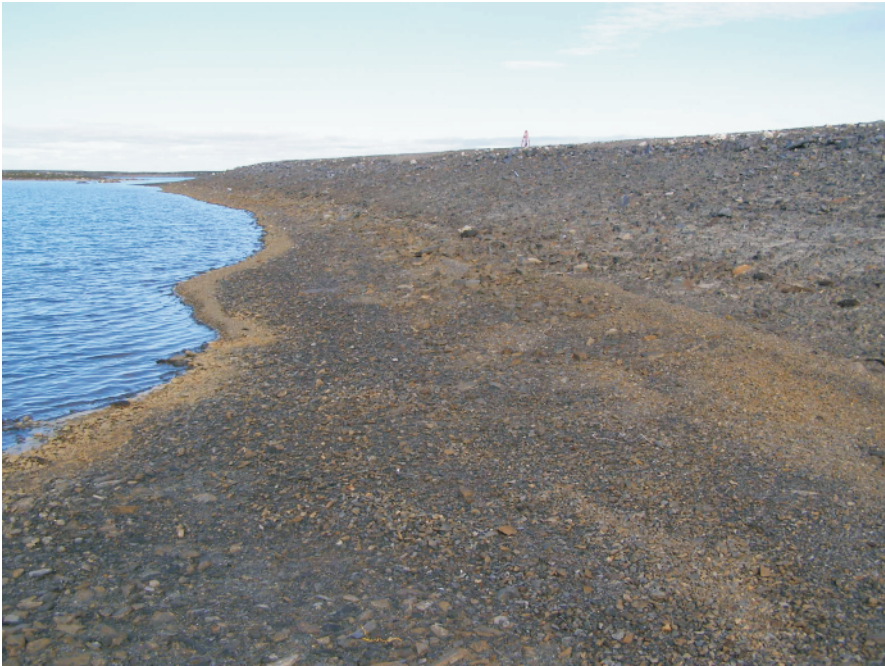
A view of the pond and dam interface on the upstream side of Dam 4. Note that the water level here appears to be about 0.5 m lower than seen in previous years, as evidenced by discolouration of the rock on the face of the dam.

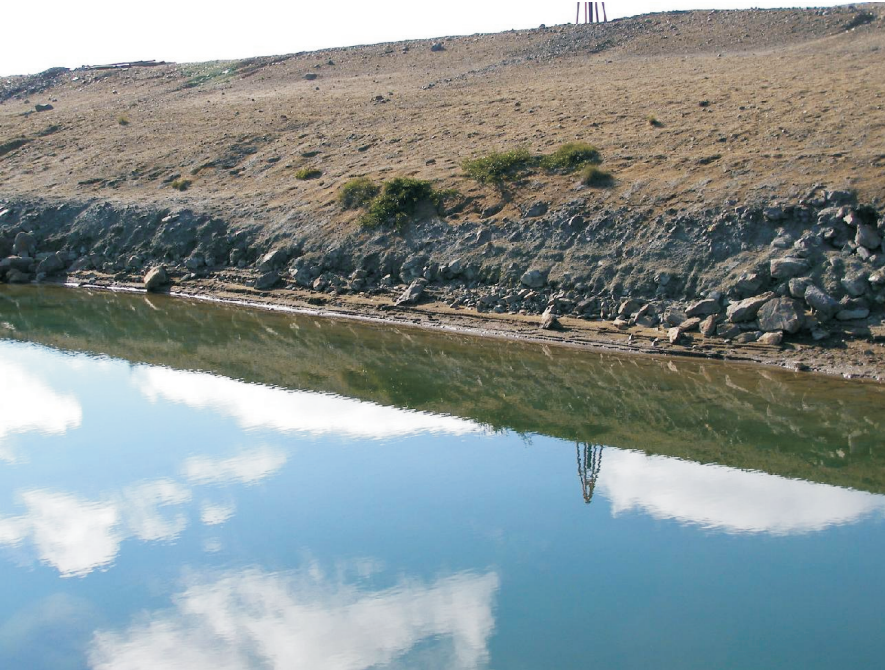
Wave erosion of the toe of Dam 4 near the right abutment.

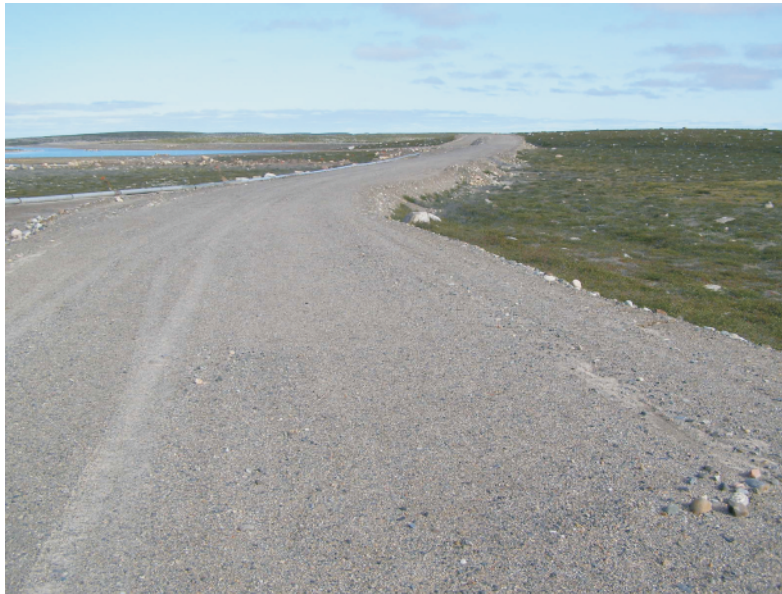
An overview of Dam 5 as seen from the right abutment.

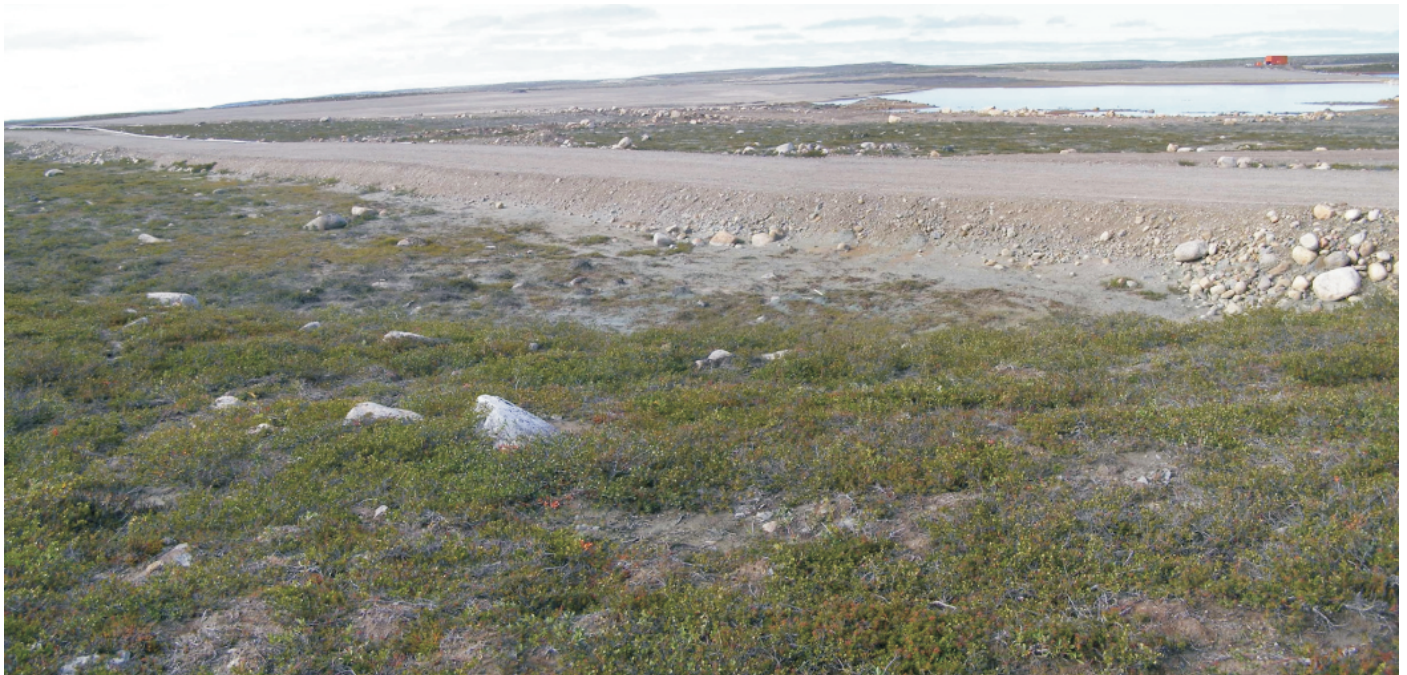
An overview of the maximum section of Dam 5. Note this dam does not currently hold any water.

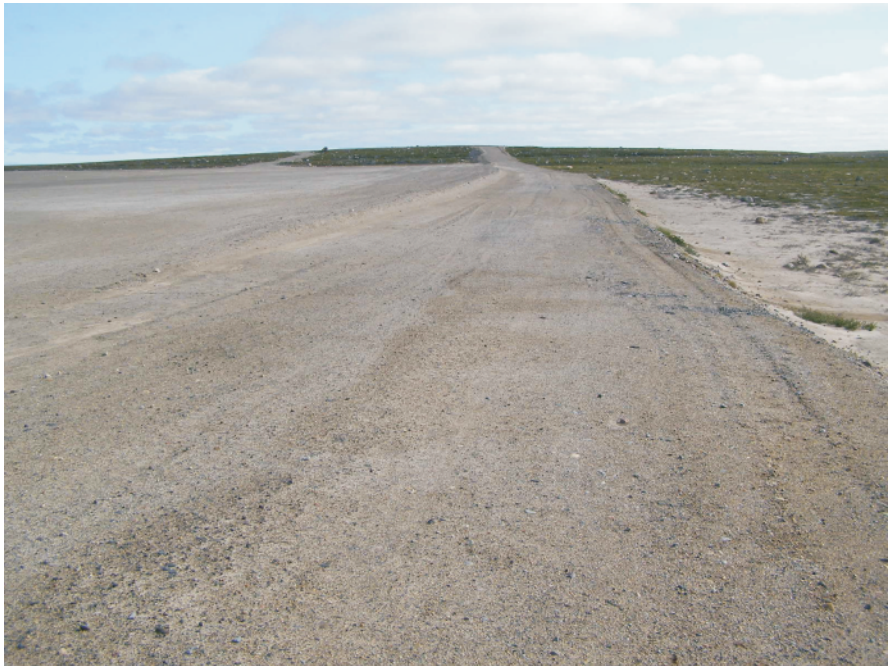
The crest of Dam 6 as seen from the right abutment. Note that the left side of the photo shows covered tailings and on the right some wind blown sand from the cover.

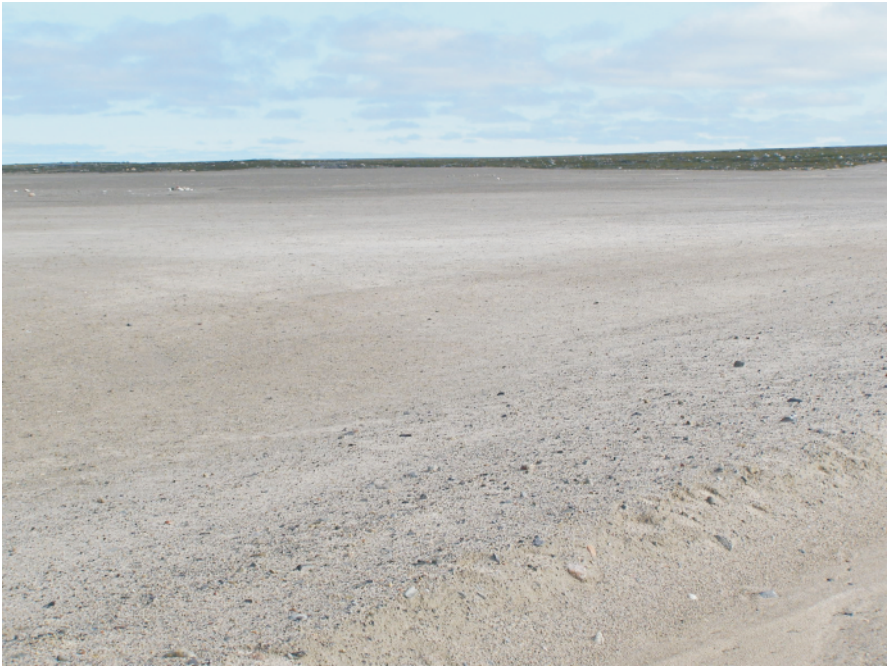
The surface of the tailings cover adjacent to Dam 6.

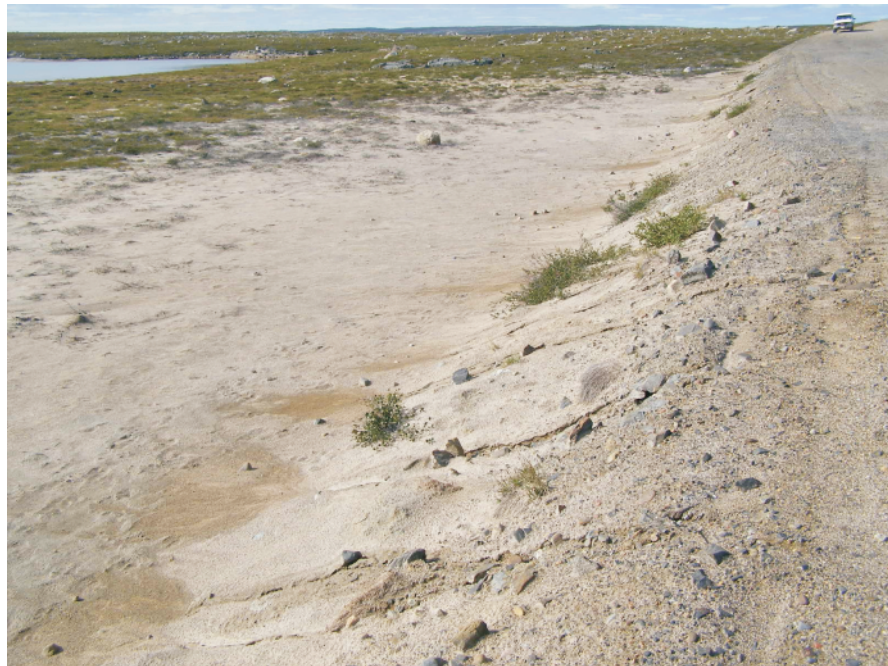
The downstream edge of Dam 6 with some minor erosion gullys
Note the sand deposited along the face of the dam after being blown over the crest from the tailings cover.

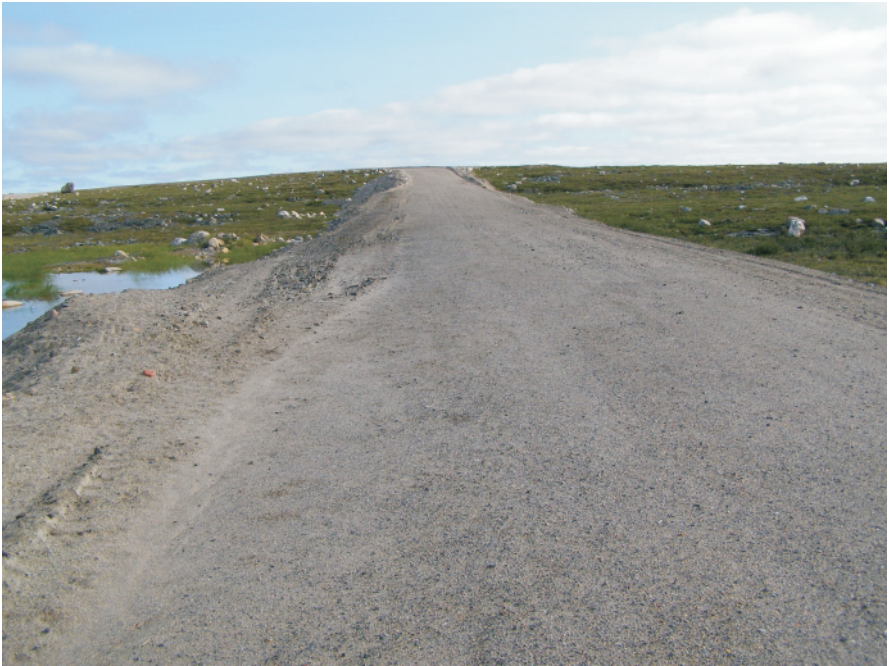
A view of the intersection of Dam 6 and the left abutment. Note that a small pond of water exists on the left side of this photo.
