2009 Annual Geotechnical Inspection Perimeter Dams Tailing Containment Area Lupin Mine, Nunavut

December 1, 2009

Ref. No. 09-161

**Re: 2009 Annual Geotechnical Inspection
Perimeter Dams Tailings Containment Area
Lupin Mine, Nunavut**

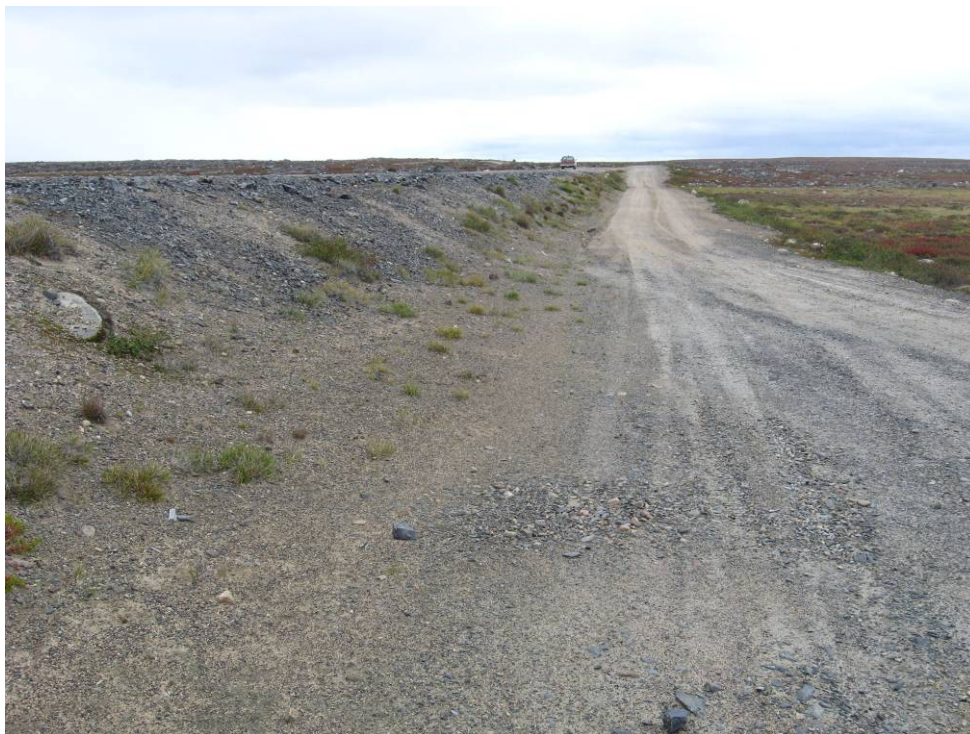
Dam 1B: Downstream

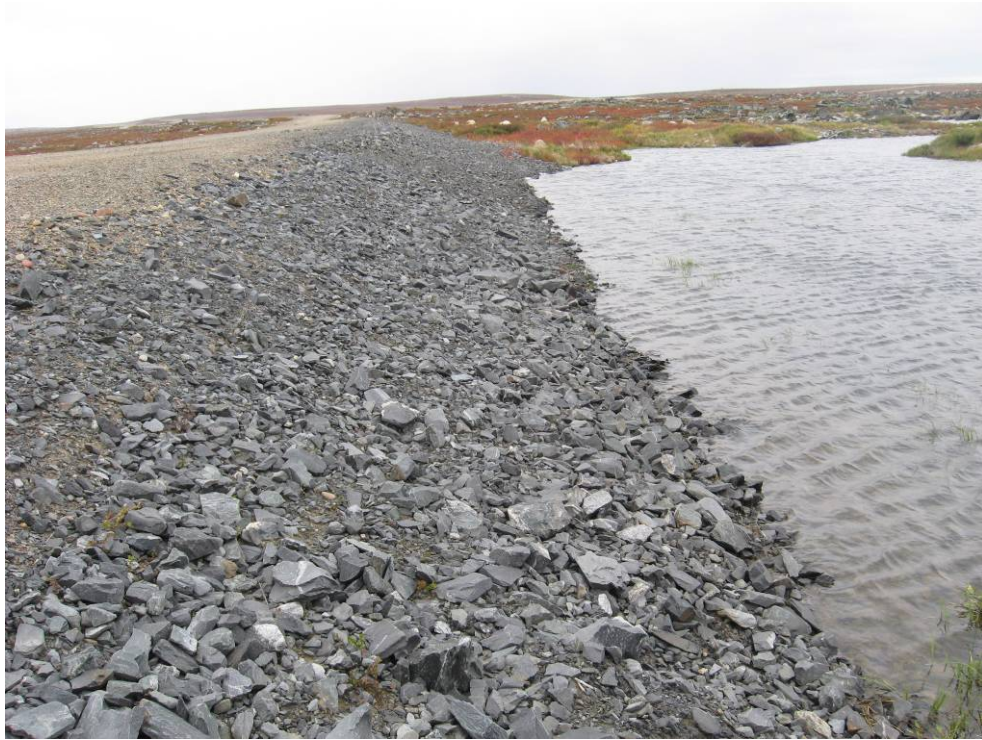
Dam 1C: Upstream

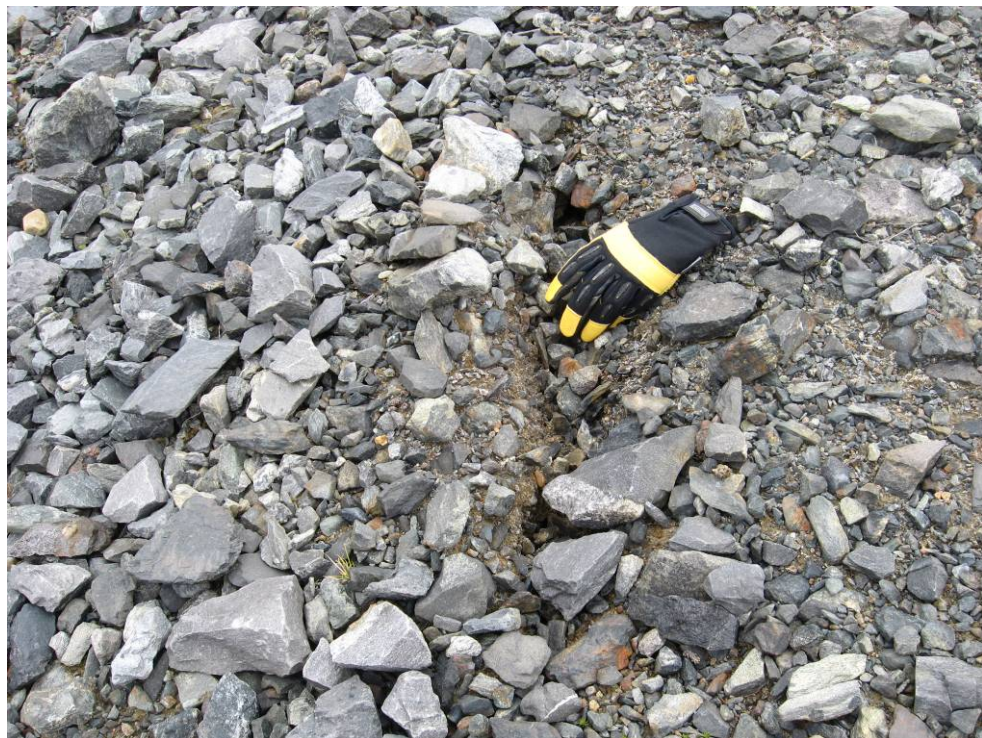
Dam 1C: Upstream-Minor Cracking

LOCATION:	West side of Pond 2.
FUNCTION:	Major perimeter closure for water retention
LENGTH:	230 +/- m
MAX HEIGHT:	2.2 +/- m above d/s tundra.
AS-BUILT CREST ELEVATION:	485.88 m
CURRENT CREST ELEVATION:	485.3 m
POND ELEV.:	483.22 m
FREEBOARD :	2.08 m
CREST WIDTH AND CONDITION:	9 +/- wide; surfaced with esker material, this dam also functions as a roadway, Crest condition is good. Animals are starting to burrow into the dam body.
RIPRAP:	Run of Mine rockfill; Cracking noted over 2/3 of dam length, approx. 0.6 m above water level (see photo following page). Potentially due to thaw of subgrade with increase in pond water level.
BACKSLOPE:	Approx. 3H; 1V, smooth slope. Access road berm appears in good condition.
SEEPAGE:	No seepage observed.
INSTRUMENTATION:	Thermistor D1A-00-1 is located in the crest, just south of the mid-point of the dam.
MAINTENANCE RECOMMENDATIONS:	Review toe in spring. Re-grading and reshaping of toe likely required at that time.

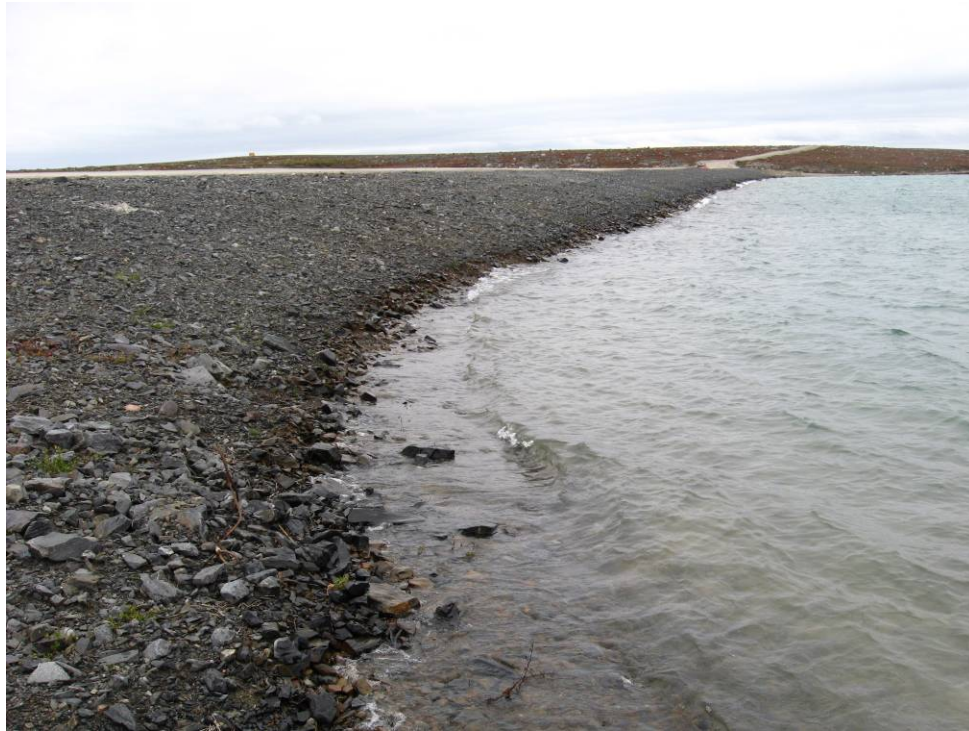
Dam 2: Upstream

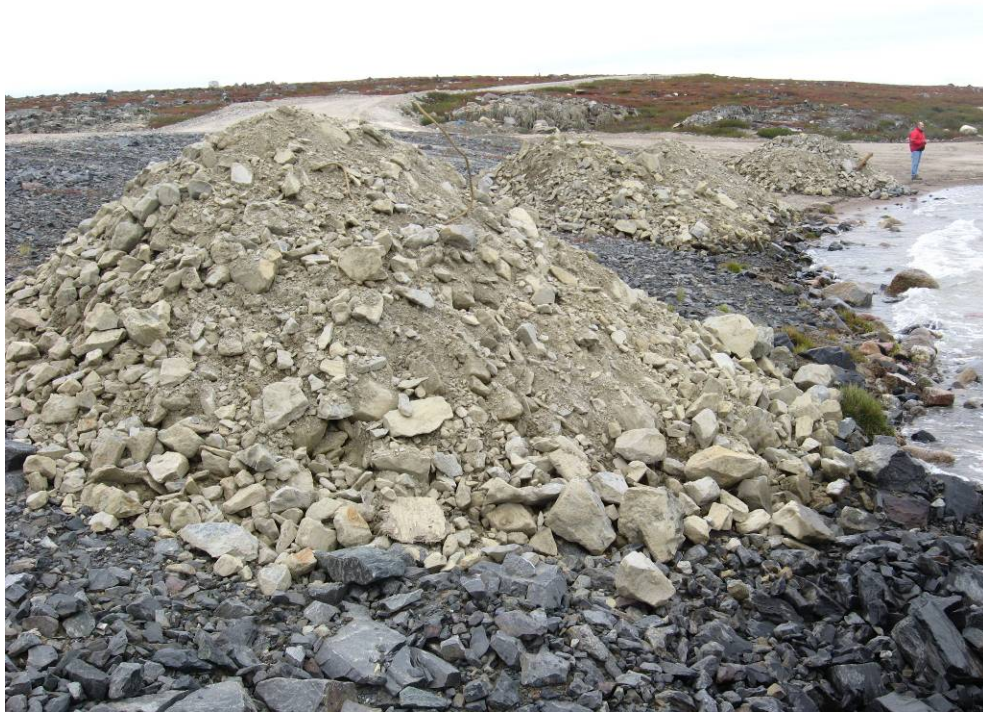
Dam 2: Upstream – New Riprap Material

LOCATION:	North end of Pond 2.
FUNCTION:	Major perimeter closure for water retention; natural pond downstream of the dam.
LENGTH:	350 +/- m
MAX HEIGHT:	5.5 +/- m above d/s tundra.
AS-BUILT CREST ELEVATION:	486.30 m
CURRENT CREST ELEVATION:	485.6 – 486.0 m
POND ELEV.:	483.22 m
FREEBOARD :	2.38 – 2.78 m
CREST WIDTH AND CONDITION:	Approx. 6 m; surfaced with esker material and used as the primary traffic route for TCA. Crest has recently been re-graded.
RIPRAP:	Run of Mine rock forms convex-upward, gently sloped upstream face. A small erosion scarp has formed on the upstream side of the dam near the waterline,
BACKSLOPE:	Variable materials but comprised mostly of esker granular material with minor rills; good condition.
SEEPAGE:	No seepage observed
INSTRUMENTATION:	Thermistor D2-00-02 is located at the north end of the crest.
MAINTENANCE RECOMMENDATIONS:	The areas of upstream erosion scarp currently being backfilled as per 2008 recommendations. This project should continue to establish corrected slope. .

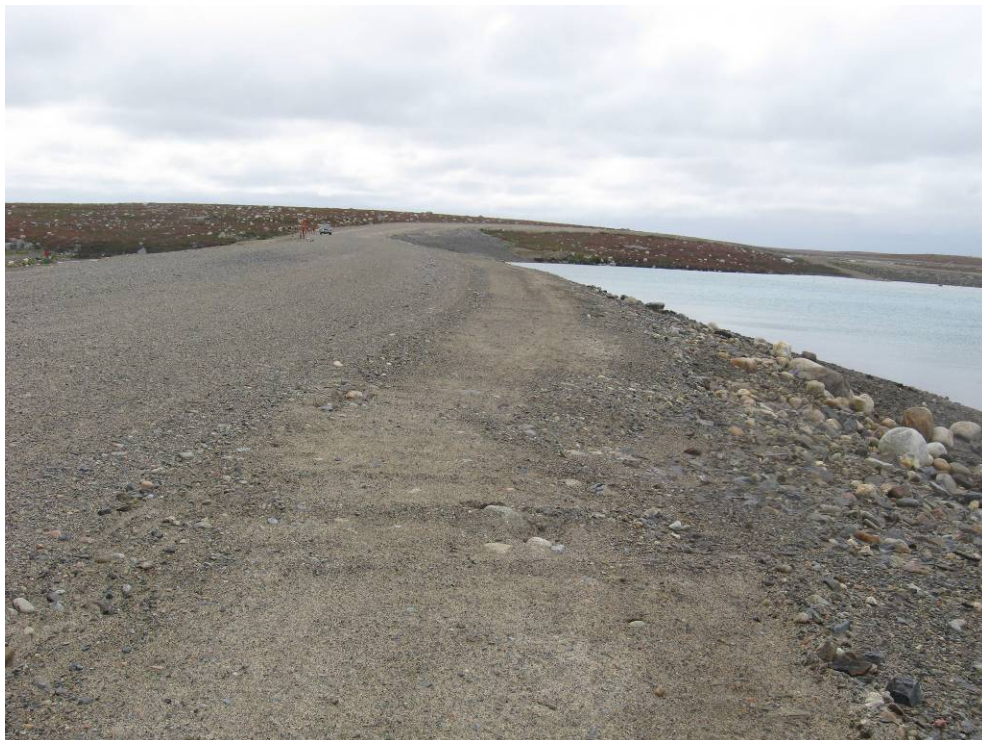
Dam 4: Upstream

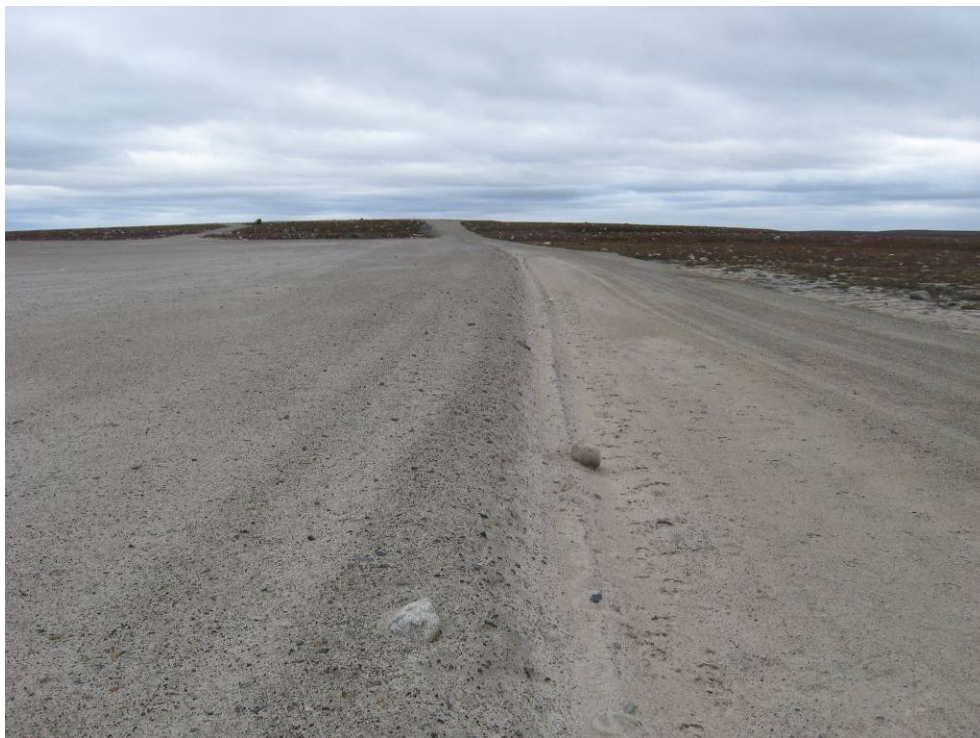
Dam 6: Upstream
