2010 Annual Geotechnical Inspection
Perimeter Dams Tailings
Containment Area
Lupin Mine, Nunavut

Prepared For:
MMG Resources Inc.

Prepared By:
TBT Engineering Consulting Group

November 3, 2010

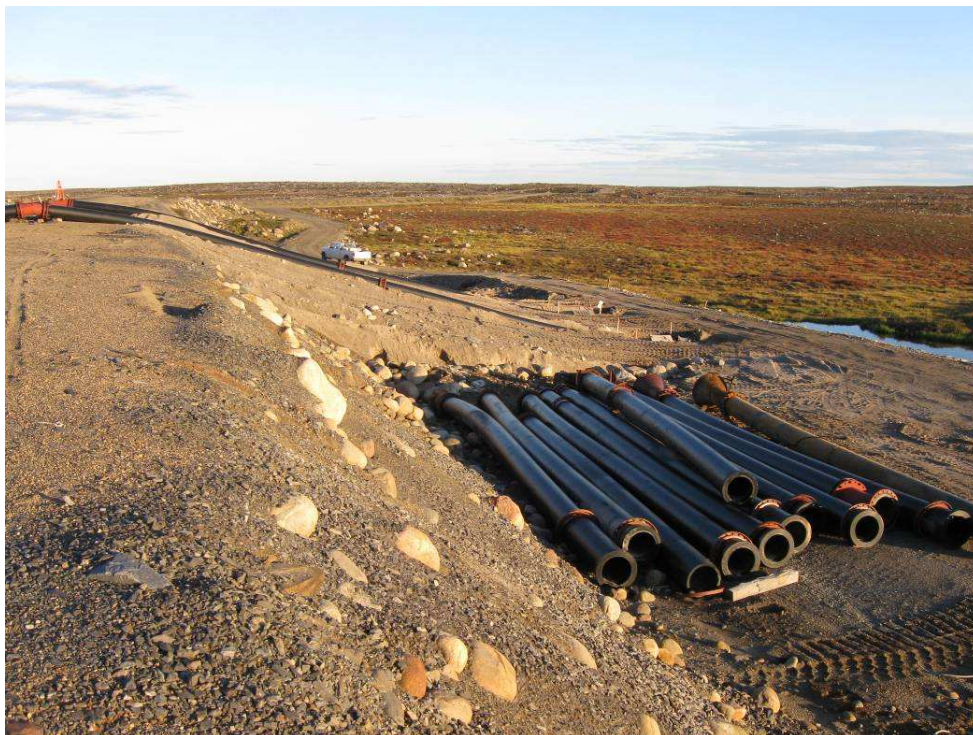
Dam 1A: Downstream – Looking South (north side of siphons)

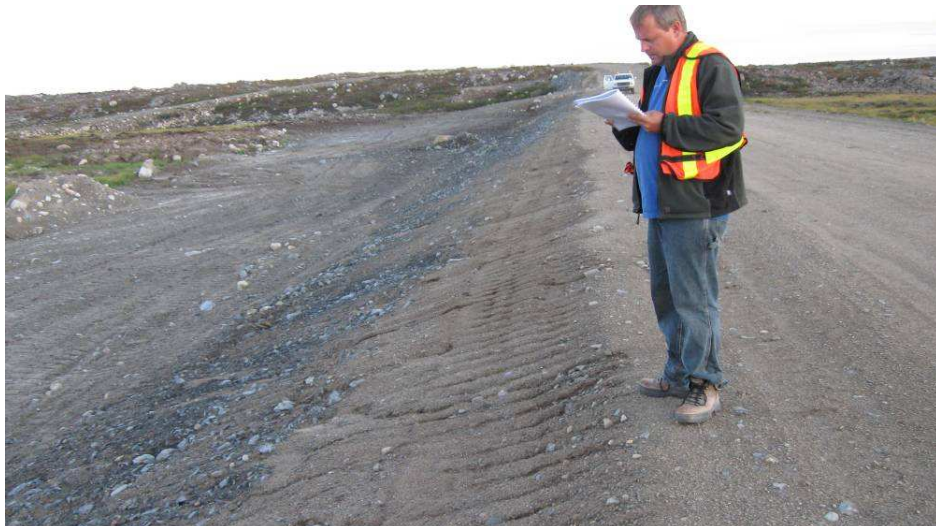
Dam 1C: Upstream (Minor Erosion Gullies on Shoulder of Granular Surfacing) Souther 2/3 of Upstream Slope Has Been Regraded/Extended with a Mixture of Rip Rap and Esker Material

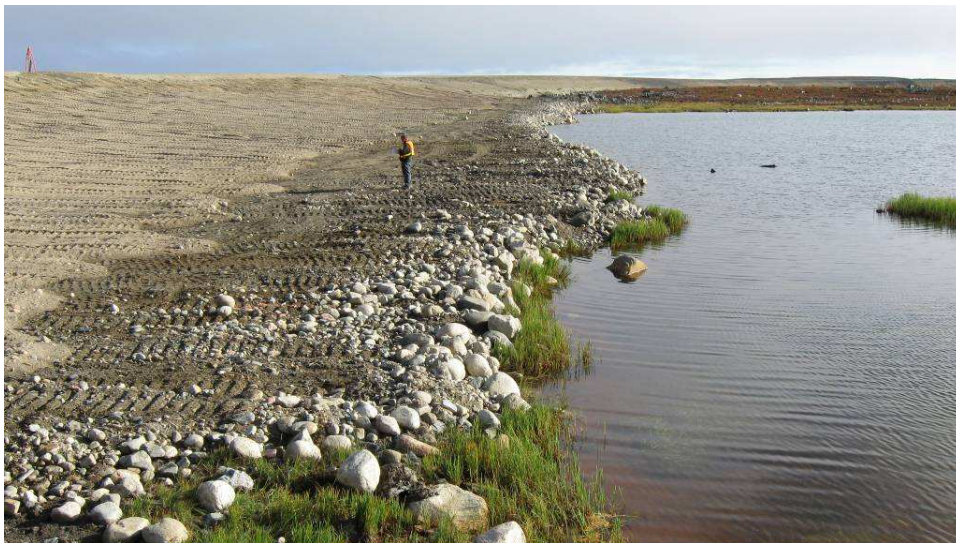
Dam 4: Downstream slope in area of old coffer dam (cobble stone).
