2011 Annual Geotechnical Inspection
Perimeter Dams
Tailings Containment Area
Lupin Mine, Nunavut

Prepared By:
TBT Engineering Consulting Group

November 22, 2011
TBTE Ref. No. 11-293

**Re: 2011 Annual Geotechnical Inspection (Revision 1)
Perimeter Dams Tailings Containment Area
Lupin Mine, Nunavut**

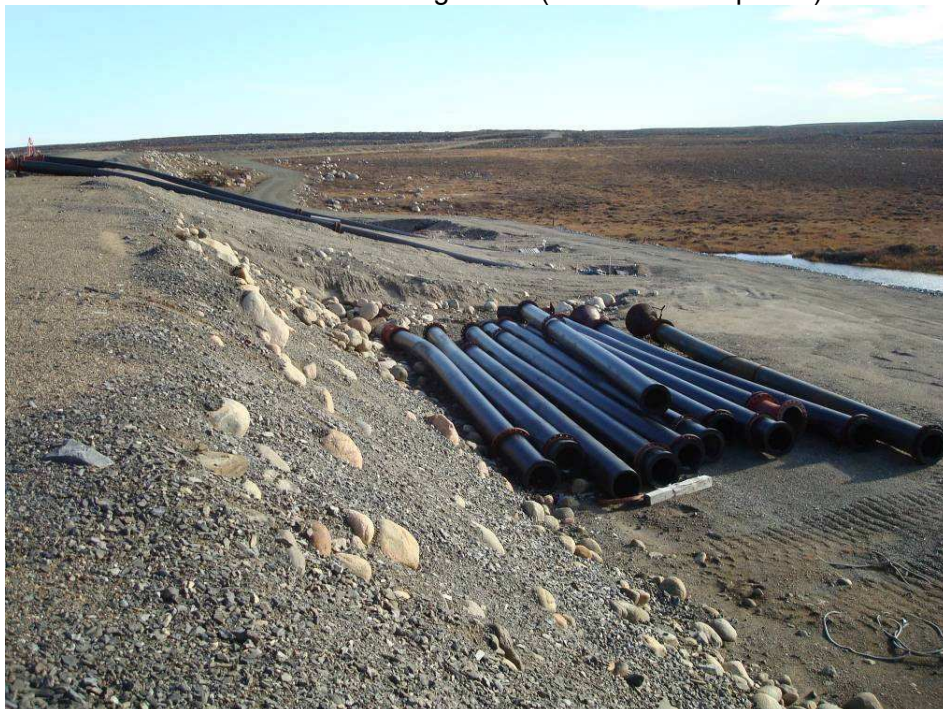
Dam 1A: Downstream – Looking South (north side of siphons) – 2011

Maintenance is recommended to repair erosion along areas of the downstream slope.

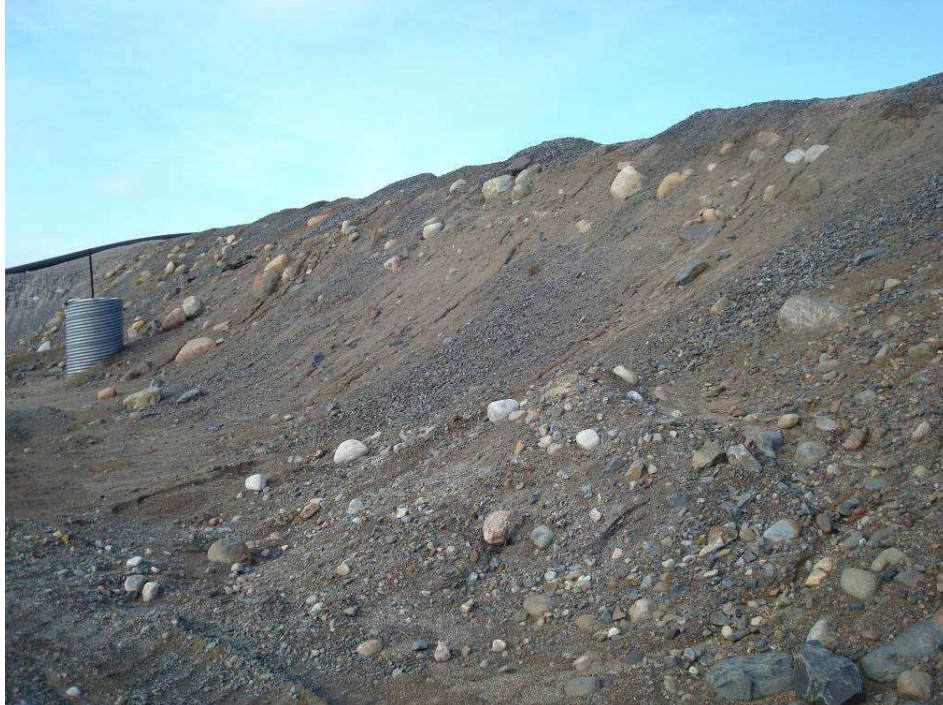
Dam 1A – Downstream Slope (south side of Siphons) Erosion Gullies – 2011

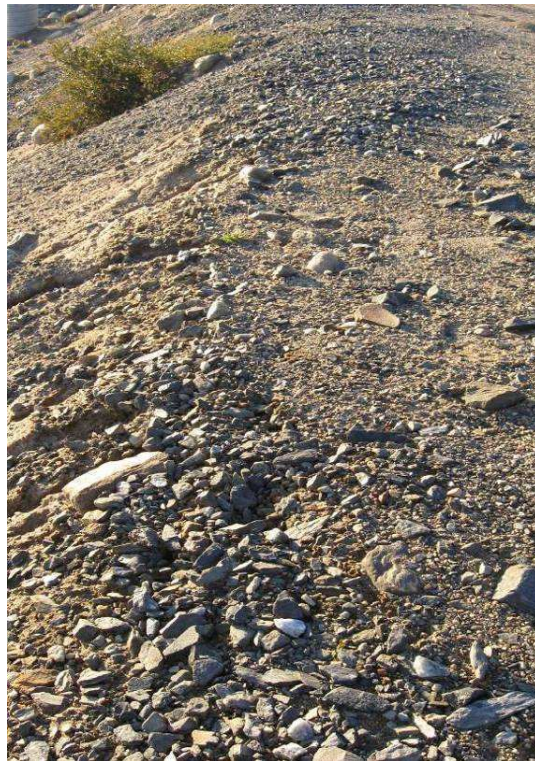
Downstream Crest: 1 m long narrow crack- 2010

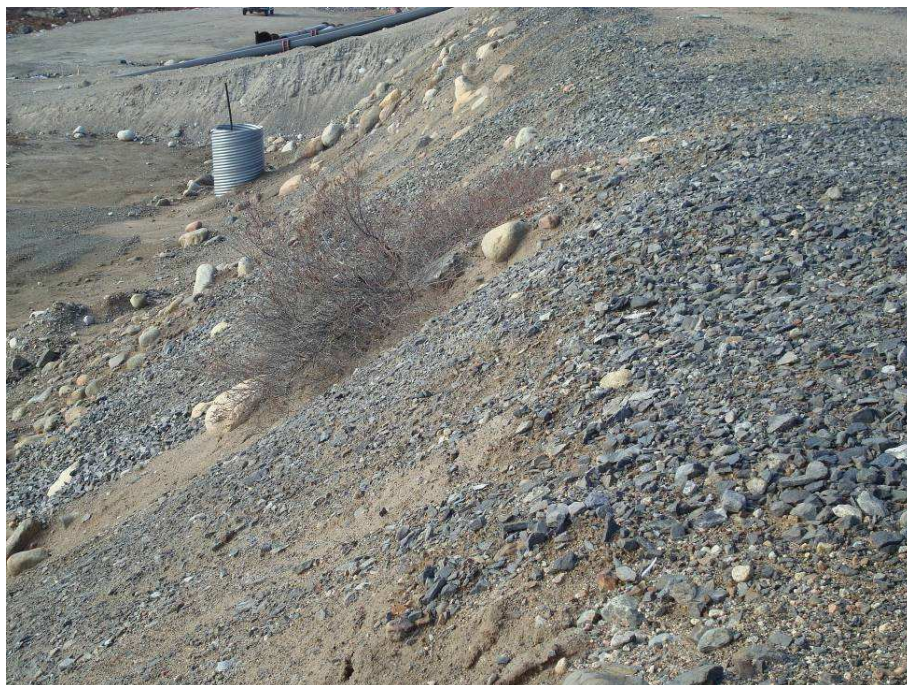
Downstream Crest: 1 m long narrow crack now filled in – 2011

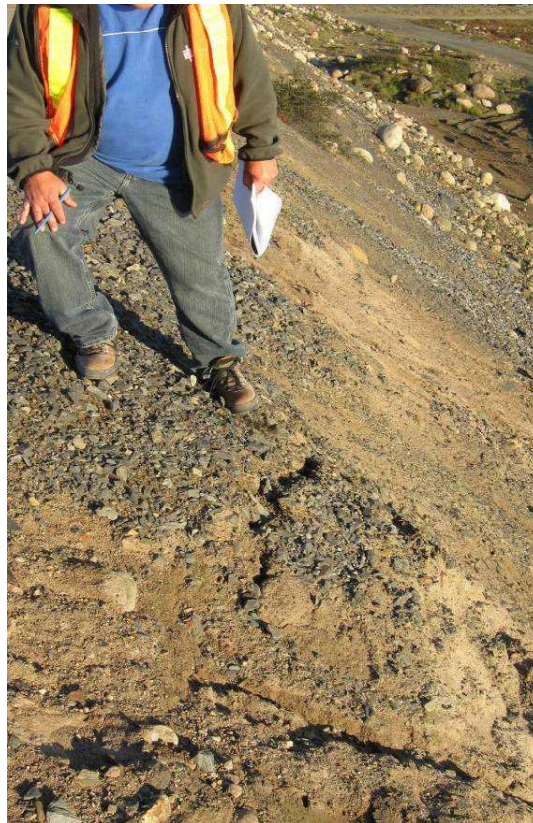
Downstream Crest: 1 m long narrow crack – 2010

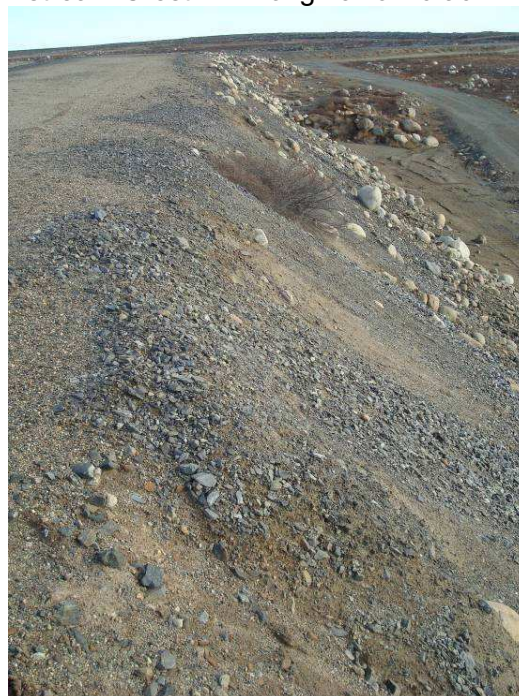
Downstream Crest: 1 m long narrow crack now in filled – 2011

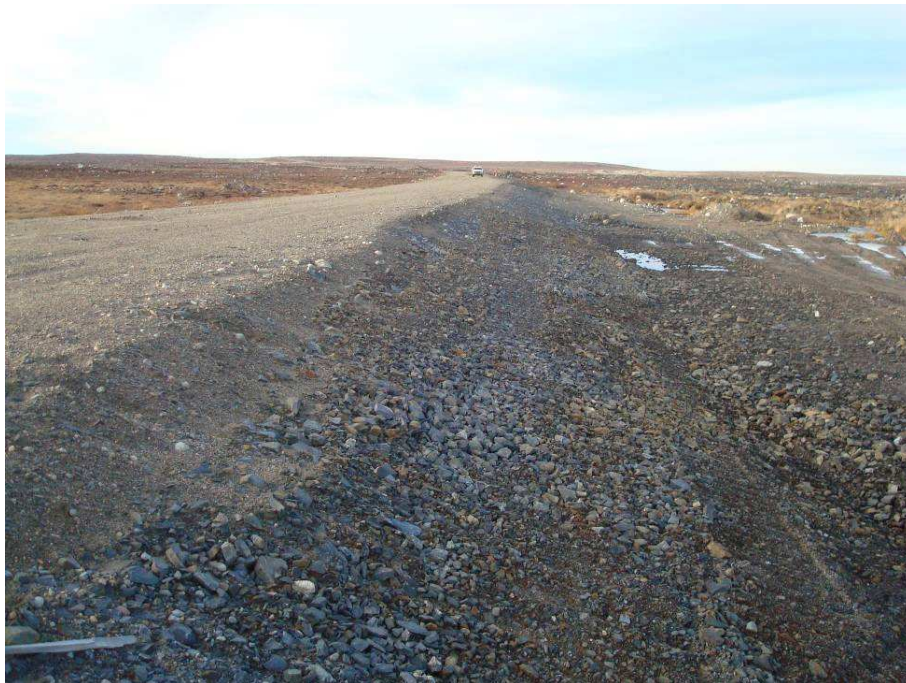
Dam 1C: Upstream (Minor Erosion Gullies on Shoulder of Granular Surfacing) – 2011

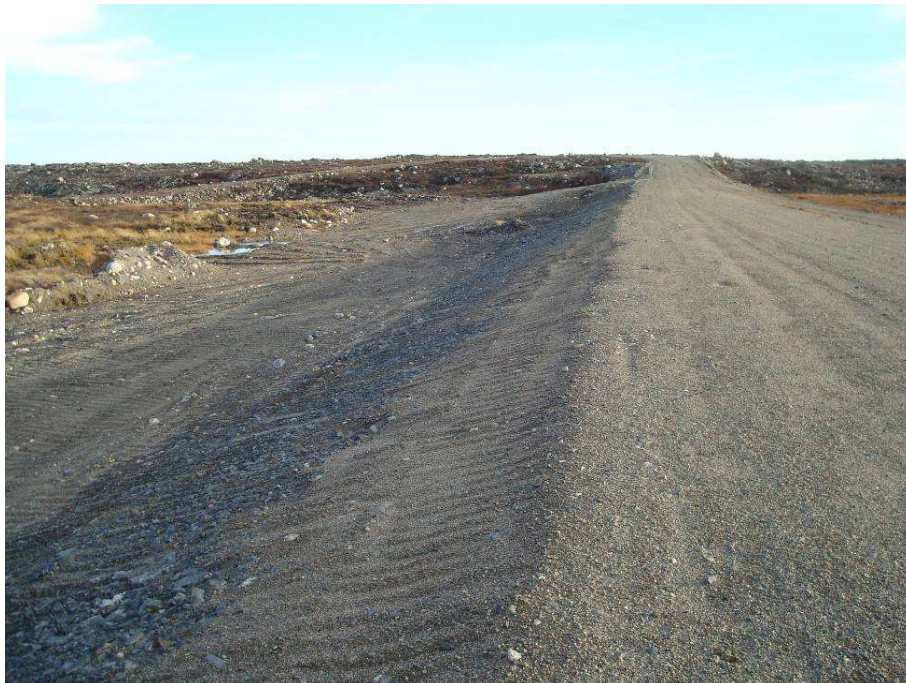
Dam 1C: Upstream (Minor Erosion Gullies on Shoulder of Granular Surfacing). – 2011

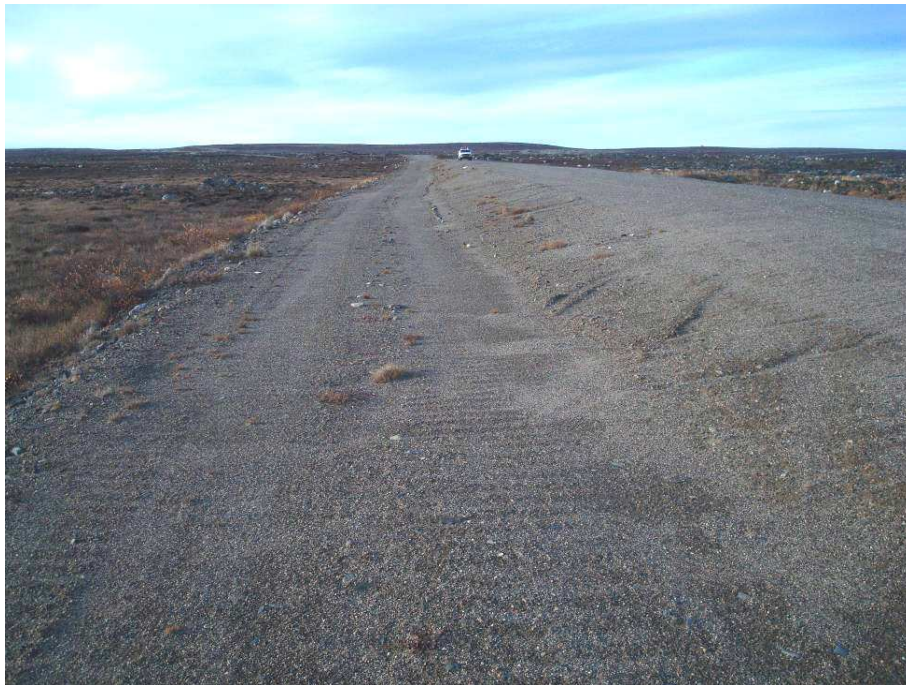
Dam 1C: Downstream Slope (Some Minor Erosion Gullies) – 2011

MAINTENANCE RECOMMENDATIONS:	Maintenance of cracking/sloughing conditions along downstream slope is recommended.
CONCLUSIONS:	The dam appears to be in a stable condition. Maintenance of downstream erosion and sloughing is recommended.

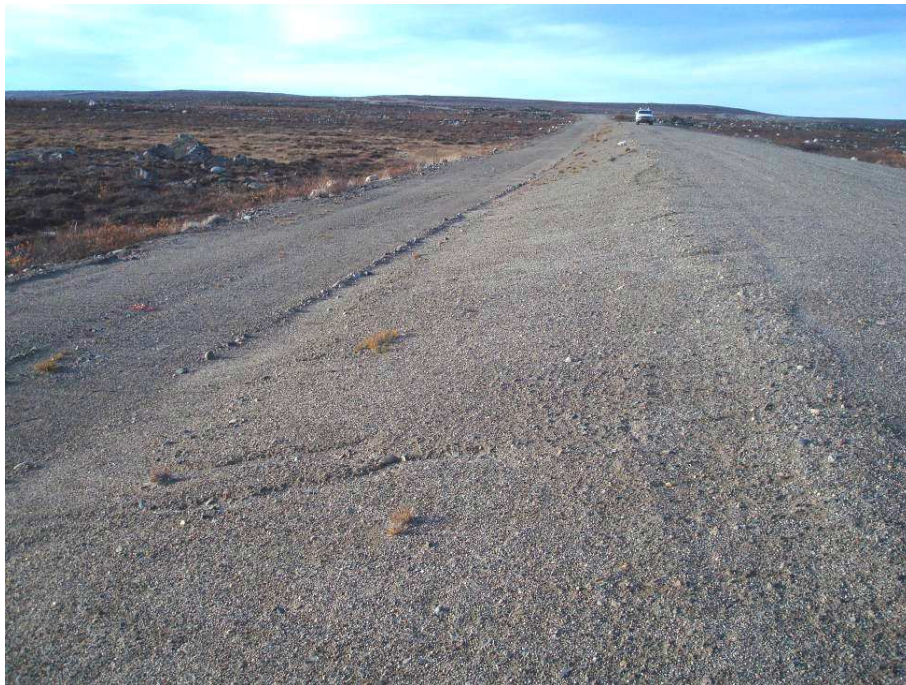
Dam 1C: Downstream Slope (Some Minor Erosion Gullies) – 2011

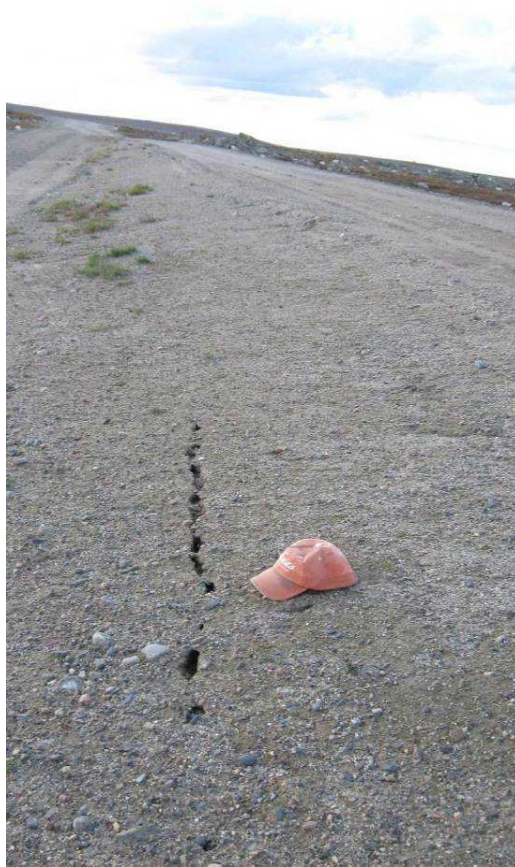
Downstream Slope (7 m long crack, 75 mm deep, north end of dam) – 2010

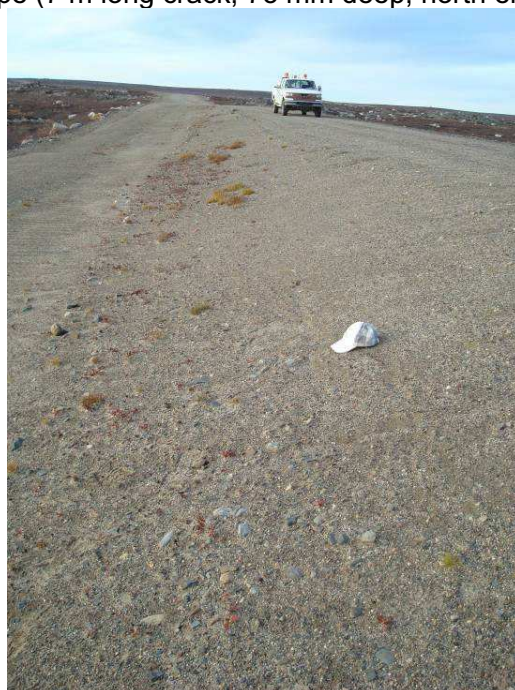
Downstream Slope (crack now in-filled) – 2011

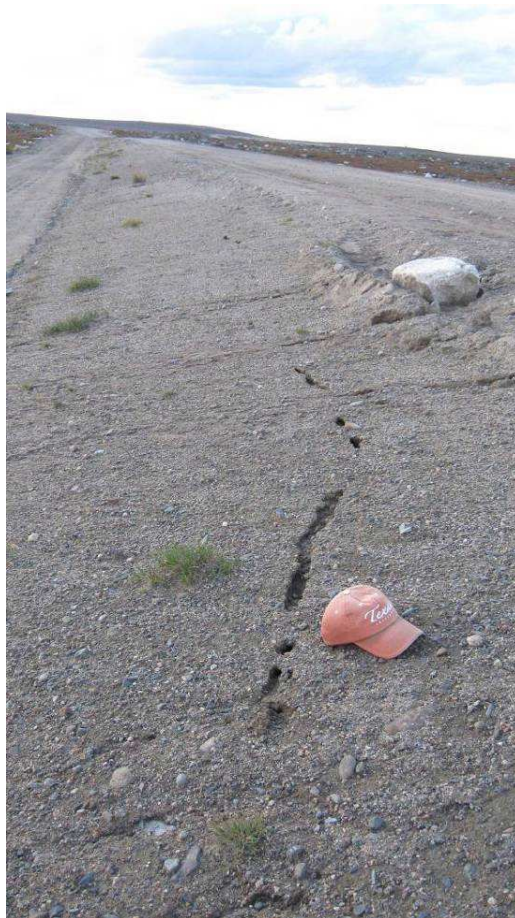
Downstream Slope (12 m long crack, middle of dam, 150 mm deep) – 2010

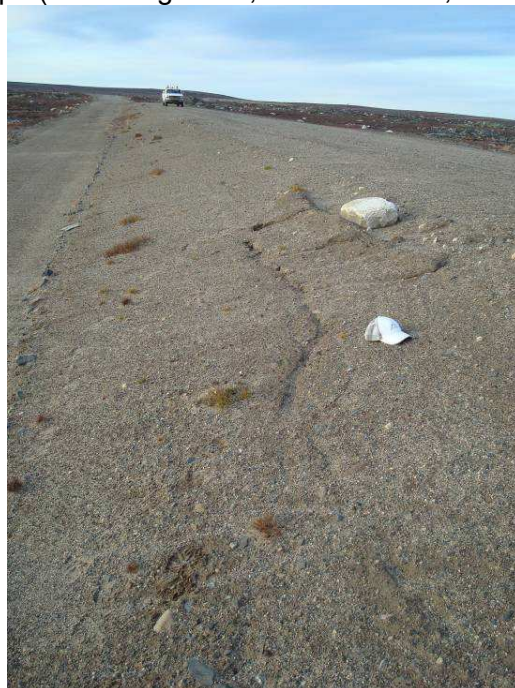
Downstream Slope (crack now partially in-filled) – 2011

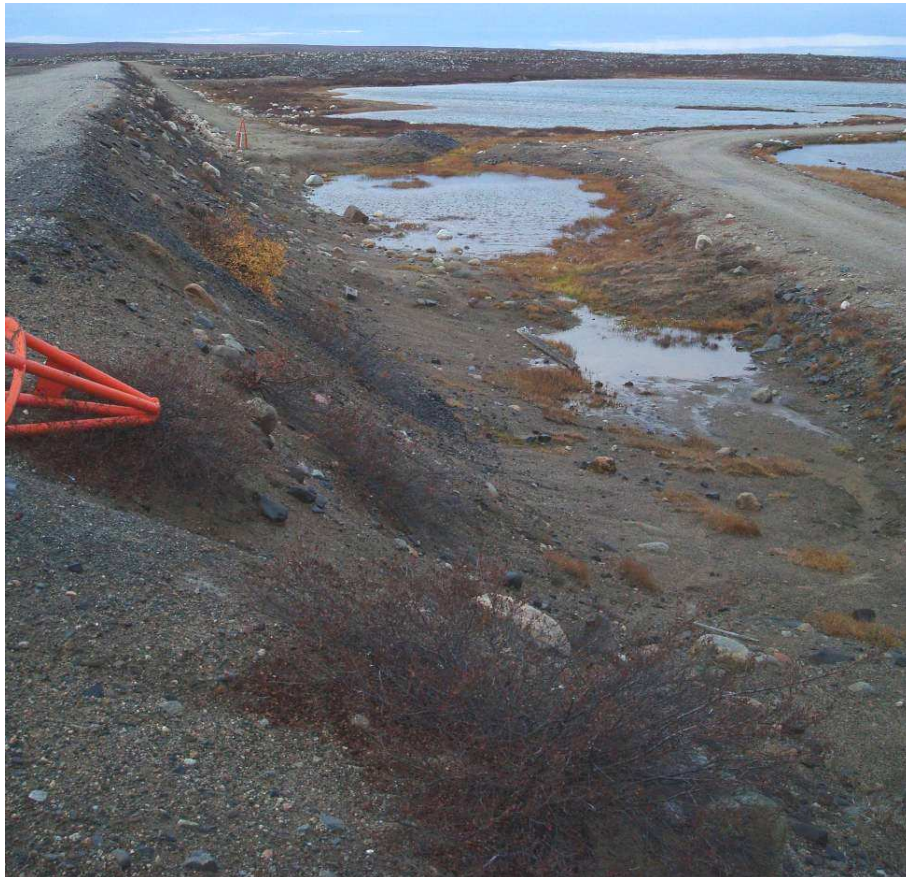
Possible Historic Seepage Collection Berm or Berms? – 2011

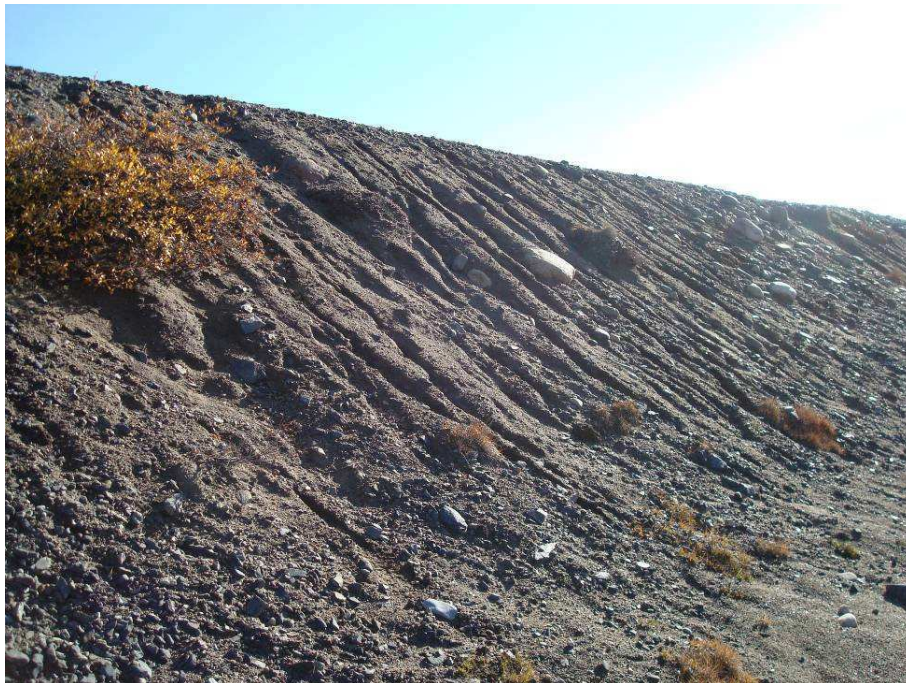
Dam 2: Downstream Slope Erosion Gullies and Rills – 2011

**MAINTENANCE
RECOMMENDATIONS:** Maintenance of erosion is recommended. At the area of seepage observed along the downstream toe, it appears that the seepage rate has increased from last year. This may be a result of a higher pond level. Currently, the seepage rate does not appear to be causing internal erosion. The seepage may be a result of thawing conditions near the northeast abutment. A sample of the seepage was collected by the client to possibly determine if seepage is from Pond 2. The results of this testing were not provided at the time of this report. This area should be monitored to identify if seepage stops during colder months, or for signs of erosion. As seepage has been observed over the last two years and it appears to be increasing, additional investigation, analyses and/or remedial measures should be considered.

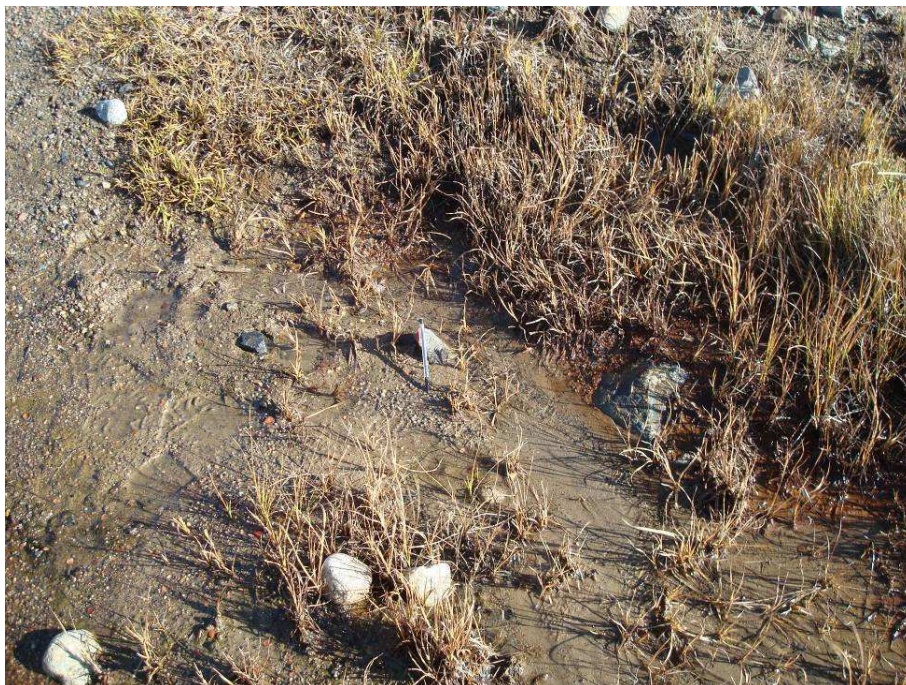
One small area of light seepage was noted along the downstream toe. This is at the same location as observed last year. The seepage rate was estimated at 4 litres/min (approximately twice as much as last year). The current freeboard has been estimated at 3.4 m (the pond level is about 0.4 m higher than last year). The increased pond level may have resulted in the observed increased seepage rate. It should also be noted that the depth to the frozen core as measured at the nearby thermistor station (Thermistor D2-002 n) is approximately 3 m. The depth to the frozen core (as measured in the fall of each year) was also noted to be low in 2006 and 2010 which likely corresponds to the warmer average annual temperatures for these years. It is possible that the depth to the frozen core locally drops to below the pond level in the area of the noted seepage. At the time of this inspection, the seepage water was free of sediment and piping conditions were not evident. It is possible the seepage conditions may become worse over time and with an increase in level of Pond 2. It is possible that some of the water ponding on the downstream side of the dam originates from seepage through the dam and/or under the dam, through the foundation soils. A sample of the seepage was collected (by representative of Elgin Mining Inc.) to assess if the source of the seepage can be correlated to Pond 2. In reviewing the 2007 annual inspection report, it appears that natural ground downstream of the toe area was usually wet prior to 2007, but was dry in 2007.

SEEPAGE:	Seepage was observed at one location along the downstream toe (located approximately 20 m south of thermistor D2-00-02). Seepage was estimated at a rate of 2 litres/min last year and has increased to an estimated 4 litres/min this year. Seepage appeared to be free of any sediment. It appears that a historic seepage containment berm may have been constructed at the seepage location as evident by what appears to be a small berm constructed from between the toe of the dam and an existing road. The small berm is now breached. The presence of a historic seepage containment berm has not been confirmed. Mine records should be reviewed to assess if seepage has been an issue at this location historically.

Dam 2: Downstream Toe (approx. 20 m South of D2-00-02) Clear Seepage at a Rate of Approx. 4 litres/min. – Th2011

As recommended last year, the geotechnical conditions at Dam 2 should be investigated to determine the in-situ fill conditions and to measure pore water levels in the dam. In addition, installation of an additional thermistor string may be considered at the seepage location to review the depth of frozen ground. Once conditions at the site are determined, remediation of the downstream slope should be undertaken. Remediation options may involve construction of suitable granular filter zones and/or construction of a suitable impermeable barrier to significantly reduce seepage losses. Widening and/or thickening of the dam to attract the aggradation of permafrost conditions into the deep foundation of the dam may also be considered as a design alternative.

It is understood that investigation, design and approvals will be undertaken in 2012 with the work scheduled for 2013. In the interim, the water ponded downstream of the dam should be sampled to ensure environmental compliance and may require containment and pump back over the dam. The water level in Pond 2, should be lowered as much as possible to reduce seepage gradients until such time as the seepage conditions are understood and/or corrective measures

can be implemented. The seepage conditions at Dam 2 should be monitored and the mine should be prepared to implement immediate temporary repair to the dam should conditions deteriorate.

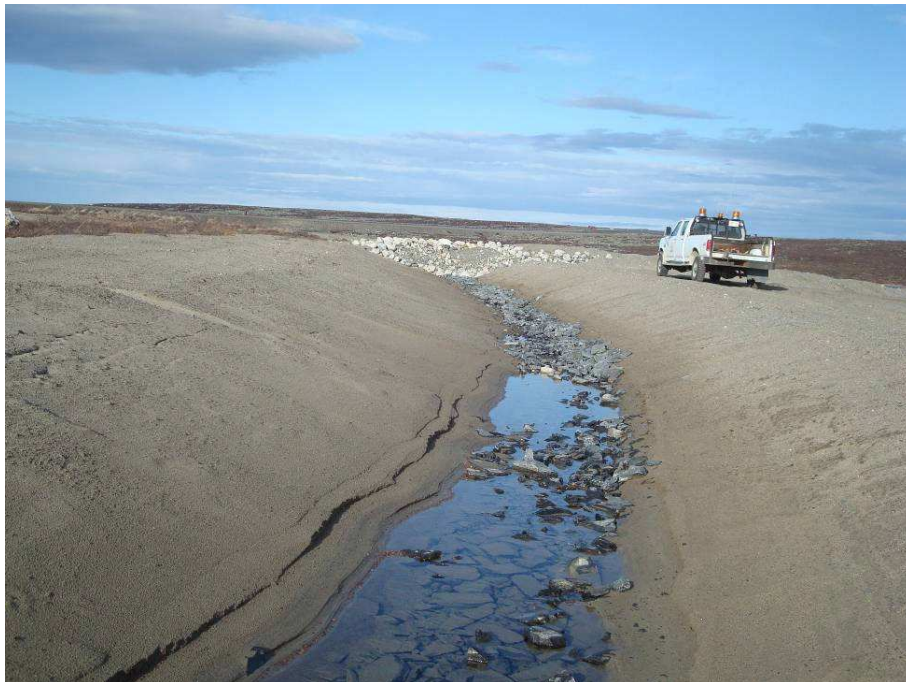
Dam 3: Upstream slope looking northwest at area of last year's ditch regrading leading. Some scour and standing water. – 2011

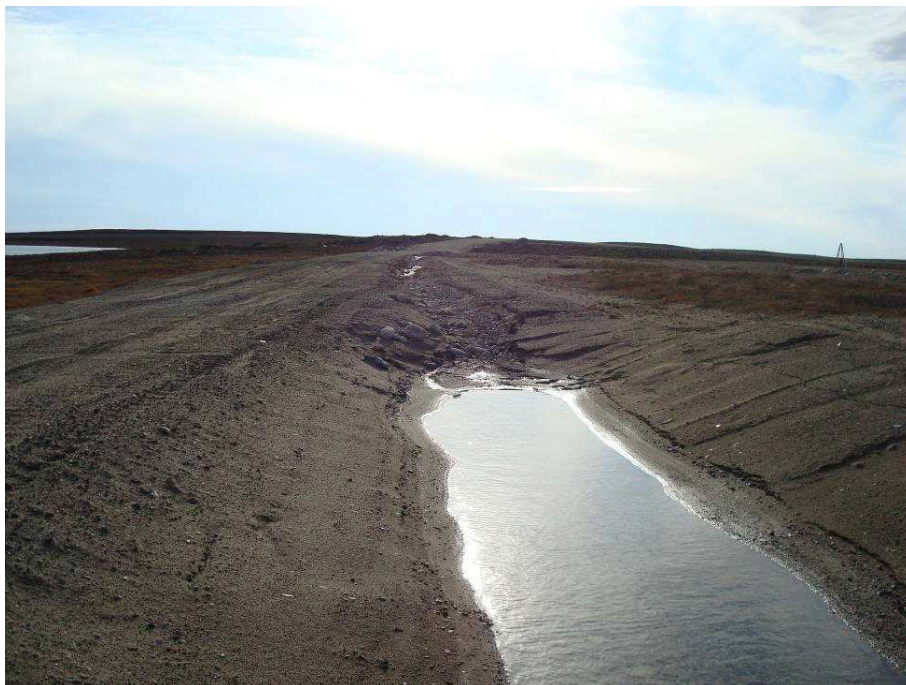
DAM 3: Upstream crest looking southeast. Loose fill on crest. End of ditch regrading. Standing water. Ditching upstream of ditch regrading treatment contains some sediment. – 2011

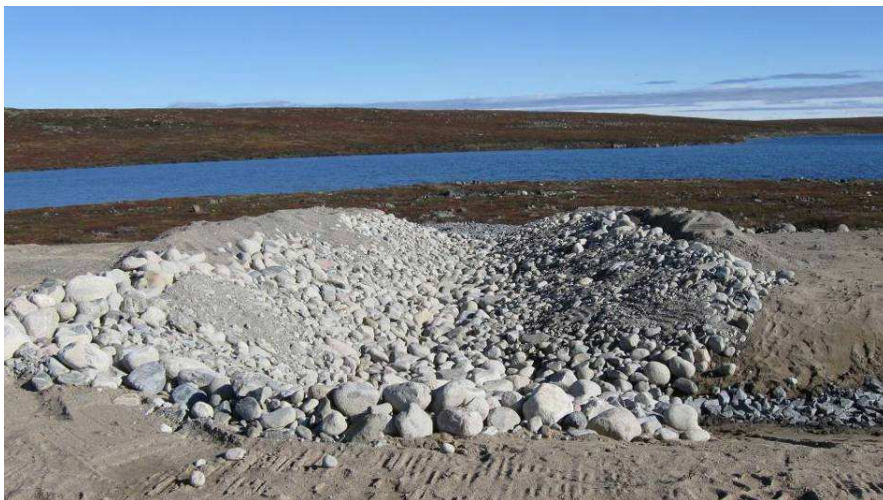
Dam 3: Spillway crossing dam at end of upstream ditch. Re-constructed last year with a grade of about 20H:1V (was specified at 30H:1V through the dam and 7H:1V along downstream slope). Through the dam crest, the new spillway has a channel base width of 2 m, not the specified 4 m. The spillway is lined with riprap and geotextile. – 2010

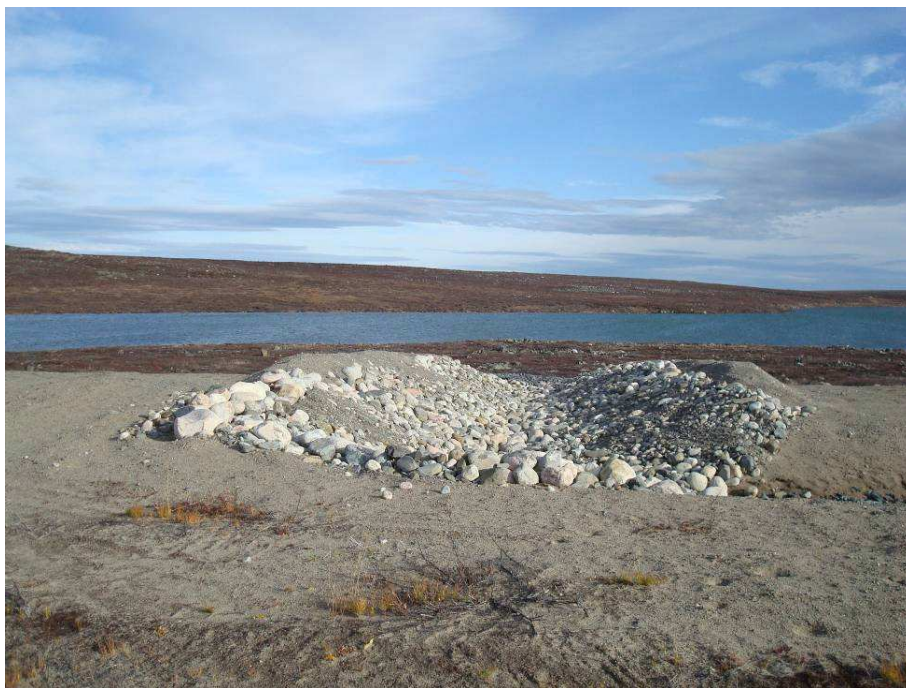
Dam 3: Spillway crossing dam at end of upstream ditch. Similar conditions to last year.
– 2011

The new spillway performance should be monitored for signs of erosion and/or inadequate capacity.

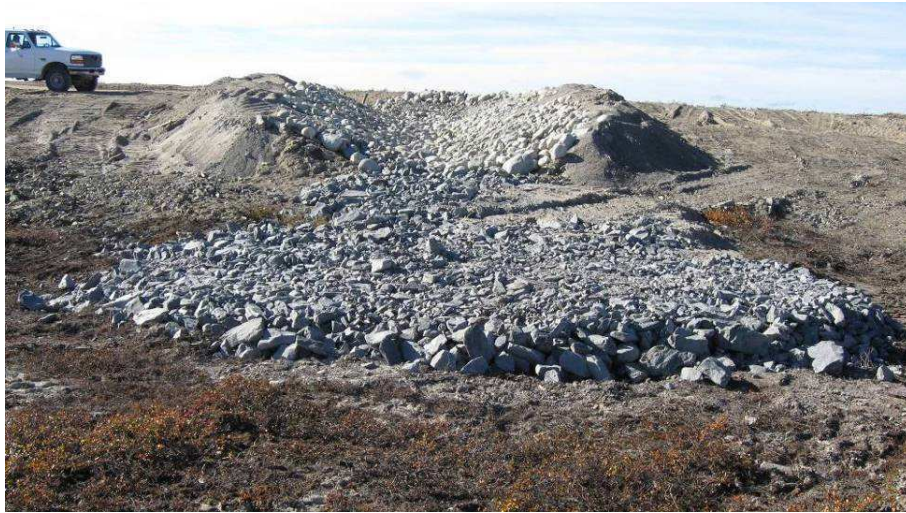
Dam 3: Downstream side of spillway (splash pad) constructed last year. Spillway side slope constructed at about 2.5H:1V (steeper than 3H:1V specified). Slopes on the outside of the spillway channel are also steeper than specified. – 2010

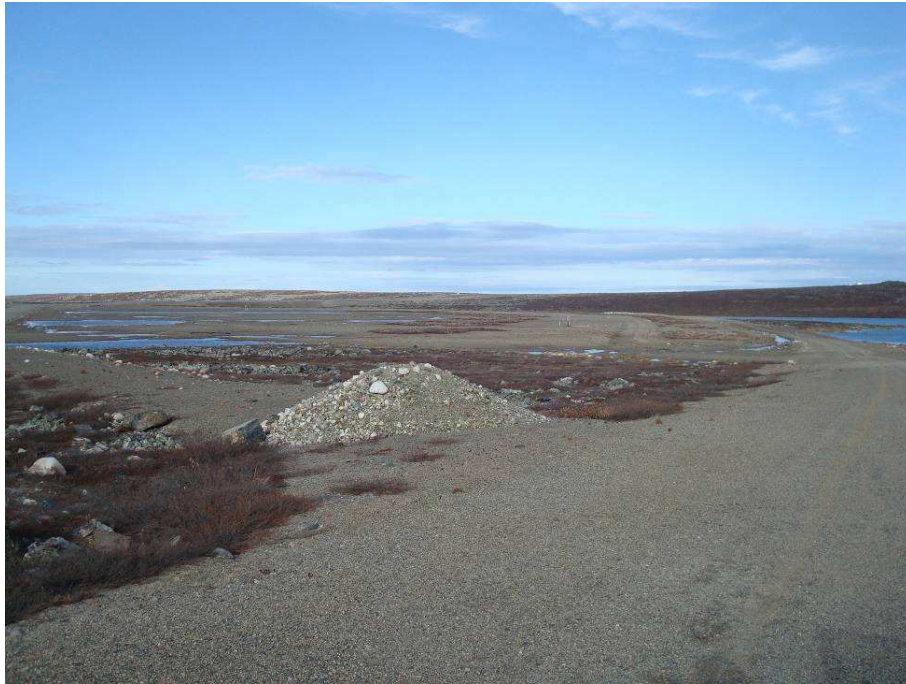
At the time of this inspection, areas of ponded water were noted on the closed cell. Regrading measures may be considered to reduce ponding.

Areas of Ponded Water onto of Cell – 2011

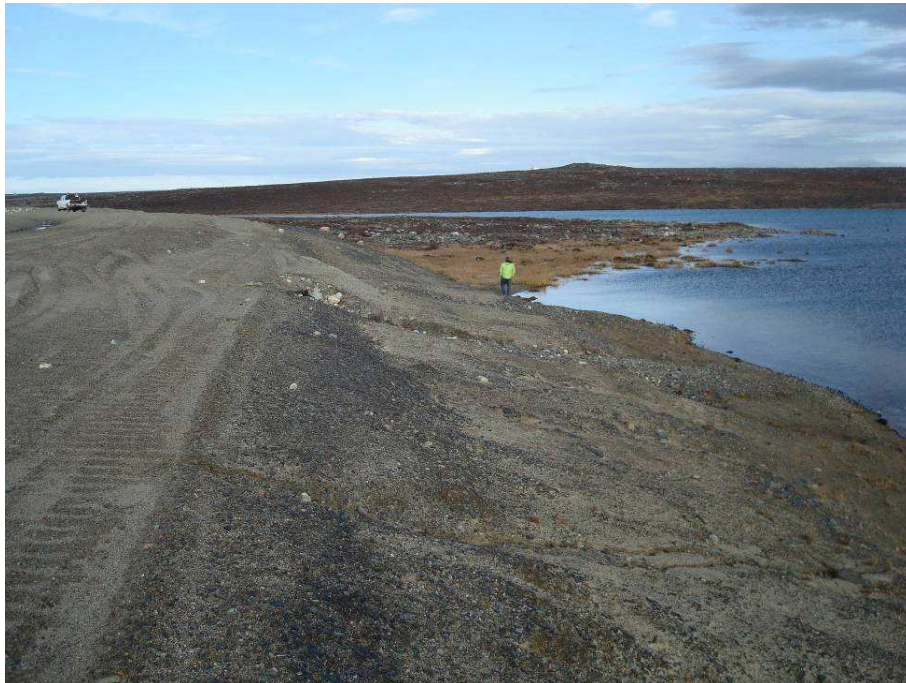
Erosion Gullies on Downstream Slope – 2011

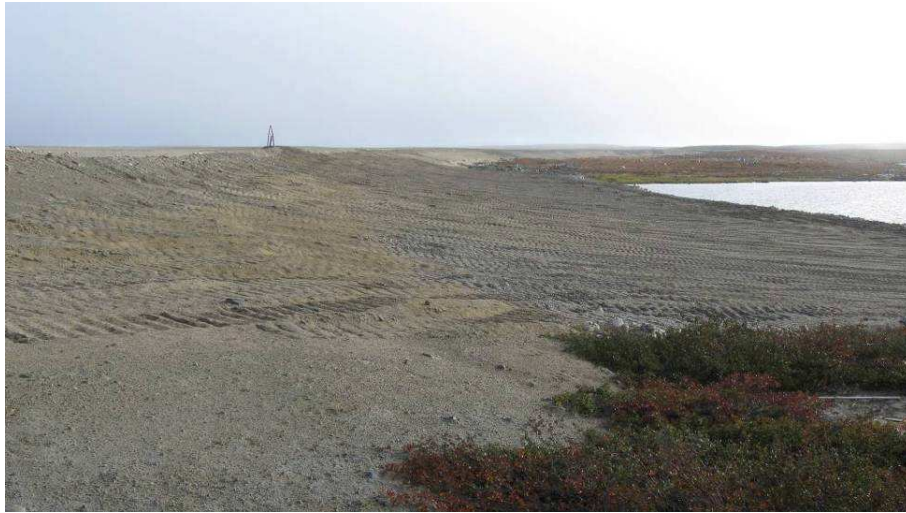
Dam 4: Downstream side, west end of dam. Area between Dam and downstream coffer dam infilled (last year) with esker material to mitigate seepage conditions. – 2010

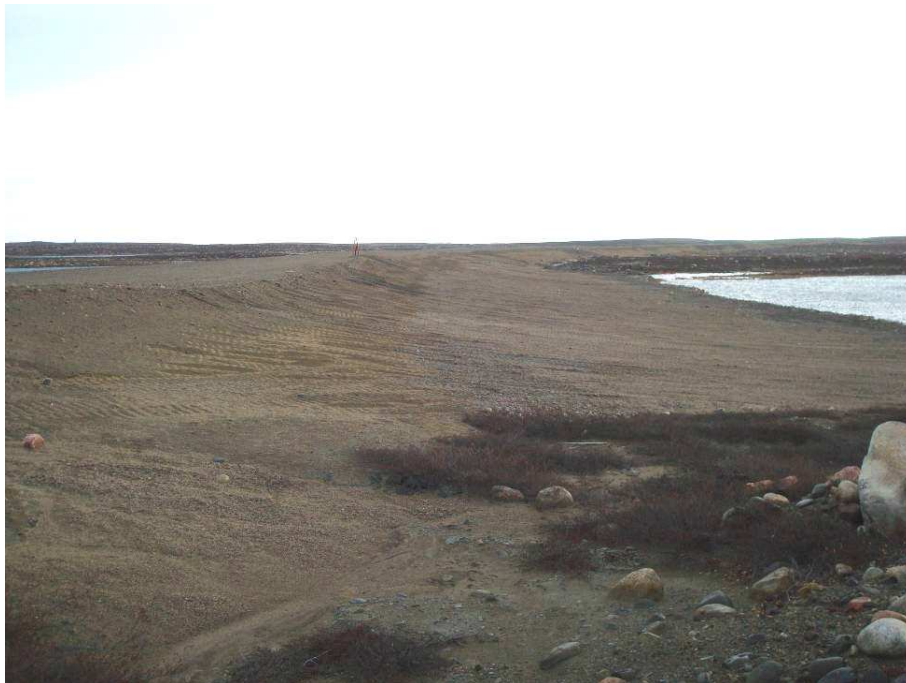
Dam 4: Downstream side, west end of dam. Some erosion gullies evident. Surface material in loose condition. No seepage observed. – 2011

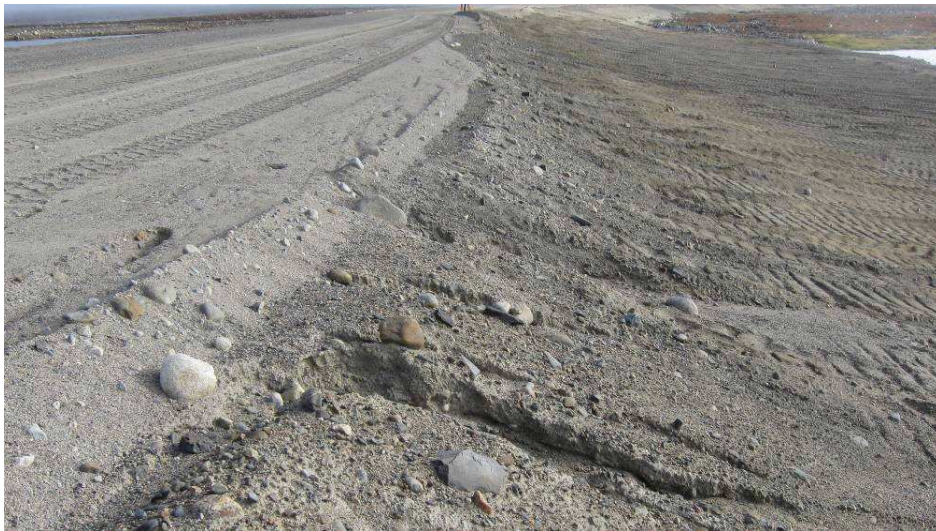
Dam 4: Downstream slope. Loose surface and erosion gullies on new infill. – 2010

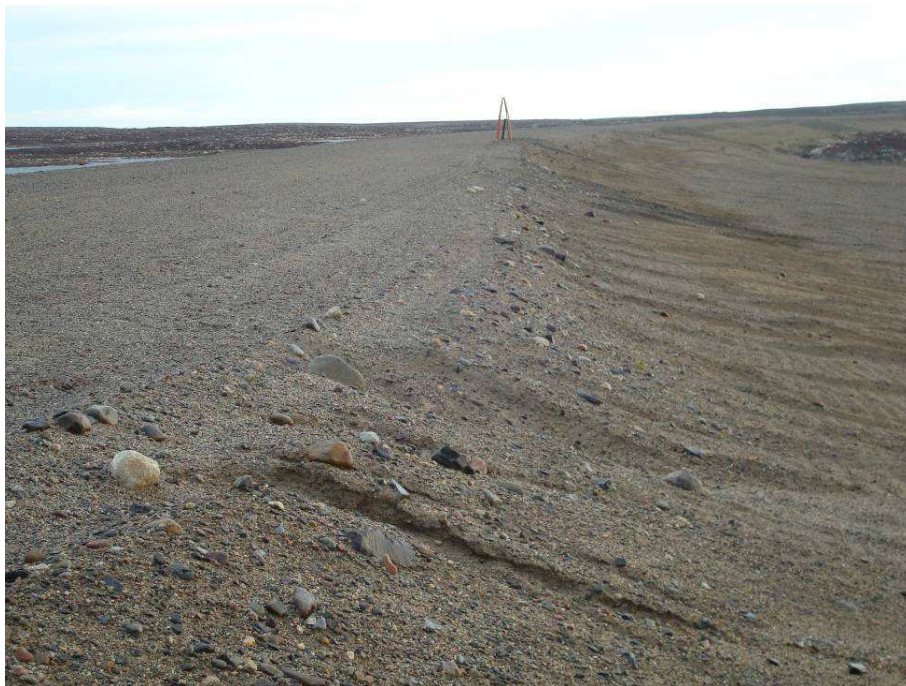
Dam 4: Downstream slope. Loose surface and erosion gullies (partially in-filled) on new infill. – 2011

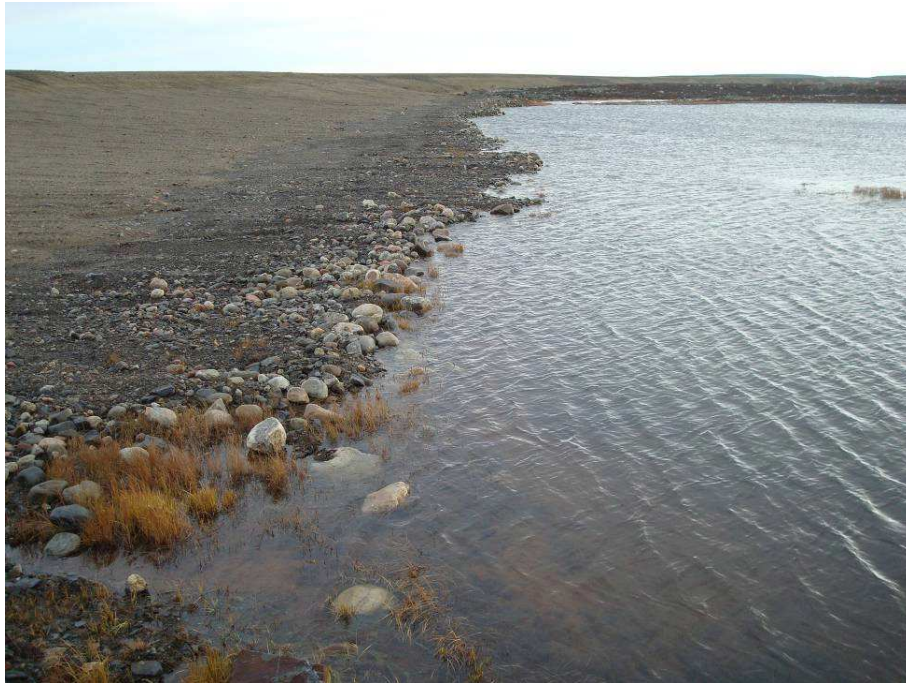
Dam 4: Downstream slope in area of old coffer dam (cobble stone). Note slightly higher downstream lake level. – 2011

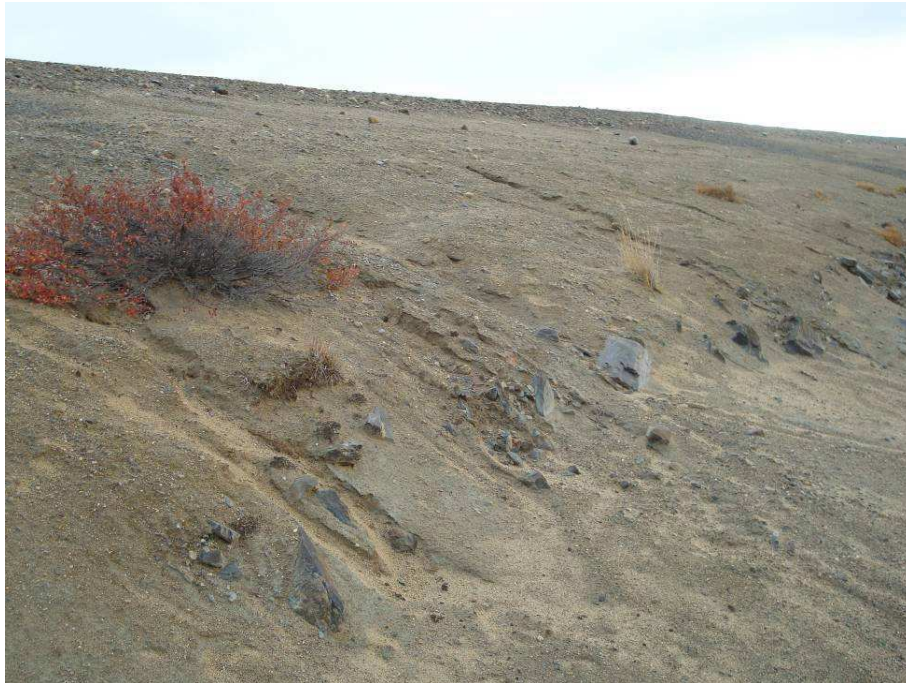
Dam 4: Downstream slope, east of cofferdam. Extensive erosion gullies (now partially in-filled) – 2011

1 m deep) have not been properly maintained along the eastern 2/3 of the dam. These were noted last year and should be repaired.

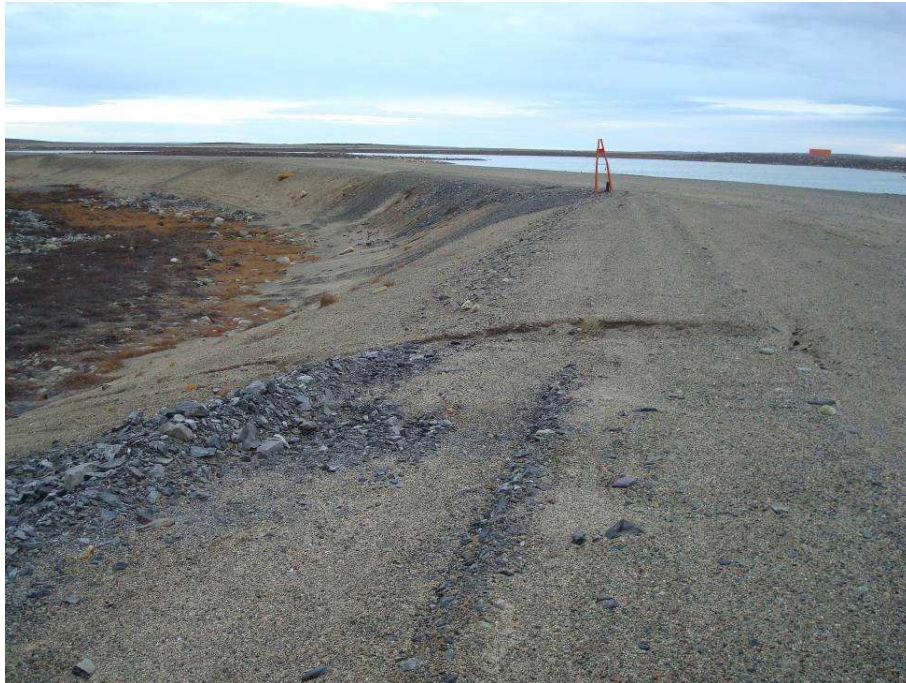
Dam 4: Downstream slope, east of cofferdam (looking west). Extensive erosion gullies – 2011

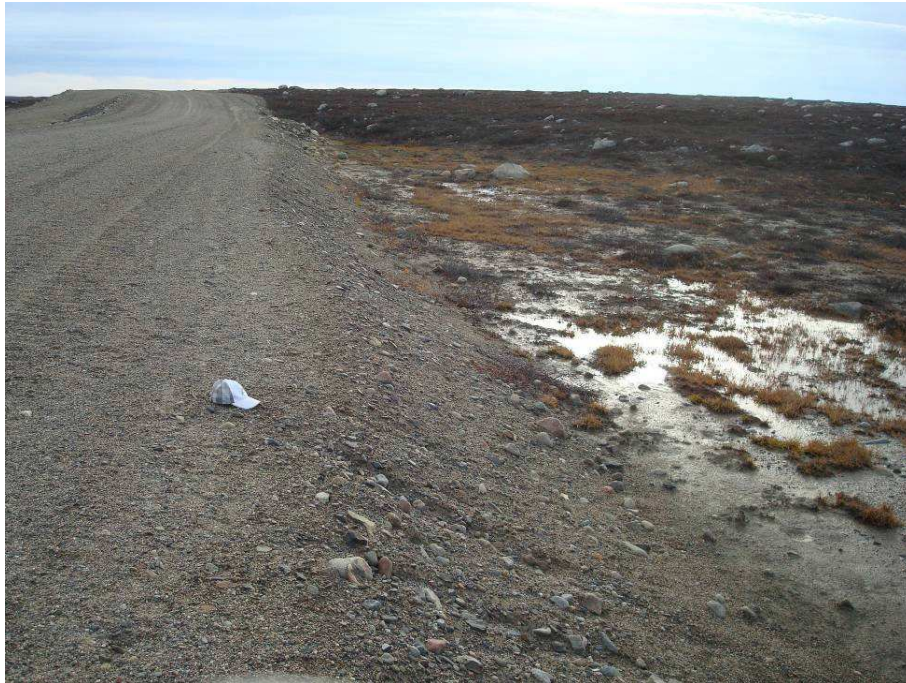
Dam 5: Downstream. Erosion gullies (partially in-filled). – 2011

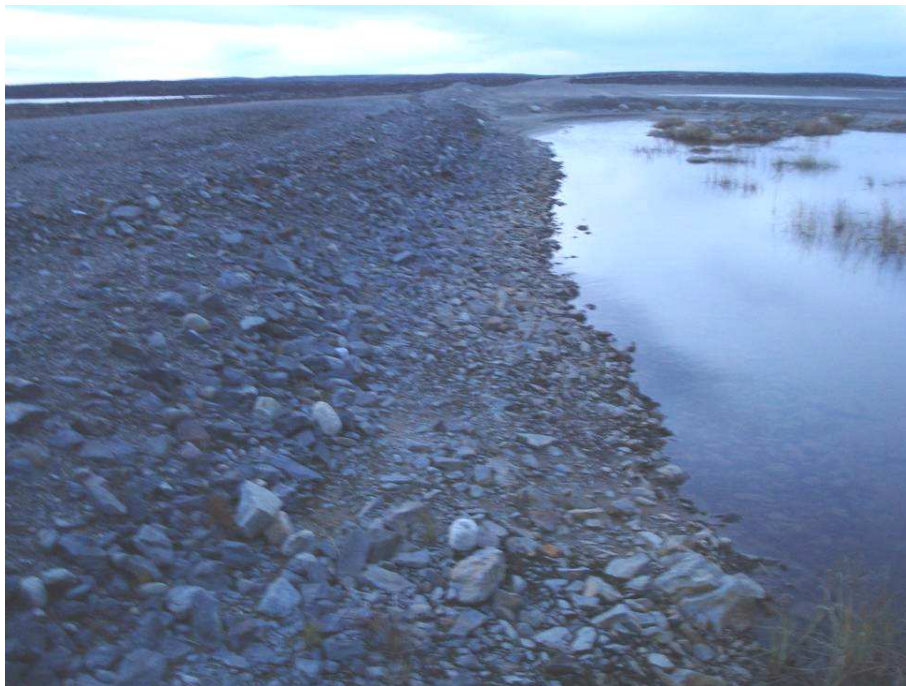
Dam 6: Upstream. Riprap in area of small pond. – 2011

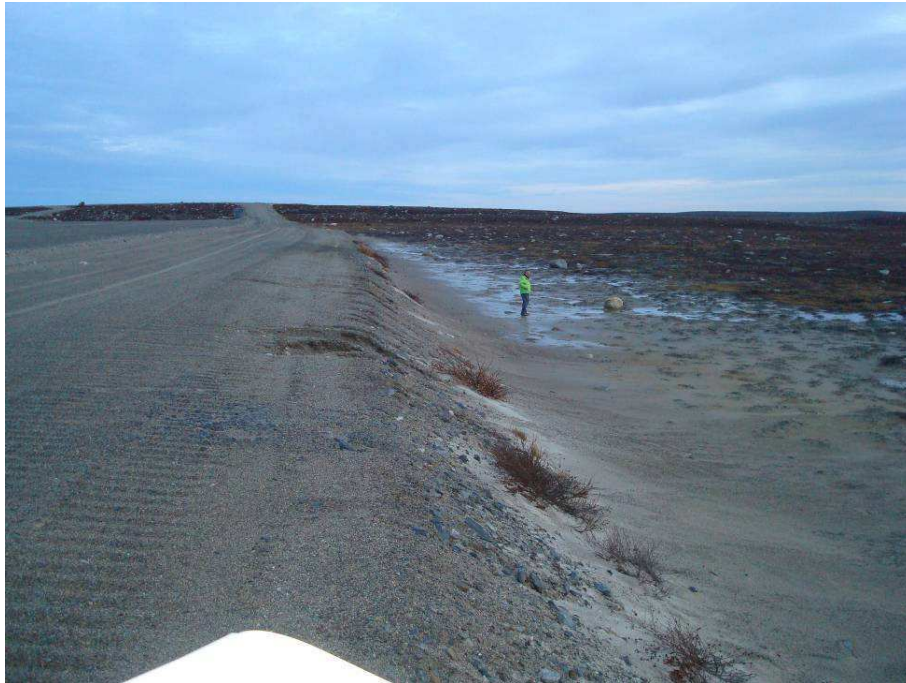
Along the downstream toe of the dam, the lower 0.5 m was observed to be saturated during this year's inspection. While no flowing seepage conditions were noted, the saturated zone at the toe and observed standing water near the toe are likely indicative of seepage. It is recommended that the ponded water near the toe be sampled to identify if it is indeed seepage from the covered cell. Additional investigation including review of the design should be considered to assess the potential for seepage losses and/or the potential for instability of the dam. In addition, thermistors and piezometers should be installed along this dam to assess the current depth of frozen core and groundwater levels across the dam. Potential remediation options (if deemed necessary) may involve construction of suitable granular filter zones and/or construction of a suitable impermeable barrier to significantly reduce seepage. Widening and/or thickening the dam to attract the aggradation of permafrost conditions into the deep foundation of the dam may also be considered as a design alternative.

Dam 6: Downstream. Erosion gullies and Standing Water Near Toe. – 2011

CONCLUSIONS:	The dam appears to be in a stable condition. Maintenance of downstream erosion is recommended. Additional investigation (including review of design) should be considered to assess potential for seepage losses and/or potential for instability of downstream slope.
