# 2013 Annual Geotechnical Inspection – Lupin Mine Tailings Containment Area, Nunavut

Lupin Mines Incorporated

SRK Consulting (Canada) Inc.  
1CL008.001  
October 2013

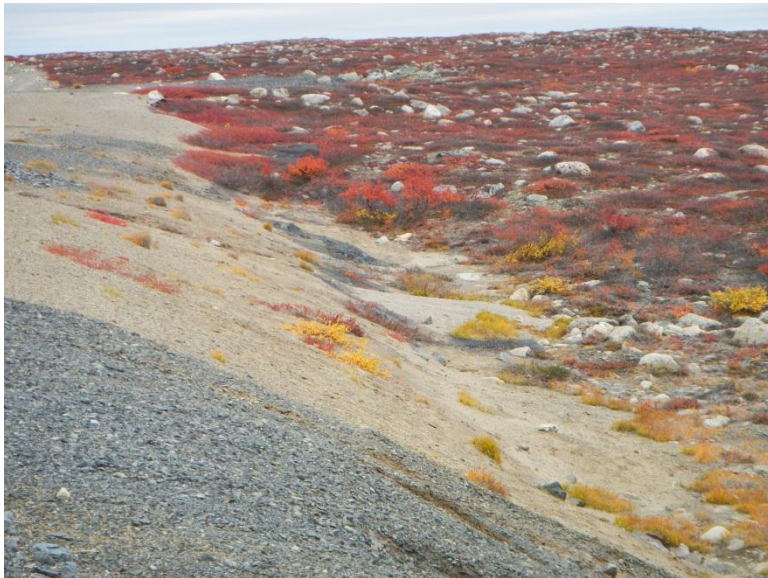
**Lupin Dam 4 eastern DS slope exposed geogrid**

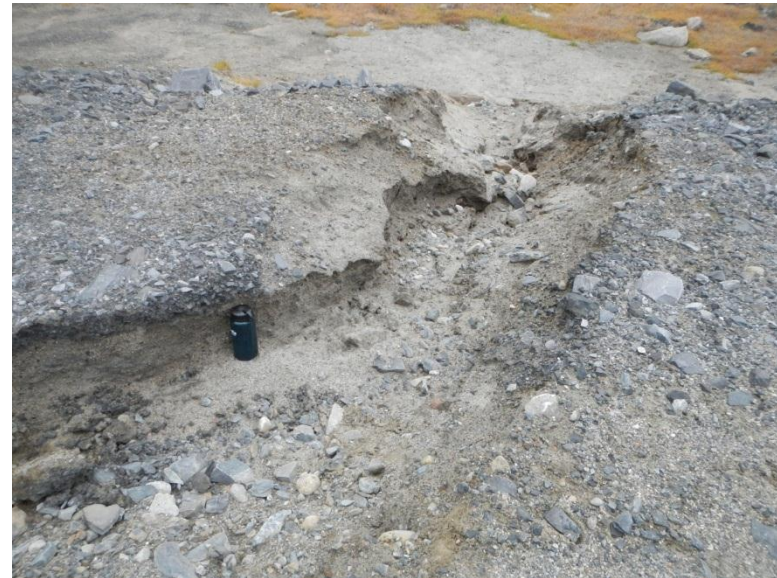
**Lupin Dam 4 eastern DS slope erosion**

With the exception of Dam M, the majority of the dams were generally found to be performing well and stable. SRK recommends that the observed erosion on Dams 1A, 3, 4, 6, L and J be monitored and repaired as required to reduce the risk of instability.

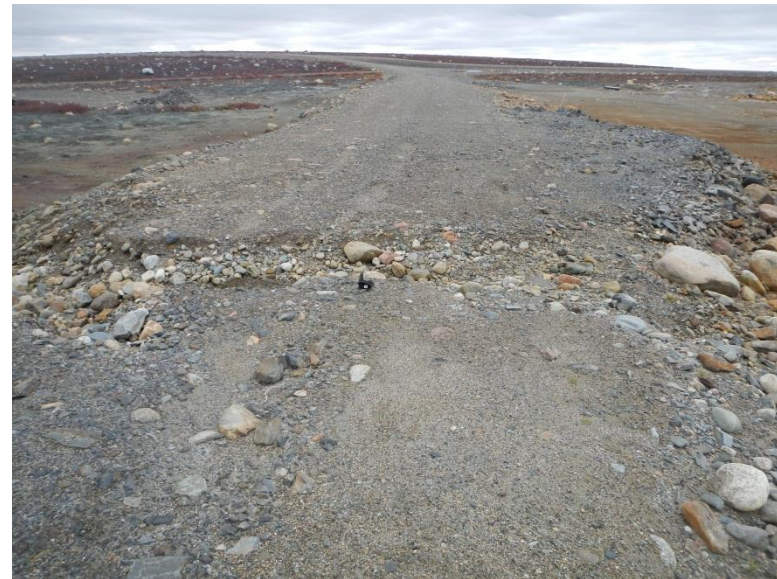
During the 2012 inspection, a substantial erosion breach was observed at the south end of Dam L. It is appears that the erosion was caused by the 2012 freshet where the water from the uncovered portion of Cell 3 breached into Cell 4. Cell 3 water level was reduced in 2012 from the treatment process and it is unlikely that Cell 3 water could breach this location again in 2014 freshet. However it is still recommended that this erosion to be repaired. Section 4 of this report provides recommendations to deal with the breached section in Dam L. The slope facing Cell 3 is observed to have considerable erosion near the toe. Monitoring should be carried out to prioritize the repair on the erosion to minimize propagation to the crest of the dam.

**Lupin Dam L erosion channel**

**Lupin Dam L erosion channel, Cell 3 view**

**Lupin Dam L erosion channel, Cell 4 view**

Dam K	Minor downstream slope surface erosion and some undercutting at toe; appears to be tailings material, from Pond 2 wave action.	Consider surface maintenance. Monitor regularly to ensure dam toe is not undercut. If so, place riprap there for protection.	Minor downstream slope surface erosion and some undercutting at toe; appears to be tailings material, from Pond 2 wave action.	Consider surface maintenance with grading and placement of fill erosions. Monitor to ensure dam toe is not undercut. If so, place riprap there for protection.
Dam L	Minor slope surface erosions and some minor undercutting at toe. Breach at southern section of dam near buttress. Seepage observed at 0.5 L/min below breach.	Consider surface maintenance. Monitor regularly to ensure dam toe is not undercut. If so, place riprap at the problematic area for protection. Repair with compacted well-graded esker material. Monitor and manage water in Cell 3 to prevent freshet overflow.	Slope surface erosions and undercutting at toe.	Consider surface maintenance with grading and placement of fill erosions. Monitor to ensure dam crest is not undercut by toe erosion. If so, place riprap at the problematic area for protection. Consider repair the breach with compacted well-graded esker material.
