2015 Annual Geotechnical Inspection – Lupin Mine Tailings Containment Area, Nunavut

Lupin Mines Incorporated

SRK Consulting (Canada) Inc.
1CL008.002
October 2015

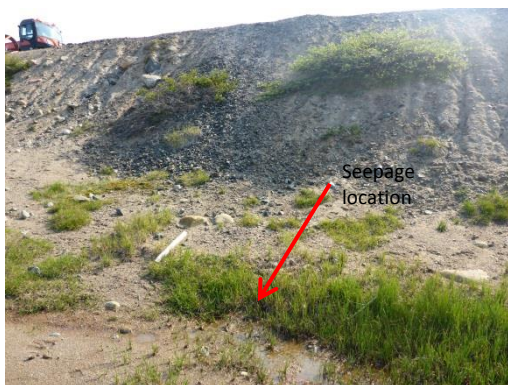
The previous annual inspection found seepage in the western buttress toe of Dam 4 into Ferguson Lake and the northern buttress toe of Dam 2 into a pond created by a cofferdam adjacent to Dam 2 Lake. Seepage at Dam 4 has not been observed since the 2011 inspection. Seepage at the toe of Dam 2 was observed in 2015, at similar flowrates since 2012. In 2015, this seepage was contained by the cofferdam downstream of north abutment and pumped back into Pond 2 when it pooled.

Photo 1: Seepage in the north abutment of Dam 2 and surface erosion

Inspection Item	2015 Inspection			2014 Inspection	
	Estimated Freeboard (m)	Observations	Recommendations	Observations	Recommendations
Dam 1B	~2 m	Minor surface erosions.	Surface maintenance e.g. grading and backfilling.	Minor surface erosions.	Consider surface maintenance.
Dam 1C	1.8 m	Minor surface erosions. No cracks observed.	Surface maintenance e.g. grading and backfilling.	Minor surface erosions. No cracks observed.	Consider surface maintenance.
Dam 2	~2 m	Minor surface erosion. Estimated seepage at the northern buttress is less than 0.1 L/min. Collection pond was emptied in 2015.	Monitor the seepage and water level in collection pond to pump the collected seepage back into Pond 2 as necessary.	Minor surface erosion. Estimated seepage at the northern buttress is less than 0.1 L/min. Collection pond is nearly full.	Consider surface maintenance. Monitor the water level in collection pond to pump the collected seepage back into Pond 2.

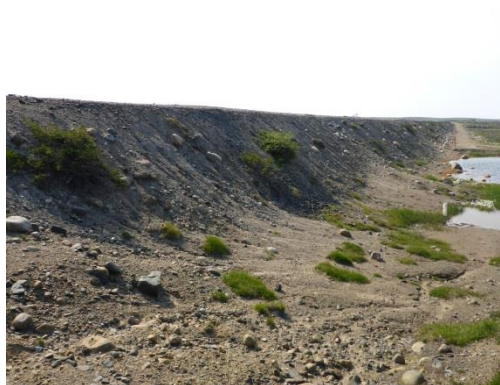
Photo 2: Looking south at the seepage collection ponds at toe of Dam 2.

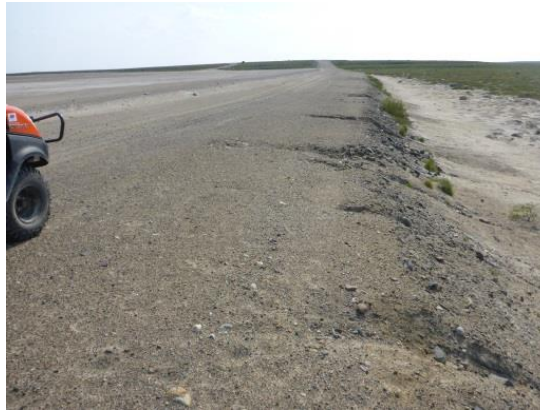
Photo 14: Close up look at one of the large erosion gully in Dam 6.

Dam 5	N/A (no water is impounded by this dam)	Minor surface erosions.	Surface maintenance e.g. backfilling and regrading.	Minor surface erosions.	Consider surface maintenance.
Dam 6	1.5 m	Surface erosion with some gullies.	Repair the deep erosion gullies, backfill depressions and regrade	Surface erosion with some gullies. No seepage or ponding.	Repair the deep erosion gullies and maintain surface.
Internal Dams ⁽¹⁾					
Dam 3D	~5 m	Minor surface and crest erosions.	Surface maintenance. e.g. backfilling and regrading. Optionally, it is recommended to complete an evaluation on the depth of frozen tailings to de-classify this facility as a dam (see Section 3.4)

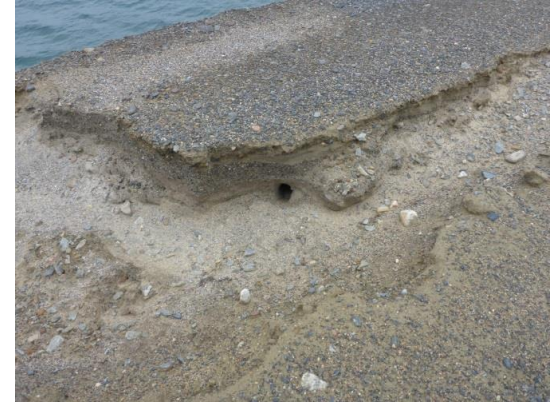
Photo 21: Close up of erosion gully in Dam 4, the burrow from ground animal.

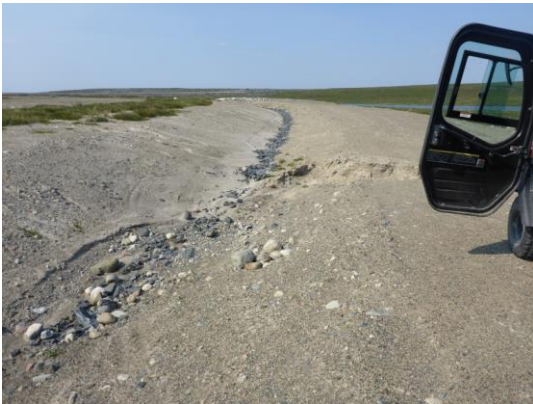
The storm ditch built within the top 2 m of Dam 3 has suffered some erosion damages from the 2014 freshet. It is believed that ponding in sections of the ditch is the main cause of the erosion damage. Because of the poor grading, the closure cover runoff water pooled, froze, and created an ice dam; which in turn forced the freshet water to overtop the ditch, over a small portion of Dam 3. Repair was completed on the damaged area in 2015 by constructing an armored channel along the alignment of the erosion, to let the drainage bypass the ponding section.

Photo 22: looking northwest at the storm ditch and erosion damage on crest of Dam 3.

Dam 3	N/A (no water is impounded by this dam)	Erosion has once again damaged the dam crest due to the poor storm ditch grading. Mitigation included converting the erosion gully into an armored storm ditch to provide proper drainage.	Repairs were completed on the eroded section by LMI after the inspection. Monitoring should be carried out to check that the new ditch is performing as intended.	Minor surface erosion. Despite repairs to the storm ditch, it does not yet have a free-draining grade.	Repairs were completed on the eroded section after the inspection by LMI. Consider to re-grade ditch to minimize ponding and monitor during freshet to prevent ice blockages.
Dam 4	~2 m	Surface erosion with a number of erosion gullies. Exposed geogrid observed near the eastern downstream toe of the dam.	Repair the deep erosion gullies, re grade surface and backfill and depressions monitor the exposed geogrid for further erosion and potential water seepage.	Surface erosion with a number of deep erosion gullies. Exposed geogrid or similar synthetic reinforcements observed near the eastern downstream toe of the dam.	Repair the deep erosion gullies and maintain the surface. Monitor the exposed geogrid for further erosion and potential water seepage.

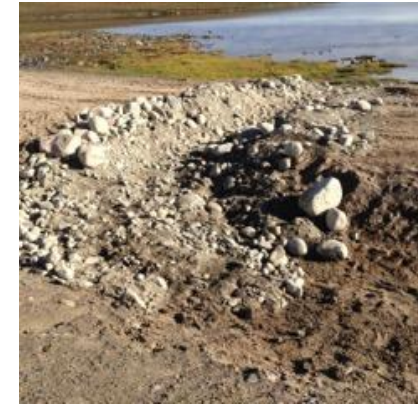
Photo 24: Looking north at the repair work completed over the eroded gully in Dam 3, including geotextile and riprap armoring.

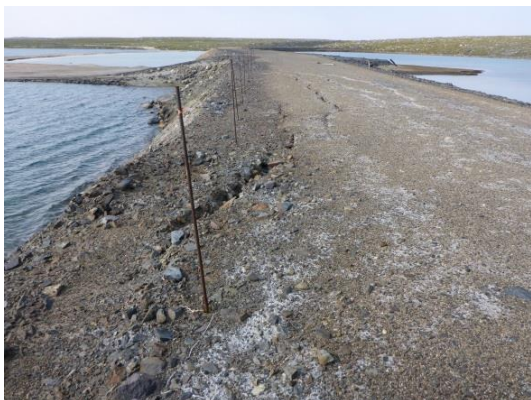
Eight significant tension cracks were observed on Dam M. Visual comparison between 2012 and 2015 photographs showed the existing cracks are widening and lengthening. Potentially, the failed portions of the dam could breach and allow the supernatant water and tailings to flow from Cell 5 into Pond 2. Because of the severity of the cracks and potential breach, LMI was advised that all vehicle traffic should avoid this section for safety reasons. A risk assessment was completed by SRK in 2012 to evaluate the potential impact on water quality and the environment in the event of a breach. The results of the assessment indicated that there would be minimal impact to the environment due to the presence of the perimeter dam containment (SRK 2012b). However, a breach in Dam M would be a concern for worker safety, site infrastructure access, future operations, and ongoing care and maintenance activities. Section 4.1 provides recommendations to address the potential risks in the event of a full breach.

Photo 28: Looking northwest at original tension cracks on Dam M, with Dam N and Pond 2 to the left.

Based on a visual inspection of the tension cracks in Dam M, possible causes could include pore water pressure from Cell 5, foundation “creep” (movement between the active layer and permafrost), or undercut erosion of toe material. It is recommended that LMI consults with the engineer-of-record to better understand the mechanism behind the tension cracks and appropriate repairs. This could involve an investigation program to determine the exact mode(s) of failure before designing the appropriate remedial measures.

In the short term, all non-authorized personnel should avoid this dam for safety reasons. SRK further recommends that a monitoring program be established to determine the rate of failure and development of new cracks. The program should include pairs of monitoring monuments placed perpendicular to the cracks: one at each end, and one in the middle of the failing sections, each with a matching monitor on the stable section of the crest. Authorized personnel should measure and record the level and distance between each set of monuments on daily bases during the summer season. Results should be compiled and reviewed each year.

To mitigate some of the stability risks, SRK recommends that LMI keep the water levels in Cell 5 and Pond 2 as low as possible to reduce potential for dam instability. It is recommended that LMI monitor Cell 5 water level and keep it as low as operable until the dam is deemed stable. Recent observations provided by SRK staff show that there is riprap armouring along the toe of Dam M and K. These armoured toes were submerged during previous inspections and were only exposed recently due to the lowering of Pond 2. It is recommended that LMI to keep the water in Pond 2 below this armored toe to minimize erosion damage and reduce stress on the dam.

To further maintain the stability of both Dams M and K, SRK recommends that as an emergency response, a toe buttress be constructed along the toe (Pond 2 side) of both dams as soon as practical. The buttress should be constructed of compacted, well-graded esker material, and placed with a downstream slope of 2H:1V (horizontal to vertical) and extend up to half the height to the existing dam crest. The buttress should have a minimum crest width of 3m and extend a minimum of 5 m beyond the failing sections at each end and armored with riprap at the Pond 2 water level. In addition to the construction of the buttress, SRK recommends that a more detailed investigation be undertaken in consultation with the Engineer-of-Record to further understand the mode of failure.

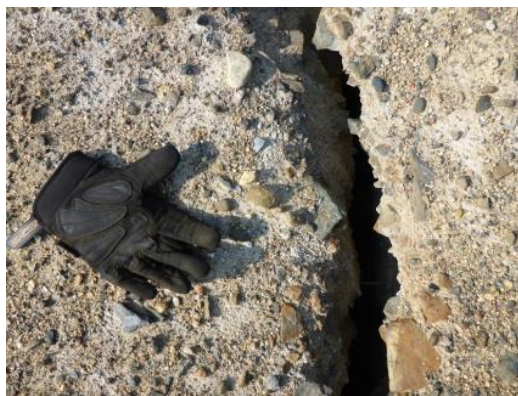
Photo 29: Close up view of the original tension cracks on Dam M.

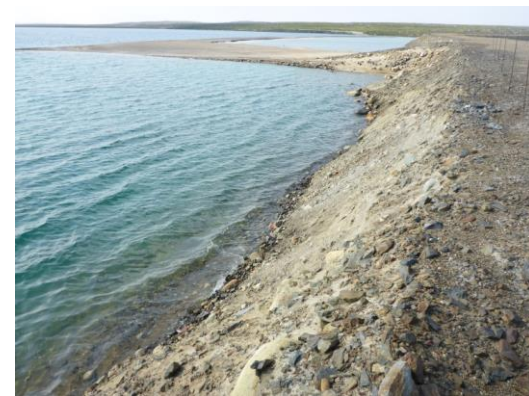
Photo 30: Looking northwest on Dam M at the over steepen slope directly downstream of the cracks, with Dam N and Pond 2 to the left.

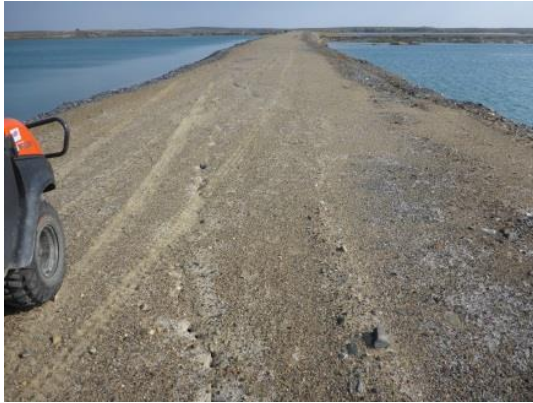
Photo 31: Close up view of Dam M at the new tension cracks observed in 2014, through the centerline of the dam, near the eastern abutment to Dam J.

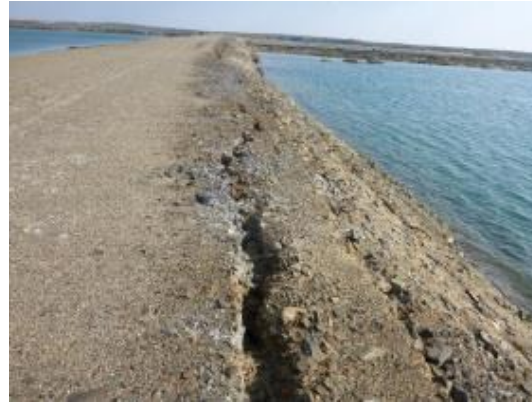
Photo 32: Close up eastern view of Dam M at the new tension cracks observed in 2014, in face of the dam toward Pond 1.

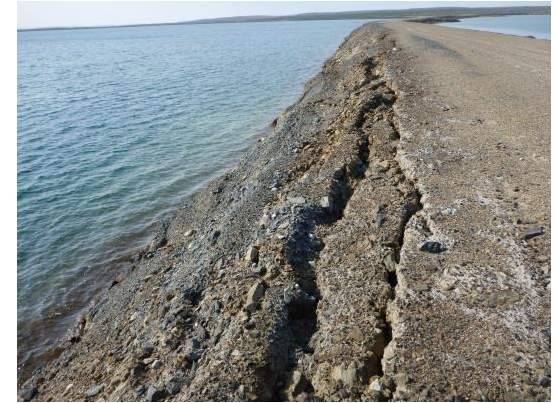
Photo 33: Close up western view of Dam M the new tension cracks observed in 2014, in face of the dam toward Pond 1, upwards of 0.3m wide and 0.5m deep.

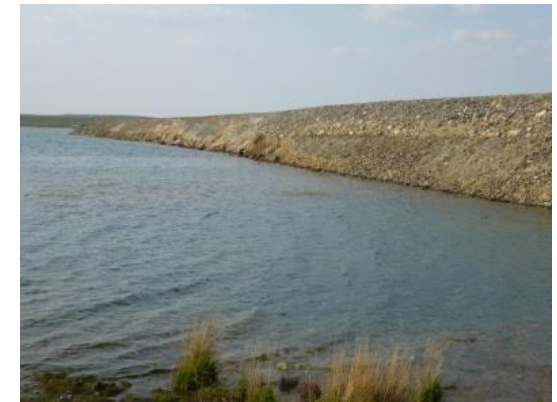
Photo 36: Looking northeast of at the Dam M facing toward pond 2. Note the failure surfaces at the toe.

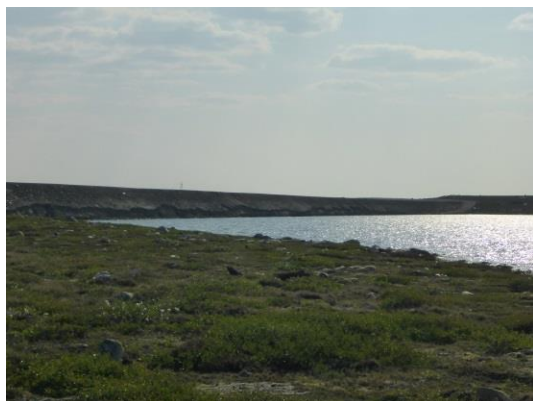
Dam K has historically experienced erosion (undercutting) at the toe of the slope due to wave action on the adjacent water in Pond 2. Minor tension cracks and a few erosion gullies were observed in the dam crest. Recent observations made by an SRK engineer during an inspection on October 7 indicate that there is in fact riprap armoring along the northern toe of Dam K. This riprap armoring was submerged during previous inspections and was only exposed recently as Pond 2 was lowered. Animal burrows were observed in the eroded gullies. It is unknown what type of animal made these burrows.

Photo 40: Looking south at Dam K facing pond 2. Note the under cut from at the toe of the dam.

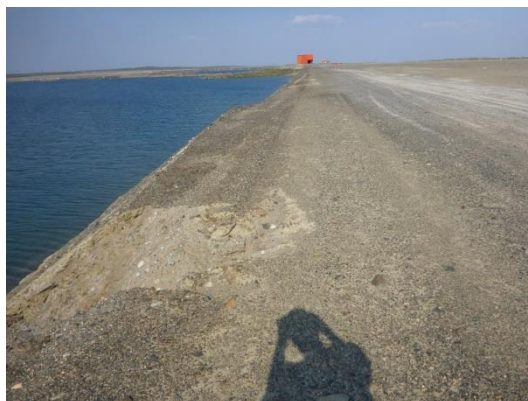
Photo 41: Close up view of erosion gully in Dam K facing pond 2.

Monitoring is recommended at Dam K to track the animal burrow activities. While it is unlikely that the ground animal would be able to penetrate the frozen core, periodic monitoring of the burrows in the summer season is recommended to check on any increase in numbers. An animal specialist should be consulted to identify and remove the animal if significant animal activities are observed or large concentrations of burrows are found within a short distance, e.g., 10 burrows in 30 m distance based on engineering judgment.

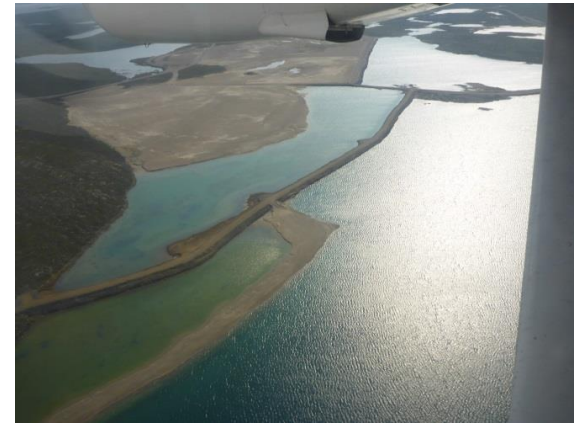
The water level in Pond 2 was higher than levels previously observed by SRK at the time of the site visits, just prior to discharge. Dam N was almost submerged. This made the dam surface difficult to travel on due to the fully saturated material. The difficulties in gaining access and the high water coverage on the dam made it difficult to carry out a proper inspection.

Photo 45: Aerial view of Dam N. Note the near submergence due to the high water level in Pond 2 during the time of visit.

As water levels in Pond 2 lower during discharge, Dam N monitoring is recommended by site personnel at the direction of a qualified person and the surveillance data should be communicated to the qualified person for review.

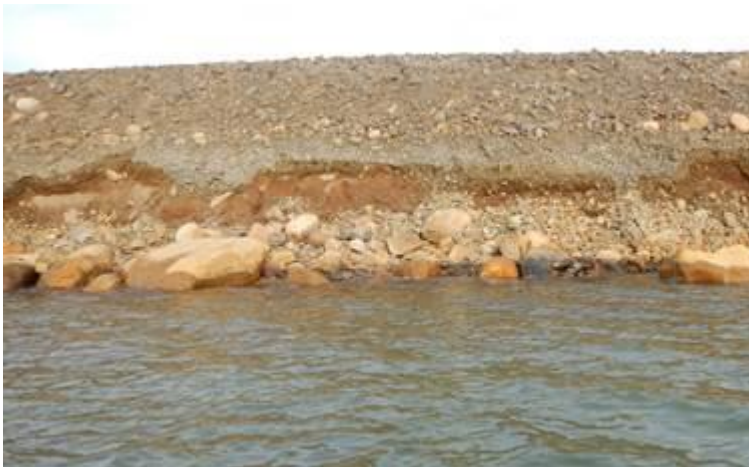
Photo 46: Picture taken on October 6th at Dam M showing the armored toe that was previously submerged in Pond 2.

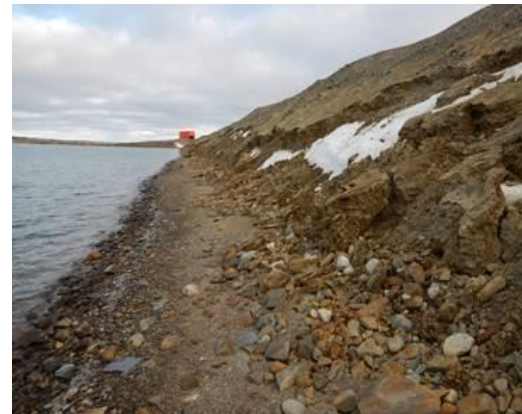
Photo 47: Picture taken on October 6th at Dam L showing the armored toe that was previously submerged in Pond 2.
