2015 Waste Management Facilities Geotechnical Inspection

Lupin Mines Incorporated

SRK Consulting (Canada) Inc.
1CL008.002
October 2015

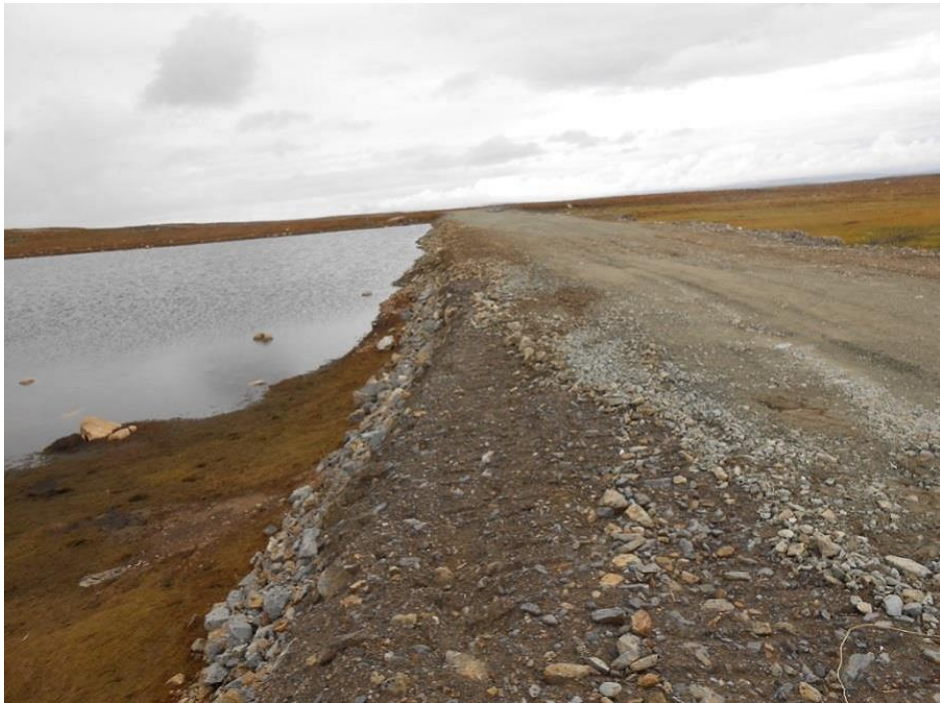
The dam is in stable condition with no geotechnical concerns. Maintenance work has been completed on the dam. The erosion on the upstream face was repaired with the installation of geotextile and riprap. The crest and the south abutment have been backfilled with additional material to provide a levelled elevation. All the deficiencies noted in the AANDC's 2014 inspection have been addressed. The freeboard is observed to be approximately 1.3 m.

Photo 1: Looking north from the Lower Sewage Dam south abutment on the repaired crest and upstream face.

The Lower Sewage Dam is in good geotechnical condition after the 2015 repairs. Visual checks are recommended in the upstream face when practicable during summer seasons for potential major erosion. Repairs should be considered if major erosion damages are found. The lower pond level is recommended to have a minimum 1 m freeboard prior to operations and winterization.

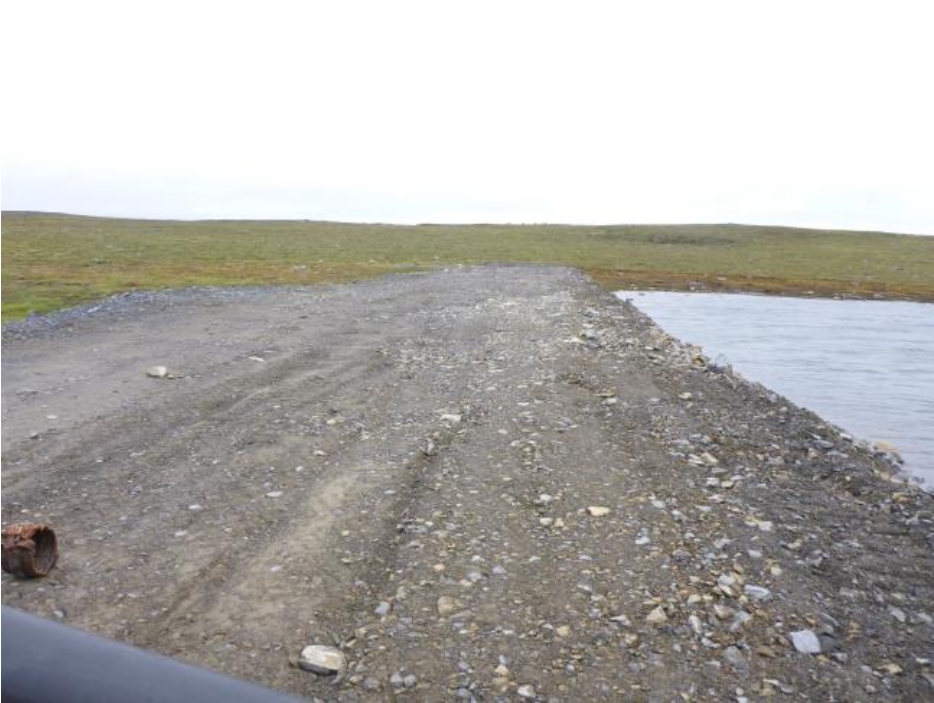
Photo 2: Looking south at the Lower Sewage Dam southern abutment on the additional fill placed to raise the elevation.

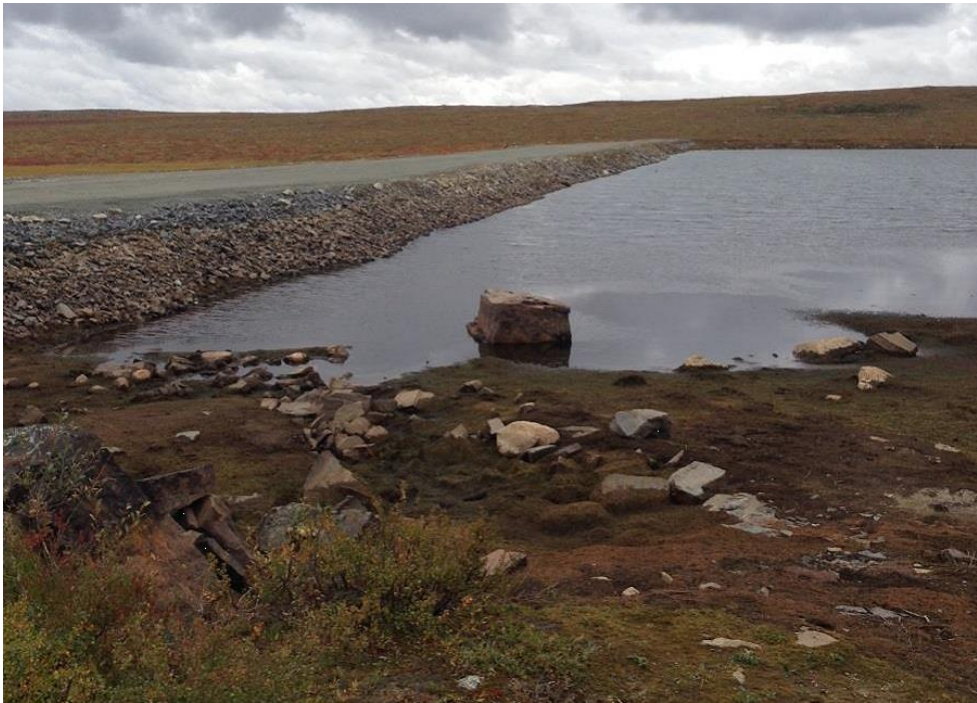
Photo 3: Look south from the Lower Sewage Dam North abutment on the repaired upstream slope and crest. Note the 1.3 meter freeboard available at the time of the photo.

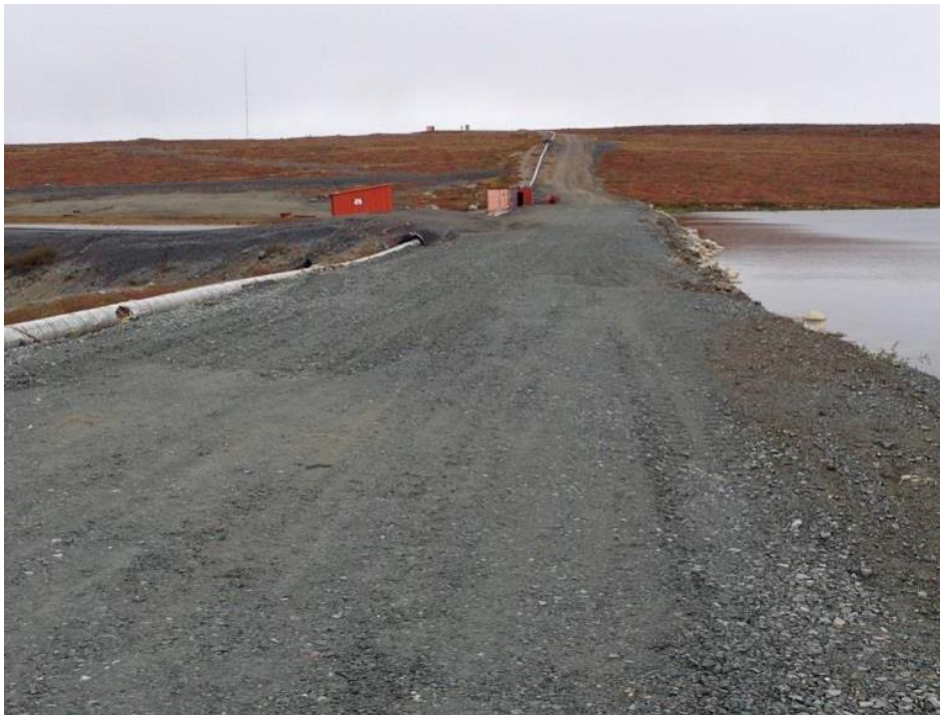
The dam is in good condition with no geotechnical concerns. Previous damages and deficiencies noted from the 2015 inspection report (AANDC 2015) had been repaired. The crest of the dam was repaired, widened and leveled with new backfill material. Tailings dump pond #1 has been

Photo 4: Looking south from the Upper Sewage Dam north abutment on the repaired crest with additional fill placement.

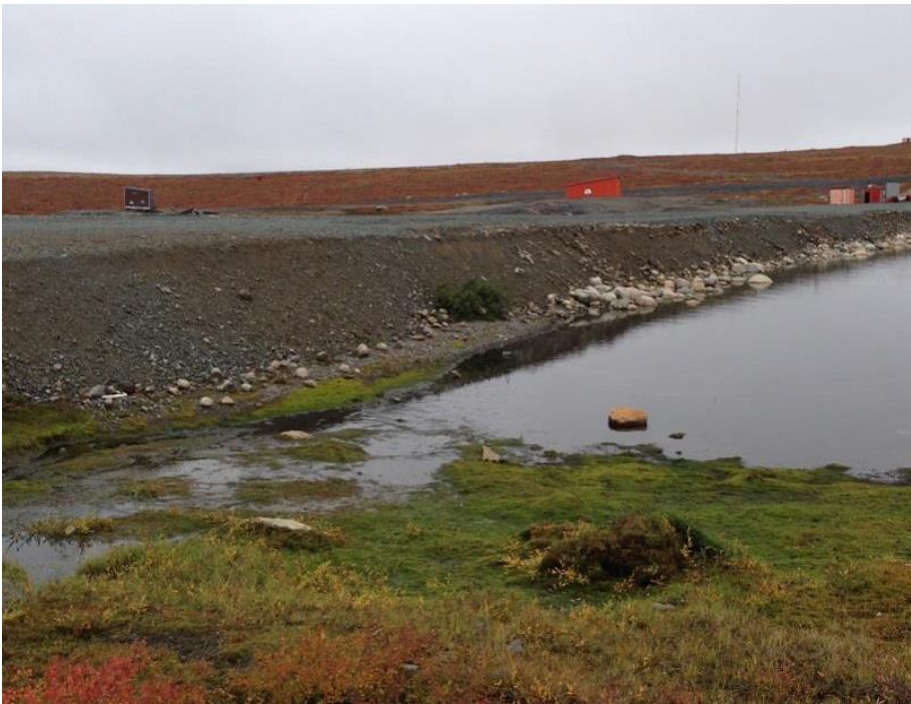
sufficiently dewatered and has no stability concerns. Geotextile and riprap was placed on the upstream face of the dam as repair. Seepage was observed discharging from the old 200 m long culvert at a rate estimated to be about 0.5 L/min. The condition of the culvert made it very difficult to accurately measure the flow. The freeboard is observed to be approximately 1.8 m.

Photo 5: Looking at repaired upstream face and crest of the Upper Sewage Dam. Note the 1.8 meter freeboard available at the time of the photo.

Both the sewage dams were repaired according to the 2014 recommendations. The current condition of the Upper Sewage Dam is in good geotechnical condition after the 2015 repairs. Periodic inspections are recommended on the buried culvert to monitor its condition and seepage rate. It appears that this culvert controls the upper lake level. If the seepage stops or further reduces, then the lake level could increase as a result. If the culvert is found to be fully collapsed or blocked and the seepage stops, then it would be recommended that the siphon pipes be reinstalled to transfer water to the lower lake. The upper pond levels is recommended to have minimum 1 m freeboard prior to operations and winterization.

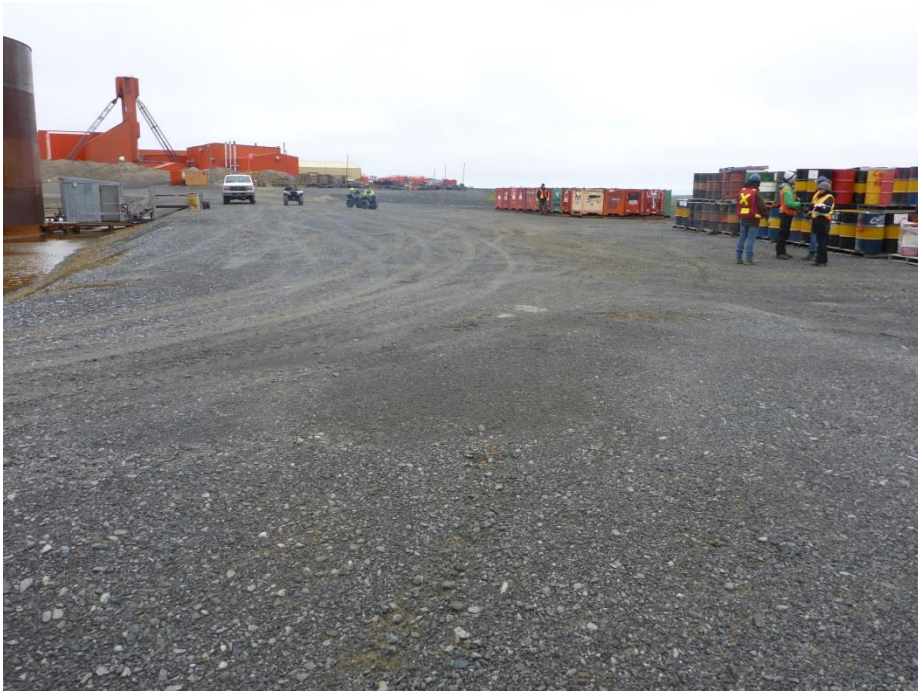
The facility is in a stable condition with no geotechnical concern. Minor ponding water was observed in the lowest point of the ditch and in one high traffic area. The berm and collection ditch are in stable condition. The downstream slopes of the facility are observed to be in stable condition without any evidence of erosion and instability. No exposed liner was observed within the facility.

Photo 6: Looking east from the back of the WOMF.

The waste oil management facility is in good geotechnical conditions. Visual checks should be done in the downstream face of the facility for erosion and within the facility for any exposed liner. Monitoring should also be done during freshet to ensure the runoff is contained within the berm and ditches.

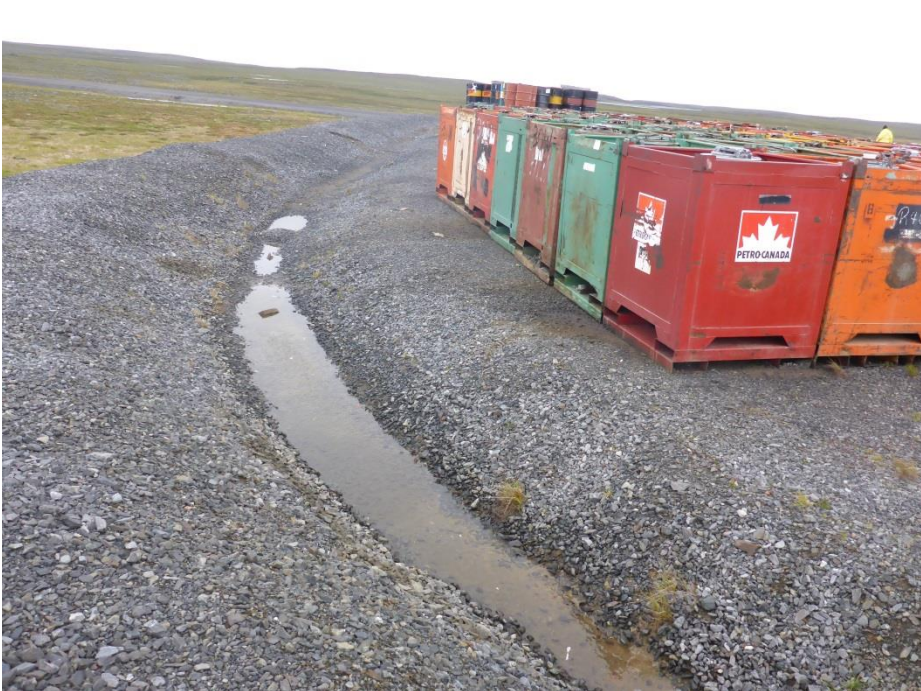
Photo 7: Looking west from the from of the front WOMF at the ditch.

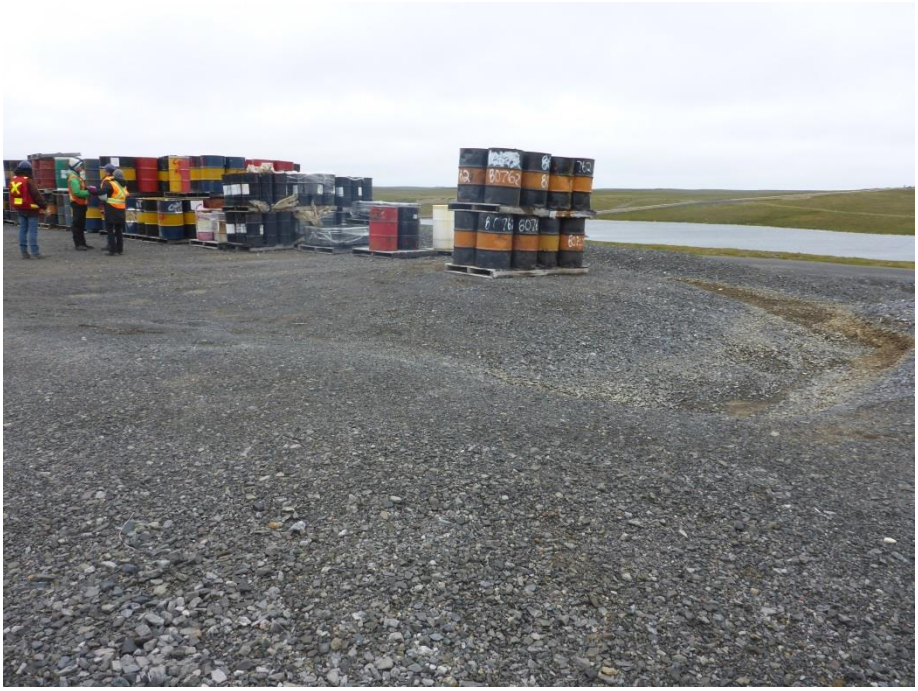
Photo 8: Looking south at the back of the WOMF and the ditch.

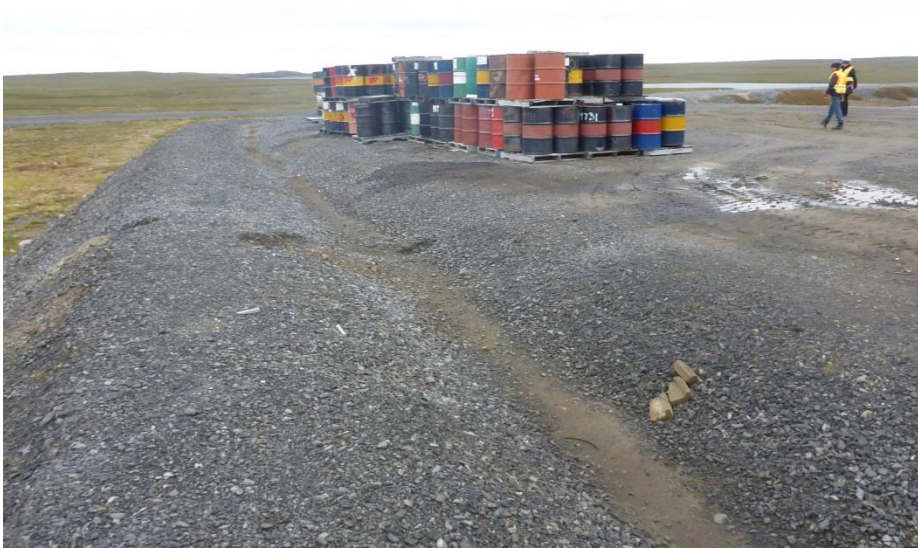
Photo 9: Looking west at the WOMF and the downstream slope.
