2016 Lupin Mine Tailings Containment Area Geotechnical Inspection

Submitted to:
Lupin Mines Incorporated

Project Number: 924-1

Date:
October 31, 2016

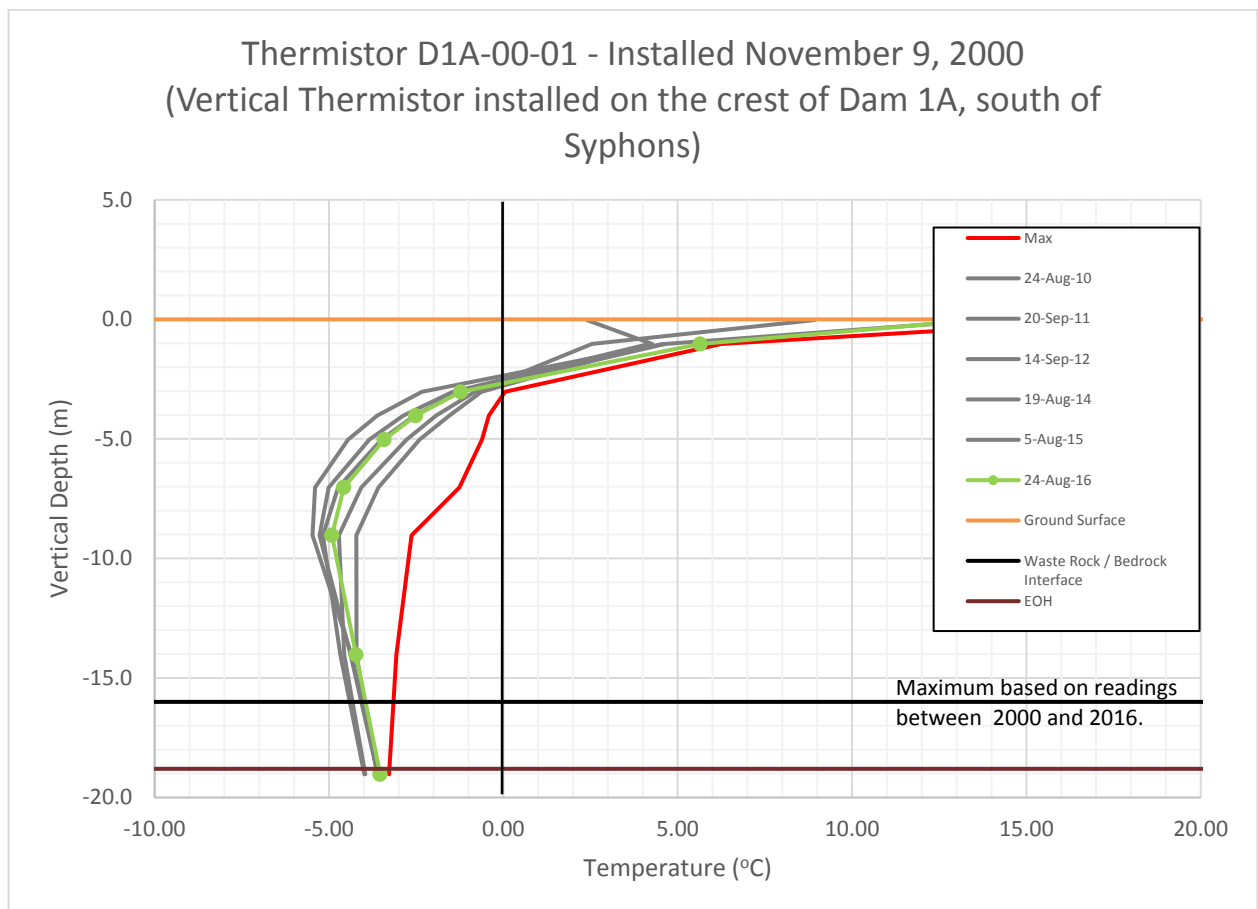
Figure 5: Thermistor Reading for D1A-00-01

For the perimeter dams, the five functional thermistors are less than 20m deep. The five thermistor readings are shown in Figures 5 to 9. The data suggests the 2016 readings are within the historical variations, taking into account annual climatic variations and time of reading. Generally, the active layer (thaw zone) ranges from 2m to 3m depth, as interpolated by the 0°C gradient line. The largest historical variation in the given data set is approximately 2.2°C (between -2.5°C and -4.7°C) in Dam 2 (D2-00-02n) at the depth of 6m.

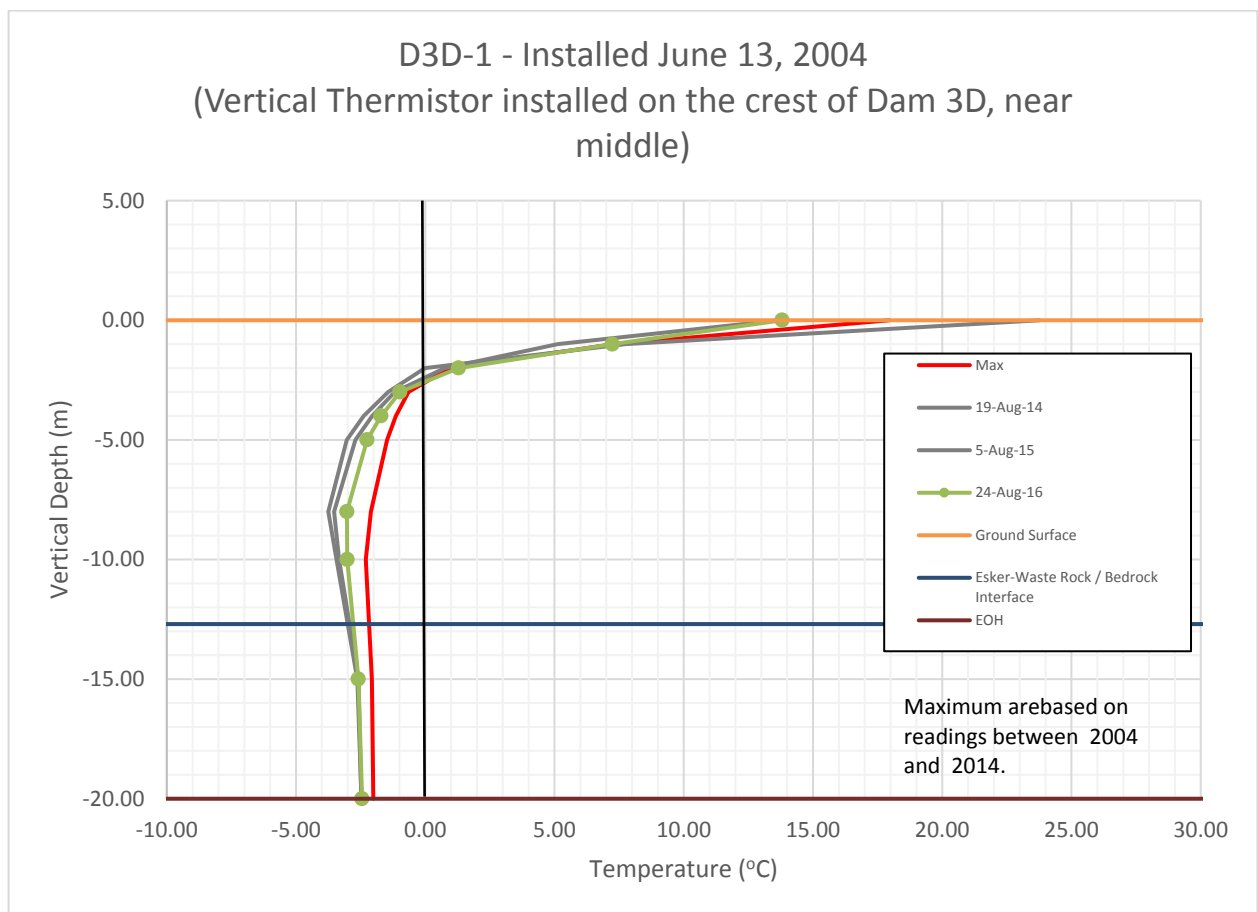
Figure 10: Thermistor Reading for D3D-1

For the internal dams, the two functional thermistors are also less than 20m deep. These were not monitored as rigorously as the ones installed in the perimeter dams, and only have recent data between 2014 and 2016. The two thermistors readings are shown in Figure 10 and Figure 11. The active layer is observed to be between 2m to 3m, as interpolated by the 0°C gradient line. The variations between the data set are less than 2°C and generally occur below the historical maximum.

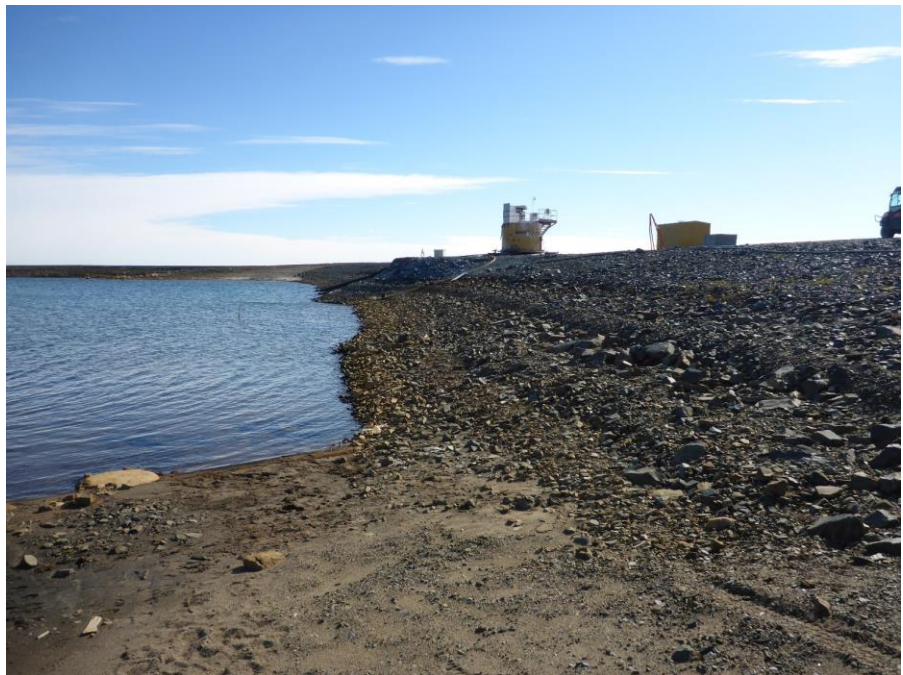
Photo 1: Looking east along the upstream slope. Note the erosion at the HWM.

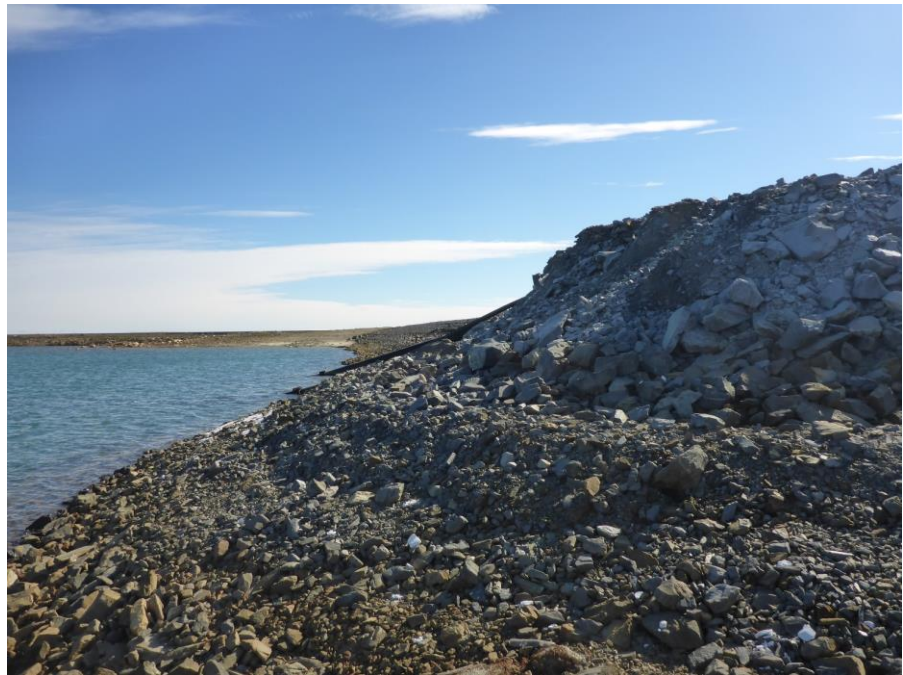
Photo 4: Looking east at the upstream slope at the over steepened work pad extension.

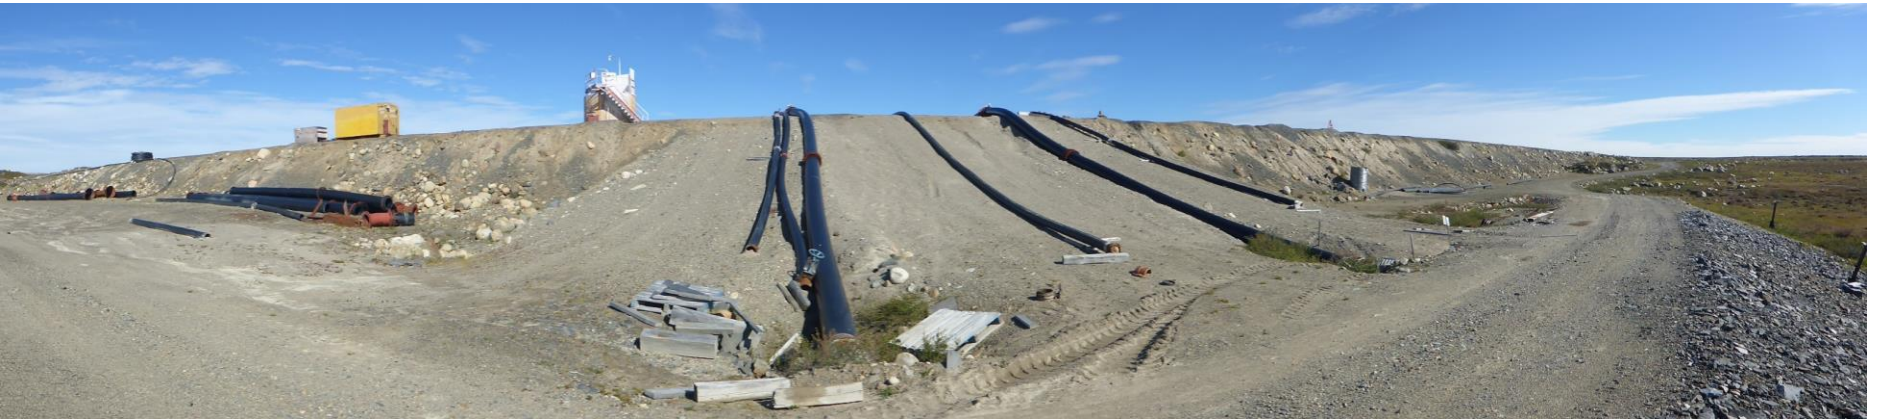
Photo 5: Panoramic view of the downstream slope at the siphon. Note the erosion gullies.

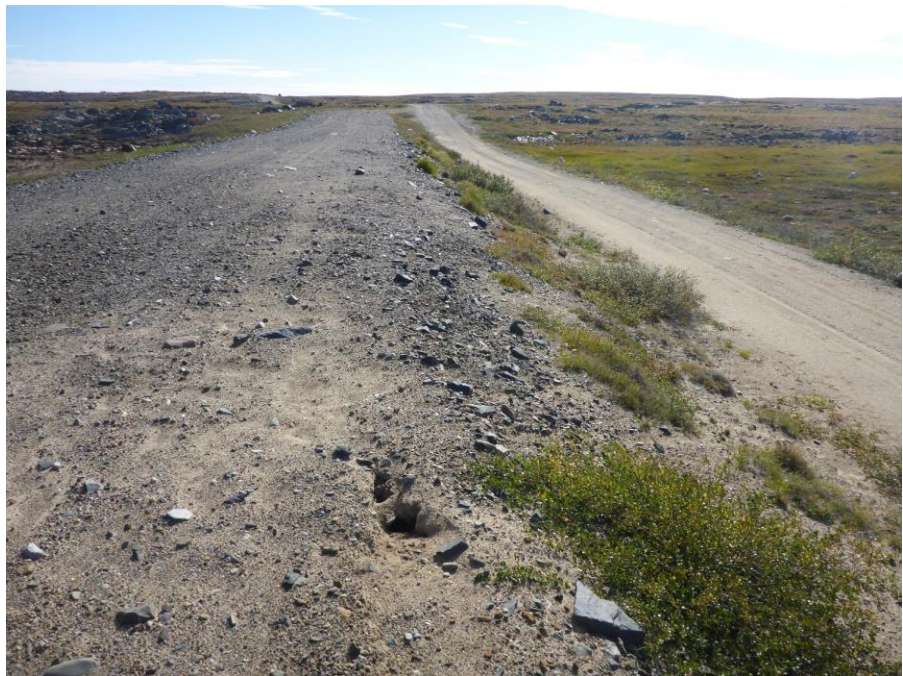
Photo 9: Looking south at the mid-point of the dam at the downstream crest. Note the animal burrow.

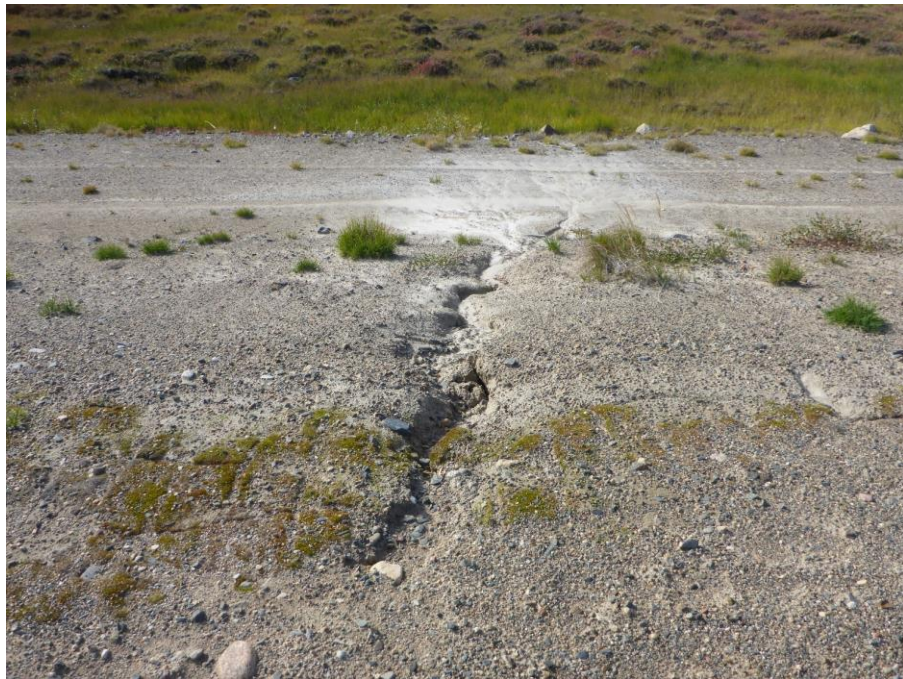
Photo 13: Looking at the erosion gully about 1/3 way past the north abutment.

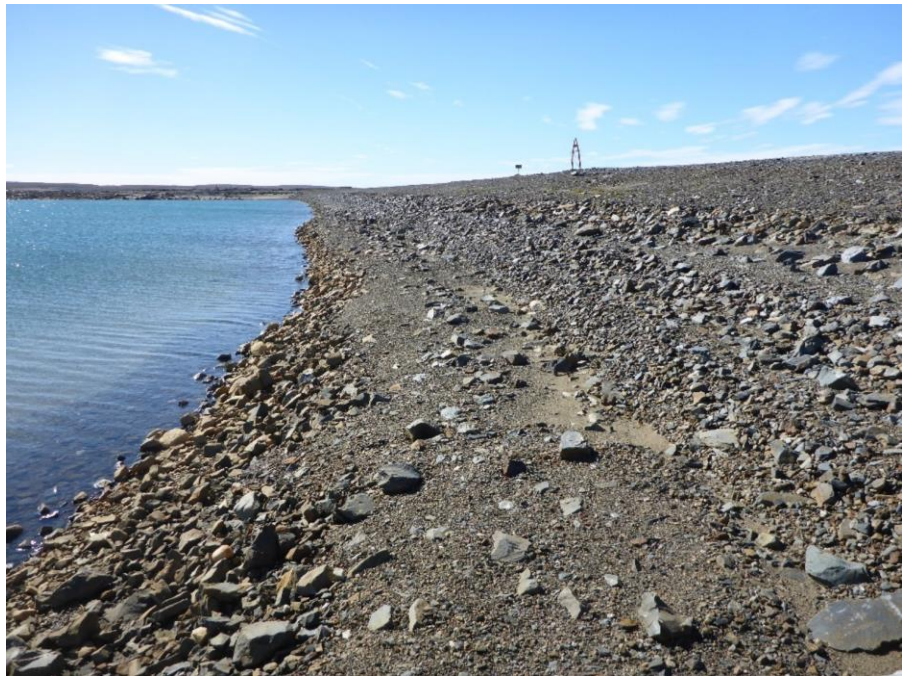
Photo 14: Looking south along the upstream slope. Note the erosion at the HWM.

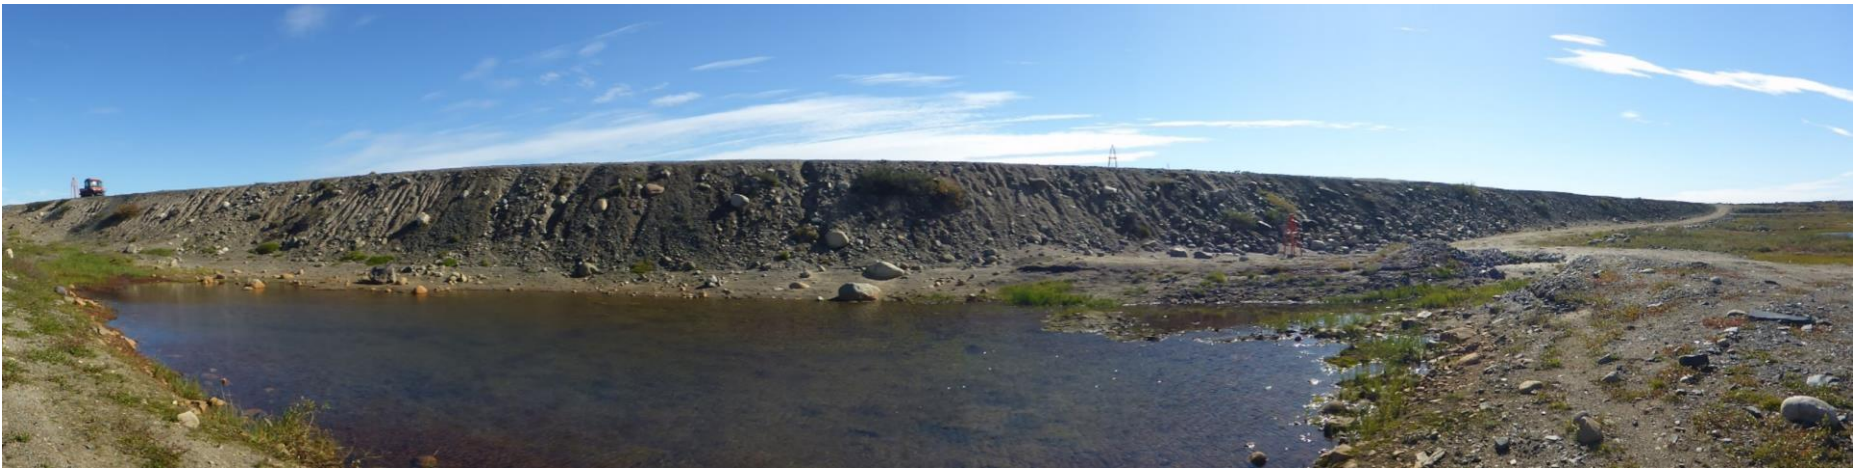
Photo 18: Panoramic view of the downstream slope at the seepage collection pond. Note the erosion gullies.

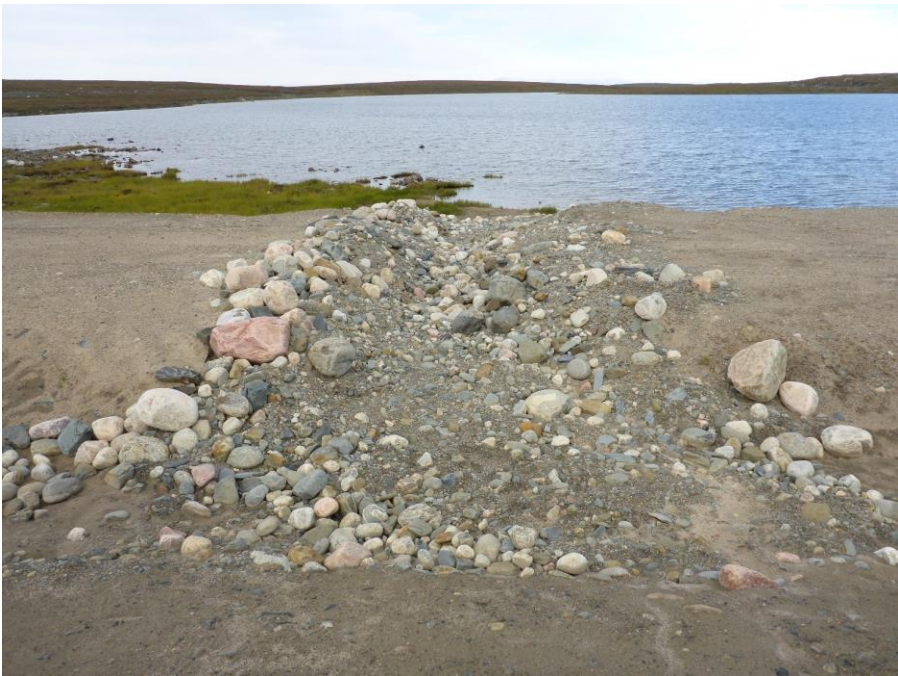
The 2015 annual inspection noted work was done to repair an erosion gully over the crest of Dam 3 (Photo 20 to 23). The repair work was done by converting the erosion gully into an armored channel to facilitate the drainage in that area. Previously this area was vulnerable to erosion due to the poor grading in the storm drain along the upstream crest of Dam 3. The 2015 repair allows the flow to bypass the problematic section of the storm drain and prevent erosion damage to Dam 3. No new erosion damage was observed in the 2016 inspection along Dam 3.

Photo 21: Looking north at the repair erosion gully with boulder armoring. Boomerang Lake is in the background.

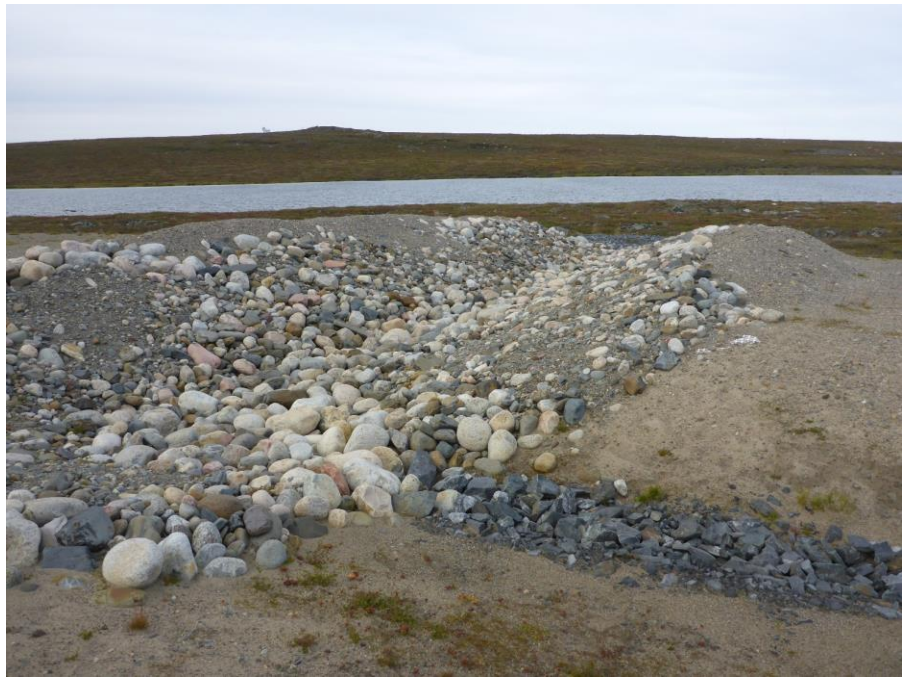
Photo 22: Looking north at the original storm drain discharge.

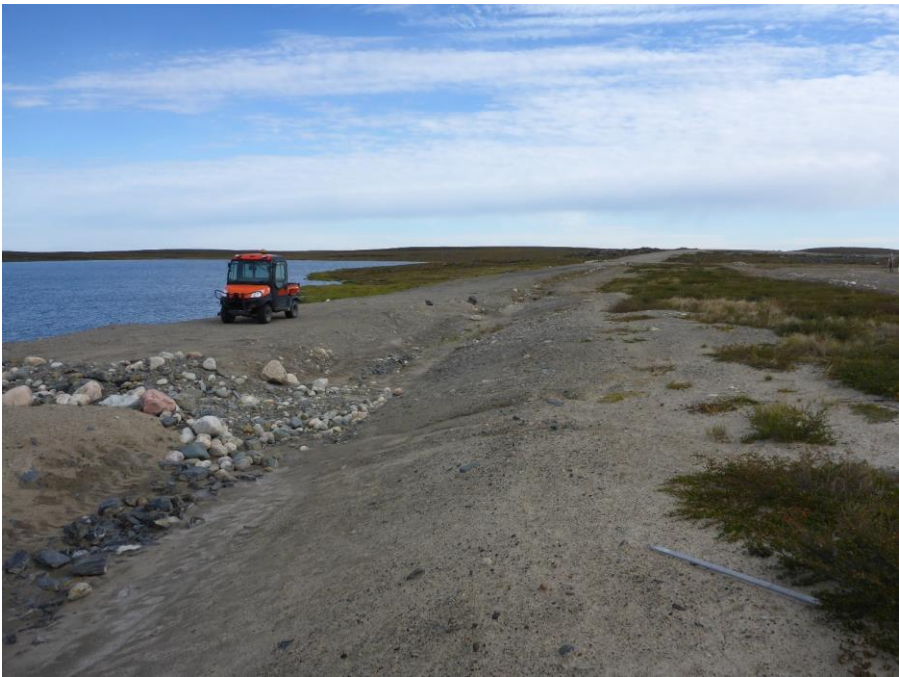
Photo 23: Looking east at the crest and storm drain, with the repaired erosion gully to the left.

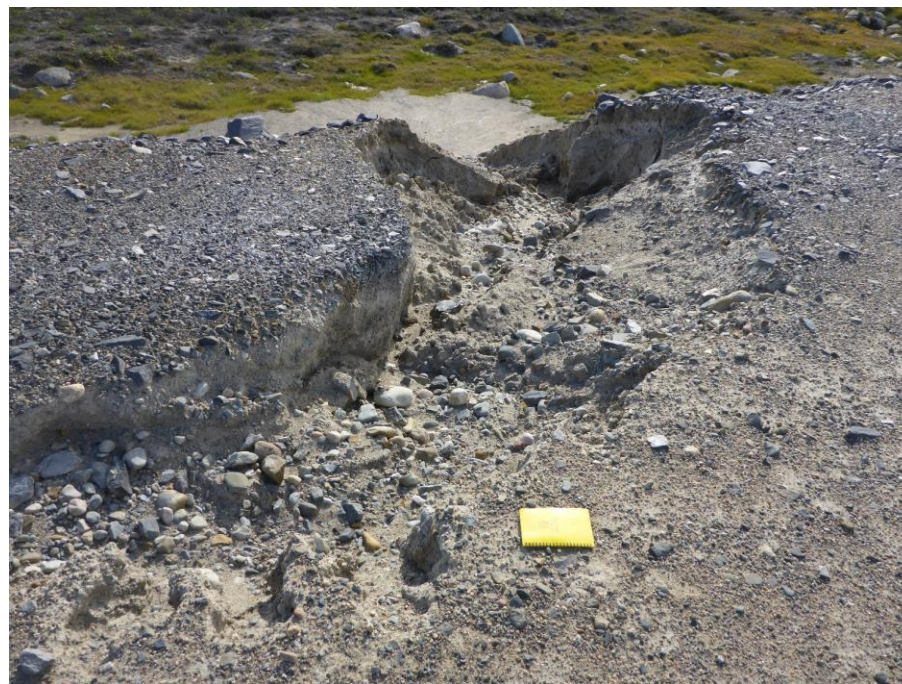
Photo 27: Looking at the erosion gully over the downstream crest at the east abutment

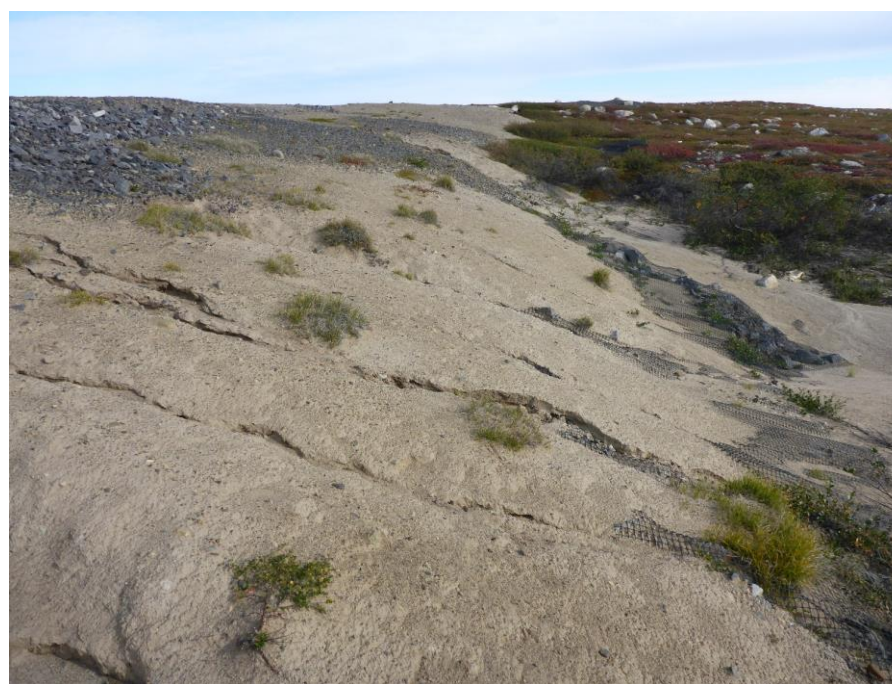
Photo 28: Looking east at the downstream slope at the east abutment. Note the erosion gullies and exposed geogrid.

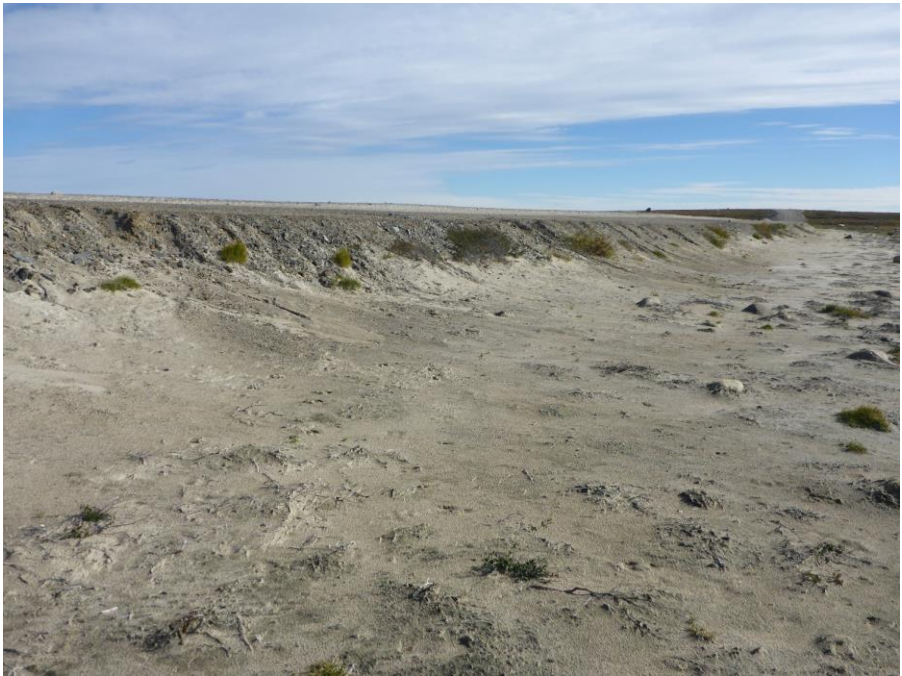
Photo 34: Looking at the downstream slope from the north abutment. Note the erosion gullies.

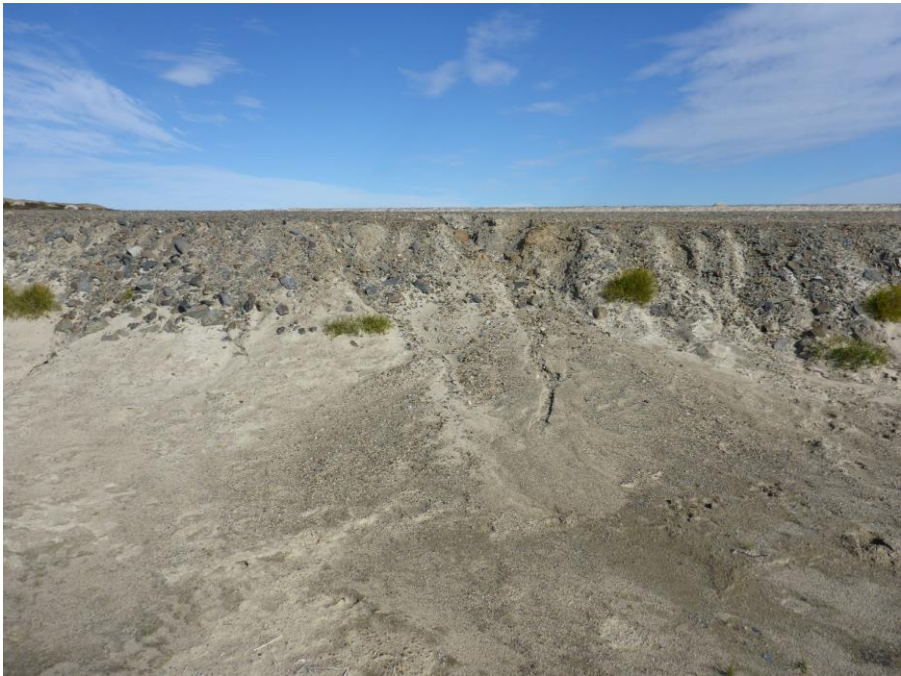
Photo 35: Close up view of the erosion gullies in the downstream slope at the mid-point of the dam.

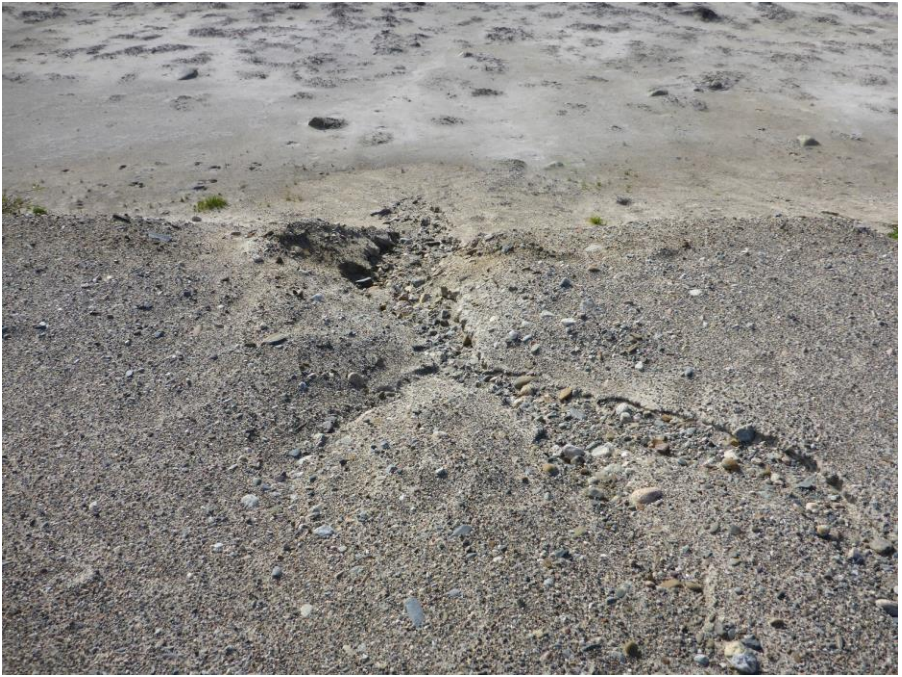
Photo 36: Looking south at the erosion gully over the downstream crest at the mid-point of the dam.

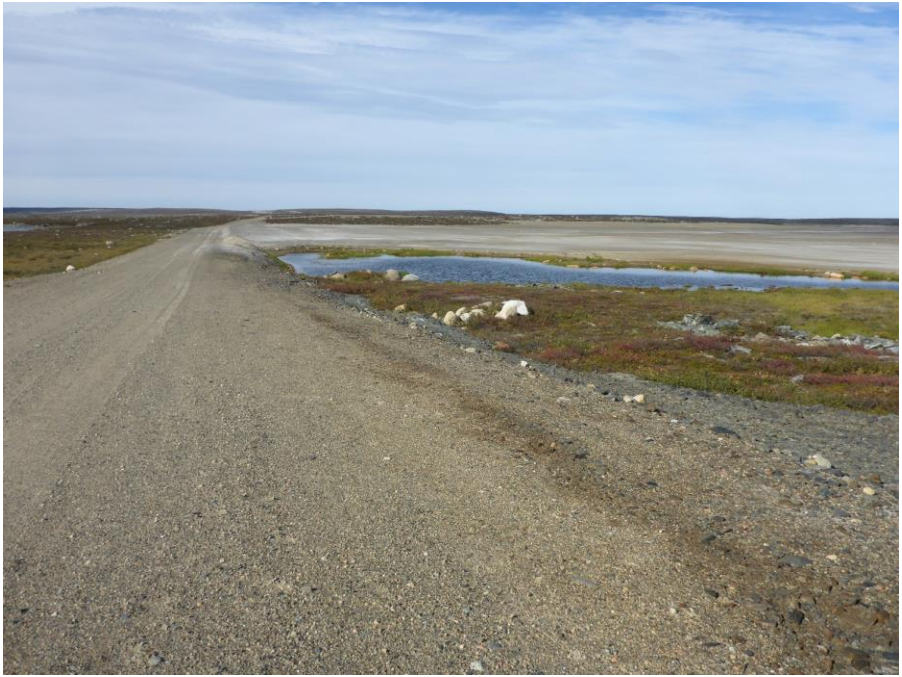
Photo 37: Looking north from the south abutment at the crest with the Cell 3 cover in the background. Note the ponding water near the south abutment.

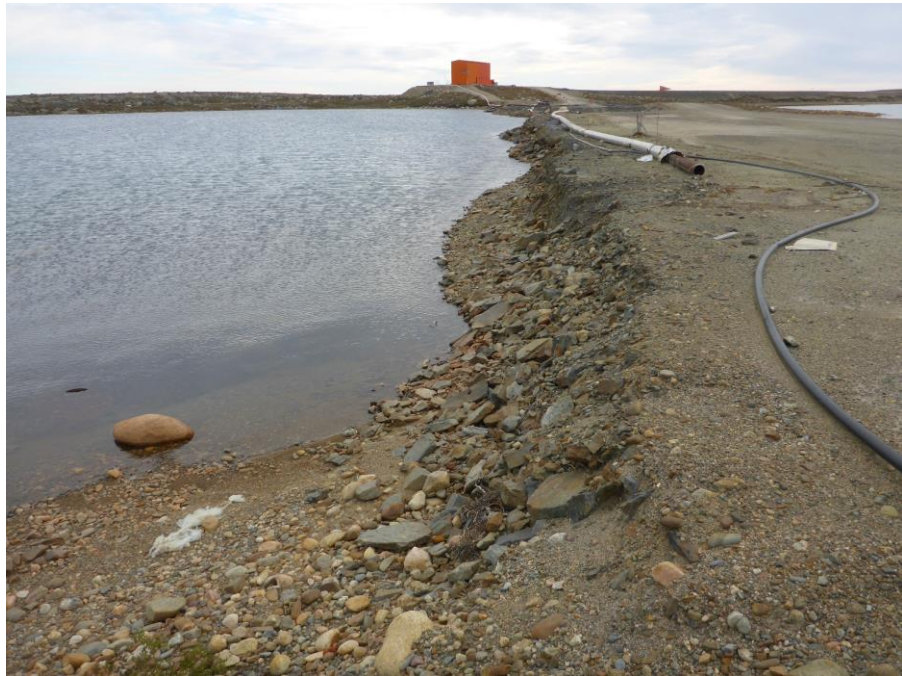
Photo 43: Looking south at the upstream slope (facing Pond 1). Note the erosion at the HWM.

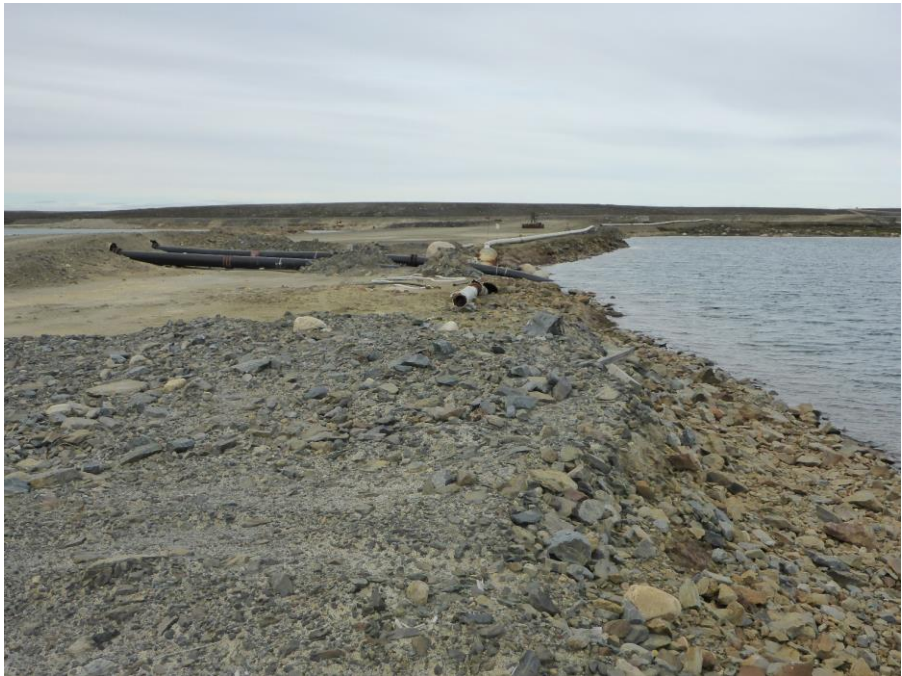
Photo 44: Looking north at the upstream slope (facing Pond 1). Note the erosion at the HWM.

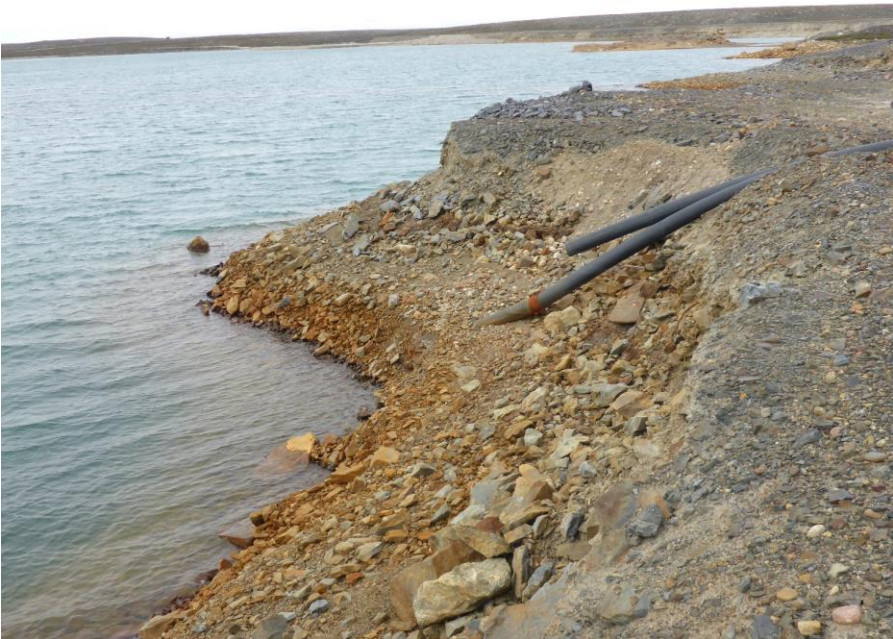
Photo 47: Close up looking north at the downstream slope (facing Pond 2). Note the undercut has caused sloughing and reduce crest width.

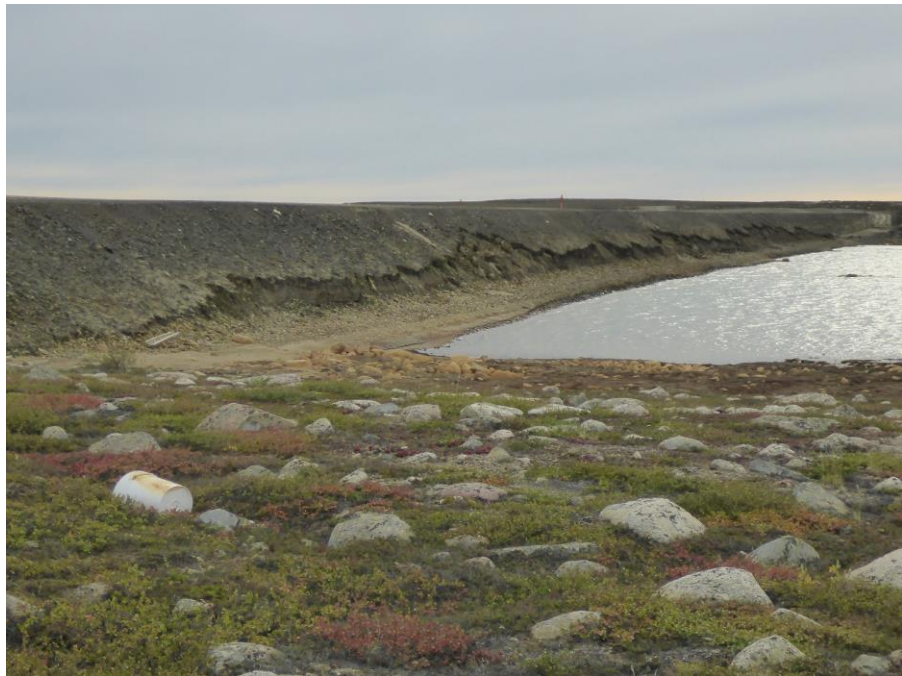
Dam K has experienced considerable undercutting at the toe from Pond 2 wave action (Photo 48 to 52). The toe was previously submerged due to high water in Pond 2, and it is now exposed allowing inspection. The erosion has not yet migrated upwards to develop sloughing and cracks. The eroded toe section is currently less susceptible to erosion due to lowered water level. This area should be closely monitored for physical change and rising water level, and repair is recommended (see Table 3).

Photo 48: Looking south at the downstream slope (facing Pond 2) from north abutment of Dam J. Note the undercut erosion at the HWM.

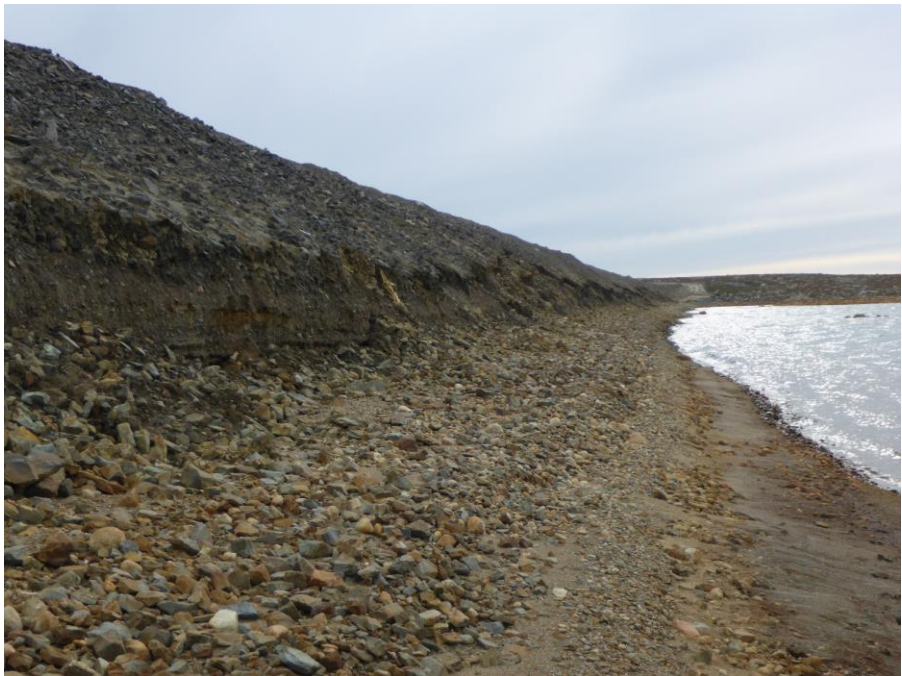
Photo 49: Looking west at the downstream slope from the toe of the dam. Note the near vertical eroded slope.

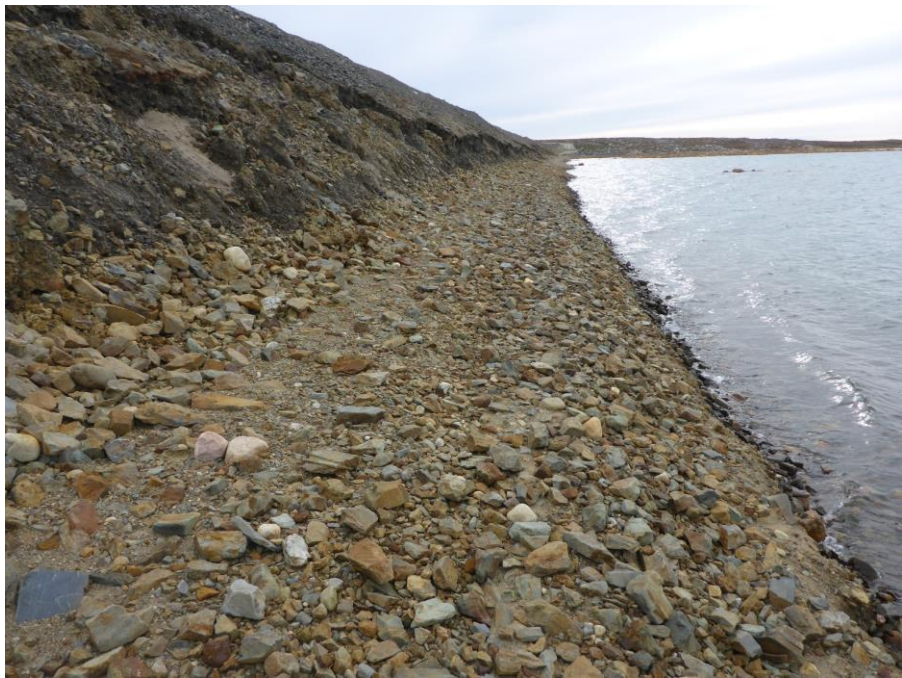
Photo 52: Close up look at the sloughing near the mid-point of the dam from the toe.

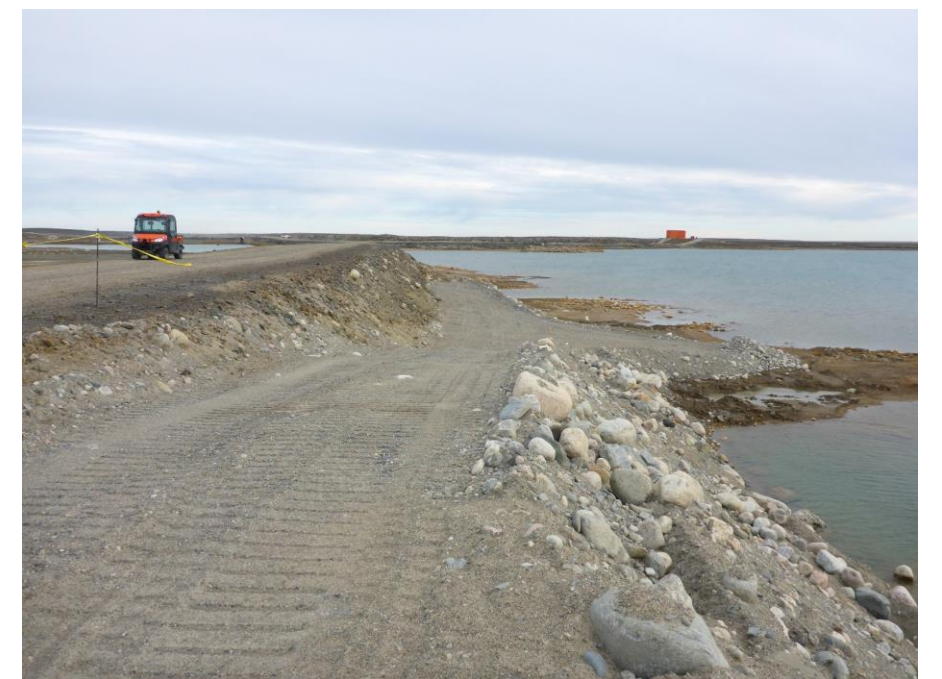
The maintenance and repair of the tension cracks were near completion in Dam M at the time of the inspection (Photo 60 and 65). With the water level in Pond 2 lowered, LMI had started the repairs to the compromised sections of the dam. The repair was completed by constructing buttresses in front of the compromised areas, and sealing the cracks to limit infiltration into the core of the dam. The buttress was to be built up to 2/3 height of the dam in lifts of 1m with compacted esker sand and gravel at a slope of approximately 2H:1V. Compaction of the buttress was done with vehicle traffic. The toe of the buttress was armored with large boulders as riprap protection. The tension cracks on the crest were removed by excavation to 1m and replaced with compacted sand and gravel to limit infiltration. The western abutment is approximately 100m long, measured from Dam N abutment, and the eastern abutment is approximately 150m long, measured from Dam J abutment. The repairs are considered completed to mitigate the risks identified in 2015. Due to the observation of the poorly graded fine sand in 2016, Norwest recommended the western and eastern buttress to be connected to form a continuous buttress to protect the exposed sand in the toe before the end of the construction season. This was communicated to and agreed by Mr. Vokey.

Photo 60: Looking southeast at the start of the western buttress from the Dam N abutment.

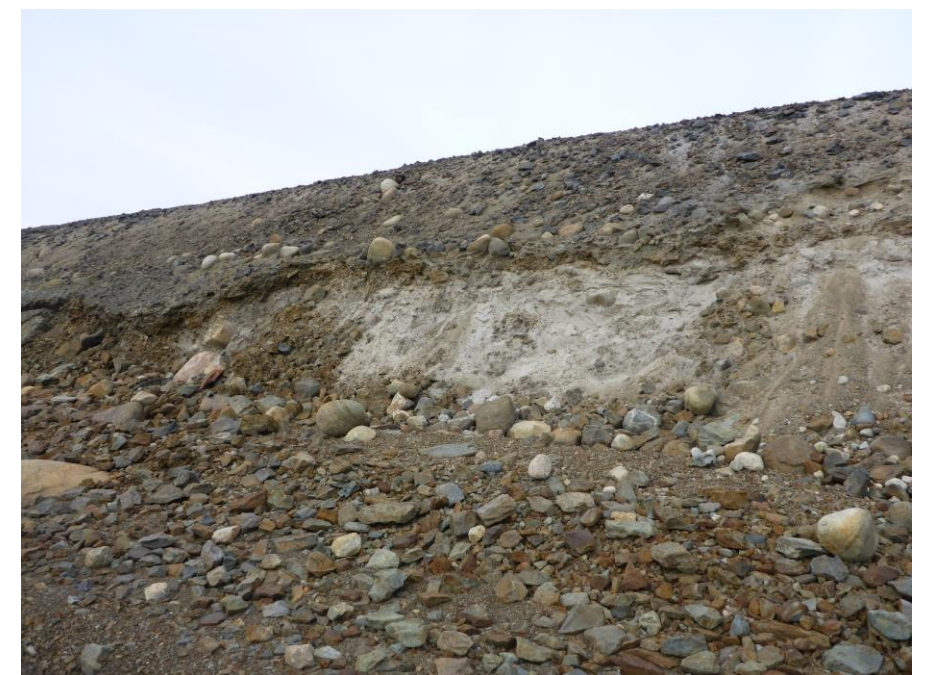
toe undercuts and the sloughed material. The inspection revealed that an approximately 20m section of dam, near the mid-point, was constructed over loose poorly graded fine sand (Photo 63 and 64). This sand can be highly susceptible to erosion and would further compromise the integrity of the dam if eroded. Significant undercuts and near vertical slopes were also found along the toe. This observation was communicated to Mr. Vokey on site.

Photo 63: Looking at the undercut and sloughed downstream toe near the mid-point of the dam. Note the exposed loose poorly graded fine sand foundation.

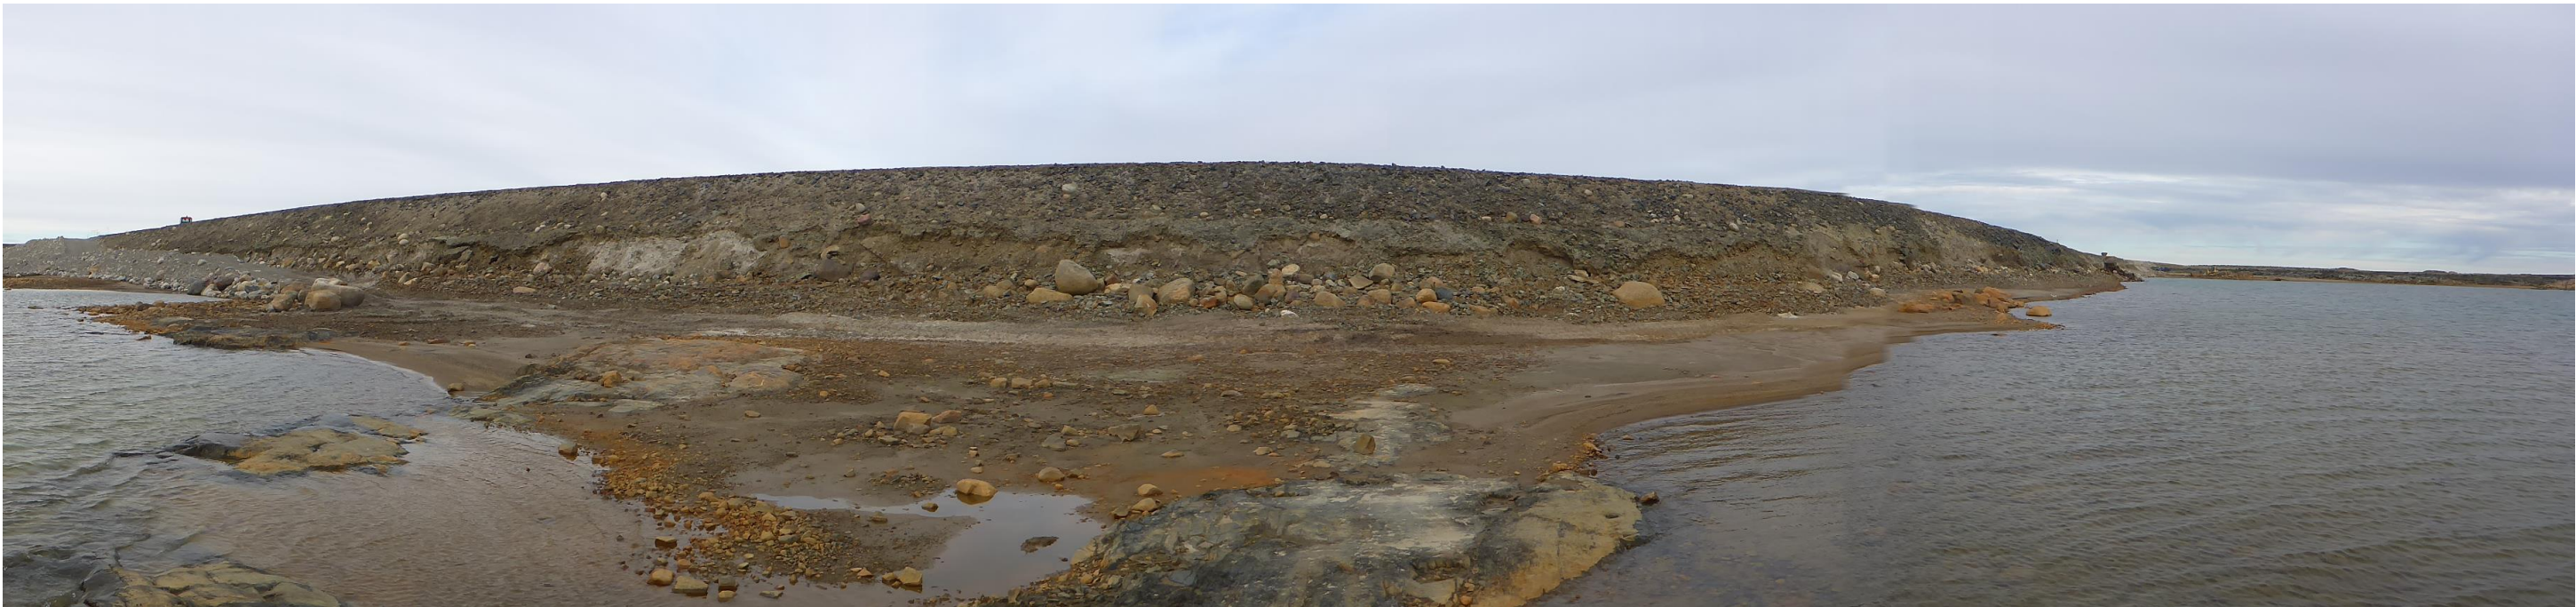
Photo 64: Panoramic view of the downstream slope from the mid-point of the dam. Note the undercut erosion and sloughing material. The loose fine sand foundation can be seen beyond the western buttress at the left.

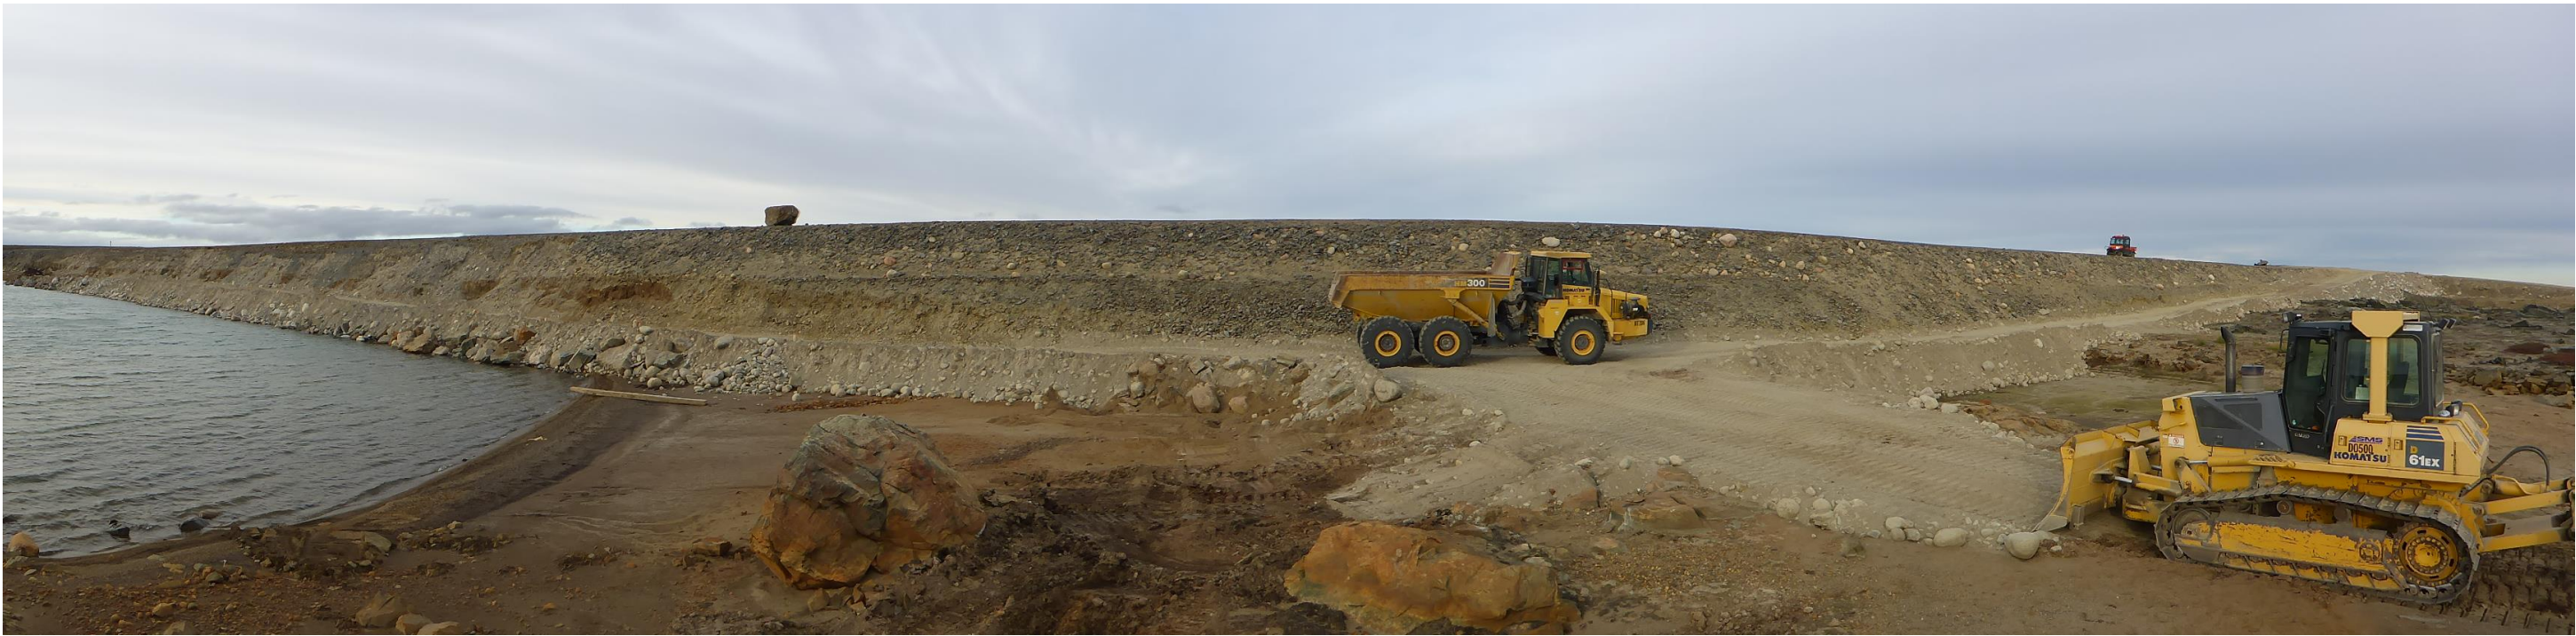
Photo 65: Panoramic view of the eastern buttress construction near the Dam J abutment.

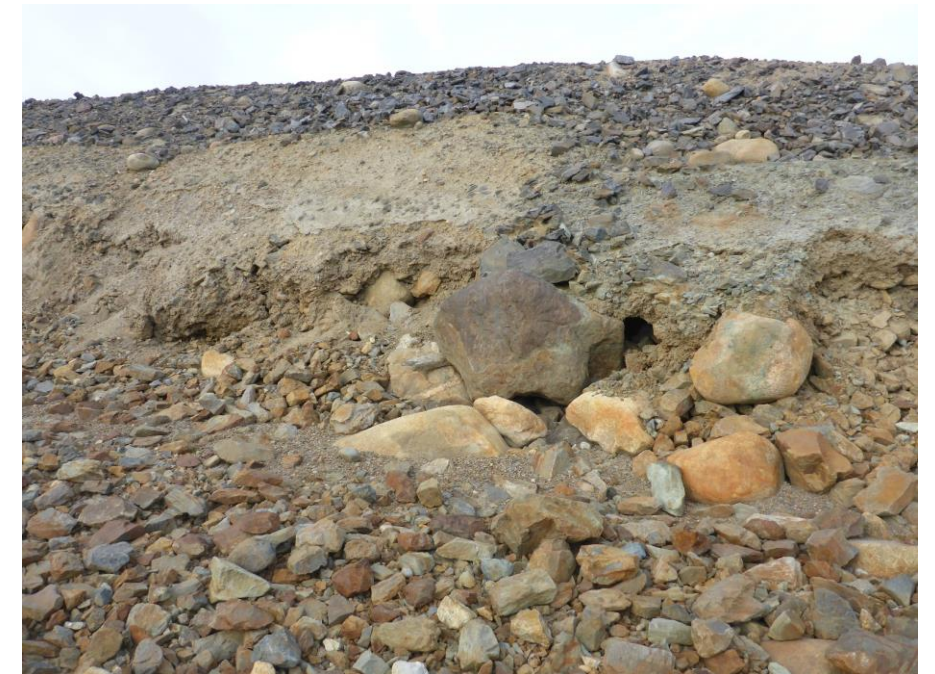
Photo 68: The significant undercut in the downstream slope at 1/3 way down from the Dam J abutment.
