2016 Lupin Mine Tailings Containment Area Geotechnical Inspection

Submitted to:
Lupin Mines Incorporated

Project Number: 924-1

Date:
October 31, 2016

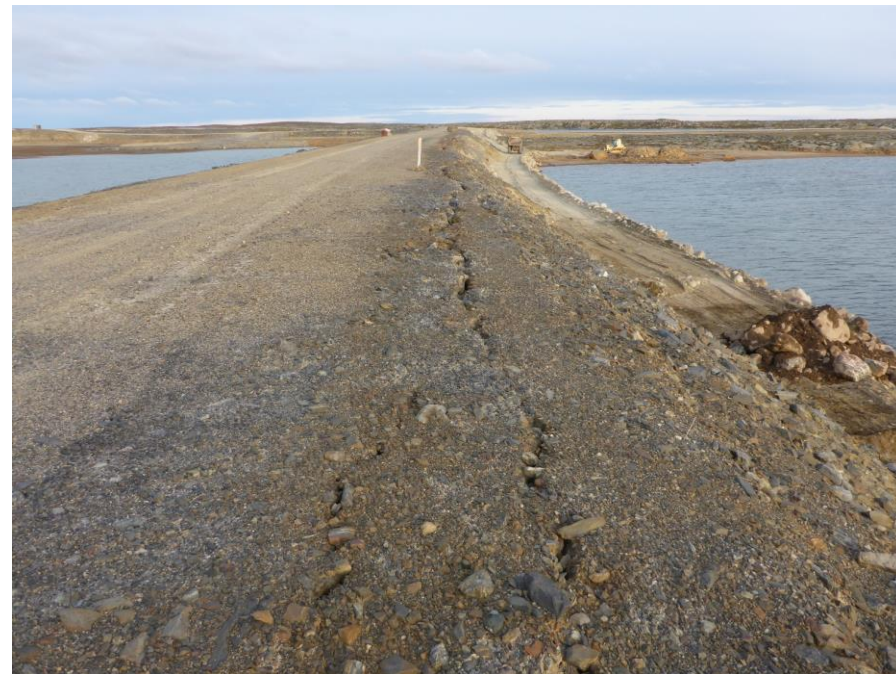
Photo 70: Looking southeast at cracks along the downstream crest near Dam J abutment, above the eastern buttress.

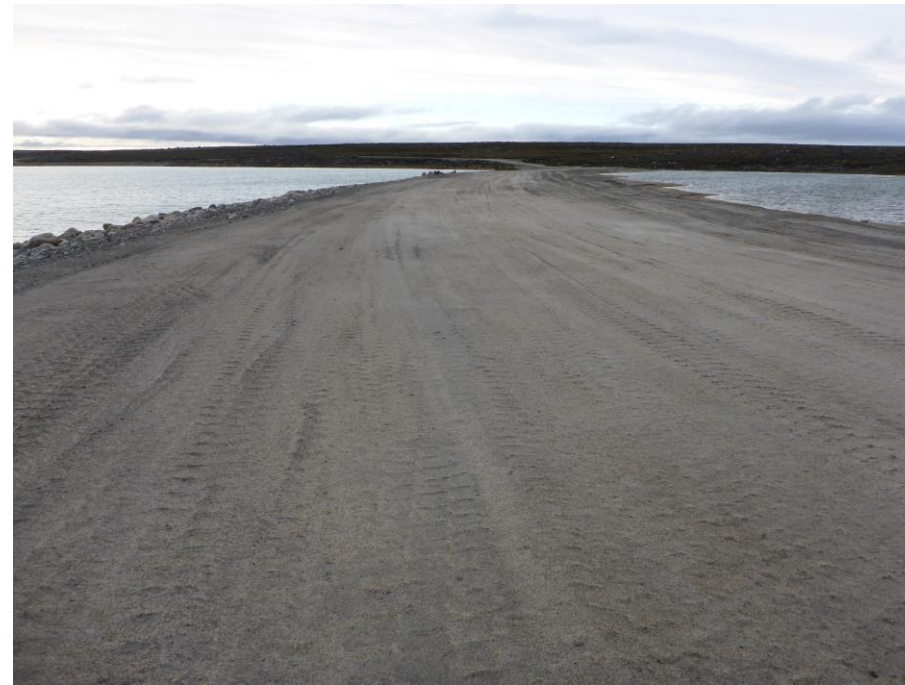
Photo 72: Looking northwest at the crest toward the north abutment. Note the water behind the dam (right) is approximately 0.5m below the crest.

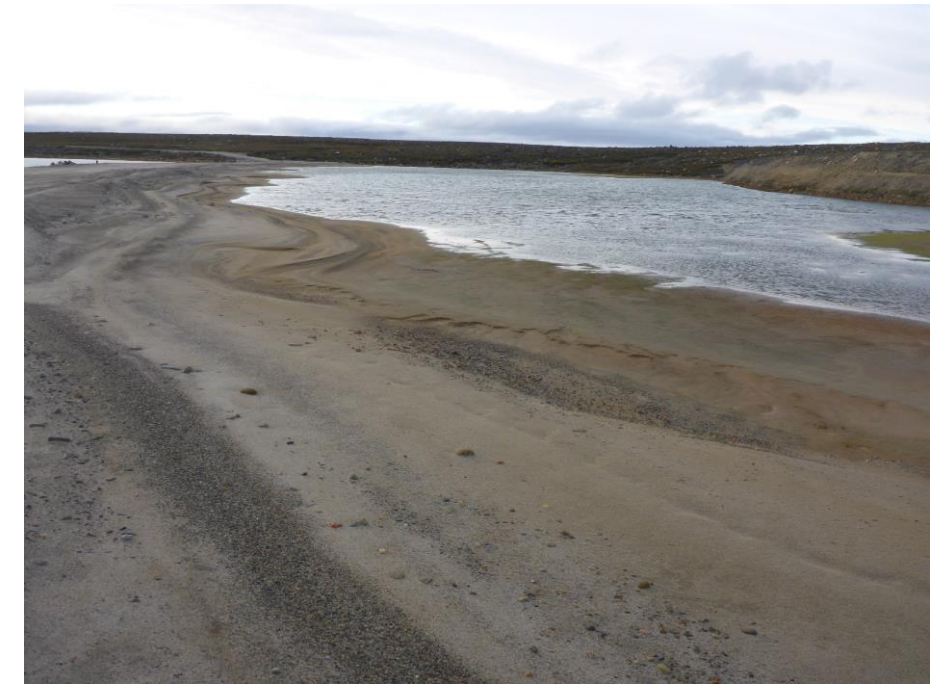
The lowered Pond 2 water level allowed inspection of Dam N, which was inaccessible in 2015. The dam was observed to be in stable condition, but with only 0.5m freeboard between it and Pond 2 (Photo 73). This was communicated with LMI site personnel, and the need to increase the freeboard to 1m to meet water license requirement. Dam N and its contents were submerged in previous years, which did not appear to have had any adverse impact on water quality or geotechnical stability. The reduced freeboard does not create any geotechnical and environmental concerns as Dam N and its contents are contained within Pond 2.

Photo 73: Looking northwest at the upstream slope.

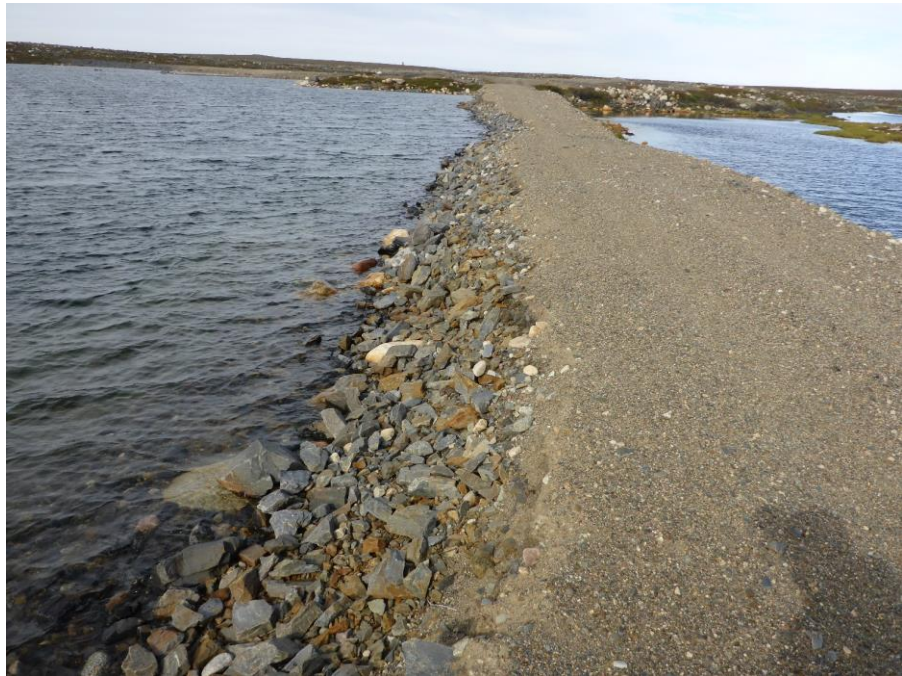
The divider dykes at the east end of Cell 4 are in poor geotechnical condition. Signs of erosion, cracks, and sloughing were noted on the upstream and downstream sides of both dykes (Photo 75 to 80). Deformations have created an uneven crest and reduced its width to around 2m in some areas. The south divider dyke has experienced sufficient sloughing to create a low spot with a freeboard of 0.4m. The slopes of the dykes vary between 2H:1V to 1H:1V in some areas.

Photo 75: Looking north at the upstream slope of the South Divider Dyke. Note the erosion at the HWM.

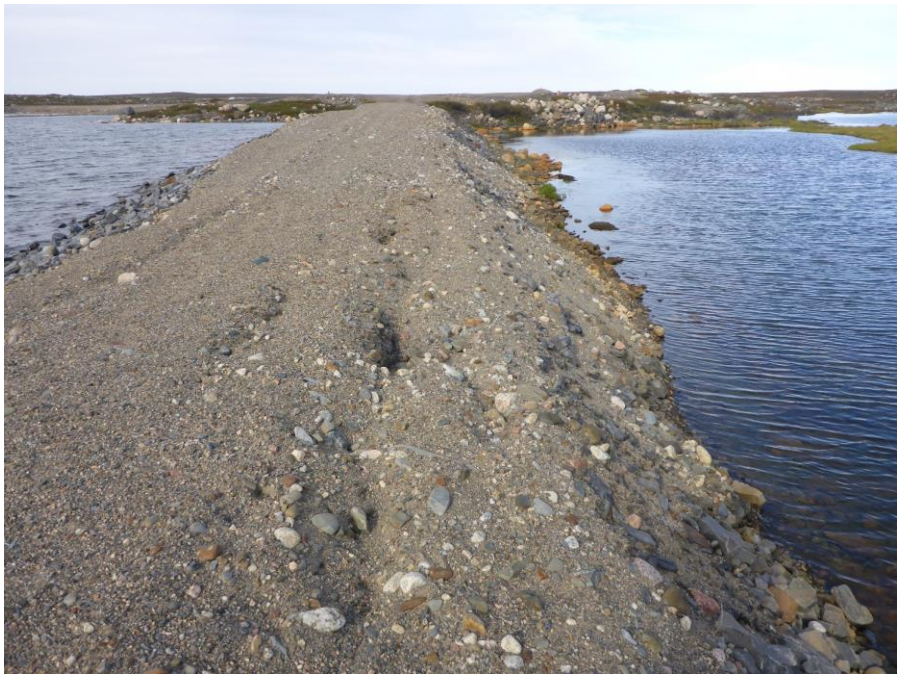
Photo 76: Looking north at the downstream slope of the South Divider Dyke. Note the sloughing and cracks.

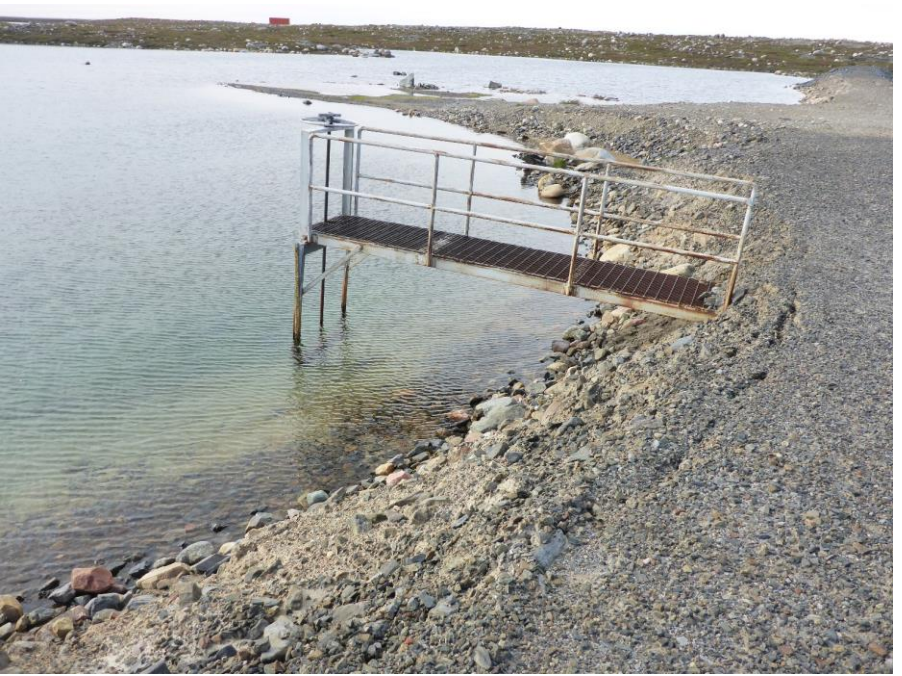
Photo 77: Looking south at the upstream slope and value control at the North Divider Dyke.

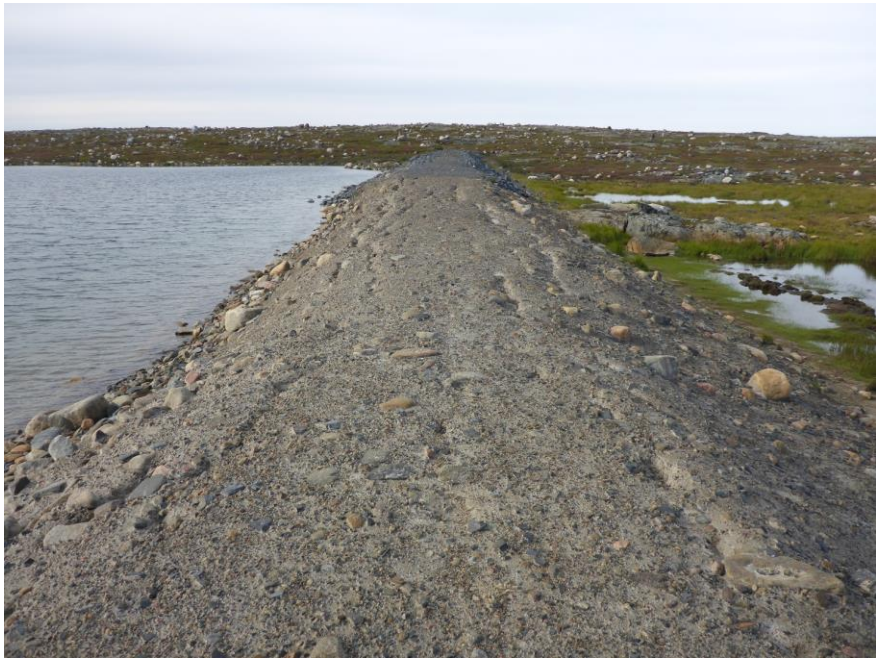
Photo 79: Looking north from value control at the crest of the North Divider Dyke. Note the sloughing, cracks and reduced width of the crest.

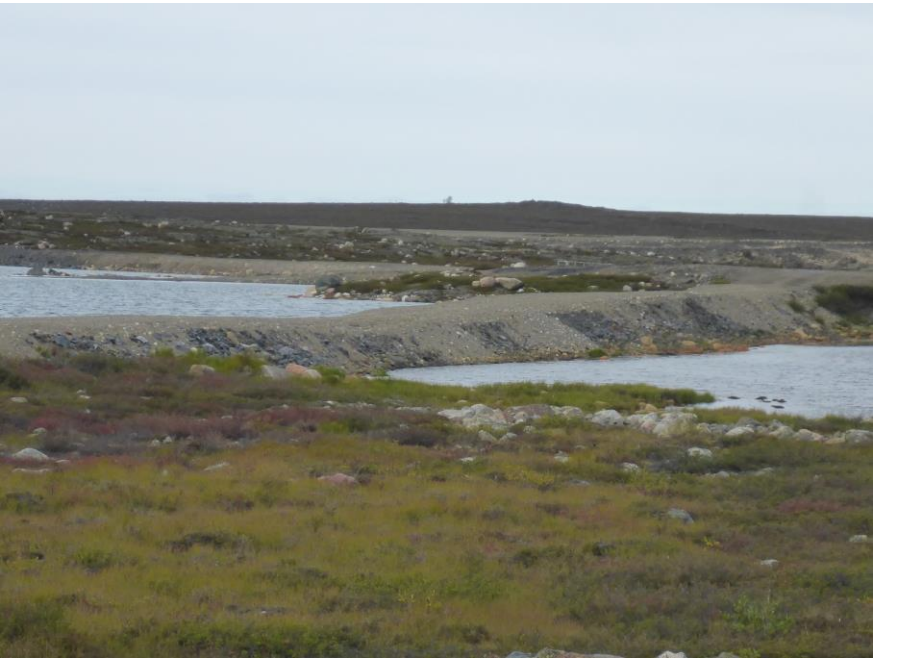
Photo 80: Looking west at the downstream slope of the South Divider Dyke. Note the low spot in the middle of the dyke.
