## LUPIN MINES INC.

### 2017 DAM SAFETY REVIEW

LMI	Lupin Mine Incorporated		
	2017 Dam Safety Inspection		
Site Inspection Photograph Log for Dam 1A and 1B			
NORWEST	PN: 924-3	FIGURE 1	REV. A

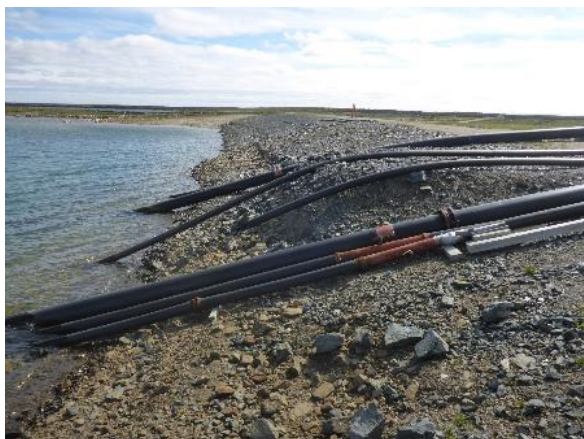
Photo 1: Looking east along the Dam 1A upstream slope. Note the erosion at the HWM.

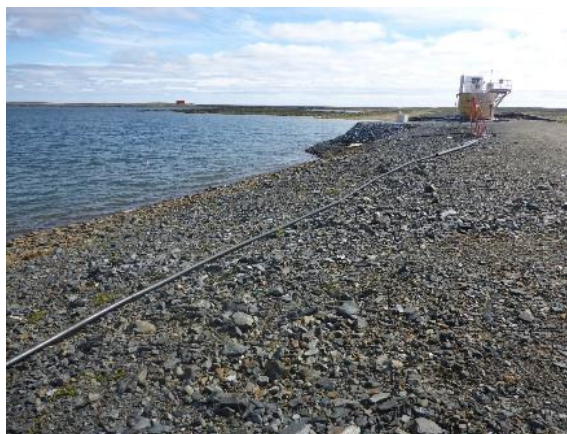
Photo 2: Looking east along the Dam 1A crest. Note the water treatment equipment and work pad extending over the upstream slope

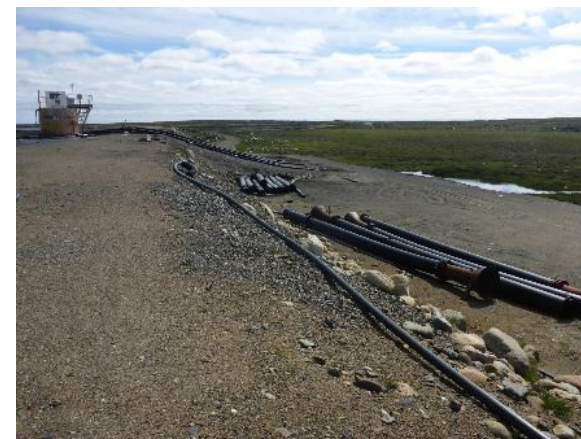
Photo 3: Looking east along the Dam 1A downstream slope. Note discharge siphons.

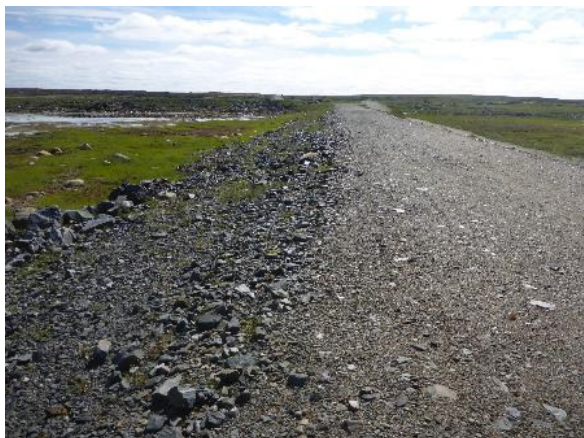
Photo 4: Looking south along the Dam 1B upstream slope. Note there is no adjacent water.

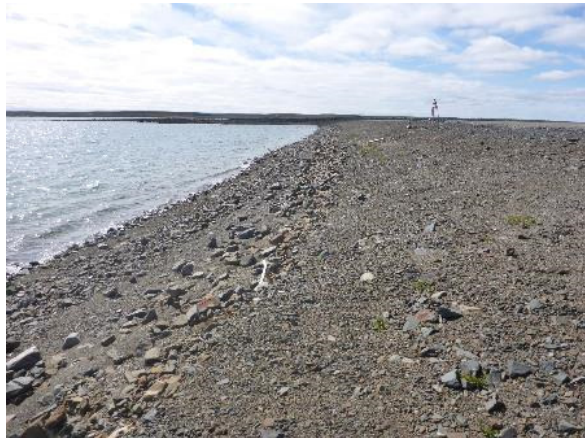
Photo 9: Looking south along the Dam 2 upstream slope. Note the erosion at the HWM.

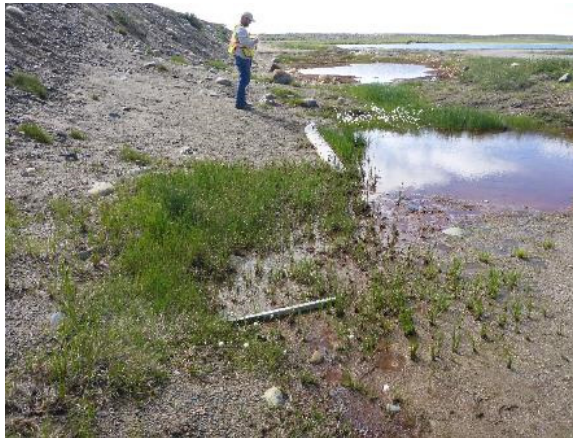
Photo 10: Looking south at the Dam 2 seepage collection pond at northern buttress.

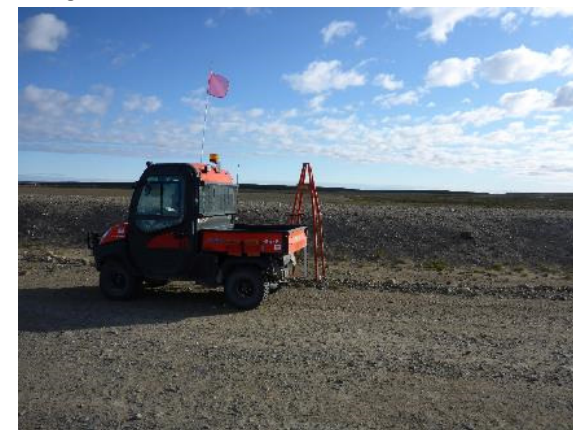
Photo 17: Looking east at the Dam 3D crest from thermistor D3D-1, with the Cell 1 cover to the right and mine rock buttress to the left.

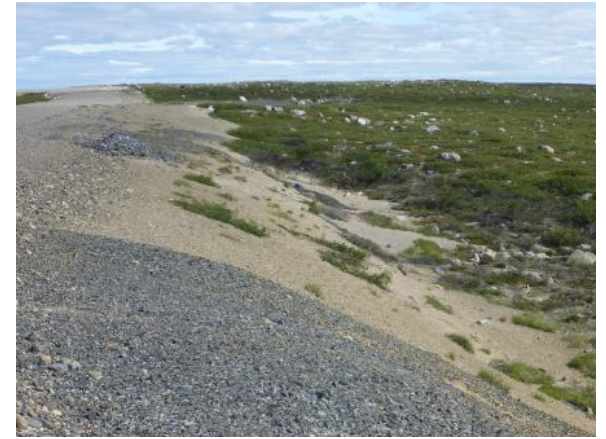
Photo 20: Looking east at the downstream slope from the east abutment

OBSERVED FEATURES	YES	NO	LOCATION	PHOTO #	COMMENTS / NOTES
Signs of phreatic surface / seepage		x			
Areas of seepage turbid		x			
Erosion		x			
Evidence of sloughing / sliding		x			
Evidence of cracking		x			
Deformation or geotechnical concern		x			
Instrumentation		x			
Vegetation		x			
Other noteworthy conditions	x		east abutment	20	historical exposed geogrid

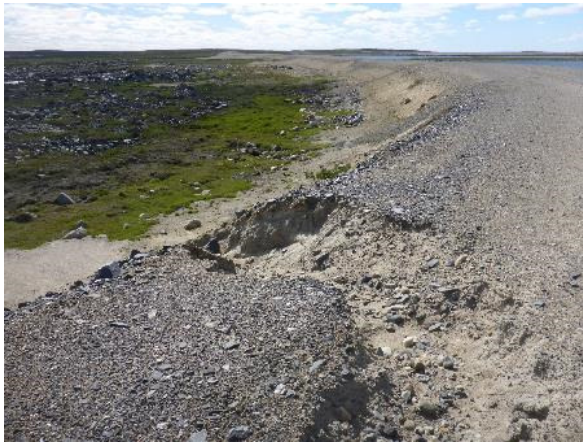
Photo 21: Looking at the erosion gully over the downstream crest at the east abutment

OBSERVED FEATURES	YES	NO	LOCATION	PHOTO #	COMMENTS / NOTES
Signs of phreatic surface / seepage		x			
Areas of seepage turbid		x			
Erosion	x		downstream slope	21	erosion gullies
Evidence of sloughing / sliding		x			
Evidence of cracking		x			
Deformation or geotechnical concern		x			
Instrumentation		x			
Vegetation		x			
Non-uniform slope		x			
Other noteworthy conditions		x

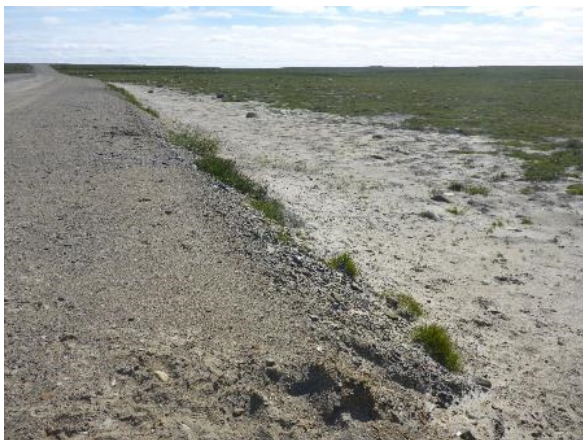
Photo 24: Looking south from the Dam 6 north abutment at the crest and downstream toe. Note the erosion at the bottom of the photo.

OBSERVED FEATURES	YES	NO	LOCATION	PHOTO #	COMMENTS / NOTES
Signs of phreatic surface / seepage		x			
Areas of seepage turbid		x			
Erosion	x		downstream slope	24	erosion gullies
Evidence of sloughing / sliding		x			
Evidence of cracking		x			
Deformation or geotechnical concern		x			
Instrumentation		x			
Vegetation		x			
Non-uniform slope		x			
Other noteworthy conditions		x

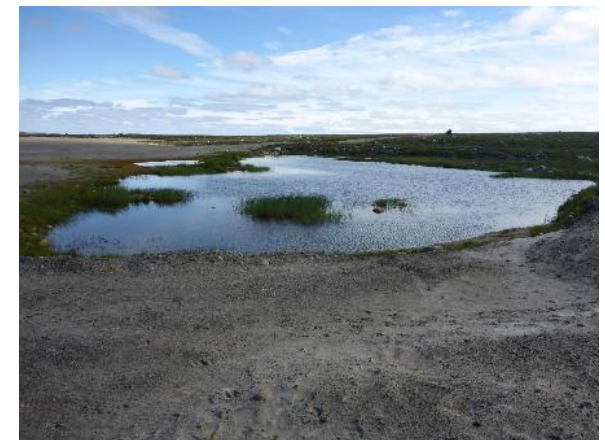
Photo 26: Natural ponding at the Dam 6 south abutment.

OBSERVED FEATURES	YES	NO	LOCATION	PHOTO #	COMMENTS / NOTES
Signs of phreatic surface / seepage		x			
Areas of seepage turbid		x			
Erosion		x			
Evidence of sloughing / sliding		x			
Evidence of cracking		x			
Deformation or geotechnical concern		x			
Instrumentation		x			
Vegetation		x			
Other noteworthy conditions	x		east abutment	26	ponding water in natural low.

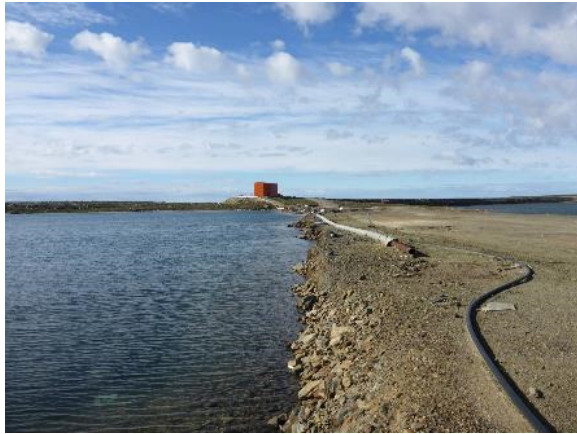
Photo 27: Looking south at the Dam J upstream slope (facing Pond 1). Note the erosion at the HWM.

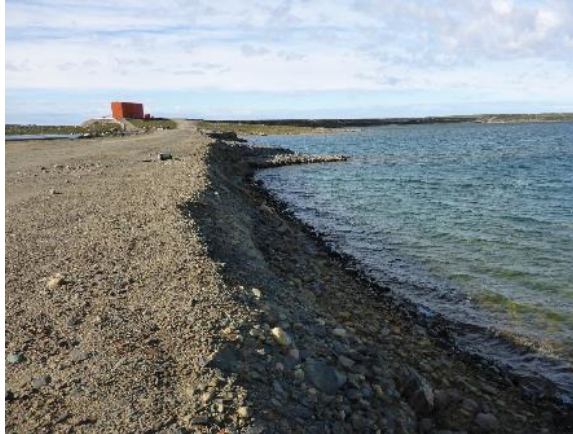
Photo 28: Looking north at the Dam J upstream slope (facing Pond 1). Note the erosion at the HWM.

OBSERVED FEATURES	YES	NO	LOCATION	PHOTO #	COMMENTS / NOTES
Signs of phreatic surface / seepage		x			
Areas of seepage turbid		x			
Erosion	x		downstream slope	28, 29	erosion at HWM
Evidence of sloughing / sliding		x			
Evidence of cracking		x			
Deformation or geotechnical concern		x			
Instrumentation		x			
Vegetation		x			
Non-uniform slope		x			
Other noteworthy conditions		x

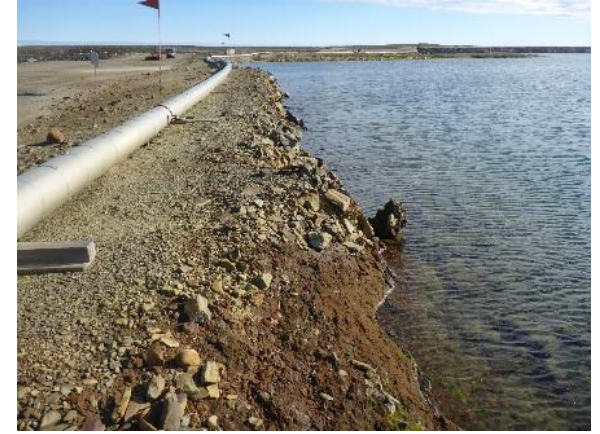
Photo 29: Close up looking north at the Dam J downstream slope (facing Pond 1). Note the undercut has caused sloughing and reduce crest width.

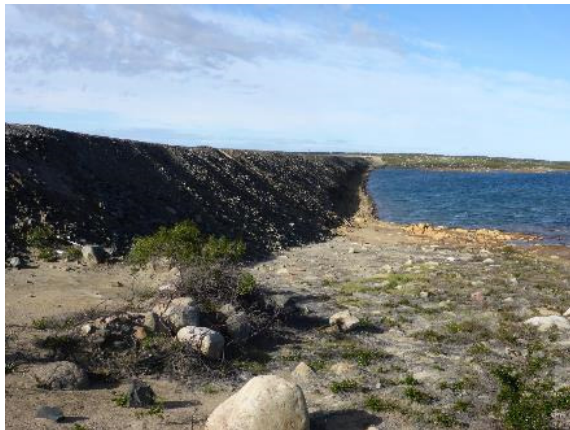
Photo 30: Looking south at the Dam K downstream slope (facing Pond 2) from north abutment of Dam J. Note the undercut erosion at the HWM.

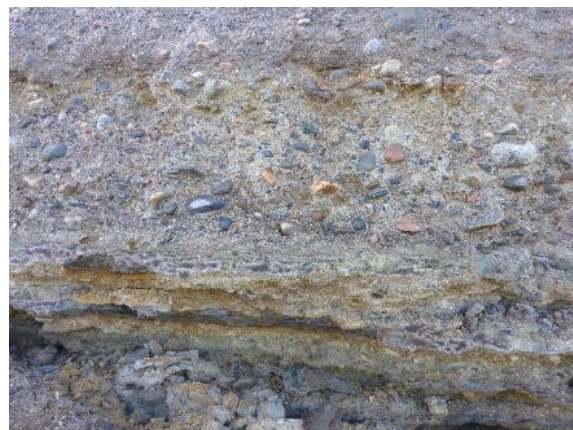
Photo 31: Close up look at the Dam K undercut erosion and the near vertical slope.

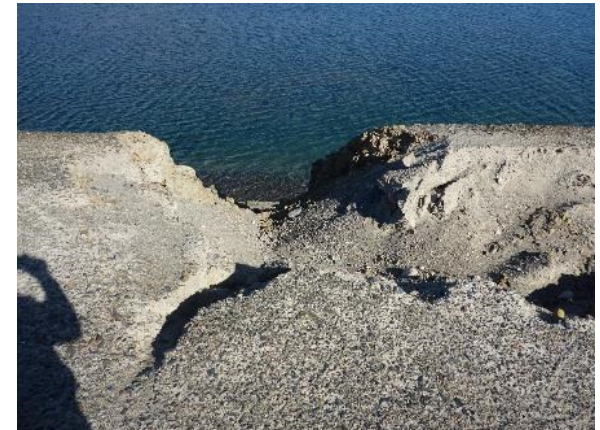
Photo 32: Close up look at the Dam K undercut erosion and the near vertical slope.

OBSERVED FEATURES	YES	NO	LOCATION	PHOTO #	COMMENTS / NOTES
Signs of phreatic surface / seepage		x			
Areas of seepage turbid		x			
Erosion	x		3 erosion gullies	32	
Evidence of sloughing / sliding		x			
Evidence of cracking		x			
Deformation or geotechnical concern		x			
Instrumentation		x			
Vegetation		x			
Non-uniform slope		x			
Other noteworthy conditions		x

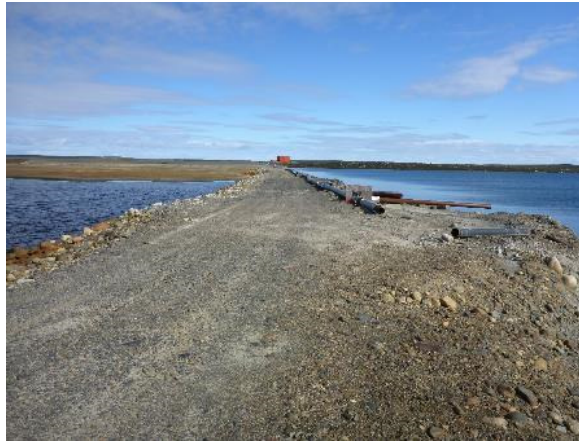
Photo 34: Looking north along the Dam L centerline. Note the reduction in crest width near the end.

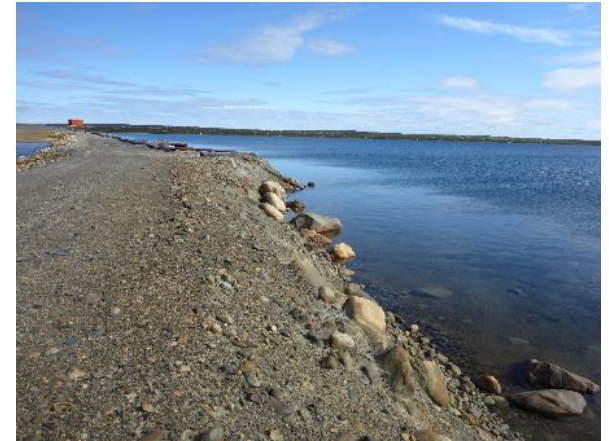
Photo 35: Looking north at the Dam L downstream slope (facing Cell 4).

OBSERVED FEATURES	YES	NO	LOCATION	PHOTO #	COMMENTS / NOTES
Signs of phreatic surface / seepage		x			
Areas of seepage turbid		x			
Erosion	x		mid-point, past cover	35	erosion gully
Evidence of sloughing / sliding		x			
Evidence of cracking		x			
Deformation or geotechnical concern		x			
Instrumentation		x			
Vegetation		x			
Non-uniform slope		x			
Other noteworthy conditions		x

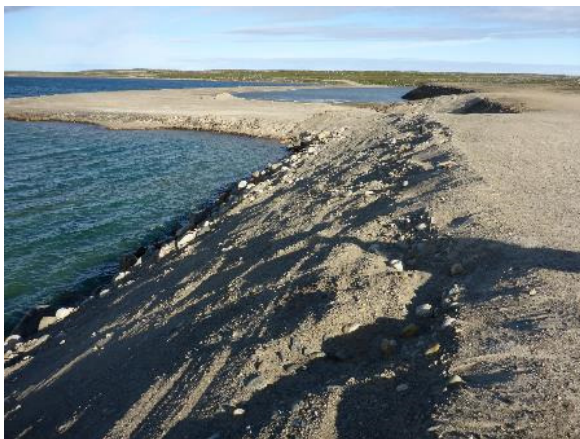
Photo 36: Looking west at the Dam M repaired buttress and armor at the toe, with Dam N and Pond 2 to the left.

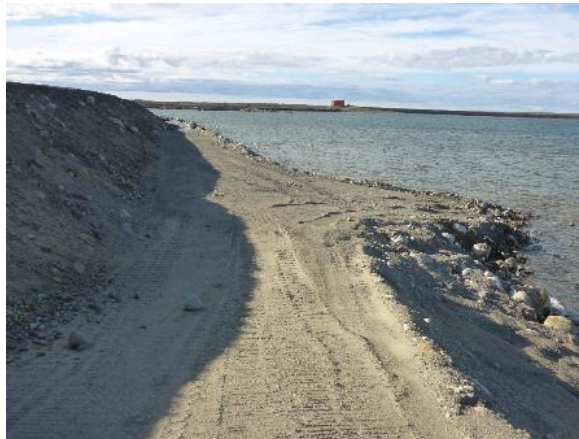
Photo 37: Close up look toward the east at the repair buttress at Dam M with armor at the toe.

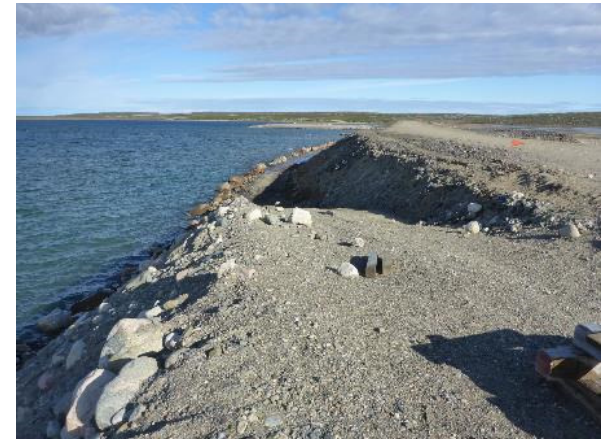
Photo 38: Looking west at the repair buttress at Dam M with armor at the toe.

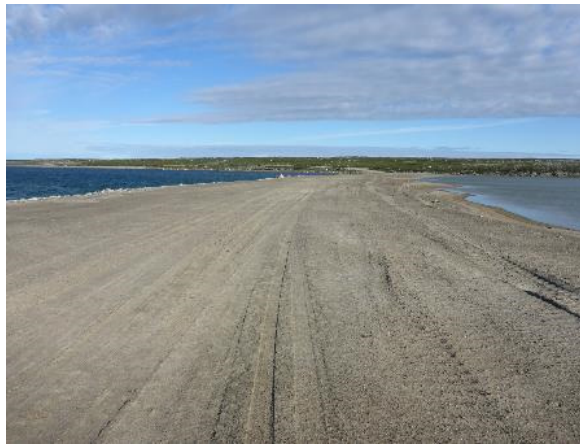
Photo 40: Looking northwest at the Dam N crest toward the north abutment. Note the water behind the dam (right) is approximately 0.8m below the crest.

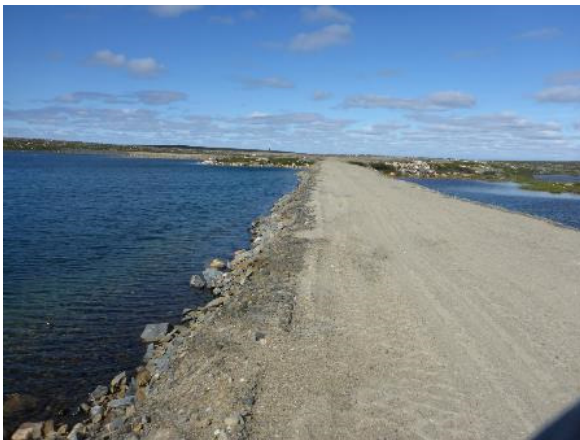
Photo 42: Looking north at the repaired section of the southern portion of the Divider Dyke.

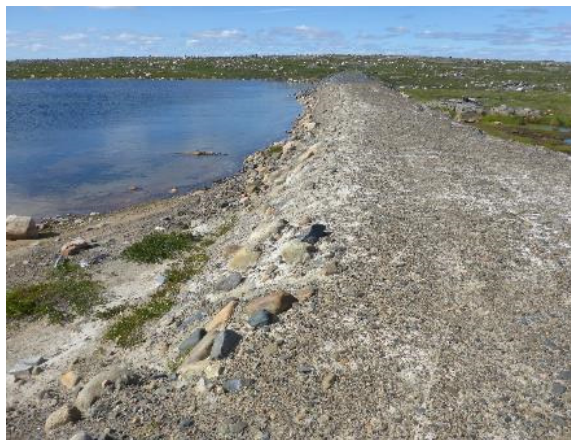
Photo 43: Looking north at the northern portion of the Divider Dyke. Note the reduced crest width and sloughing and cracks.

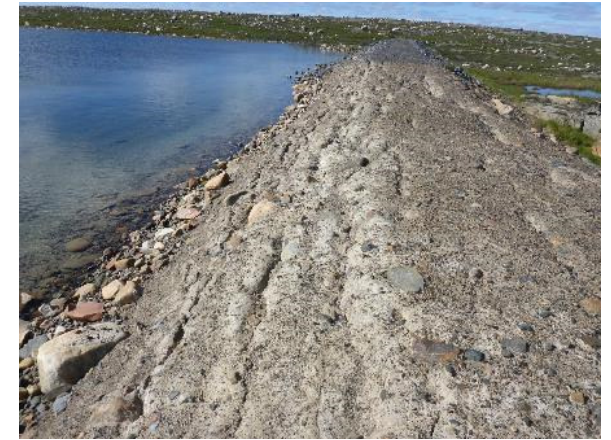
Photo 44: Close up look of the sloughing and cracks on the northern section of the Divider Dyke.
