2017 Lupin Mine Tailings Containment Area Geotechnical Inspection

Submitted to:
Lupin Mines Incorporated

Project Number: 924-3

Date:
September 24, 2017

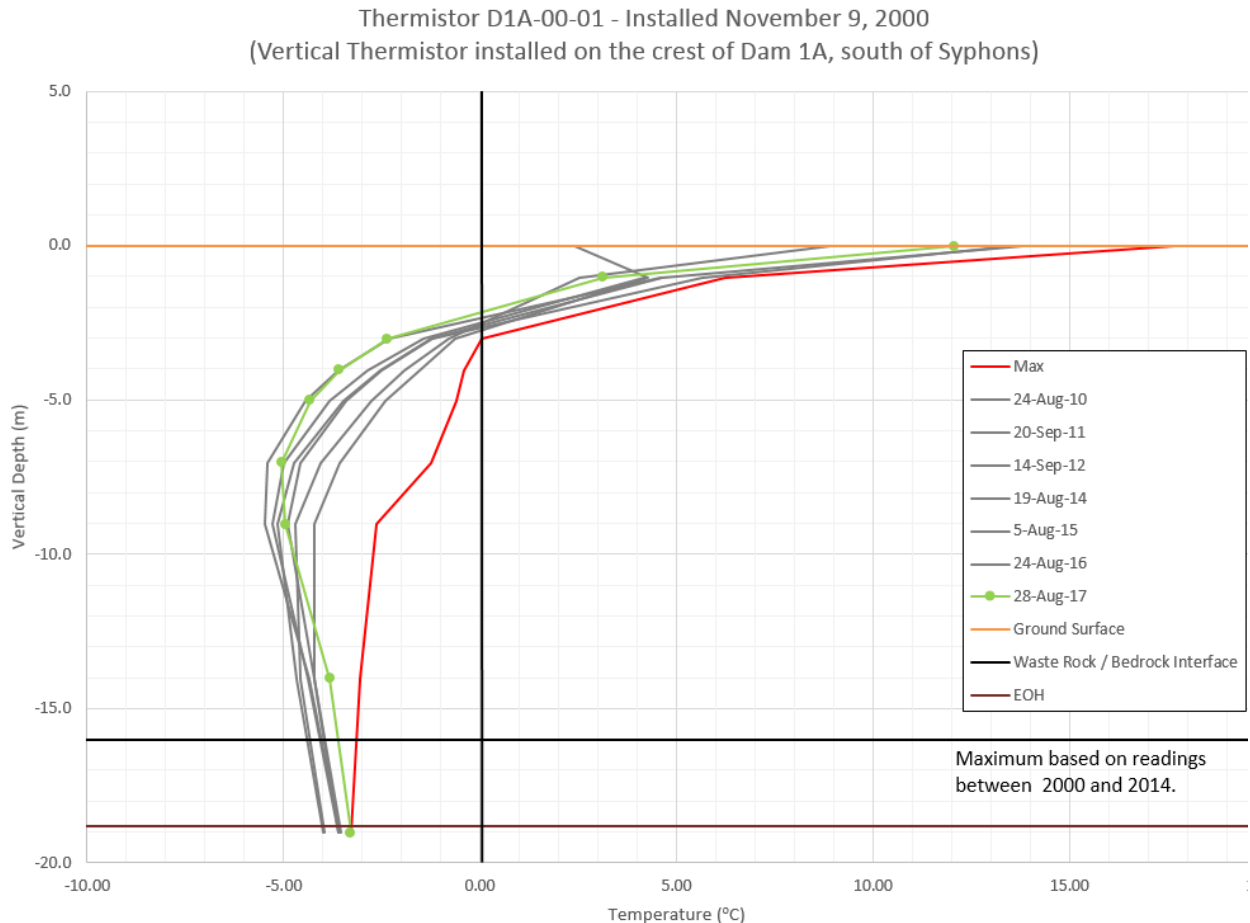
Figure 5: Thermistor Reading for D1A-00-01

For the perimeter dams, the five functional thermistors are less than 20m deep. The five thermistor readings are shown in Figures 5 to 9. The data suggests the 2017 readings are within the historical variations, taking into account annual climatic variations and time of reading. Generally, the active layer (thaw zone) ranges from 2m to 3m depth, as interpolated by the 0°C gradient line. The largest historical variation in the given data set is approximately 2.2°C (between -2.5°C and -4.7°C) in Dam 2 (D2-00-02n) at the depth of 6m.

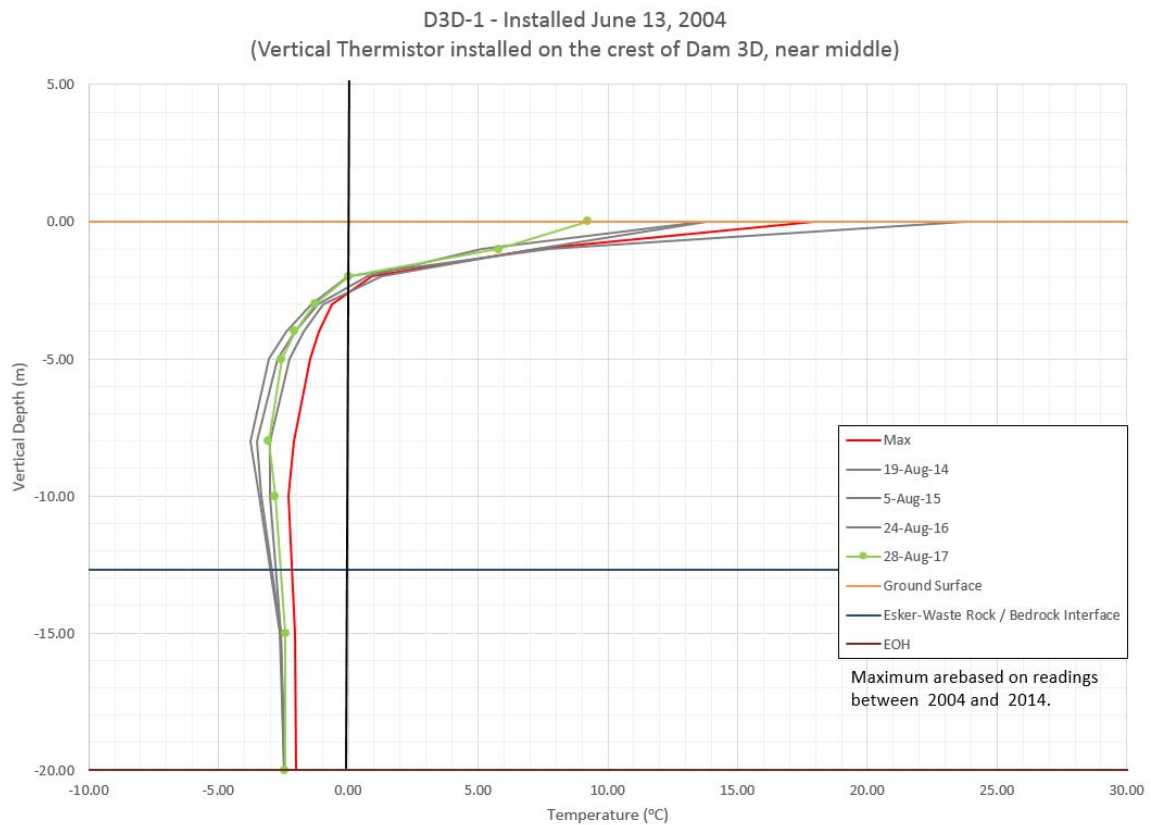
Figure 10: Thermistor Reading for D3D-1

For the internal dams, the two functional thermistors are also less than 20m deep. These were not monitored as rigorously as the ones installed in the perimeter dams, and only have recent data between 2014 and 2017. The two thermistors readings are shown in Figure 10 and Figure 11. The active layer is observed to be between 2m to 3m, as interpolated by the 0°C gradient line. The variations between the data set are less than 2°C and generally occur below the historical maximum.
