2018 Lupin Mine Tailings Area Inspection Report

Annual Geotechnical Inspection of the
Tailings Containment Area

November 16, 2018

Lupin Mines Incorporated

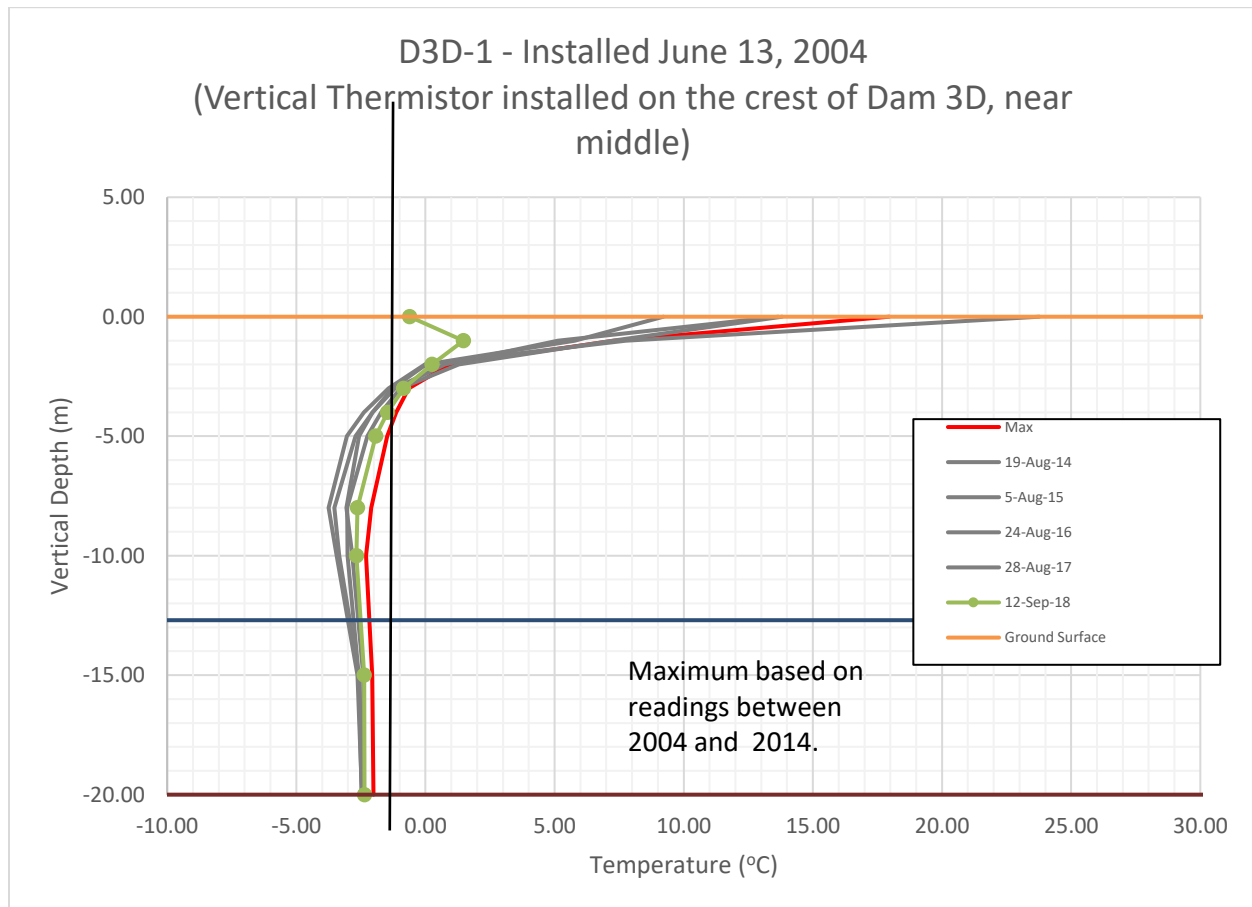
Figure 3-6: Thermistor Reading for Dam 3D

For the internal dams, the two functional thermistors are also less than 20m deep. These were not monitored as rigorously as the ones installed in the perimeter dams, and only have recent data between 2014 and 2017. The two thermistor readings are shown in the figures below. The active layer is observed to be between 2m to 3m, as interpolated by the 0°C gradient line. The variations between the data set are less than 2°C and generally occur below the historical maximum.

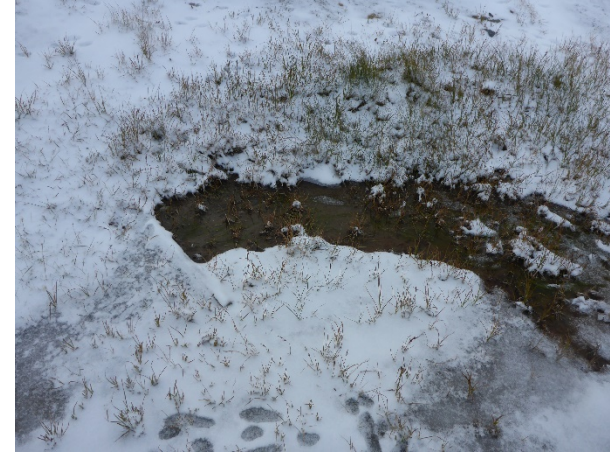
Previous annual inspections noted seepage from the northern toe buttress of Dam 2 into the seepage collection pond adjacent to Dam 2 Lake. This seepage was not observed during this inspection due to winter conditions, but a small amount of open water was present in the seepage collection pond. It is assumed that a small, undetermined amount of leakage is continuing.

Photo 12: The small amount of open water at the seepage collection pond.

- Monitor the seepage at Dam 2 and manage it as necessary by pumping the seepage back into Pond 2.
- LMI is currently monitoring and managing the water in Cell 5 as part of the cover construction work. This monitoring and water management should continue to prevent damage to newly repaired Dam M.
- General repairs on surface and slope erosion at the HWM.

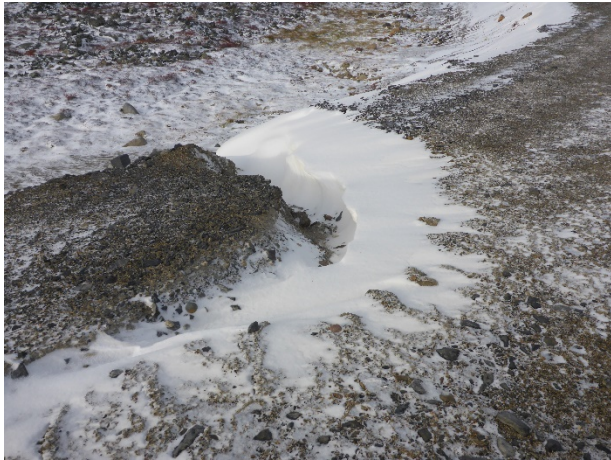
Photo 19: Looking south at an erosion gully near the east abutment of Dam 4.

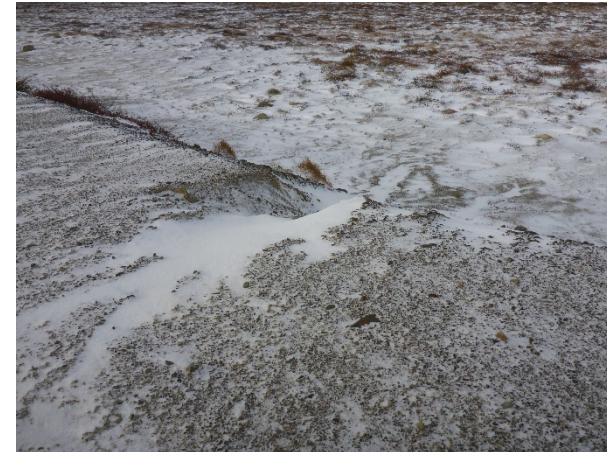
Photo 22: Looking southwest at one of the erosion gullies at the downstream crest of Dam 5.

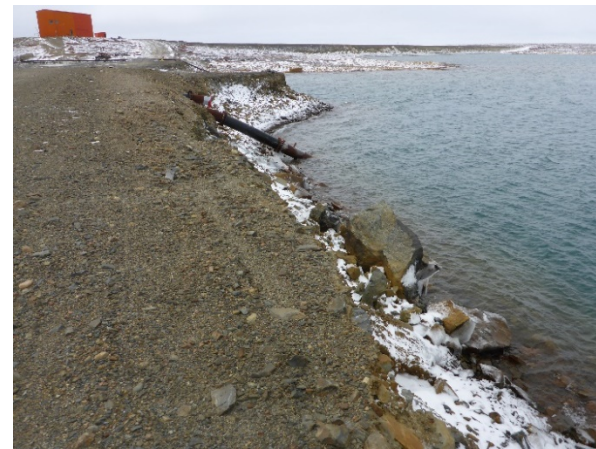
All of the internal dams have some erosion on their downstream slopes, associated with either surface runoff or wave action at the HWM. Dam 3D also has some crest erosion from the surface runoff. Dam J and Dam L both have wave action erosion at the HWM that has reduced their crest widths. Maintenance should be considered to repair the erosion on the slopes of Dam 3D, Dam J and Dam L.

Photo 27: Looking south at the eroded downstream slope of Dam J.

Dam J	1.1 ⁽²⁾	Over steepened slope due to erosion and reduced crest width in some sections.	Repair the eroded slope and crest with compacted sand and gravel.	Erosion gullies on slopes. Over steepened slope due to erosion and reduced crest width in some sections.	Repair the eroded slope and crest with compacted sand and gravel.
Dam K	N/A ⁽¹⁾	Erosion at HWM and five large erosion gullies in the downstream crest. Near vertical slope at the eroded toe.	Prioritize the repair the eroded gullies at the crest and toe, and armor the slope up to the HWM with boulders to limit further erosion. Repair should be done while the Pond 2 water level is lowered for access.	Erosion at HWM and erosion gullies in the downstream crest. Near vertical slope at the eroded toe.	Repair the eroded gullies at the crest and toe, and armor the slope up to the HWM with boulders to limit further erosion. Monitor the crest for cracks and sloughing until repairs are completed. Repair should be done while the Pond 2 water level is lower for access.

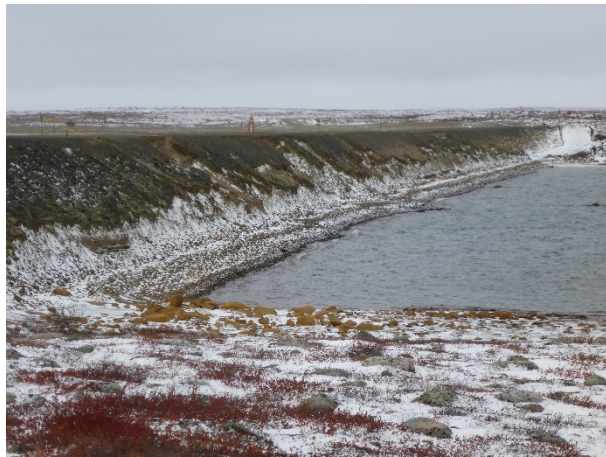
Dam K has experienced considerable undercutting at the toe from Pond 2 wave action. There are five large erosion gullies at the downstream crest from overland flow over the cover. These gullies are sufficiently wide and deep that the permafrost within the structure could be compromised. This area should be prioritized for repairs in the next construction season.

The Dam K toe has significant erosion below the HWM from the wave action in Pond 2. The erosion has undercut the toe of the dam and created near vertical slopes in several areas. The downstream crest has five significant erosion gullies caused by surface overflow from the cover. These gullies are sufficiently wide and deep that the slopes of the dam and permafrost condition within the structure could be compromised. Initial maintenance and repair should be completed to replace the eroded material at the toe with compacted sand and gravel armored with boulders/riprap for wave protection. Once the repair at the toe is complete, loose crest material should be removed and additional compacted fill should be placed in lifts to repair the erosion gullies. All the proposed work should be endorsed by the Engineer-of-Record prior to commencement.

Photo 31: Looking southwest from the east abutment of the eroded toe at Dam K

The water level in Pond 2 was lowered in 2017 following water treatment and discharge. LMI should consider the timing and planning of the repair work in 2019 when the Pond 2 water level is still below the eroded zone at the toe.

1. Repair the erosion gullies and toe at Dam K. Repair the eroded toe at Dam K with compacted sand and gravel to restore the original design configuration and armor the repaired toe with boulders/riprap for wave protection. Once that is completed, remove any loose crest material and repair the crest with compacted sand and gravel.
2. Repair the northern section of the Divider Dykes with compacted sand and gravel to restore the original design configuration, including side slopes, a leveled crest and armoring up to the HWM, as directed by the Engineer-of-Record.
3. Monitor the water level behind Dam N and lower the water level to maintain a minimum 1m freeboard.

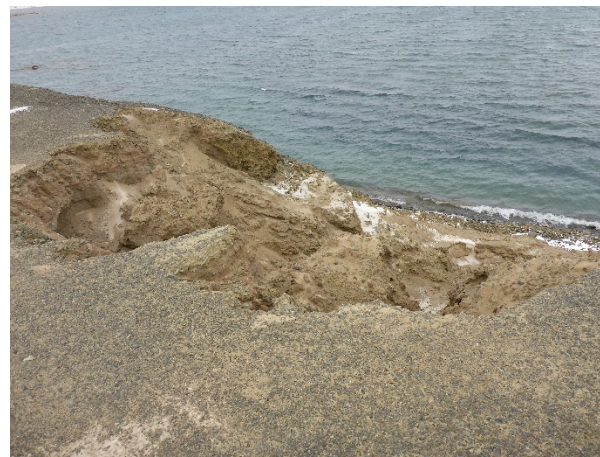
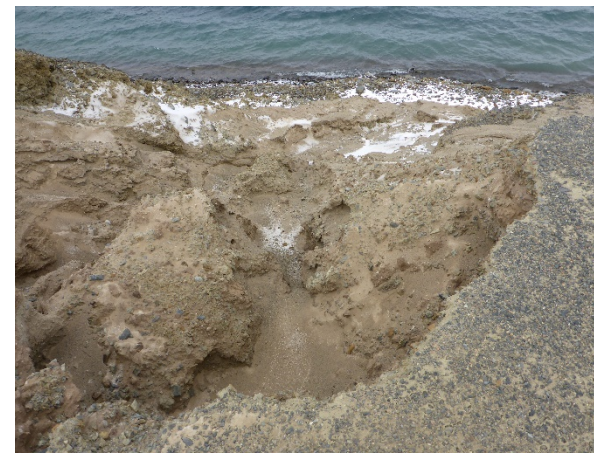
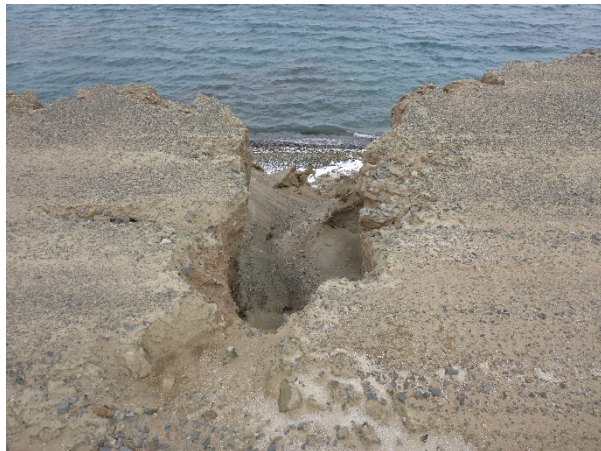
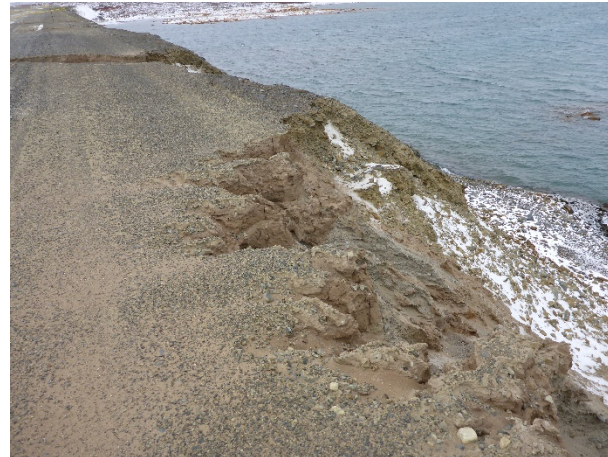
Photo 31: Looking northwest at one of the five erosion gullies along the upstream crest of Dam K

Photo 32: Looking northwest, down toward the toe at one of the five erosion gullies along the upstream crest of Dam K

Photo 33: Looking northwest at another one of the five erosion gullies along the upstream crest of Dam K

Photo 34: Looking southwest from near the east abutment along the downstream crest of Dam K at the erosion gullies.

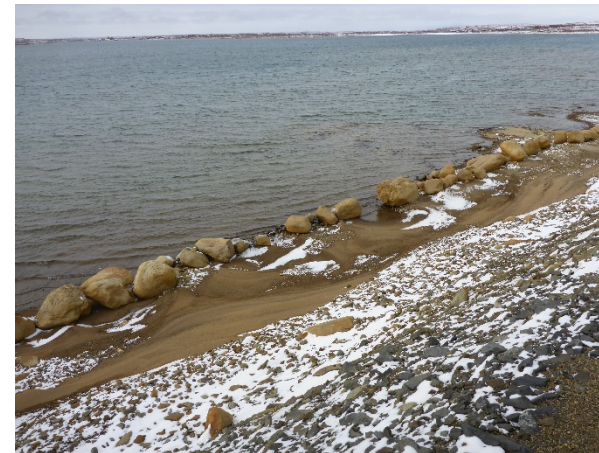
Dam M was repaired with a reinforcement buttress and crest surface backfill in 2016 (Norwest 2016). The toe of the buttress has experienced some wave erosion at the HWM. The water level has been lowered following water treatment and discharge and the buttress toe are now currently protected by the original riprap armor as per original construction. Repair should be considered for the toe erosion when practicable.

Photo 43: Looking southwest at the riprap armor at the toe of reinforcement buttress.

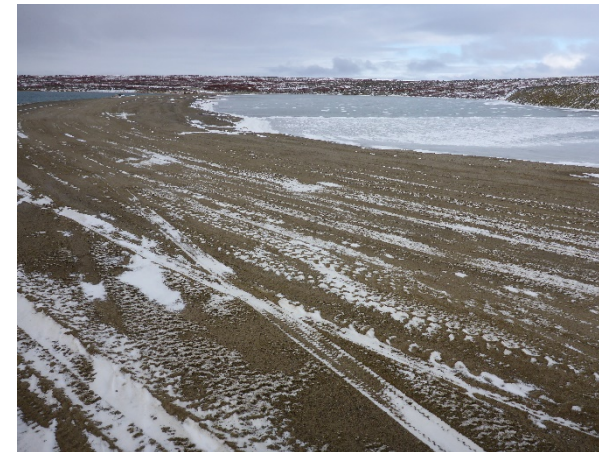
Dam N was observed to be in stable condition, but with only 0.5m freeboard between it and Pond 2. This was communicated with LMI site personnel, and the need to increase the freeboard to 1m to meet water license requirement was highlighted. It was agreed that the water behind Dam N would be lowered after water treatment operations when practicable. Dam N and its contents were submerged in previous years and this did not appear to have had any adverse impact on its geotechnical stability. The reduced freeboard does not create any geotechnical and environmental concerns as Dam N and its contents are contained within Pond 2.

Photo 46: Looking north at the crest of Dam N and ponding water with less than 1m freeboard.

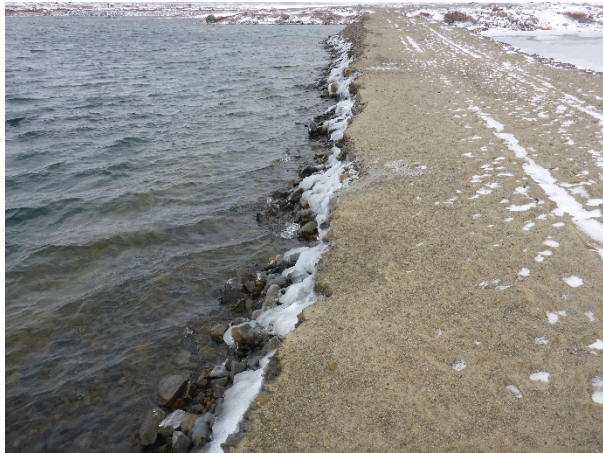
Photo 47: Looking north at the repaired upstream slope and crest of the southern divider dyke.

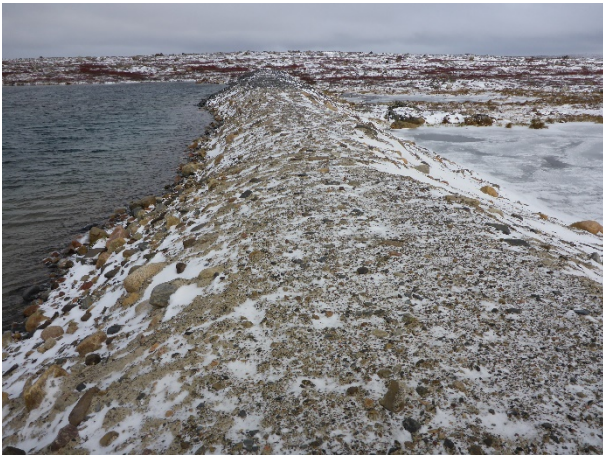
The northern section of the divider dykes at the east end of Cell 4 is in poor condition, while the southern section has been repaired. Signs of erosion, cracks, and sloughing were noted on the upstream and downstream sides of both dykes. Deformations have created an uneven crest and reduced its width to approximately 2m in some areas. The

south divider dyke has experienced sufficient sloughing to create a low spot with a freeboard of around 1m. The slopes of the dykes vary between 2H:1V to 1H:1V in some areas that is caused by undercutting and sloughing.

Photo 50: Looking north at the eroded crest slopes and sloughed crest of northern divider dyke.

Inspection Item	2018 Inspection			2017 Inspection	
	Estimated Freeboard (m)	Observation	Recommendations	Observations	Recommendations
Dam M	2.5	Minor erosion at the downstream toe above the riprap protection	Repair the eroded toe areas.	Tension cracks have been excavated and backfilled, and over steepened slopes have been buttressed and armored at the toe.	Monitor the repair for erosion and settlements.
Dam N	0.5 ⁽²⁾	Minor wave action erosion at HWM.	Monitor the water level behind Dam N and lower the water when practicable to yield minimum 1m freeboard.	Minor wave action erosion at HWM.	Monitor the water level behind Dam N and manage it as necessary to yield minimum 1m freeboard.
Divider Dykes	0.4 ⁽²⁾	Erosion, sloughing and cracks along upstream and downstream of the northern portion of the dyke. Uneven crest level and reduced crest width.	Second priority to complete the repair to the northern section	Erosion, sloughing and cracks along upstream and downstream of the northern portion of the dyke. Uneven crest level and reduced crest width.	Repair has been done to the southern section of the dyke. Complete similar repair to the northern section
