2019 Lupin Mine Tailings Area Inspection Report

Annual Geotechnical Inspection of the
Tailings Containment Area

October 24, 2019

Lupin Mines Incorporated

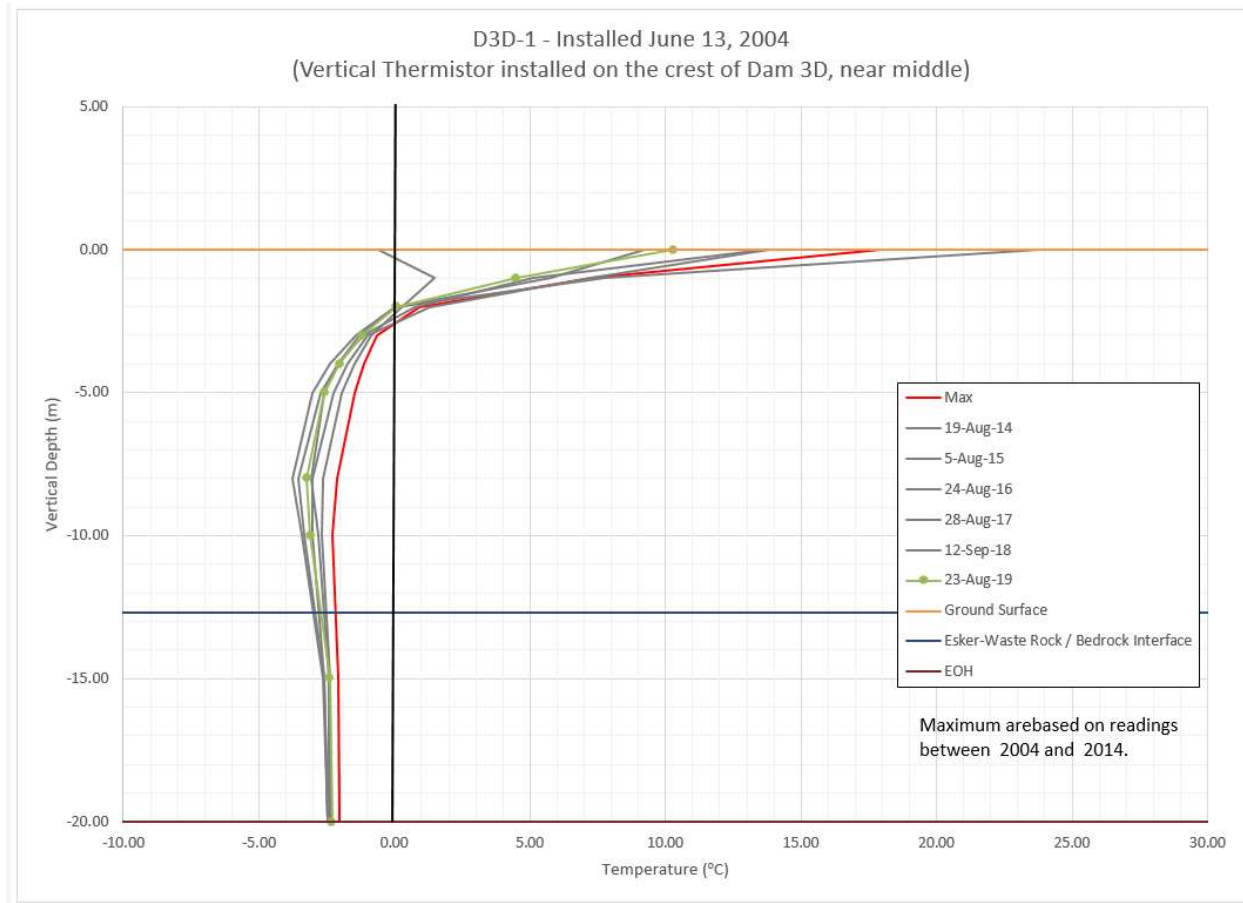
Figure 3-6: Thermistor Reading for Dam 3D

For the internal dams, the two functional thermistors are also less than 20m deep in Dam K and Dam 3D. These were not historically monitored as rigorously as the ones installed in the perimeter dams, and only have recent data from 2014. The two thermistor readings are shown in the figures below. The active layer is observed to be between 2m to 3m, as interpolated by the 0°C gradient line. The variations between the data set are less than 2°C and generally occur below the historical maximum.

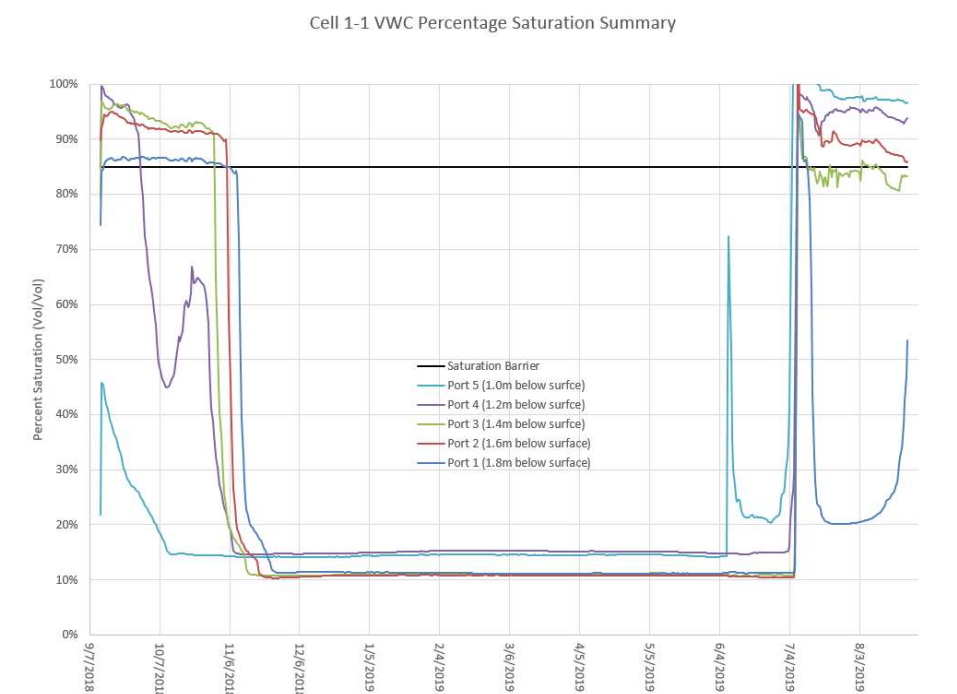
Figure 3-8: Cell 1-1 VWC Percentage Saturation Summary

The figure below shows the percentage saturation for VWC in Cell 1. All sensors show frozen conditions between November and July. In addition, all sensors indicate some variability in the initial data recorded between September and October 2018, potentially related to the method of installation. This variability can be confirmed with longer monitoring periods once a long-term trend is established. There is a spike in the percentage of saturation in all sensors in early July related to overall thawing. The 2019 data indicated Ports 5, 4 and 2 are above 85% saturation once thawed. Port 3 showed a variable trend but remains above 80% saturation.

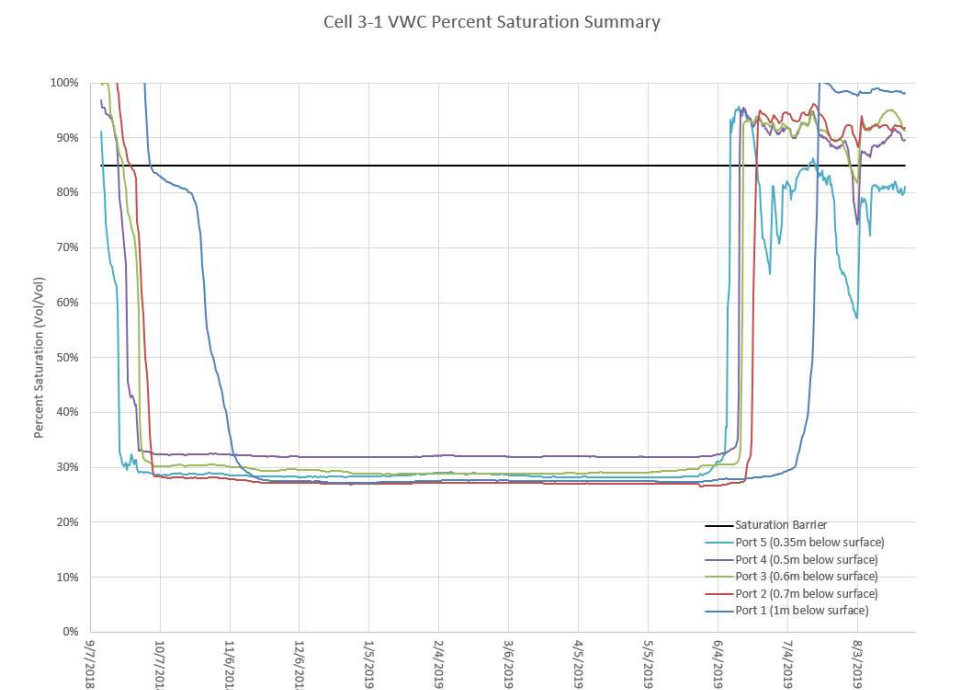
Figure 3-9: Cell 3-1 Port 1 VWC Result

The figure below shows the percentage saturation for VWC in Cell 3. The majority of the sensors show frozen conditions between October and June. Similar to Cell 1-1 VWC, all sensors indicate there might be variability at the initial data collection period between September and October 2018 potentially related to the method of installation. This variability can be confirmed with longer monitoring periods once a long-term trend is established. There is a spike in percentage of saturation in the top sensors in June signaling overall thawing. The 2019 data indicated Ports 4 to 1 are above 85% saturation once thawed. Port 5 showed a variable trend between 57% to 86% saturation, mostly related to surface evaporation and rehydration from rain.

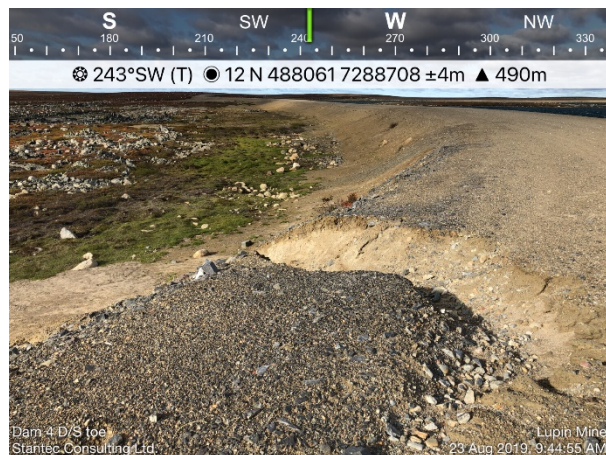
Photo 19: Looking southwest at an erosion gully near the east abutment of Dam 4.

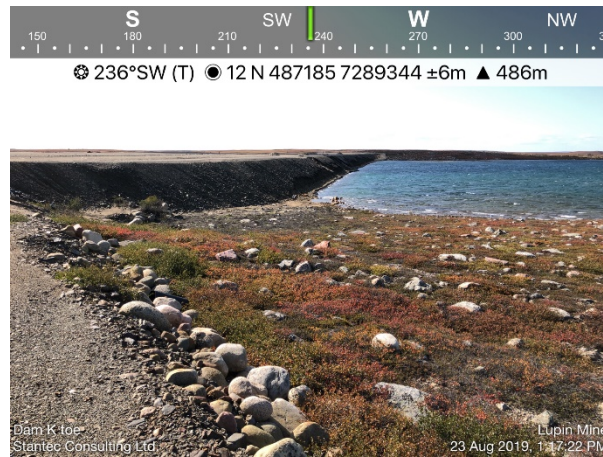
Dam K has experienced considerable undercutting at the toe from Pond 2 wave action that was previously recommended for repair in this year. However, due to the water level in Pond 2, the undercutting at the toe had not yet been repaired. In addition to the undercutting, there were five large erosion gullies at the downstream crest caused by overland flow over the cover. These gullies were sufficiently wide and deep that the permafrost within the structure could be compromised. The crest gullies were partially repaired in early July 2019 and temporary ditches were constructed upstream of the erosion to mitigate further damage the area. The overall repair plan is to lower the water level in 2020 to allow access to the toe and construct a buttress to reinforce the dam, and also repair crest.

The Dam K toe has significant erosion below the HWM from the wave action in Pond 2. The erosion has undercut the toe of the dam and created near vertical slopes in several areas. The downstream crest has five significant erosion gullies caused by surface overflow from the cover. 2019 maintenance and repair were completed to fill some of the crest erosion gullies and temporary ditches were constructed to mitigate further damage from surface water flows. However, the toe erosion repair was not completed due to the high Pond 2 water level. The proposed plan is to lower Pond 2 water in 2020 to allow access along the toe for repair. The repair should include a buttress along the toe to reinforce the dam and riprap at closure water level elevation for protection. Once the repair at the toe is complete, any loose crest material should be removed, and additional compacted fill should be placed in lifts to complete the repair of the erosion gullies. All the proposed work should be endorsed by the Engineer-of-Record prior to commencement.

Photo 32: Looking southwest from the east abutment of the eroded toe at Dam K

1. Lower the Pond 2 water and repair the erosion gullies and eroded toe at Dam K. The toe at Dam K should be repaired with compacted sand and gravel to restore the original design configuration and armor the repaired toe with boulders/riprap for wave protection. Once that is completed, remove any loose crest material and repair the crest with compacted sand and gravel.
2. Repair the northern section of the Divider Dyke with compacted sand and gravel to restore the original design configuration, including side slopes, a leveled crest and armoring up to the HWM. Finalize the repair with sufficient fill on the southern section of the Divider Dyke to restore the original configuration. Fully and effectively plug the malfunctioning gate valve to prevent the flow from Cell 4 into Pond 1 and maintain the intended TCA water management.

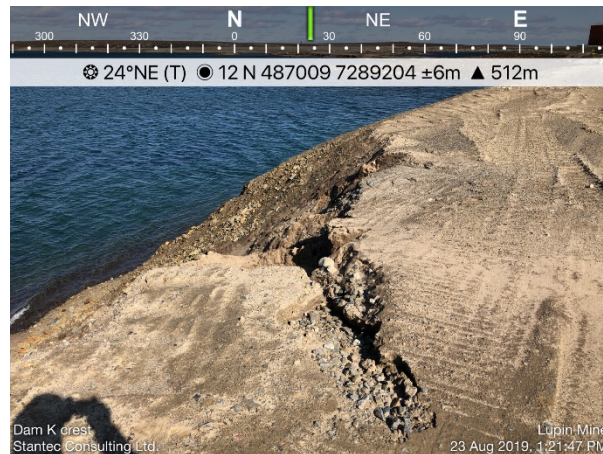
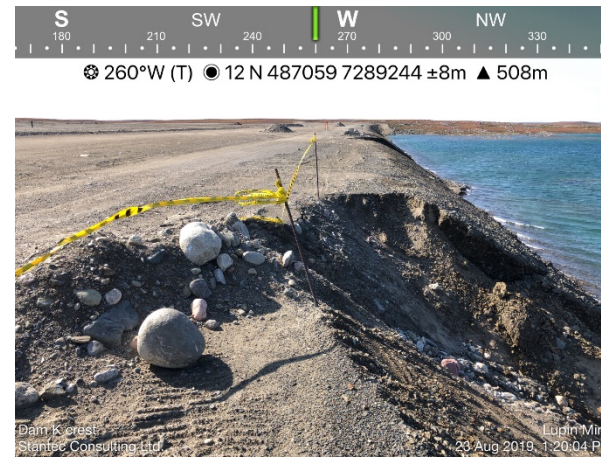
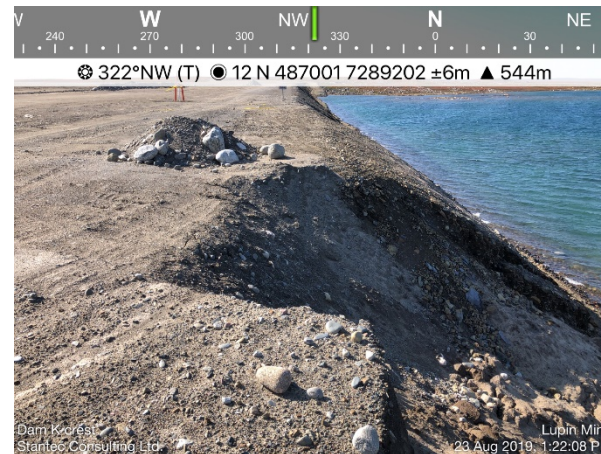
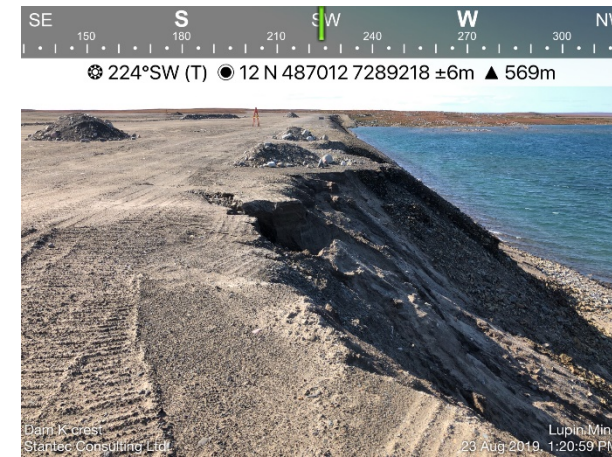
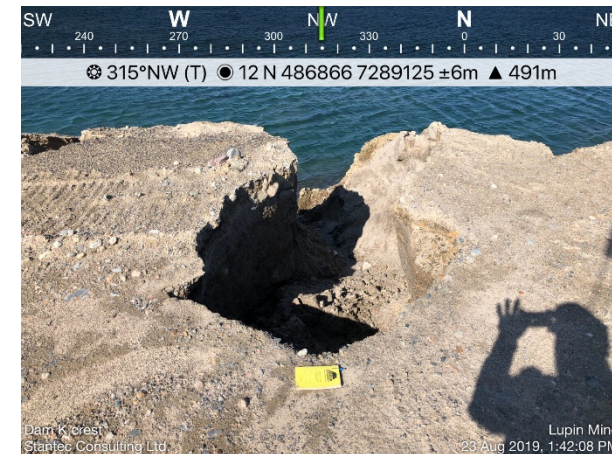
Photo 35: Looking north down toward the toe at one repaired but sloughed gullies along the downstream crest of Dam K

Photo 33: Looking west at one of the repaired but sloughed gullies along the downstream crest of Dam K

Photo 36: Looking north down toward the toe at one repaired but sloughed gullies along the downstream crest of Dam K

Photo 34: Looking southwest, down toward the toe at one repaired but sloughed gullies along the downstream crest of Dam K

Photo 37: Looking northwest down toward the toe at one repaired but sloughed gullies along the downstream crest of Dam K

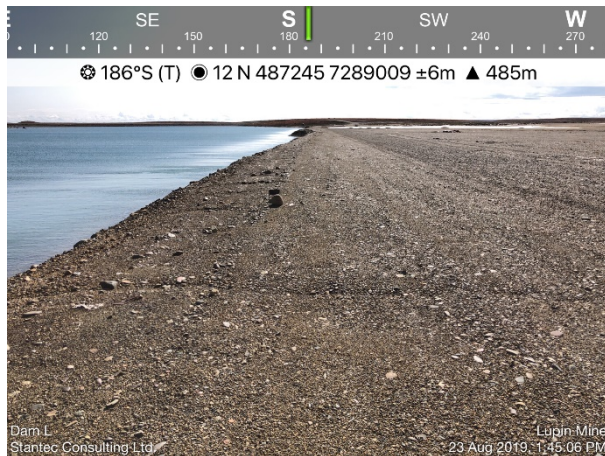
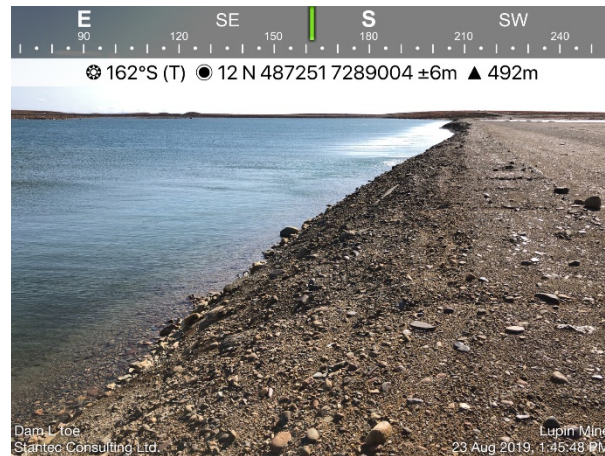
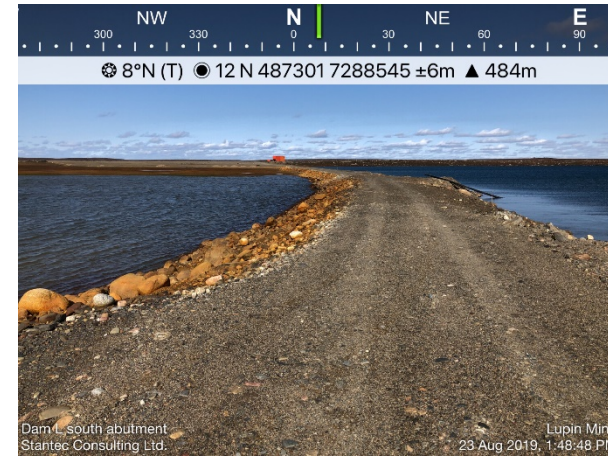
Dam L	1.5 ⁽²⁾	Erosion in the crest and slopes.	Repair the eroded upstream slope, crest and armor the downstream toe for protection.	Erosion in the crest and slopes.	Repair the eroded upstream slope, crest and armor the downstream toe for protection.
Dam M	2.5	Sloughing in localize sections of the buttress due to raised water level.	Repair the sloughed section of the buttress once the water level is lowered.	Minor erosion at the downstream toe above the riprap protection	Repair the eroded toe areas.
Dam N	0.5 ⁽²⁾	Minor wave action erosion at HWM.	Monitor the water level behind Dam N and lower the water when practicable to yield minimum 1m freeboard.	Minor wave action erosion at HWM.	Monitor the water level behind Dam N and lower the water when practicable to yield minimum 1m freeboard.
Divider Dykes	0.4 ⁽²⁾	Erosion, sloughing and cracks along upstream and	Add fill to the uneven crest level to restore minimum	Erosion, sloughing and cracks along upstream and	Second priority to complete the repair

Photo 41: Looking south at the Dam L crest from the north abutment.

Photo 42: Looking south at the downstream slope of Dam L.

Photo 43: Looking north at the Dam L crest from the south abutment.

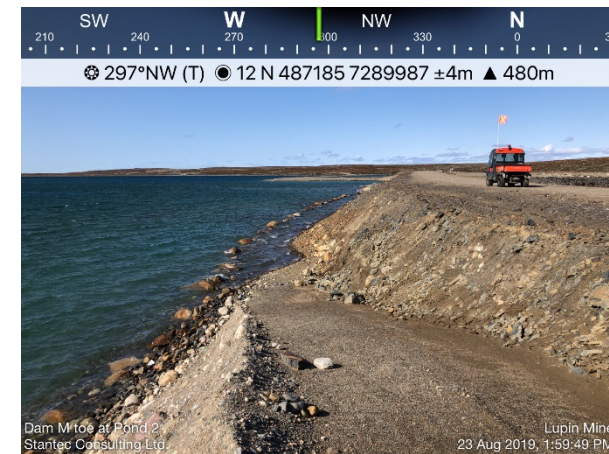
Dam M was repaired with a reinforcement buttress and crest surface backfill in 2016 (Norwest 2016). The toe of the buttress has experienced some wave erosion at the HWM. The water level has risen in 2019 and the buttress toe along with the riprap are now currently submerged and localized minor sloughing was observed. Repair of the buttress sloughing should be carried out when practicable.

Photo 6 Looking west at the sloughed and submerged toe of reinforcement buttress.

- Monitor the seepage at Dam 2 and manage it as necessary by pumping the seepage back into Pond 2.
- Once the Pond 2 water level is lowered, the sloughed section of the buttress should be repaired to original elevation and shape. LMI is currently monitoring and managing the water in Cell 5 as part of the maintenance work. This monitoring and water management should continue to prevent damage to Dam M.
- General repairs on surface and slope erosion at the HWM.

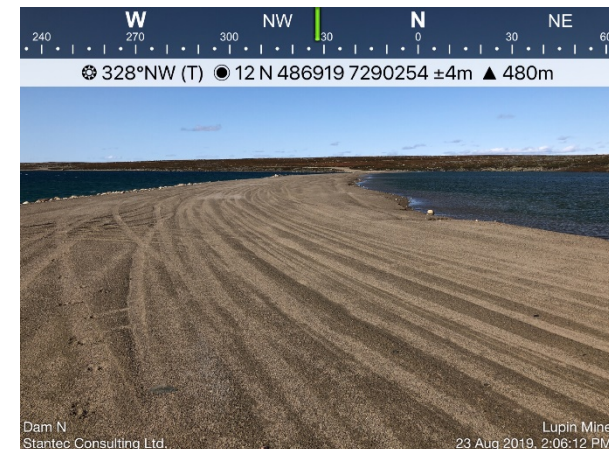
Dam N was observed to be in stable condition, but it had only 0.5m of freeboard between it and Pond 2. This was communicated with LMI site personnel, and the need to increase the freeboard to 1m to meet water license requirement was highlighted. It was agreed that the water behind Dam N would be lowered when practicable, after water treatment operations. Dam N and its contents were submerged in previous years and this did not appear to have had any adverse impact on geotechnical stability. The reduced freeboard does not create any geotechnical or environmental concerns as Dam N and its contents are contained within Pond 2.

Photo 49: Looking north at the crest of Dam N and ponding water with less than 1m freeboard.

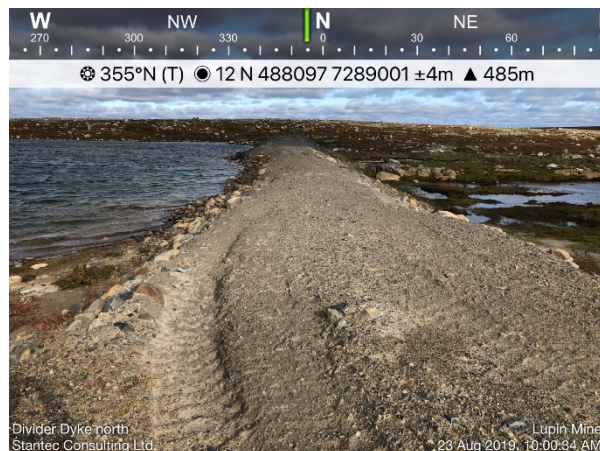
The northern ends of the divider dykes at the east end of Cell 4 were in poor condition. Signs of erosion, cracks, and sloughing were noted on both the upstream and downstream sides of both dykes. Deformations have created an uneven crest and have reduced crest width to approximately 2m in some areas. The south divider dyke has experienced sufficient sloughing to create a low spot with a freeboard of less than 1m. The gate valve within the dyke was found to be malfunctioning and water was allowed to flow freely from Cell 4 into Pond 1. While the malfunctioning gate does not compromise the stability of the dyke, it does create negative impact on the overall TCA water management. Immediately after the site inspection, Stantec communicated to site personnel that additional fill must be placed along the sloughed section of the south divider dyke to maintain a minimum 1m of freeboard. In addition, the gate valve should be plugged to limit flow into Pond 1 and meet TCA water management objectives. Since the site inspection LMI has informed Stantec that both tasks were partially completed, where fill was placed to restore a minimum 1m freeboard and cement was used to partially plug the flow through from Cell 4 into Pond 1.

Photo 53: Looking north at the eroded crest slopes and sloughed crest of northern divider dyke.

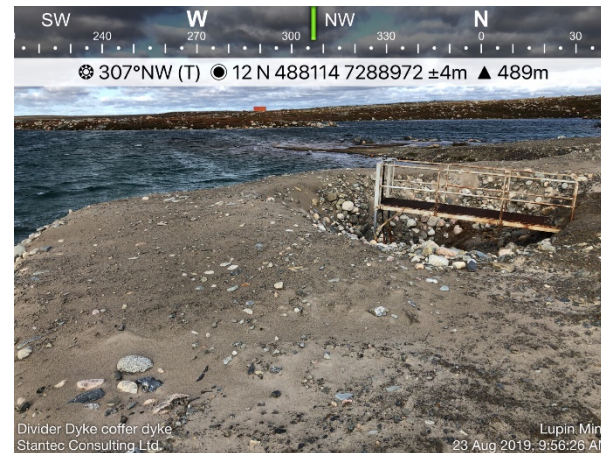
Photo 51: Looking northwest at a temporary coffer dam to reduce the flow through the malfunctioning gate valve.

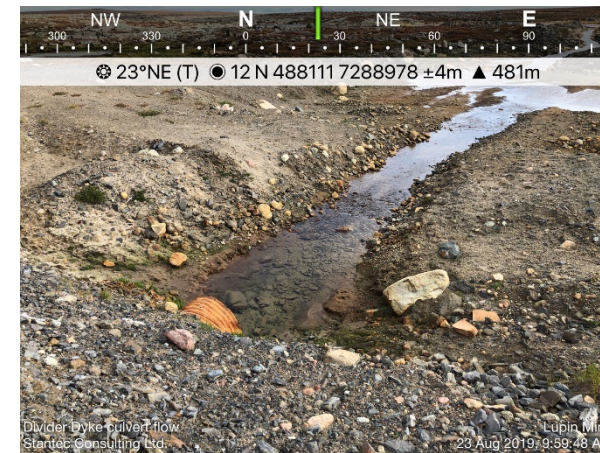
Photo 52: Looking north at the culvert discharge at the malfunctioning gate valve.
