2021 Lupin Mine Tailings Area Inspection Report

Annual Geotechnical Inspection of the
Tailings Containment Area

November 5, 2021

Lupin Mines Incorporated

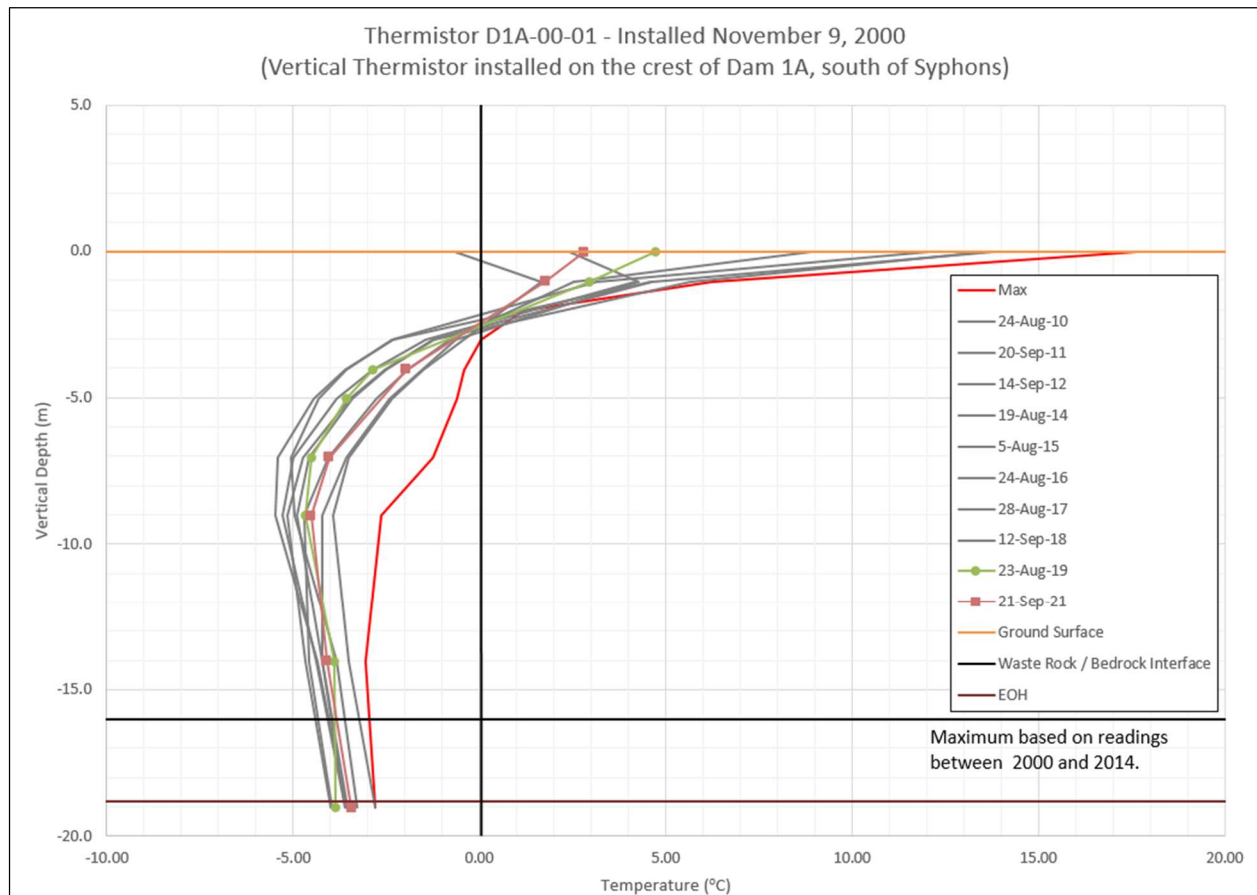
Figure 3-1: Thermistor Reading for Dam 1A

For the perimeter dams, the four functioning thermistors are less than 20m deep. The five thermistor readings are shown in the figures below. The data suggests the 2021 readings are within the historical variations, taking into account annual climatic variations and time of reading. Generally, the active layer (thaw zone) ranges from 2m to 3m depth, as interpolated by the 0°C gradient line. The largest historical variation in the 2020 data set is approximately 3.3°C (between -1.2°C and -4.5°C) in Dam 1 (D1A-00-01s) at the depth of 7m.

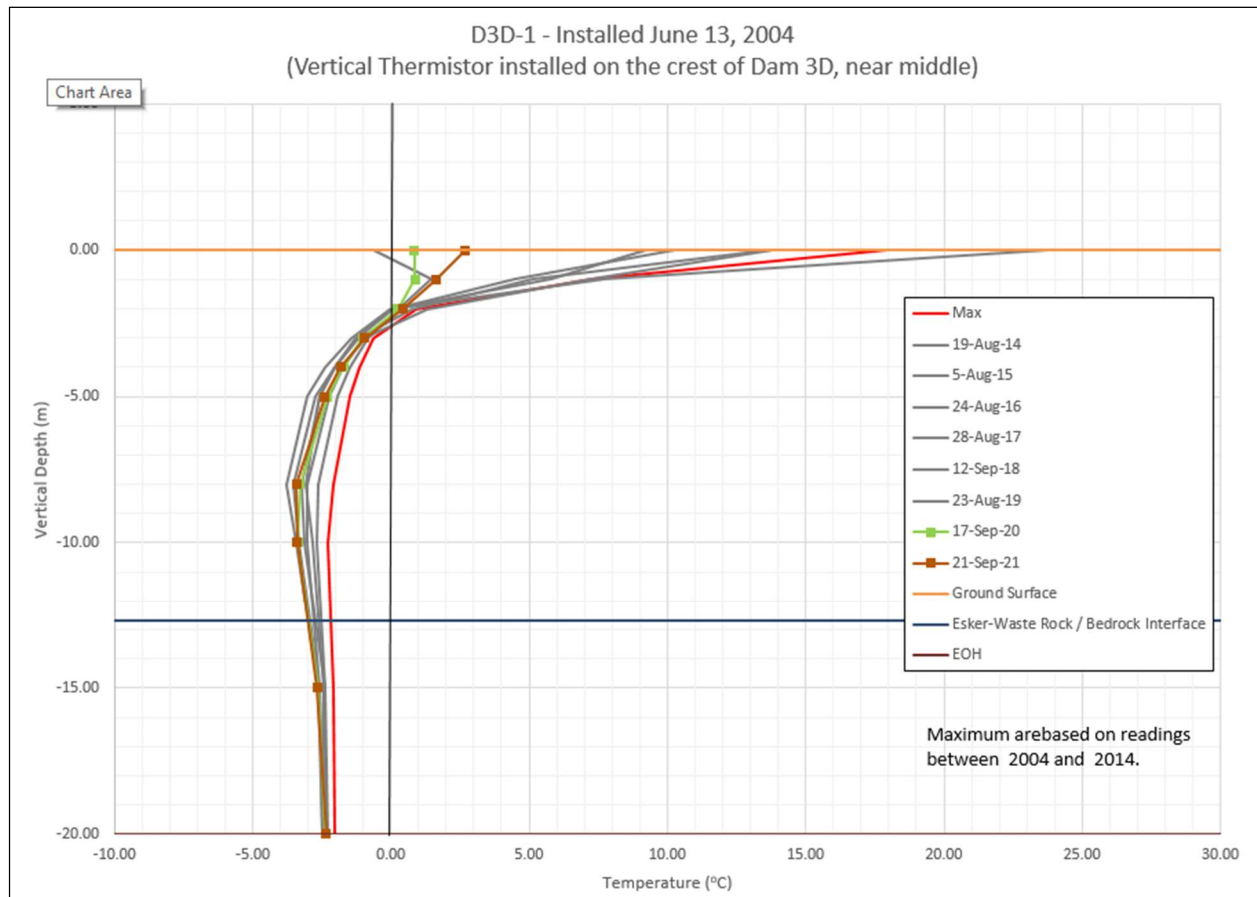
Figure 3-5: Thermistor Reading for Dam 3D

For the internal dams, the two functional thermistors are also less than 20m deep in Dam K and Dam 3D. These were not historically monitored as rigorously as the ones installed in the perimeter dams, and only have recent data from 2014. The two thermistor readings are shown in the figures below. The active layer is observed to be between 2m to 3m, as interpolated by the 0°C gradient line. The variations between the data sets are less than 2°C and generally occur below the historical maximum.

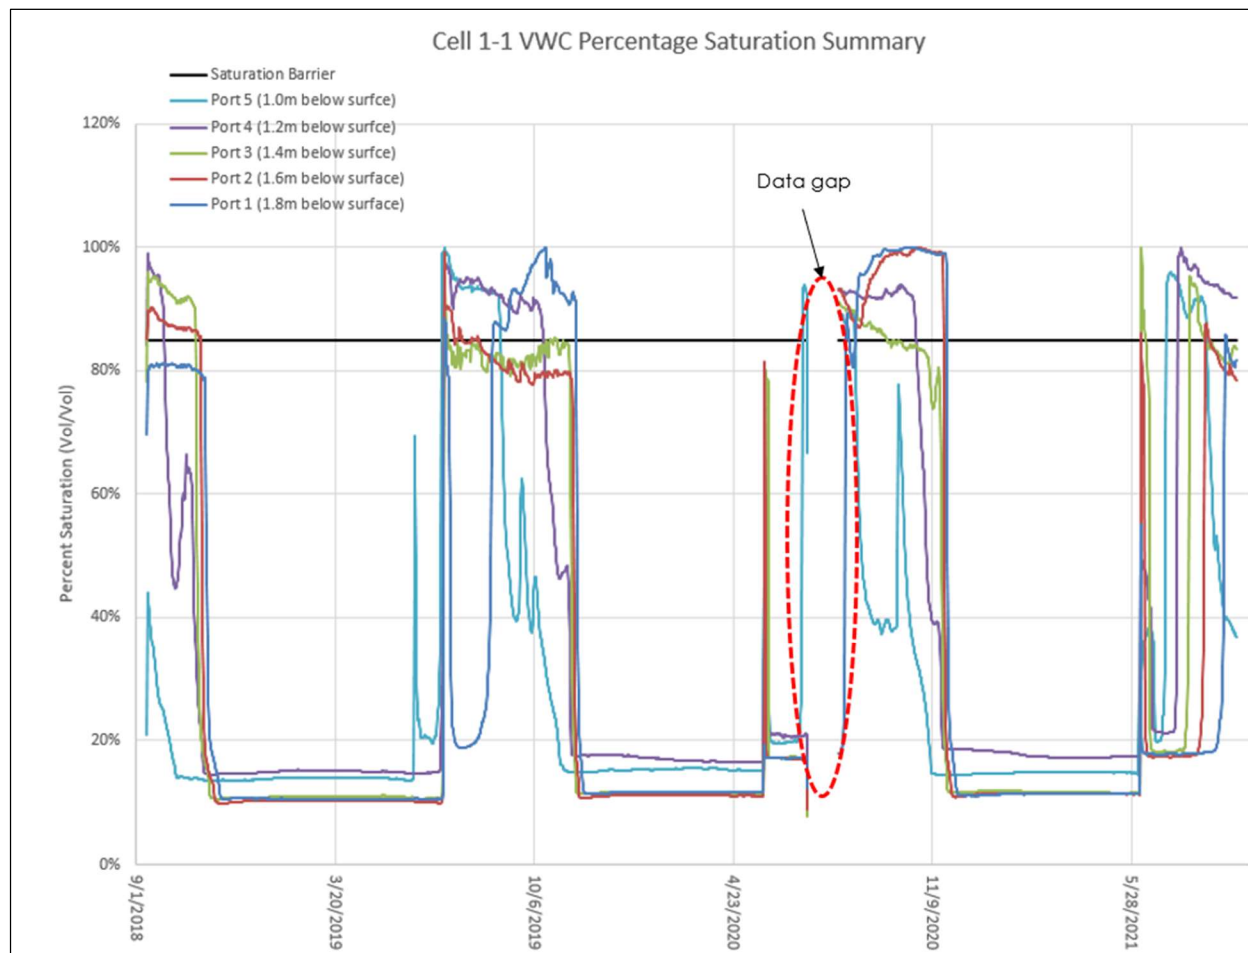
Figure 3-7: Cell 1-1 VWC Percentage Saturation Summary

The figure below shows the percentage saturation for VWC in Cell 1. All sensors show frozen conditions between November and July. There is a spike in the percentage of saturation in all sensors in early July related to overall thawing. The 2021 data indicated Port 4 moisture contents are above 85% saturation once thawed. Port 1, 2 and 3 that are at a lower elevation than Port 4 showed a variable trend but remains around 80% saturation. After in depth review of the data, it is found that the lower degree of saturation in Port 1 through 3 could be contributed to near freezing temperatures measured at depth. The WCC interpret frozen material as voids thus reporting a lower degree of saturation.

It should be noted that there is a gap in data collection between July 6th to August 7th, 2020. The cause of the data gap is unknown and will be noted for documentation.

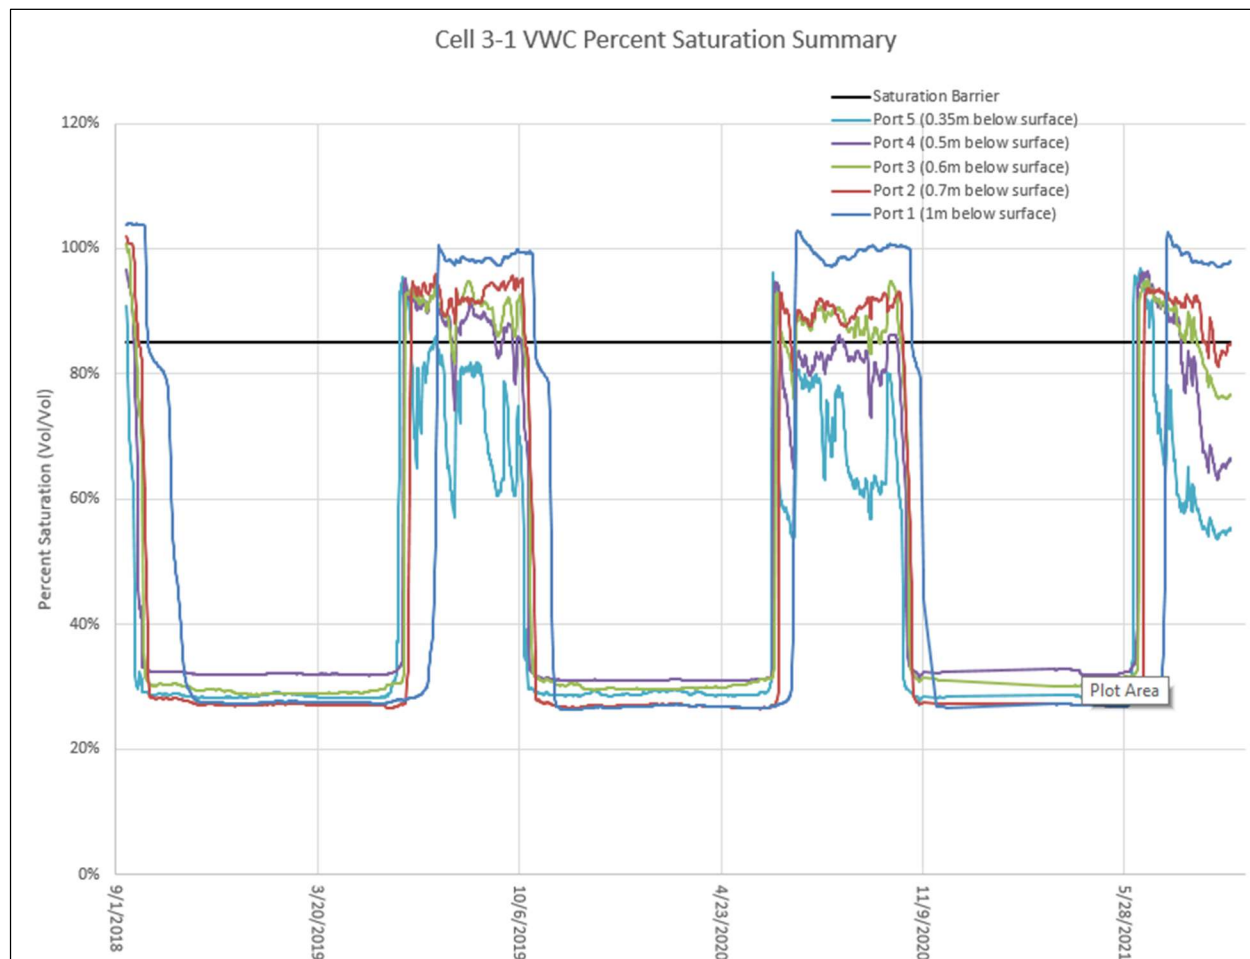
Figure 3-8: Cell 3-1 Port 1 VWC Result

The figure below shows the percentage saturation for VWC in Cell 3. The majority of the sensors show frozen conditions between October and June. There is a spike in percentage of saturation in the top sensors in June signaling overall thawing. The 2021 data indicate the lower portion of the over as shown by Ports 1 and 2 are generally above 85% saturation once thawed. The upper portion cover as shown in Port 3 to 5 showed a variable trend between 57% to 86% saturation, mostly related to surface evaporation and rehydration from rain. It is assumed that the tailings remain to be inert as the lower portion of the cover is above 85% saturation.

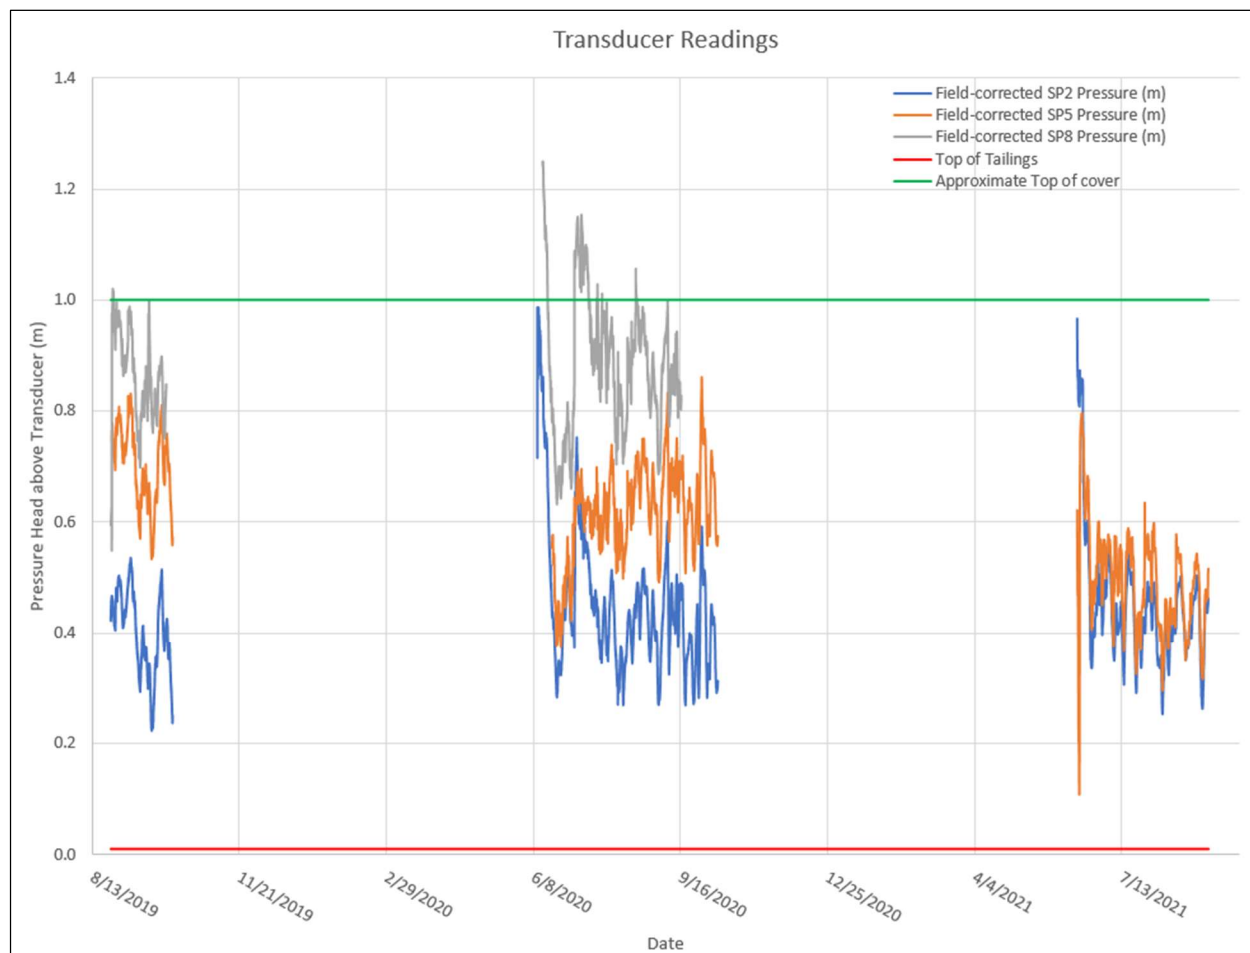
Figure 3-9: Transducer Results

indicates there is minimum 0.2m of water above the tailings/cover contact. Reading above the top cover indicated ponding above the cover. According to the transducers data, the cover and tailings are reporting to be saturated at these locations, indicating the cover is functioning as designed. SP-8 was not read in 2020 and 2021 due to limited access where cover around the standpipe was either ponded or too soft for traffic.

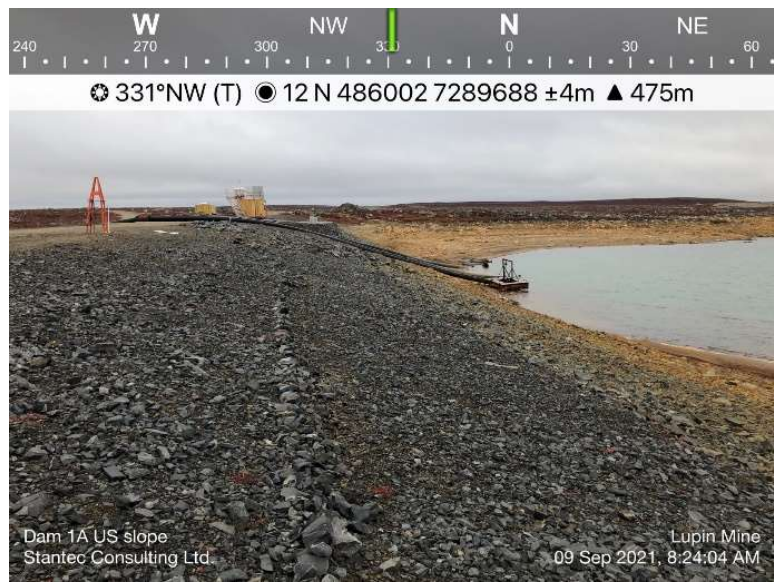
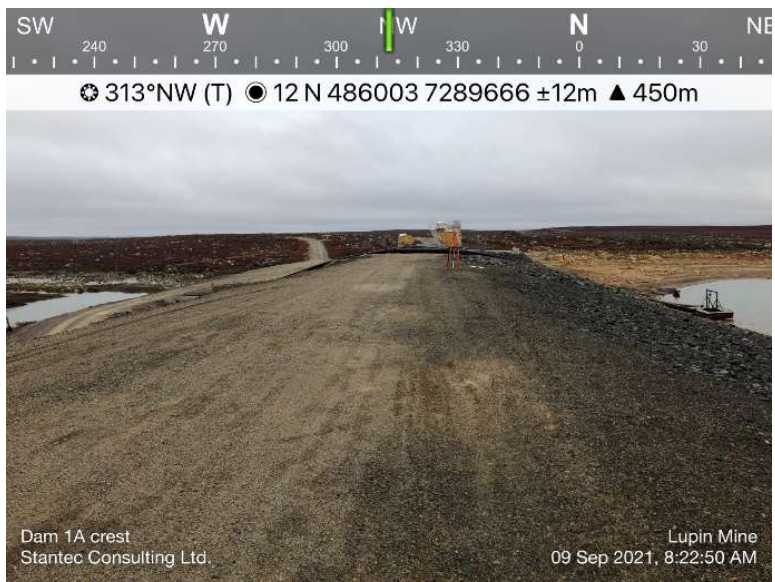
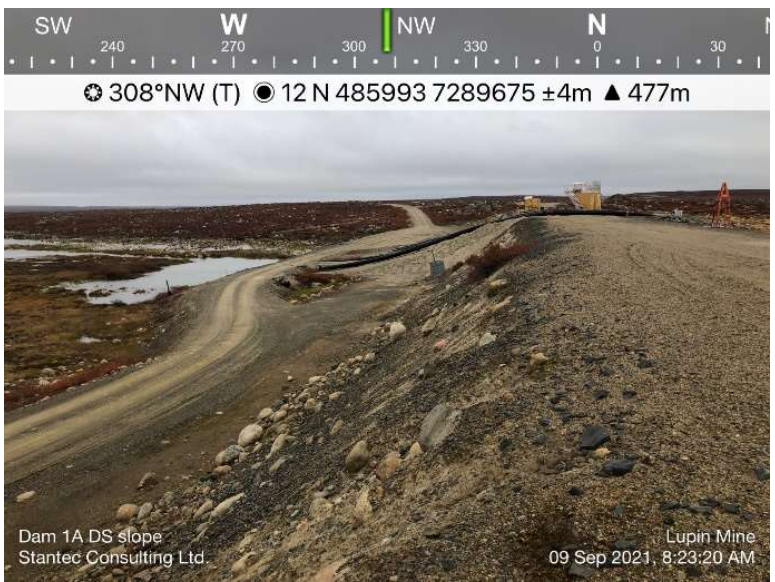
Photo 1: Looking northwest at the upstream slope of Dam 1A

Photo 2: Looking northwest at the crest of Dam 1A

Photo 3: Looking northwest at the downstream slope of Dam 1A

Inspection Item	2021 Inspection			2020 Inspection	
	Estimated Freeboard (m)	Observation	Recommendations	Observations	Recommendations
Perimeter Dams					
Dam 1A	6.25	Minor erosion on slopes with some deep erosion gullies. The damaged thermistor was repaired.	Repair deep erosion gullies if new deformation is observed.	Minor erosion on slopes with some deep erosion gullies. The thermistor was damaged.	Repair deep erosion gullies. Repair the thermistor if practicable.
Dam 1B	5.74	Pond 2 water was approximately >50m upstream from the dam.	Surface maintenance, e.g., grading and backfilling if new deformation is observed.	Pond 2 water was approximately 50m upstream from the dam.	Surface maintenance, e.g., grading and backfilling.
Dam 1C	5.66	Pond 2 water was approximately >50m upstream from the dam.	Surface maintenance e.g., grading and backfilling if new deformation is observed.	Pond 2 water was approximately 50m upstream from the dam.	Surface maintenance e.g., grading and backfilling.

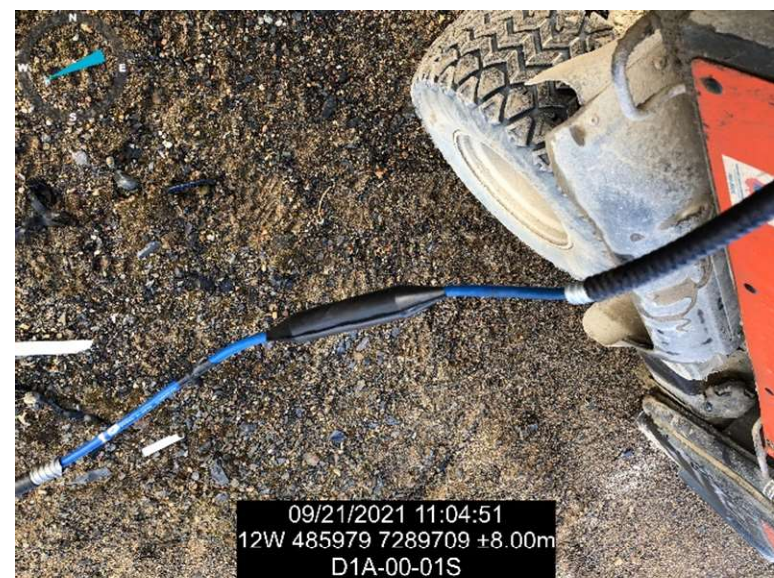
Photo 4: View of the repaired thermistor at Dam 1A.

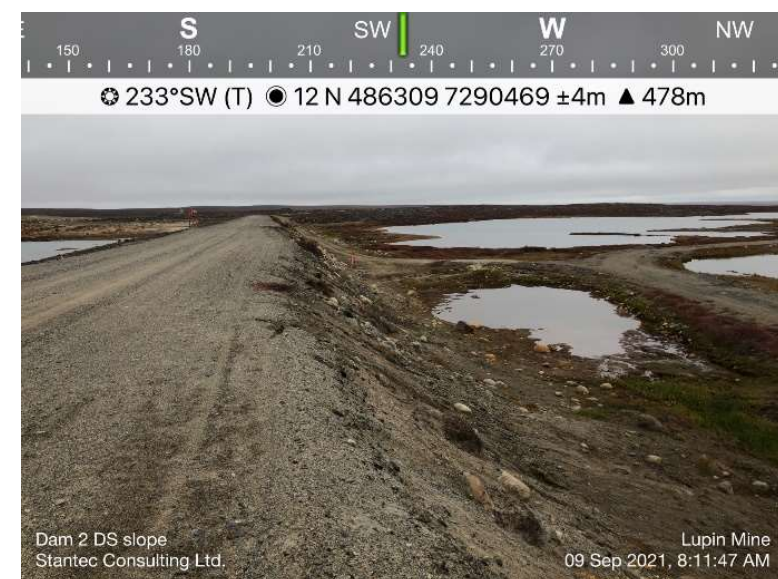
Previous annual inspections noted seepage from the northern toe buttress of Dam 2 into the seepage collection pond adjacent to the Dam 2 Lake. Seepage was not observed during the 2021 inspection, but water was seen to be present in the seepage collection pond. It was communicated on site that the seepage water should be pumped back to Pond 2 as per requirement.

Photo 11: Looking southwest at the downstream slope of Dam 2 with the seepage collection pond.

Dam 2	6.30	Minor erosion in the slopes. Seepage was not observed. Water was found in the seepage collection pond.	Repair the thermistor if practicable. Surface maintenance e.g., grading and backfilling if new deformation is observed. Pump seepage back into Pond 2.	Minor erosion in the slopes. Minor seepage was observed (<1L/min). Water was found in the seepage collection pond.	Surface maintenance e.g., grading and backfilling. Pump seepage back into Pond 2 (this was done after inspection overseen by EOR representative)
Dam 3	No water is impounded by this dam	Minor erosion in the downstream slope.	Surface maintenance e.g., grading and backfilling if new deformation is observed.	Minor erosion in the downstream slope.	Surface maintenance e.g., grading and backfilling.
Dam 4	5.95	Minor erosion in the slopes and wave erosion at HWM. One of the thermistors is damaged but could not be repaired in 2021 due to timing.	Surface and toe maintenance e.g., grading and backfilling if new deformation is observed. Repair the thermistor if practicable.	Minor erosion in the slopes and wave erosion at HWM. One of the thermistors is damaged.	Surface and toe maintenance e.g., grading and backfilling. Repair the thermistor if practicable.

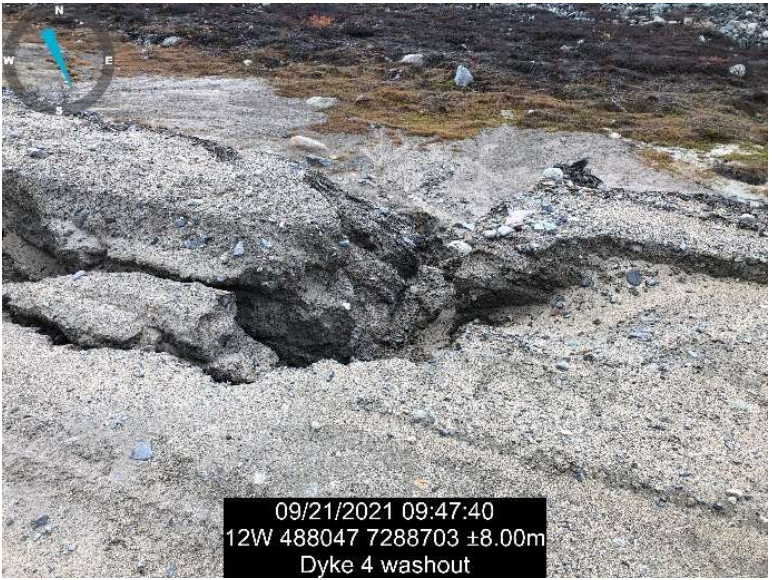
Photo 18: View of the erosion at the D/S crest of Dam 4 near the east abutment

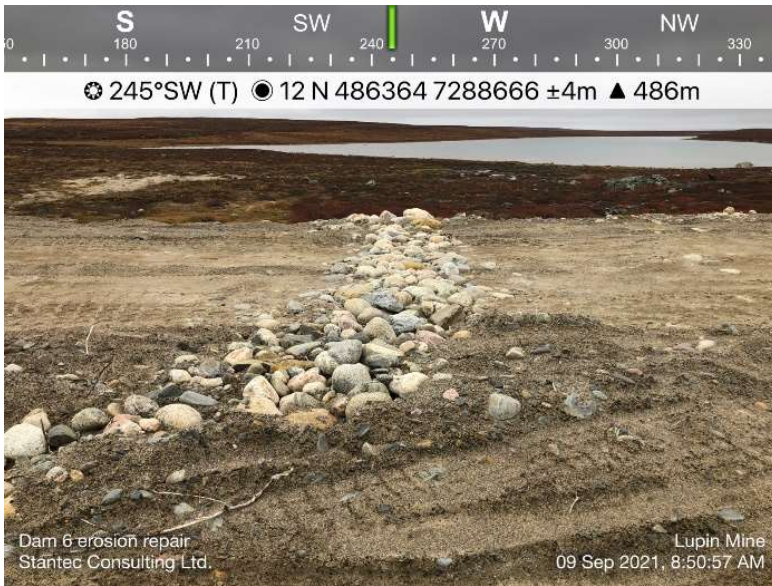
It was noted by the site engineer that a minor surface erosion occurred on Dam 6 during early freshet around the first week of June. The erosion is a shallow surface erosion, approximately 2m wide and 0.5m deep on the crest of Dam near the north abutment. Immediate active water management (pumping) was done to reroute the freshet water and the erosion was repaired with compacted coarse sand and gravel with cobble, under the supervision of the site engineer with direction from the EOR.

Photo 24: Looking southwest at the erosion repair at Dam 6.

Inspection Item	2021 Inspection			2020 Inspection	
	Estimated Freeboard (m)	Observation	Recommendations	Observations	Recommendations
Dam 6	N/A ⁽¹⁾	Shallow erosion occurred near the north abutment and immediately repaired with coarse sand gravel.	Monitor the repaired location for deformation and future freshet flow.	Ponding in a natural low at the south abutment. Erosion gullies in the downstream slope.	Surface maintenance e.g. grading and backfilling. Monitor the ponded water level near the south abutment.
Internal Dams					
Dam 3D	No water is impounded by this dam	Minor erosion in the slopes.	Surface and slope maintenance e.g., grading and backfilling if new deformation is observed.	Minor erosion in the slopes.	Surface and slope maintenance e.g., grading and backfilling.
Dam J	4.80	Over-steepened slope due to previous highwater erosion.	Repair the eroded slope with compacted sand and gravel if new deformation is observed prior to final closure.	Over-steepened slope due to erosion.	Repair the eroded slope with compacted sand and gravel.

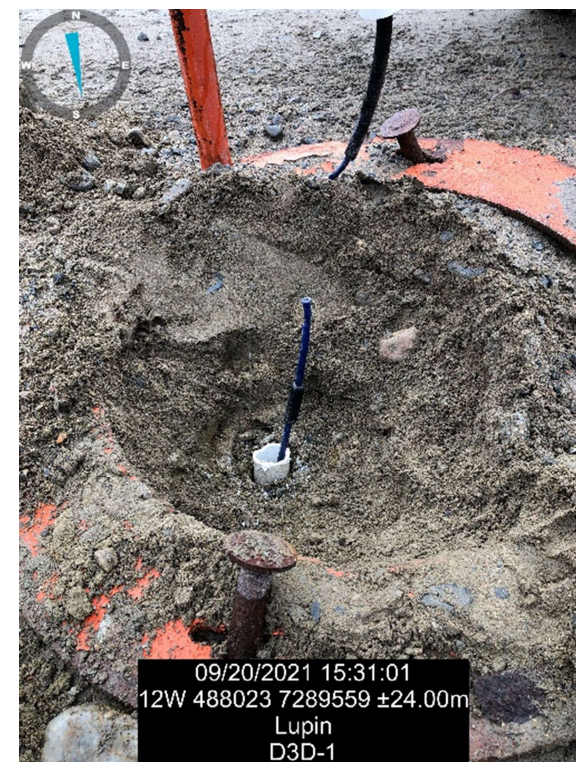
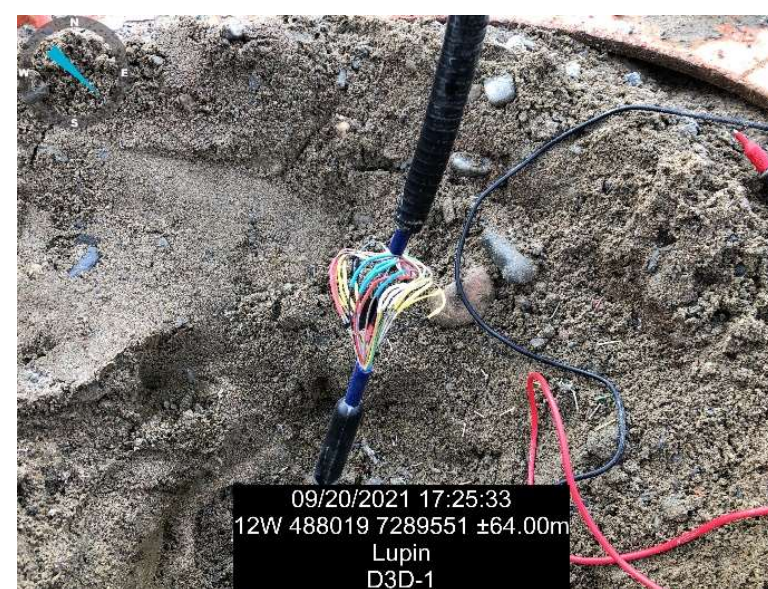
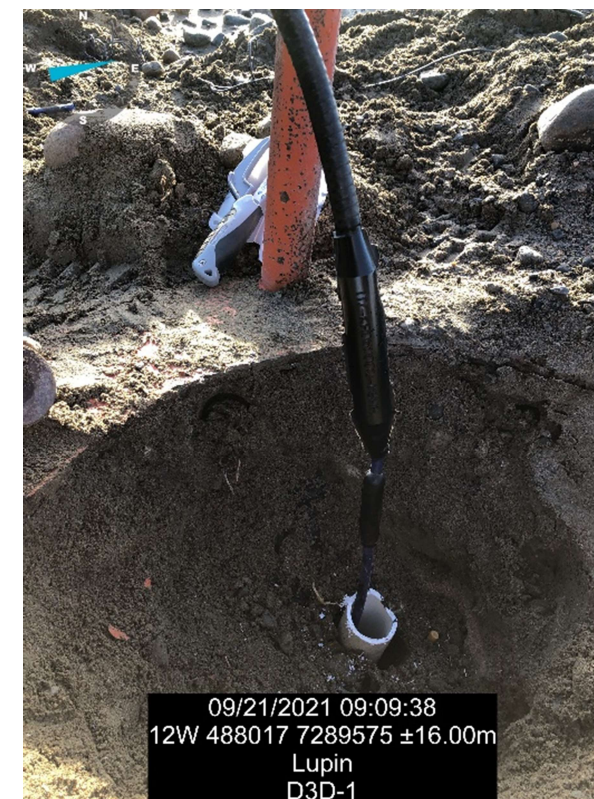
Photo 28: Exposing the damaged section of the damaged D3D thermistor

Photo 29: Reconnecting the damaged cables.

Photo 30: Finalized repair of the D3D thermistor.

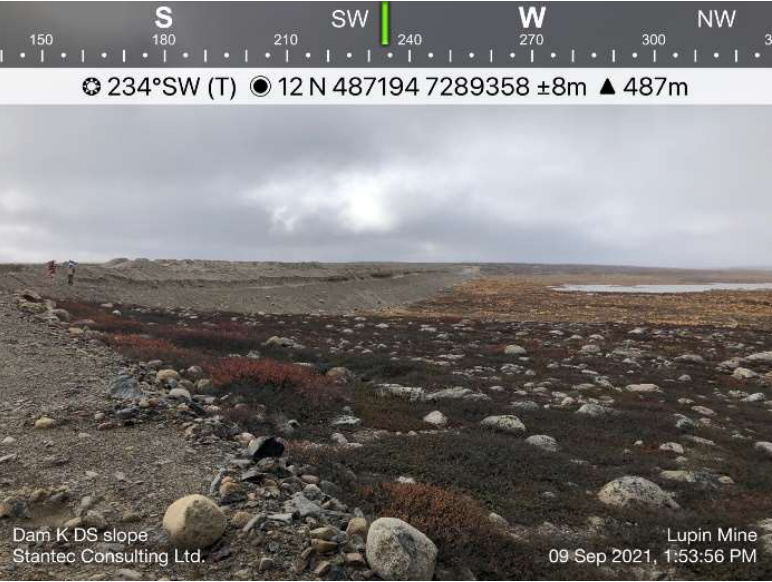
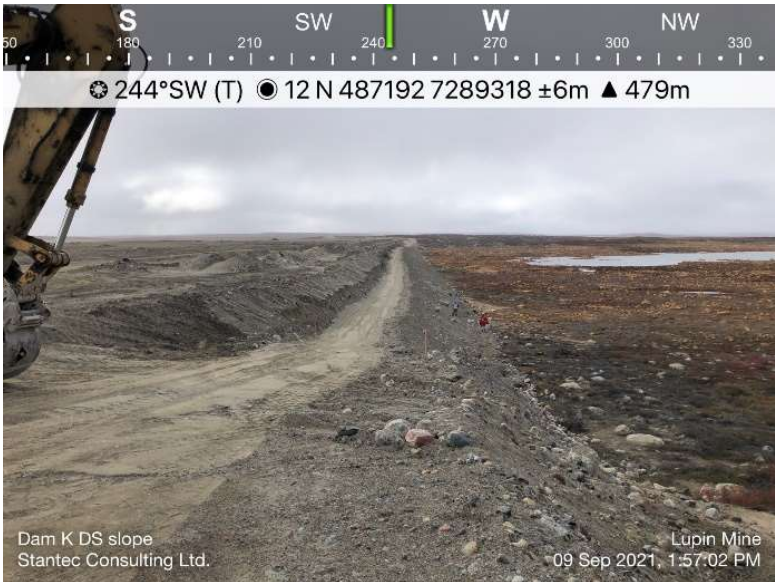
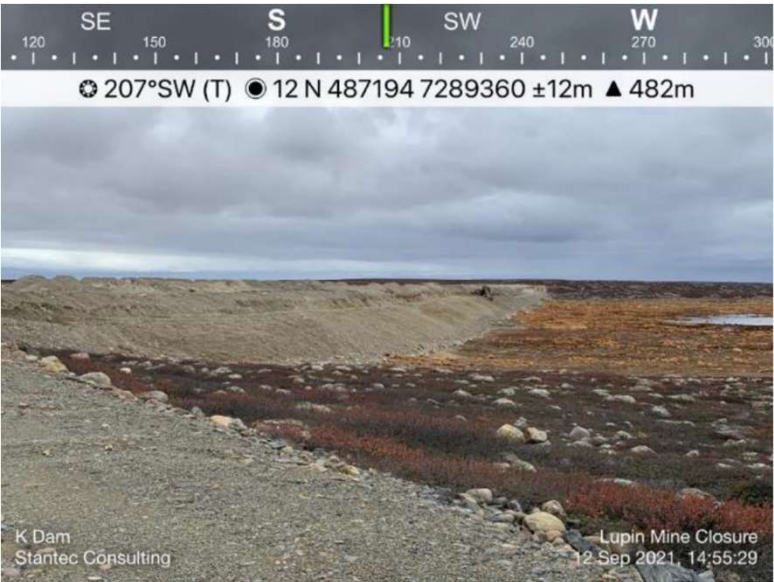
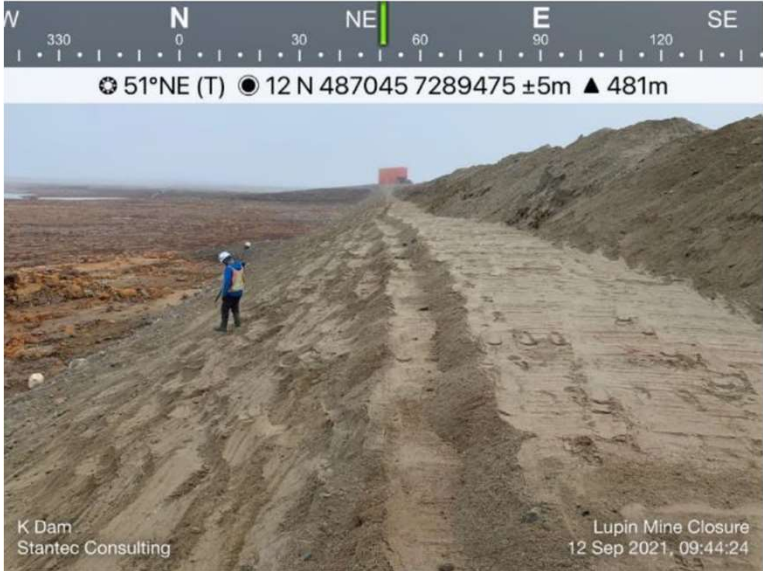
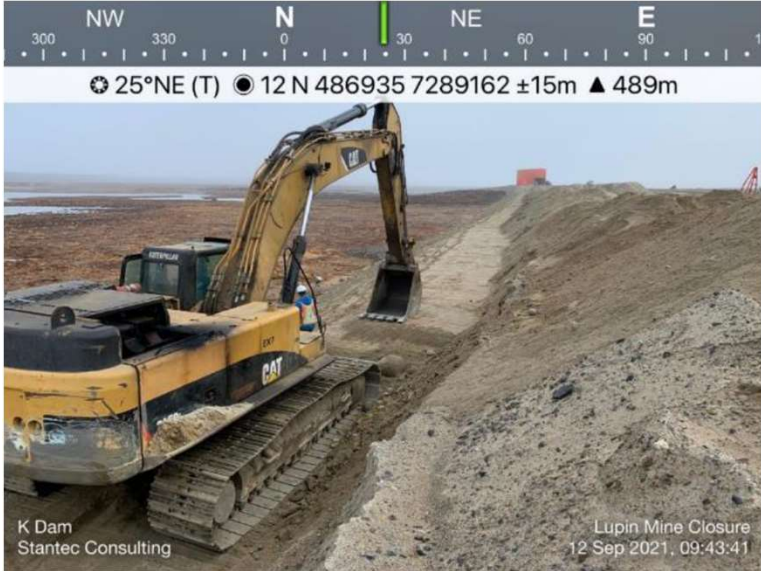
Dam K underwent closure construction and was resloped to 2H:1V or flatter. All of the deformations noted from previous years has been repaired as part of the closure activities. The reslope was done by partially excavating the buttress constructed last year and using the excavated fill in areas that needed material. The fill was compacted using a compactor where applicable and also compacted by the excavator bucket in thin lifts (<200mm) where the compactor could not be used. The closure construction was overseen by a designated EOR representative to ensure the reslope was constructed using appropriate material and compacted accordingly. A summary construction report (Stantec 2021a) was submitted to document the work done on Dam K.

Photo 31: Looking southwest at the resloping being constructed over the buttress at Dam K.

Photo 32: Looking southwest on the ongoing resloping work over the compacted buttress.

Photo 33: Looking southwest toward the south abutment of the reslope with compaction being carried out by the excavator.

Photo 34: Looking northeast at the reslope with thin layered compaction being carried out by the excavator.

Photo 35: Looking northeast at the reslope with thin layered compaction being carried out by the excavator.

Dam K	N/A ⁽¹⁾	Dam was resloped according to final closure design to 2H:1V or flatter with compacted sand with gravel.	Monitor the resloped location for deformation.	A reinforced buttress was constructed along the eroded toe. The erosion gullies at the crest have been repaired.	Finalize the re-slope of the buttress to 2H:1V design to achieve final closure configuration.
Dam L	4.72	Cell 3 cover was completed with surface channel leading to the outlet structure near the south abutment in Dam L. Work as done according to closure design and overseen by site engineer. All temporary structure from last year were removed prior to closure construction.	Monitor the outlet structure for deformation and performance issues.	A section of the dam was breached without authorization and backfilled without engineering supervision. The dam was raised by 0.8m temporary to manage freshet.	Monitor the proximity of the breach location for seepage, instability, and potential downstream damage from the water discharge.

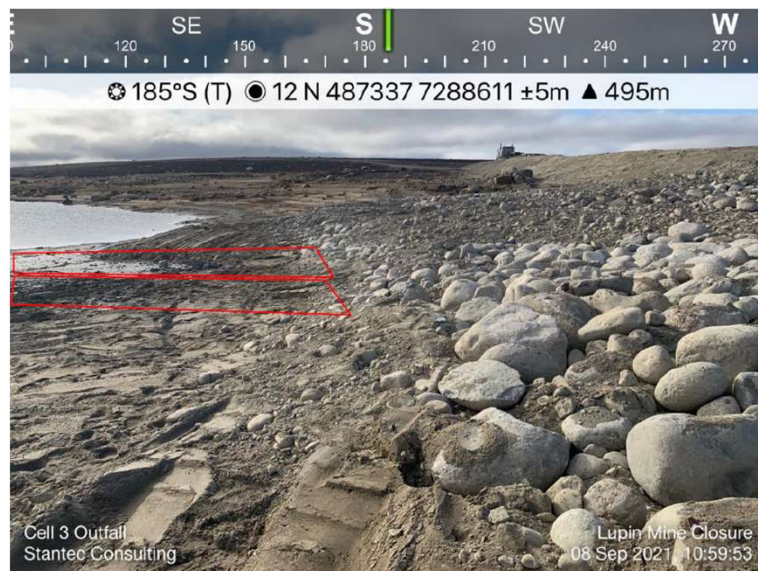
Photo 41: Cell 3 outlet that need to be field extended for transition into the shoreline.

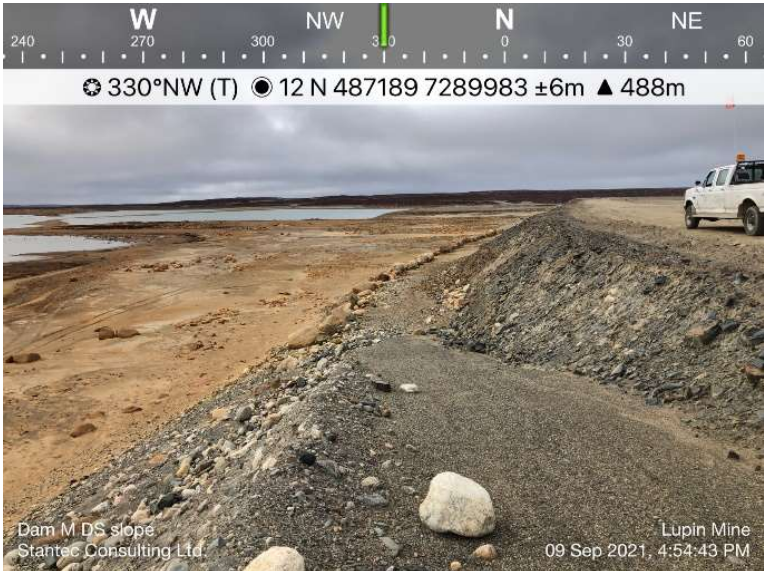
The buttress at Dam M experienced localized minor sloughing in 2020. During 2020 closure activities, a minor localized failure caused by a construction incident was observed by the EOR representative. This area was monitored

by the EOR representative throughout 2021 and further deformation was observed. Upon the 2021 inspection, it was determined that this localized failure does not impact the overall stability of Dam M and further repair was suspended to be completed during the final reslope to minimize risks.

Photo 45: Looking northwest at the reinforcement buttress of Dam M at the toe of the dam.

Dam M	No water is impounded by this dam	No new observable deformations along Dam M, including the 2020 incident area. Cell 5 cover is completed, and ponding	Repair the sloughed section of the buttress and the localized failed section once the water level is lowered. Re-slope the	Sloughing in localized sections of the buttress due to raised water level during 2020 freshet. A construction incident has caused a	Repair the sloughed section of the buttress and the localized failed section once the water level is lowered. Re-slope the

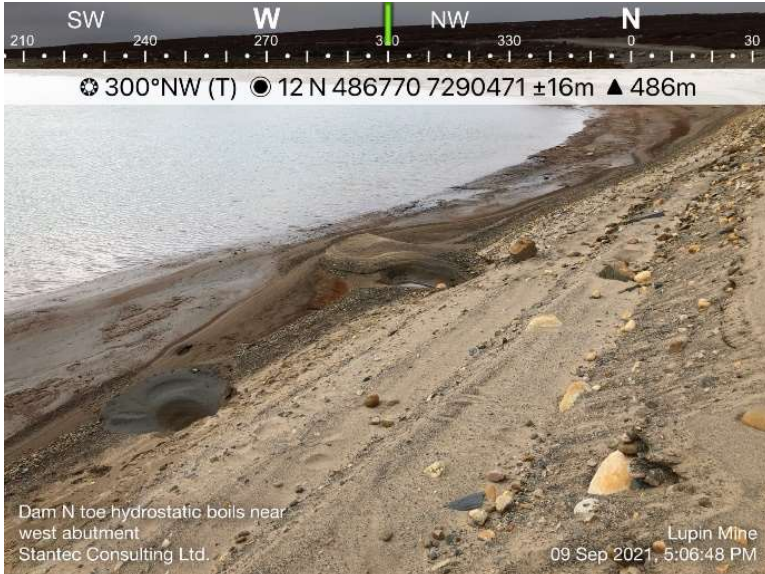
There was visual evidence of a couple of small sand boils noted along the toe of Dam N, although they were not actively showing seepage or flow at the time of inspection. Based on communication with the site engineer, it is surmised the sand boils were caused by excess pore pressure from construction traffic on the Cell N cover. This area has been monitored since and no active flow was observed. The area will be monitored in 2022 during the Cell N construction.

Photo 49: The tailings boils observed near the north abutment of Dam N

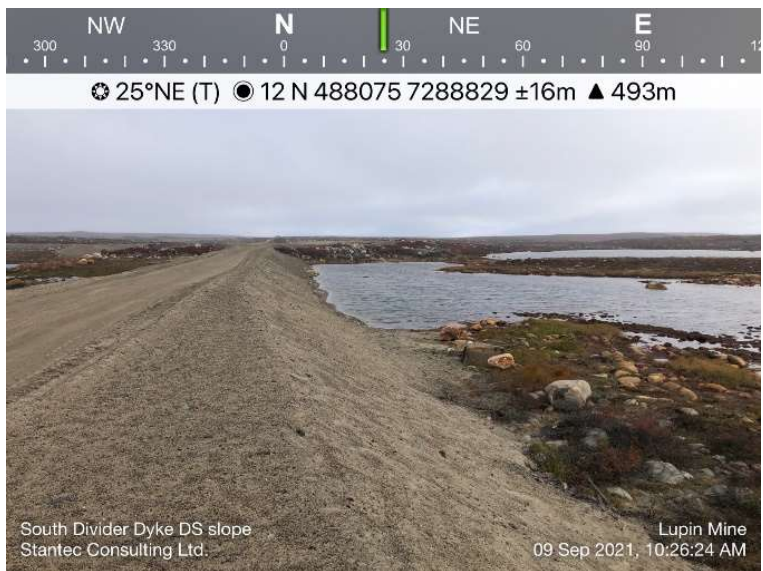
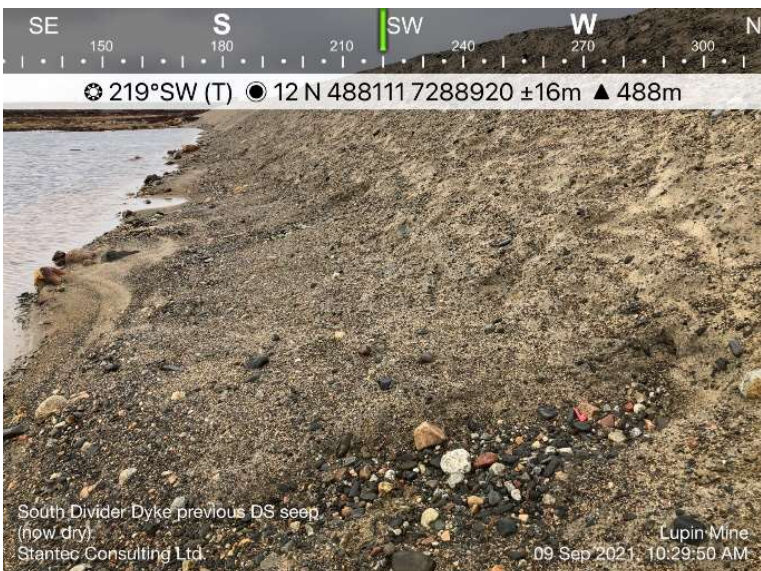
Photo 51: Looking northeast at the downstream slope and the old seepage zones at the toe of the divider dyke. No seepage was observed.

Photo 52: Looking southwest at one of the old seepage zones at the toe and no seepage is observed.

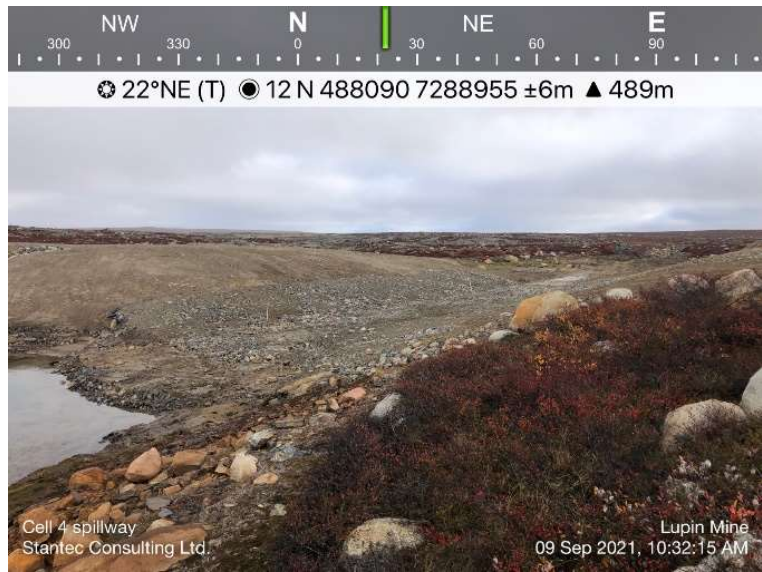
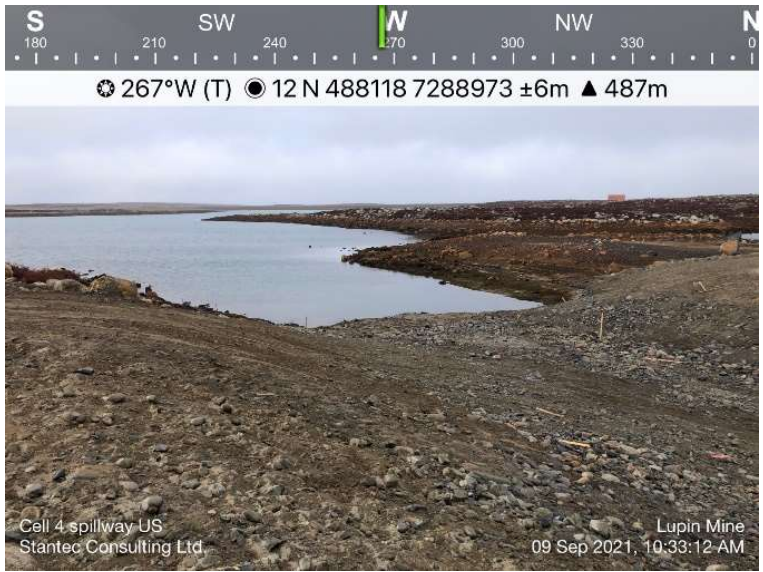
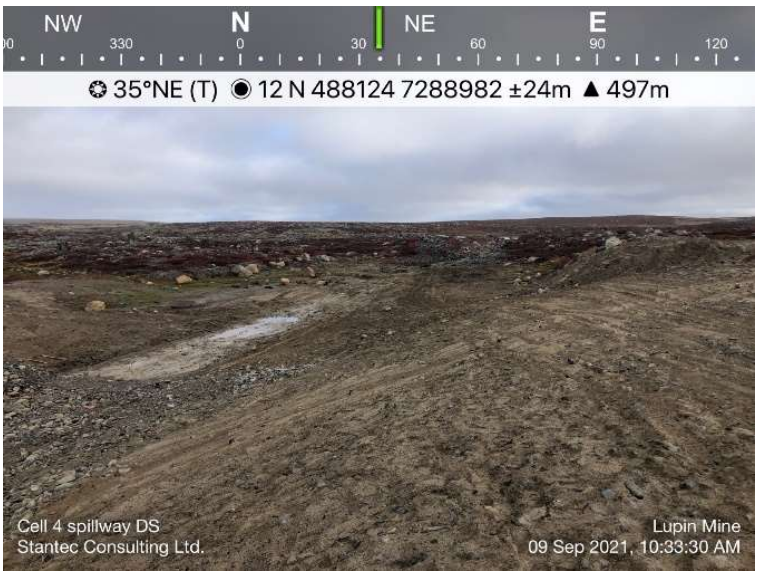
An engineered spillway was constructed through the Divider Dyke along the old culvert alignment. The spillway is passively controlling the Cell 4 water level at El. 484m. The lowered water effectively rendered the Divider Dyke to be an overland feature as it will no longer retain Cell 4 water. As the water was lowered to below the dam, the seepages noted last year were not observed in 2021. The closure work was overseen by the EOR representative to ensure quality assurance. A summary construction report (Stantec 2021d) was submitted to document the work done in the Divider Dyke.

Photo 53: the newly constructed Cell 4 spillway through the Divider Dyke.

Photo 54: the inlet of Cell 4 spillway through the Divider Dyke.

Photo 55: the outlet of Cell 4 spillway through the Divider Dyke into the Chain Lake area.
