## Technical Memorandum

**Date:** 16 June 2007

**RE:** AWPAR Stream Crossing Monitoring Reconnaissance, 15 June 2007

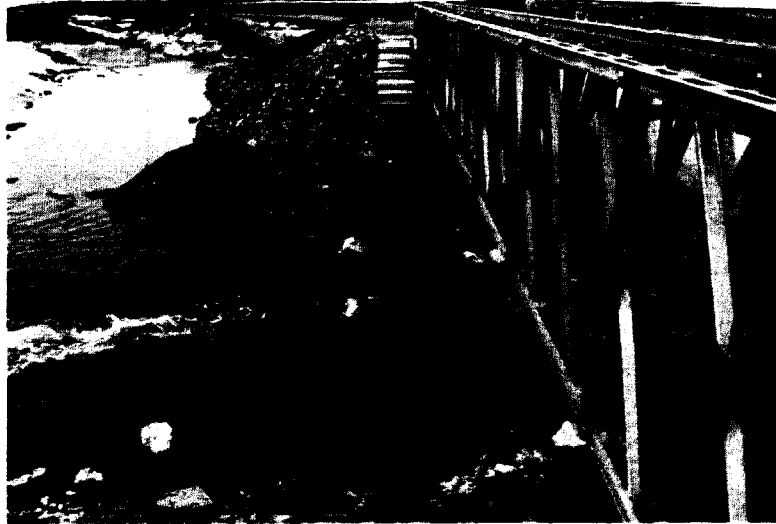
- Stockpiled materials in or immediately adjacent to the currently wetted channel (one U/S N side<sup>1</sup>; two D/S S side) (**Photos 1 and 2**) – these materials consist of a range of size classes including relatively fine grains. The piles should be removed with a backhoe and moved well away from the stream channel. Larger material (e.g., boulders) from the stockpiles should be retained and used for increased stabilization of abutment on the U/S S side. Work from the N side will require entering the stream for access, however the substrate in the access zone consists primarily of boulders and the activity poses much less risk than the inevitable consequences of inaction<sup>2</sup>.

**Photo 1. R02 – Stockpiled materials at stream margin (U/S N side).**

Conducting this work is considered **high priority**.
