## Technical Memorandum

**Date:** 19 June 2007

**RE:** AWPAR Mitigation Update 19 June 2007

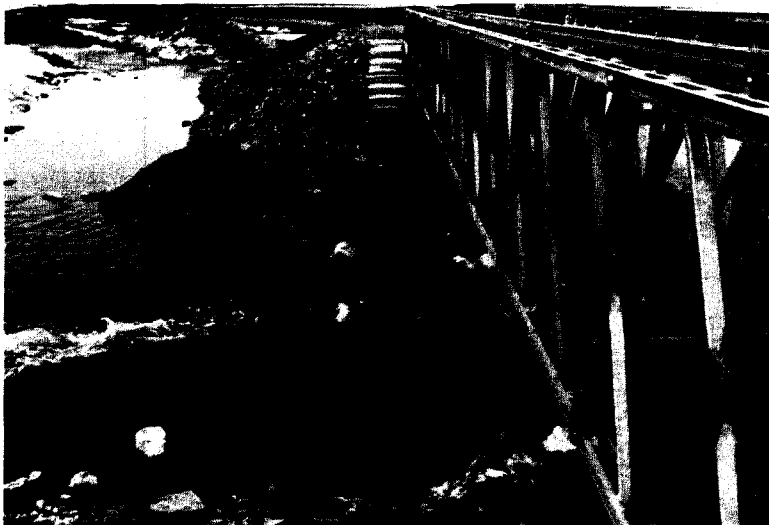
- **R02** – The issues:
  - Stockpiled materials in or immediately adjacent to the currently wetted channel (one U/S N side<sup>1</sup>; two D/S S side) – The two D/S S side stockpiles were excavated with a backhoe on June 16 (see photos). Detailed monitoring was conducted downstream as these stockpiles were right in the channel; water quality findings as described above. Water levels were too

**Photo 1. R02 – Stockpiled materials at stream margin (U/S N side) (15Jun07).**

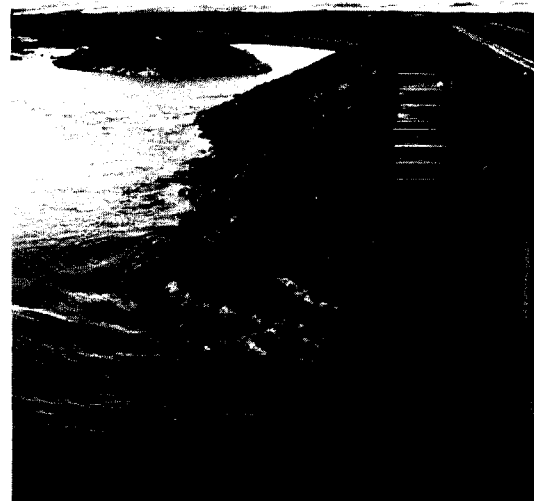
high to safely access the U/S N stockpile (comprised of primarily of gravel-sized or larger material); this pile was washed downstream by strong flows on June 18.

**Photo 2. R02 –U/S N side stockpile unreachable due to high water (18Jun07).**

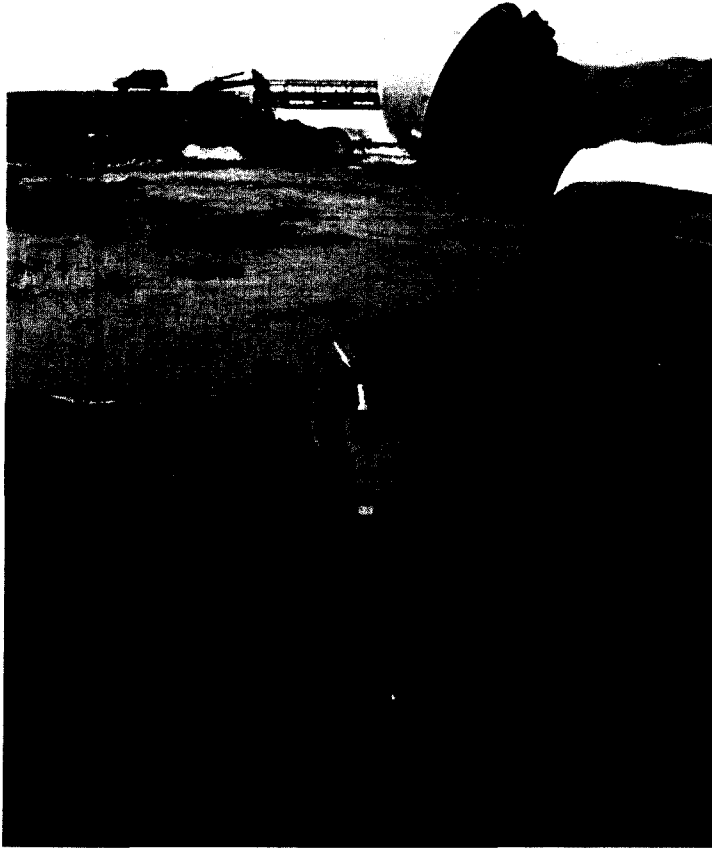
Water quality remains generally good based on continued turbidity monitoring. Downstream conditions have been assessed in detail, with turbid water being found primarily in localized pockets (if present at all) along the channel margins and immediately adjacent to the bridge approaches; these collectively comprise a negligible proportion of the channel and discharge as a whole.

**Photo 5. R02 – Turbidity monitoring downstream during stockpile removal (D/S S side) (16Jun07)**

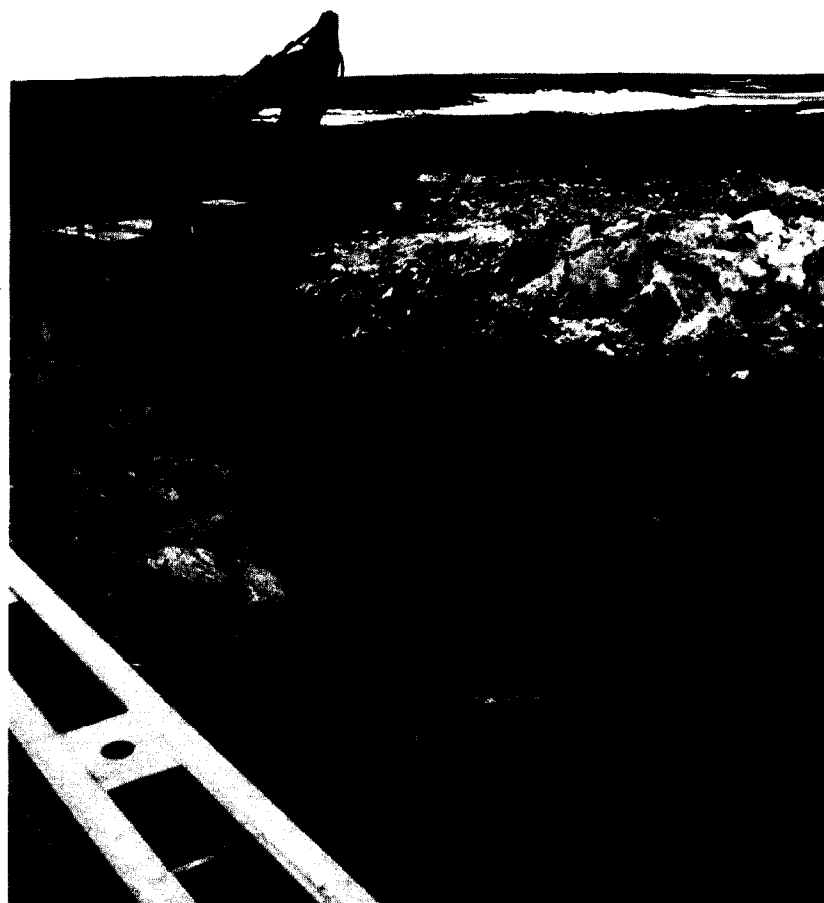
**Photo 8. R02 – Adding boulders to stabilize unstable bank area (U/S S side) (17Jun07)**

**Photo 9. R02 – Adding boulders to stabilize unstable bank area (U/S S side) (17Jun07)**

- Unstable bank/riparian area associated with ice bridge approach (U/S S side) – This area was partially addressed on June 17, with larger materials collected from the D/S stockpiles. Coverage by the larger material was not adequate and placement of large gravel/small cobble material was recommended to fill in the gaps and provide further stabilization. This work was scheduled for completion by June 20.

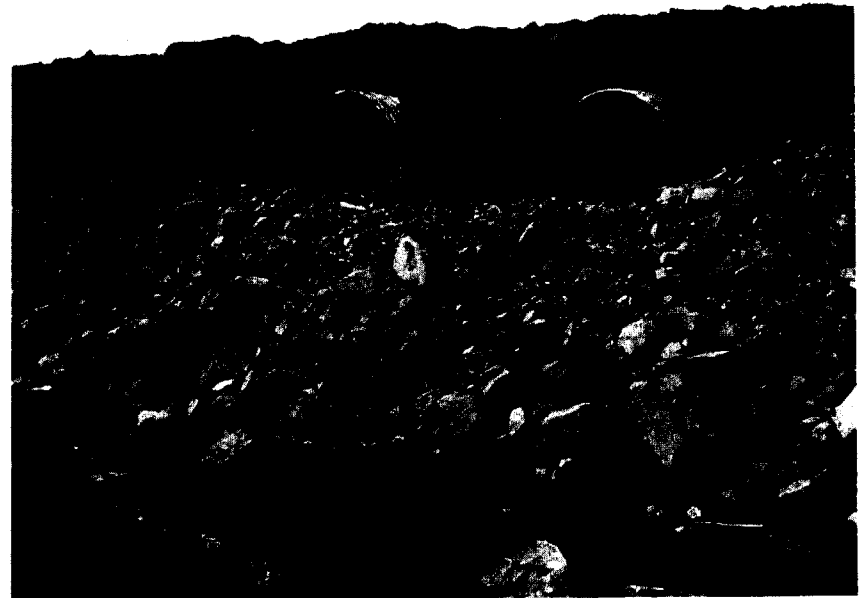
**Photo 12. R02 – D/S side showing newly added culverts and road material (19Jun07).**

- **Seepage through approach on N side of channel** – This new task was made **high priority** on June 18, when rising water levels were approaching road height. It is clear that this long approach (approximately 80 meters of encroachment into the stream channel) will likely require several culverts to mitigate through-road seepage and associated road stability problems. Several options were considered (raise road level, cut temporary spillway, install culvert), but a combination of all three was selected to maximize road stability and hence provide the greatest control of potential sedimentation. A culvert was installed at slightly below former road height to act as a spillway and the road was built up approximately 0.75 m over the previous height. This work was completed on June 19 and will be monitored for success.

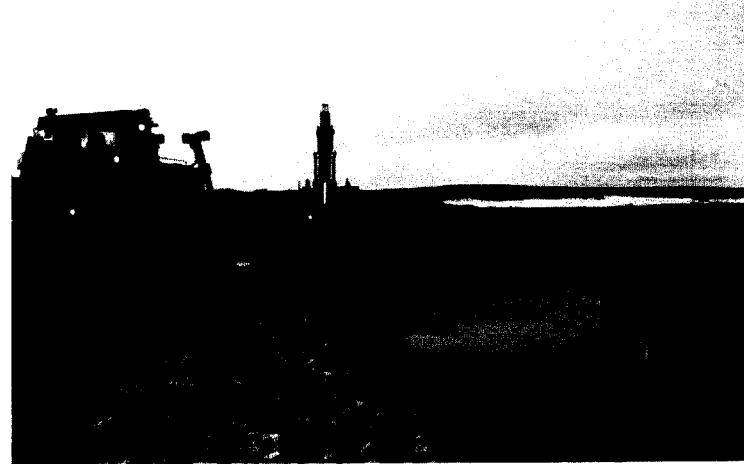
**Photo 14. R07 – Sediment settling pond with silt curtain while road is being raised (18Jun07)**

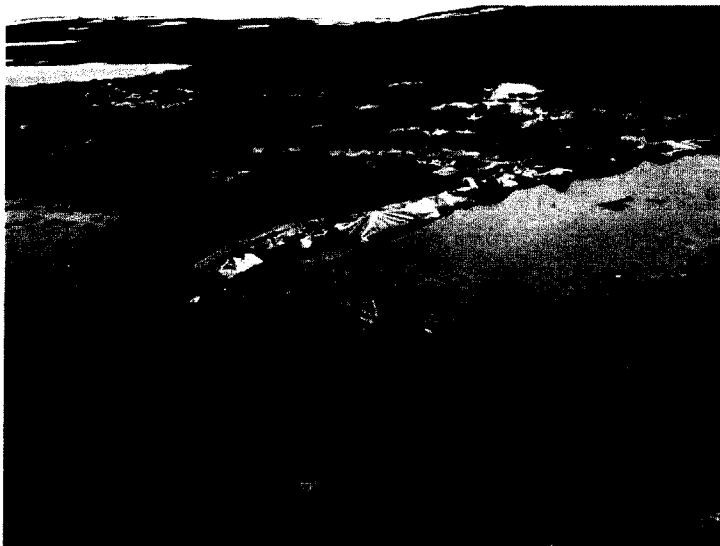
**Photo 15. R07 – Settling pond showing clear water (19Jun07)**
