# Nunavut Impact Review Board 2019

## Site Visit Report

***Meadowbank Gold Project*** (NIRB File No. 03MN107) and ***Whale Tail Pit Project*** (NIRB File No. 16MN056)

Agnico Eagle Mines Ltd.

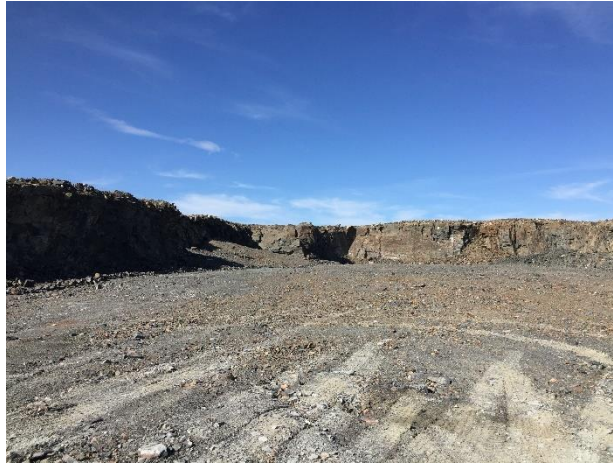
- d) As in previous years, remediation has been ongoing at Quarry 22 following storage of contaminated hydrocarbon soil in previous years with the soil/gravel still testing positive for hydrocarbons (see [Photo 10](#)). No remediation work was conducted in 2018 and 2019 due to active Peregrine Falcon nests at this quarry, but plans were in place to continue the remediation work in September 2019.

**Photo 10: Quarry 22 along the AWAR**

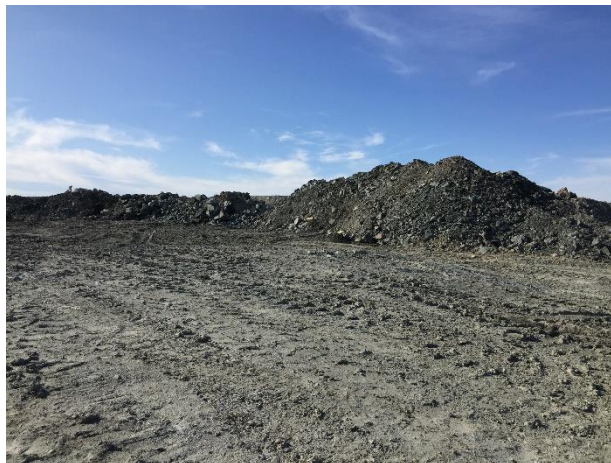
- e) During the site visit, it was observed that the second landfarm constructed in 2017 continues to operate with the addition of on-site nutrients (sewage sludge) to assist in the biodegradation of contaminated hydrocarbon soils (see [Photo 20](#)). The original landfarm, developed in 2013 and located next to the South Cell Tailings Facility was flooded with tailings deposition in 2017.

**Photo 20: Landfarm at Meadowbank Mine Site**

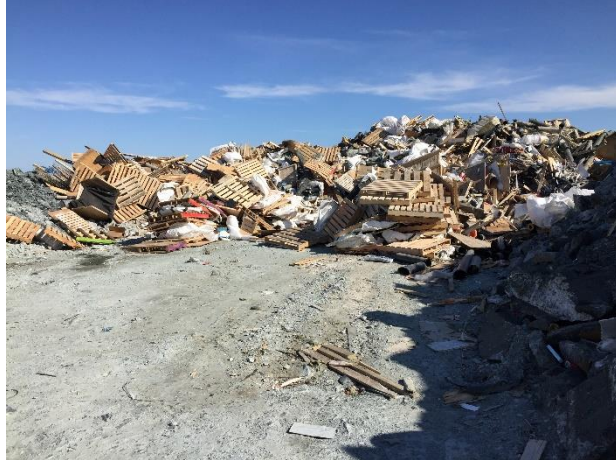
- f) As per previous NIRB site visits, and during the 2019 site visit that Agnico Eagle continues to segregate and store all domestic, hazardous, and combustible wastes in marked seacans prior to these materials being incinerated or shipped to the appropriate and approved off-site disposal facilities (see [Photo 21](#)).
- g) Agnico Eagle stated that the landfill is frequently inspected by employees to ward off any wildlife that may be present, to ensure wastes are segregated appropriately, and that wastes designated to the incinerator or metal dump do not end up in the landfill (see [Photo 22](#)).

**Photo 22: Landfill at Meadowbank mine site**

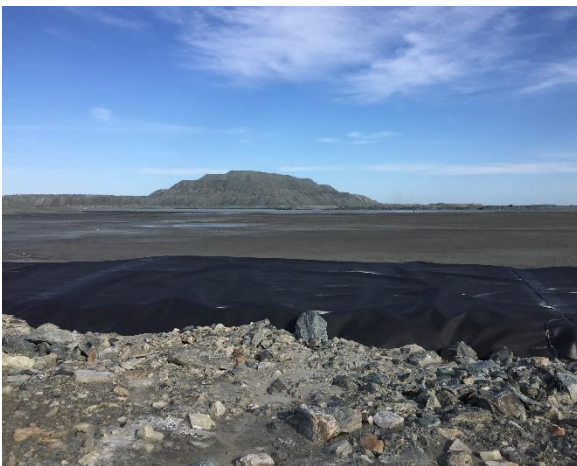
During the site visit, NIRB staff observed that reclamation was ongoing at the North Cell of the tailings storage facility and it was noted that reclamation has not commenced at the South Cell. Agnico Eagle staff stated that tailings will continue to be deposited into South Cell until the cell is full (see [Photo 27](#) and [Photo 28](#)).

**Photo 27: Tailings Storage Facility – North Cell**

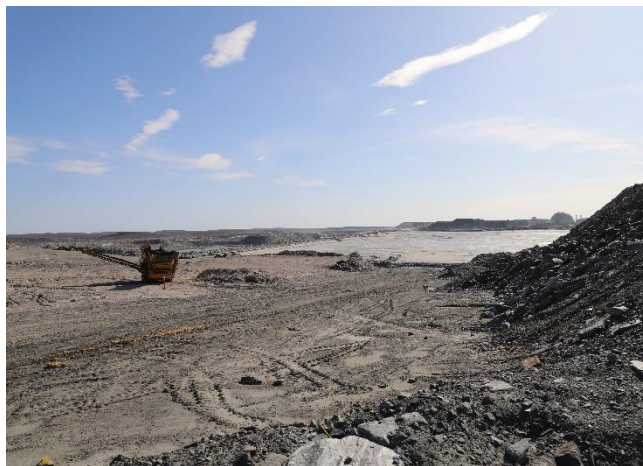
**Photo 28: Tailings Storage Facility – South Cell**

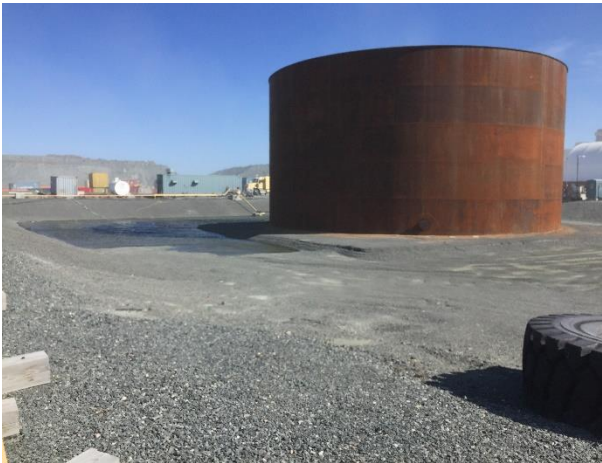
Water was observed within the secondary storage containment facilities for the fuel tank farms but there was no visible sheen on the water or discernable hydrocarbon odours at either the Baker Lake or the Meadowbank site fuel facilities (see [Photo 29](#) to [Photo 32](#)). The liner at the Baker Lake Fuel Storage facility was exposed and it was noted by Agnico Eagle staff that this may be due to the amount of rainfall over the summer that washed away the gravel that usually covers the liner. No indication was provided on whether or not the liner would be fixed or covered with gravel.

**Photo 31: Meadowbank Fuel Tank Farm Facility**

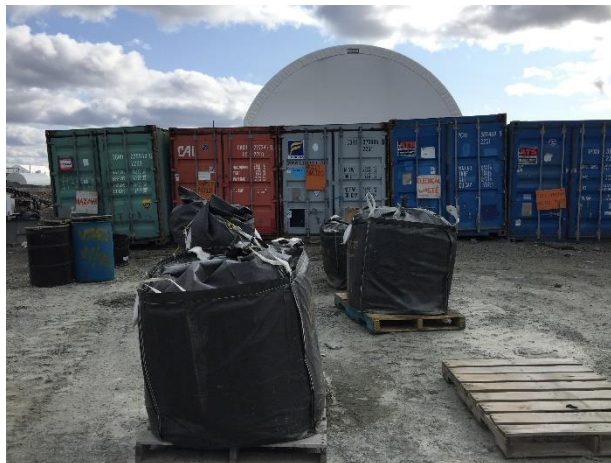
- c) It was noted during the 2019 site visit that Agnico Eagle had started to segregate and store all domestic, hazardous, and combustible wastes in marked seacans prior to these materials being incinerated at the Meadowbank site or shipped to the appropriate and approved off-site disposal facilities (see [Photo 47](#)).

**Photo 47: Seacans used for waste segregation and storage area at Whale Tail Site**

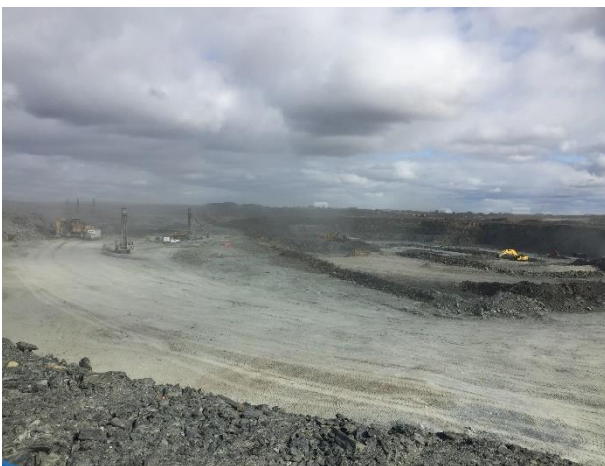
During the site visit, it was noted that dust suppressants were not being applied to the whole AWAR (see [Section 3.2.3.2](#) for further discussion), along the haul-road to the Whale Tail site nor at the Whale Tail site. Agnico Eagle noted that water is the only dust suppressant being used along the Haul-road; however, none was applied due to the heavy rains received. Further, it was observed during the site visit that no dust suppressants were applied at the Whale Tail site including at the North Basin Pit which was later confirmed by the Agnico Eagle staff (see [Photo 41](#), [Photo 49](#) and [Photo 50](#)). The reason for not applying suppressants at the time was due to the heavy rains received in August. Dust monitoring continues to be conducted along multiple stations along the Haul-road which was observed during the site visit (see [Photo 51](#)).

**Photo 49: Dust over the North Basin Pit**

Term and Condition 2 requires that the Proponent verify commitments to the utilization of dust suppressants along the AWAR, the Amaruq Haul-road and any other roads and trails associated with the Project. To date, this condition has not been met by the Proponent as dust suppressants have not been employed along the whole AWAR, the Amaruq Haul-road and the Whale Tail Pit site roads.

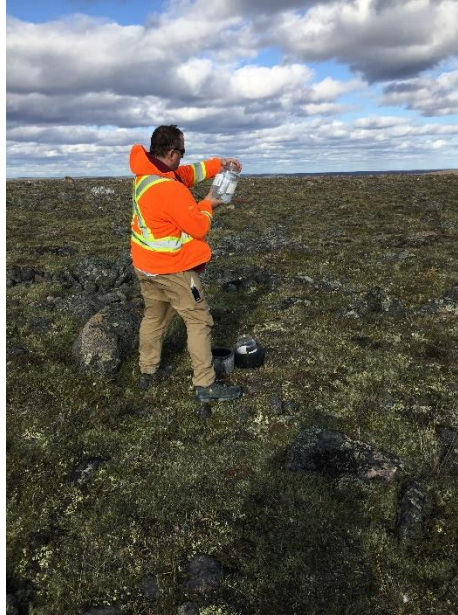
**Photo 51: Dust Monitoring Station along the Haul-road**
