# Nunavut Impact Review Board 2019

## Site Visit Report

***Meadowbank Gold Project*** (NIRB File No. 03MN107) and ***Whale Tail Pit Project*** (NIRB File No. 16MN056)

Agnico Eagle Mines Ltd.

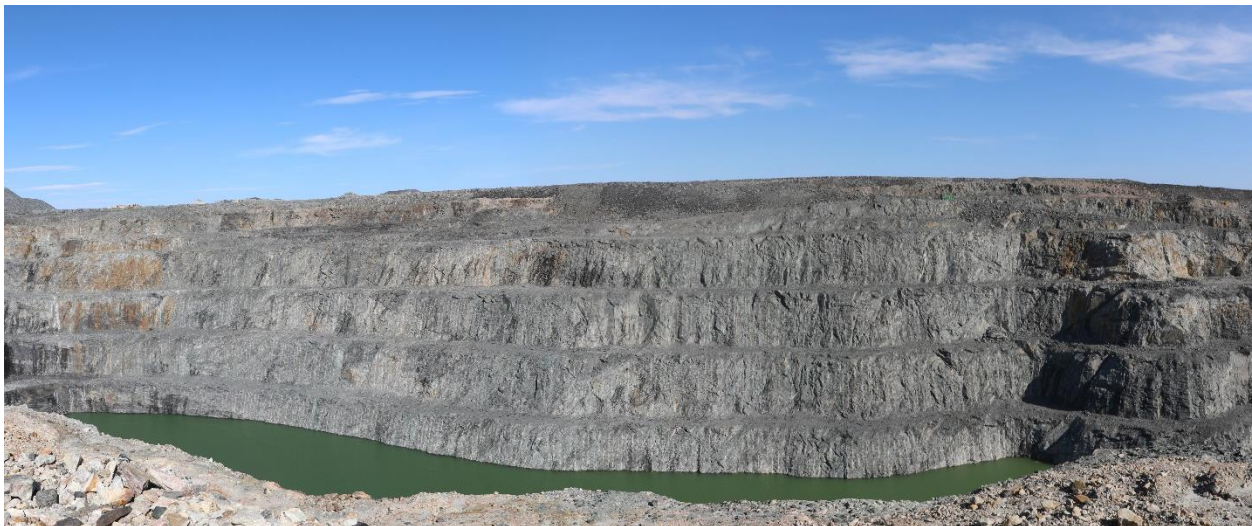
- a) Active drilling was ongoing at Portage Pit (see [Photo 11](#) and [Photo 12](#)), while mining ended earlier in the year at Vault Pit (see [Photo 13](#) and [Photo 14](#)) and at the Phaser and BB Pits (see [Photo 15](#) and [Photo 16](#)). Mining at the Goose Pit had ended in early 2015 and the pit has been allowed to slowly fill in naturally with water (see [Photo 17](#))
- b) As noted last year, an ice sheet was observed on the walls of the Vault Pit (see [Photo 13](#)) and it continues to be there this year.
- c) During the site visit, tailings were being disposed of into Goose Pit (see [Photo 18](#)) as one of the two (2) in-pit tailings facilities at the time of the site visit.

**Photo 11: Portage Pit A**

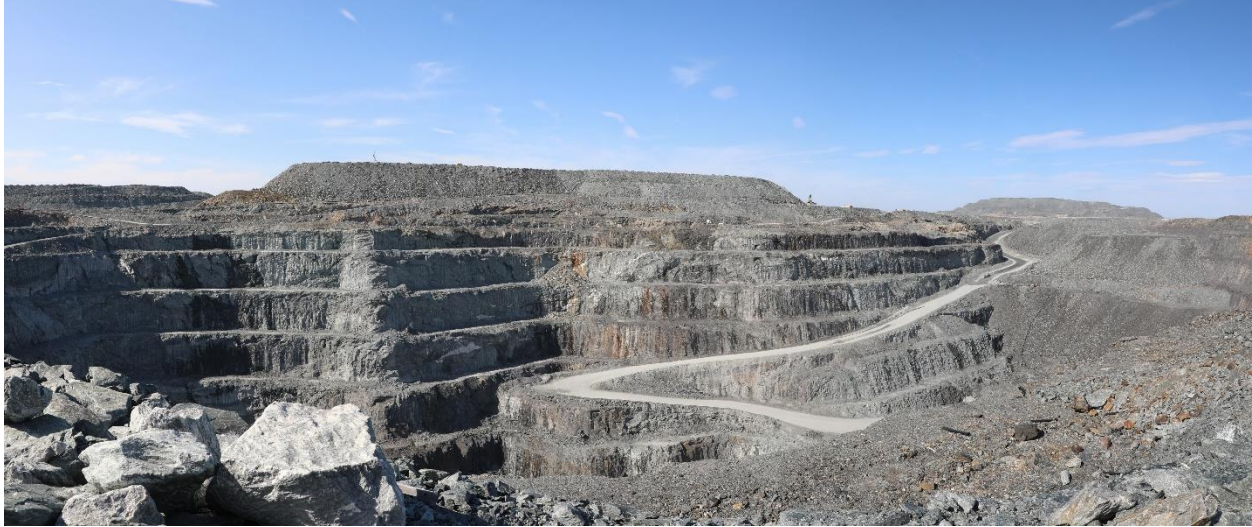
**Photo 12: Portage Pit E**

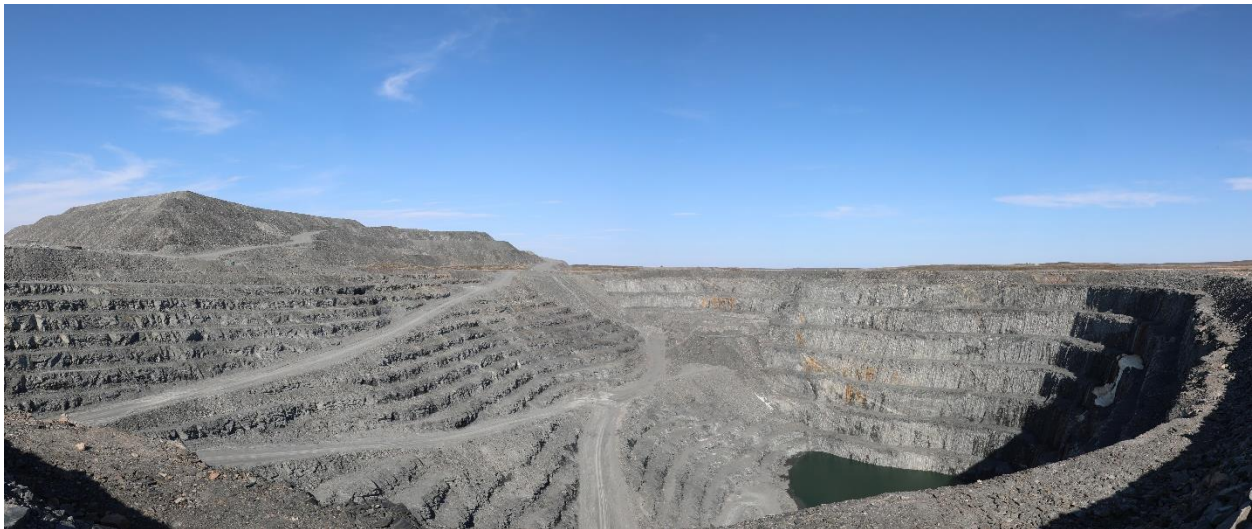
**Photo 13: Vault Pit – looking east**

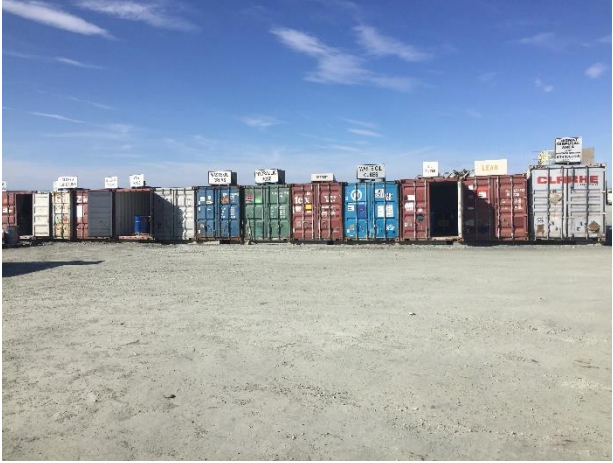
- f) As per previous NIRB site visits, and during the 2019 site visit that Agnico Eagle continues to segregate and store all domestic, hazardous, and combustible wastes in marked seacans prior to these materials being incinerated or shipped to the appropriate and approved off-site disposal facilities (see [Photo 21](#)).
- g) Agnico Eagle stated that the landfill is frequently inspected by employees to ward off any wildlife that may be present, to ensure wastes are segregated appropriately, and that wastes designated to the incinerator or metal dump do not end up in the landfill (see [Photo 22](#)).

**Photo 21: Seacans used for waste segregation and storage area at Meadowbank Mine Site**

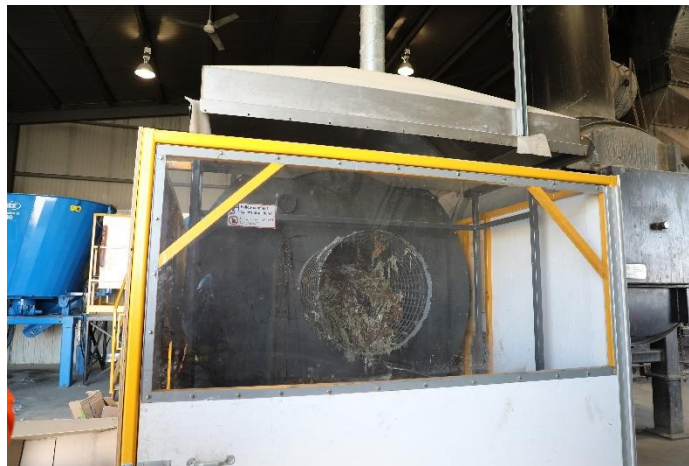
- h) In 2019 Agnico Eagle started a composting program located at the incinerator building with the compost materials being disposed of at the landfill (see [Photo 23](#)). The composter was installed to reduce the quantity of waste burned by the incinerator.

**Photo 23: Compost program at the incinerator building**

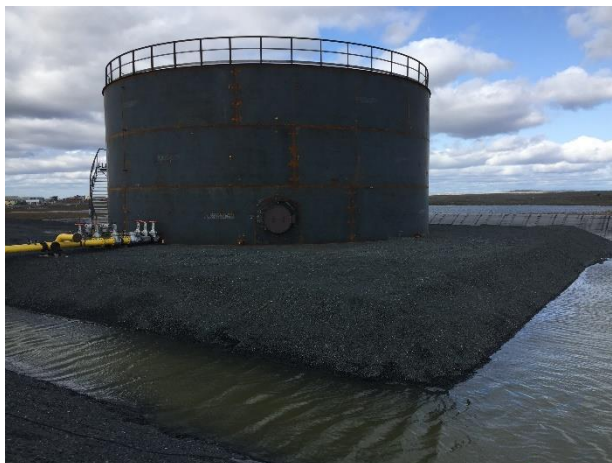
- d) Water was observed within the secondary storage containment facility for the fuel tank farm at the Whale Tail Pit site but there was no visible sheen on the water or discernable hydrocarbon odours (see [Photo 48](#)).

**Photo 48: Whale Tail Pit Fuel Tank Farm Facility**

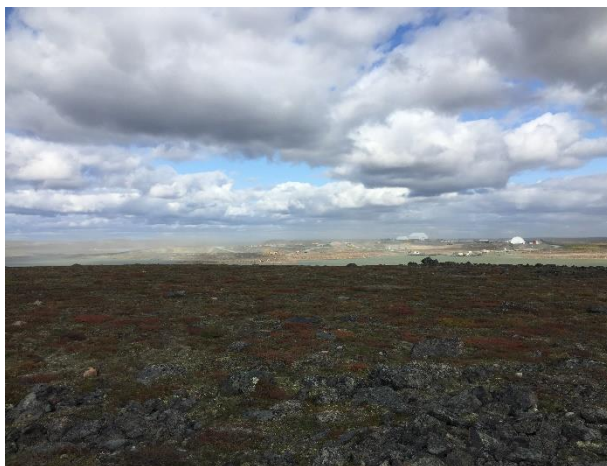
During the site visit, it was noted that dust suppressants were not being applied to the whole AWAR (see [Section 3.2.3.2](#) for further discussion), along the haul-road to the Whale Tail site nor at the Whale Tail site. Agnico Eagle noted that water is the only dust suppressant being used along the Haul-road; however, none was applied due to the heavy rains received. Further, it was observed during the site visit that no dust suppressants were applied at the Whale Tail site including at the North Basin Pit which was later confirmed by the Agnico Eagle staff (see [Photo 41](#), [Photo 49](#) and [Photo 50](#)). The reason for not applying suppressants at the time was due to the heavy rains received in August. Dust monitoring continues to be conducted along multiple stations along the Haul-road which was observed during the site visit (see [Photo 51](#)).

**Photo 50: Dust over the Whale Tail site**

Term and Condition 2 requires that the Proponent verify commitments to the utilization of dust suppressants along the AWAR, the Amaruq Haul-road and any other roads and trails associated with the Project. To date, this condition has not been met by the Proponent as dust suppressants have not been employed along the whole AWAR, the Amaruq Haul-road and the Whale Tail Pit site roads.
