Full Report Title: 2012 Site Visit Report for the Nunavut Impact Review Board's Monitoring of Agnico-Eagle Mines Ltd.'s Meadowbank Gold Project (NIRB File No. 03MN107)

Project: Meadowbank Gold Project
Project Location: Kivalliq Region, Nunavut

Site visit dates: September 12-13, 2012
Last site visit: September 12-13, 2011

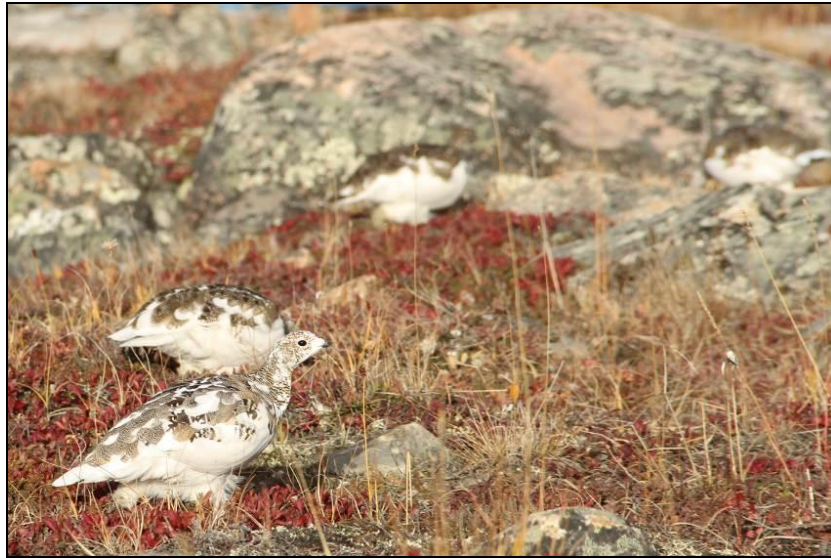
- a. While travelling along the access road to and from the Meadowbank site and the hamlet of Baker Lake, the Monitoring Officer noted some wildlife, including muskoxen, Ptarmigan, Sandhill cranes, Snow geese (and blue geese) and Northern Pintail. Very little wildlife was observed at site; Willow Ptarmigan was observed near the air monitoring station and a pair of loons flew over the Bay-Goose Dike (Photo 1).

Photo 1: Willow Ptarmigan observed around the Meadowbank site

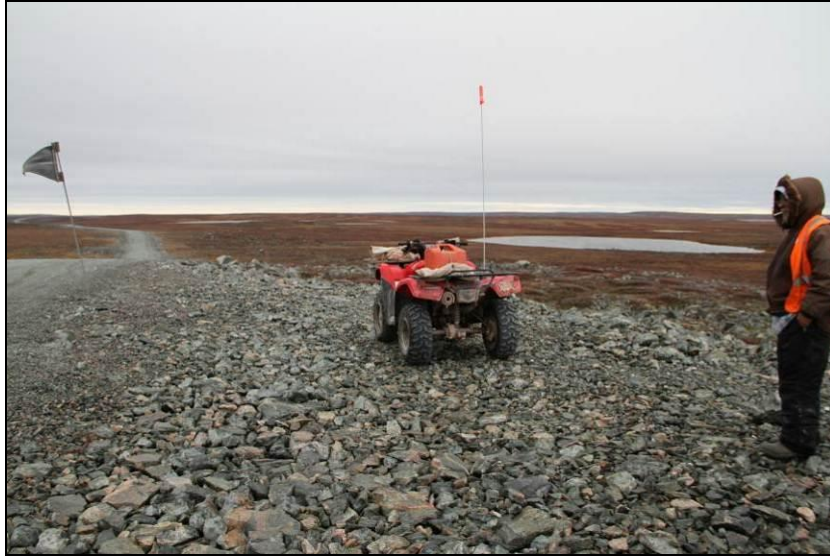
- b. During the bus ride from the hamlet of Baker Lake to the Meadowbank site on September 12, 2012, an all-terrain vehicle (ATV) travelling northbound was observed near kilometre 28, and another ATV was observed on the land near kilometre 76. When returning to the hamlet of Baker Lake from the Meadowbank site on September 13, 2012, one ATV travelling southbound was observed near kilometre 50. All public users of the access road had the required buggy whip installed on their ATV's and were observed to be wearing the safety vests loaned out by AEM (see Photo 2).

Photo 2: Public user of the access road using safety vest and buggy whip installed – near kilometre 50

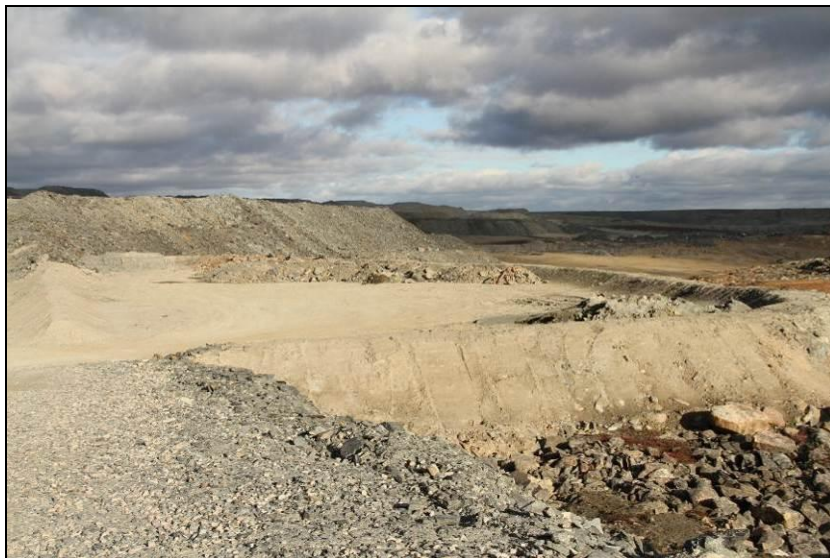
- c. Mr. Buck mentioned that while AEM may not develop a landfarm, it was considering the development of a contaminated soil storage/pilot remediation site. The plan as explained would be to use on-site nutrients to initiate bioremediation in the hydrocarbon contaminates soils. The current site being used to conduct the initial study for the contaminated soil storage/pilot remediation program is located on the south side of the stormwater dike, upstream of the future south cell of the tailings storage facility (TSF). This location was selected to allow capture of any contaminated water that might leach out of the contaminated soils into the TSF (see Photo 3).

Photo 3: Contaminated soil storage/pilot remediation site

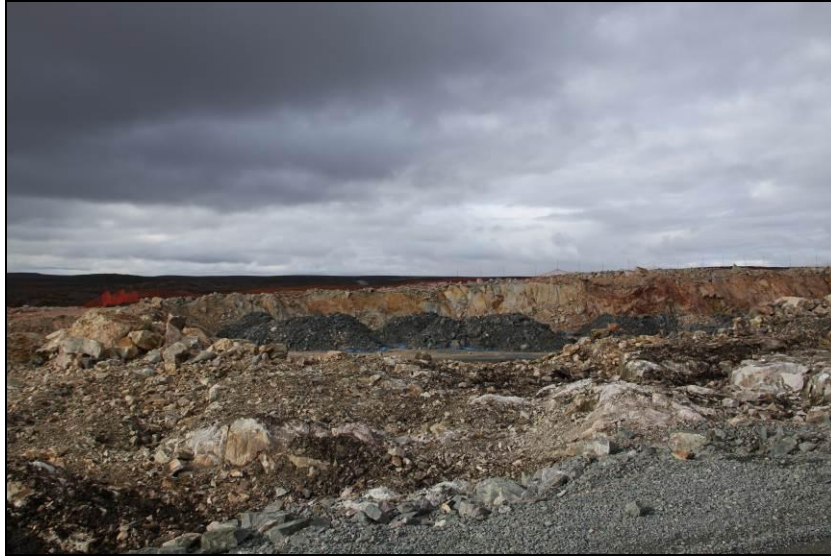
- d. The Monitoring Officer was informed that the contaminated soil previously stored in Quarry 5 had been moved to the contaminated soil storage/pilot remediation site. Photo 4 shows the conditions of Quarry 5 during the Monitoring Officer's 2011 site visit while Photo 5 shows the conditions of the Quarry 5 during the Monitoring Officer's 2012 site visit.
- e. Mr. Buck indicated during site visit discussions that all contaminated soil from Quarry 6 had been removed by September 2010 and that no further contaminated soil would be stored at this quarry site.

Photo 4: Quarry 5 in 2011 containing contaminated soil from fuel spill at kilometre 22 along the access road

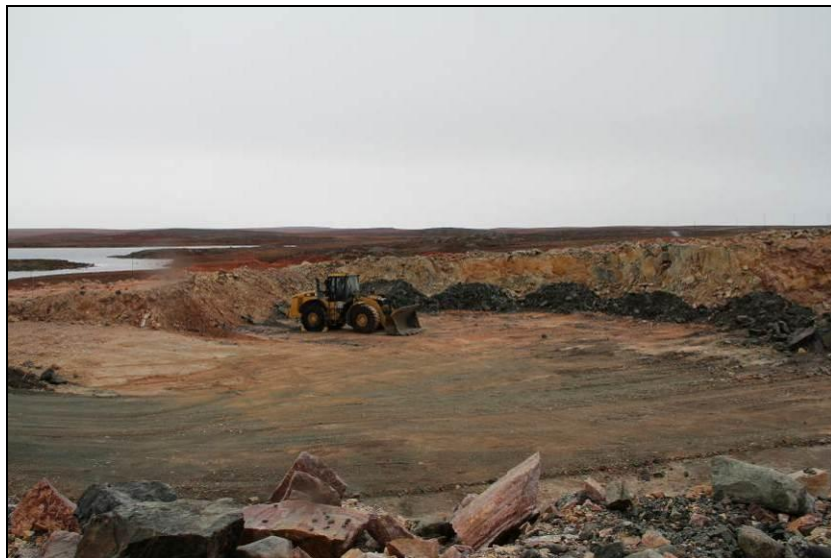
Photo 5: Quarry 5 in 2012

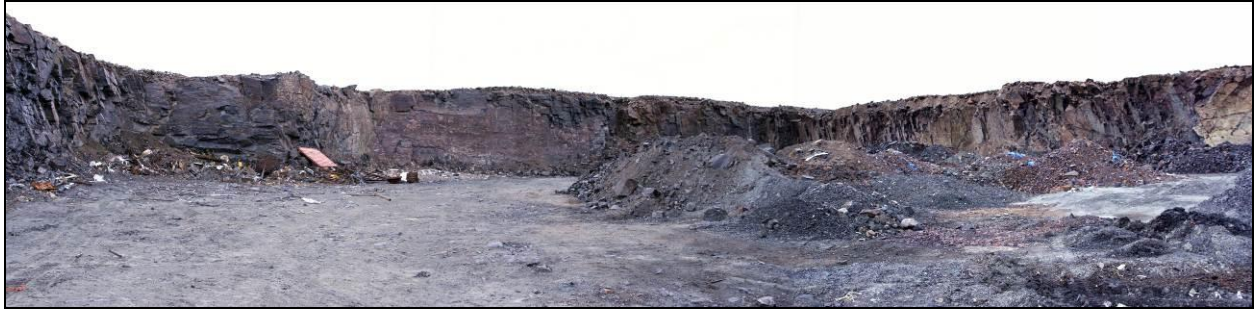
- f. Quarry 22 remains in service as a temporary land farm and storage area for contaminated soils. AEM indicated that it plans to remove the contaminated soil to the pilot remediation site in the near future. Currently, Quarry 22 is not being used to store other material as had been the case in the past (see Photo 6).

Photo 6: Quarry 22 serving as storage for contaminated soil

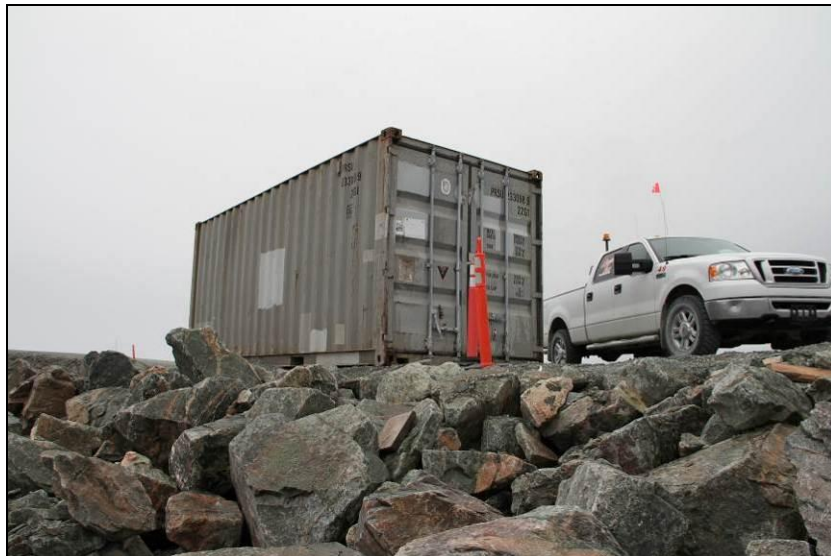
- g. The Monitoring Officer noted that the environmental emergency sea-cans containing booms, shovels, absorbent pads, and other miscellaneous spill response equipment were located at every bridge crossing. Further, two additional environmental emergency sea-cans, one containing spill response equipment and another containing a boat with motor were located at the Baker Lake laydown facility (see Photo 7 and Photo 8).

Photo 7: Environmental emergency sea-can near kilometre 22

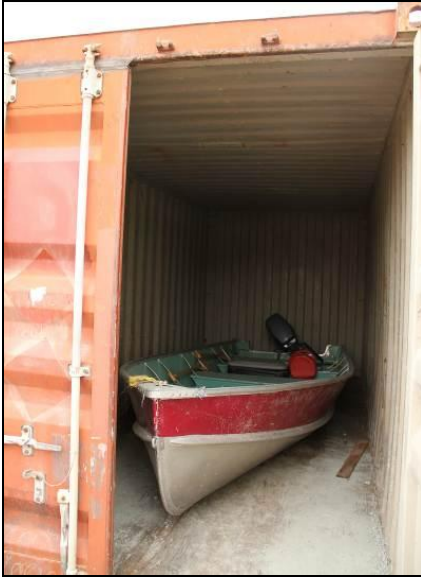
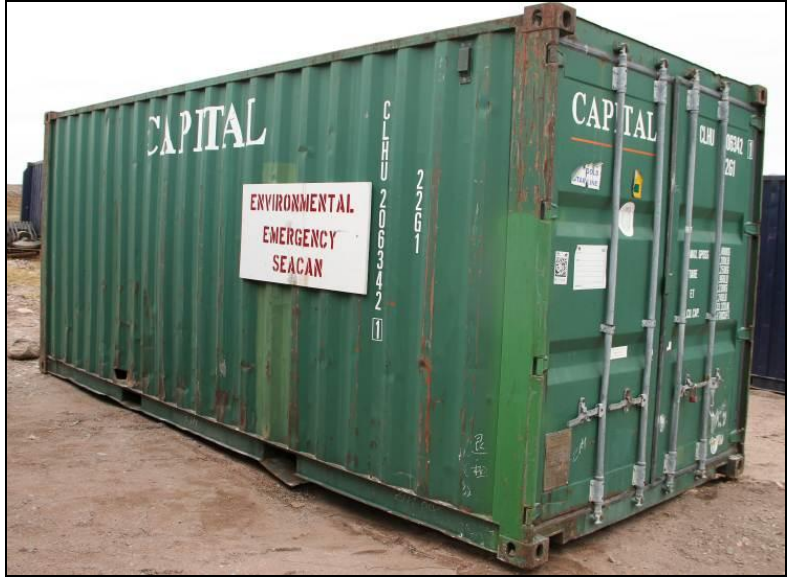
Photo 8: Environmental emergency sea-cans at the Baker Lake laydown facility

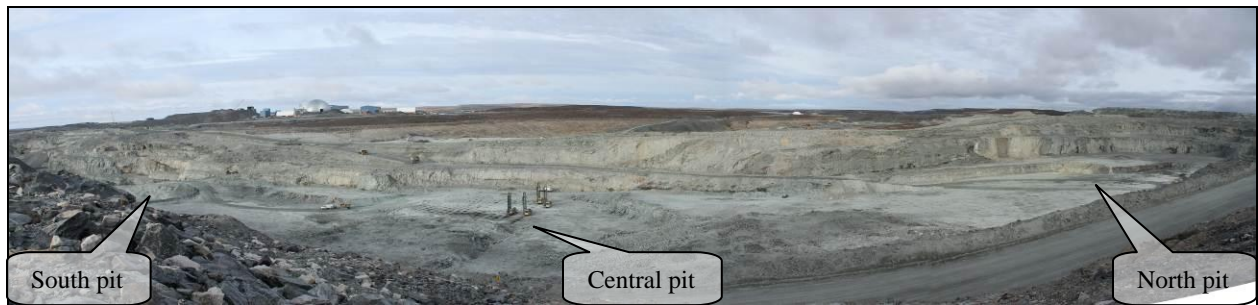
Photo 9: Portage Pit

- h. Active blasting and drilling were ongoing at the North, Central and South Portage pits, with daily geotechnical inspections being undertaken to ensure the safety of all employees and contractors working in the active mine area (see Photo 9).

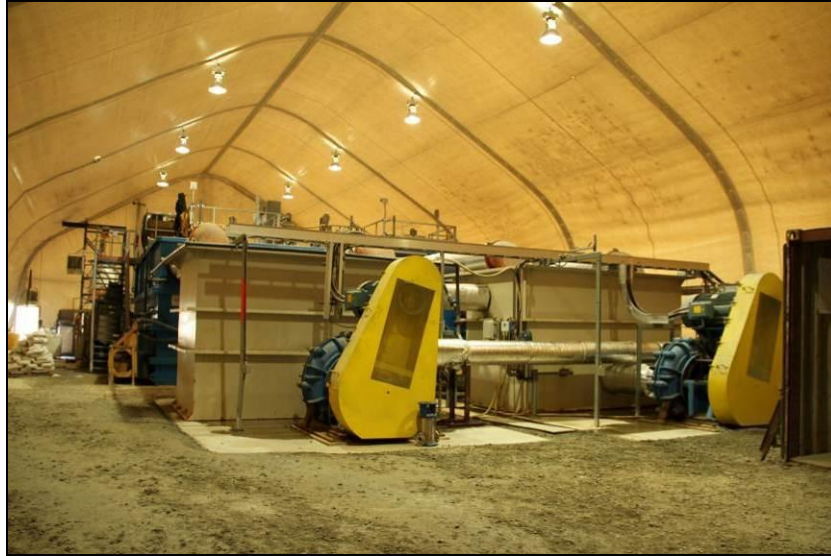
Photo 11: Water treatment facility

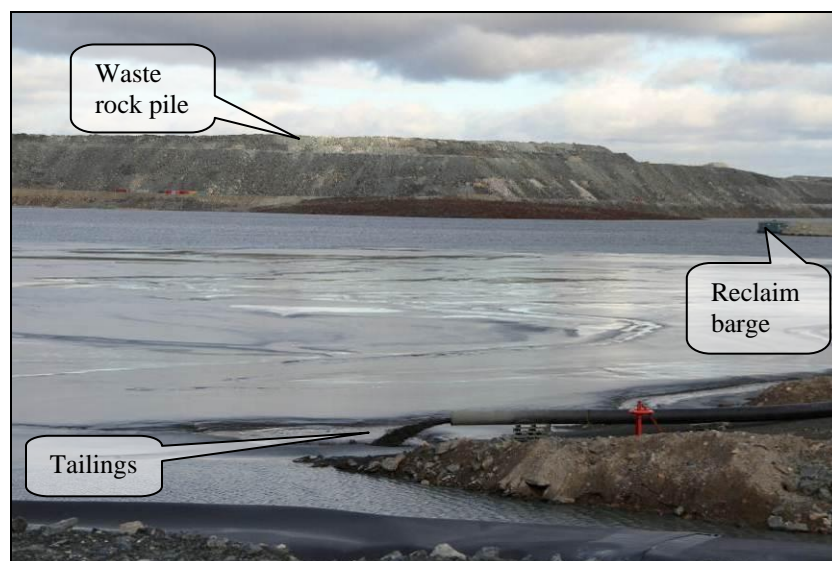
- j. By the end of 2011, approximately 4.07 million tonnes of tailings had been placed in the TSF (Photo 12) since the start of the project. A structure known as the ‘reclaim barge’ is used to re-circulate water from the TSF back to the mill for reuse within the processing cycle (Photo 12). It was noted during the 2012 site visit that the TSF did not contain as much water as was observed during the 2011 site visit. The diversion ditch north of the TSF had been completed in the fall of 2011, preventing water from entering the TSF during the freshet season, a situation that had occurred in 2011 prior to the completion of the diversion ditch. As mentioned in the 2011 Site Visit Report, AEM noted that tailings with a dryer consistency to the tailings deposited within the TSF provide something of a “beach” in the TSF which helps to protect the dikes and to prevent ice formation (see Photo 13). There did not appear to be any apparent rips to the liners that were exposed within Saddle Dam #1 and Saddle Dam #2 (Photo 13).

Photo 12: Tailings storage facility – north cell

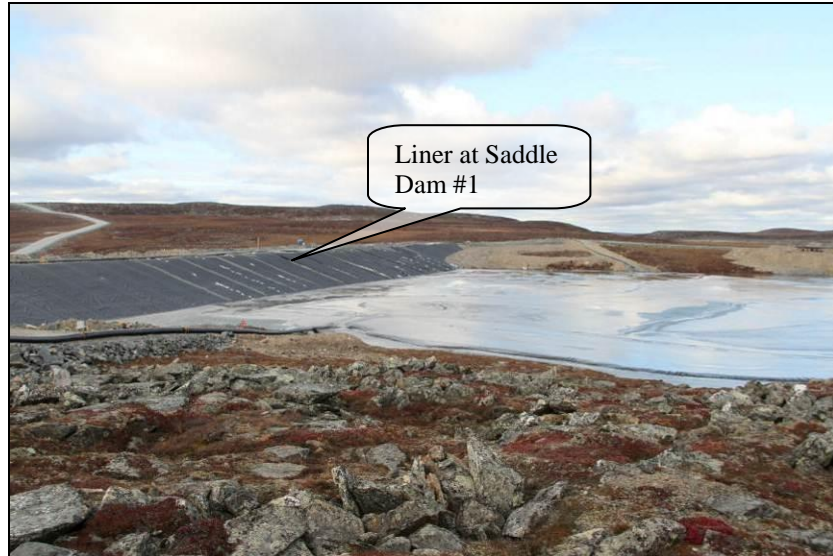
Photo 13: “Beach” tailings with Saddle Dam #1 in the background

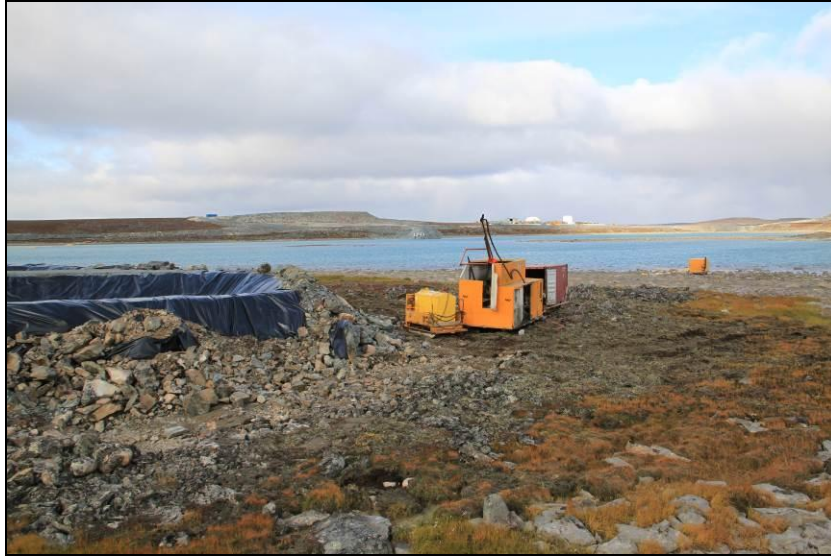
At the time of the site visit, only one groundwater monitoring well appeared to be operational. AEM noted that the last operational groundwater monitoring well of those installed in 2003 became damaged from frost action in 2010. Three of the four defective wells were replaced in 2006 but were again damaged by frost action. Two of the wells were again replaced in 2008 with a more robust design. In 2011, two monitoring wells were installed, one on Goose Island to replace one of the 2003 wells and one at the tailings storage facility to replace one of the 2007 wells. Only one of the wells replaced in 2008 was sampled in 2011 as the second well showed blockage and no samples could be taken. Mr. Buck indicated that during the 2012 sampling program, one well was damaged during movement of equipment on Goose Island and another was damaged during sampling, leaving only one functional well. AEM indicated that it plans to re-evaluate the groundwater monitoring program to determine how best to improve the effectiveness of the wells and the collection of groundwater samples. Photo 16 provides an example of development of a groundwater well near the Bay-Goose basin.

Photo 16: Drilling of groundwater well, near Bay-Goose basin (photo taken September 2011)

Regarding Condition 8, only one groundwater well appeared to have been operational during the 2012 site visit. The Monitoring Officer acknowledges that further re-evaluation of the groundwater well monitoring program is to be conducted by AEM.

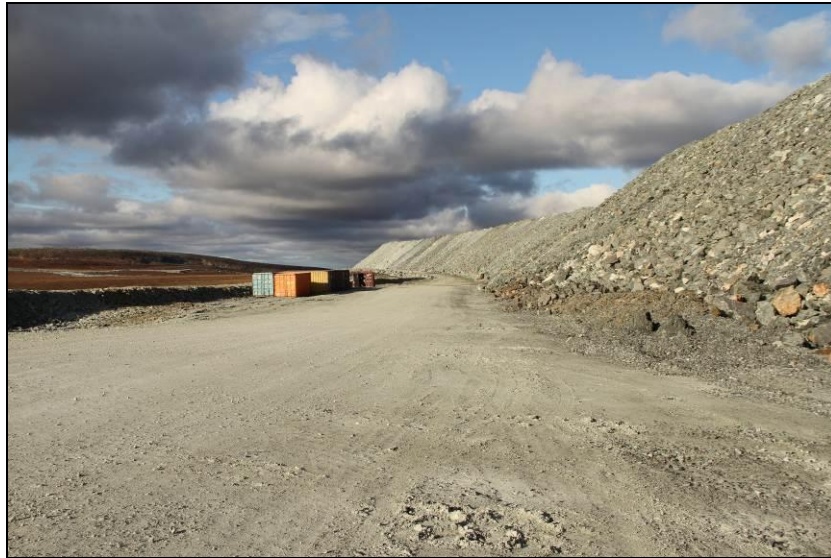
Mr. Buck indicated that AEM sampled every fourth blast hole and conducted an on-site analysis of the percentages of sulphur and carbon present in these samples. These results would then be used to differentiate between non-potentially acid generating (NPAG) and potentially acid generating (PAG) materials and to differentiate both of these from ore material. This information would then be used by mine surveyors and geologists to delineate the dig limits within the blasted rock and to guide the shovel and loader operators in directing where the rock is to be taken from. Most of the NPAG material has been used to construct the dikes, dams, roads, and pads at site, while the PAG rock is used at the TSF, stormwater dike, and rockfill road. Any remaining PAG rock material is sent to the Portage waste rock facility (Photo 17).

Photo 17: Waste Rock Facility

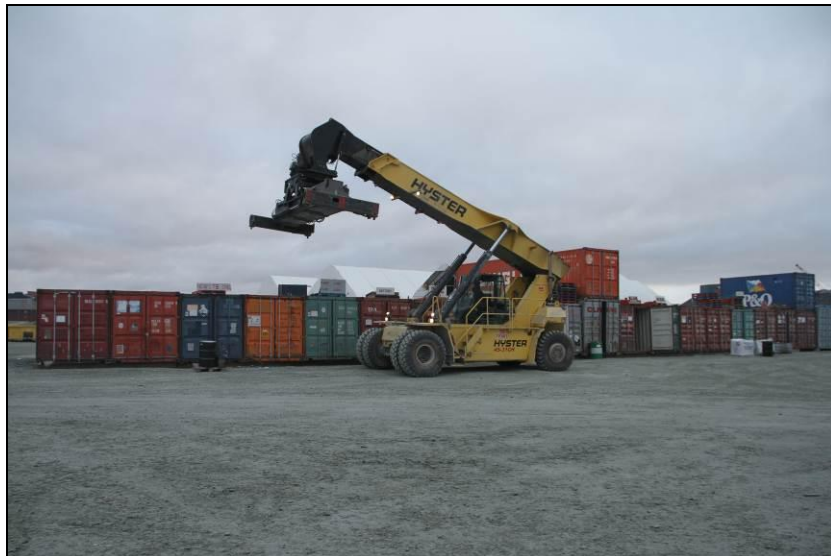
During the 2012 site visit, it was noted that AEM is segregating and storing all domestic, hazardous, and combustible wastes in marked sea-cans prior to these materials being incinerated or shipped to appropriate and approved off-site disposal facilities (Photo 18). Sea-cans filled

Photo 18: Sea-cans used for waste segregation and storage area

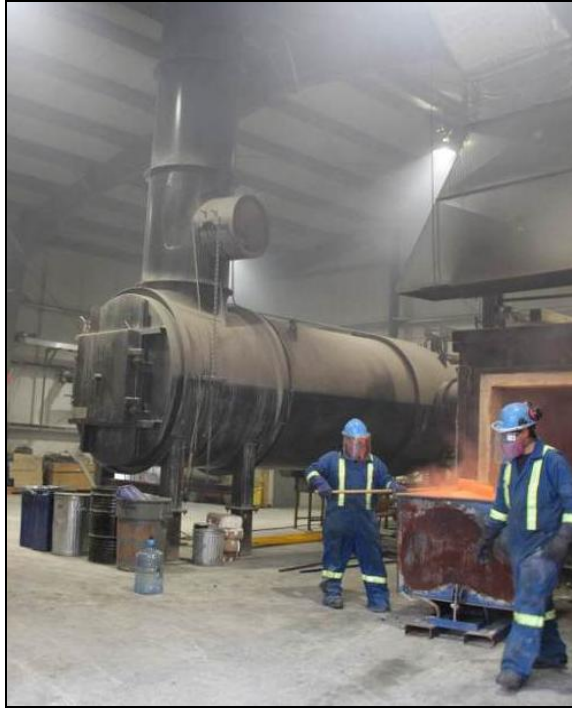
The Meadowbank site dual chamber forced air incinerator remains in service for the combustion of all non-hazardous, combustible materials at the site (Photo 19). Approximately 1.7 tonnes of domestic garbage is incinerated per day; however, Mr. Buck indicated that there are plans in place to improve waste management by reducing the amount of domestic garbage produced at site. Some examples provided include replacing paper coffee cups with plastic coffee cups, using plastic lunch boxes and trays instead of paper bags, recycling wood products by finding a second use for it at site or taking it to Baker Lake where it could be used by community members. It was also noted during the site visit that open burning was being conducted of some of the non-hazardous wastes on site (Photo 20).

Photo 19: Dual chamber forced air incinerator at the Meadowbank site

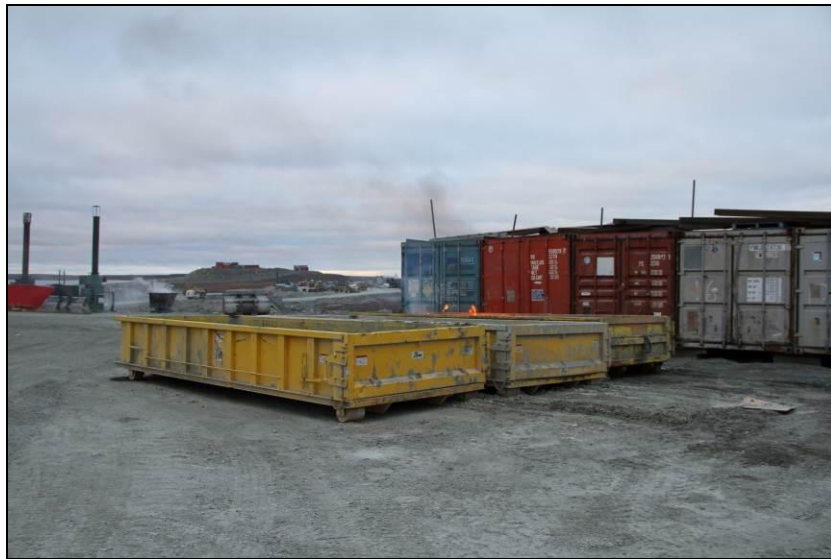
Photo 20: Open burning of non-hazardous wastes

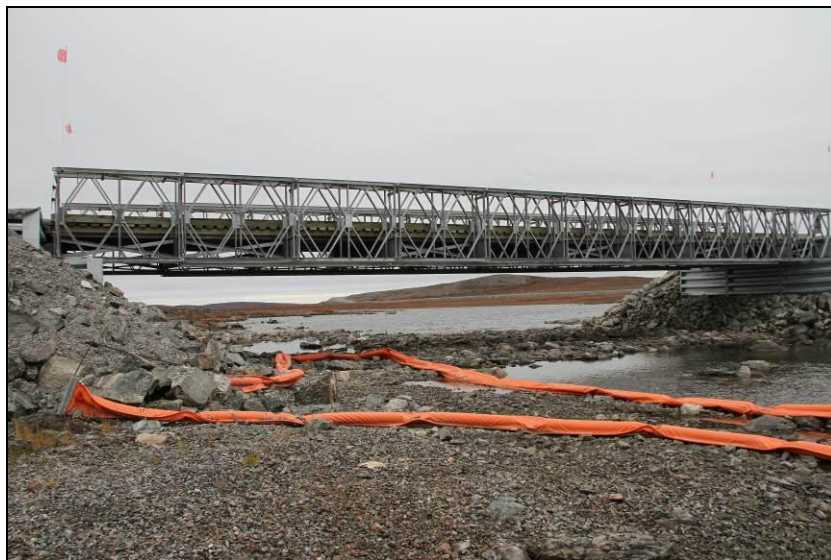
Mr. Buck indicated that cleanup of the spill that occurred near kilometre 22 of the access road in October 2010 was still ongoing in the summer of 2012 (Photo 21). The booms deployed in the watercourse nearby continue to be monitored weekly in the summer of 2012 to confirm that contaminated water have not entered the waterbody downstream of the booms. In addition, Mr. Buck indicated that approximately 550 litres of water was treated in the summer of 2012 and the site will continue to be monitored for the next 2 years to ensure that any contaminated water is cleaned up.

Photo 21: Bridge near kilometre 22

Condition 26 requires that spills be cleaned up immediately and that the site be kept clean of debris. The Monitoring Officer was informed during the 2012 site visit that the spill at kilometre 22 was still undergoing treatment for hydrocarbons. AEM indicated that ongoing monitoring of this site would continue for an additional 2 years to ensure that no contaminated materials remain at the site. Furthermore, some instances of wind-blown debris scattered around the site were noted, possibly requiring management of waste piles or the development of additional on-site waste management practices.

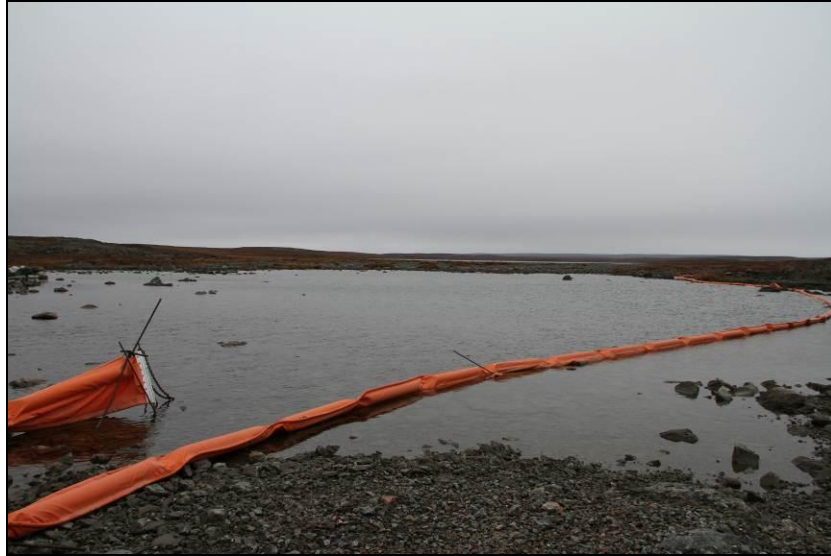
The Monitoring Officer noted no fuel contamination, staining of the water or hydrocarbon odours at the spill site (see Photo 22).

Photo 22: Booms and screens in place at bridge near kilometre 22

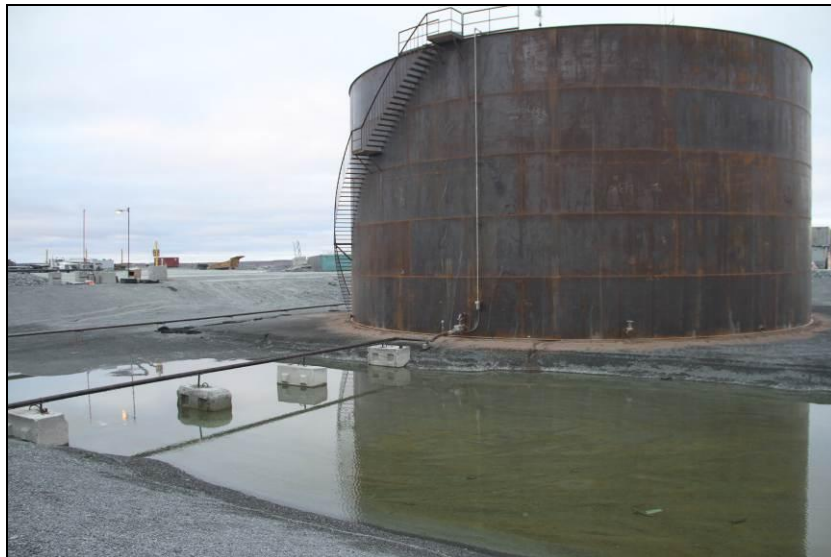
During the 2012 site visit, the Monitoring Officer observed that all of AEM’s fuel and hazardous materials associated with the Meadowbank project appeared to be stored in a safe and environmentally protective manner (i.e. secondary containment at fuel storage areas and secure containment of hazardous materials; see Photo 23 and Photo 24).

Photo 23: Meadowbank on-site fuel tank farm

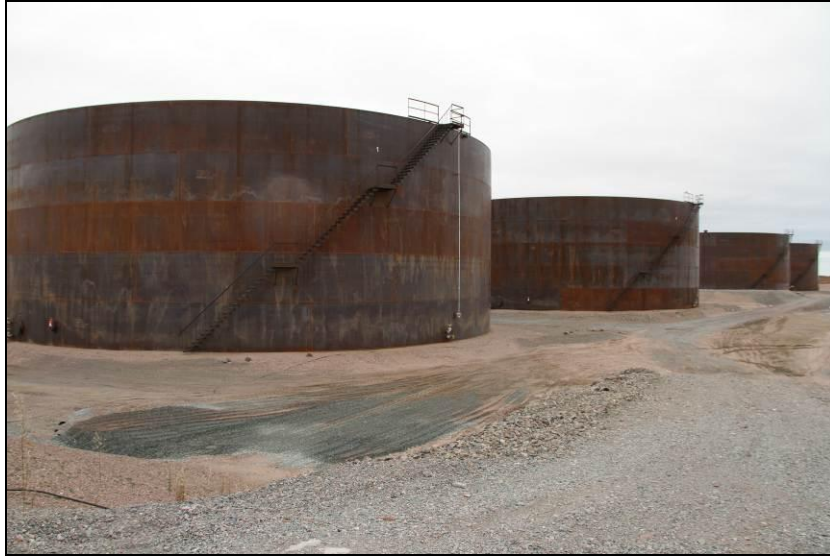
Photo 24: Baker Lake bulk fuel storage facility

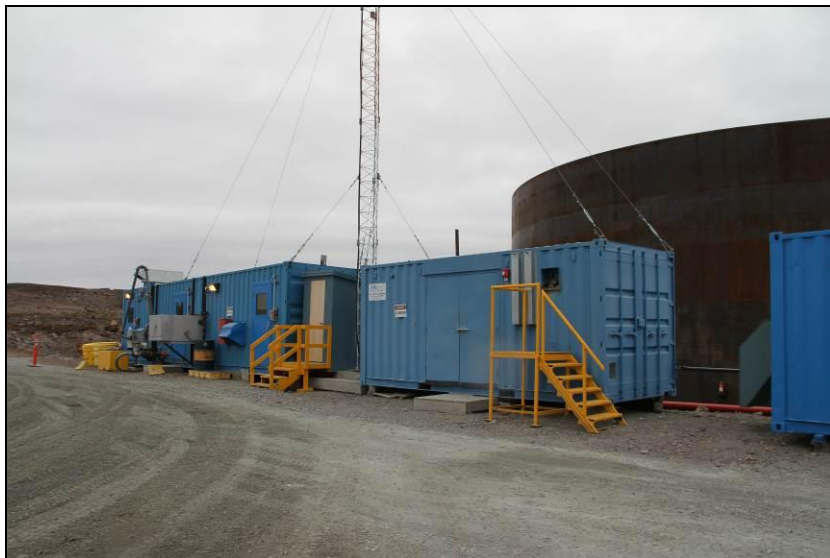
The fuel transfer station on site and at the Baker Lake bulk fuel storage facility appeared to be well contained and properly set up for the re-fuelling of vehicles (Photo 25). No hydrocarbon odours were noted at either the Meadowbank fuel tank farm or the Baker Lake bulk fuel storage facility. No sheen was observed on the water within the Meadowbank fuel tank farm or the Baker Lake bulk fuel storage facility; however, some fuel staining was observed at the Meadowbank fuel tank farm (Photo 26).

Photo 25: Baker Lake fuel transfer station

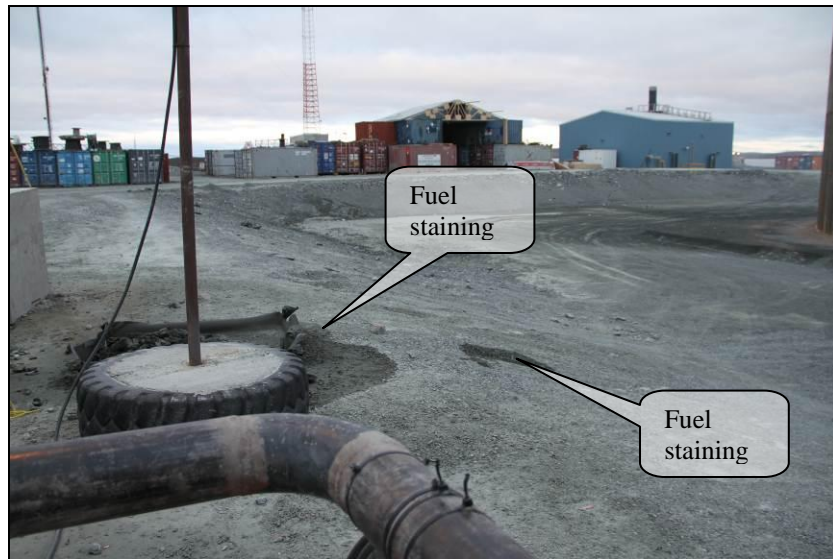
Photo 26: Staining observed at the Meadowbank on-site fuel tank farm

Condition 27 requires that the Proponent use safe, environmentally protective methods for areas used to store fuel or hazardous materials. The Monitoring Officer noted that some staining was observed at the edge of the berm of the fuel tank farm containment facility.

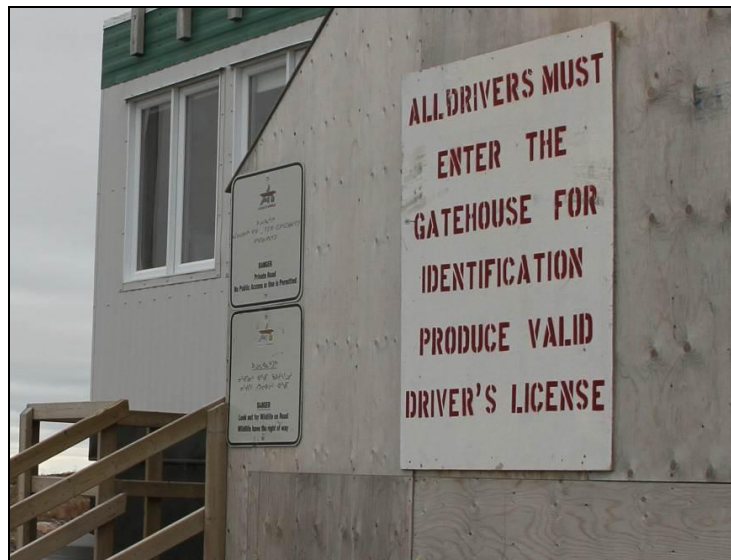
As per Condition 32(b), AEM submitted a copy of its updated Transportation Management Plan to the NIRB on May 13, 2010. One of the features of the access road as described within the plan is the placement of refuge stations every 10 kilometres. The Monitoring Officer noted that these refuge stations (emergency sea-cans) were not located on the road and was informed by Mr. Buck that the sea-cans were removed because items within the stations were being stolen and that the refuge stations were not serving the original and intended purpose. The signs as required per Condition 32(c) were posted in both English and Inuktitut at the gatehouse (Photo 28) and at each major bridge crossing (on the side of the environmental emergency sea-cans).

However the signs were not located at 10 kilometre intervals along the road as these signs had been originally placed on the sides of the emergency sea-cans along the road. AEM indicated that the signs would be replaced as soon as possible.

Photo 28: Signs posted at gatehouse at kilometre 5

AEM appeared to be following the requirements of amended Condition 32 as were able to be observed at the site, with the exception of not having the English and Inuktitut signs placed at every 10 km intervals along the access road as required by item (c).

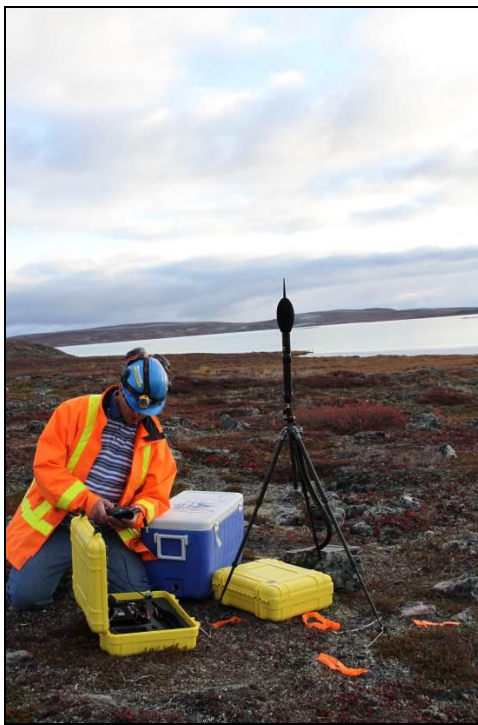
Five locations were monitored for noise during the 2011 and 2012 summer periods. Mine activities such as helicopter and other air traffic, the use of construction and operation heavy equipment and blasting were found to be the dominant mine noise sources (Photo 29).

Photo 29: Noise monitoring station #5

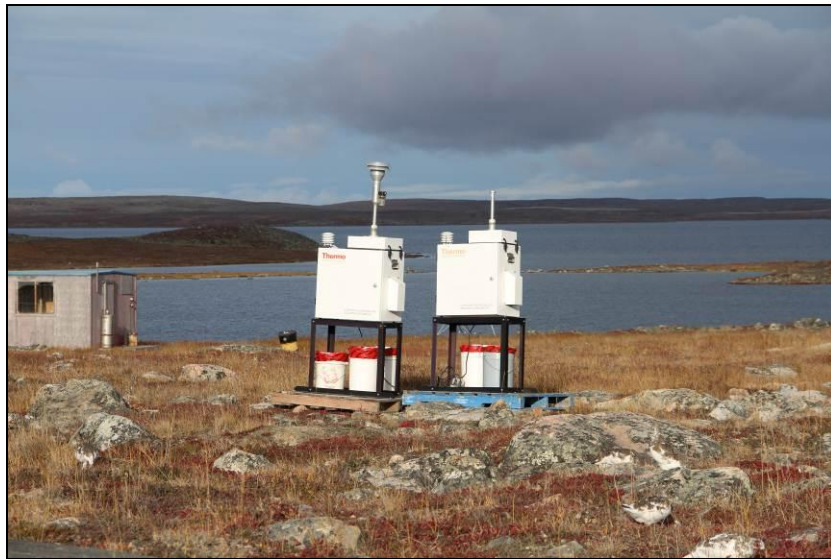
The air monitoring stations were installed by the end of October 2011 and monitoring started in November 2011 (see Photo 30). Partisol sampling station required heated shelter and electricity, they are planned to be installed in 2012.

Photo 30: Air monitoring stations

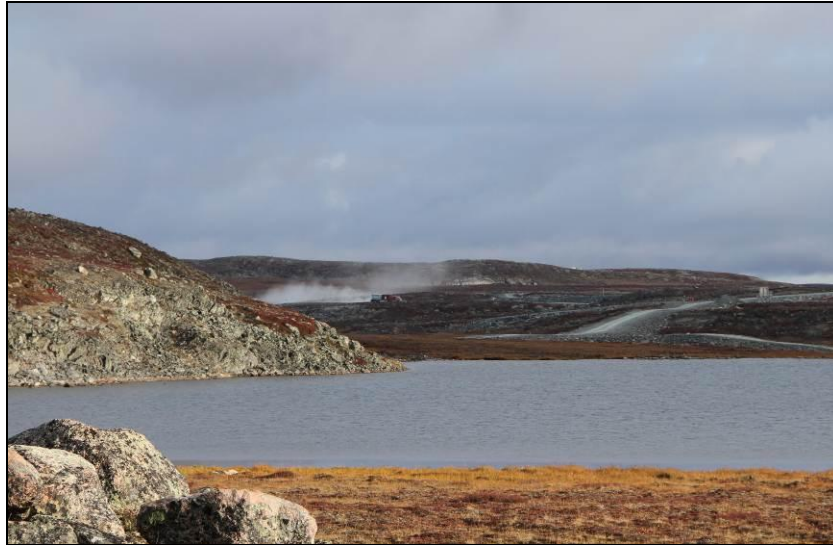
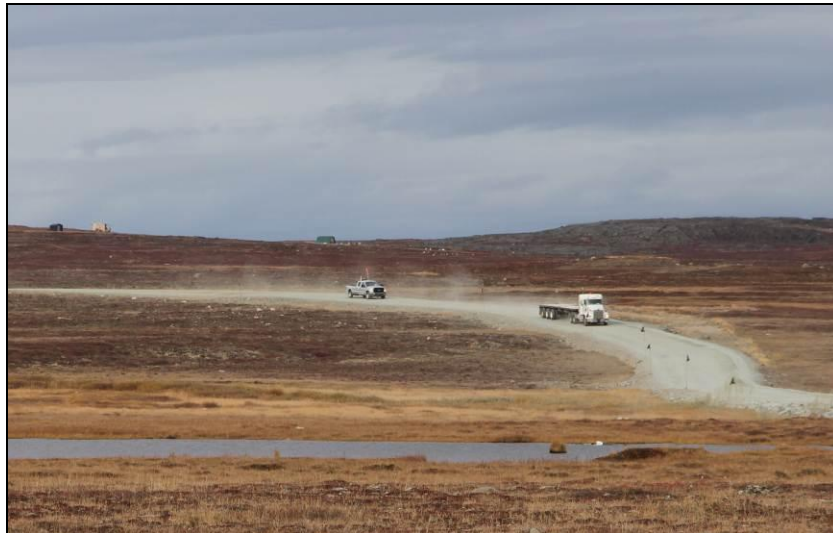
Calcium chloride and water are administered on the roads to suppress dust around the Meadowbank site and from the Baker Lake dock facility to the gatehouse. AEM is currently testing the use of a vegetable oil derivative on the airstrip as a dust control suppressant and plans to evaluate the feasibility of using it as an alternative or in addition to calcium chloride. The Monitoring Officer noted that no dust suppression was employed along the access road (Photo 31(a) and (b)).

Photo 31(a): Vehicles on Meadowbank All-Weather Private Access Road

The Proponent did not appear to have fully met the requirements of Condition 74, as dust suppression techniques, while applied at the Meadowbank site, had not been applied to the access road. However, AEM indicated that plans are in place to conduct future dust monitoring studies along the access road to determine the best options to deal with the dust created on the access road.

Mr. Buck indicated that AEM plans to conduct dust monitoring along the access road in order to determine if there have been any impacts to vegetation from the dust. AEM indicated that currently, the use of dust suppressants is not planned along the access road.

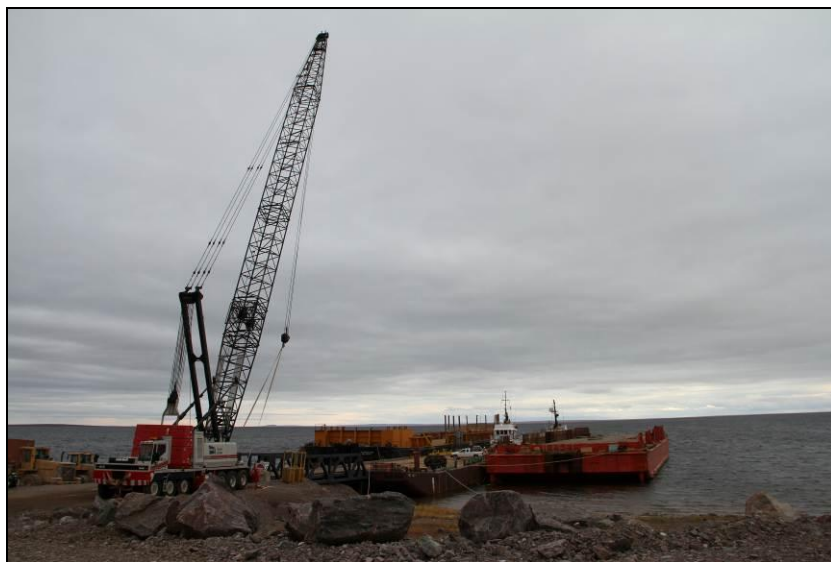
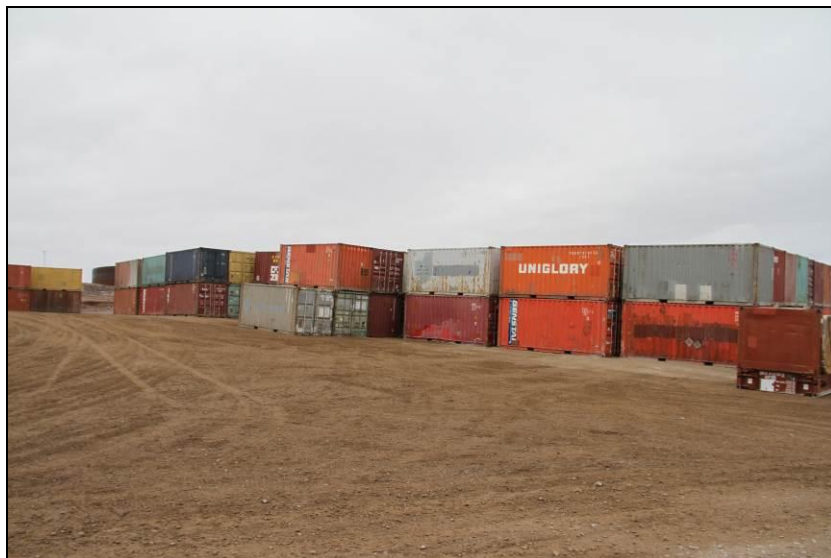
Further, the Monitoring Officer did note that these areas were kept impressively clean with sea-cans well organized during the 2012 site visit (see Photo 32 and Photo 33).
